PROPERTY INSPECTION OR ASSESSMENT OF DAMAGES

ADDRESS: 000 SW 00 AVE DAVIE, FL
CLIENT: YOUR NAME HERE
ID No: 123
DATE: 01-01-XXXX

PROPERTY INSPECTION – 000 SW 00 AVE DAVIE, FL
ATTACHMENT - PHOTOGRAPHS
DATE: 01-01-XXXX

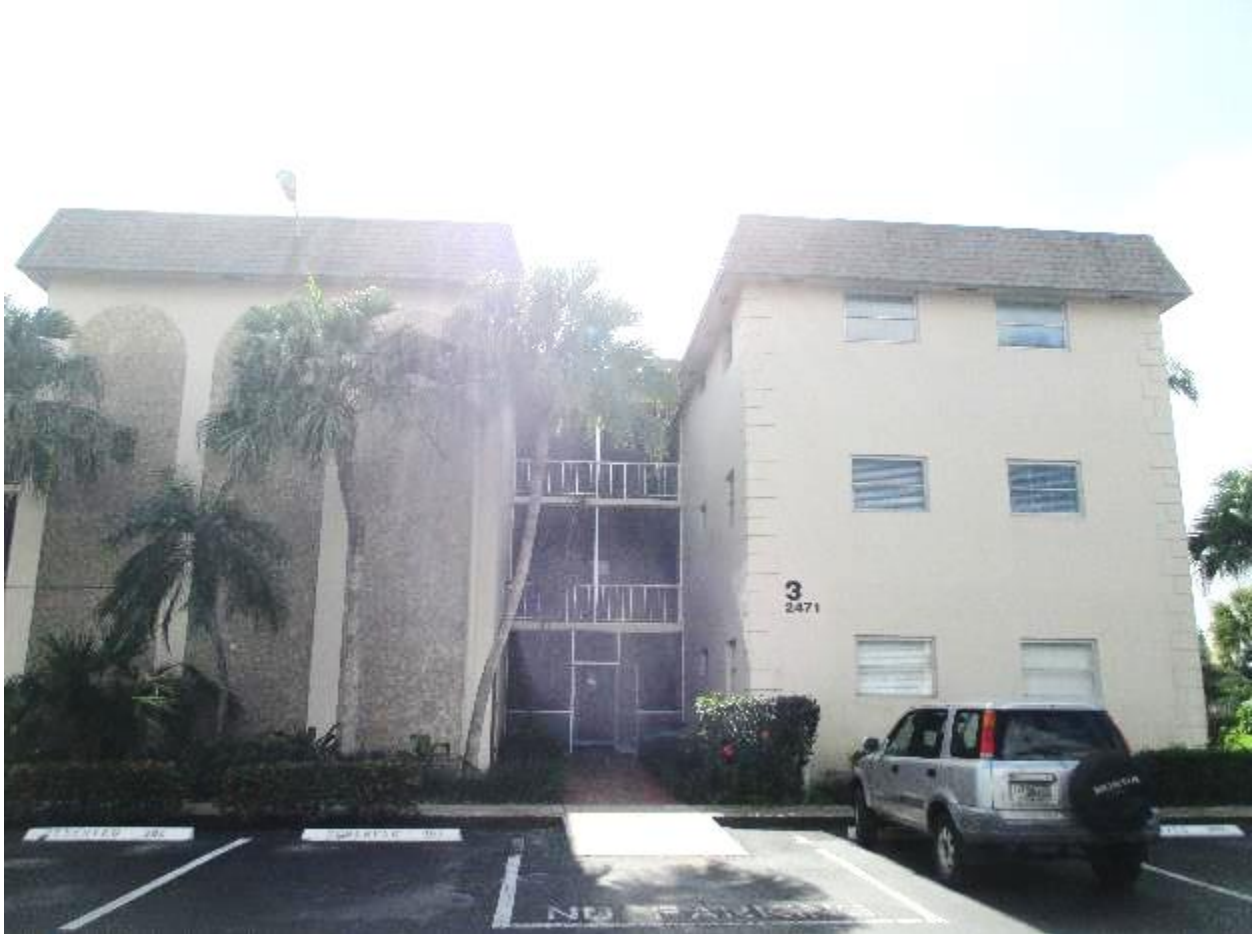
Exterior view.

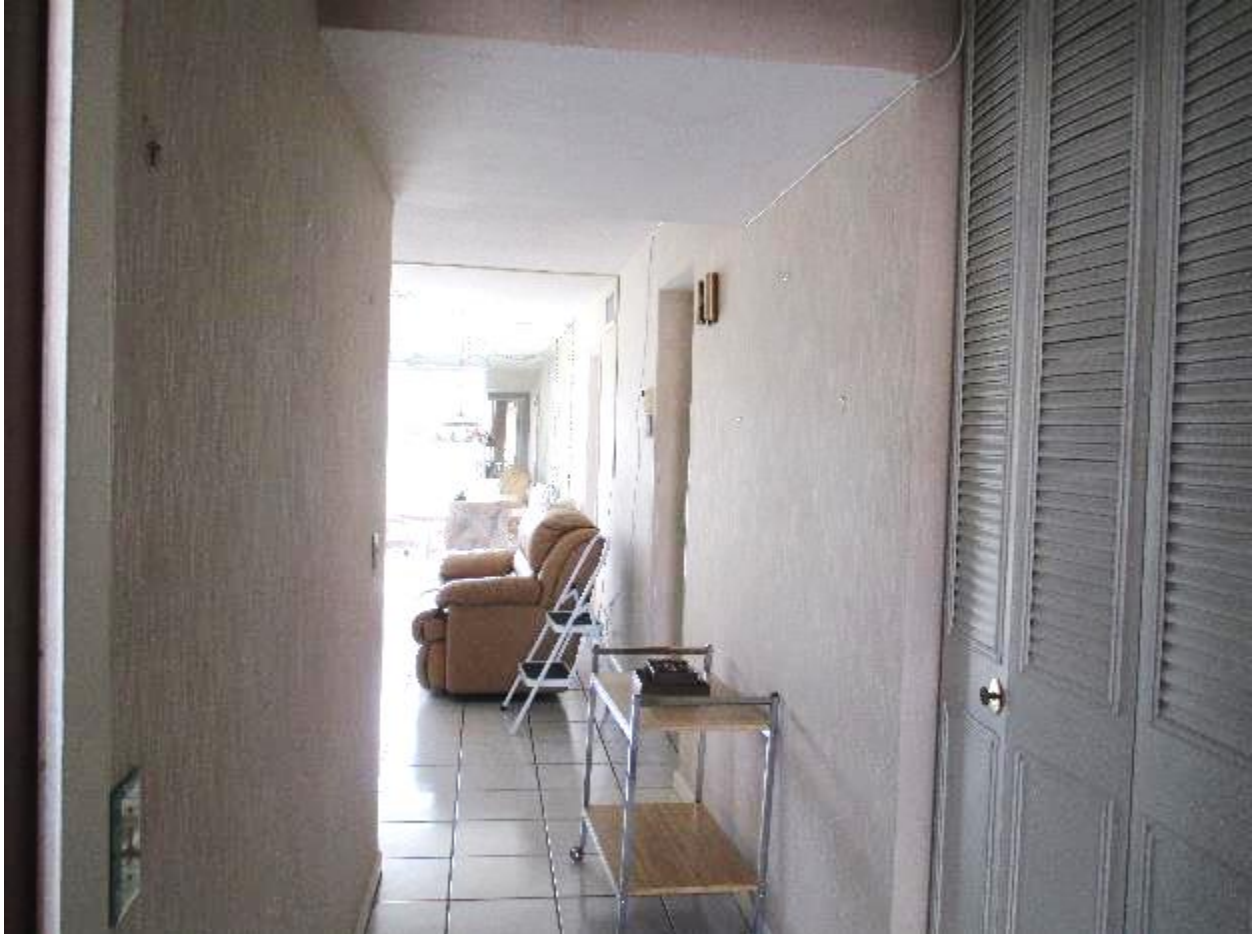
Wall paper removal required. Refinish of walls and preparation for paint job is needed.

Interior rehabilitation must include and no limited to:

Interior prime and paint.

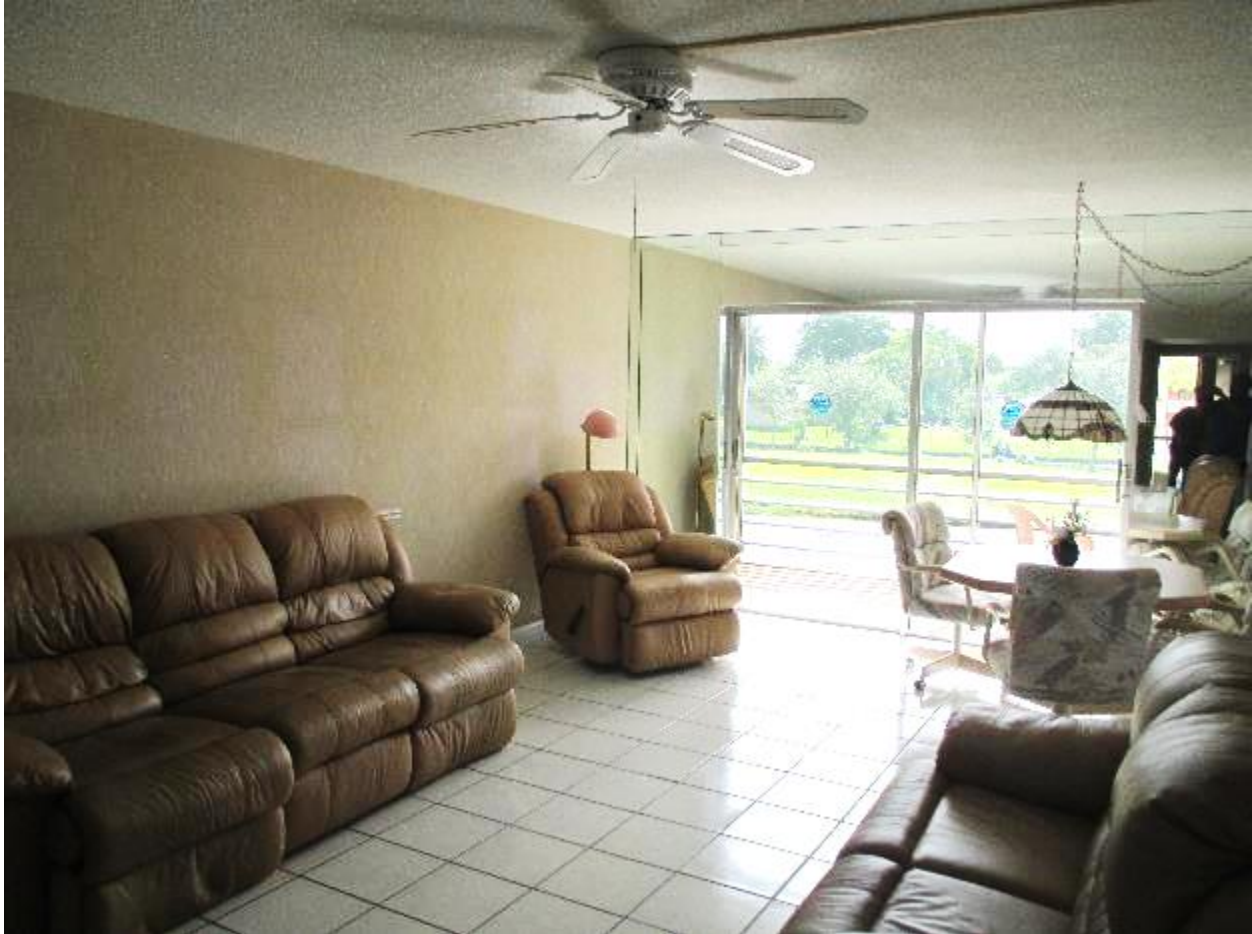
Wall paper removal required. Refinish of walls and preparation for paint job is needed.

Interior rehabilitation must include and no limited to:

Interior prime and paint.

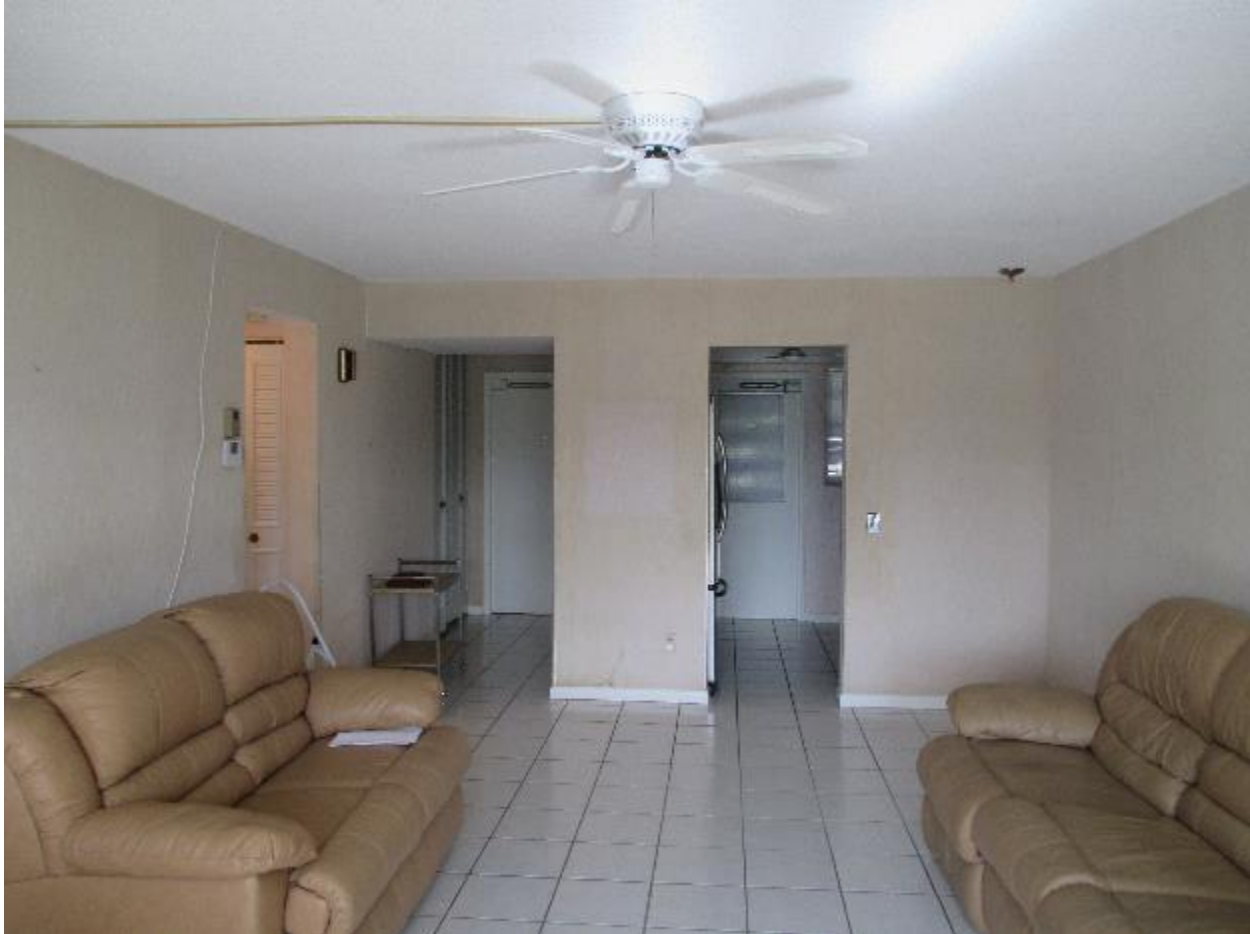
Wall paper removal required. Refinish of walls and preparation for paint job is needed.

Interior rehabilitation must include and no limited to:

Interior prime and paint.

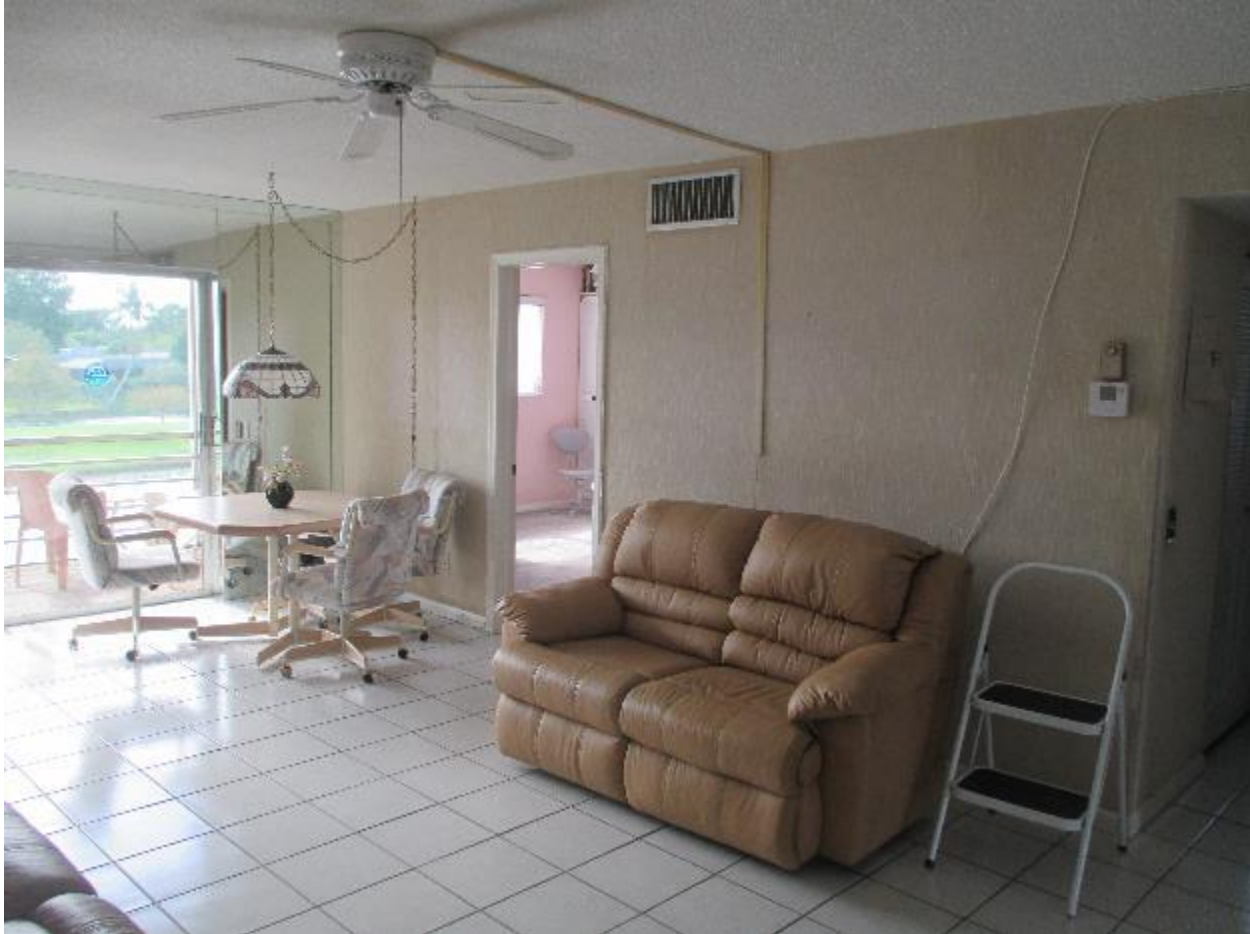
Wall paper removal required. Refinish of walls and preparation for paint job is needed.

Interior rehabilitation must include and no limited to:

Interior prime and paint.

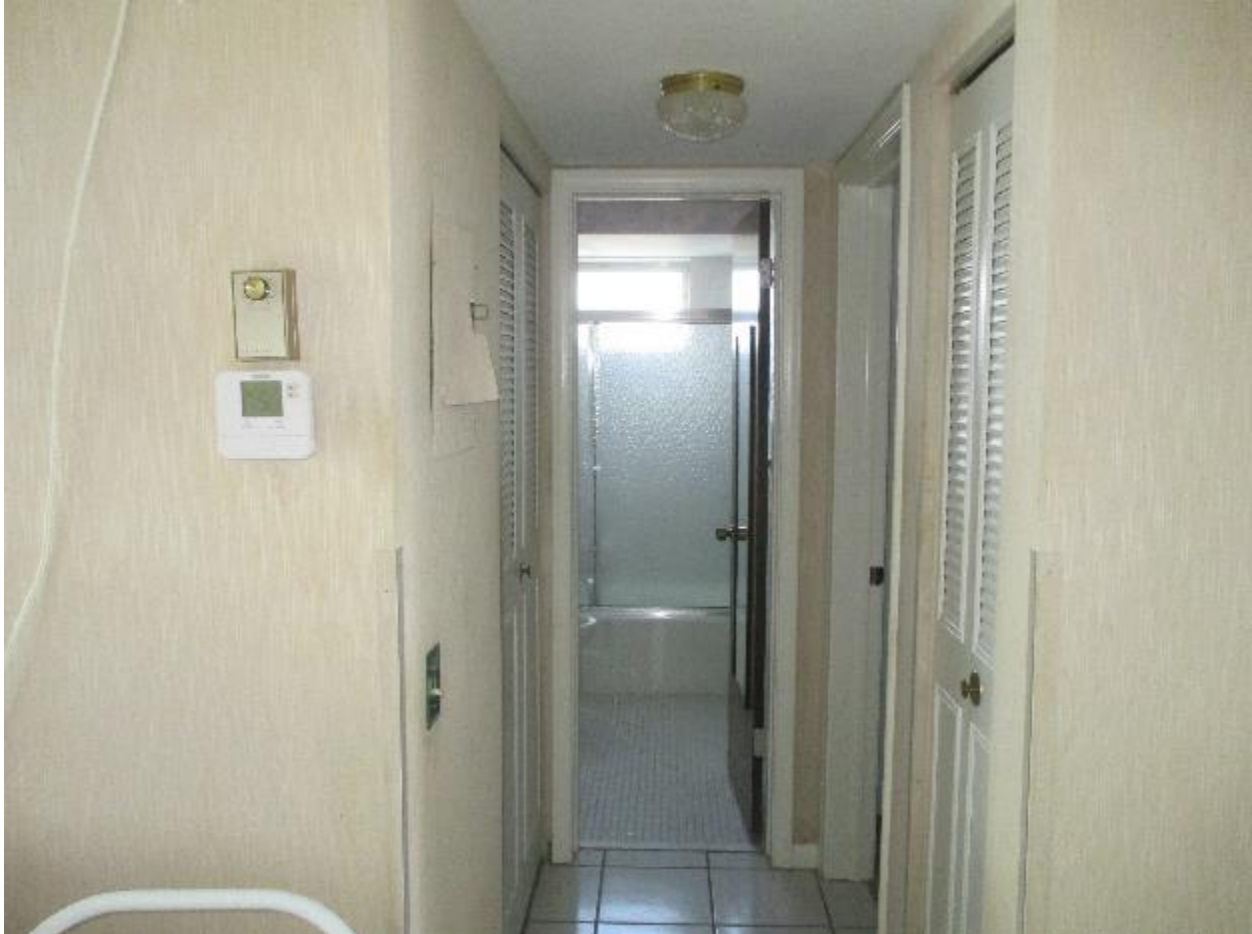
Wall paper removal required. Refinish of walls and preparation for paint job is needed.

Interior rehabilitation must include and no limited to:

Interior prime and paint.

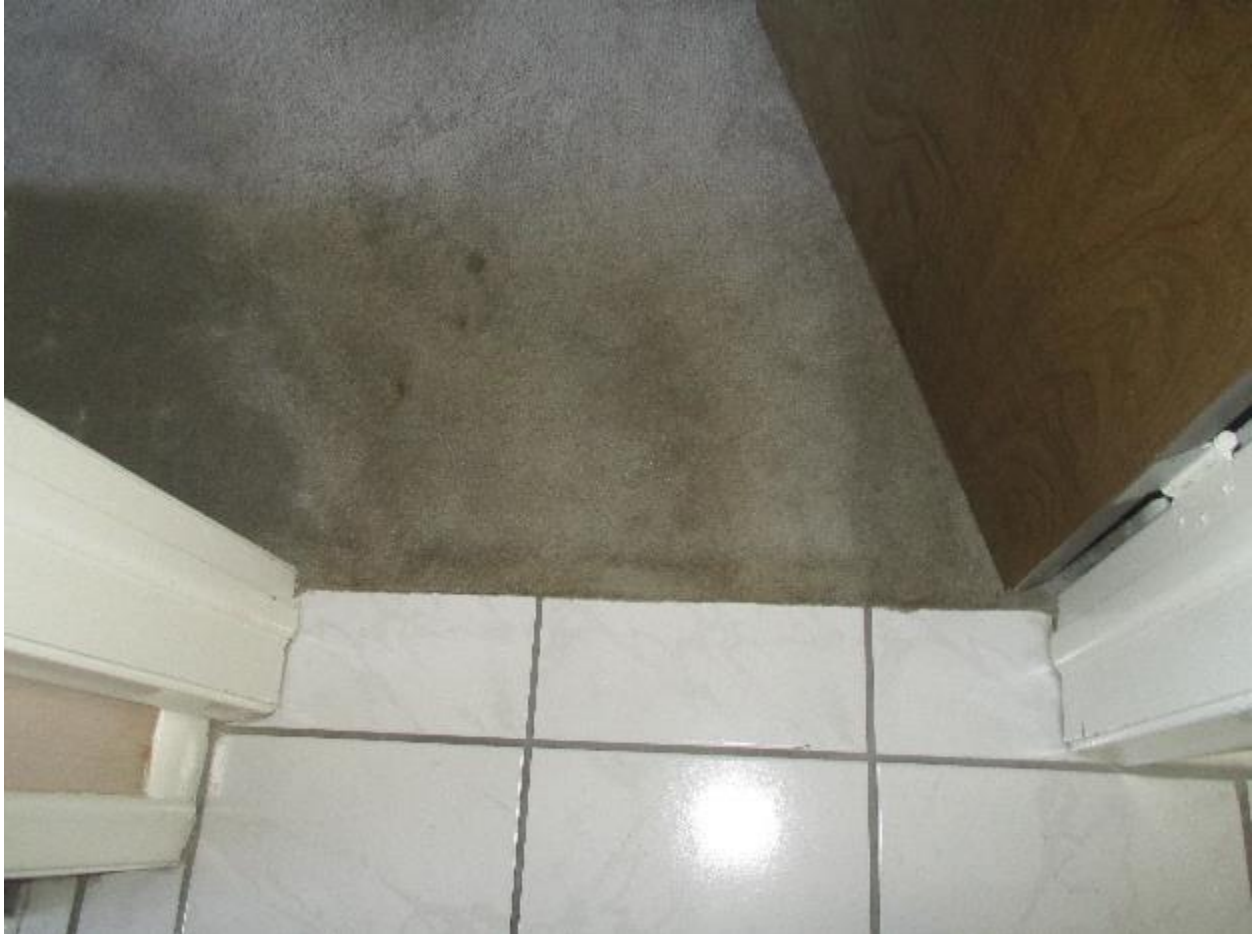
Carpet replacement required.

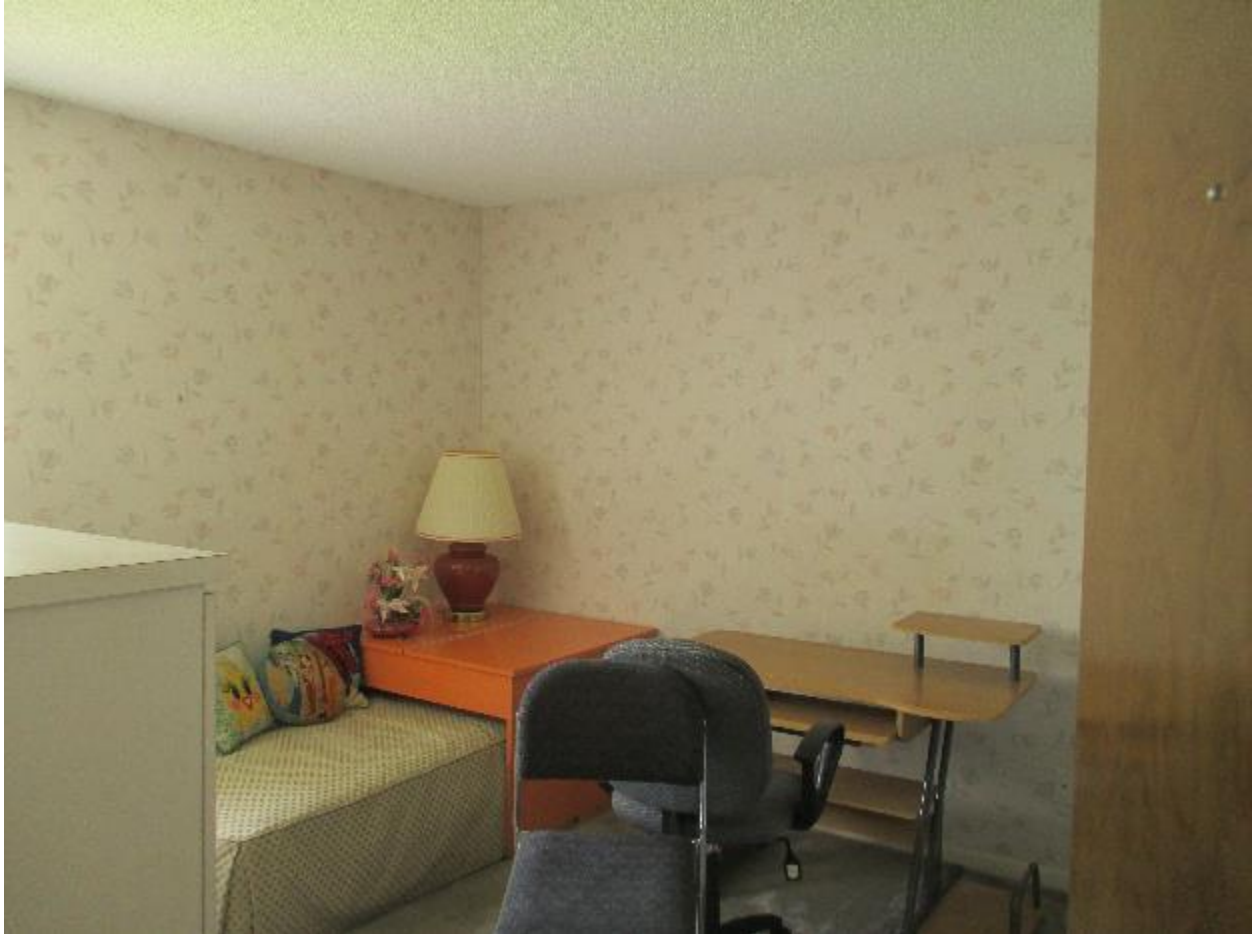
Wall paper removal required. Refinish of walls and preparation for paint job is needed.

Interior rehabilitation must include and no limited to:

Interior prime and paint.

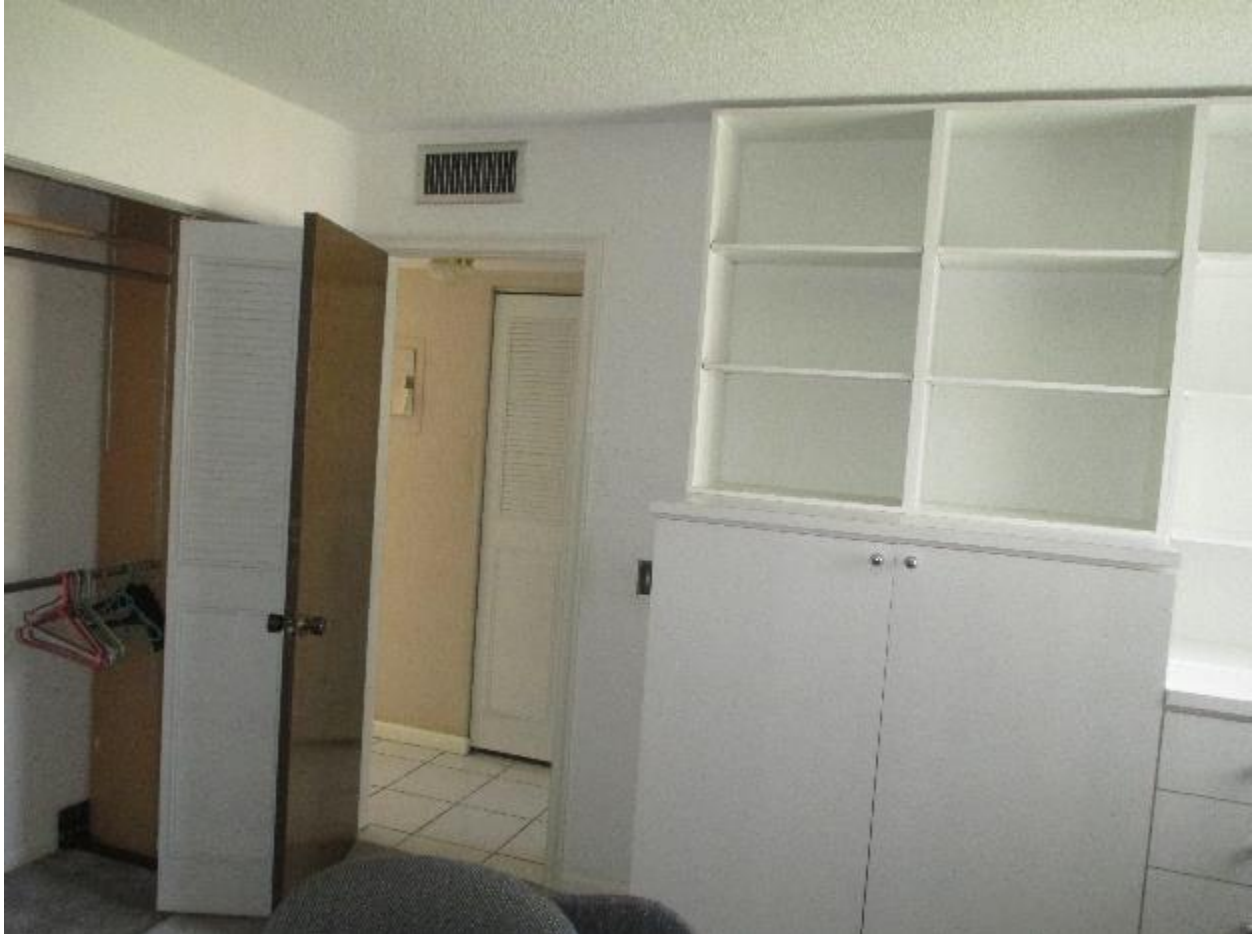
Wall paper removal required. Refinish of walls and preparation for paint job is needed.

Interior rehabilitation must include and no limited to:

Interior prime and paint.

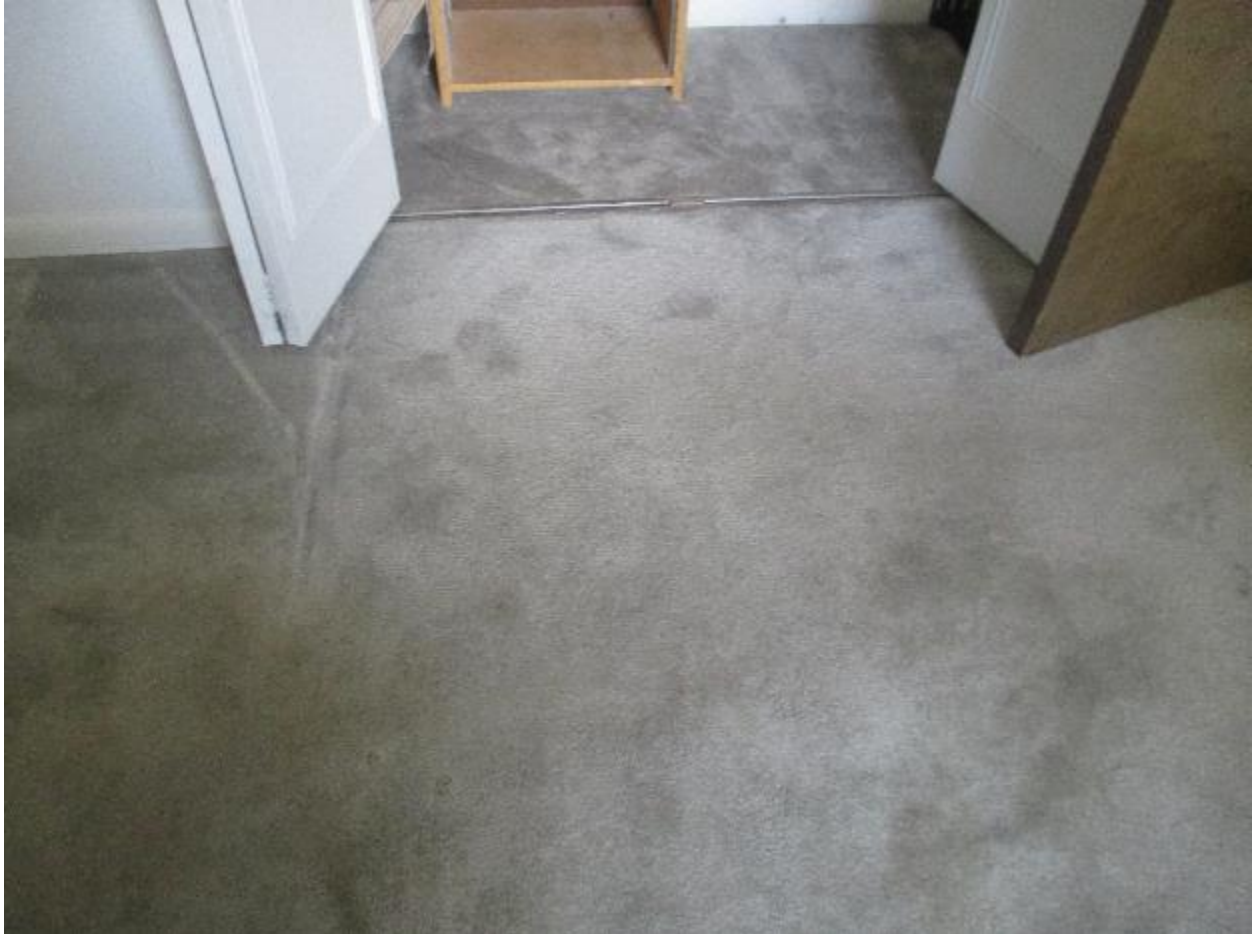
Carpet replacement required.

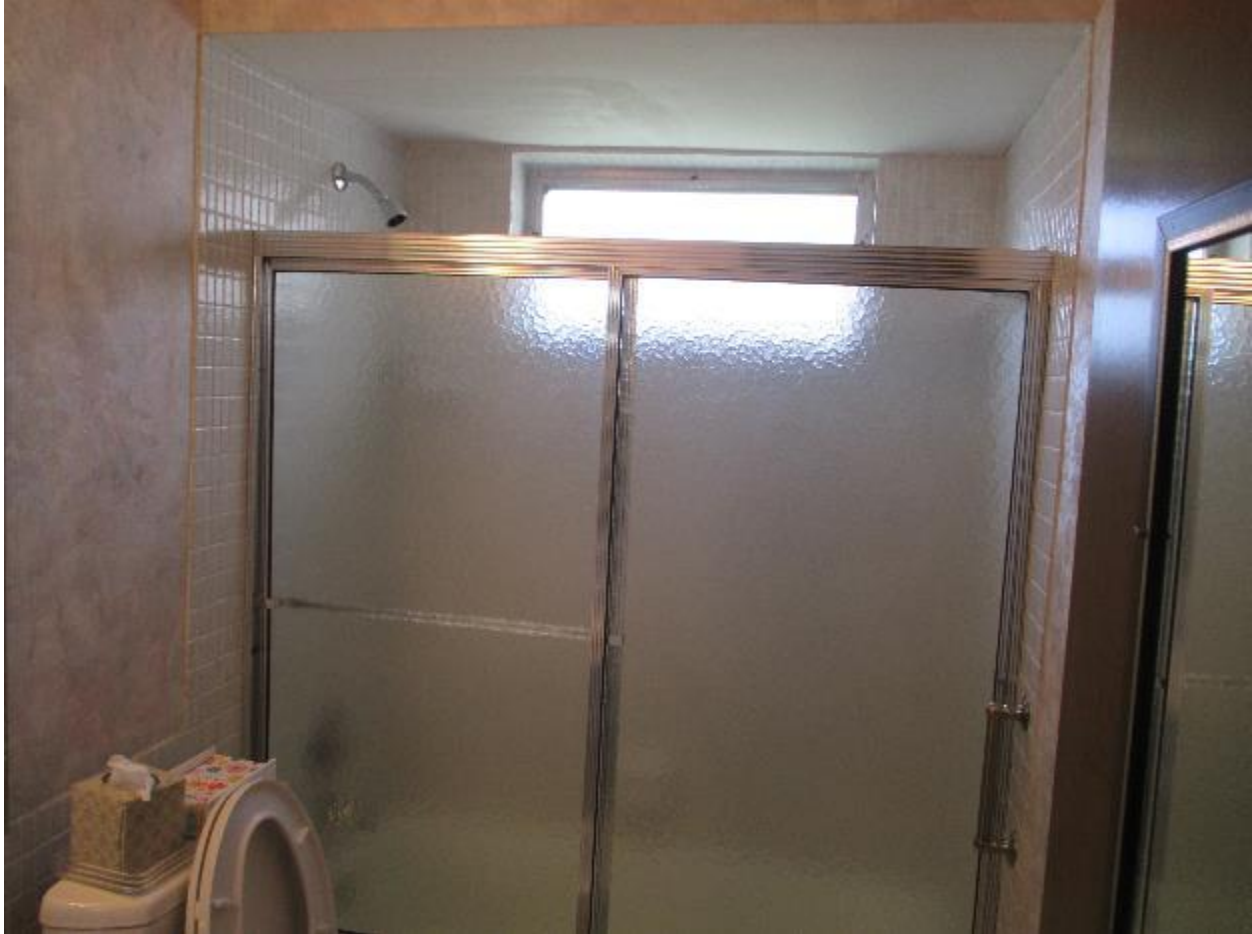
Interior finishes were found in general good condition at the time of inspection with exceptions as noted and shown in photographs.

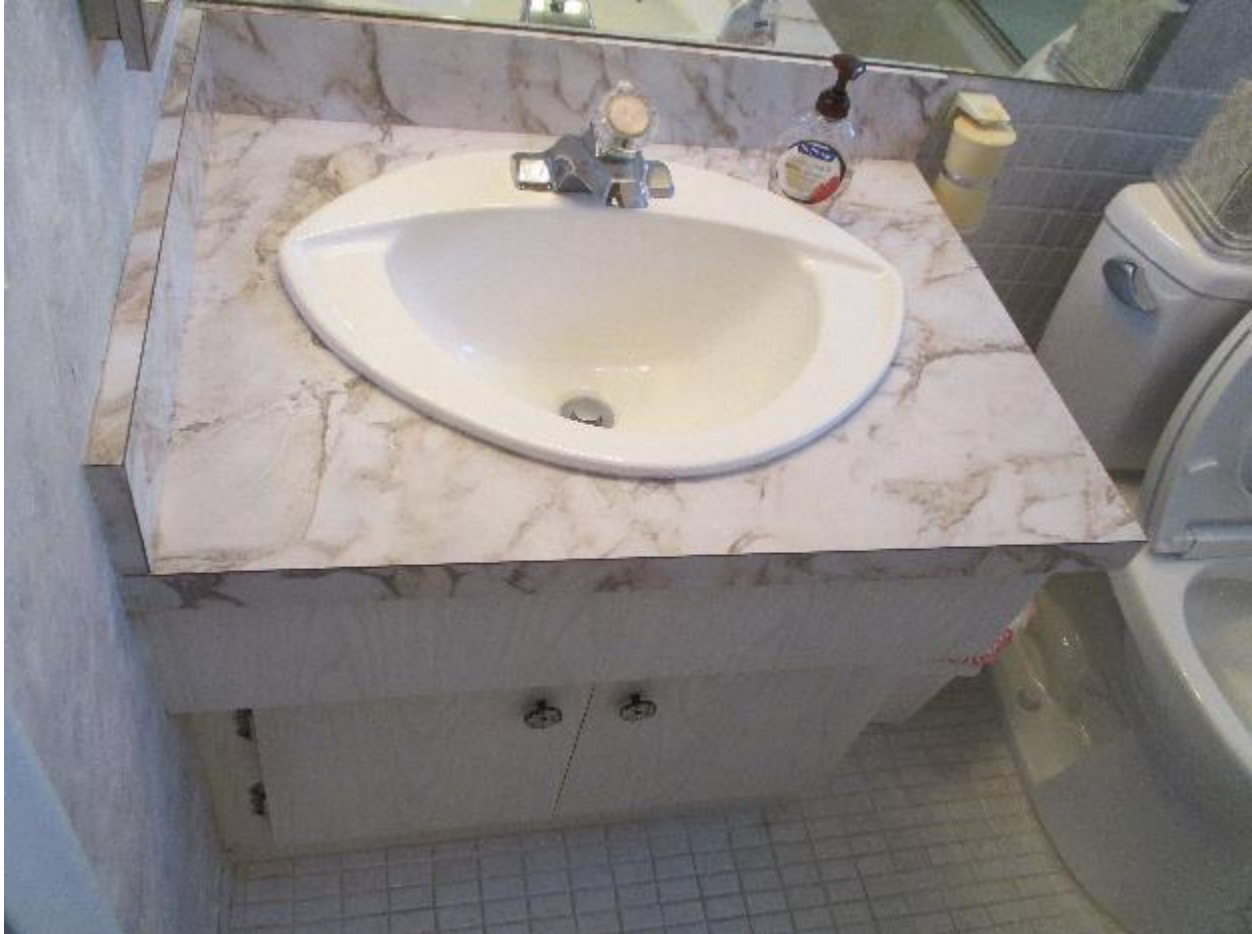
Interior finishes were found in general good condition at the time of inspection with exceptions as noted and shown in photographs.

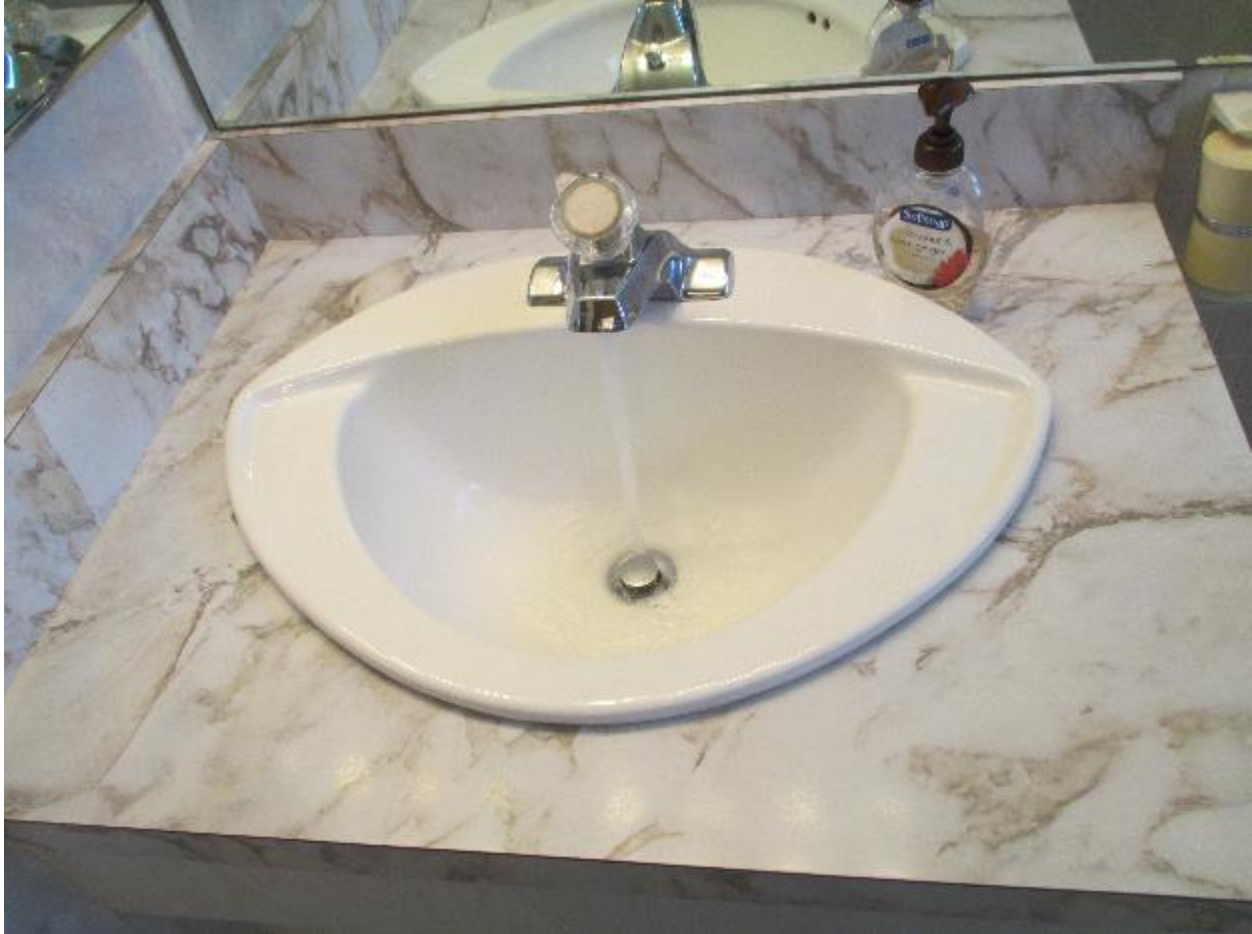
Plumbing systems tested for proper flow. No leaks or deficiencies noted on drain and supply lines.

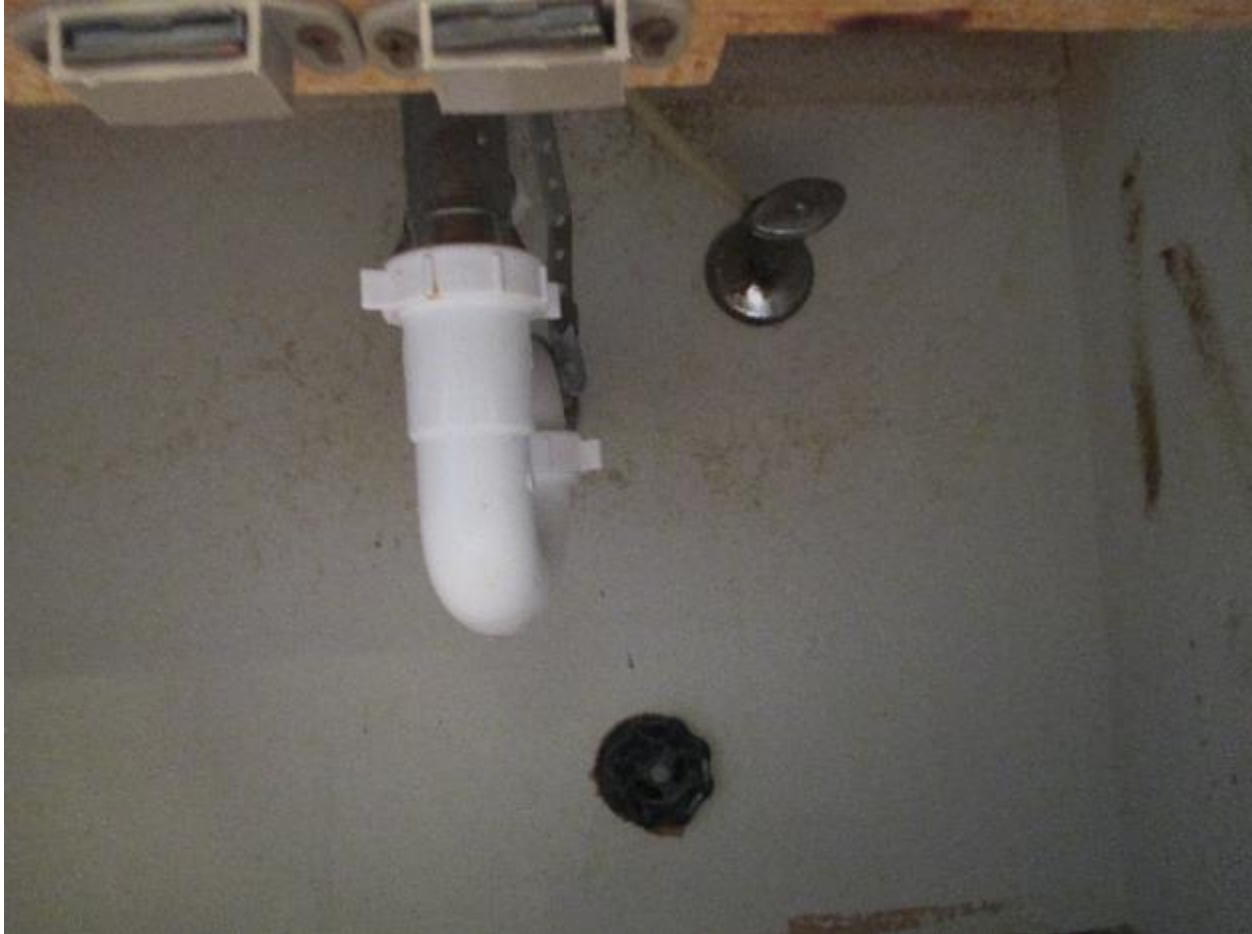
Plumbing systems tested for proper flow. No leaks or deficiencies noted on drain and supply lines.

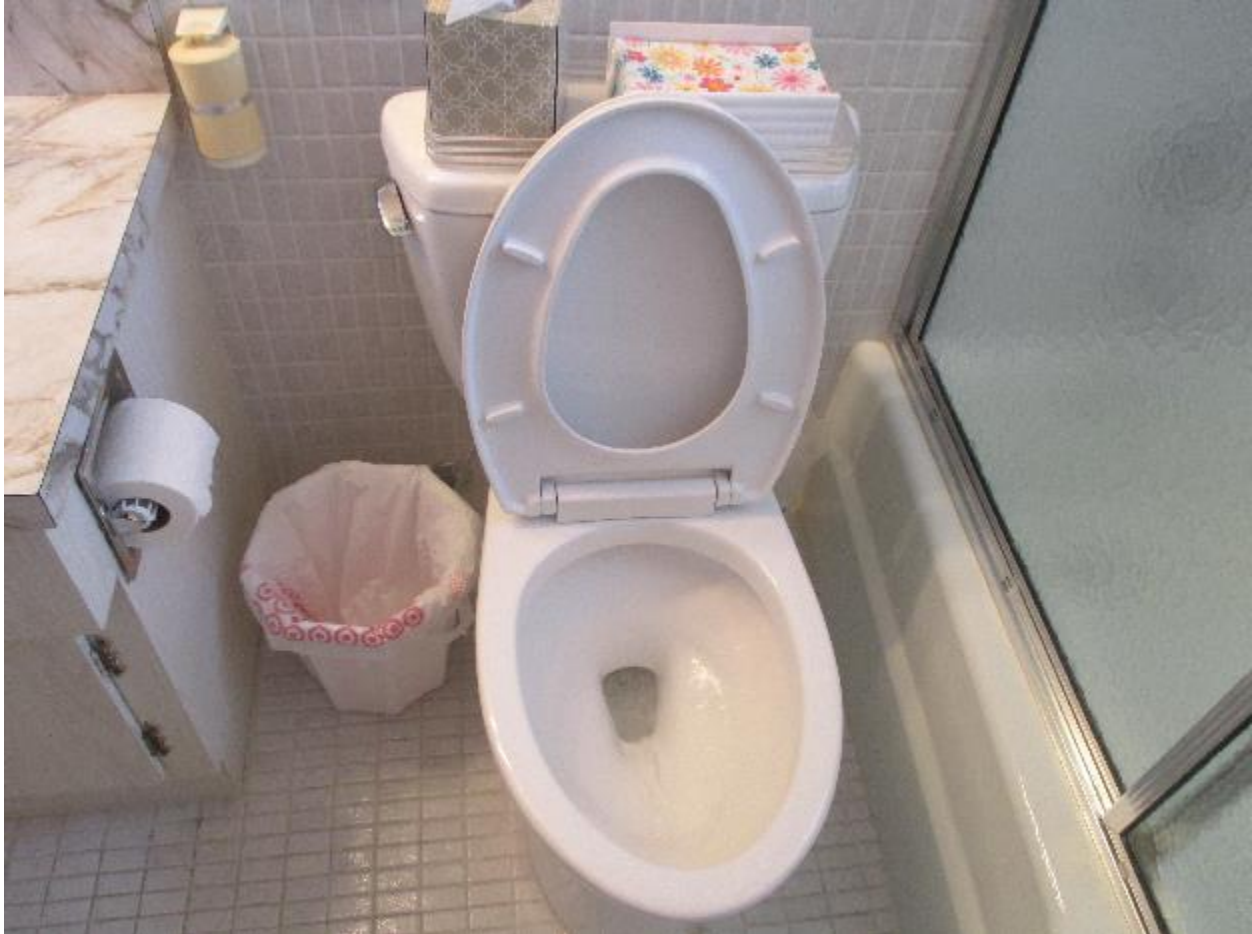
Interior finishes were found in general good condition at the time of inspection with exceptions as noted and shown in photographs.

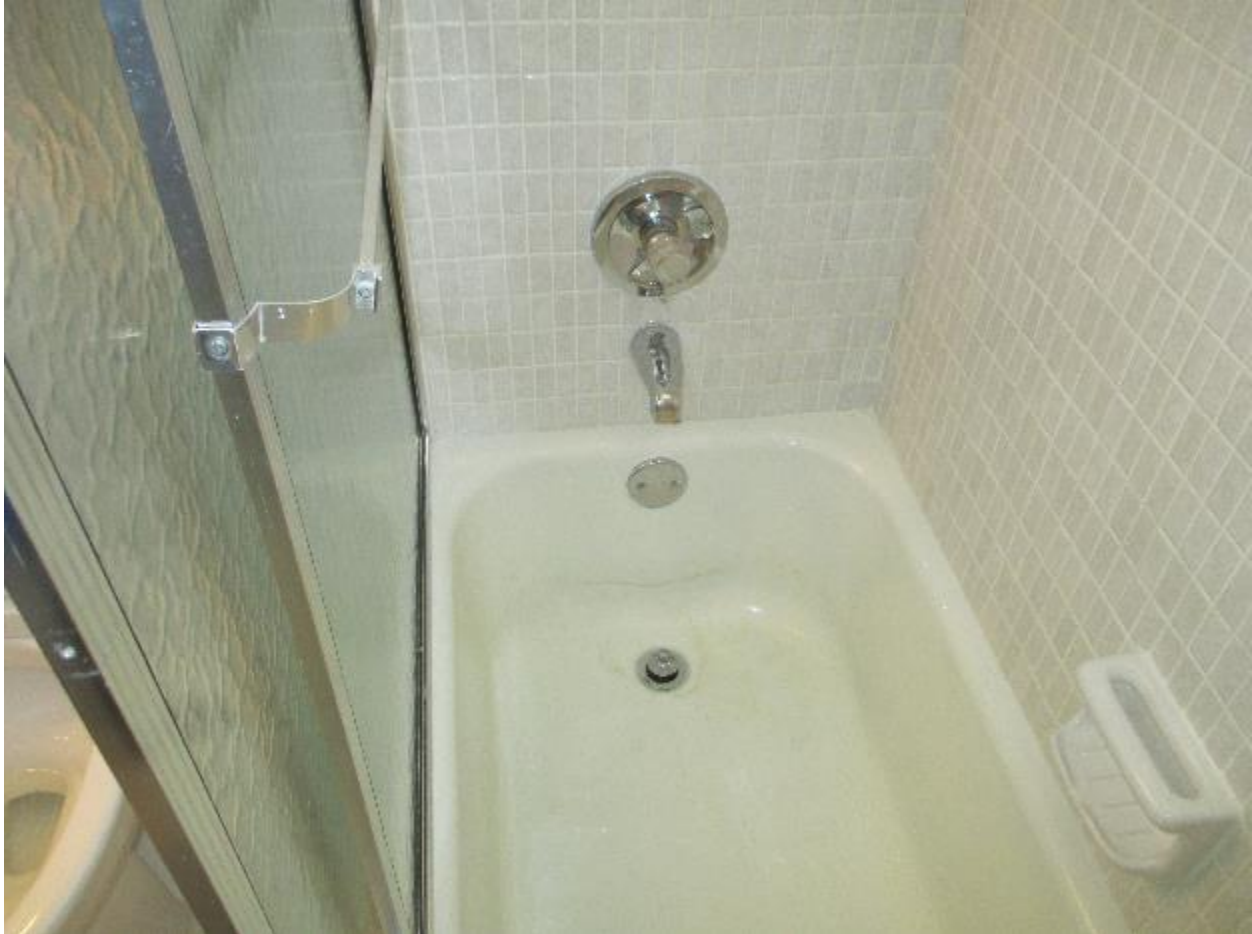
Interior finishes were found in general good condition at the time of inspection with exceptions as noted and shown in photographs.

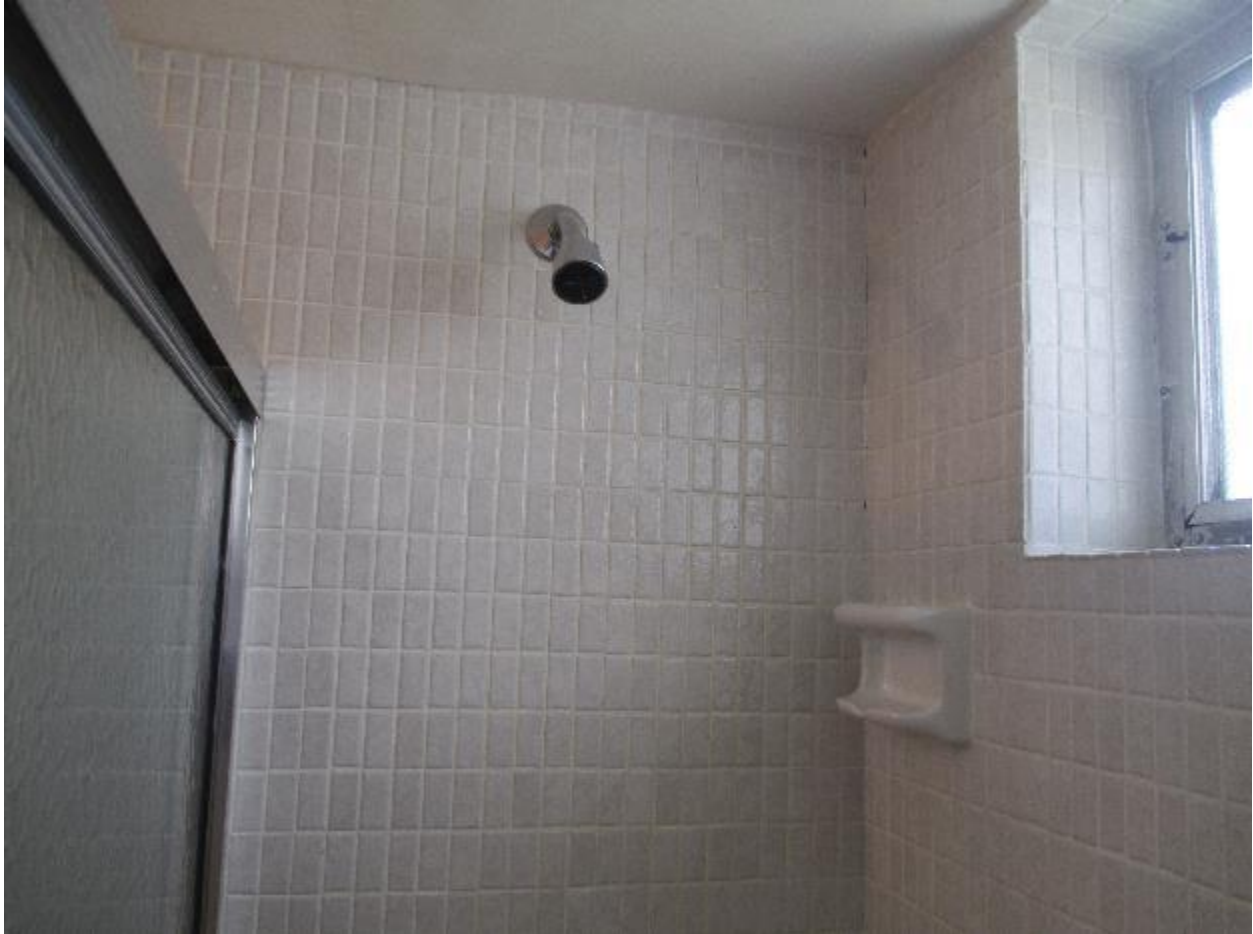
Interior finishes were found in general good condition at the time of inspection with exceptions as noted and shown in photographs.

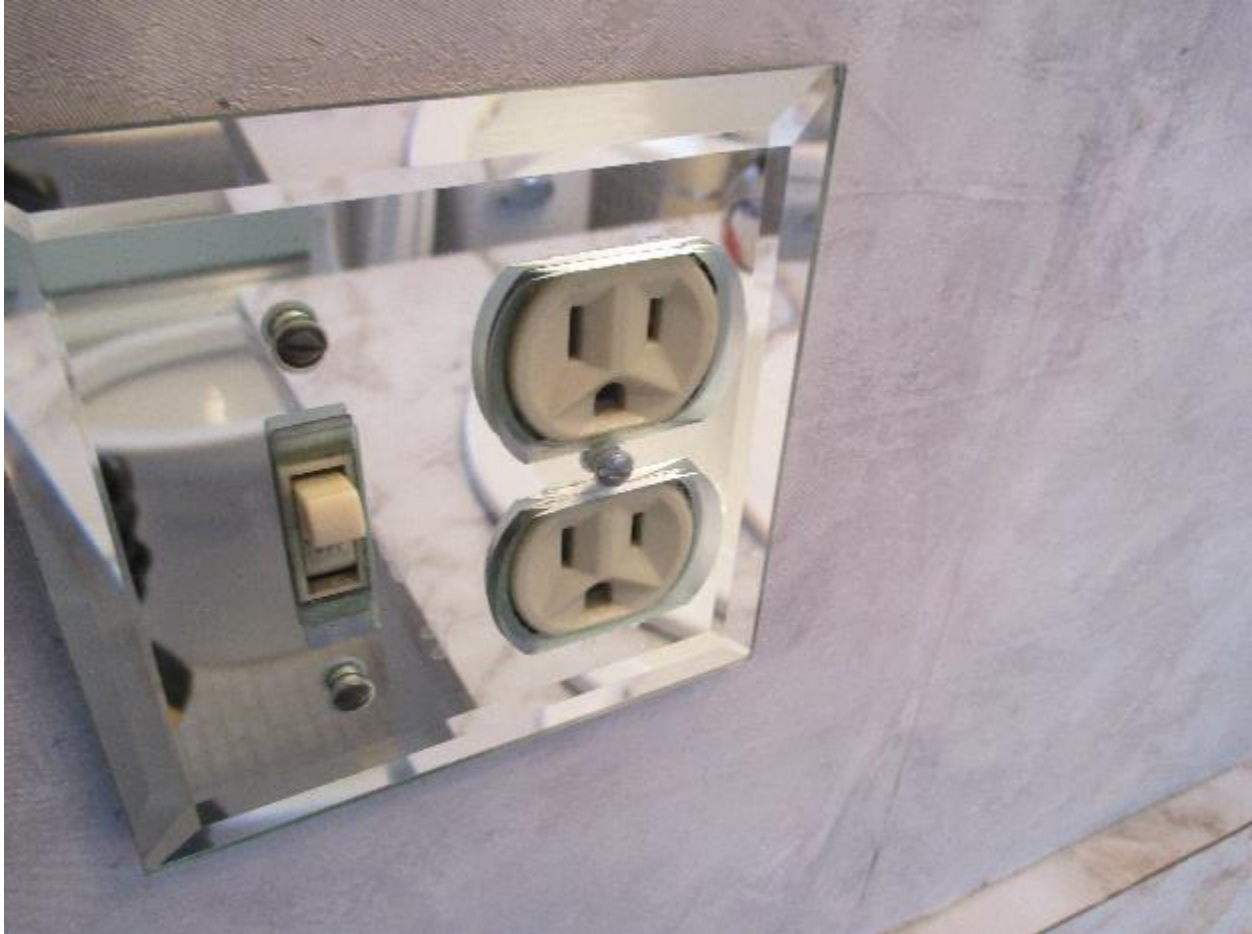
GFCI receptacles installation is required at wet areas such as bathrooms and kitchens.

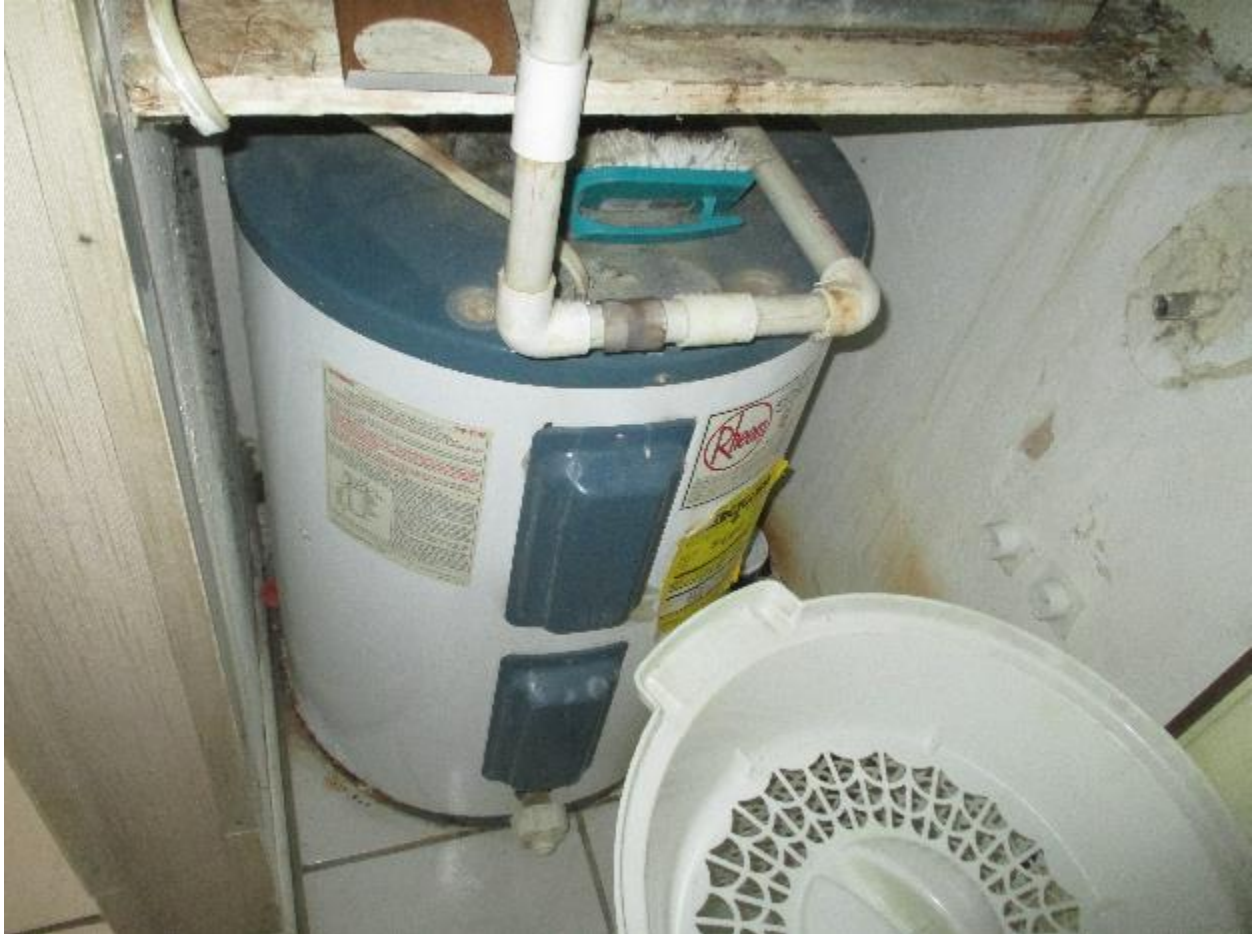
Water heater in good working condition at the time of inspection.
