PROPERTY INSPECTION OR ASSESSMENT OF DAMAGES

ADDRESS: 000 SW 00 AVE DAVIE, FL
CLIENT: YOUR NAME HERE
ID No: 123
DATE: 01-01-XXXX

PROPERTY INSPECTION – 000 SW 00 AVE DAVIE, FL
ATTACHMENT - PHOTOGRAPHS
DATE: 01-01-XXXX

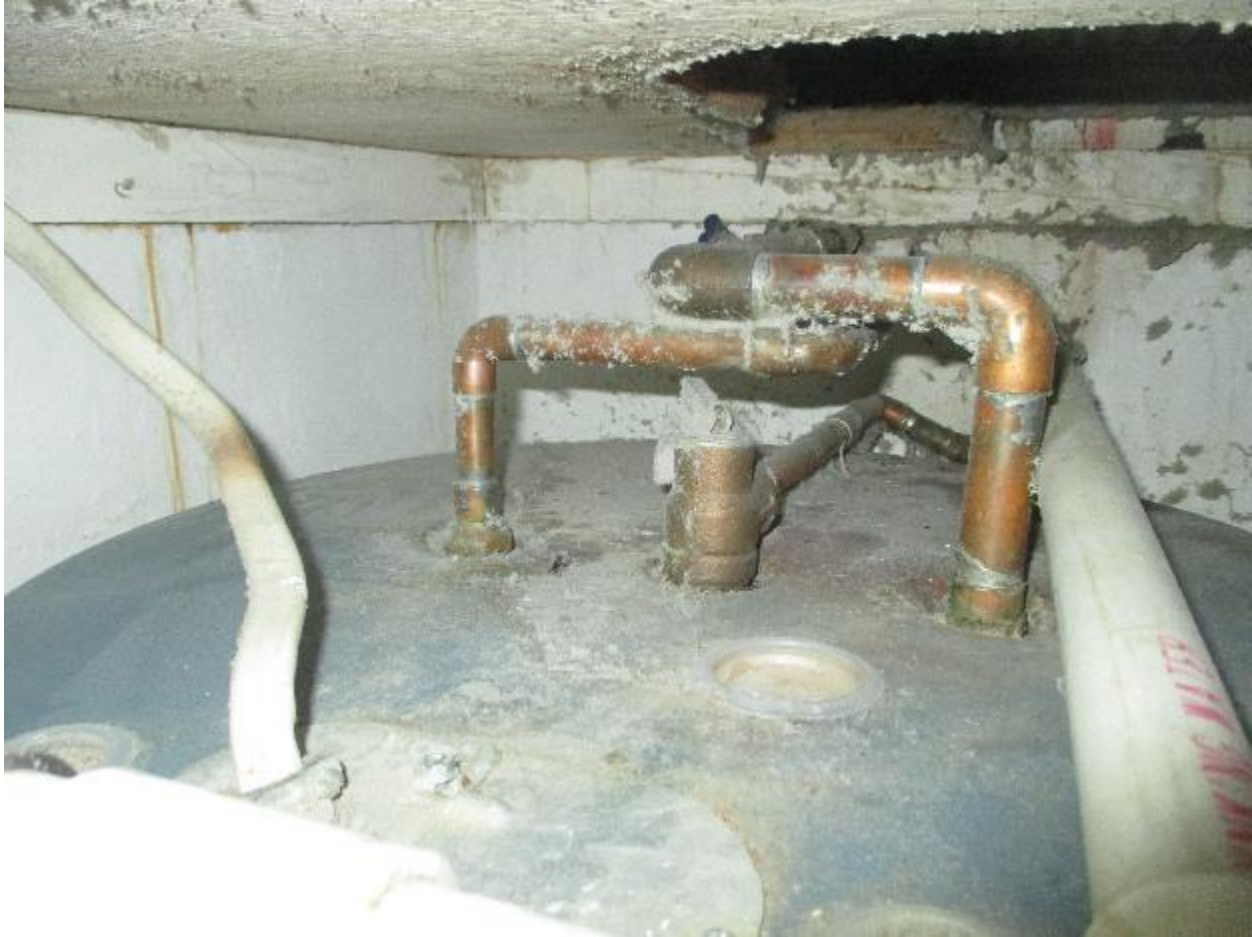
Water heater in good working condition at the time of inspection.

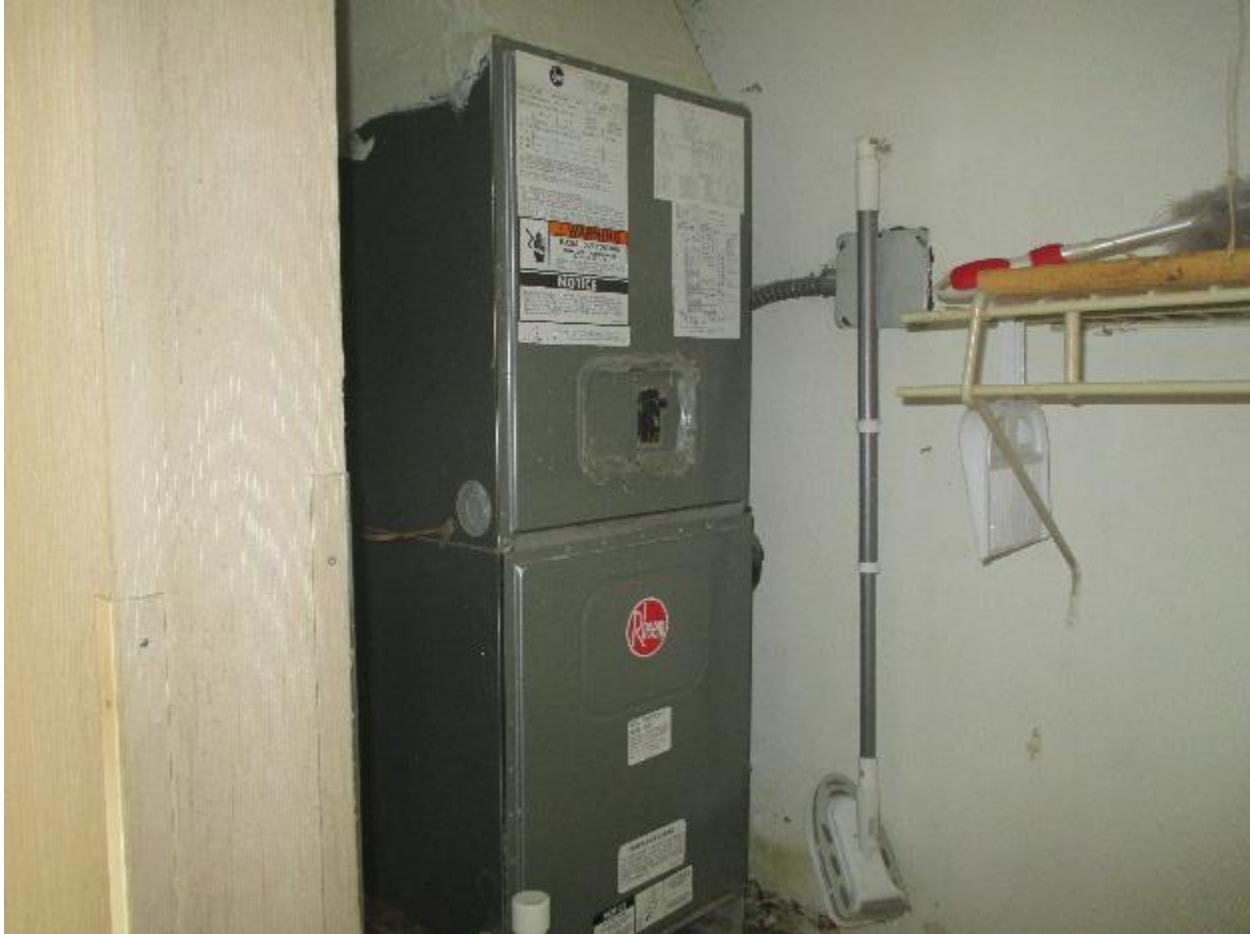
HVAC in good working condition at the time of inspection.

Central HVAC system is near the end of its useful life. Manufacturer tag dated **1997**. System is **20** years old. All HVAC over 15 years old are recommended for replacement.

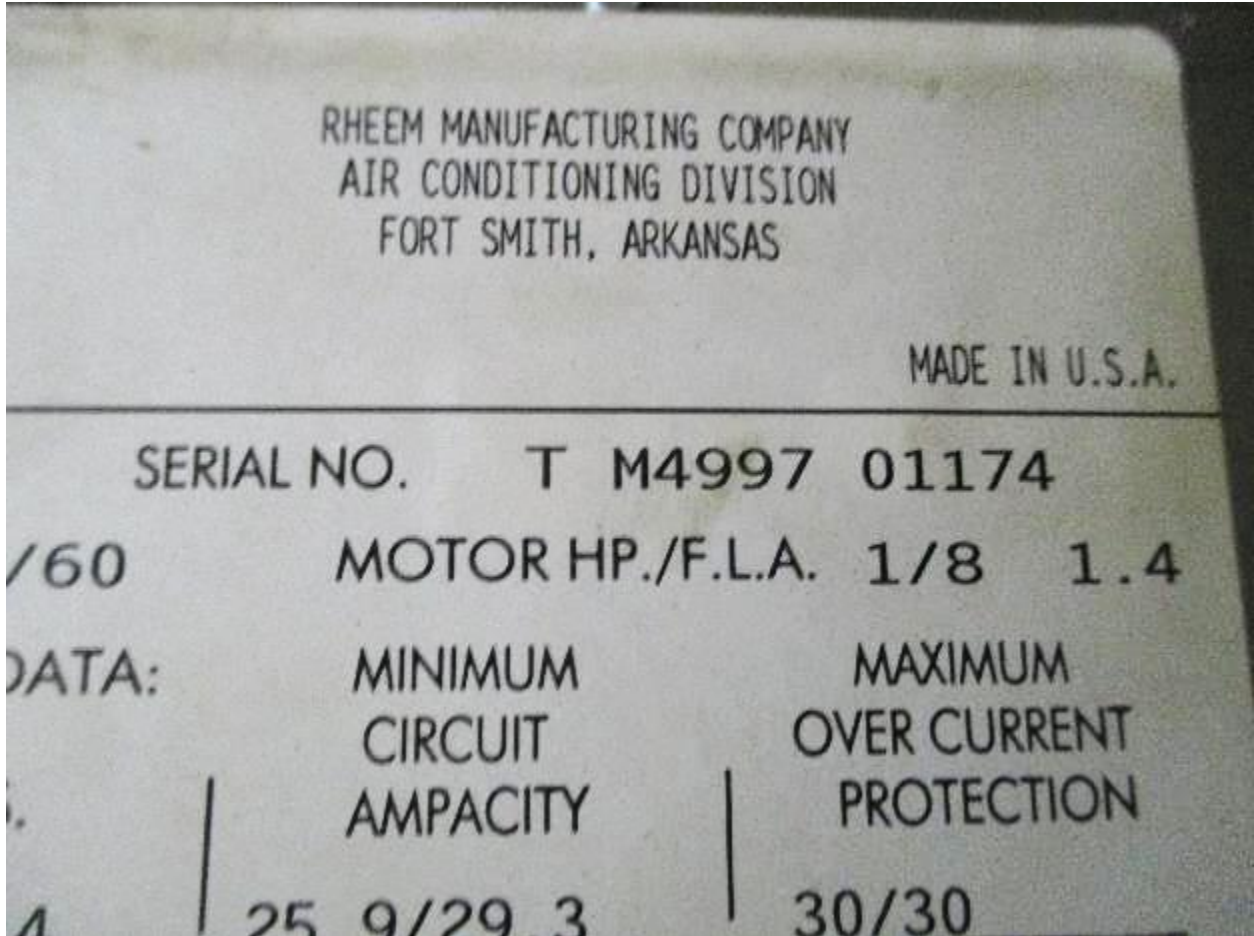
HVAC in good working condition at the time of inspection.

Central HVAC system is near the end of its useful life. Manufacturer tag dated 1997. System is 20 years old. All HVAC over 15 years old are recommended for replacement.

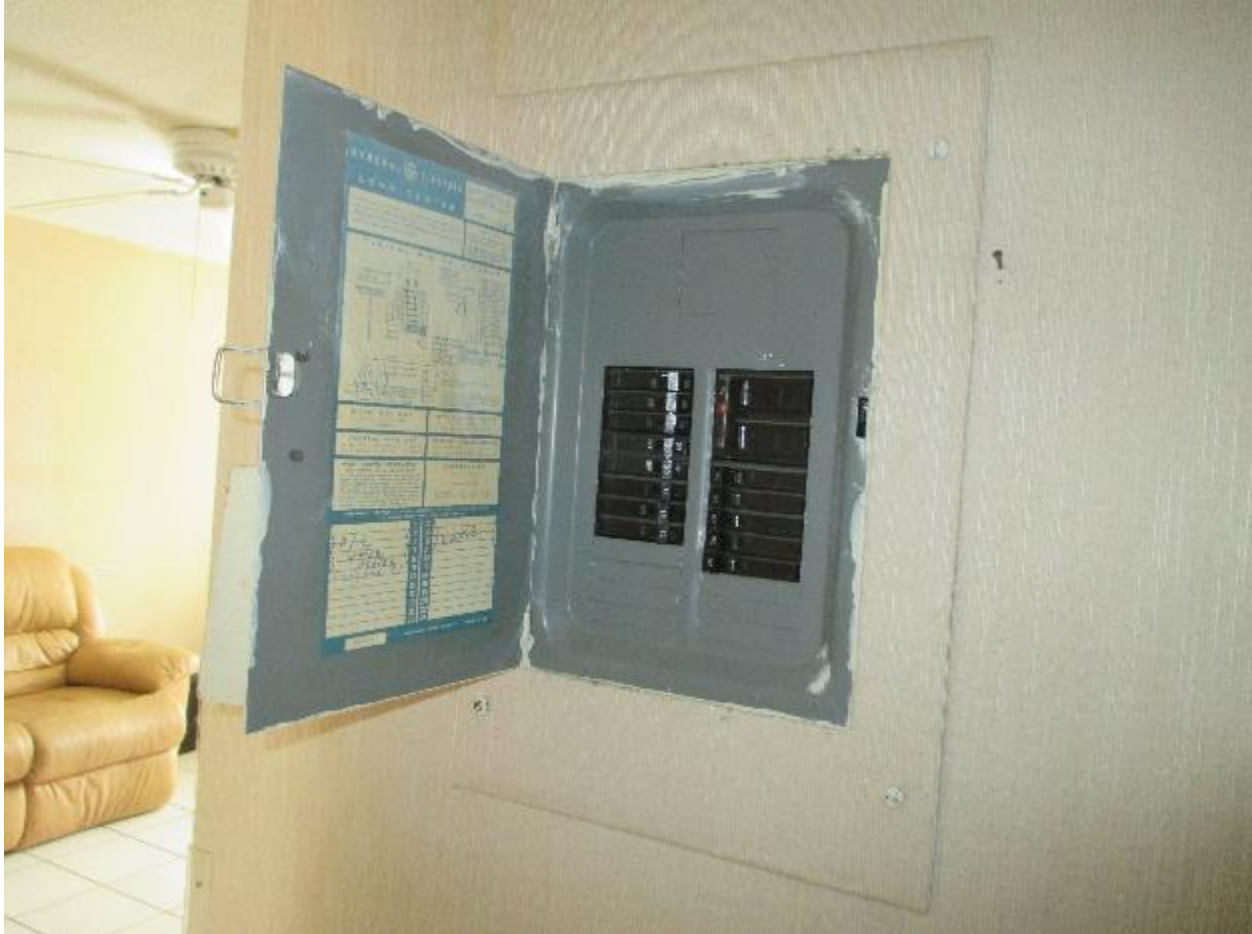
Electrical wires / Breaker panel double tap noted during inspection.

All aluminum wires must be removed and replaced by copper wires. Rewiring required.

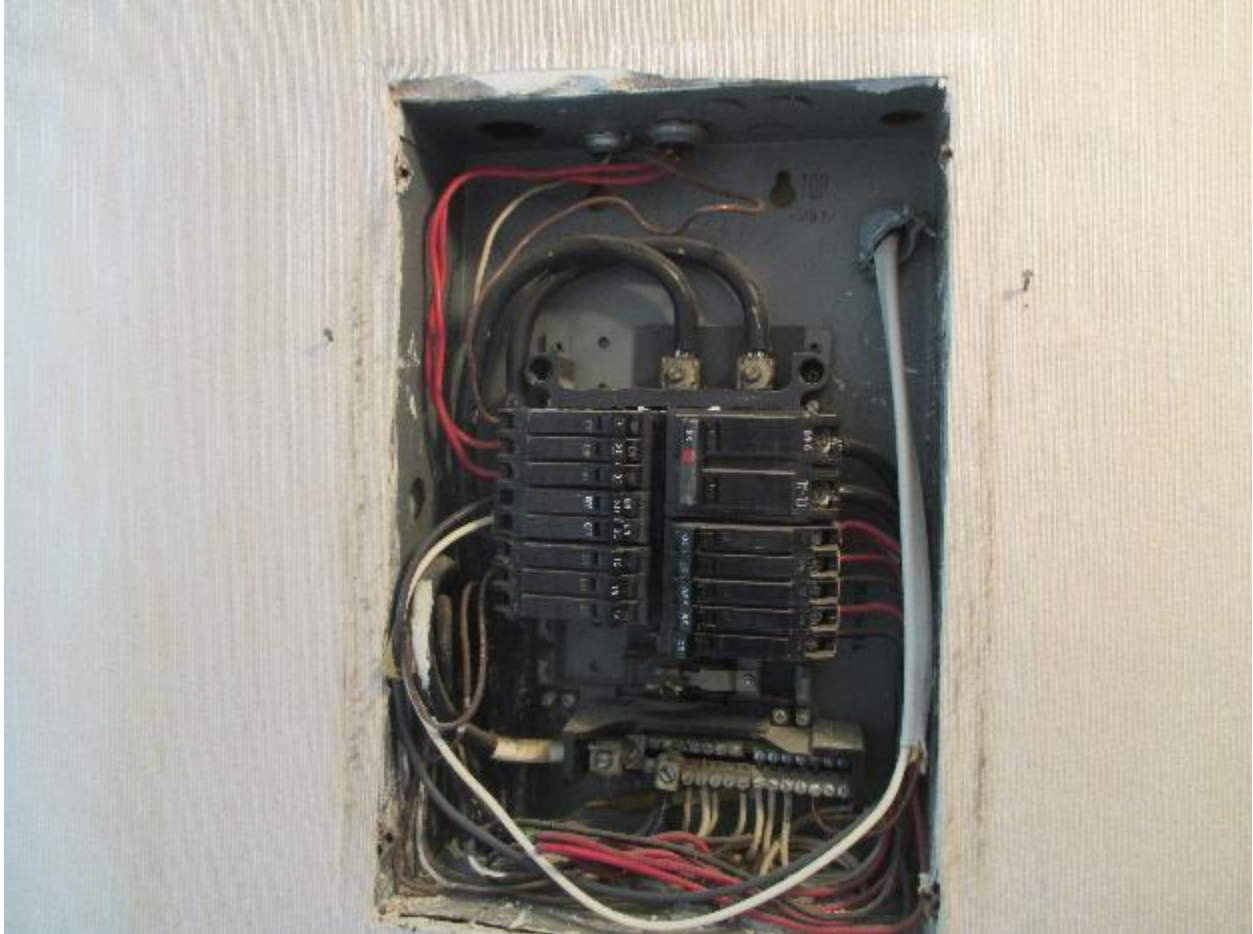
Electrical wires / Breaker panel double tap noted during inspection.

All aluminum wires must be removed and replaced by copper wires. Rewiring required.

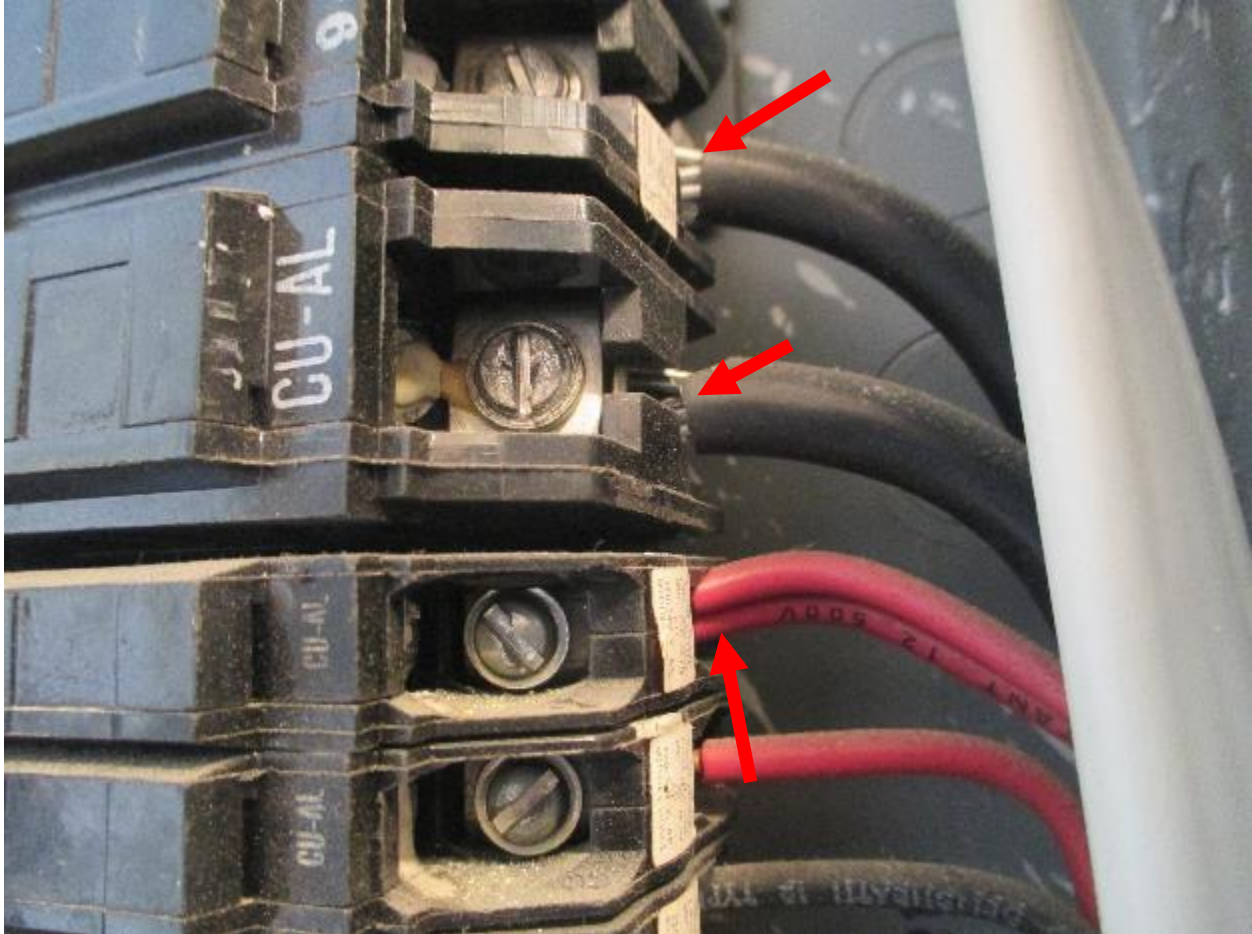
Electrical wires / Breaker panel double tap noted during inspection.

All aluminum wires must be removed and replaced by copper wires. Rewiring required.

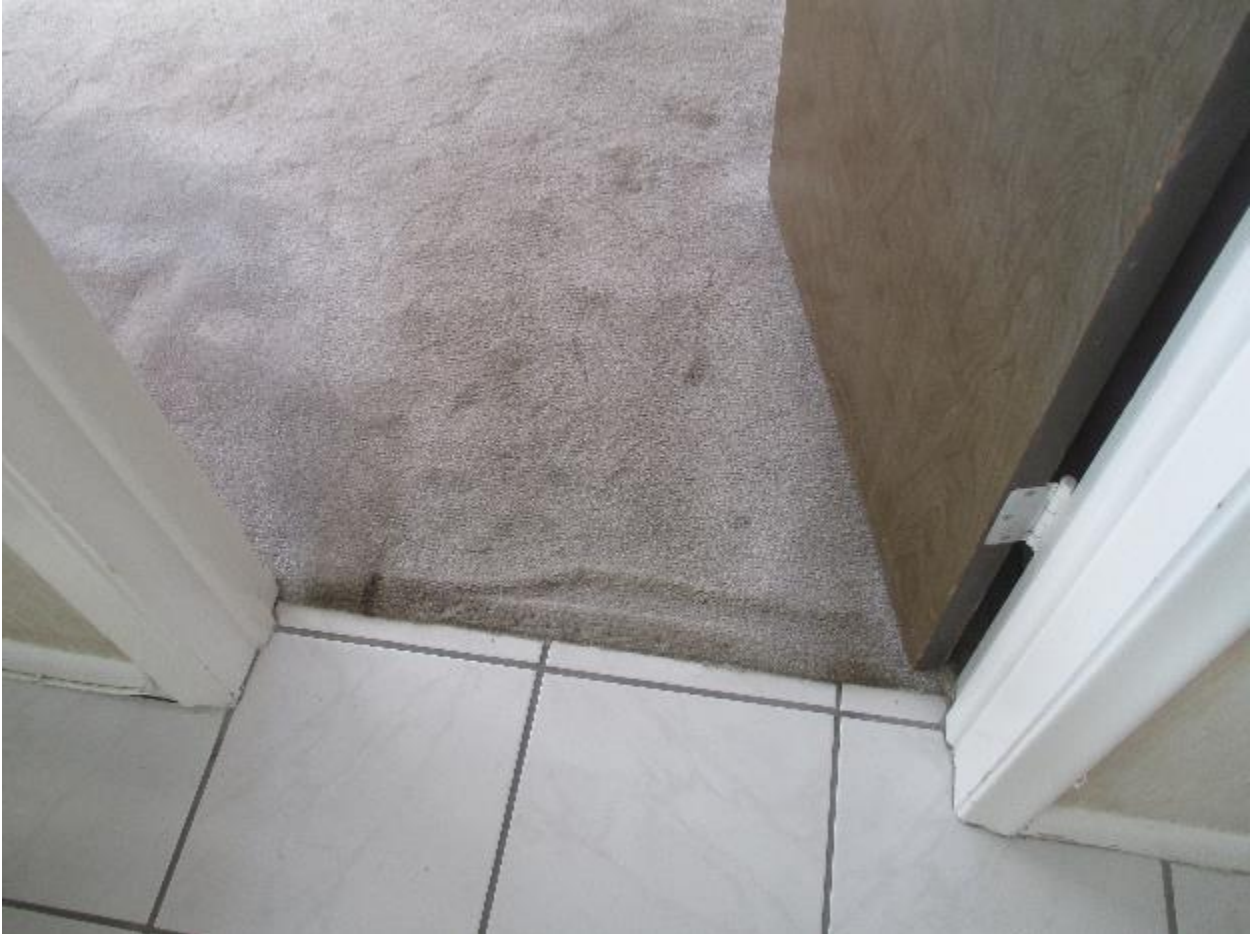
Carpet replacement required.

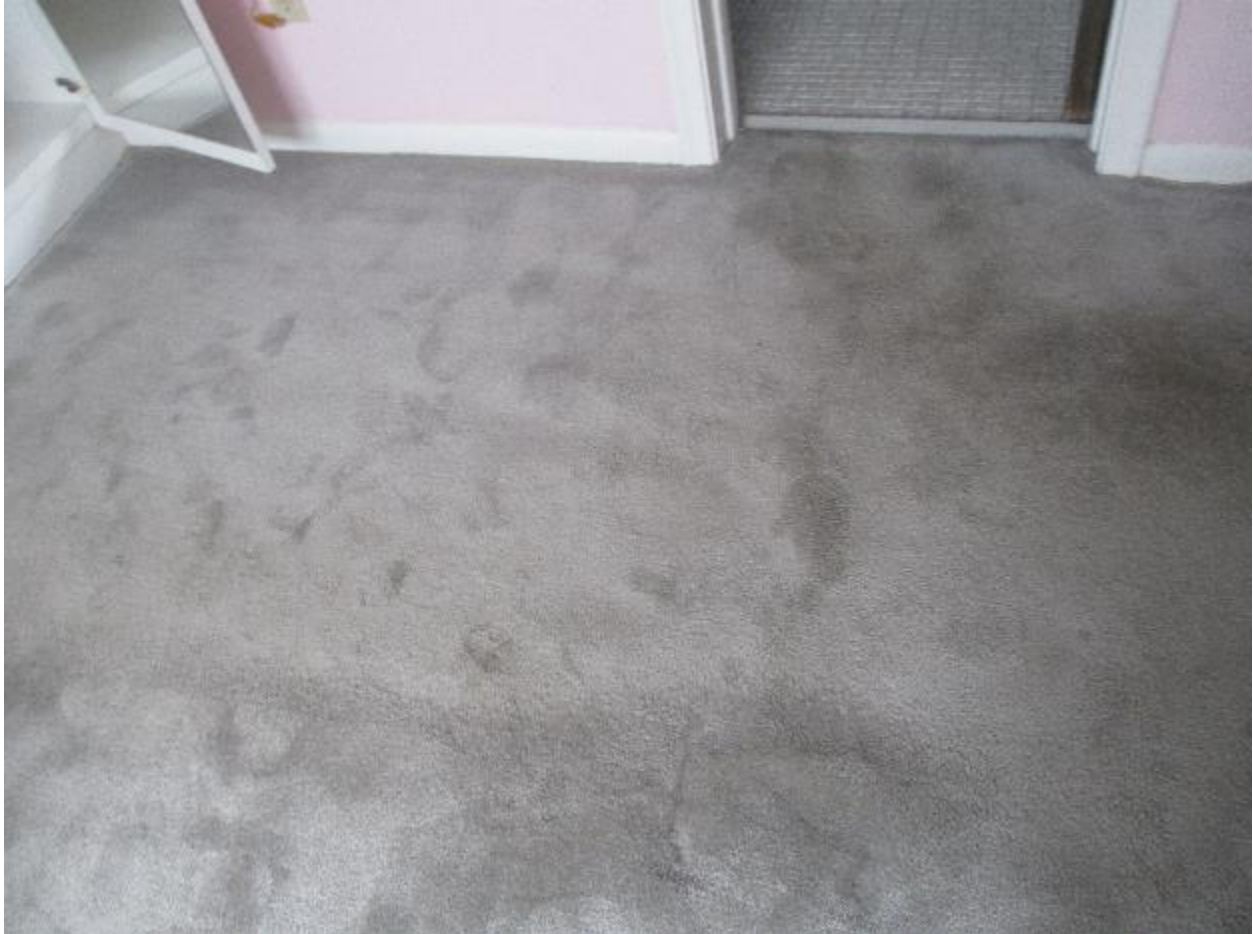
Carpet replacement required.

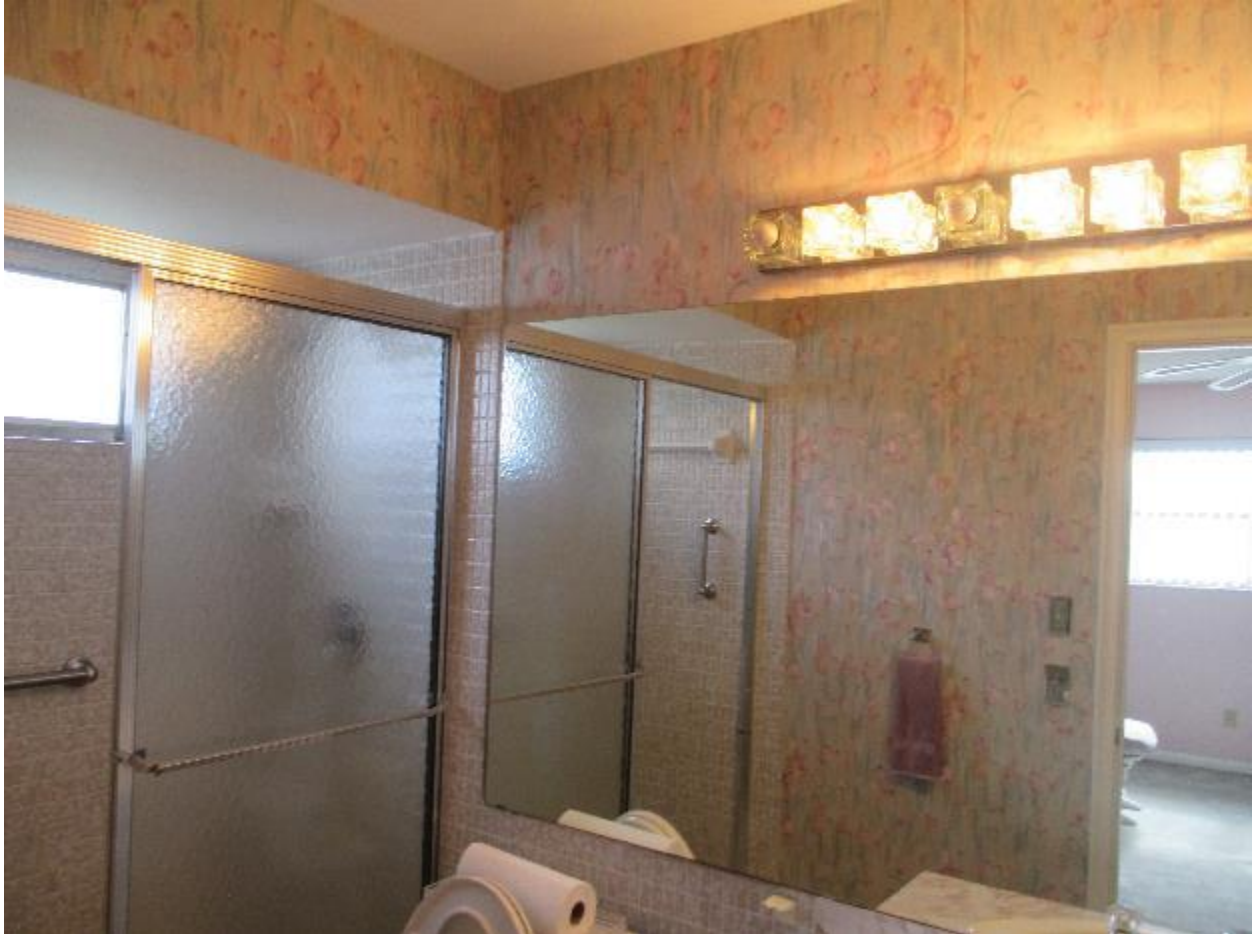
Interior finishes were found in general good condition at the time of inspection with exceptions as noted and shown in photographs.

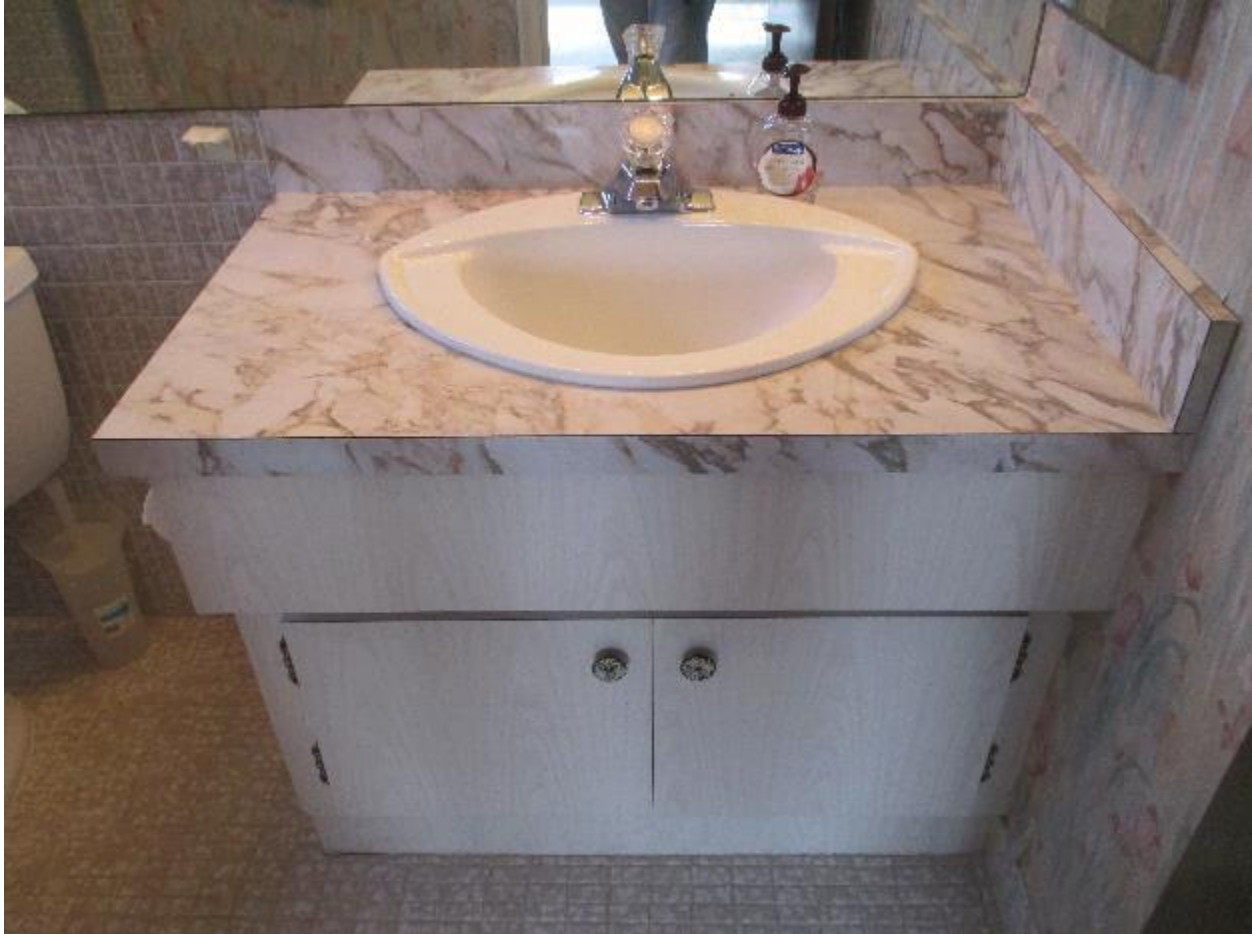
Interior finishes were found in general good condition at the time of inspection with exceptions as noted and shown in photographs.

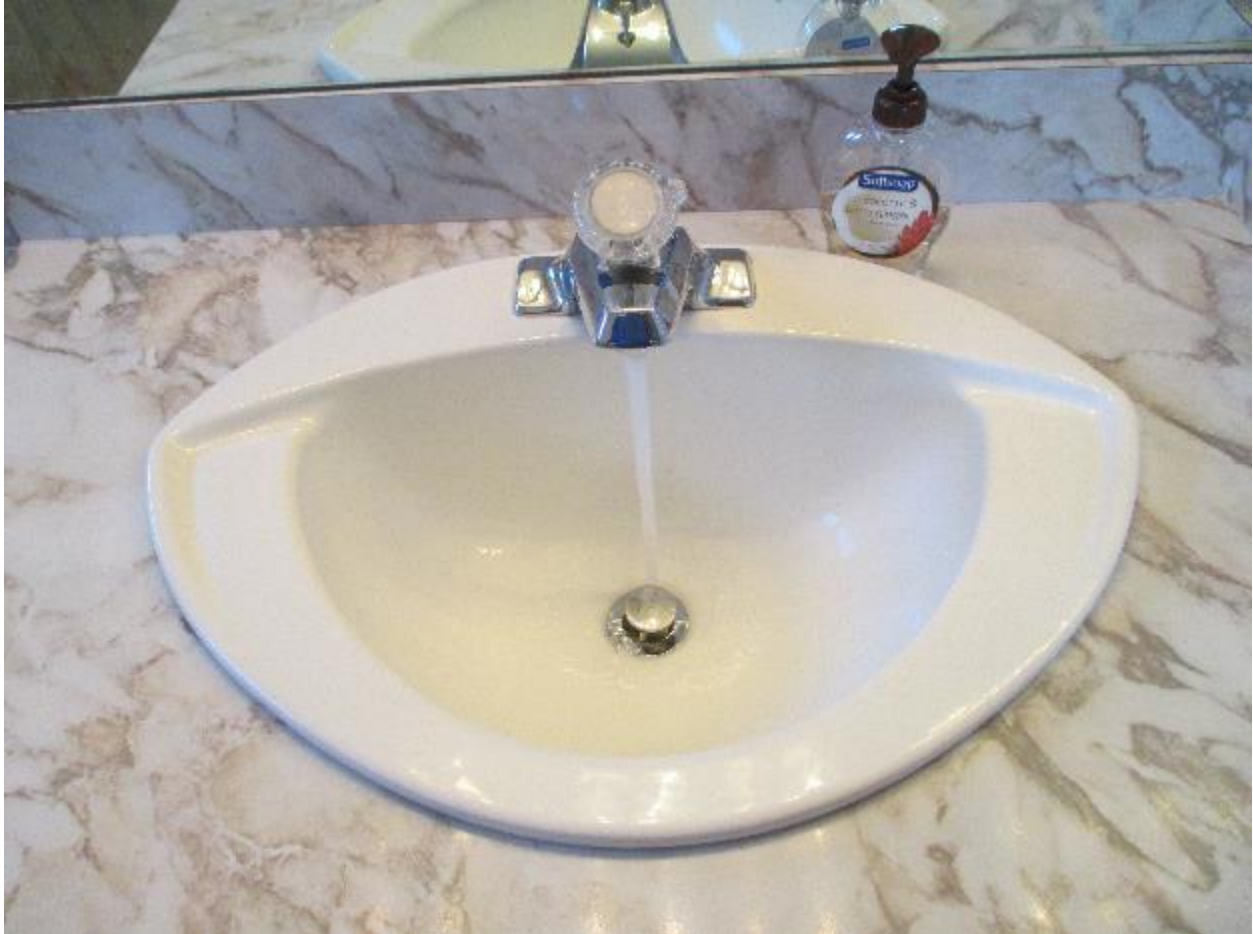
Plumbing systems tested for proper flow. No leaks or deficiencies noted on drain and supply lines.

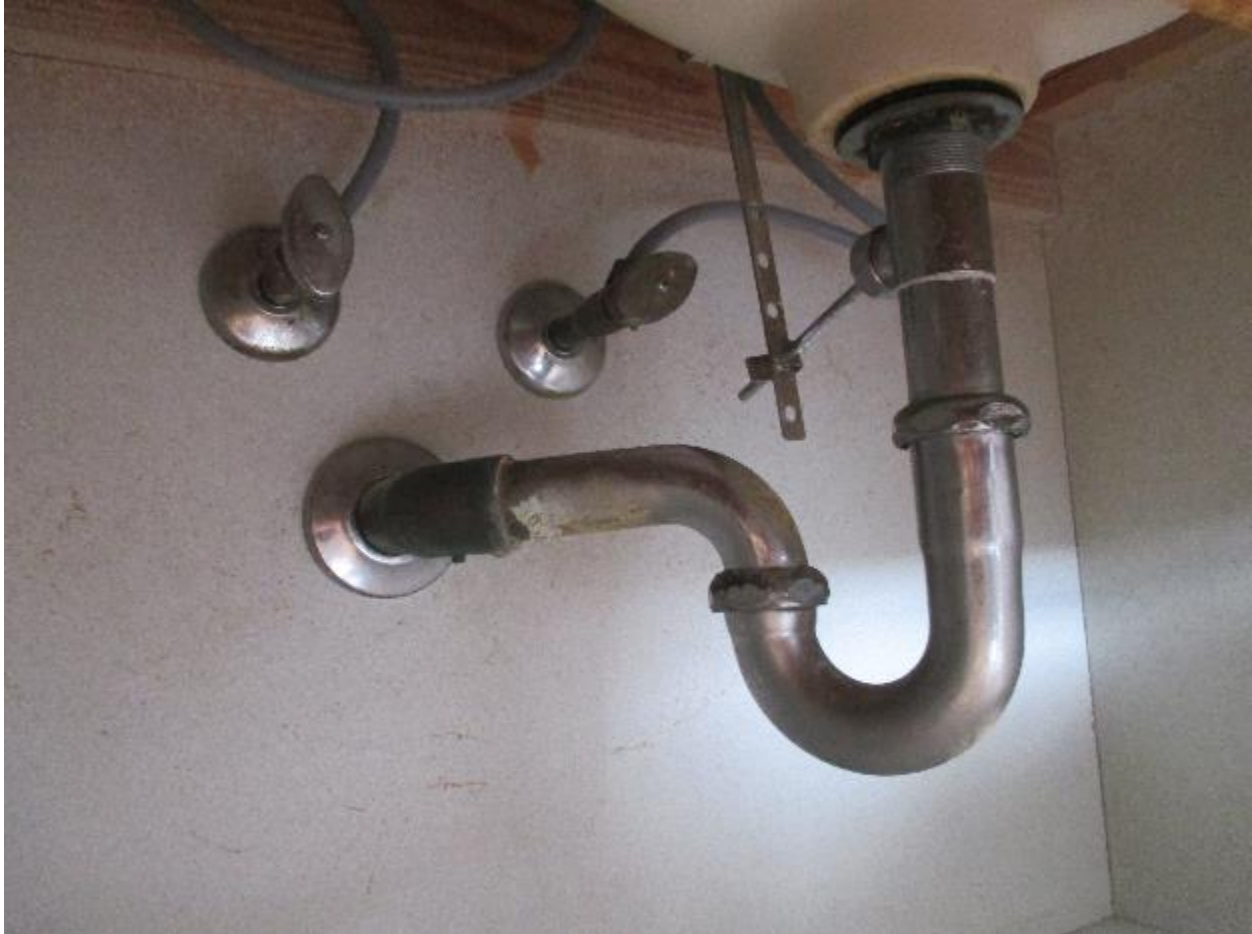
Plumbing systems tested for proper flow. No leaks or deficiencies noted on drain and supply lines.

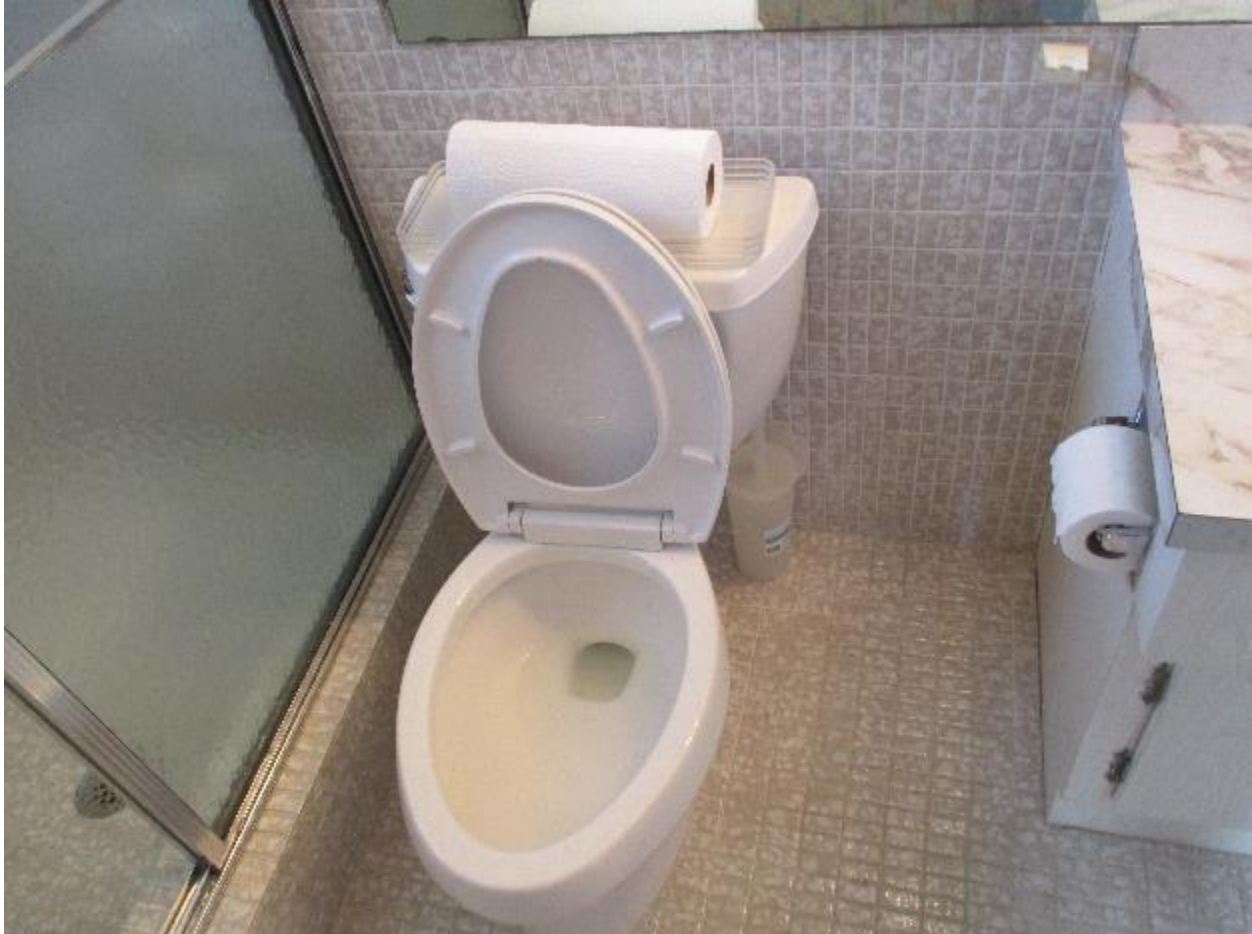
Interior finishes were found in general good condition at the time of inspection with exceptions as noted and shown in photographs.

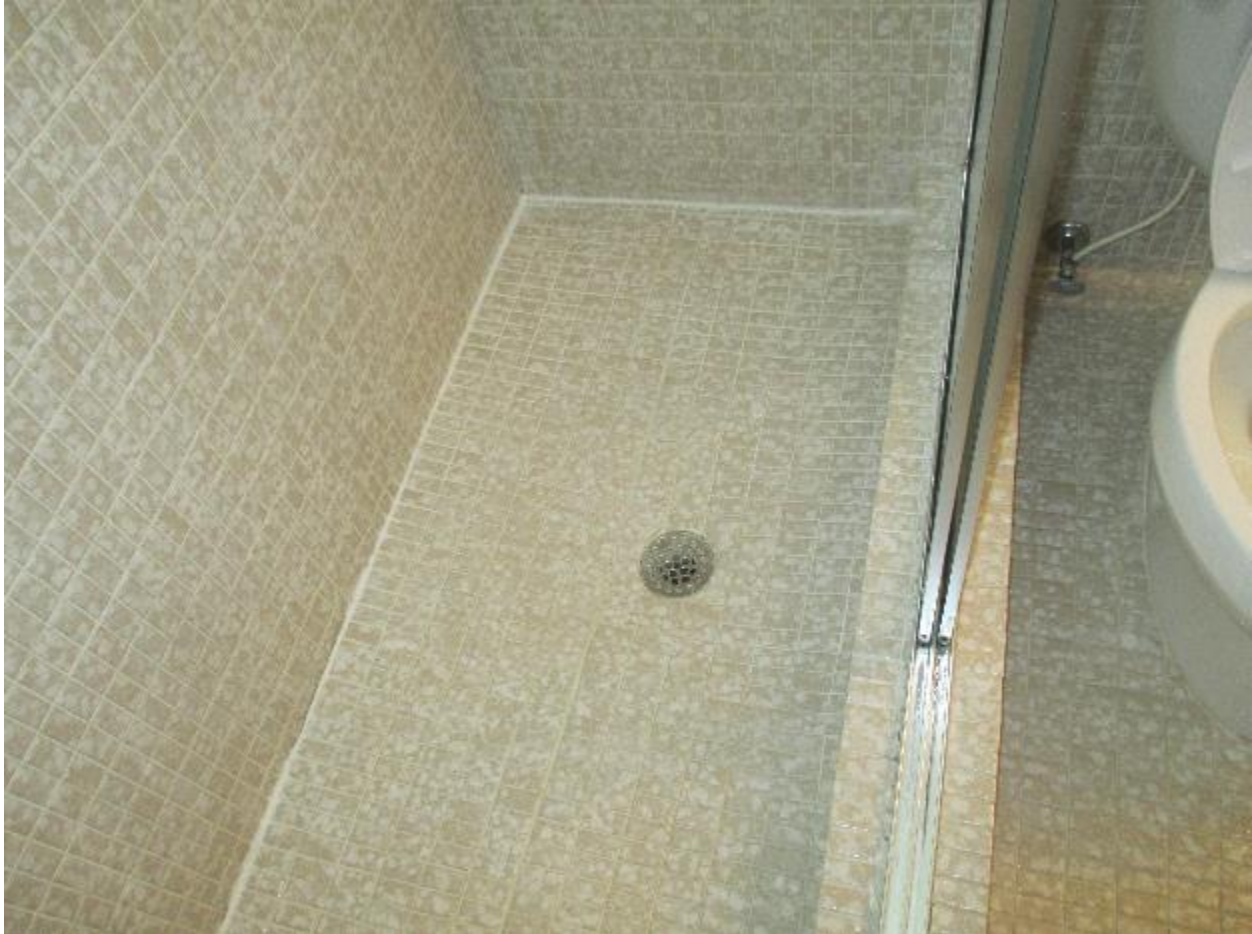
Interior finishes were found in general good condition at the time of inspection with exceptions as noted and shown in photographs.

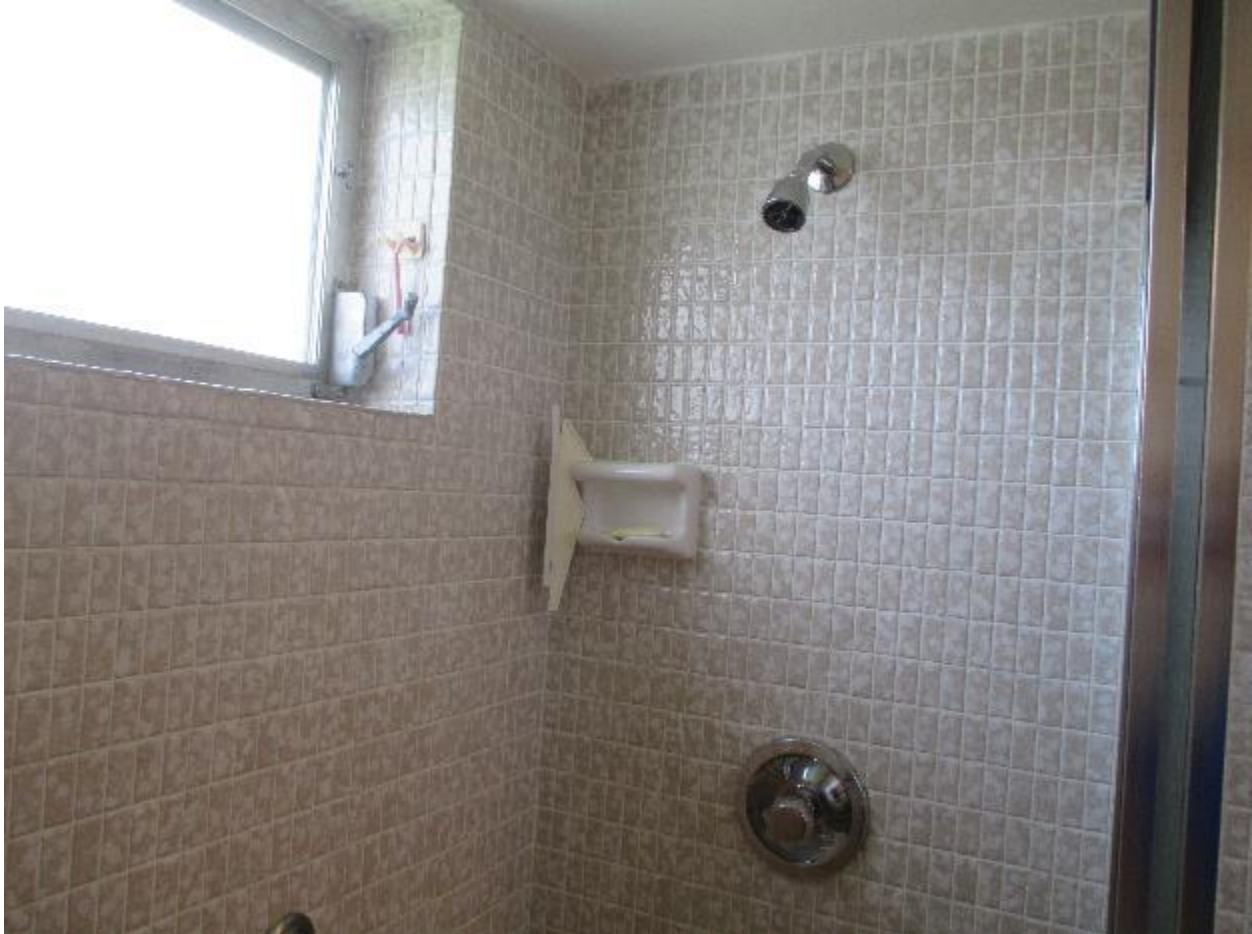
Interior finishes were found in general good condition at the time of inspection with exceptions as noted and shown in photographs.

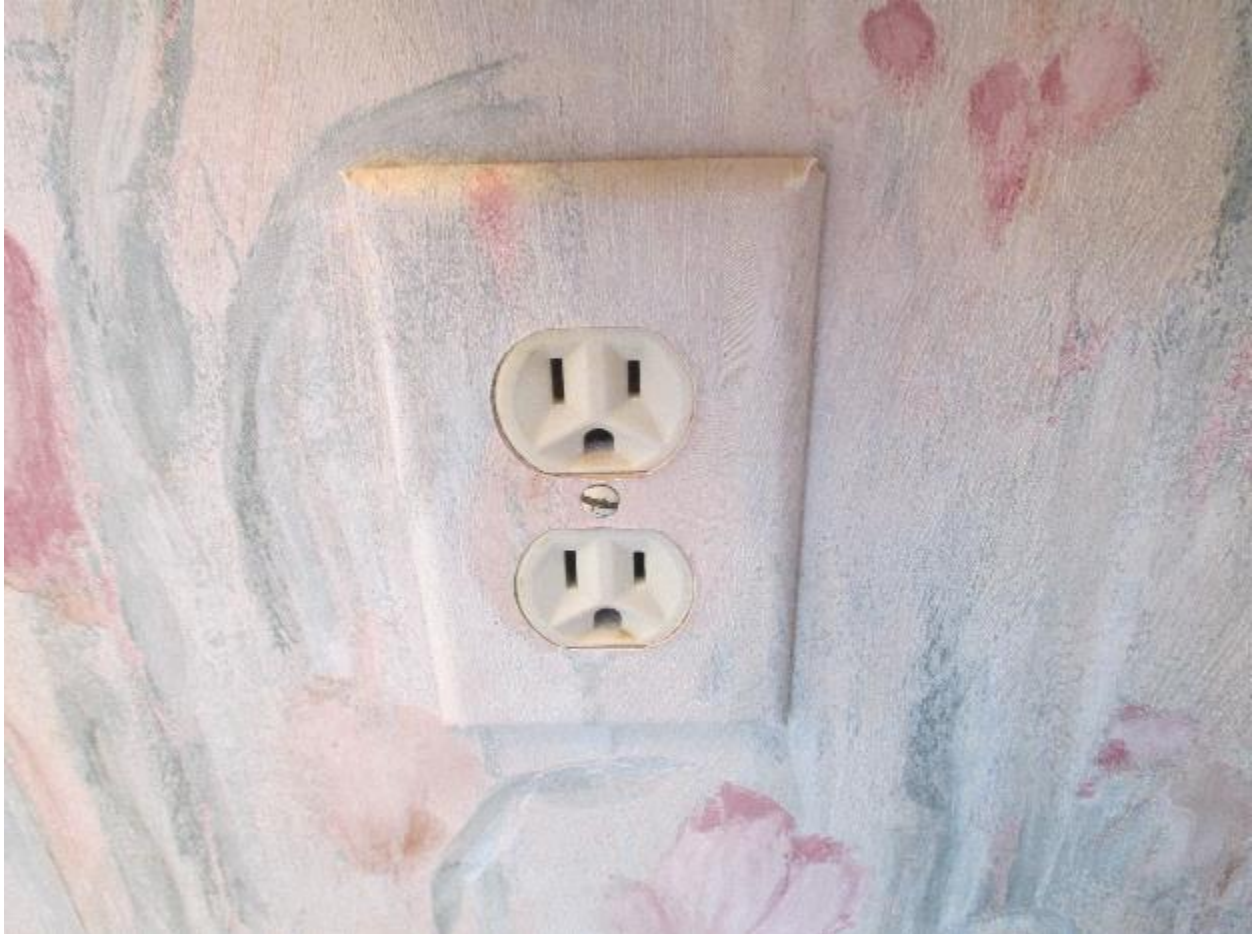
GFCI receptacles installation is required at wet areas such as bathrooms and kitchens.

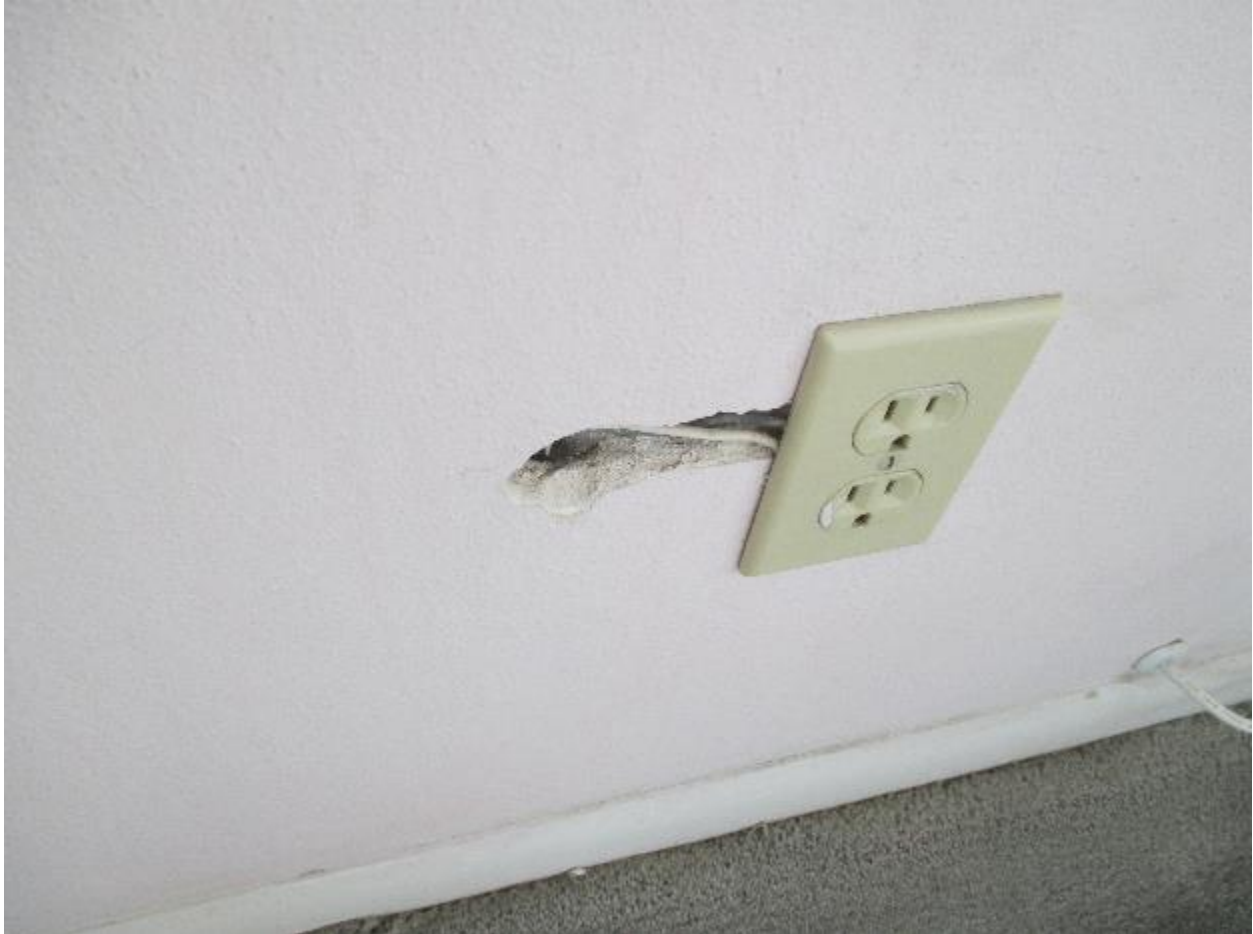
Drywall repairs required.

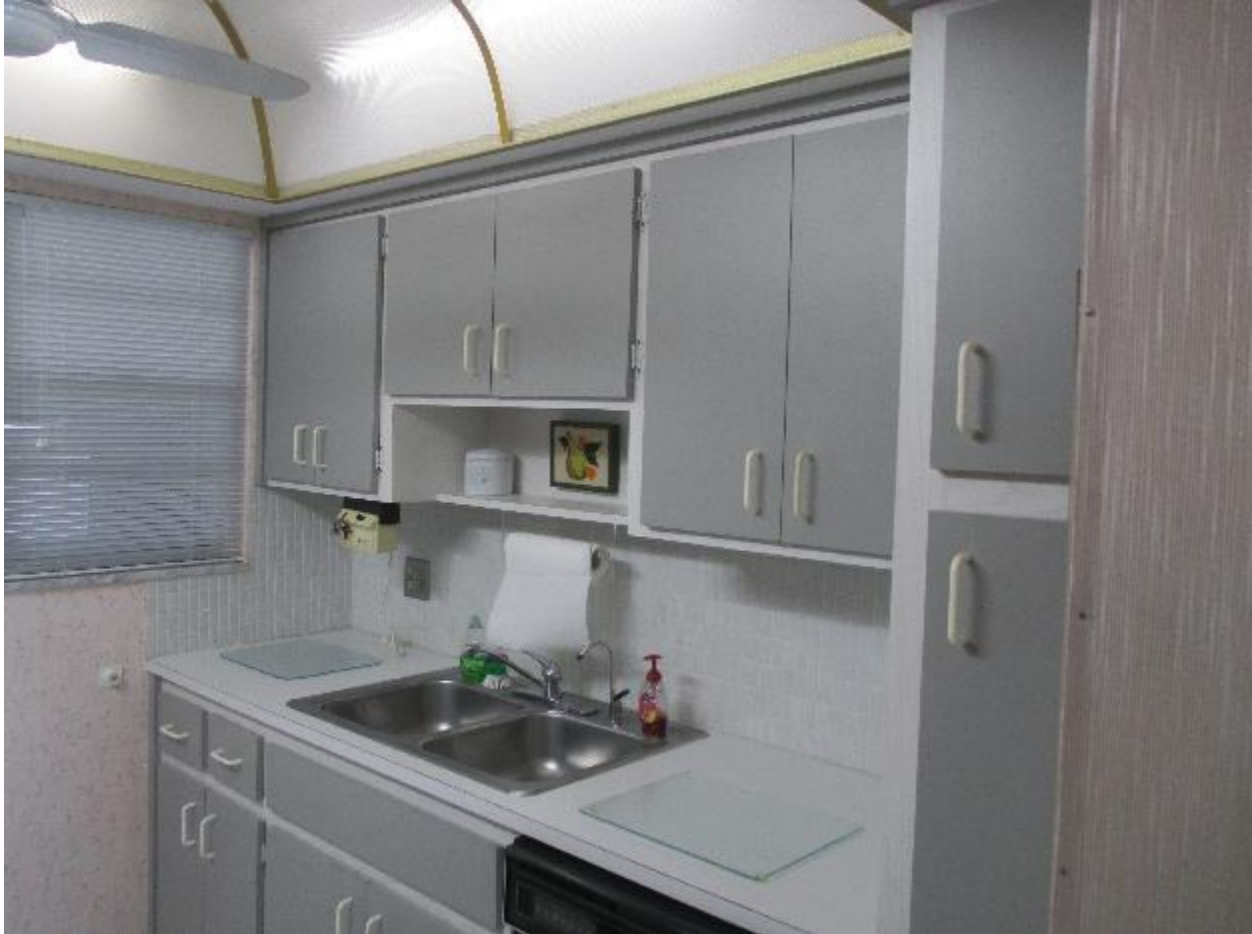
Interior finishes were found in general good condition at the time of inspection with exceptions as noted and shown in photographs.

No warranties or guarantees expressed on used appliances. We recommend to make allowances for the replacement appliances on this specific property.

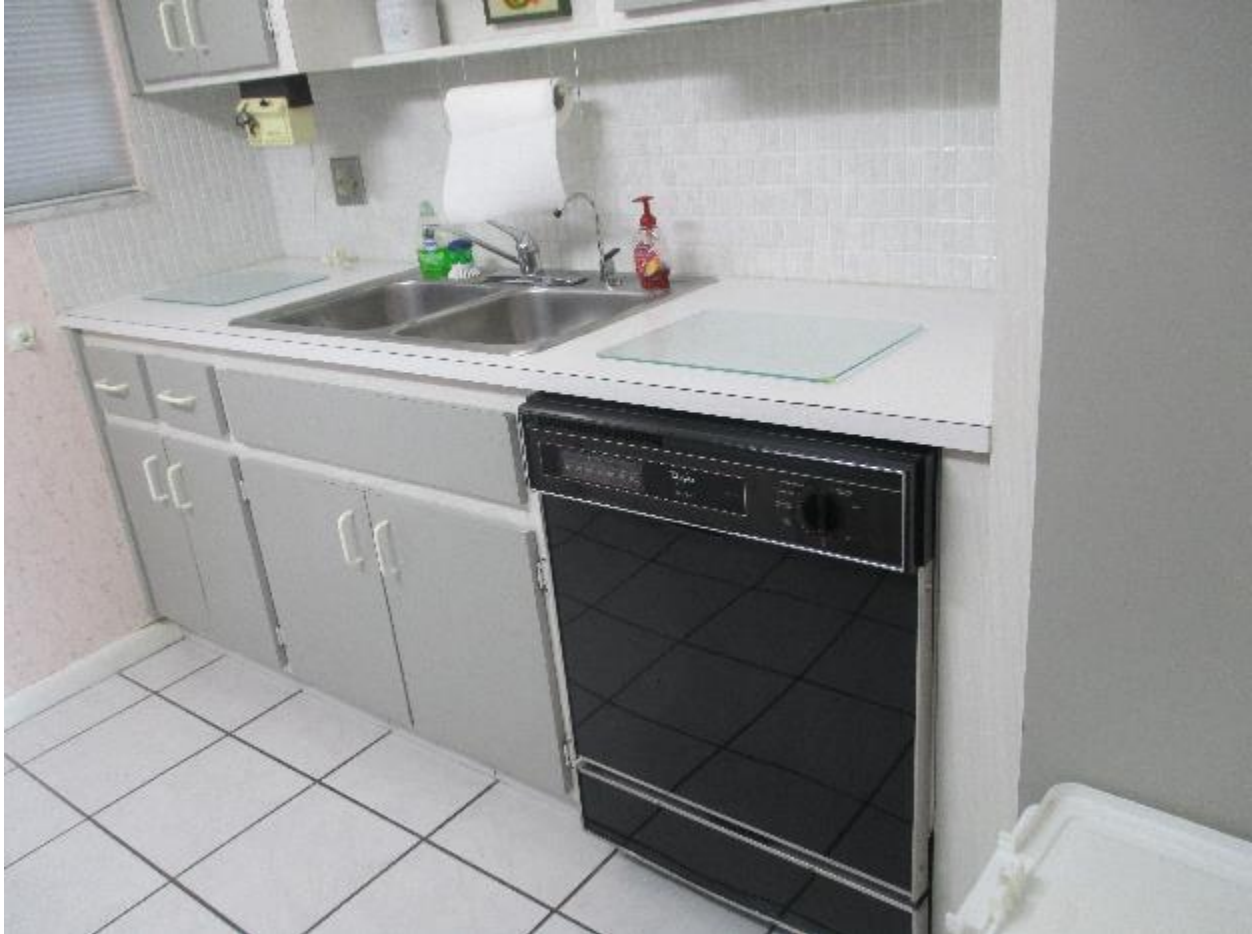
Interior finishes were found in general good condition at the time of inspection with exceptions as noted and shown in photographs.

No warranties or guarantees expressed on used appliances. We recommend to make allowances for the replacement appliances on this specific property.
