PROPERTY INSPECTION OR ASSESSMENT OF DAMAGES

ADDRESS: 000 SW 00 AVE DAVIE, FL
CLIENT: YOUR NAME HERE
ID No: 123
DATE: 01-01-XXXX

PROPERTY INSPECTION – 000 SW 00 AVE DAVIE, FL
ATTACHMENT - PHOTOGRAPHS
DATE: 01-01-XXXX

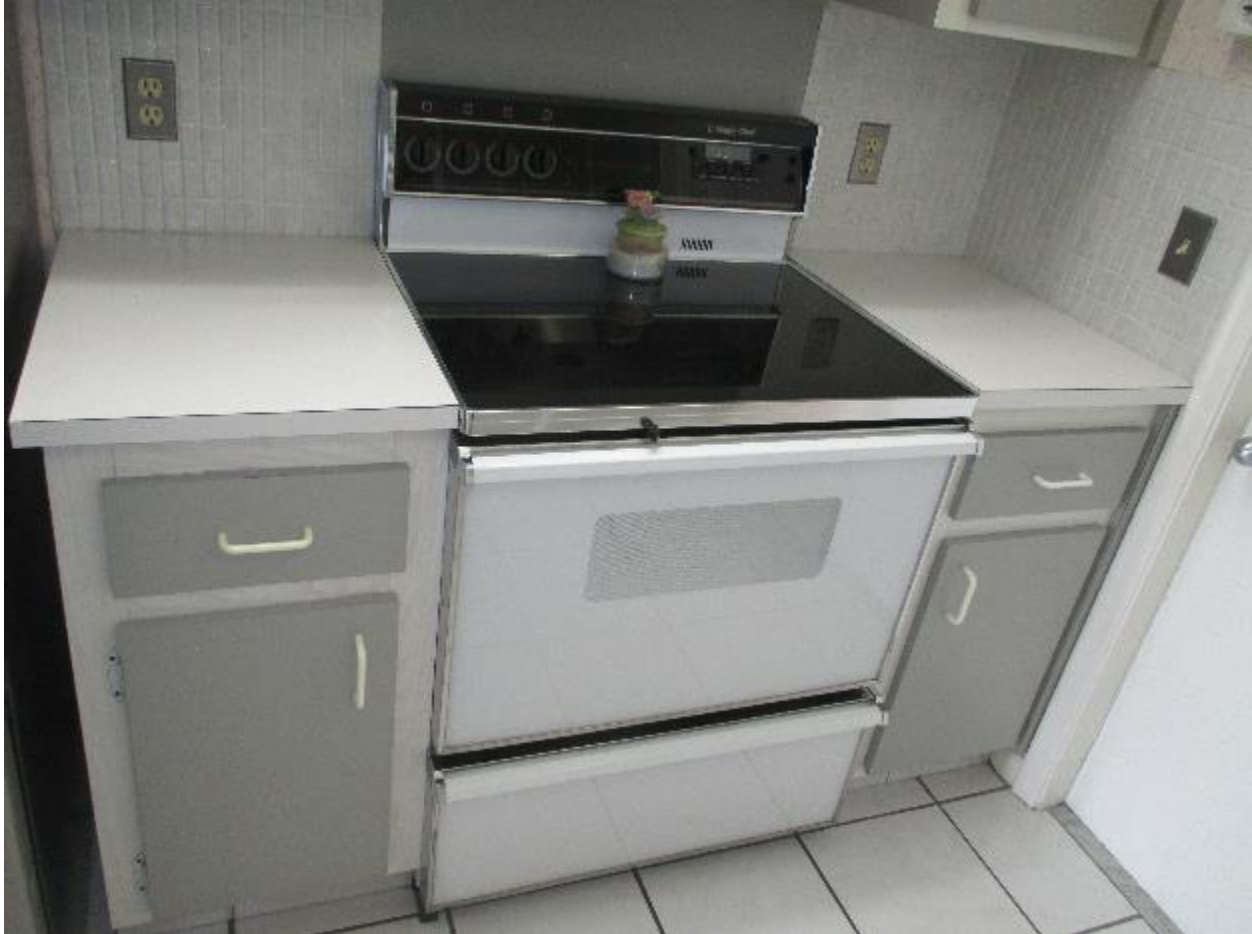
Interior finishes were found in general good condition at the time of inspection with exceptions as noted and shown in photographs.

No warranties or guarantees expressed on used appliances. We recommend to make allowances for the replacement appliances on this specific property.

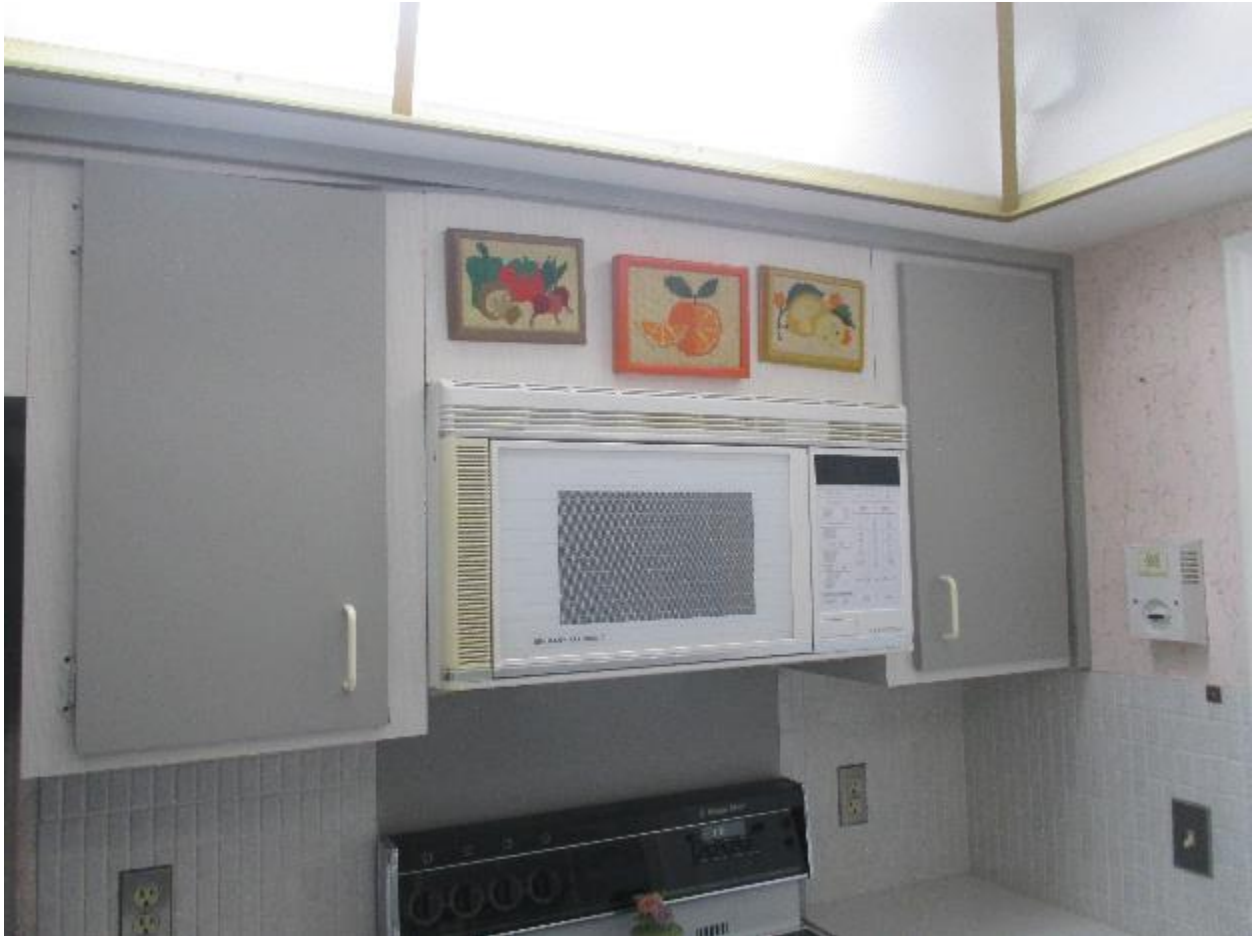
Interior finishes were found in general good condition at the time of inspection with exceptions as noted and shown in photographs.

No warranties or guarantees expressed on used appliances. We recommend to make allowances for the replacement appliances on this specific property.

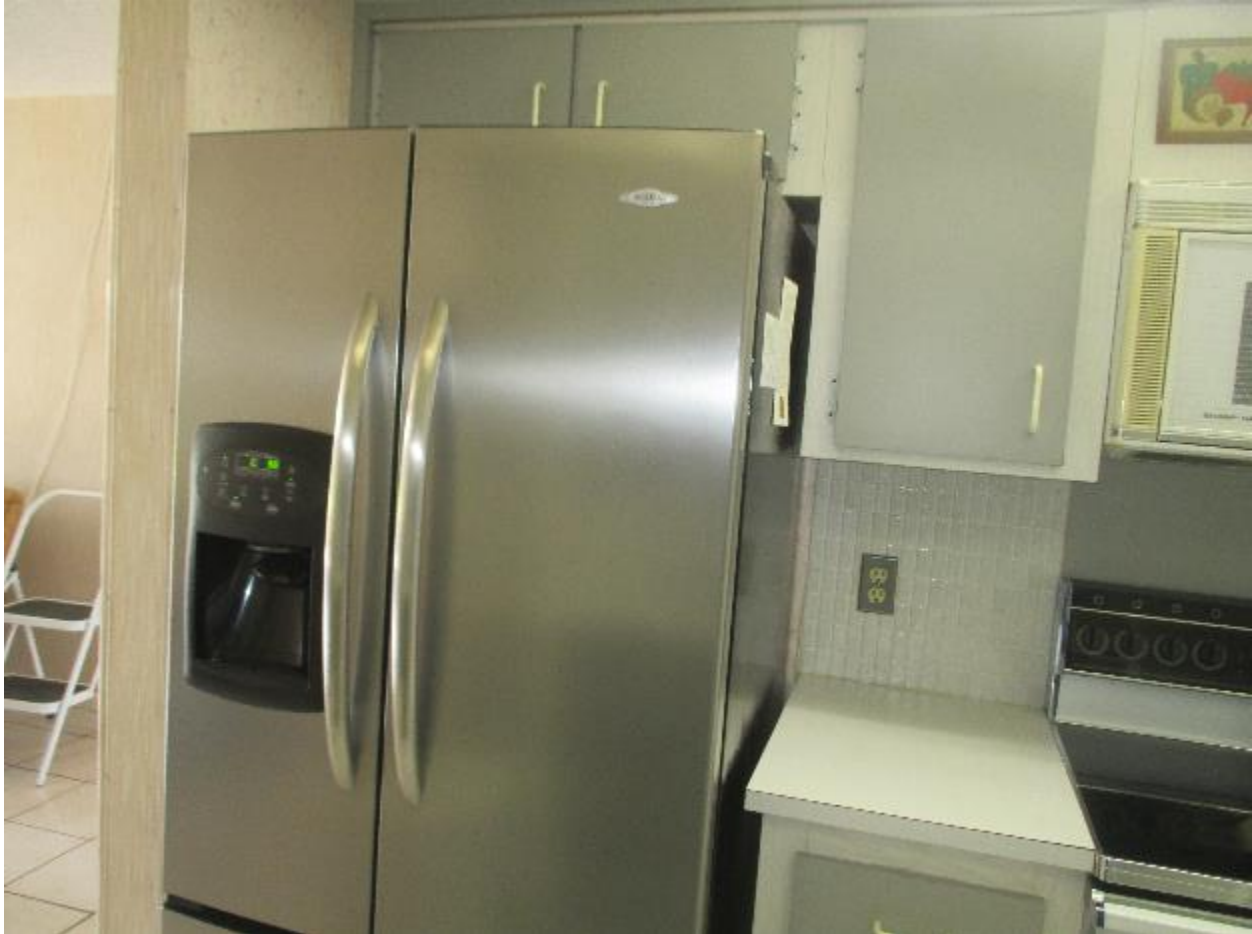
Interior finishes were found in general good condition at the time of inspection with exceptions as noted and shown in photographs.

No warranties or guarantees expressed on used appliances. Appliances found in working condition at the time of inspection.

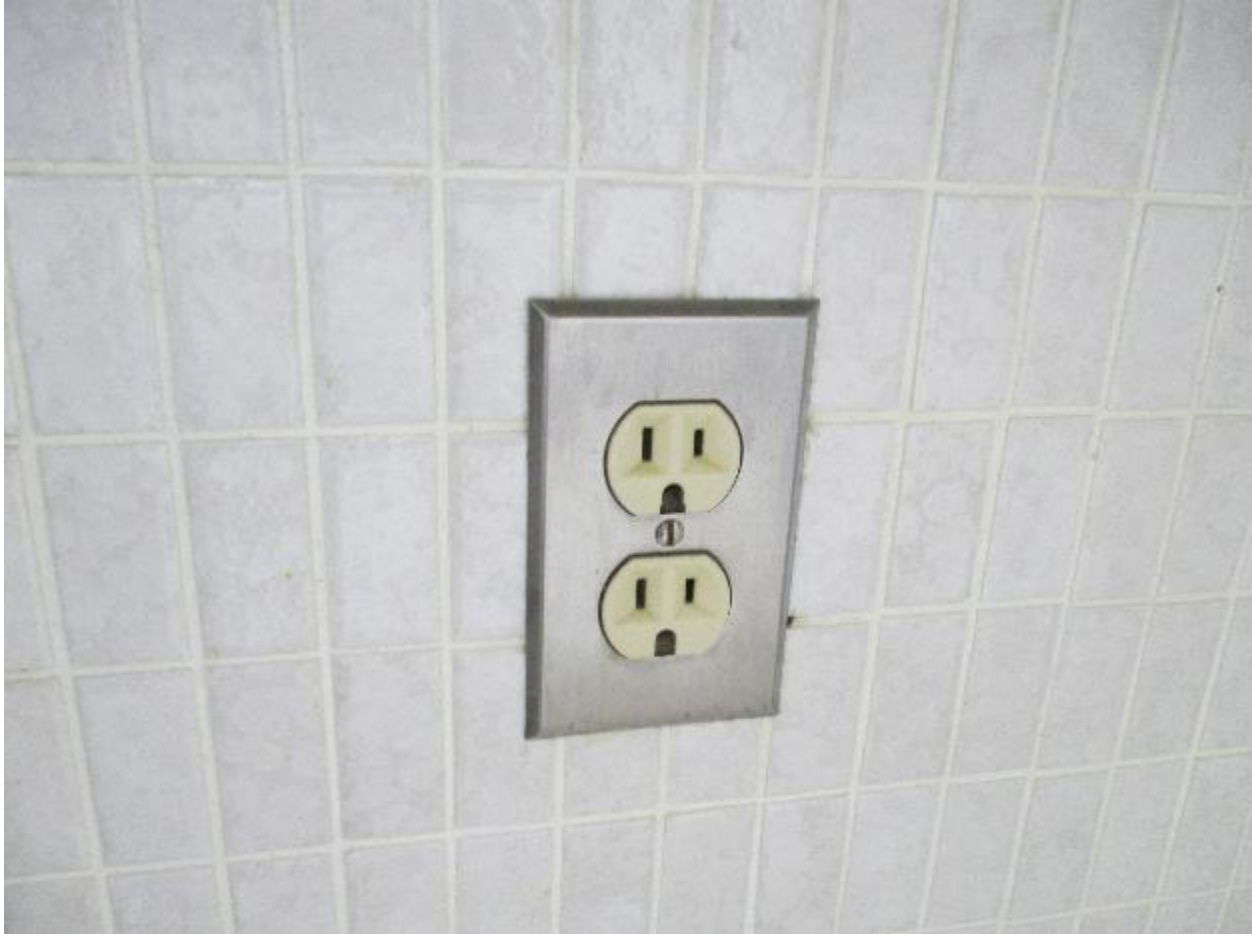
GFCI receptacles installation is required at wet areas such as bathrooms and kitchens.

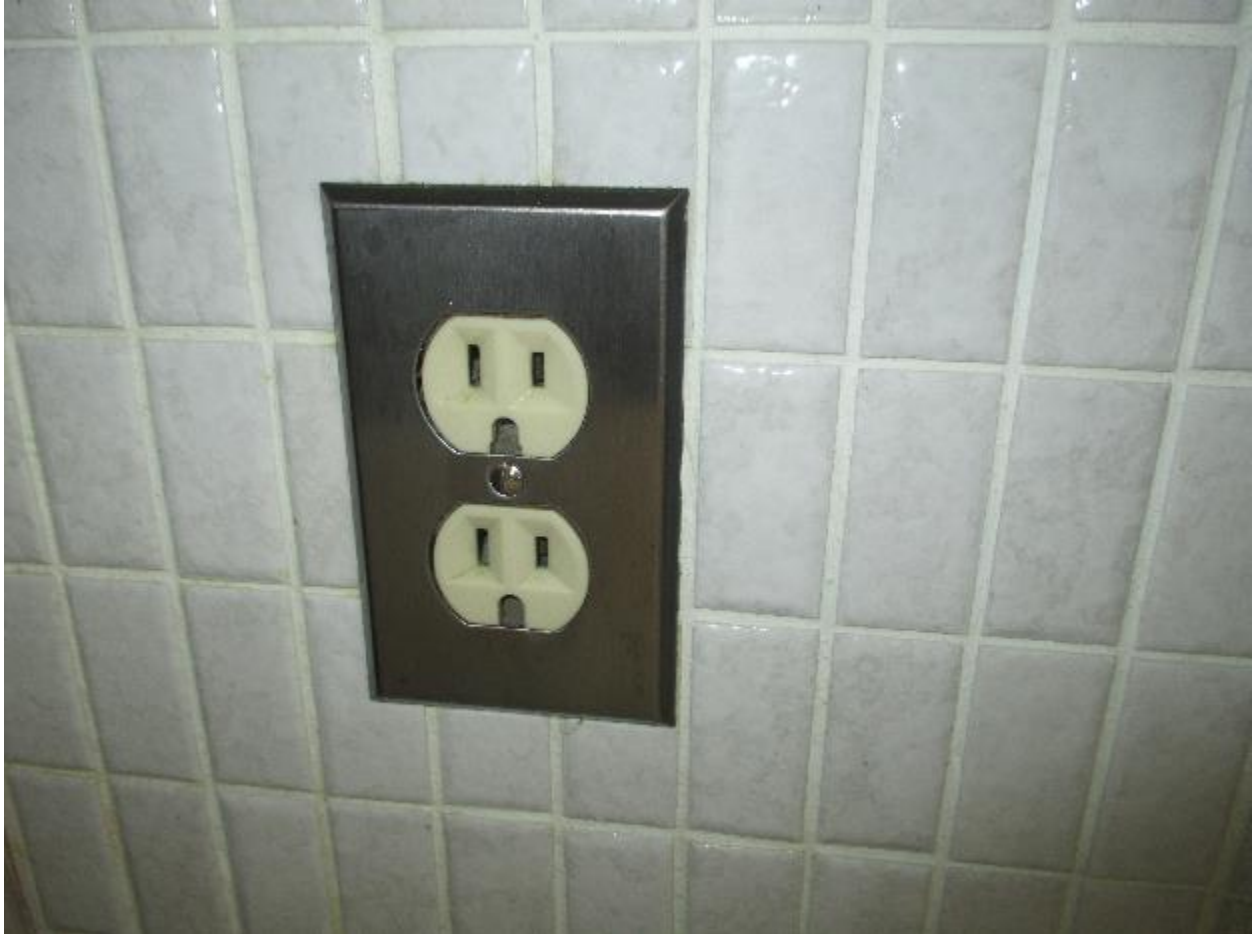
GFCI receptacles installation is required at wet areas such as bathrooms and kitchens.

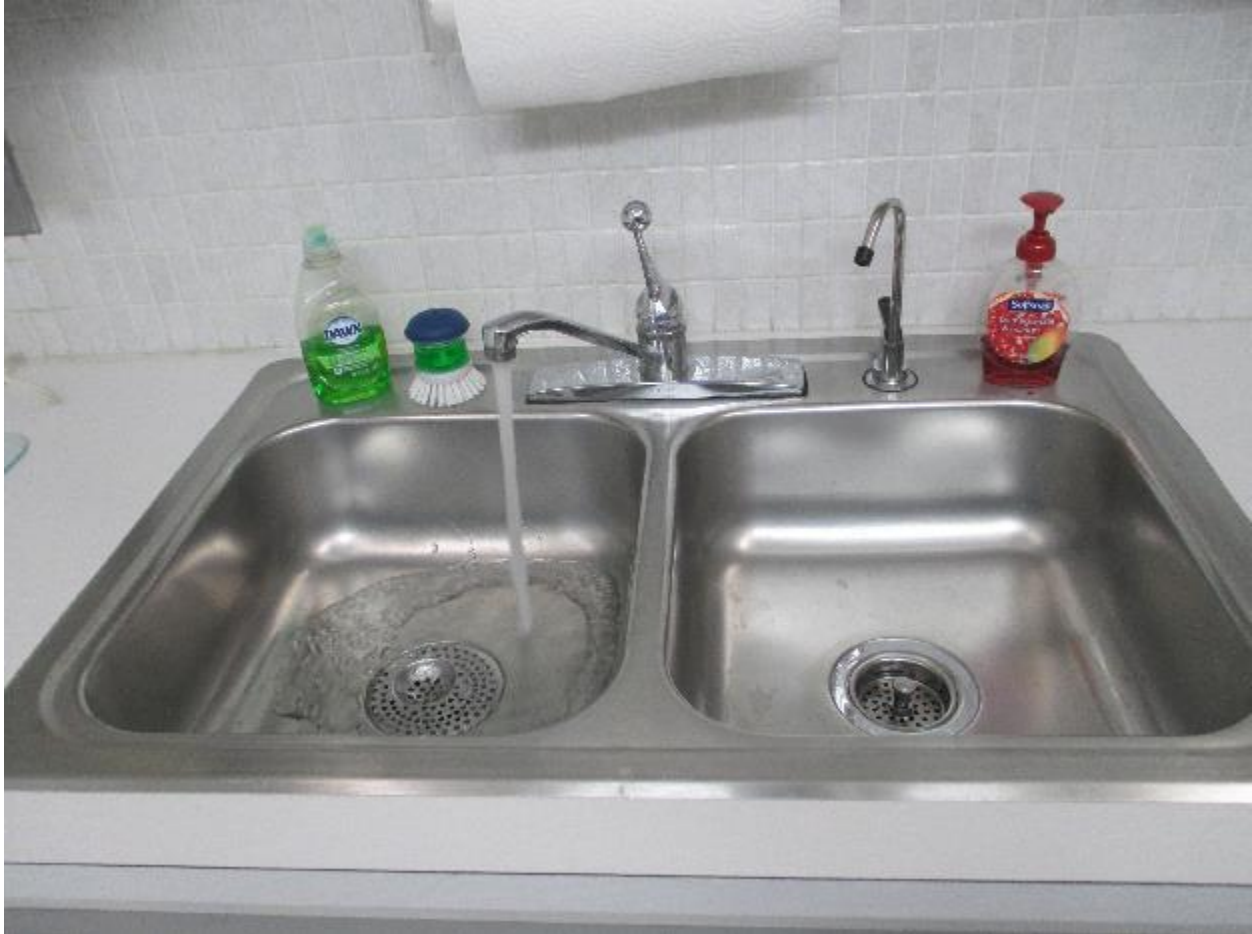
Plumbing systems tested for proper flow. No leaks or deficiencies noted on drain and supply lines.

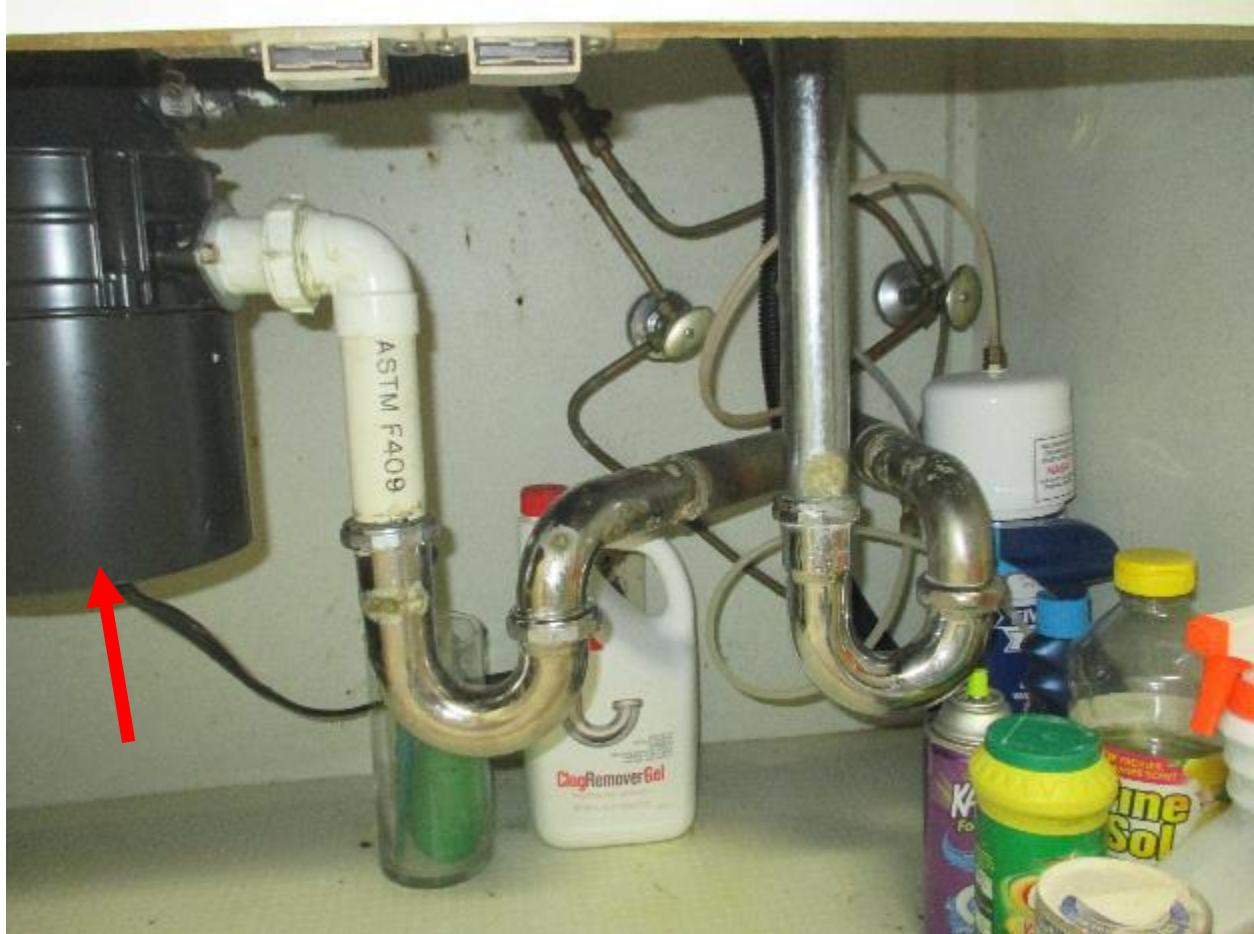
Plumbing systems tested for proper flow. No leaks or deficiencies noted on drain and supply lines.

Replace garbage disposal.

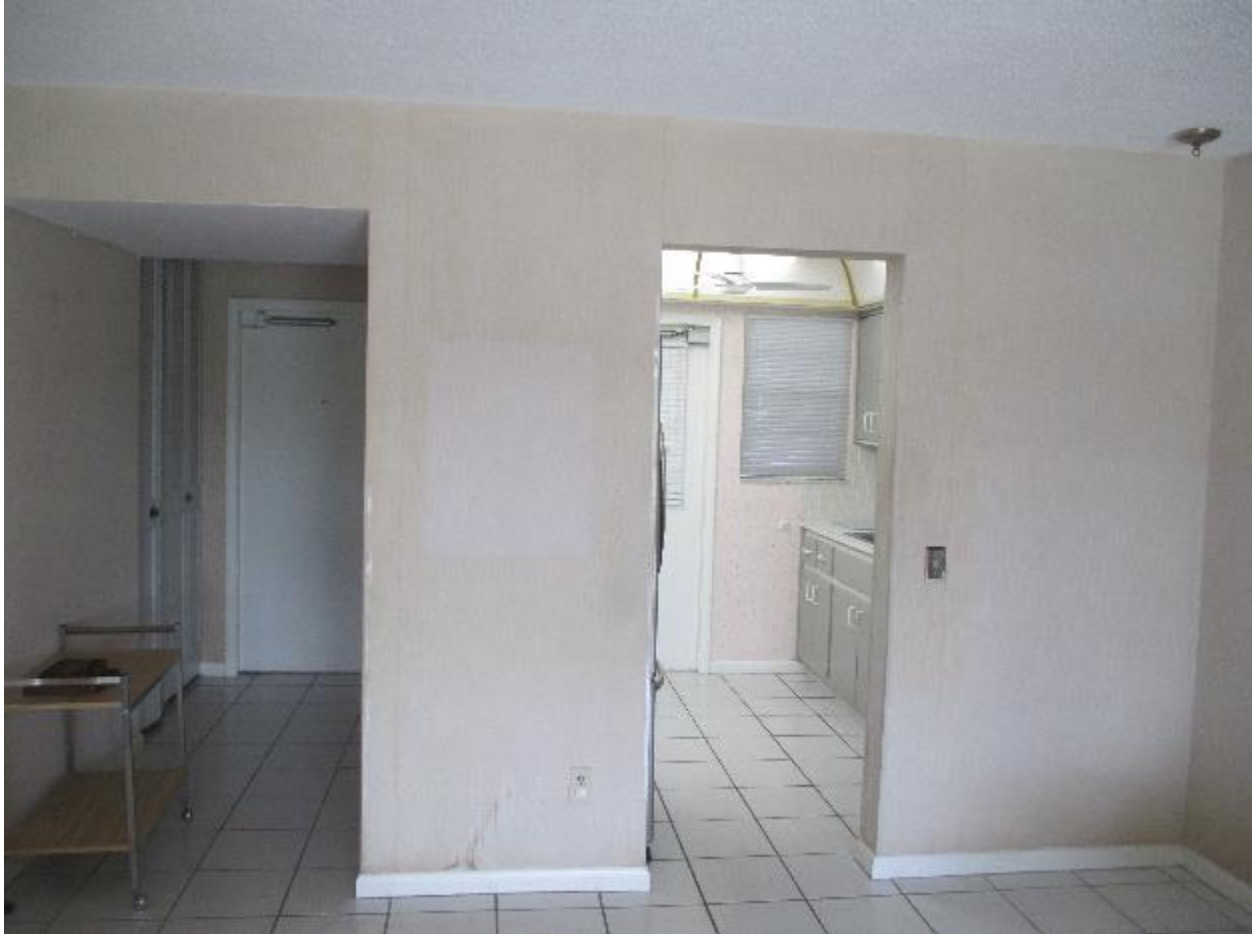
Wall paper removal required. Refinish of walls and preparation for paint job is needed.

Interior rehabilitation must include and no limited to:

Interior prime and paint.

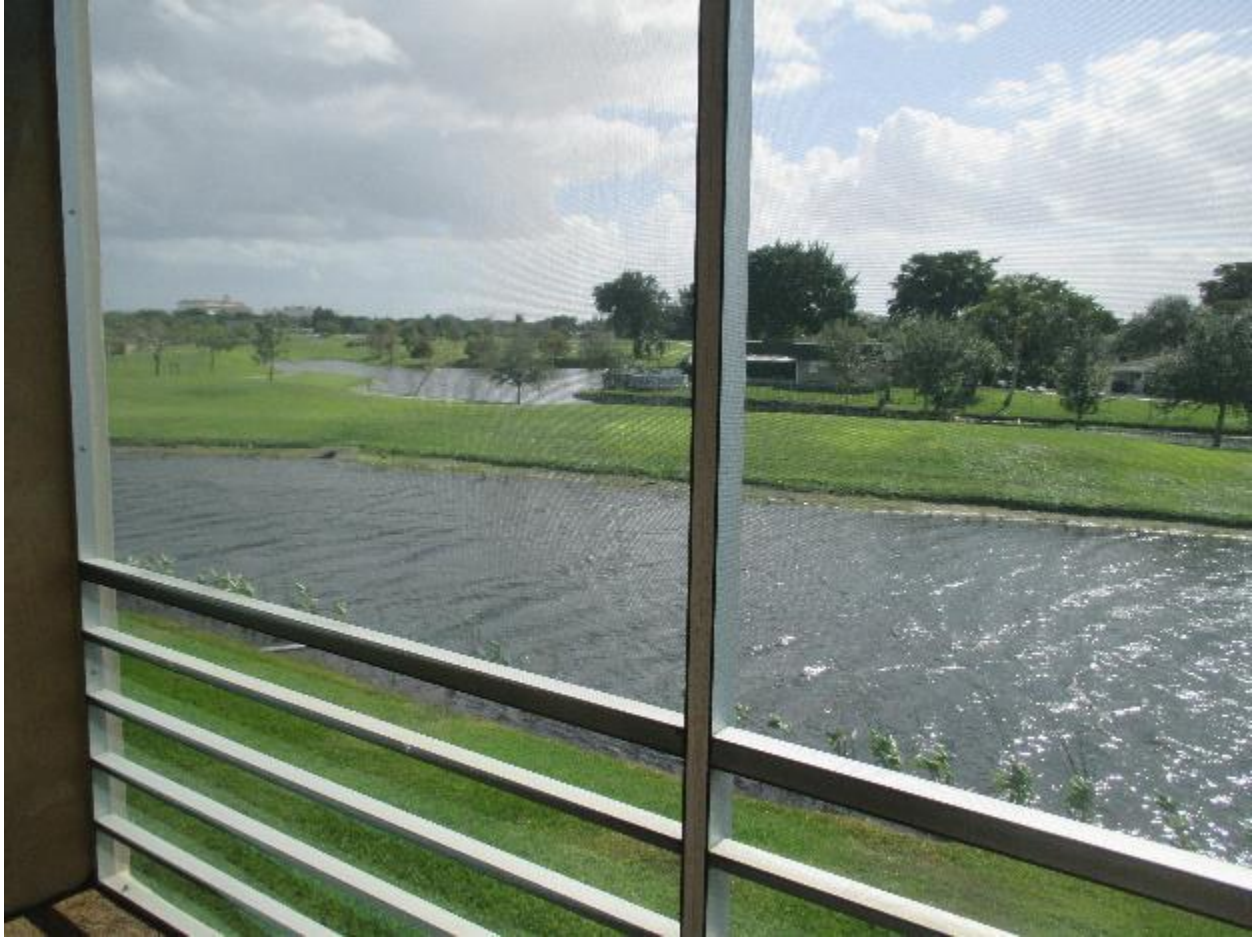
Screened balcony requires repairs.

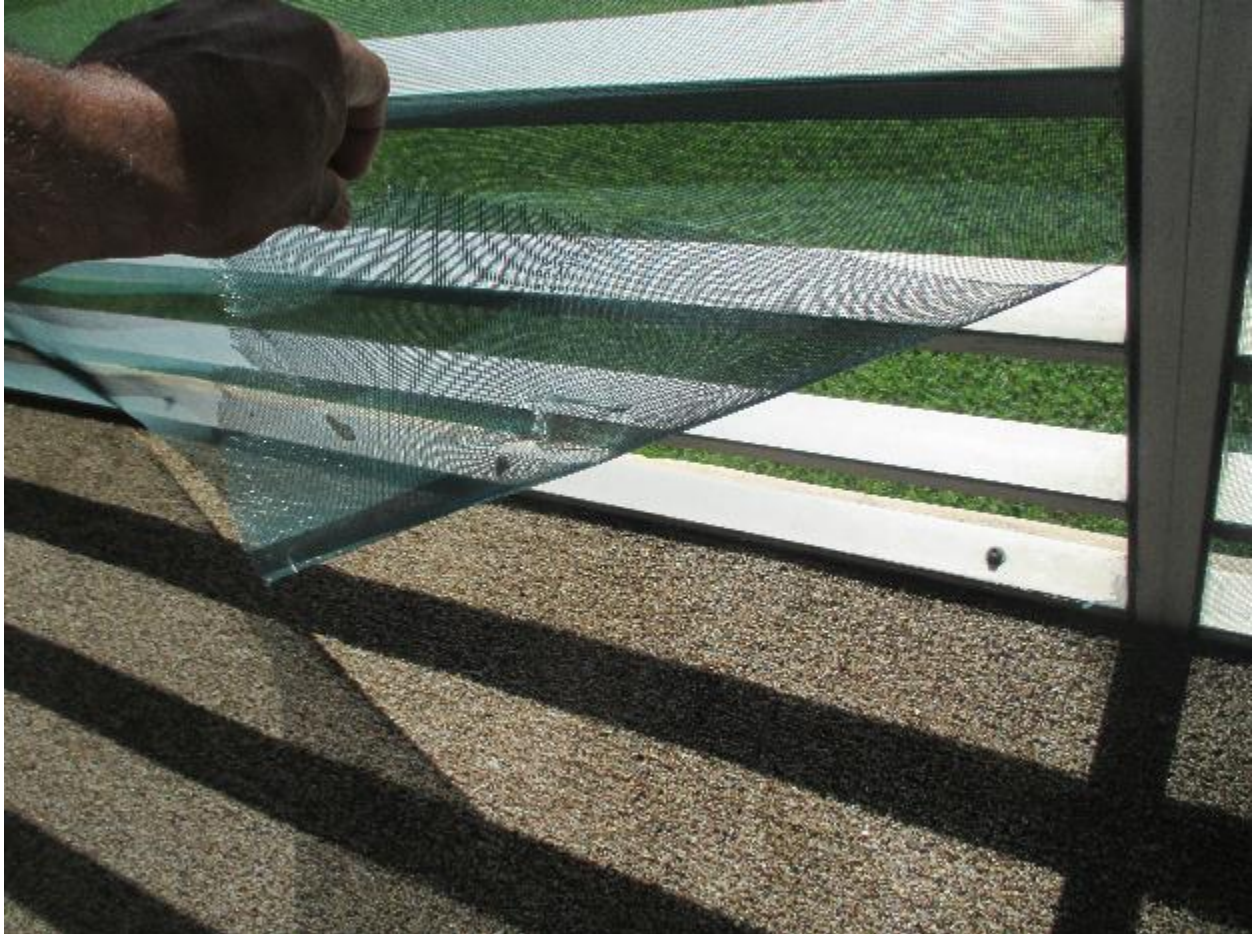
Screened balcony requires repairs.

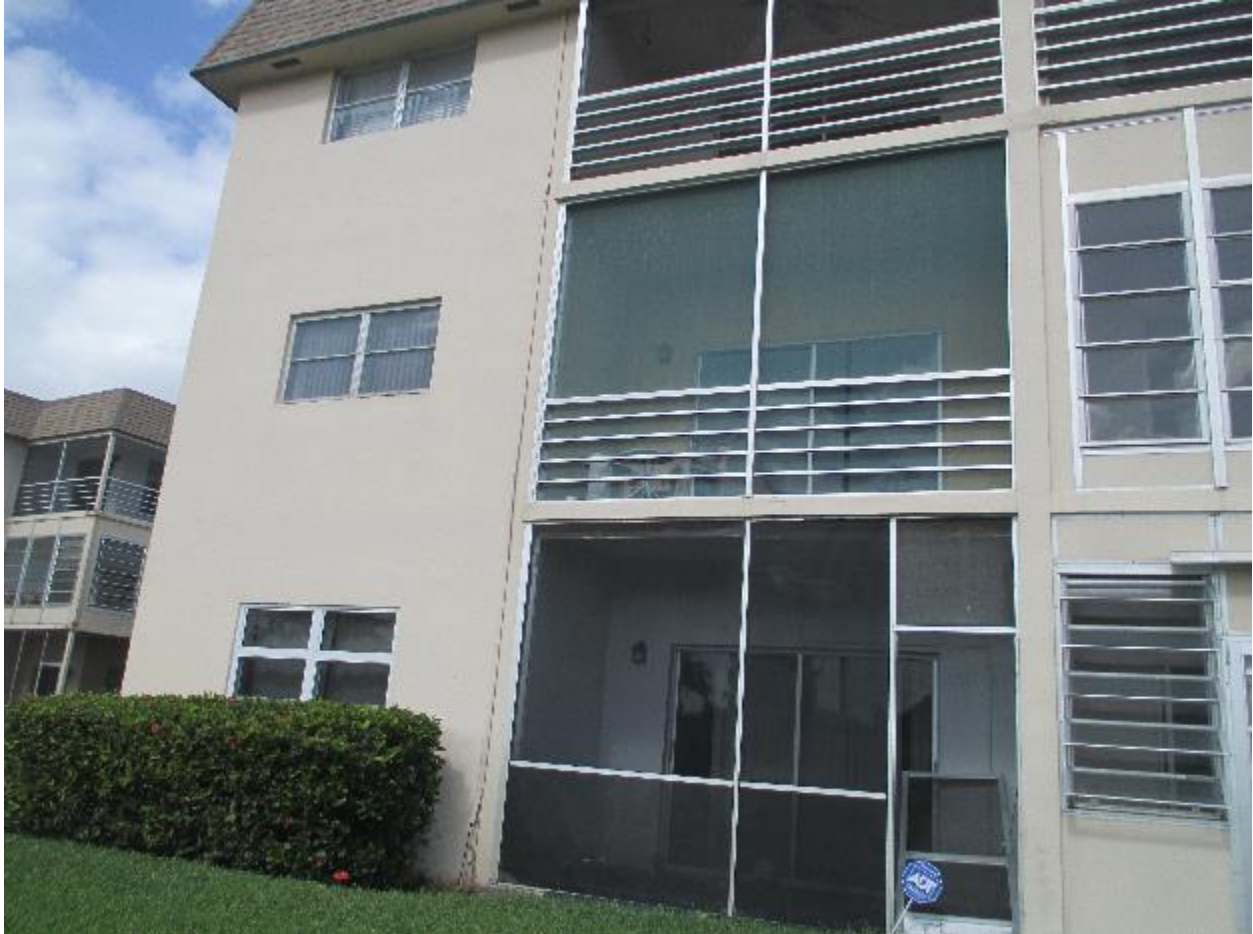
Exterior finishes were found in general good condition at the time of inspection with exceptions as noted and shown in photographs.
