PROPERTY INSPECTION OR ASSESSMENT OF DAMAGES

ADDRESS: Somewhere, FL
CLIENT: GAIA GC
ID No: 2015000
DATE: 12/31/2015

INSPECTION OR ASSESSMENT BY:

GAIA CONSTRUCTION INC.
CGC 1516136 **FLORIDA**
HI-2792 **FLORIDA**
8028867-B2 **INTERNATIONAL CODE COUNCIL**

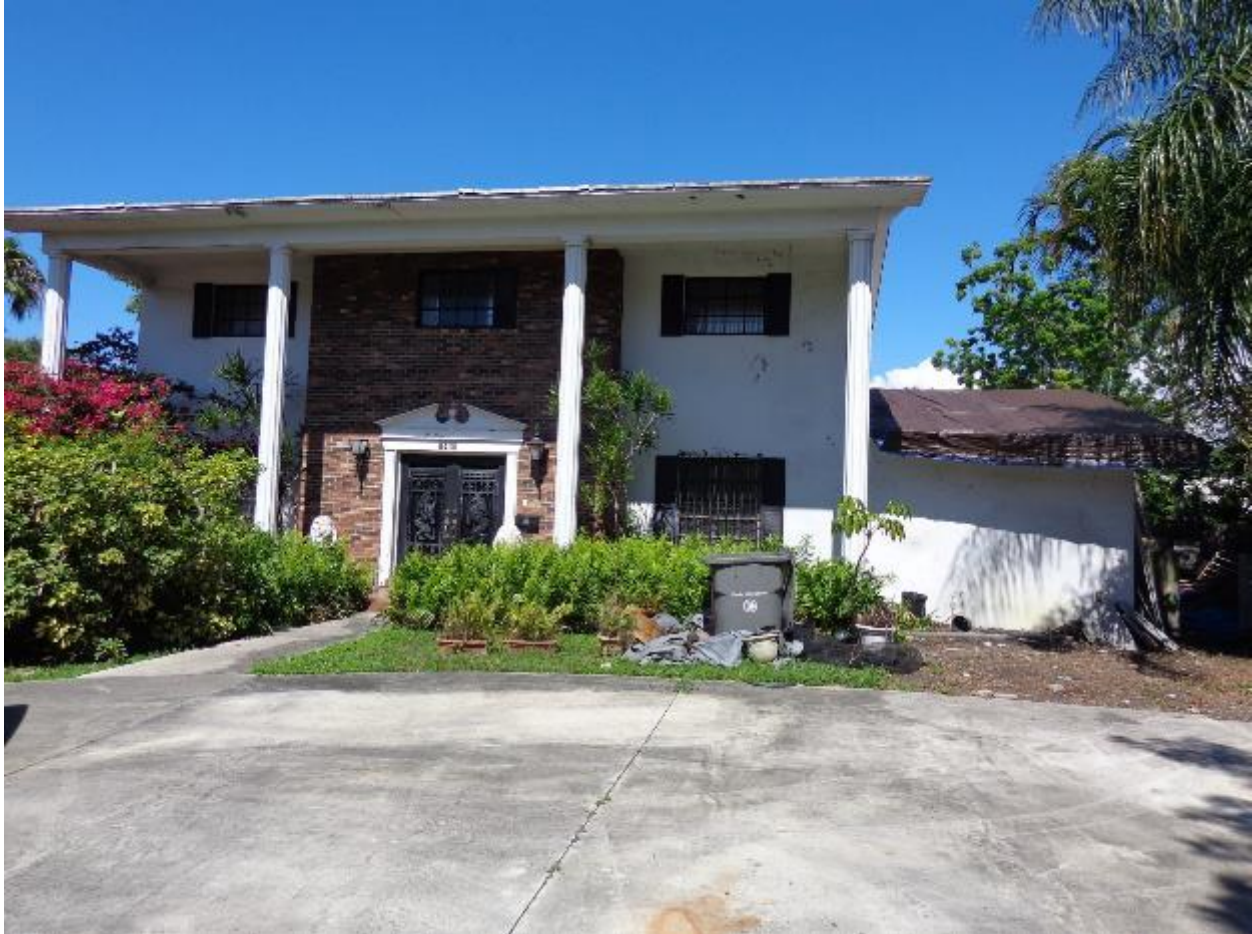
Pressure wash and paint, replace obsolete and failing window system, replace exterior doors, fascia and soffit rotted wood replacement, overgrown vegetation removal, structural repairs required. Refer to attached photographs for details.

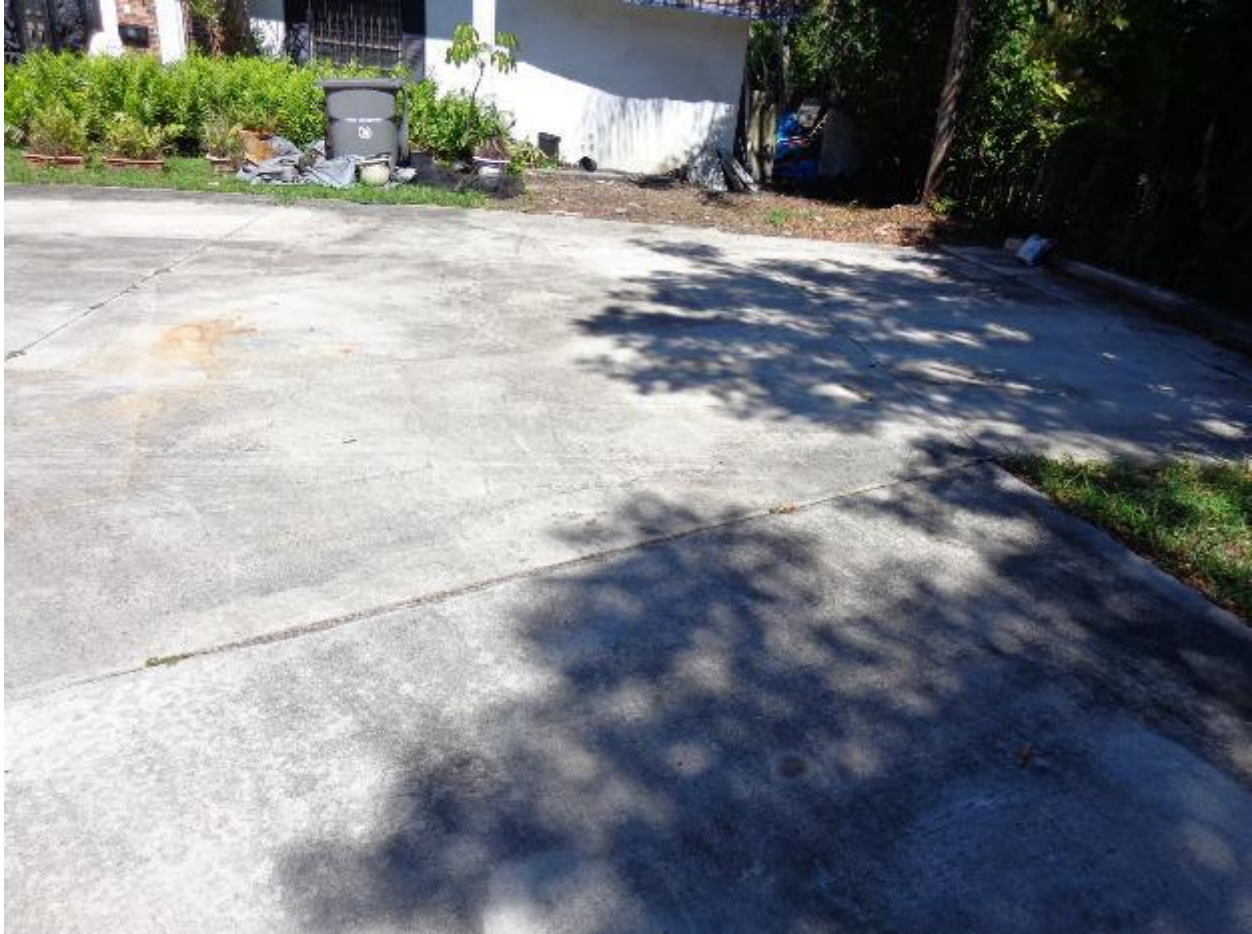
Driveway requires pressure wash.

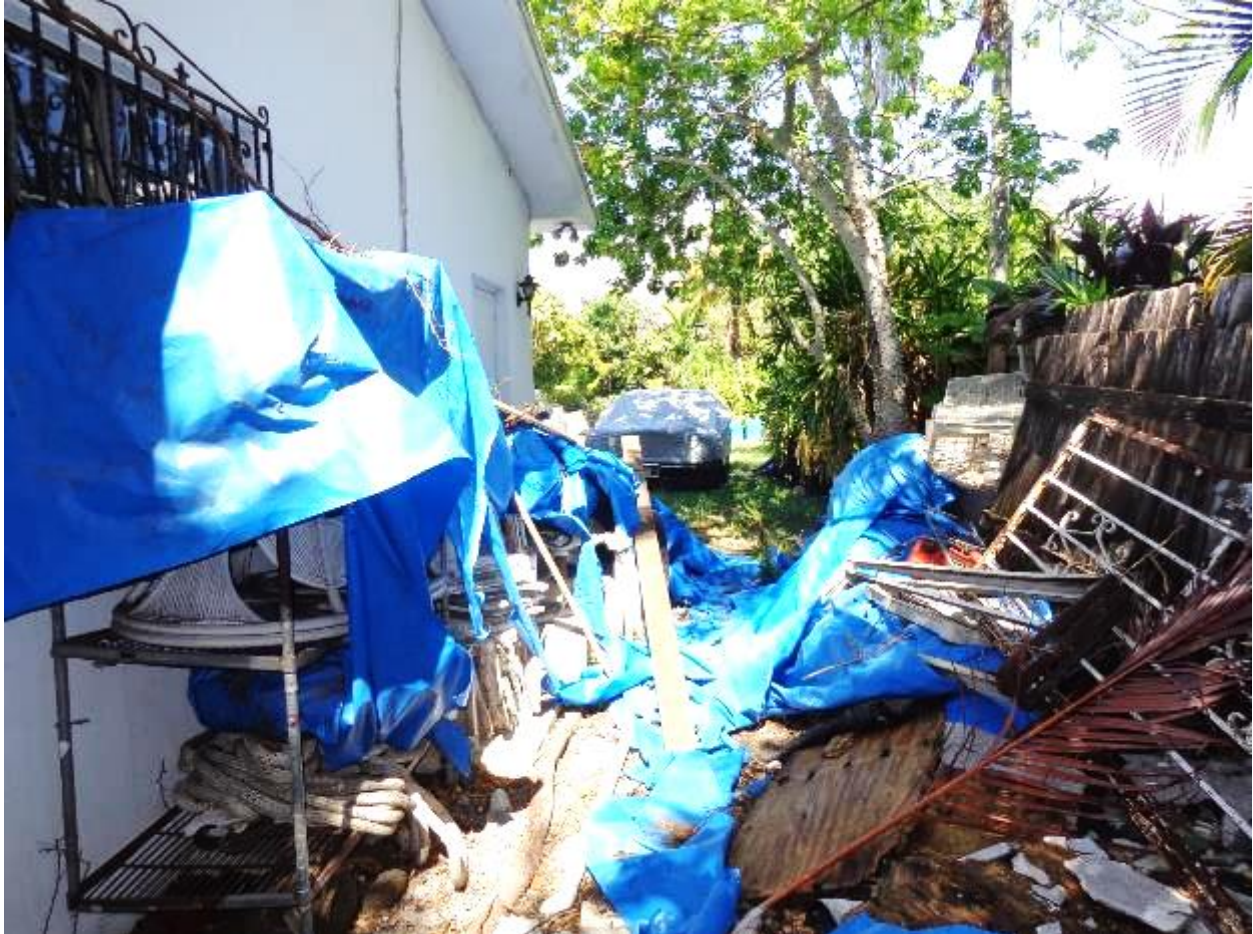
Pressure wash and paint, replace obsolete and failing window system, replace exterior doors, fascia and soffit rotted wood replacement, overgrown vegetation removal, structural repairs required. Refer to attached photographs for details.

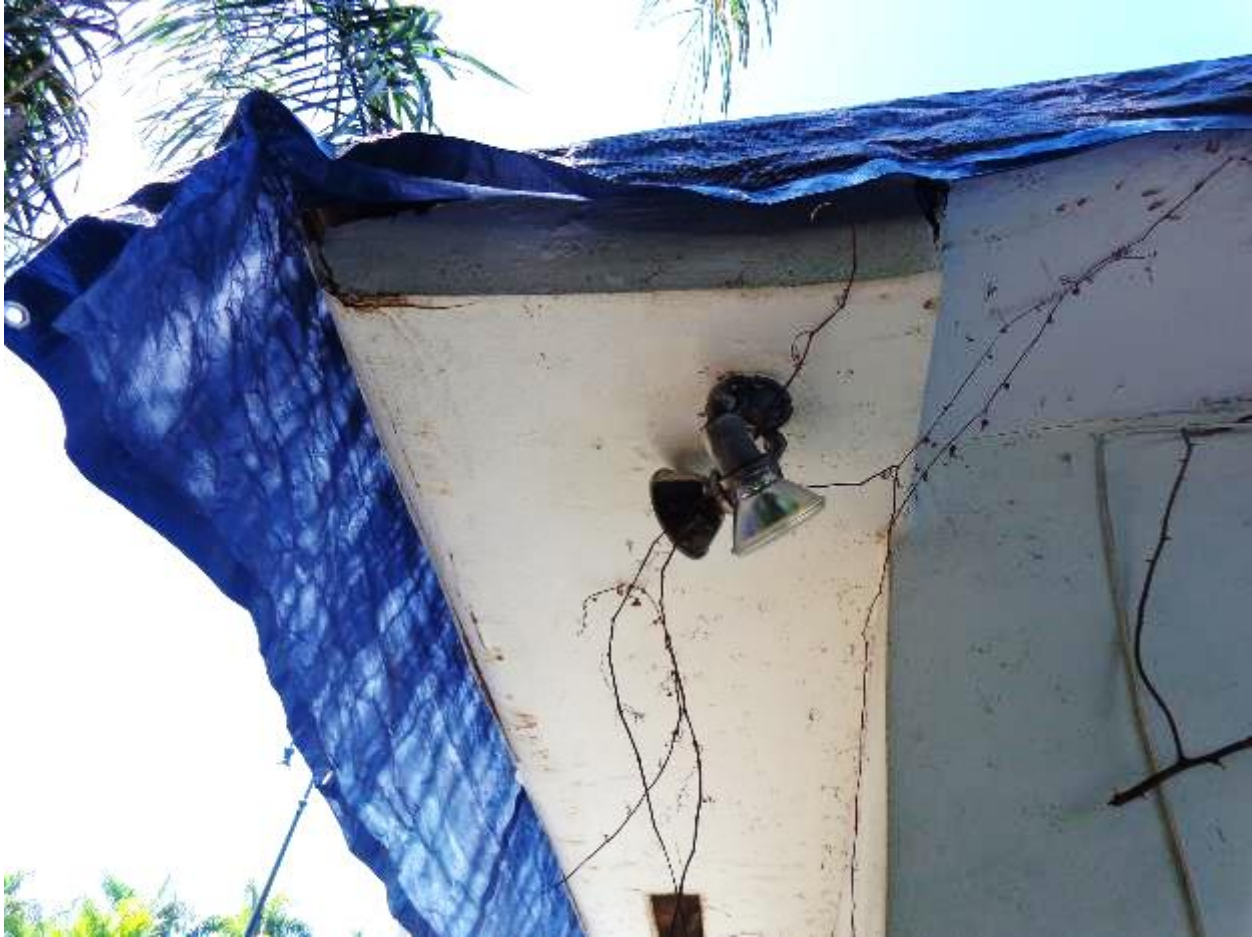
Stucco repairs required.

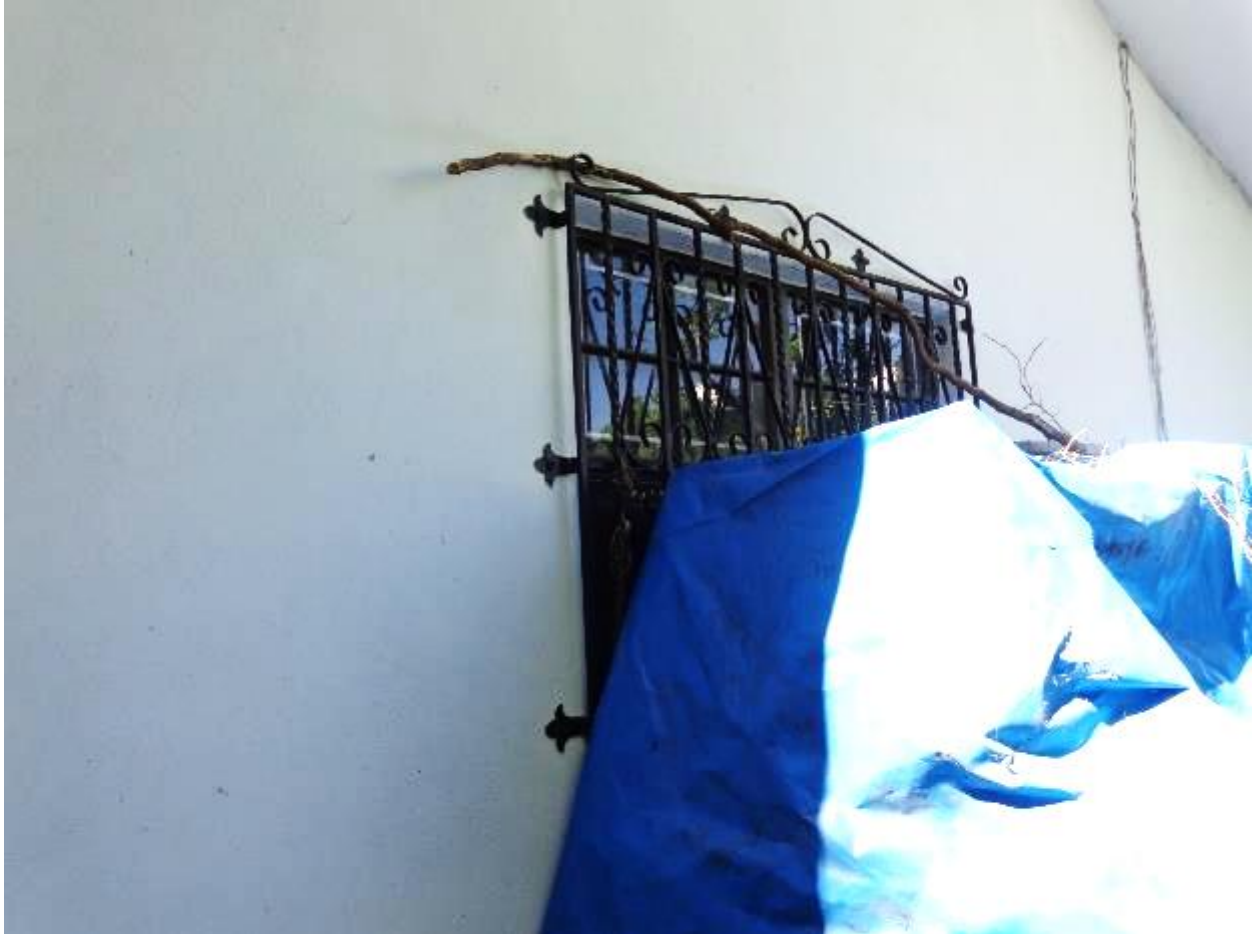
Removal of iron bars required to allow for emergency egress.

It is recommended a full replacement of windows with impact glass as per current code and avoid the installation of hurricane shutters.

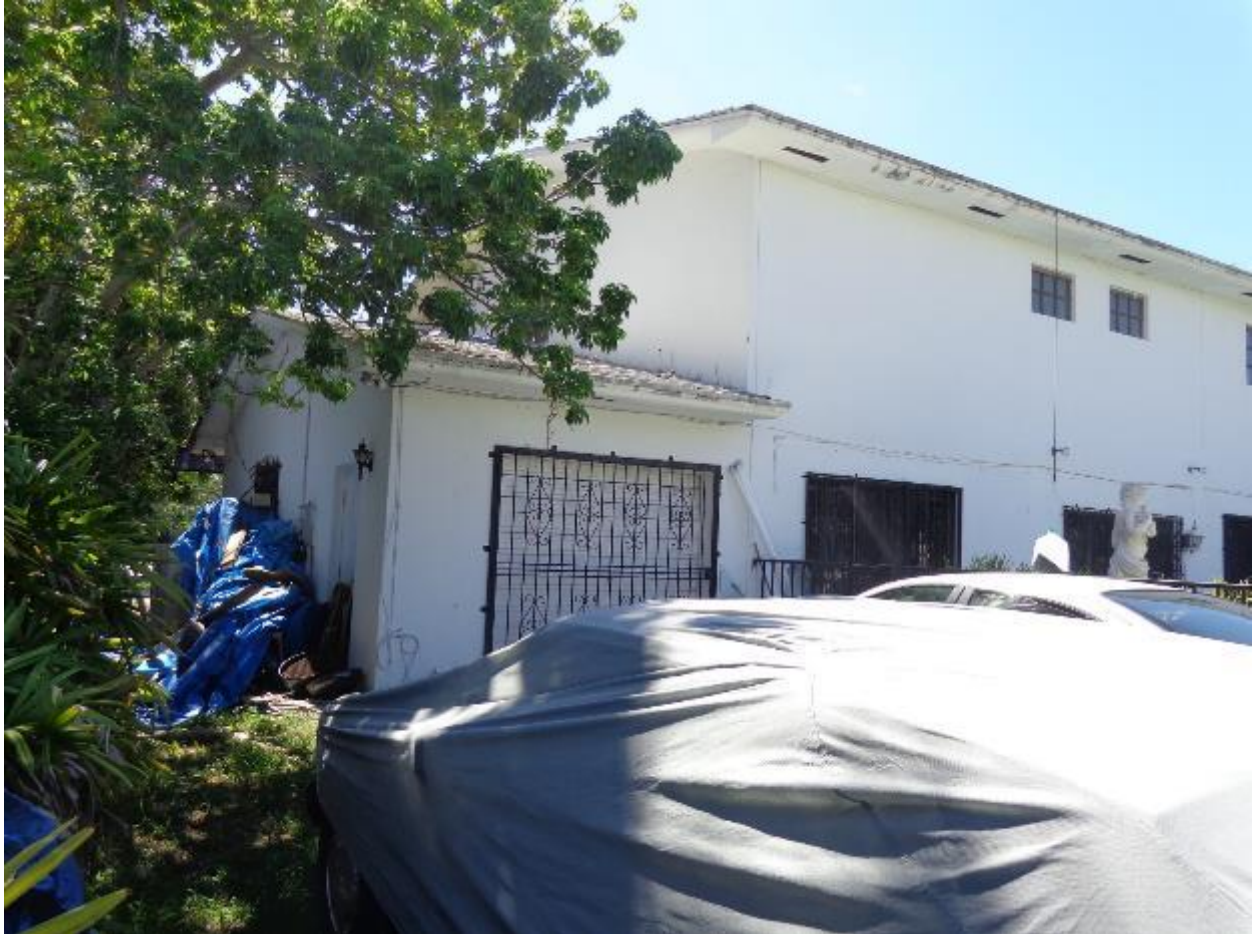
Pressure wash and paint, replace obsolete and failing window system,
replace exterior doors, fascia and soffit rotted wood replacement,
overgrown

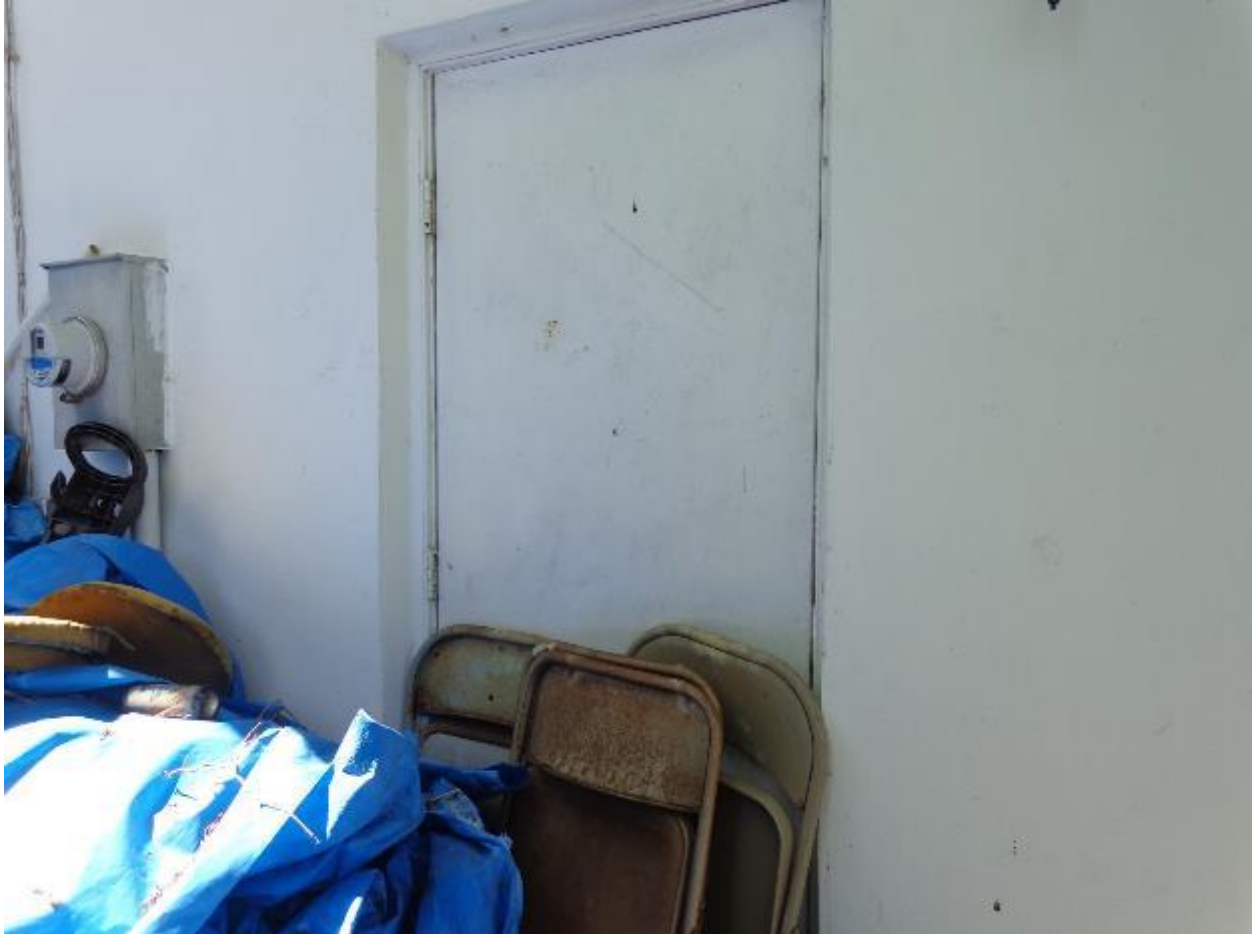
Exterior door(s) require replacement. Currently beyond possibilities of repair.

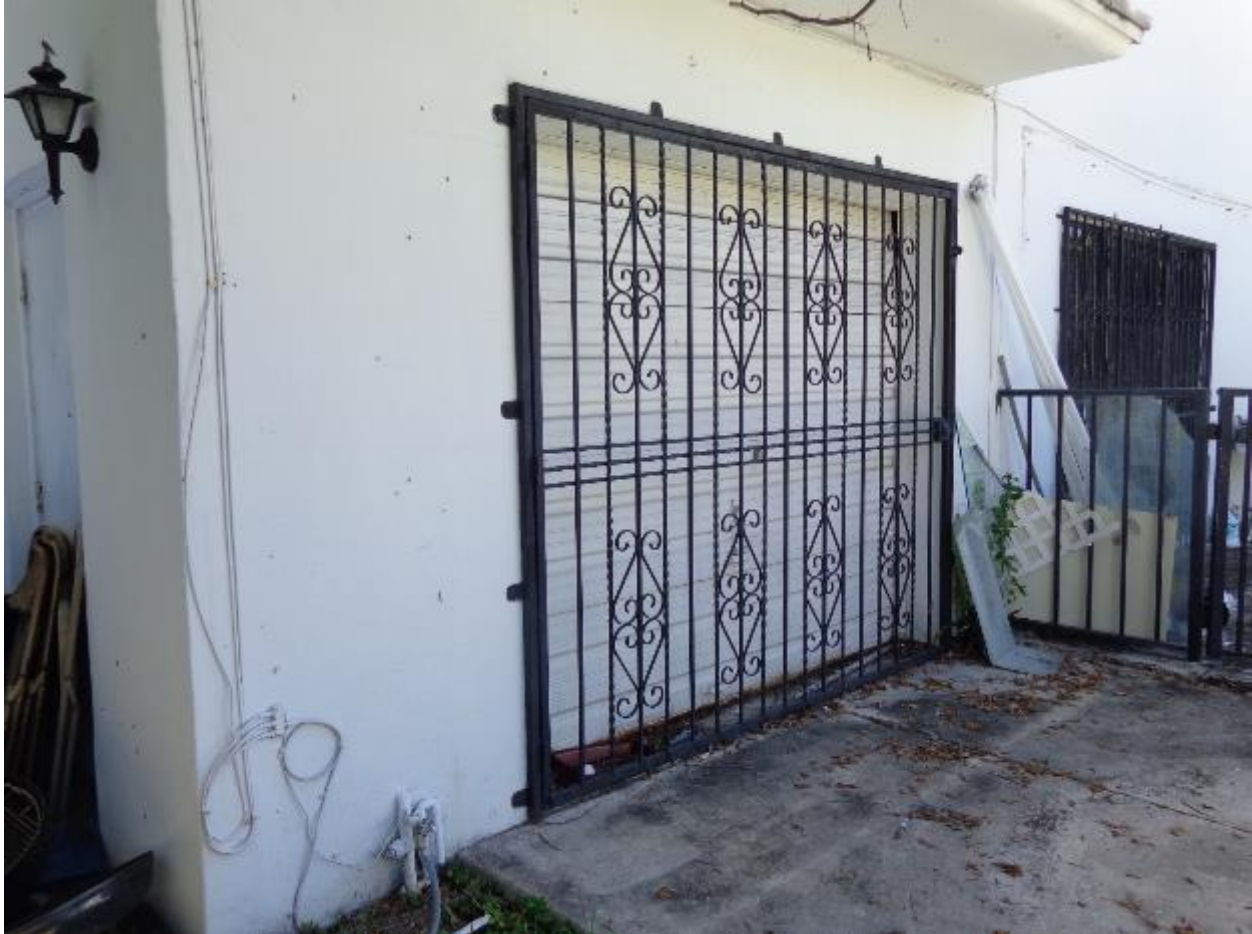
Removal of iron bars required to allow for emergency egress.

Garage doors require replacement, currently corroded and damaged beyond possibilities of repairs.

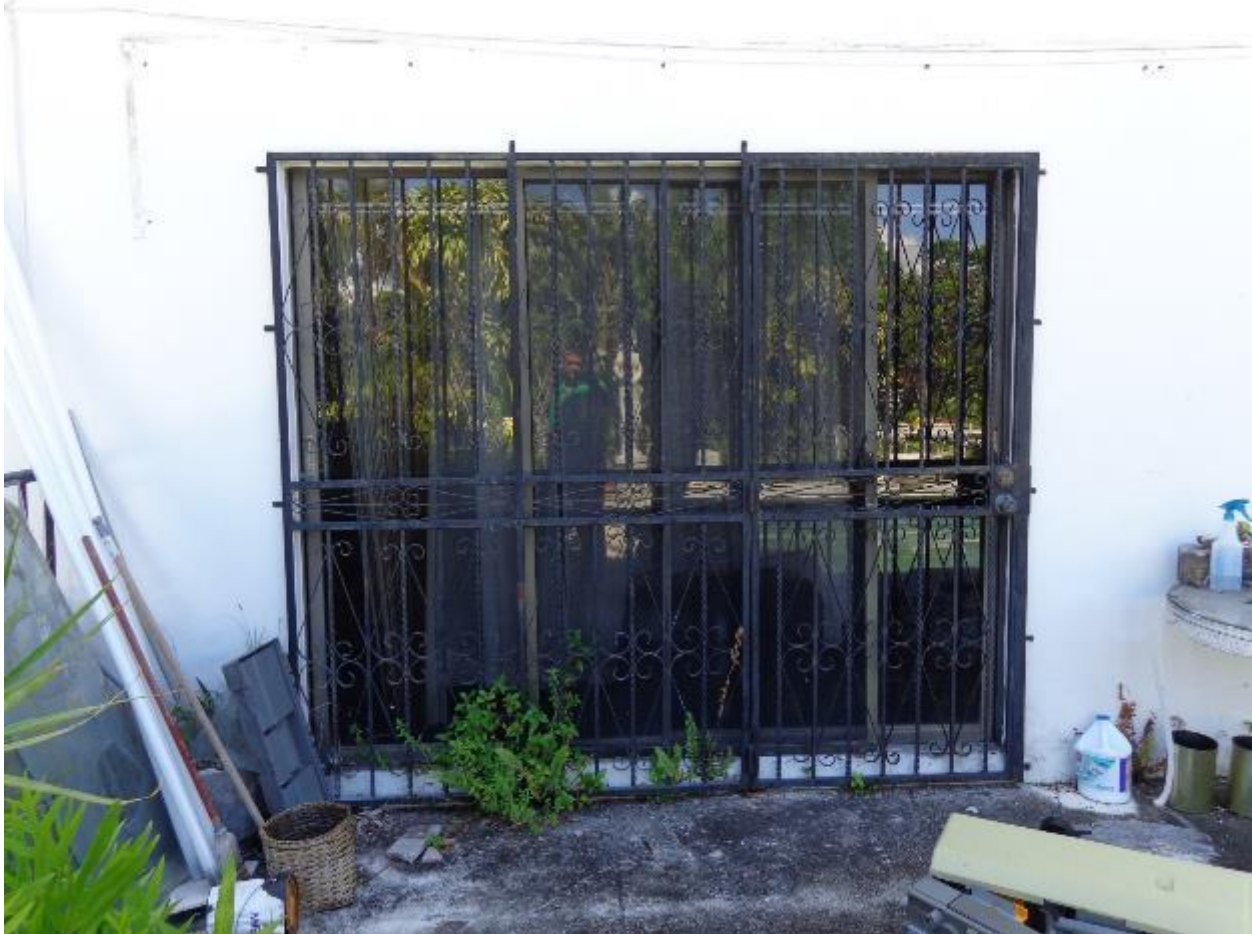
Removal of iron bars required to allow for emergency egress.

It is recommended a full replacement of windows with impact glass as per current code and avoid the installation of hurricane shutters.

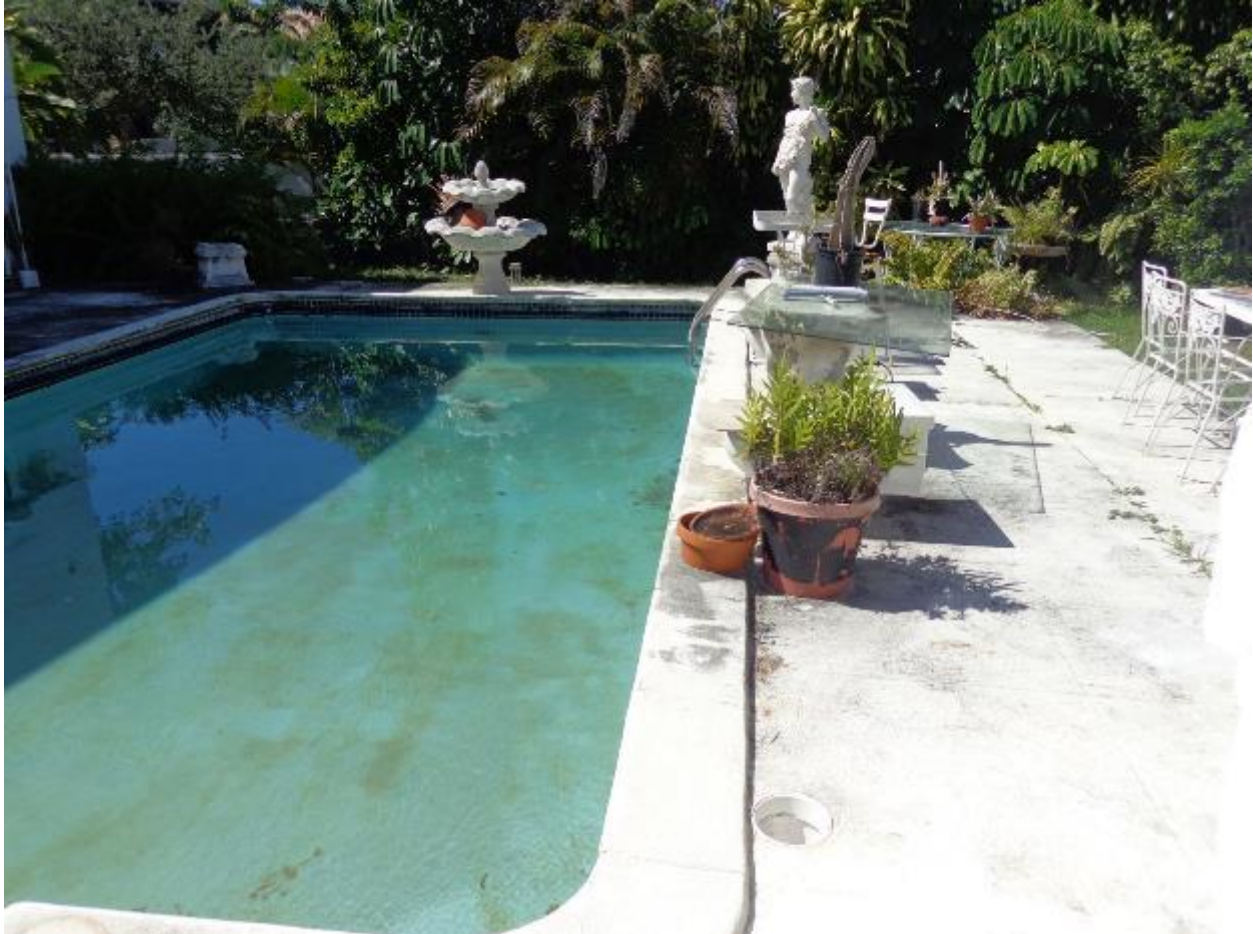
We did perform a limited visual examination of the pool condition. Allowances must be made for re-surfacing. Diamond-brite or similar coating required.

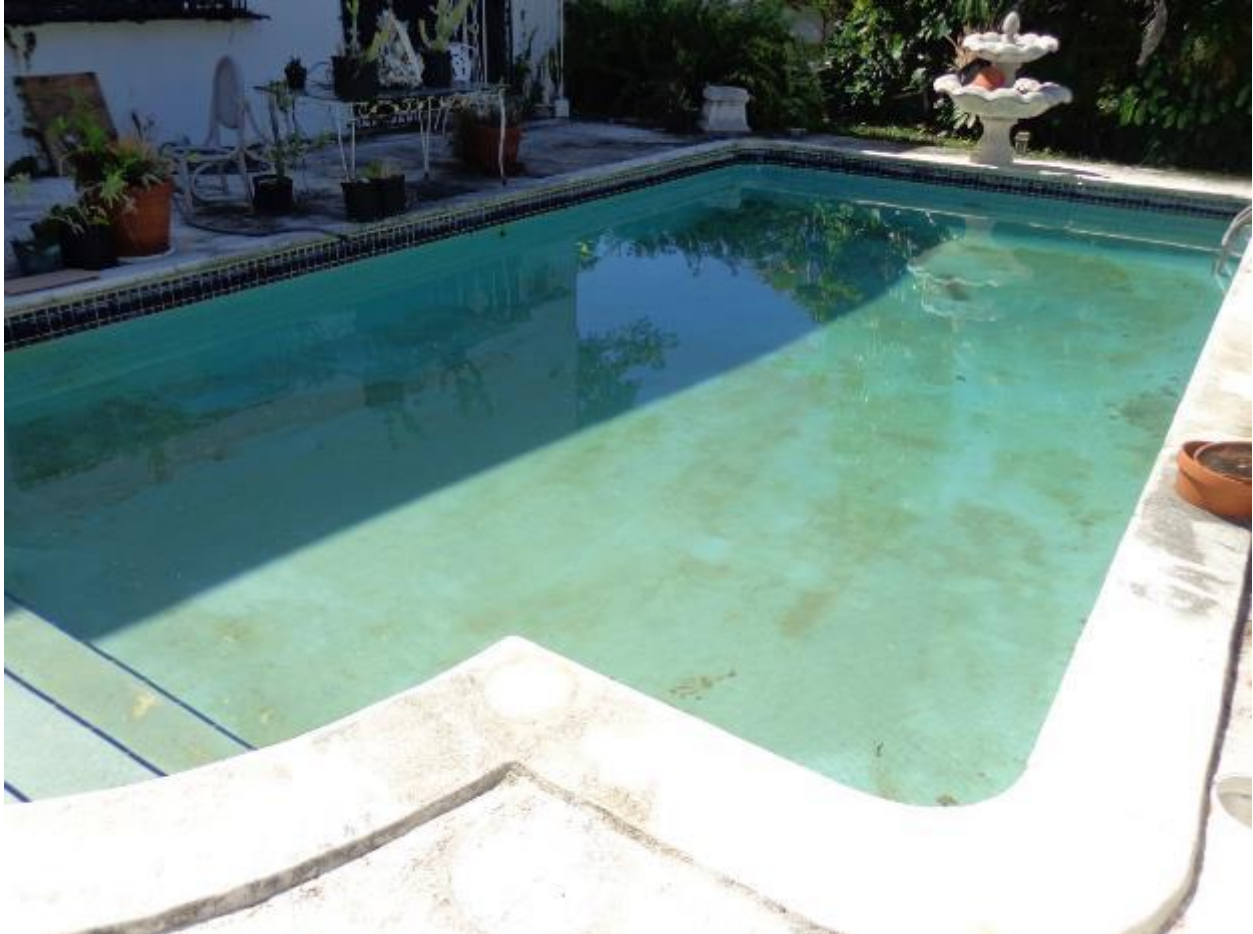
We did perform a limited visual examination of the pool condition. Allowances must be made for re-surfacing. Diamond-brite or similar coating required.

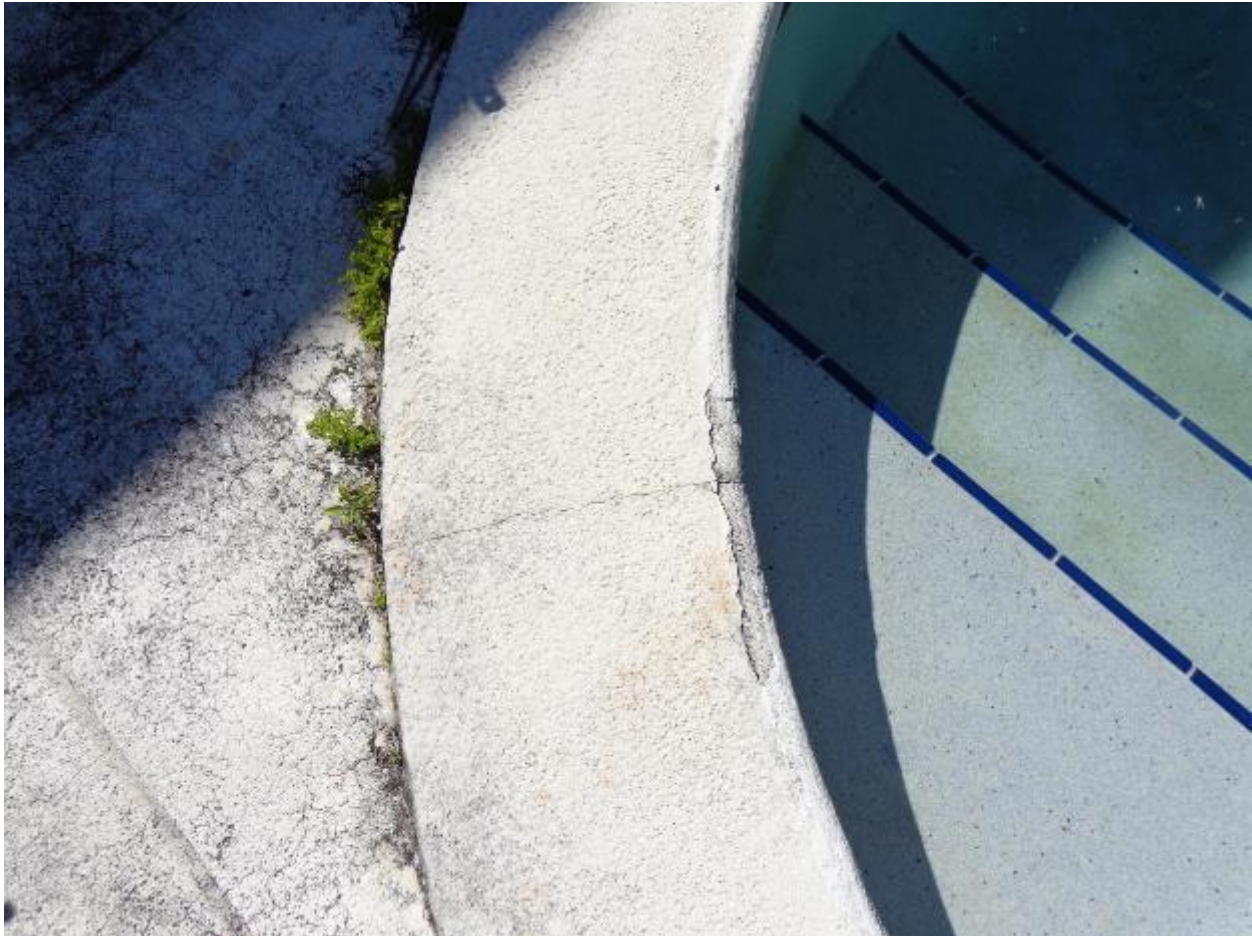
Pool deck requires structural repairs and resurfacing (concrete).

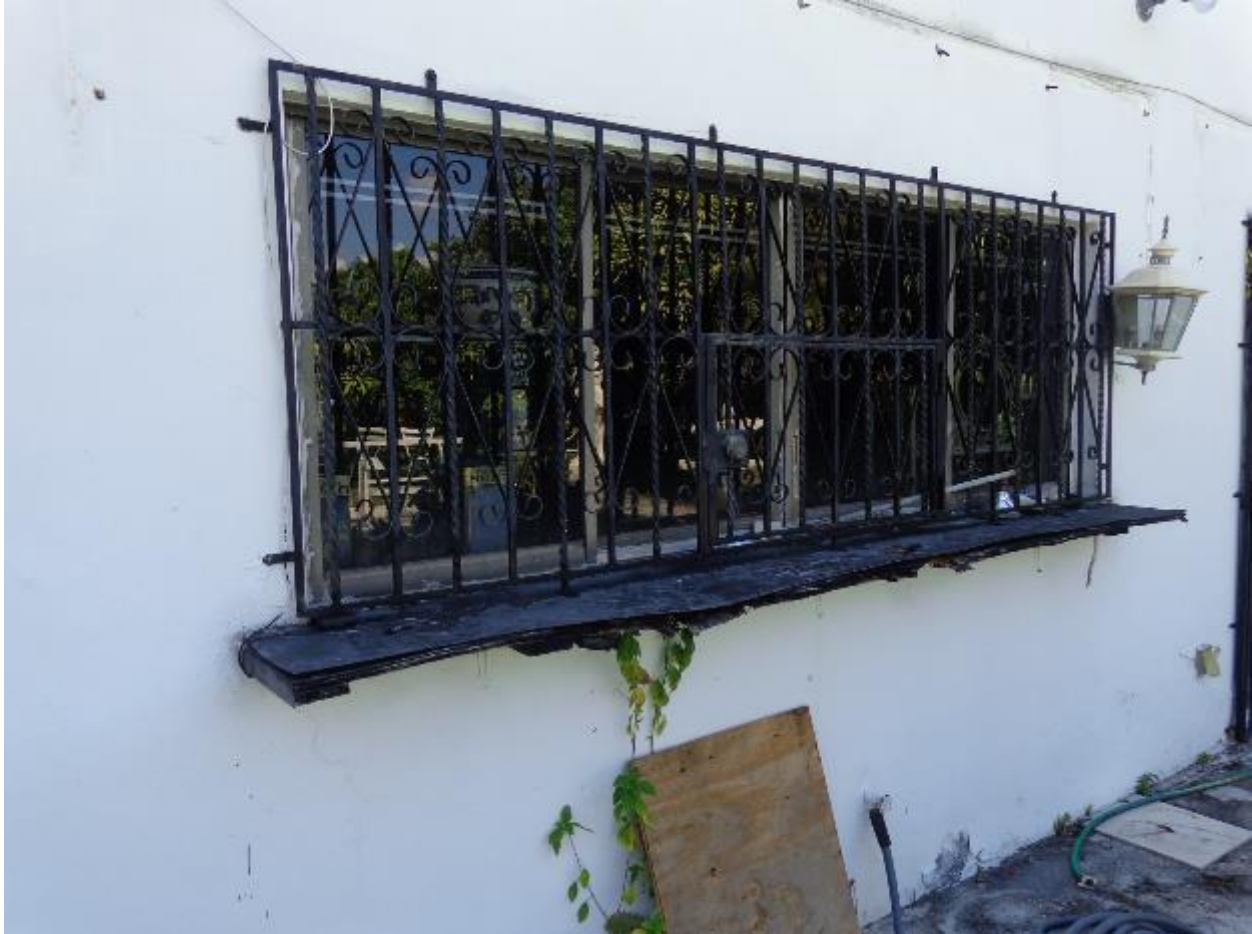
Removal of iron bars required to allow for emergency egress.

It is recommended a full replacement of windows with impact glass as per current code and avoid the installation of hurricane shutters.

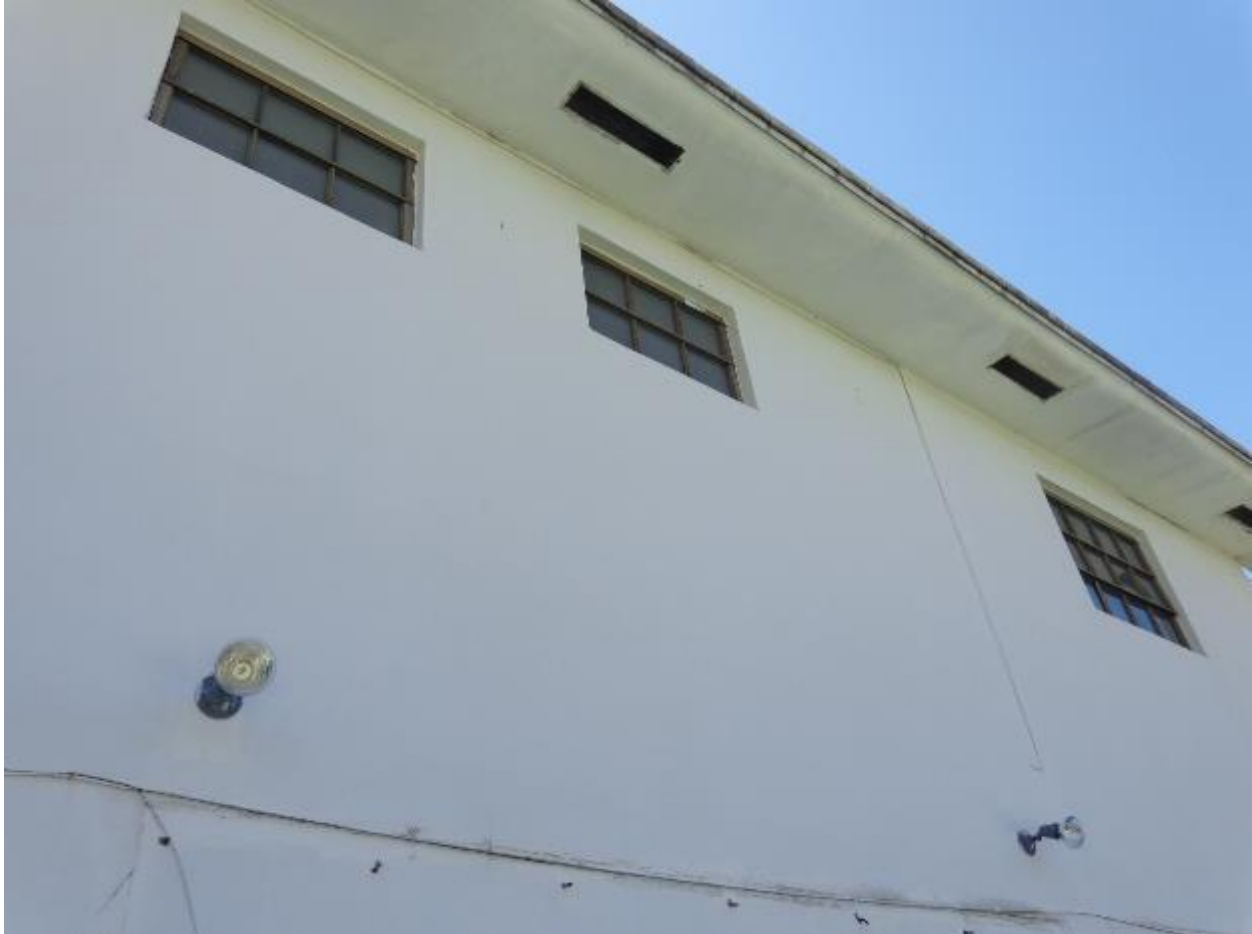
It is recommended a full replacement of windows with impact glass as per current code and avoid the installation of hurricane shutters.

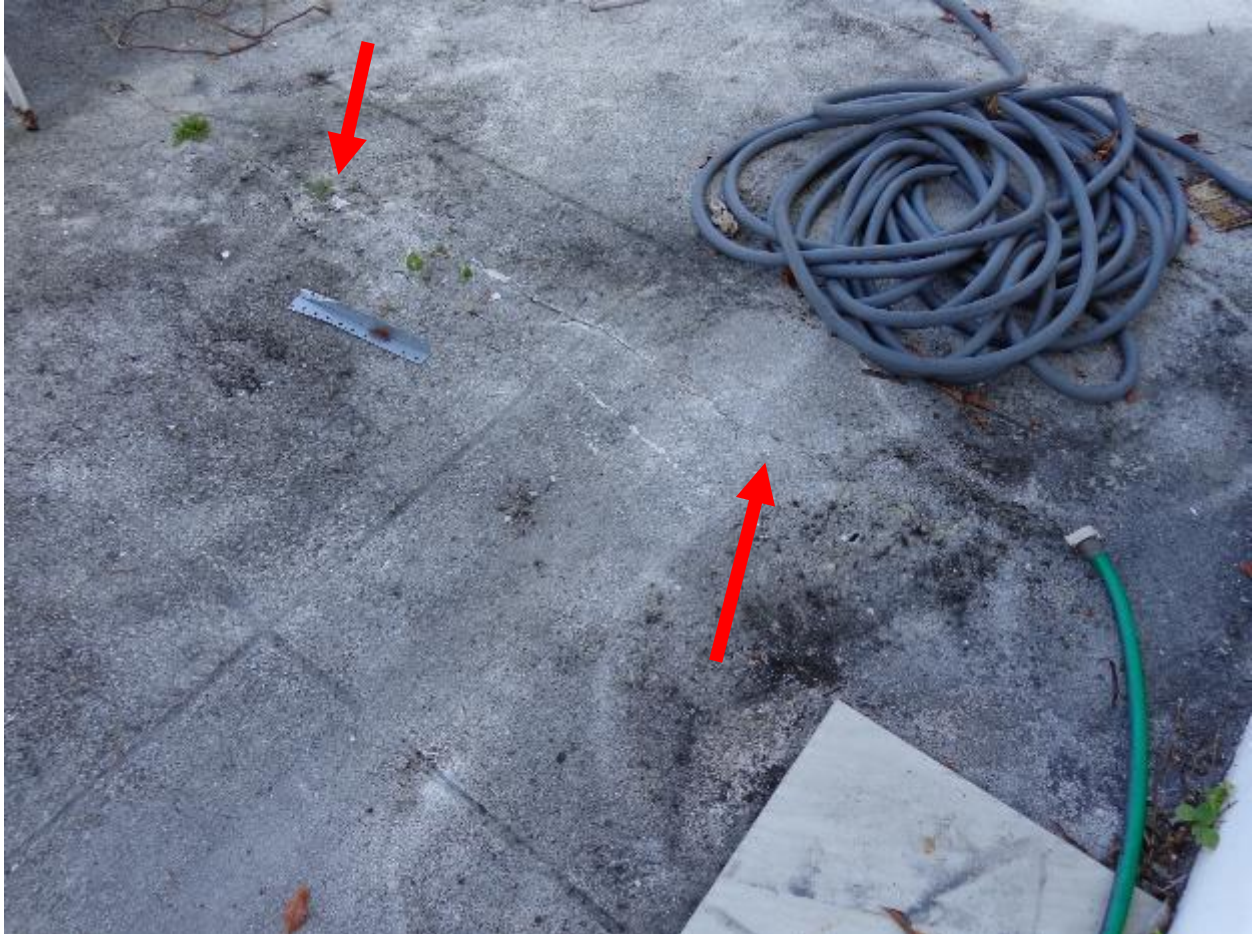
Pool deck requires structural repairs and resurfacing (concrete).

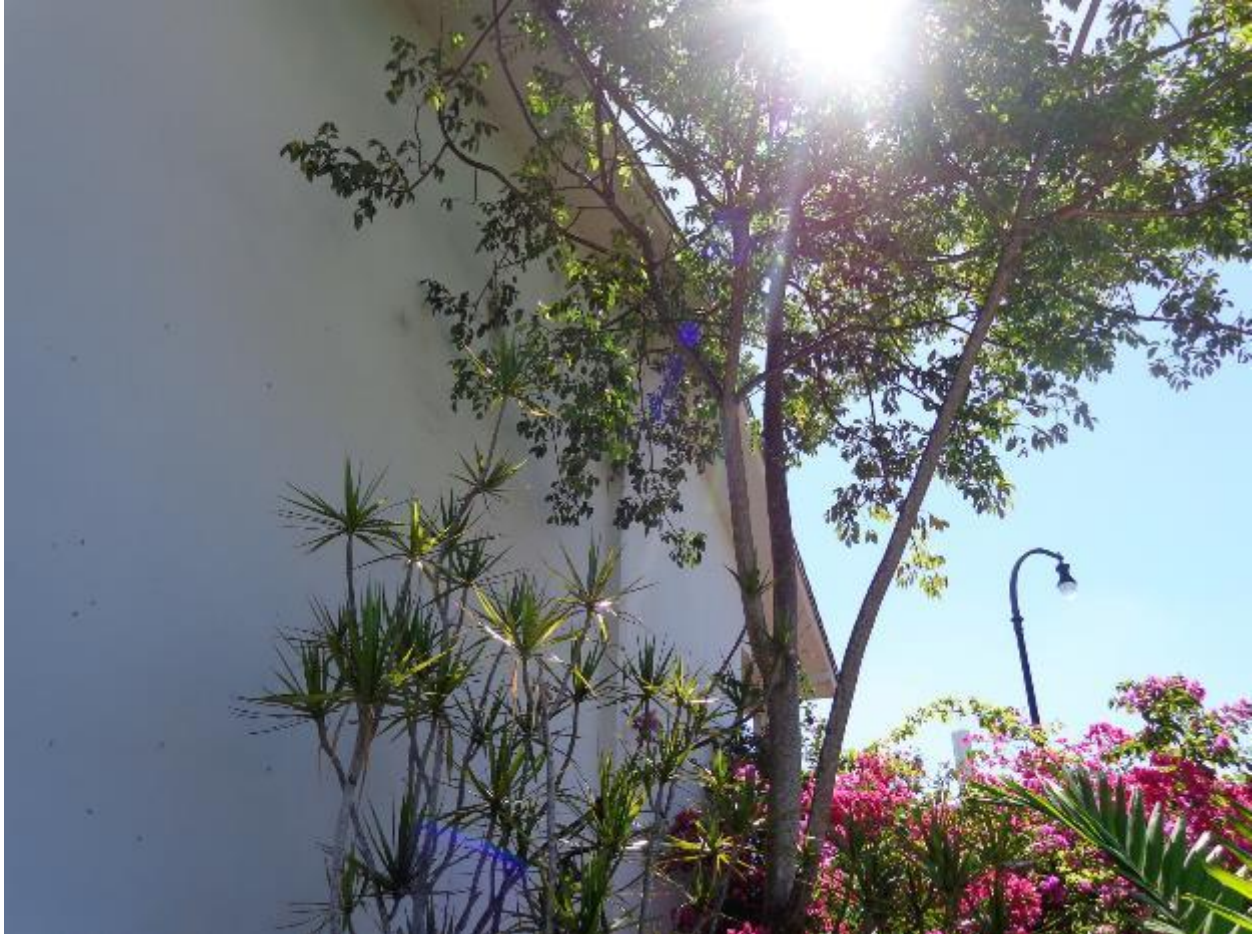
Allowances must be made for the removal of overgrown vegetation.

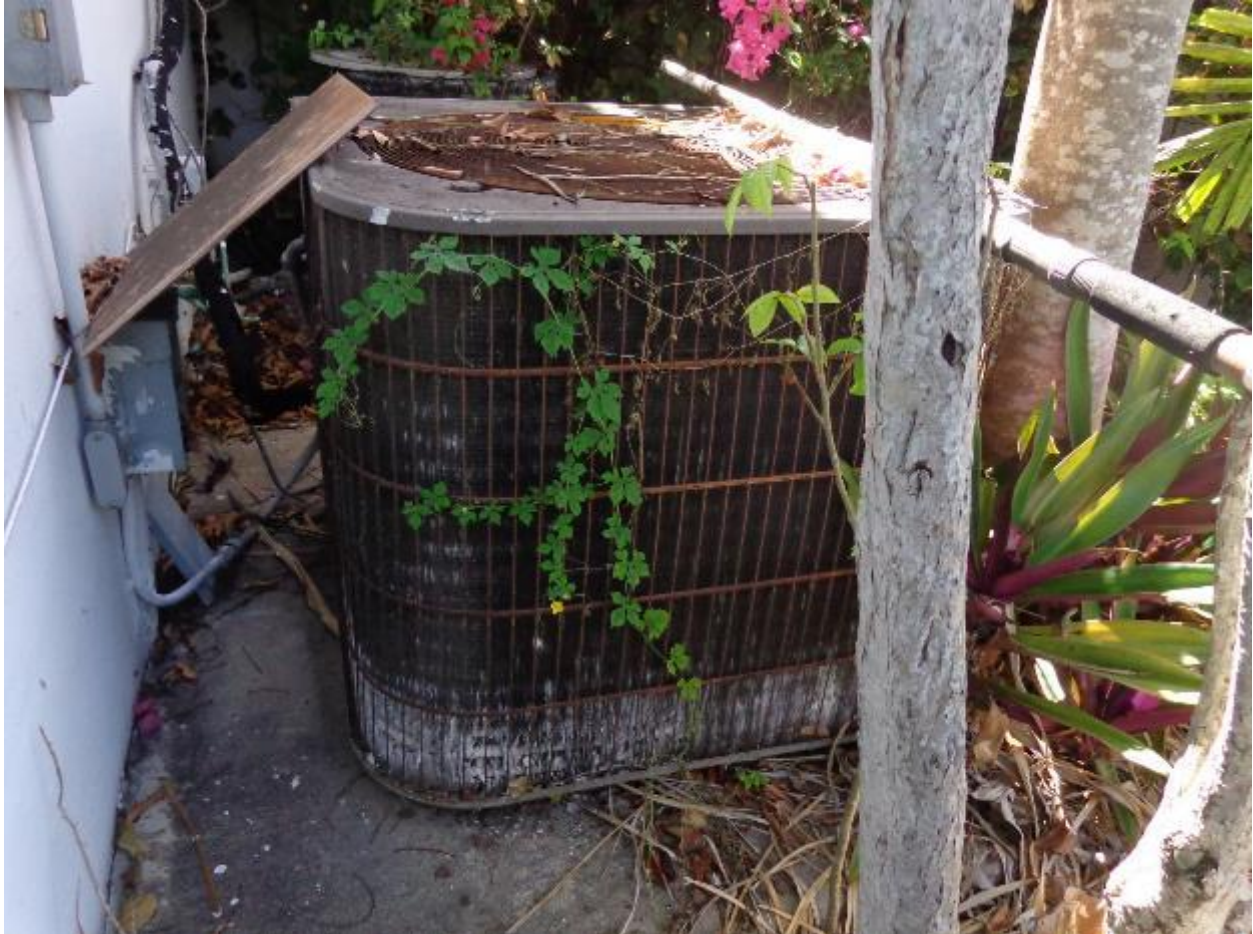
Both HVAC did not operate during the inspection, allowances must be made for repair or replacement

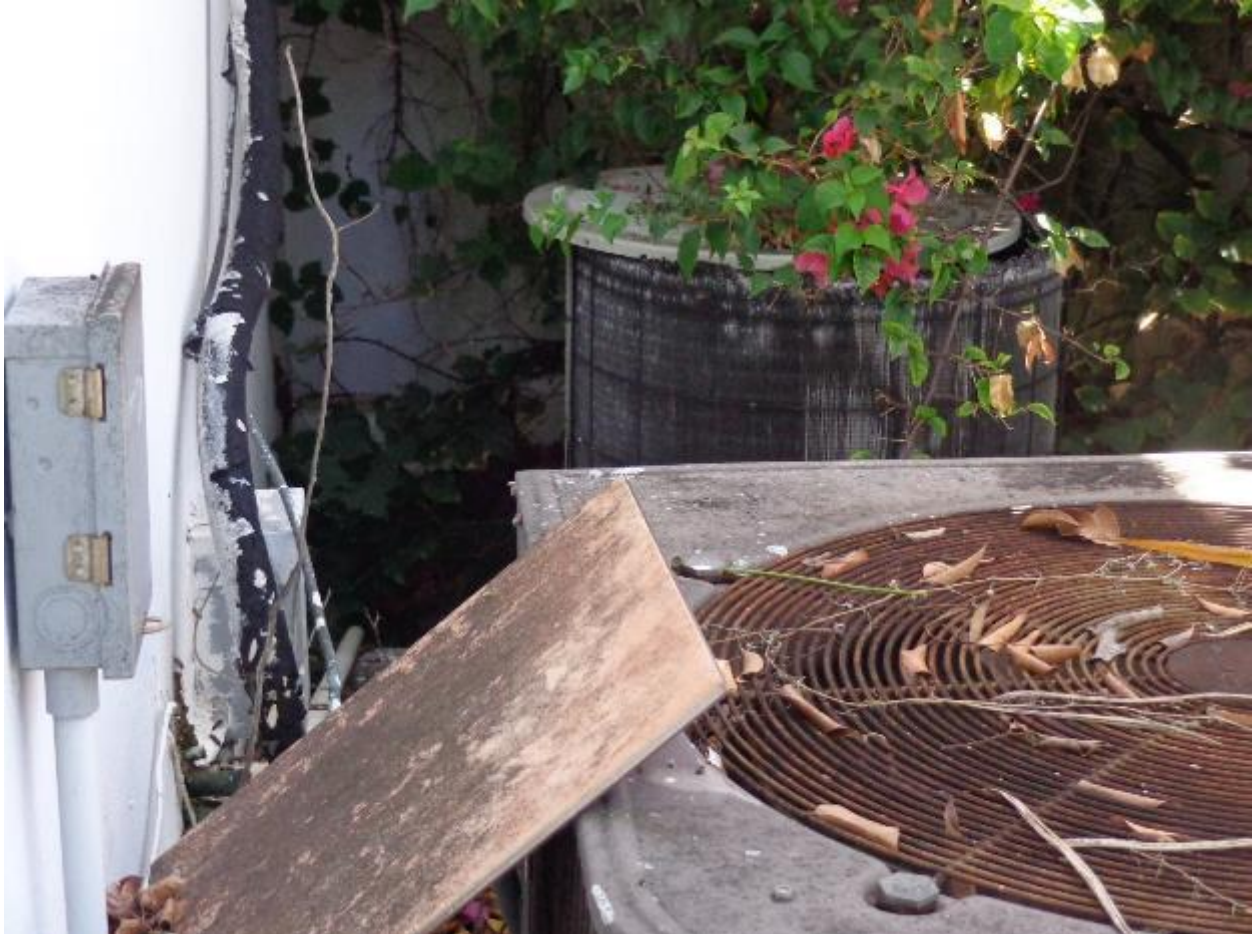
Both HVAC did not operate during the inspection, allowances must be made for repair or replacement

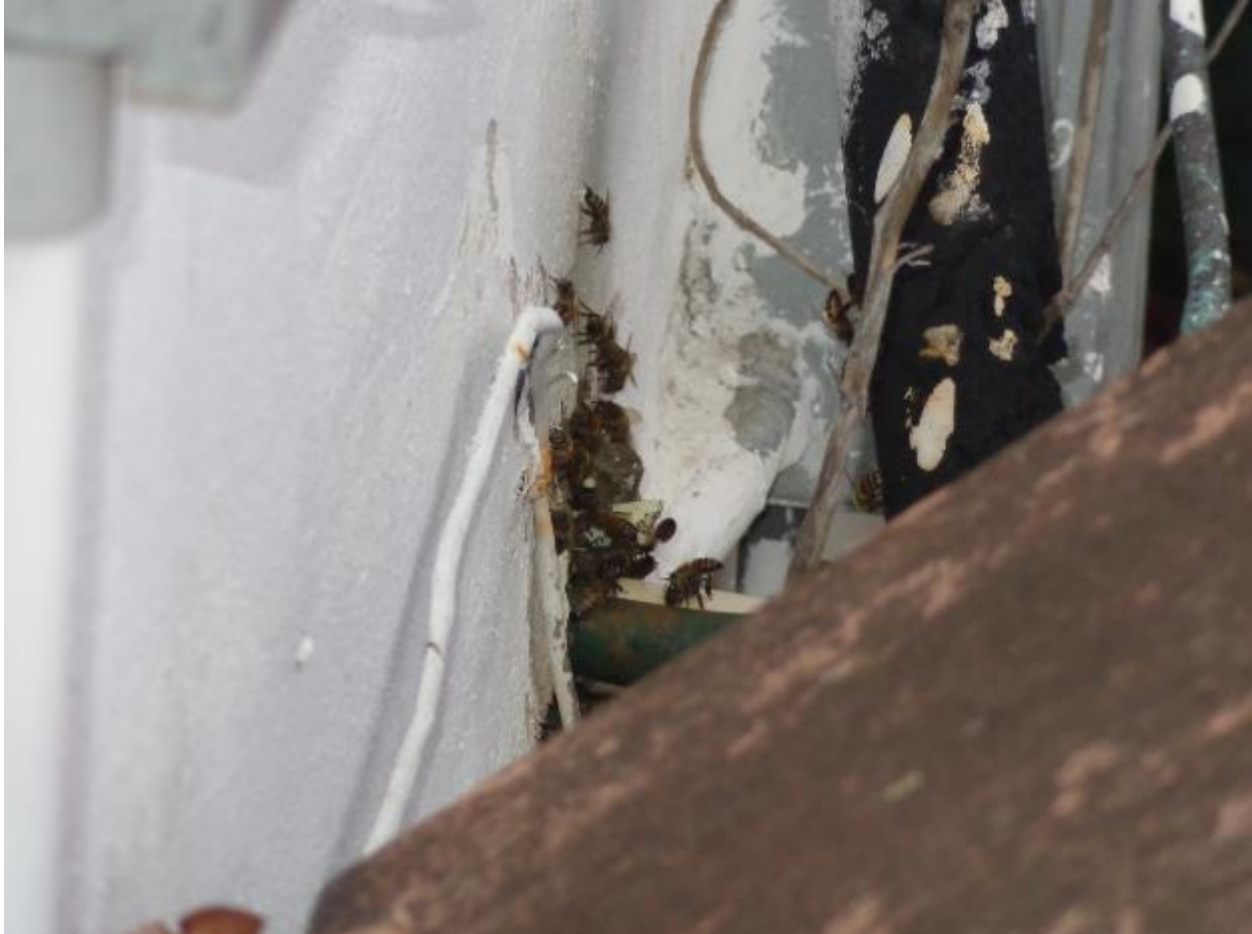
Active Beehive requires removal by a trained professional.
