PROPERTY INSPECTION OR ASSESSMENT OF DAMAGES

ADDRESS: Somewhere, FL
CLIENT: GAIA GC
ID No: 2015000
DATE: 12/31/2015

INSPECTION OR ASSESSMENT BY:

GAIA CONSTRUCTION INC.
CGC 1516136 **FLORIDA**
HI-2792 **FLORIDA**
8028867-B2 **INTERNATIONAL CODE COUNCIL**

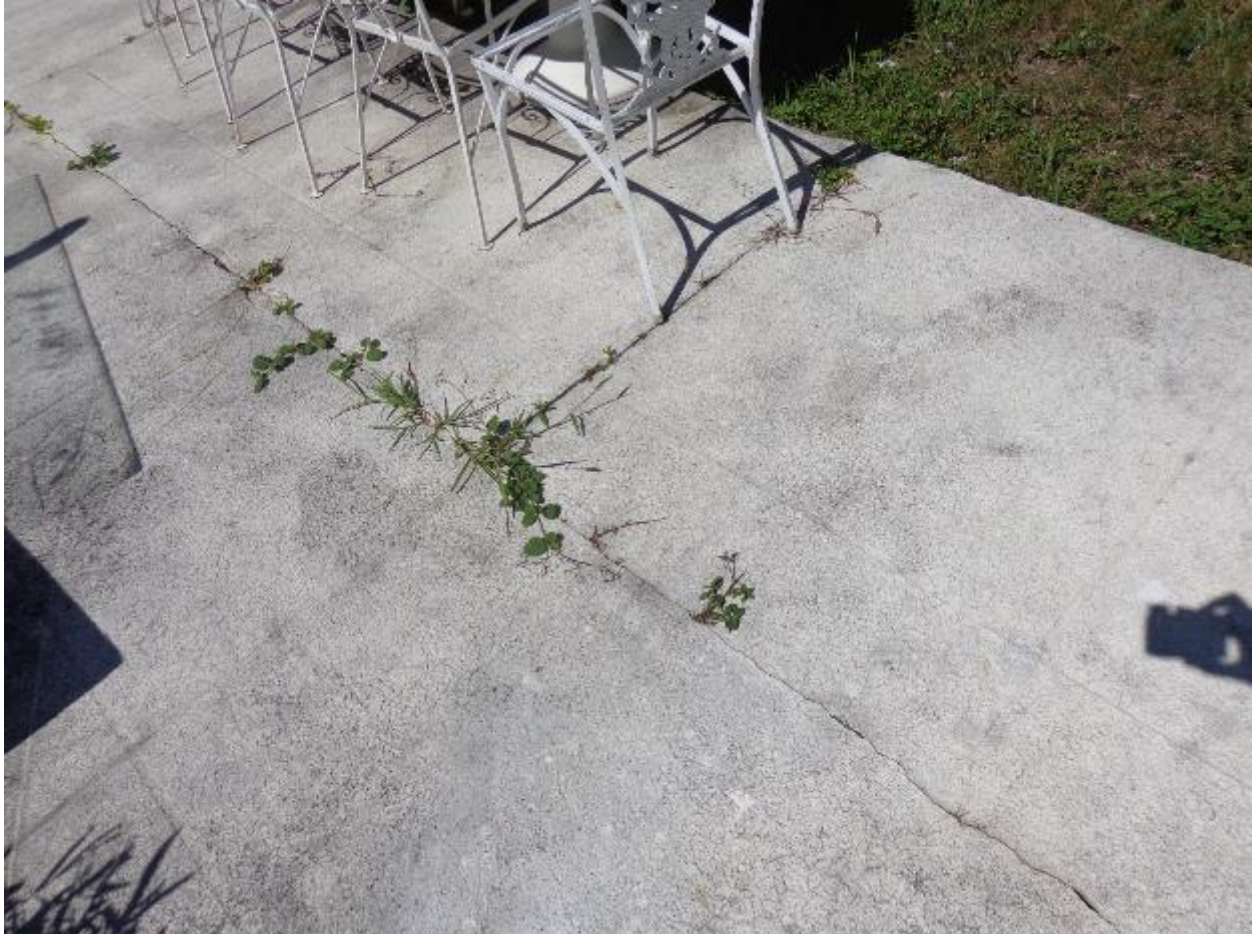
Pool deck requires structural repairs and resurfacing (concrete).

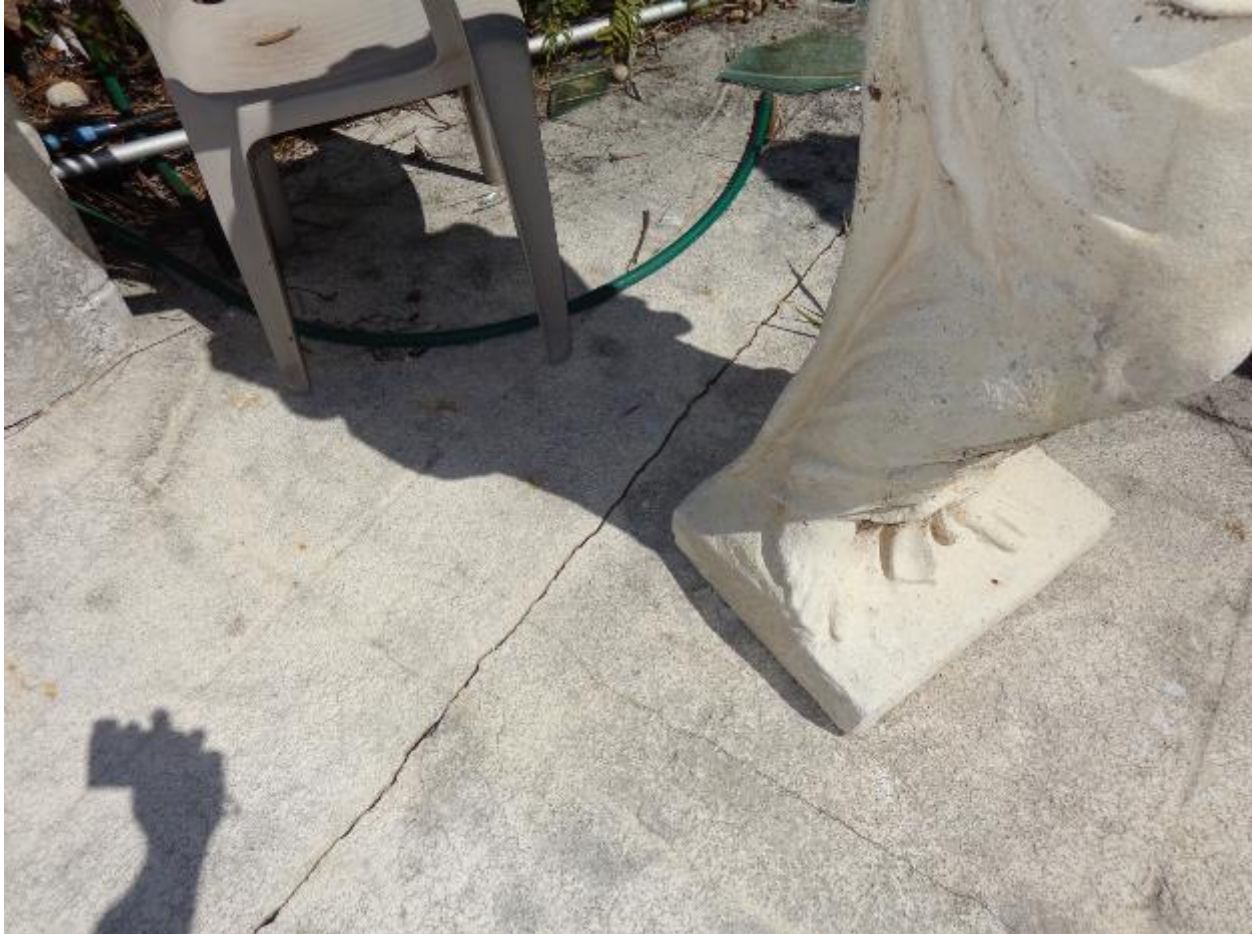
Pool deck requires structural repairs and resurfacing (concrete).

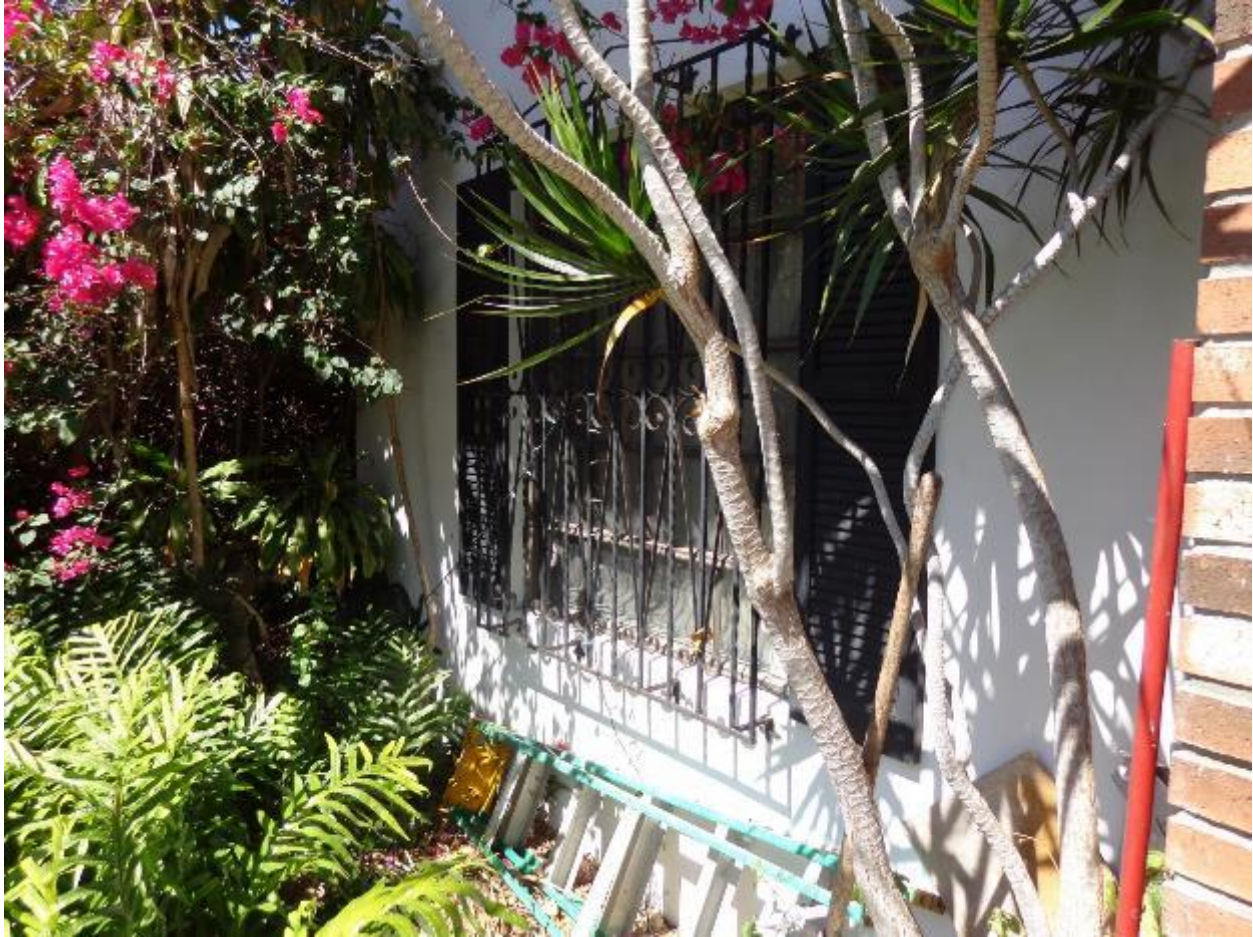
Removal of iron bars required to allow for emergency egress.

It is recommended a full replacement of windows with impact glass as per current code and avoid the installation of hurricane shutters.

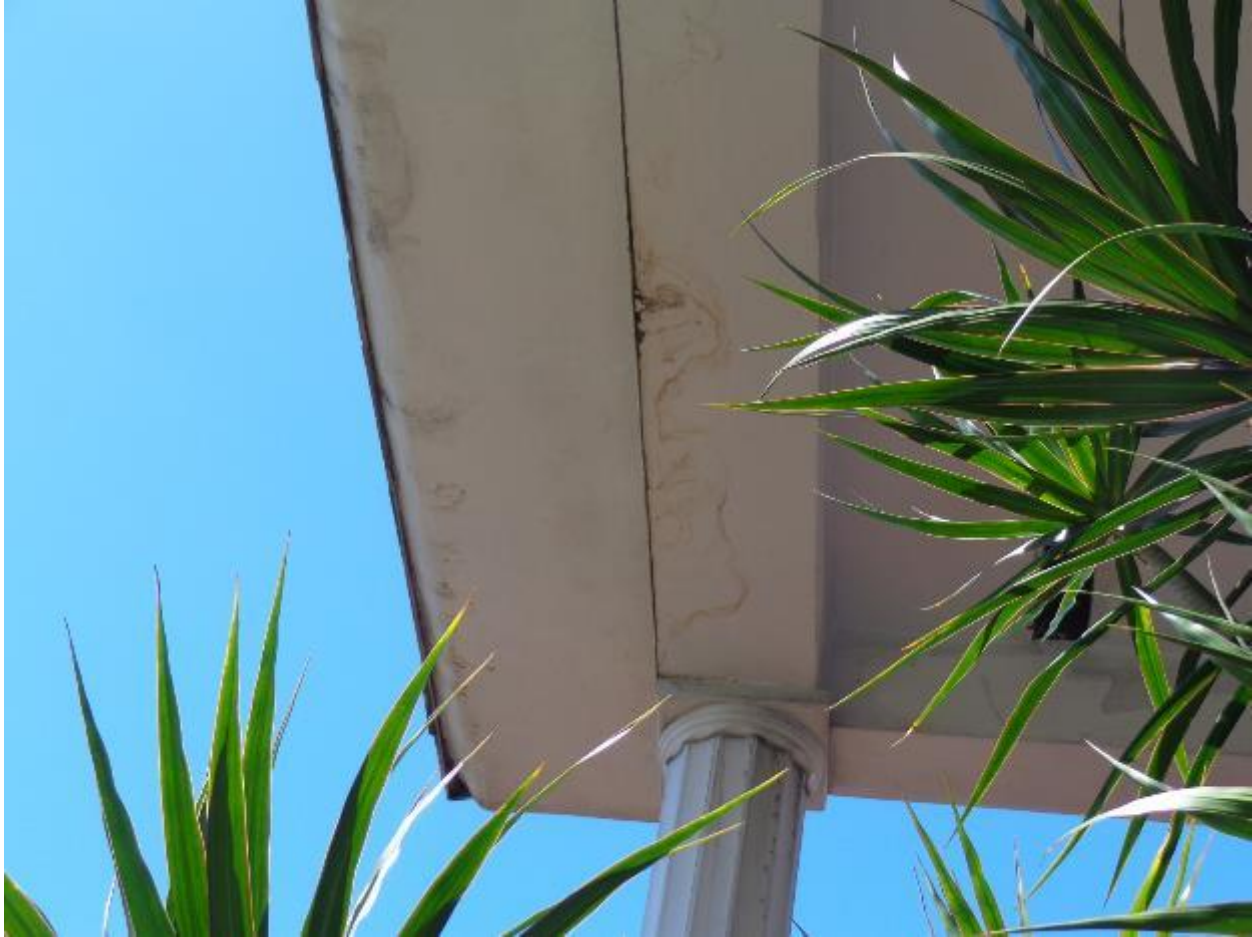
Signs of water infiltration due to roof failure noticed. Allowances must be made for roofing and stucco repairs.

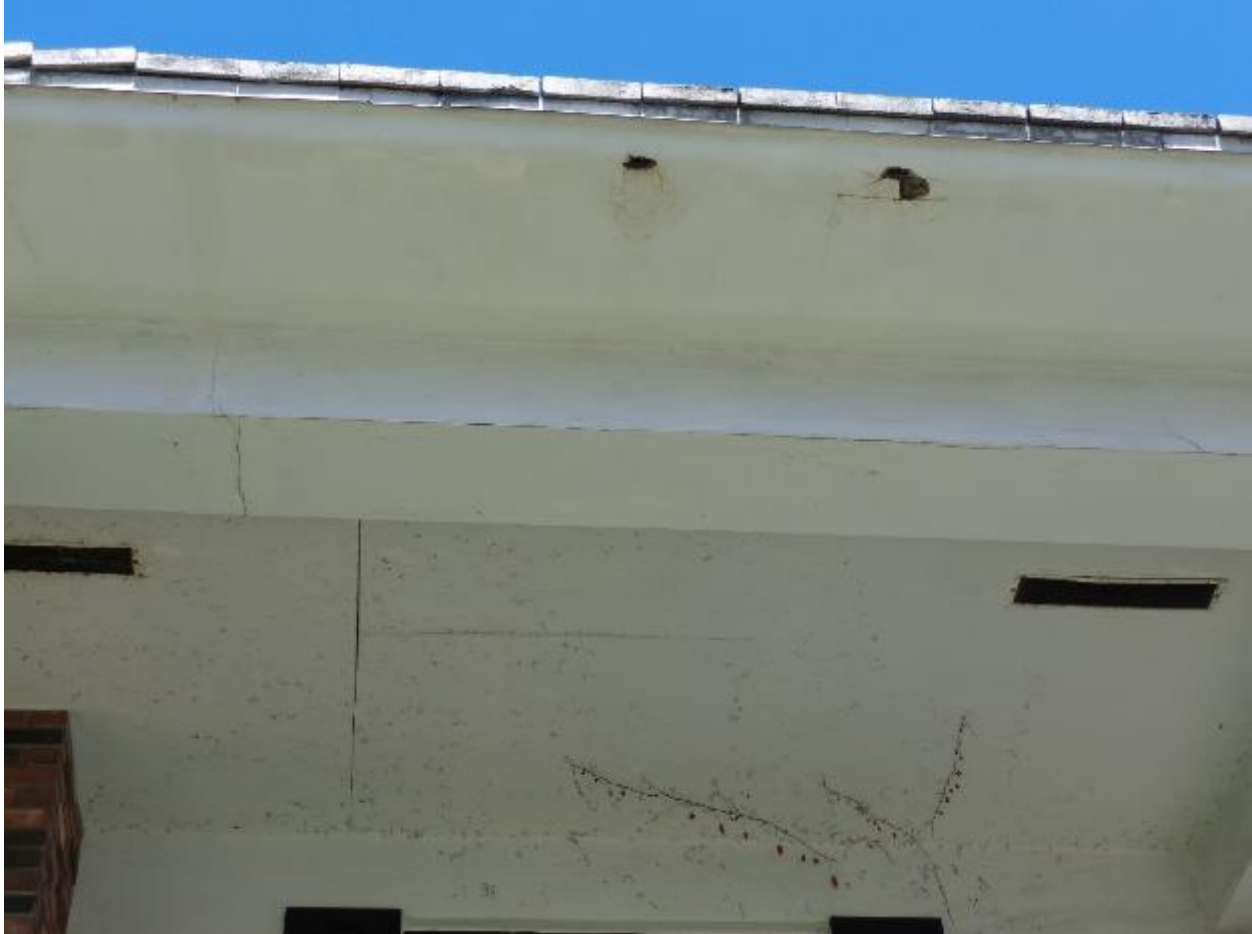
Signs of water infiltration due to roof failure noticed. Allowances must be made for roofing and stucco repairs.

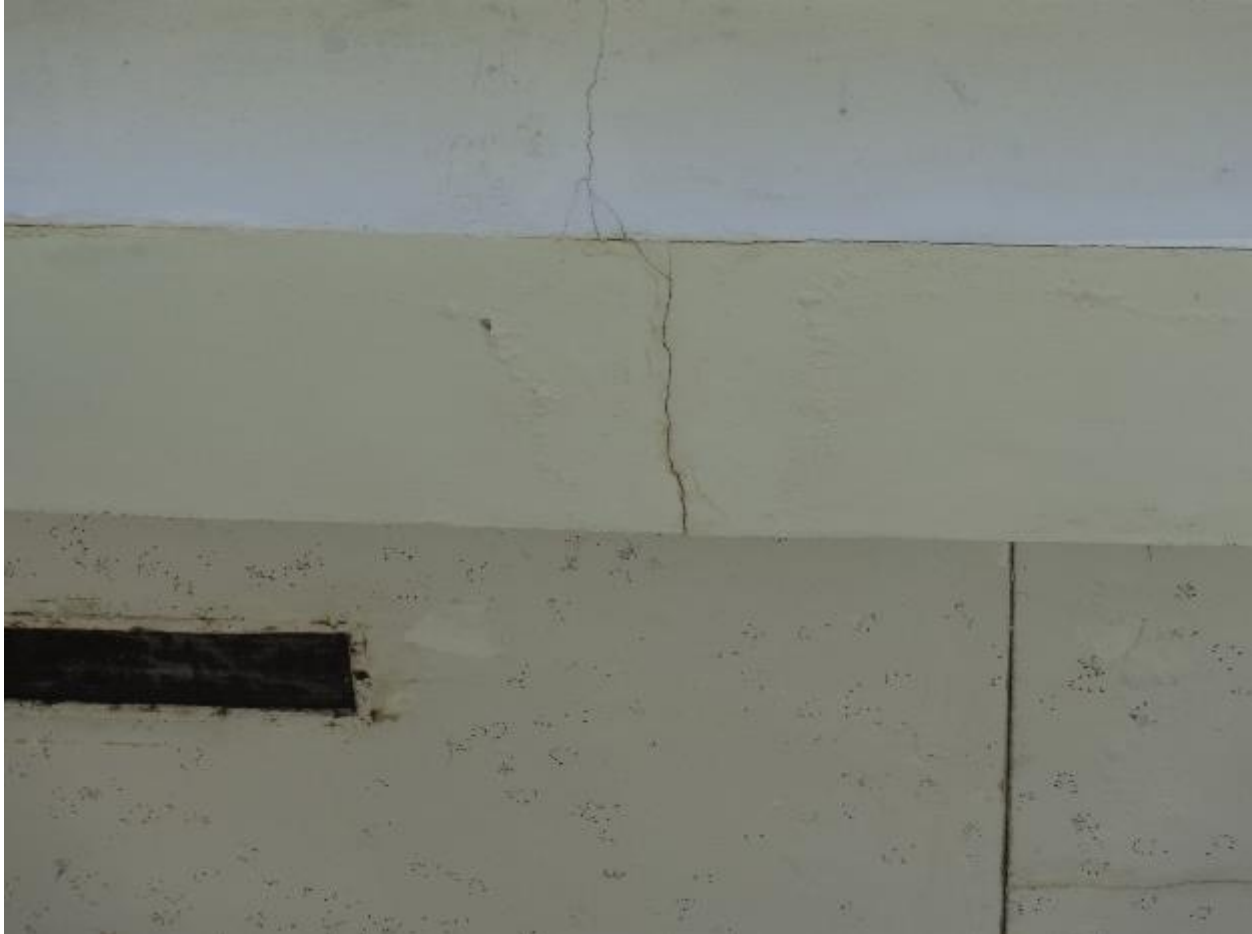
Cracks on vertical planes due to foundation settlement indicating downward and lateral movement. These types of cracks do compromise the ability of the building to function as designed and avoid water intrusion. Structural repair and proper waterproofing treatment are required to avoid further damage to the interior of the building and water infiltration.

Signs of water infiltration due to roof failure noticed. Allowances must be made for roofing and stucco repairs.

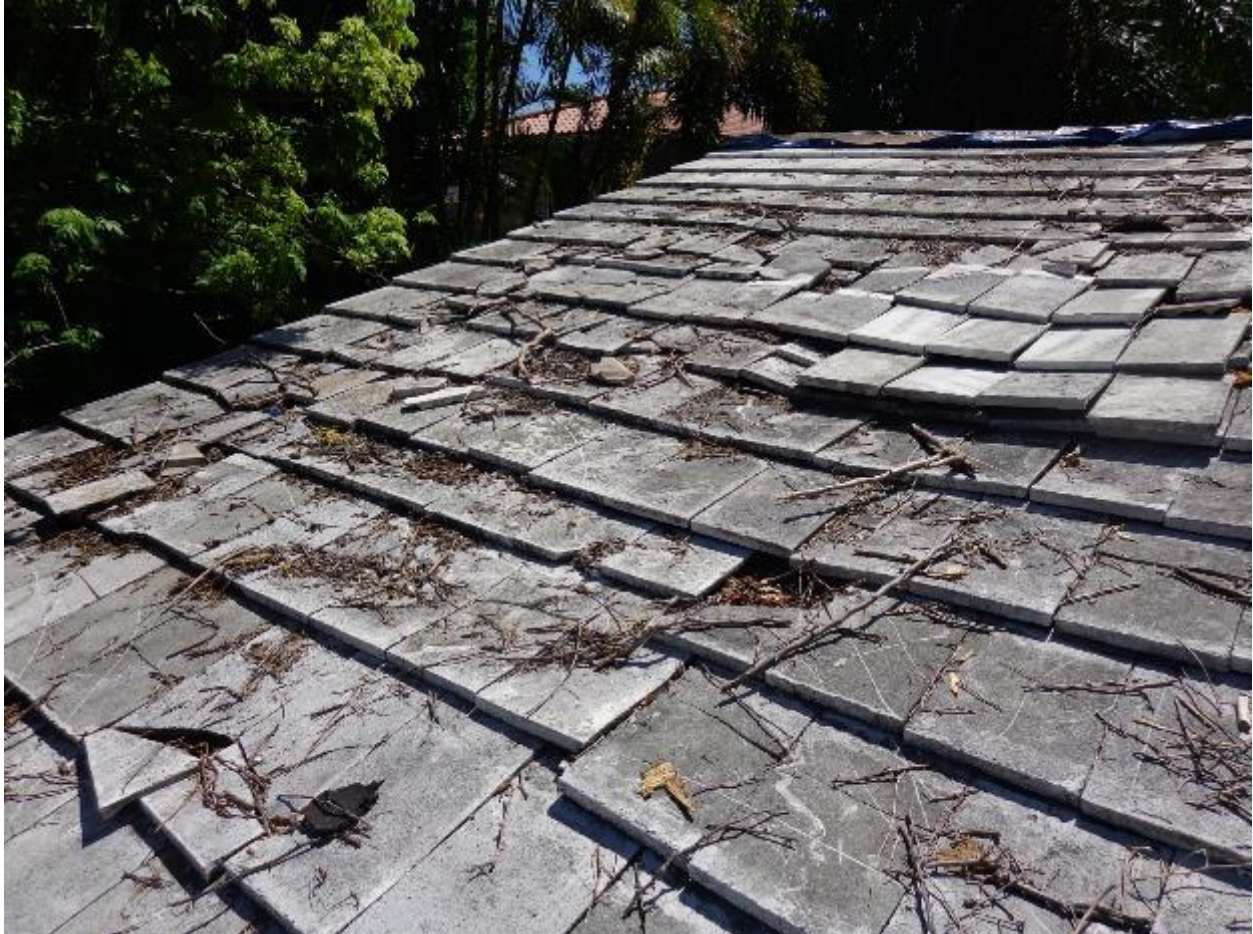
Roof covering has reached the end of its useful life; new roofing is required to be installed on the entire property.

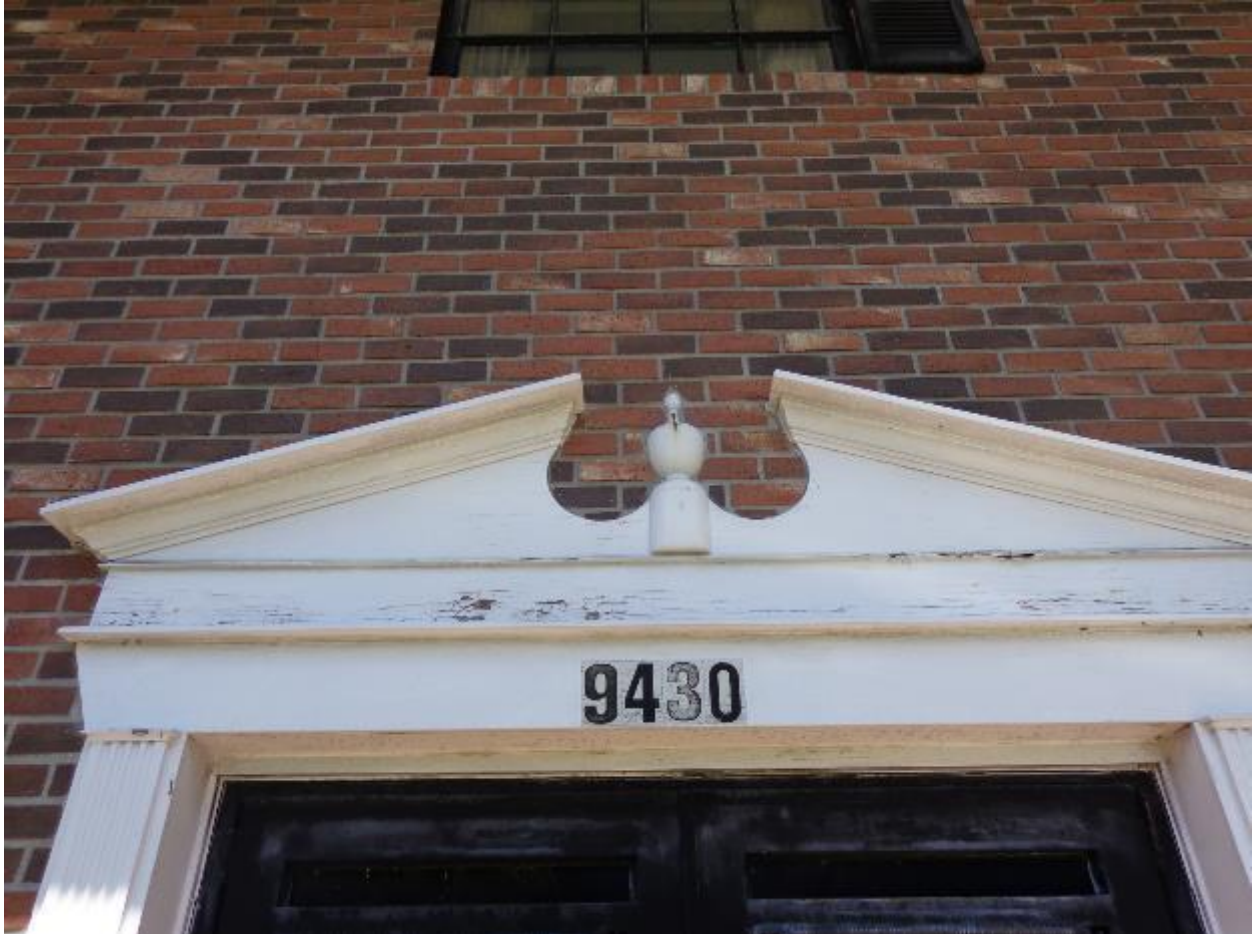
Rotted wood requires replacement.

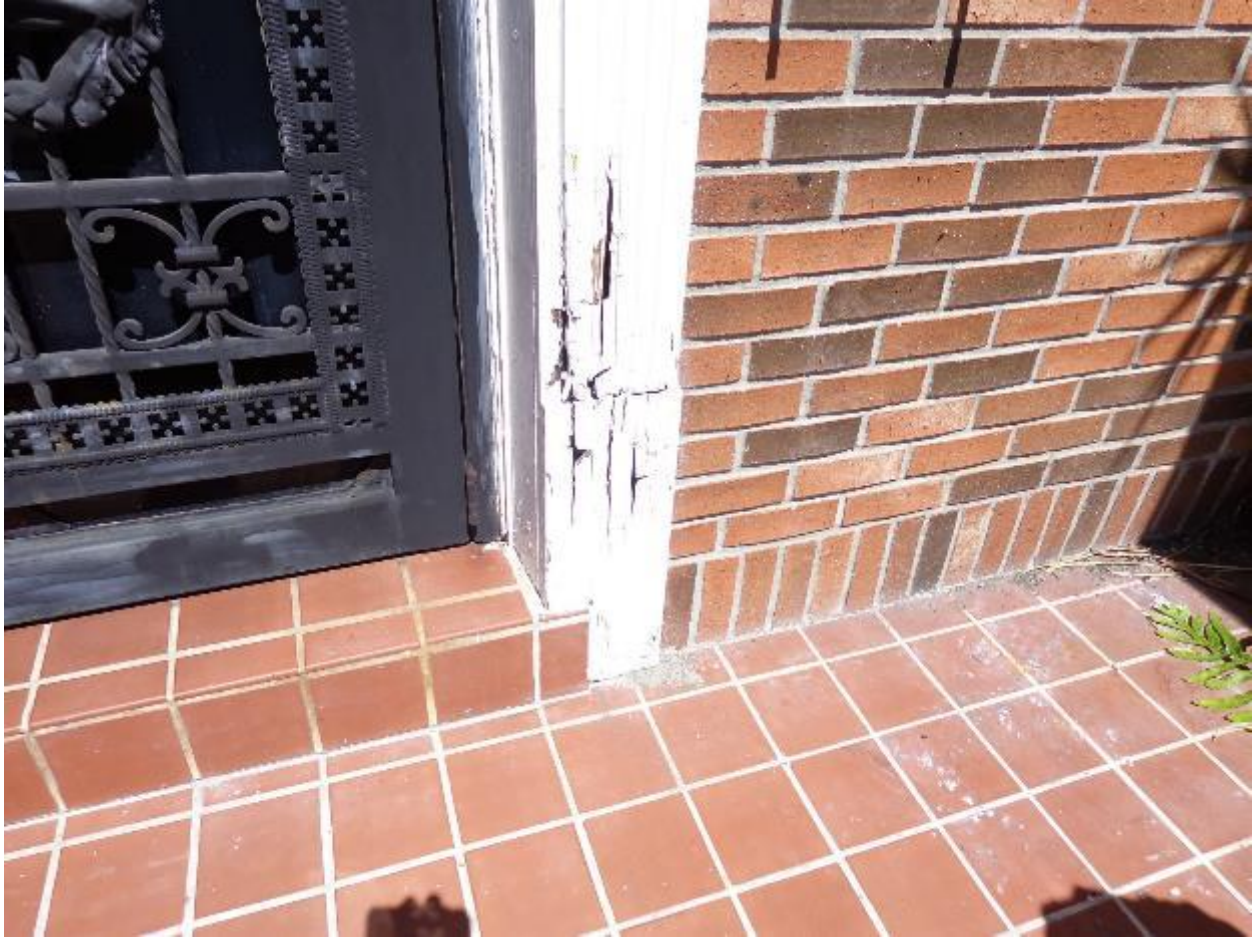
Rotted wood requires replacement.

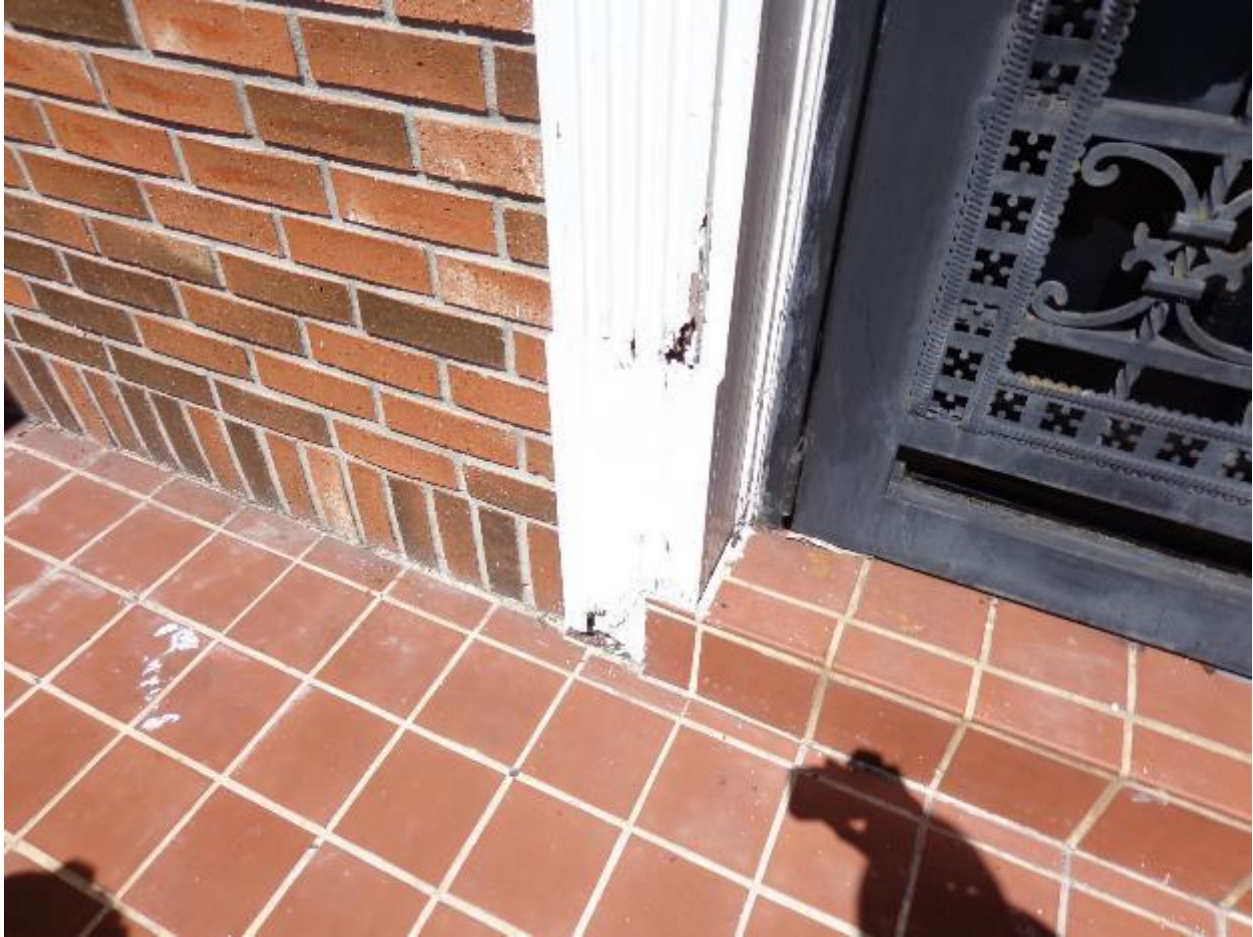
Rotted wood requires replacement.

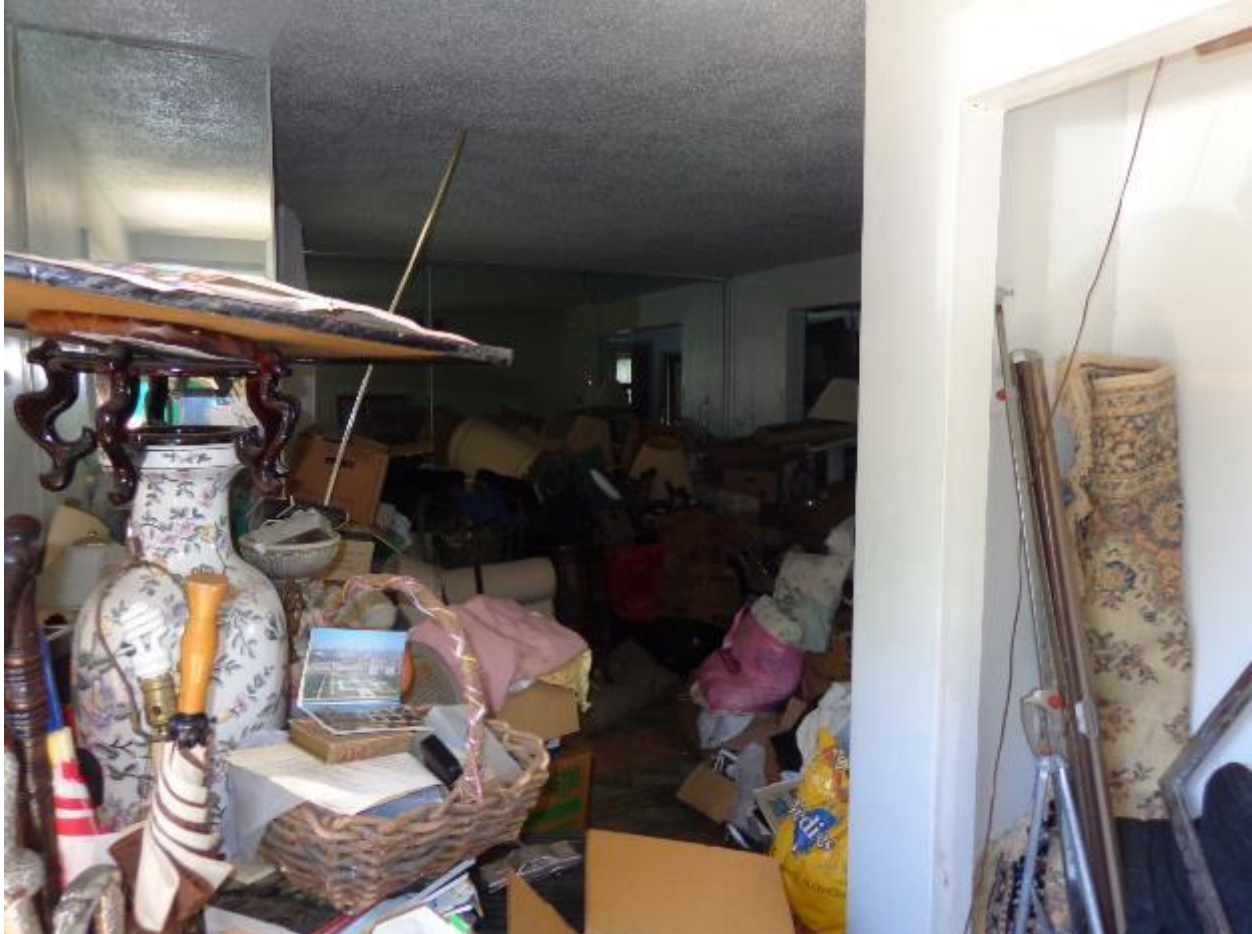
A complete rehabilitation of the interior must be done in order to provide move in conditions. Plumbing, electrical and Ac systems require replacement or repairs. Wood destroying organism active in the property.

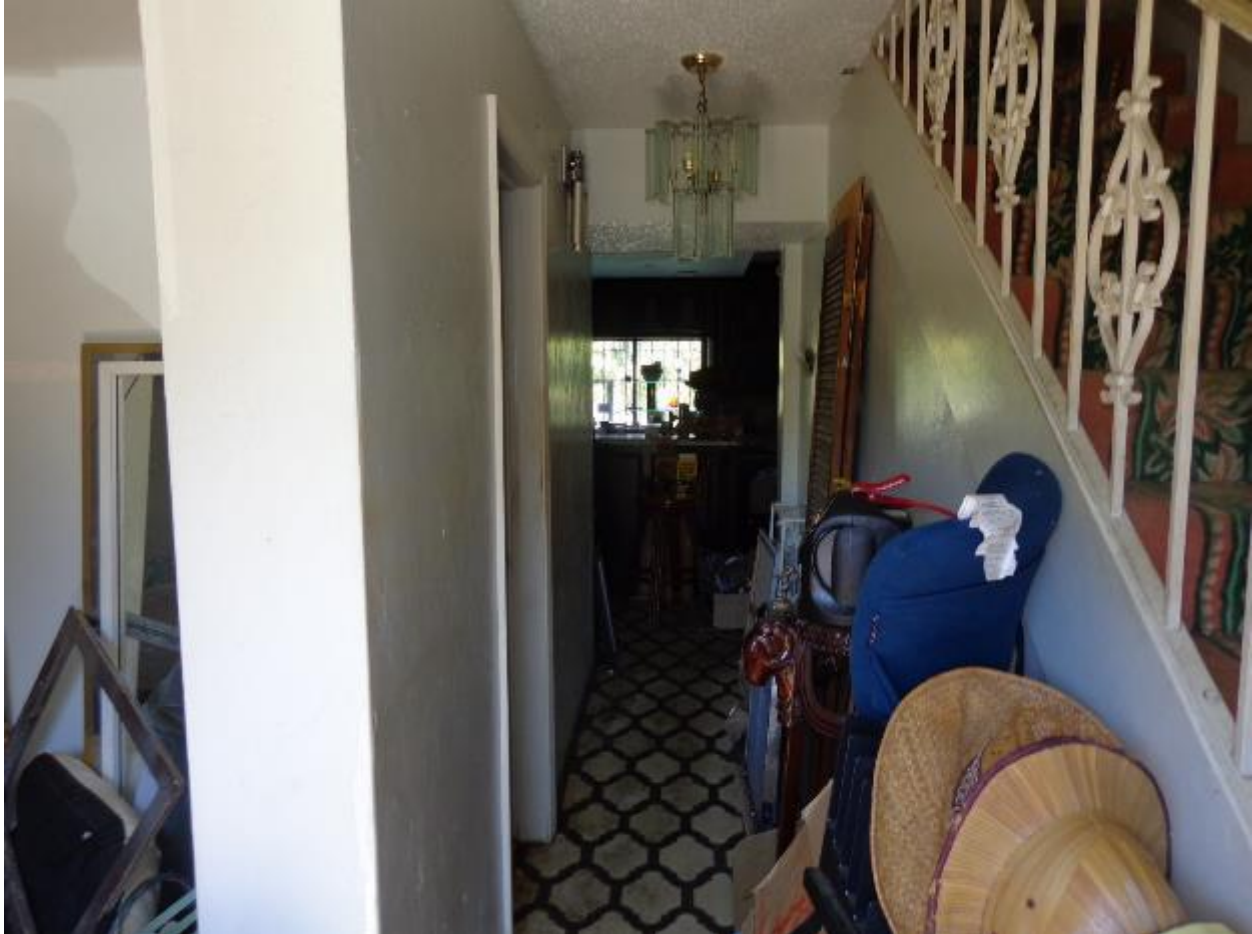
A complete rehabilitation of the interior must be done in order to provide move in conditions. Plumbing, electrical and Ac systems require replacement or repairs. Wood destroying organism active in the property.

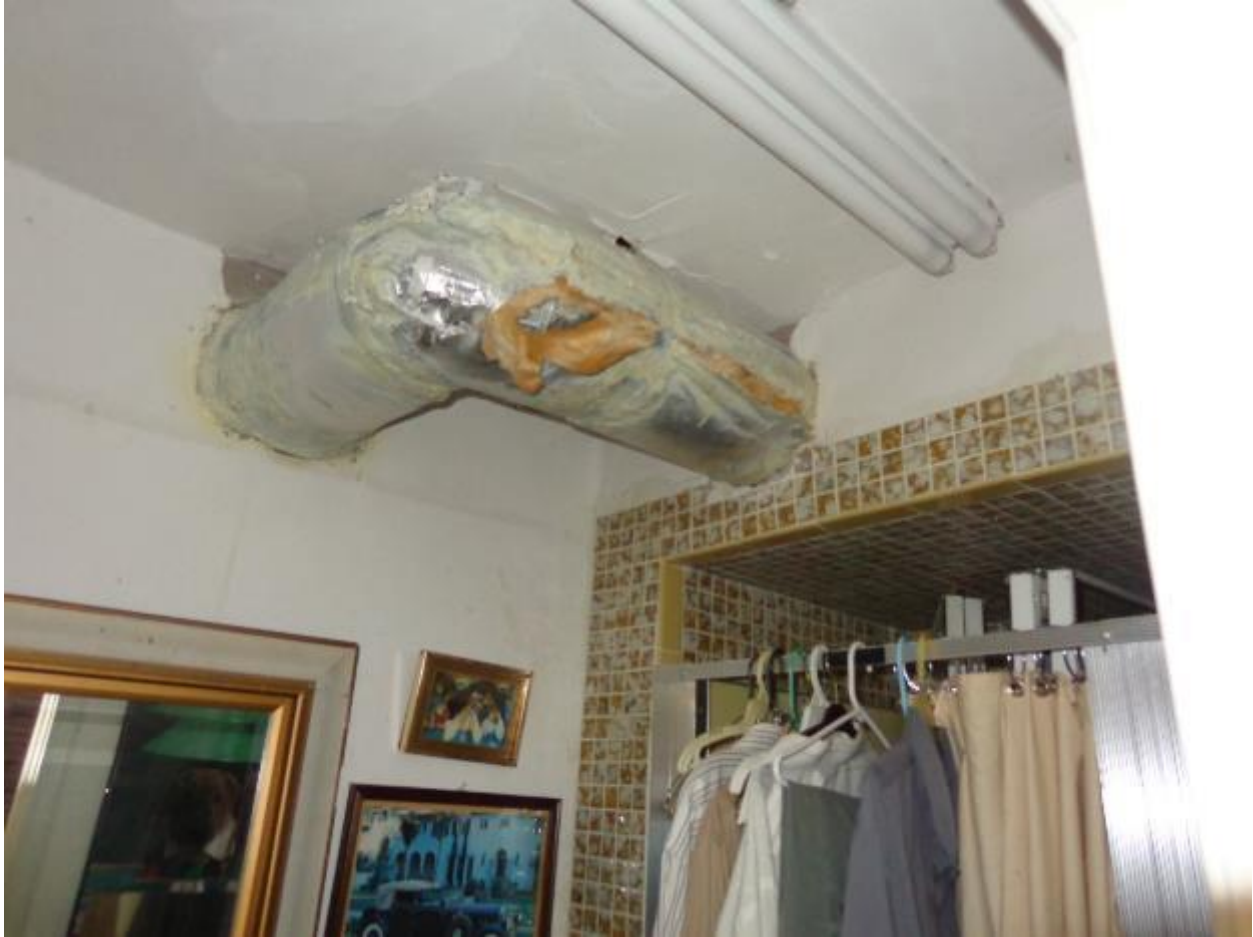
Duct work repairs required.

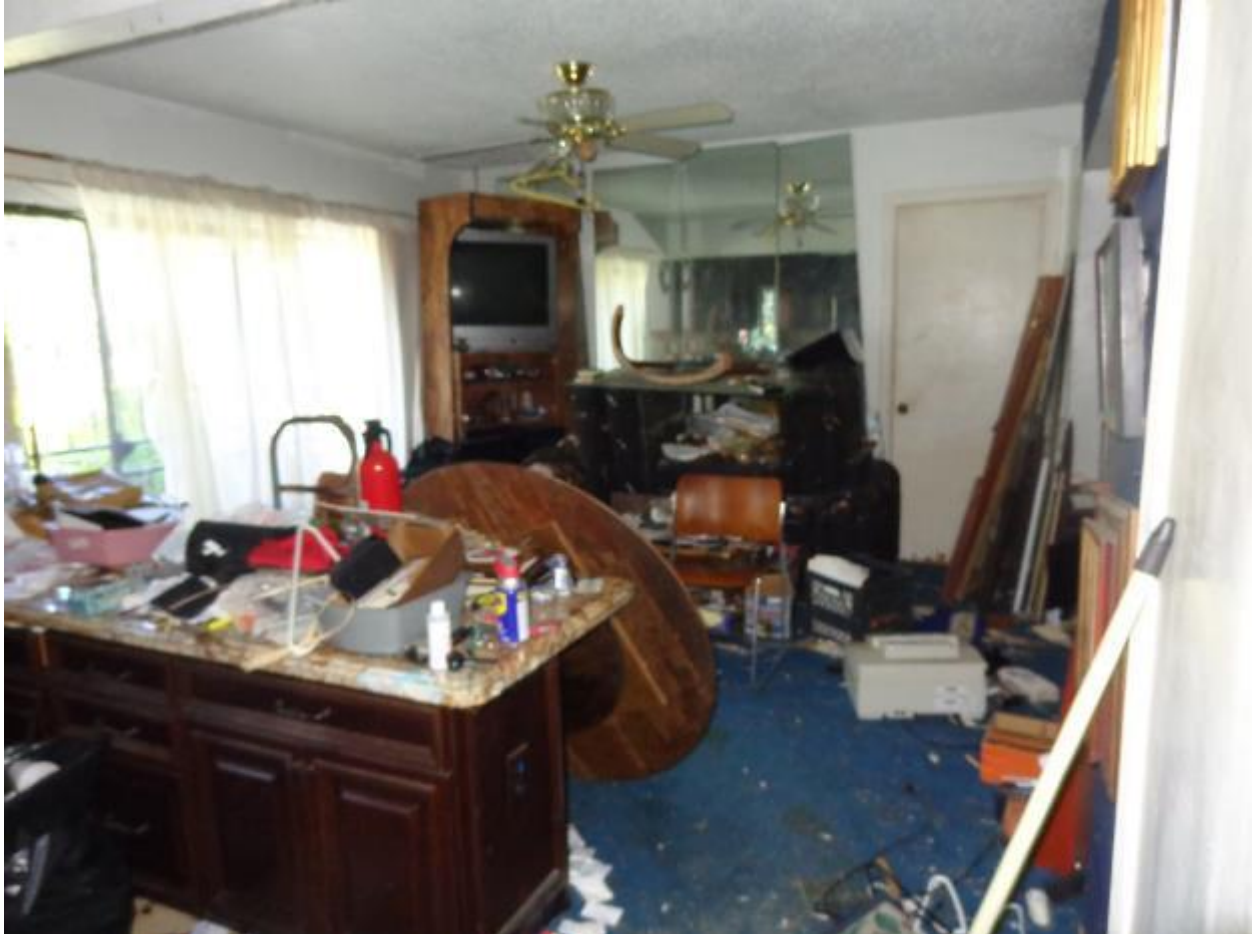
A complete rehabilitation of the interior must be done in order to provide move in conditions. Plumbing, electrical and Ac systems require replacement or repairs. Wood destroying organism active in the property.

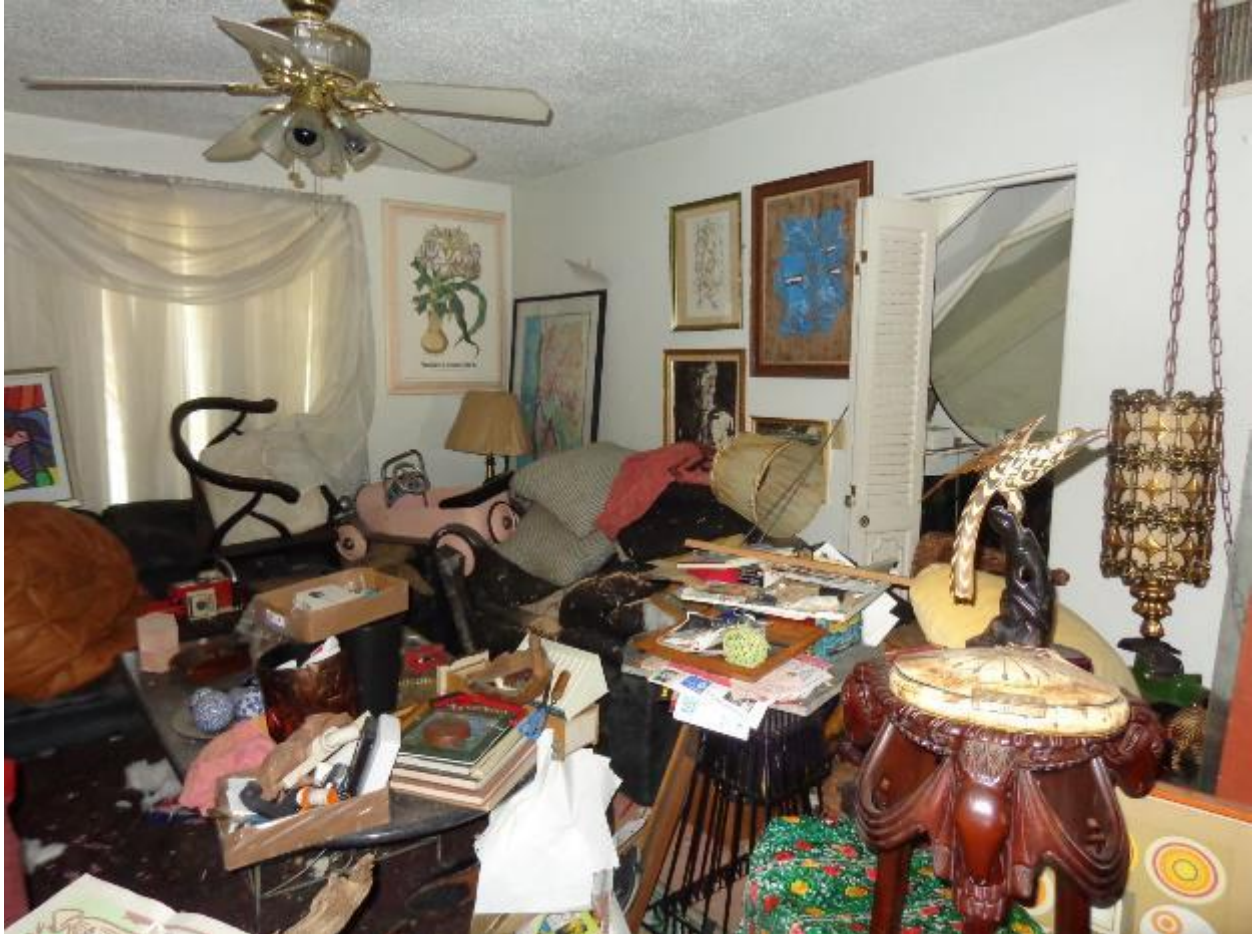
A complete rehabilitation of the interior must be done in order to provide move in conditions. Plumbing, electrical and Ac systems require replacement or repairs. Wood destroying organism active in the property.

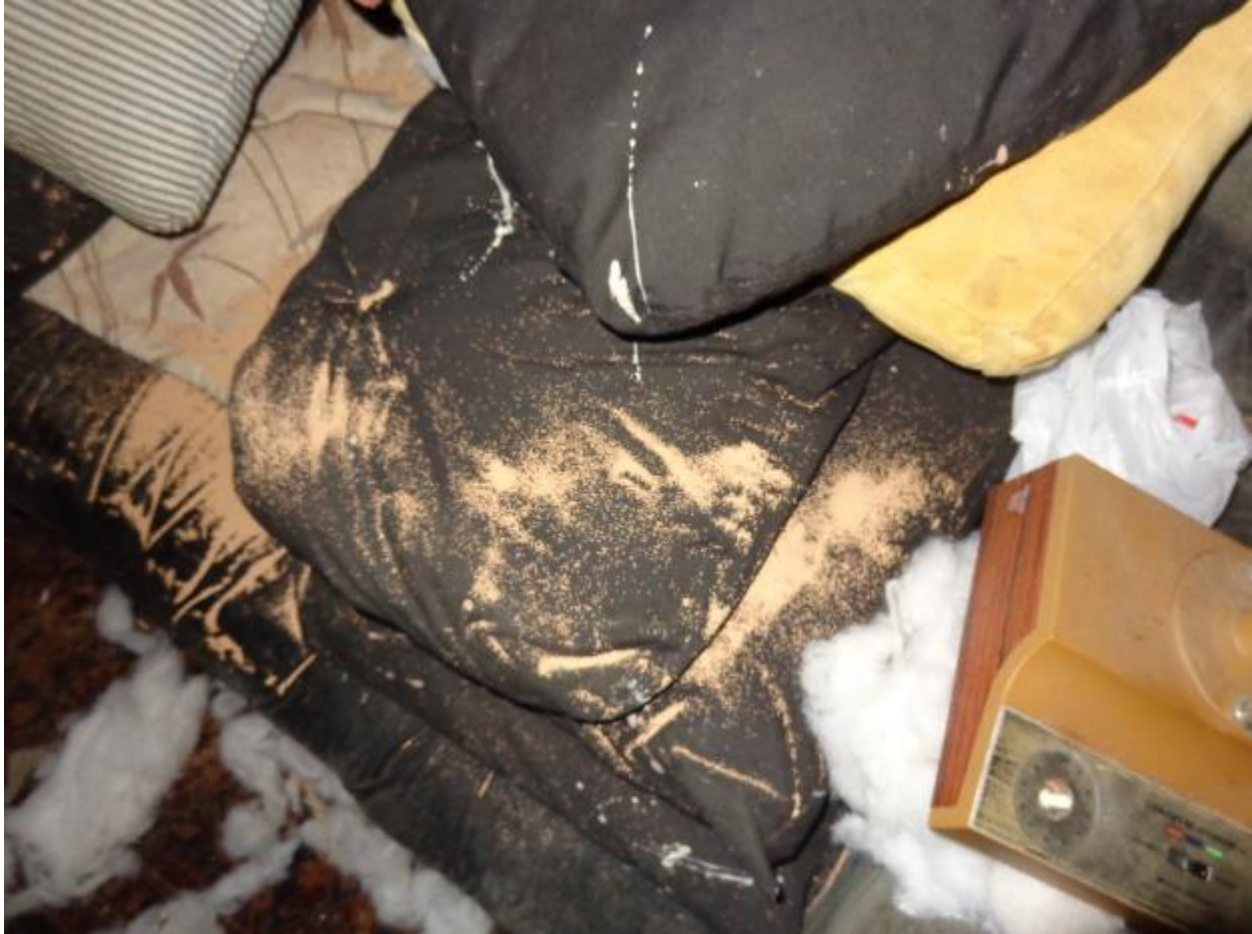
Signs of wood destroying organism related damage were noted during inspection. We recommend to have the property treated against WDO using a certified pest control company.

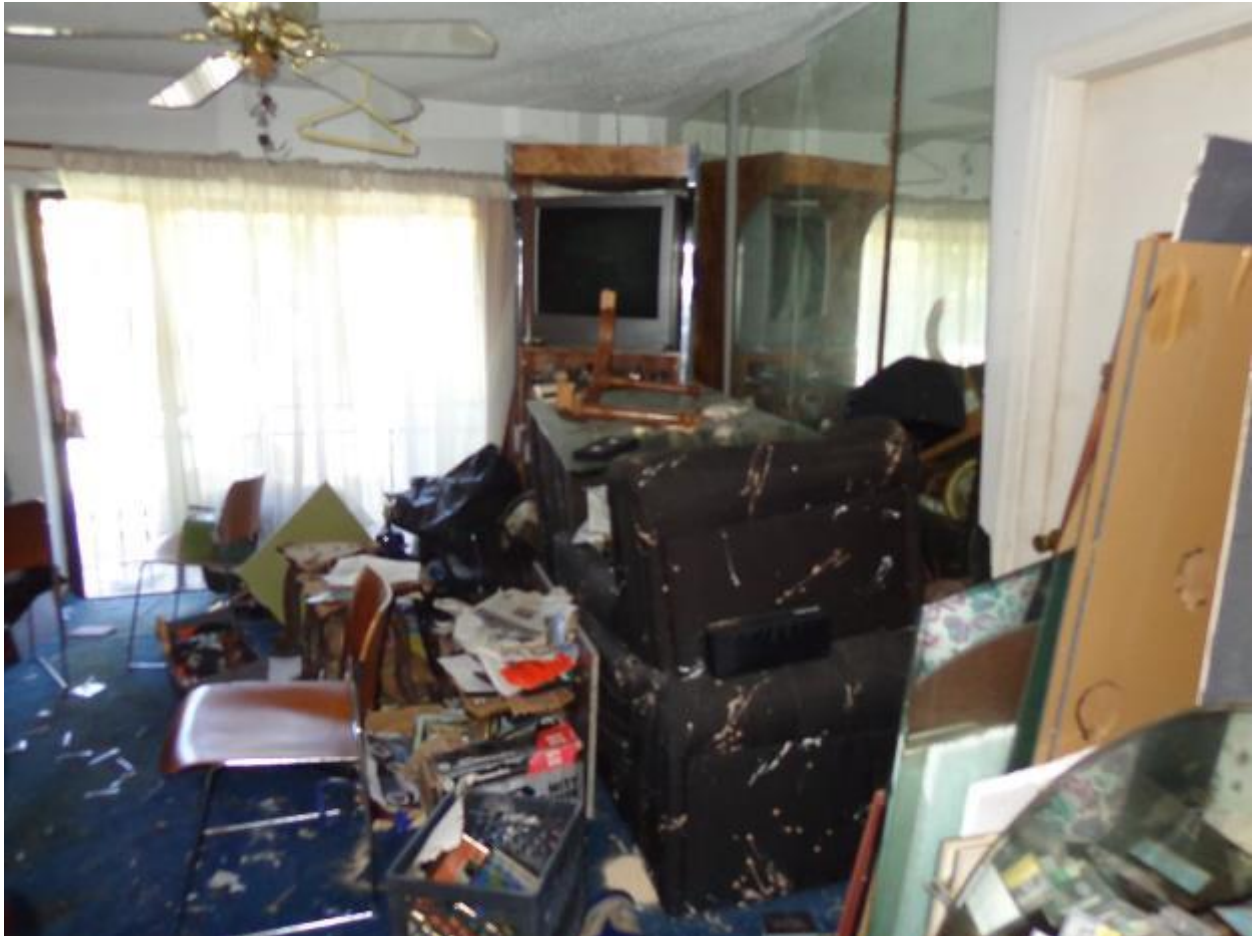
A complete rehabilitation of the interior must be done in order to provide move in conditions. Plumbing, electrical and Ac systems require replacement or repairs. Wood destroying organism active in the property.

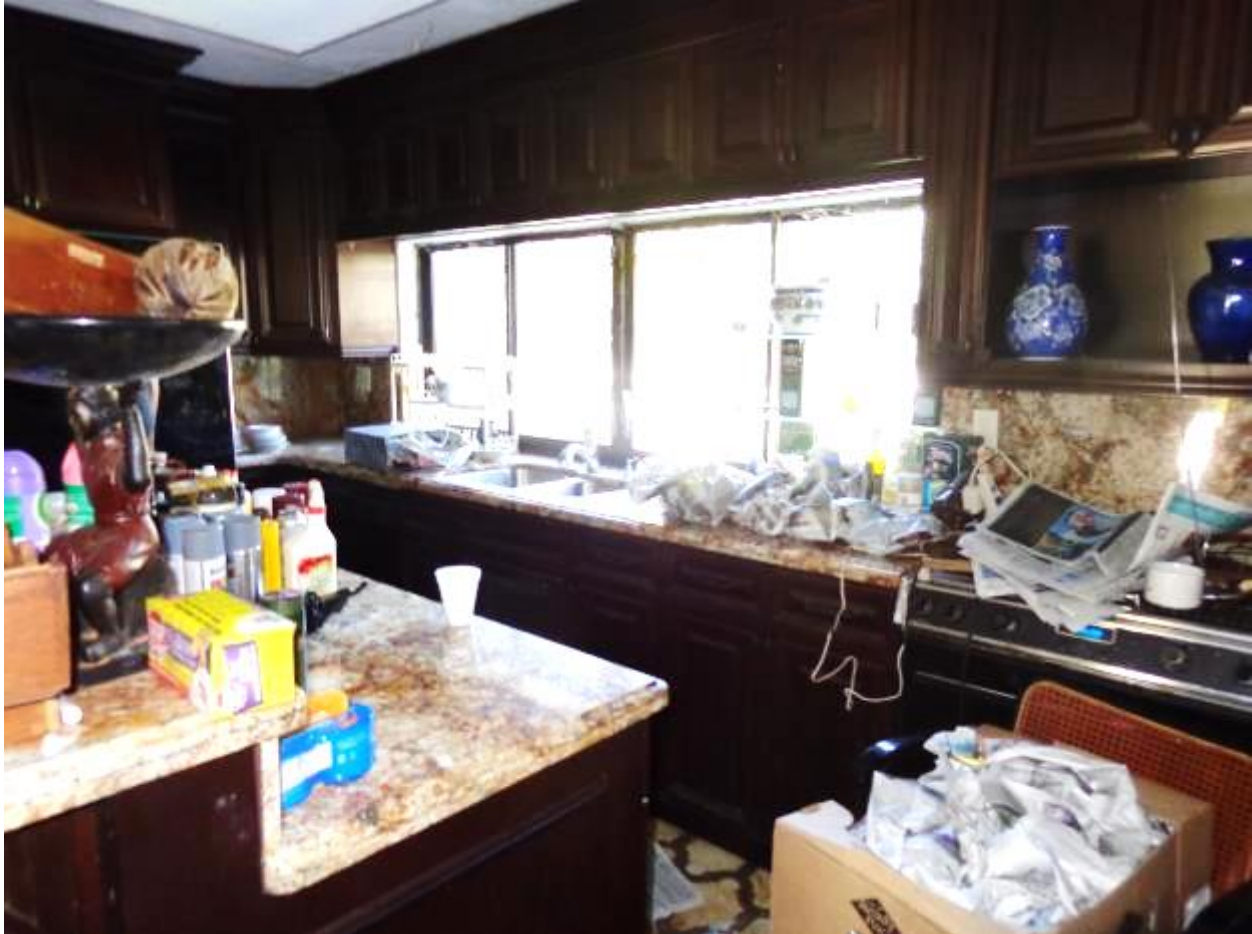
Kitchen in general good condition. Requires new appliances and proper hookup of kitchen sink.

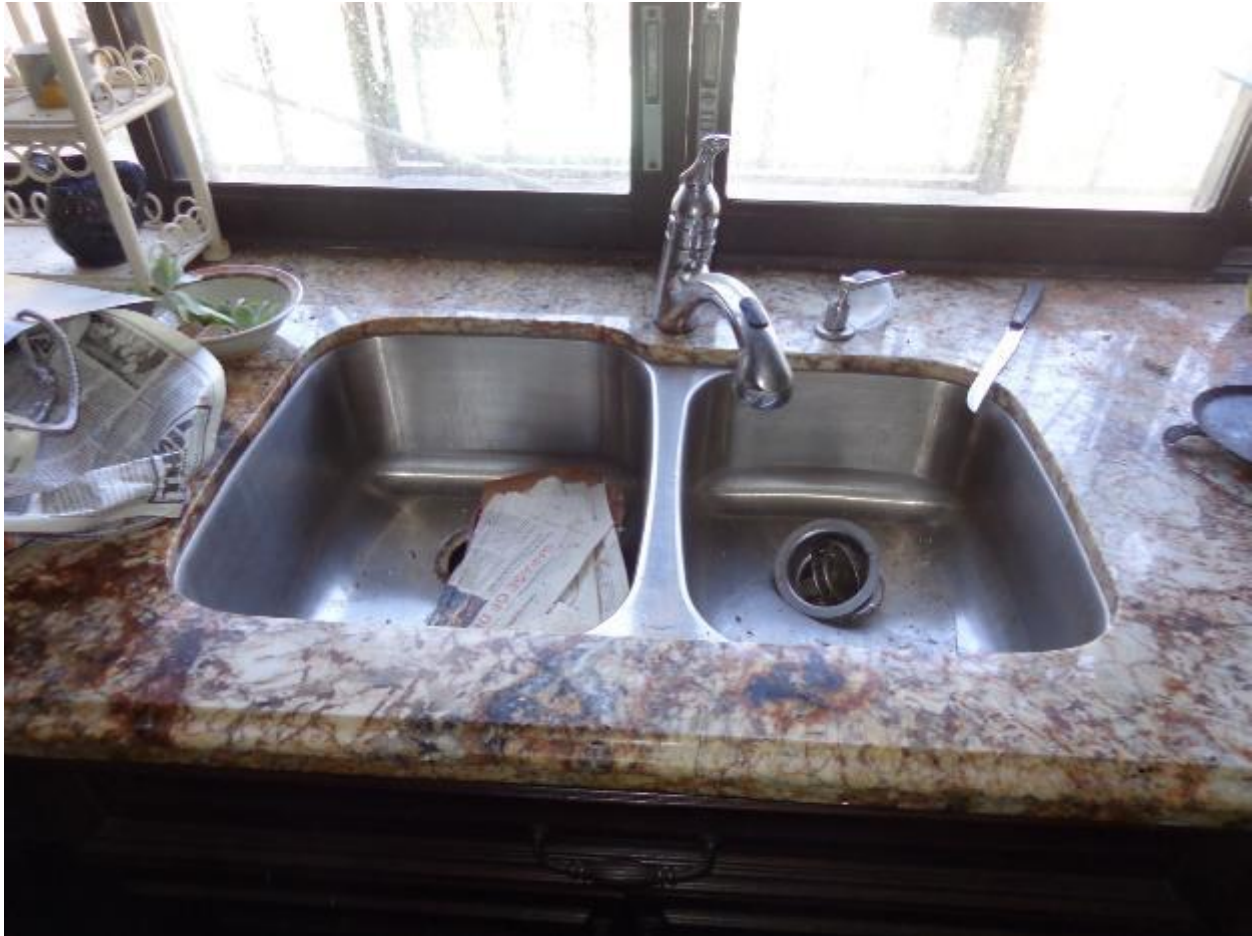
Kitchen in general good condition. Requires new appliances and proper

hookup of kitchen sink.
