PROPERTY INSPECTION OR ASSESSMENT OF DAMAGES

ADDRESS: Somewhere, FL
CLIENT: GAIA GC
ID No: 2015000
DATE: 12/31/2015

INSPECTION OR ASSESSMENT BY:

GAIA CONSTRUCTION INC.
CGC 1516136 **FLORIDA**
HI-2792 **FLORIDA**
8028867-B2 **INTERNATIONAL CODE COUNCIL**

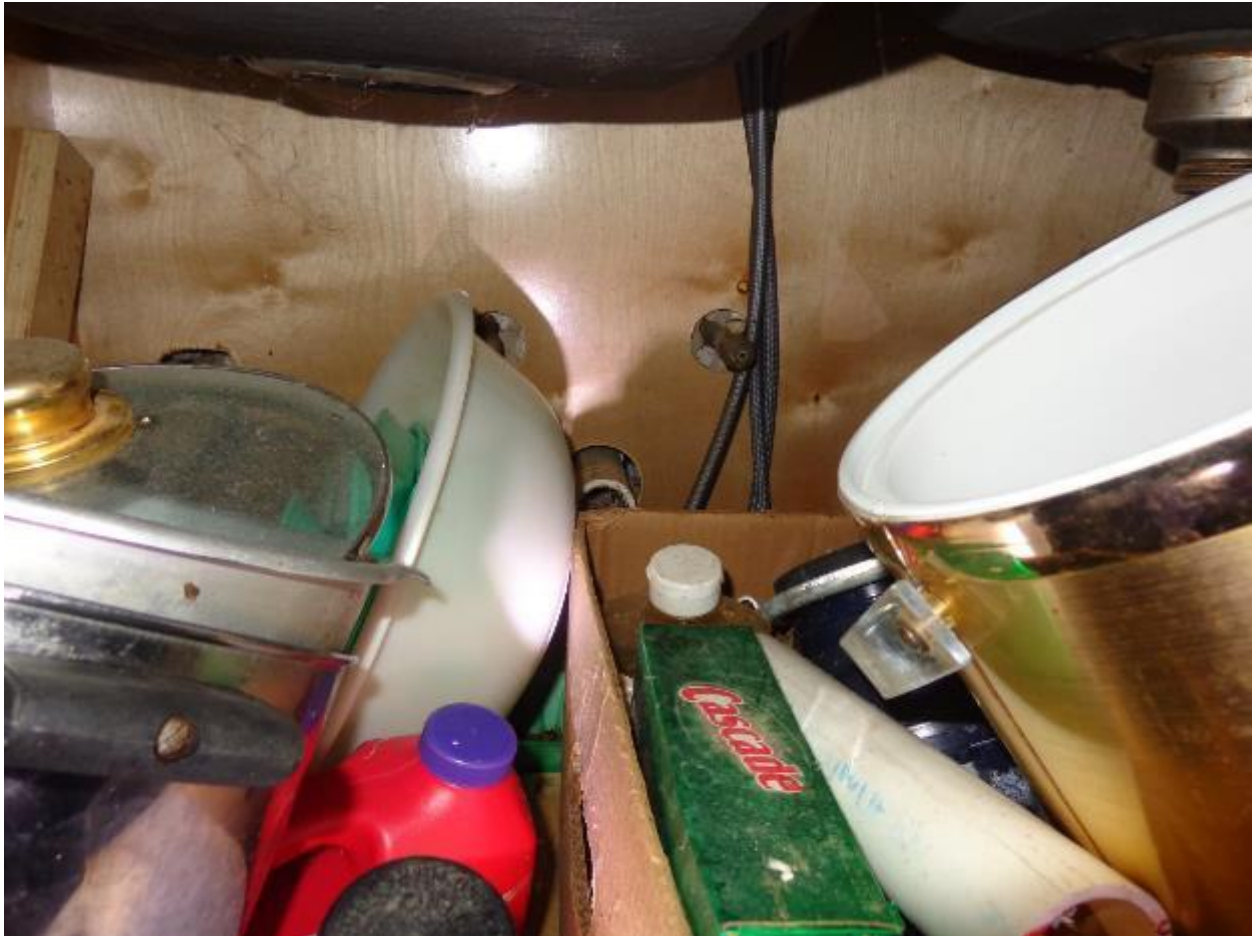
Kitchen in general good condition. Requires new appliances and proper hookup of kitchen sink.

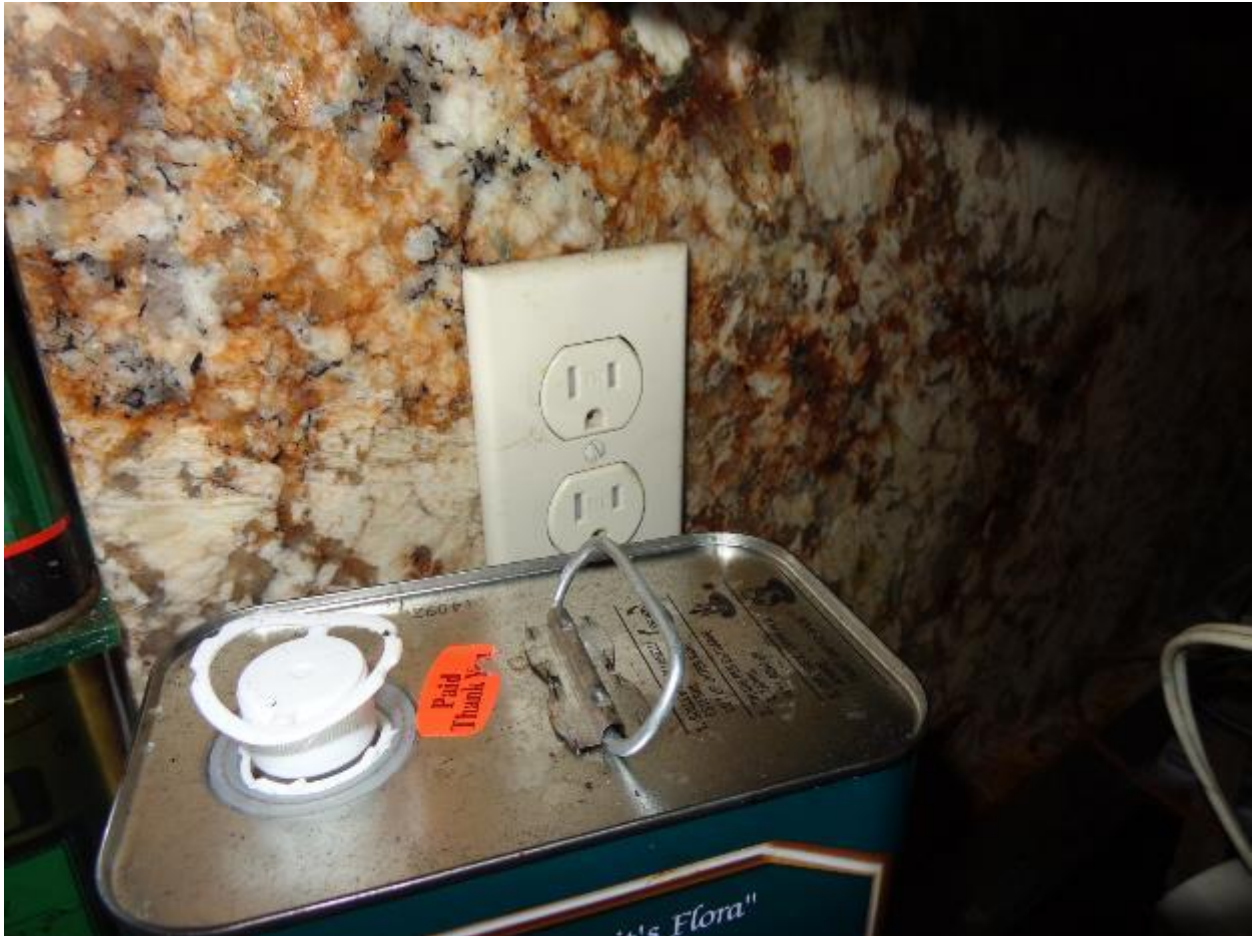
GFCI receptacles installation is required at wet areas such as bathrooms and kitchens.

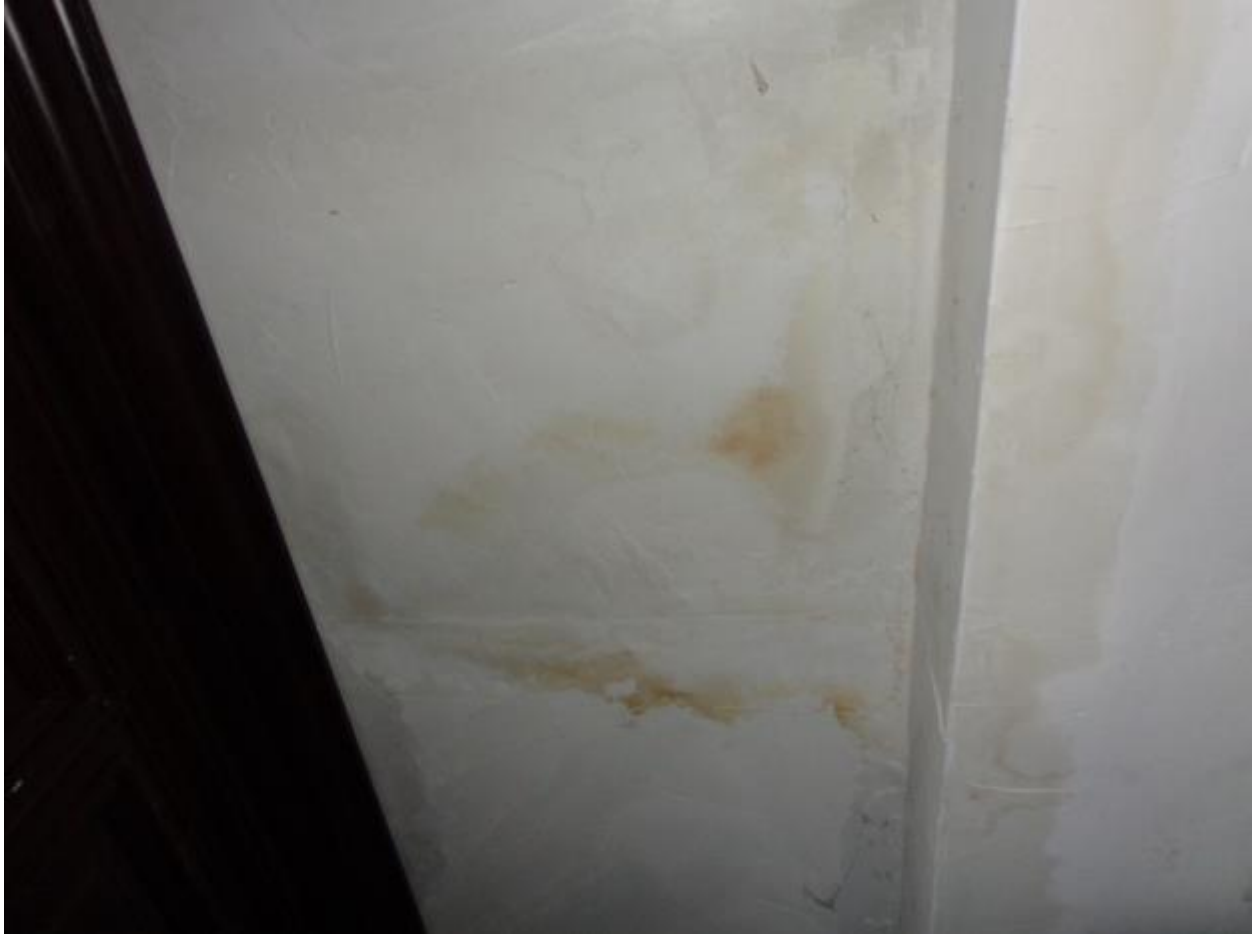
Signs of water infiltration due to roof failure noticed at the habitable space ceiling; allowances must be made for roofing and ceiling repair

Mold growth caused by water damage is visible. Do not attempt to remove damaged surfaces related to Mold growth or with signs of mold growth on your own. Hire only licensed and Insured Mold remediation services.

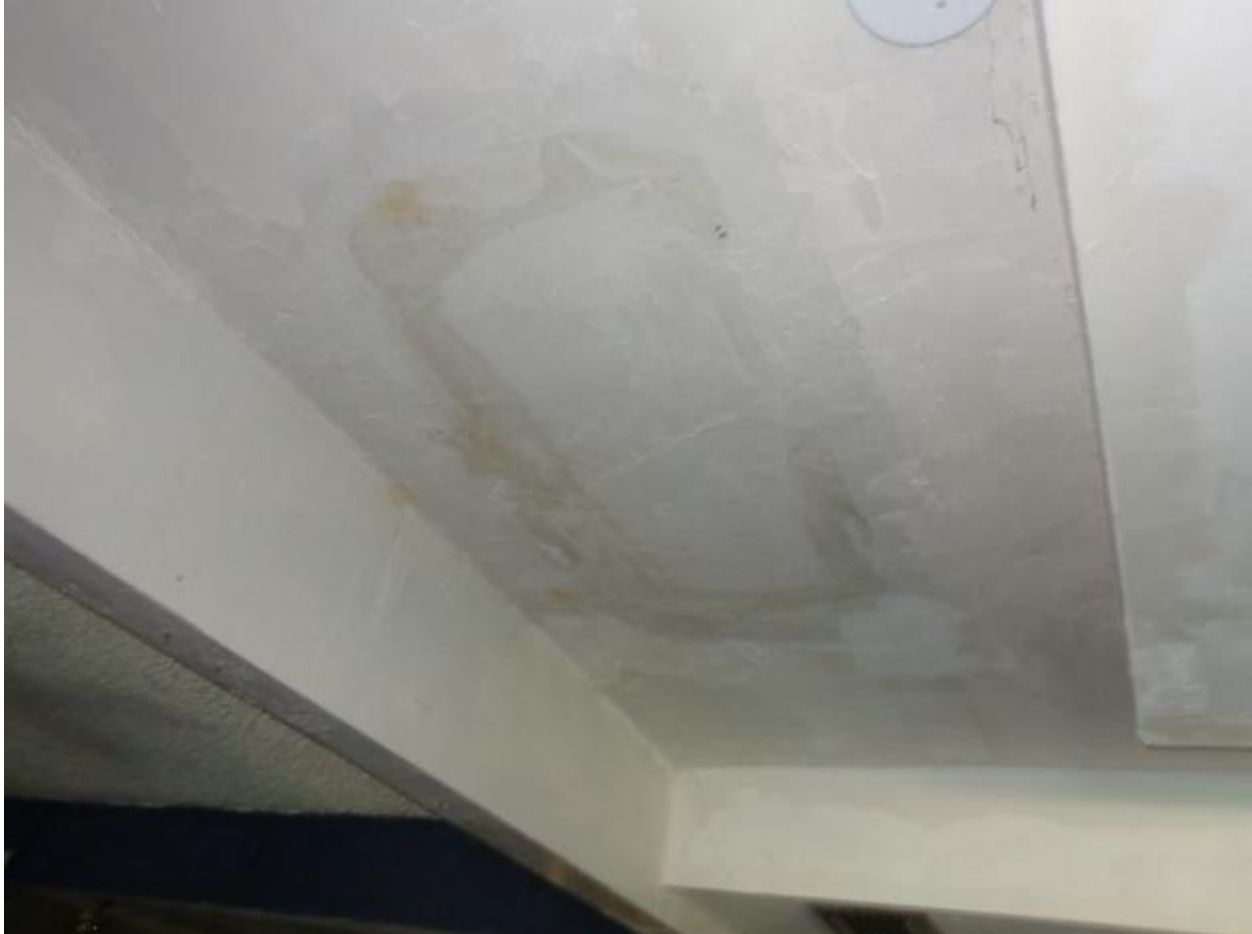
Signs of water infiltration due to roof failure noticed at the habitable space ceiling; allowances must be made for roofing and ceiling repair

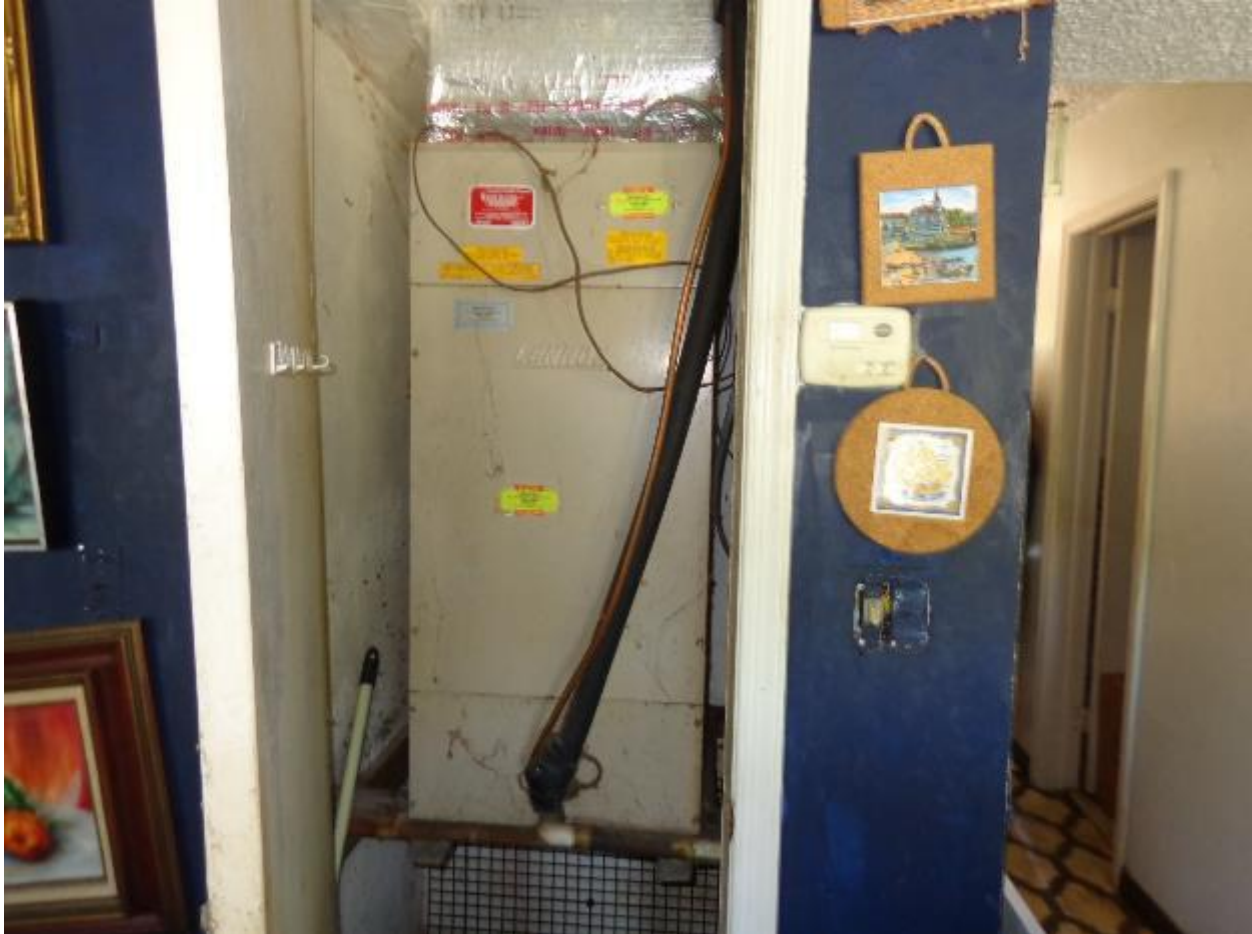
HVAC did not operate during the inspection, allowances must be made for repair or replacement

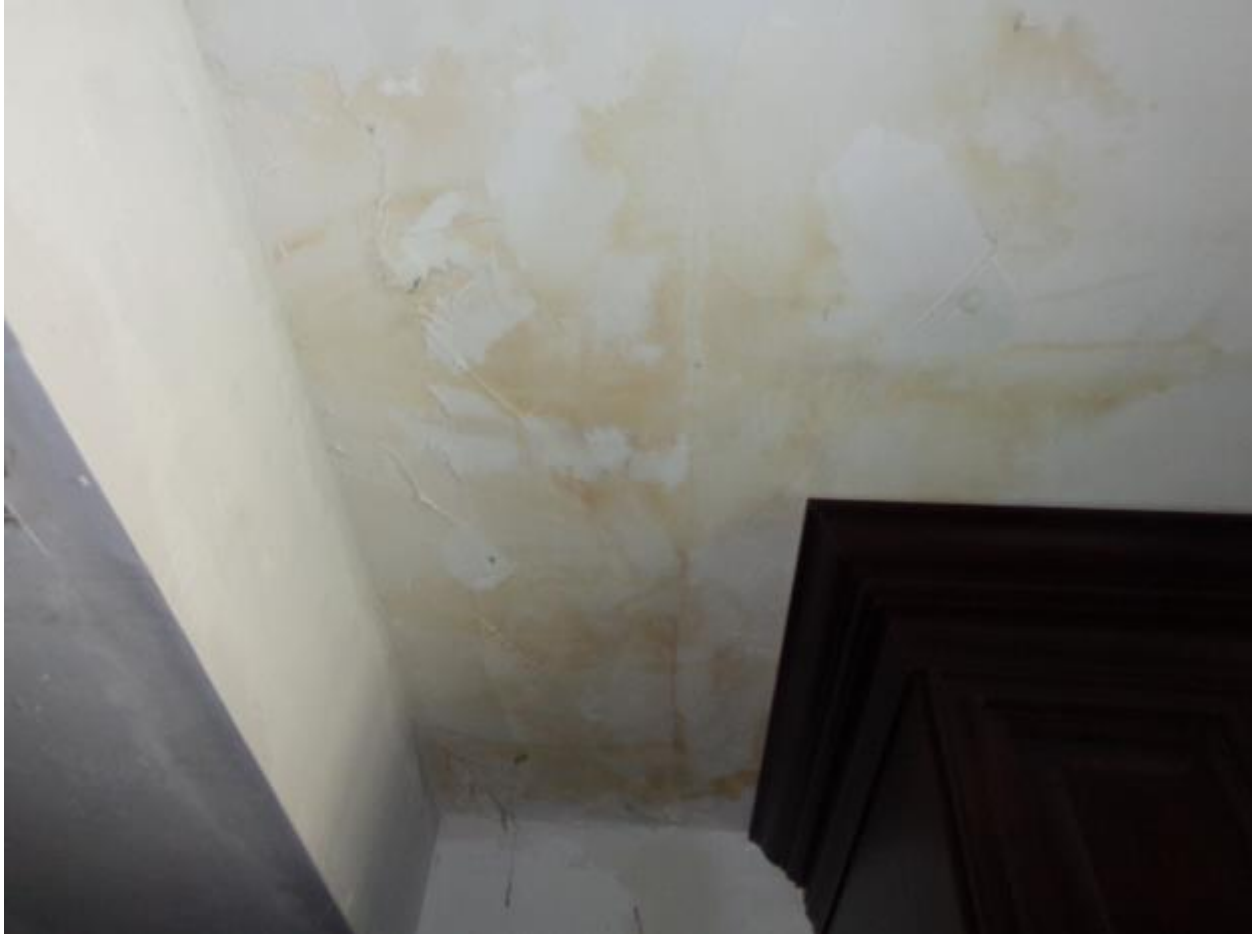
Signs of water infiltration due to roof failure noticed at the habitable space ceiling; allowances must be made for roofing and ceiling repair.

Mold growth caused by water damage is visible. Do not attempt to remove damaged surfaces related to Mold growth or with signs of mold growth on your own. Hire only licensed and Insured Mold remediation services.

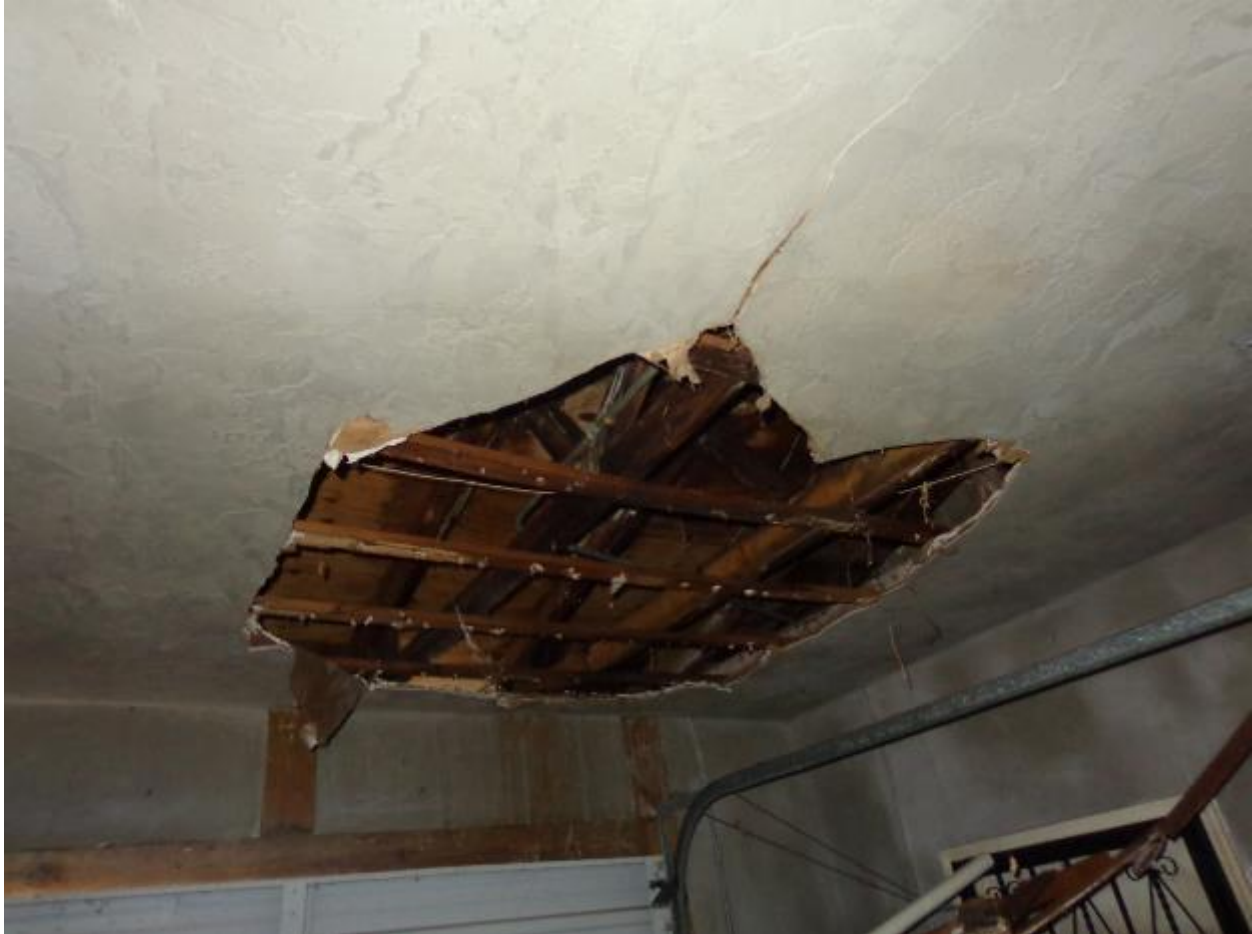
Signs of water infiltration due to roof failure noticed at the habitable space ceiling; allowances must be made for roofing and ceiling repair.

Drywall repairs required.

Mold growth caused by water damage is visible. Do not attempt to remove damaged surfaces related to Mold growth or with signs of mold growth on your own. Hire only licensed and Insured Mold remediation services.

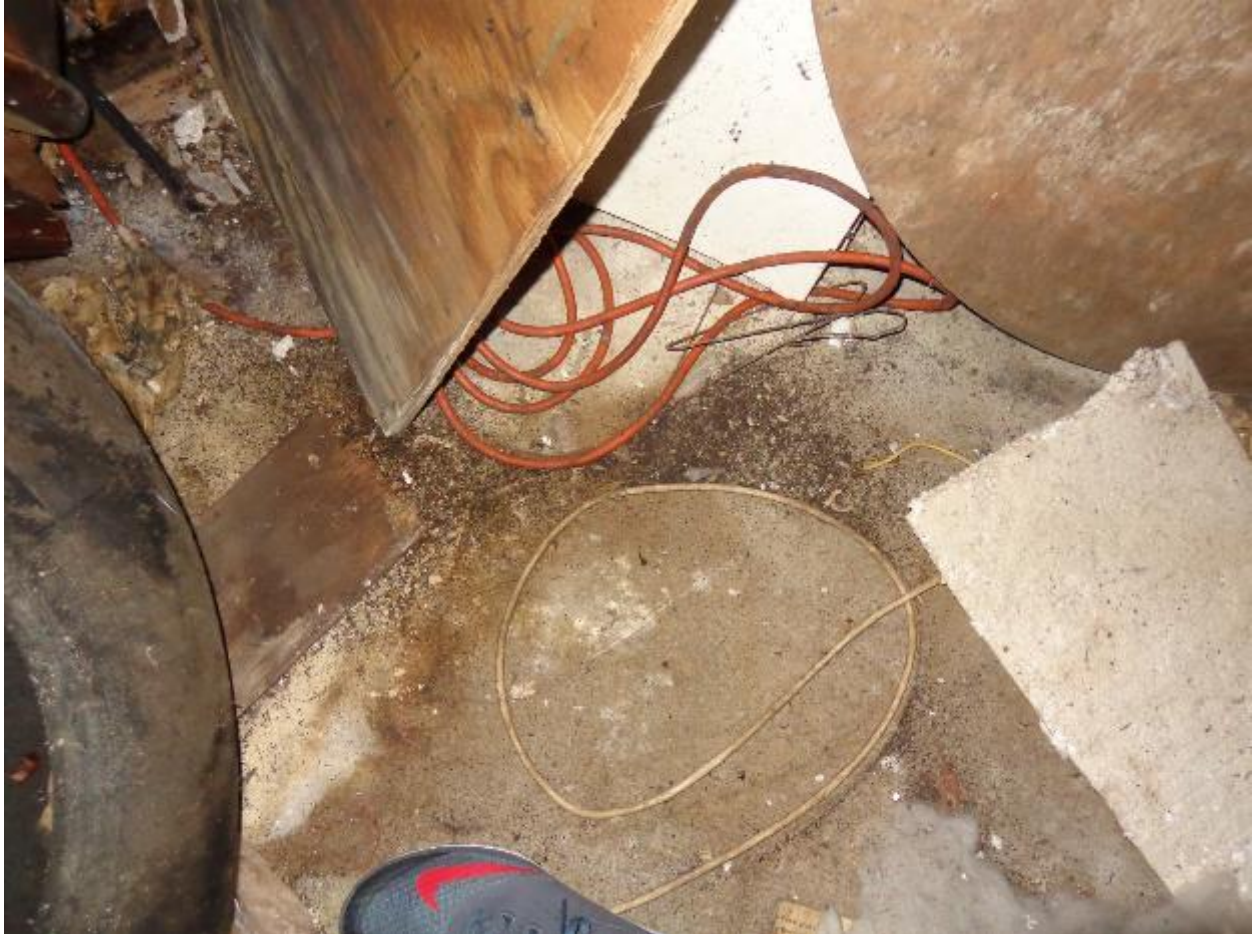
Signs of wood destroying organism related damage were noted during inspection. We recommend to have the property treated against WDO using a certified pest control company.

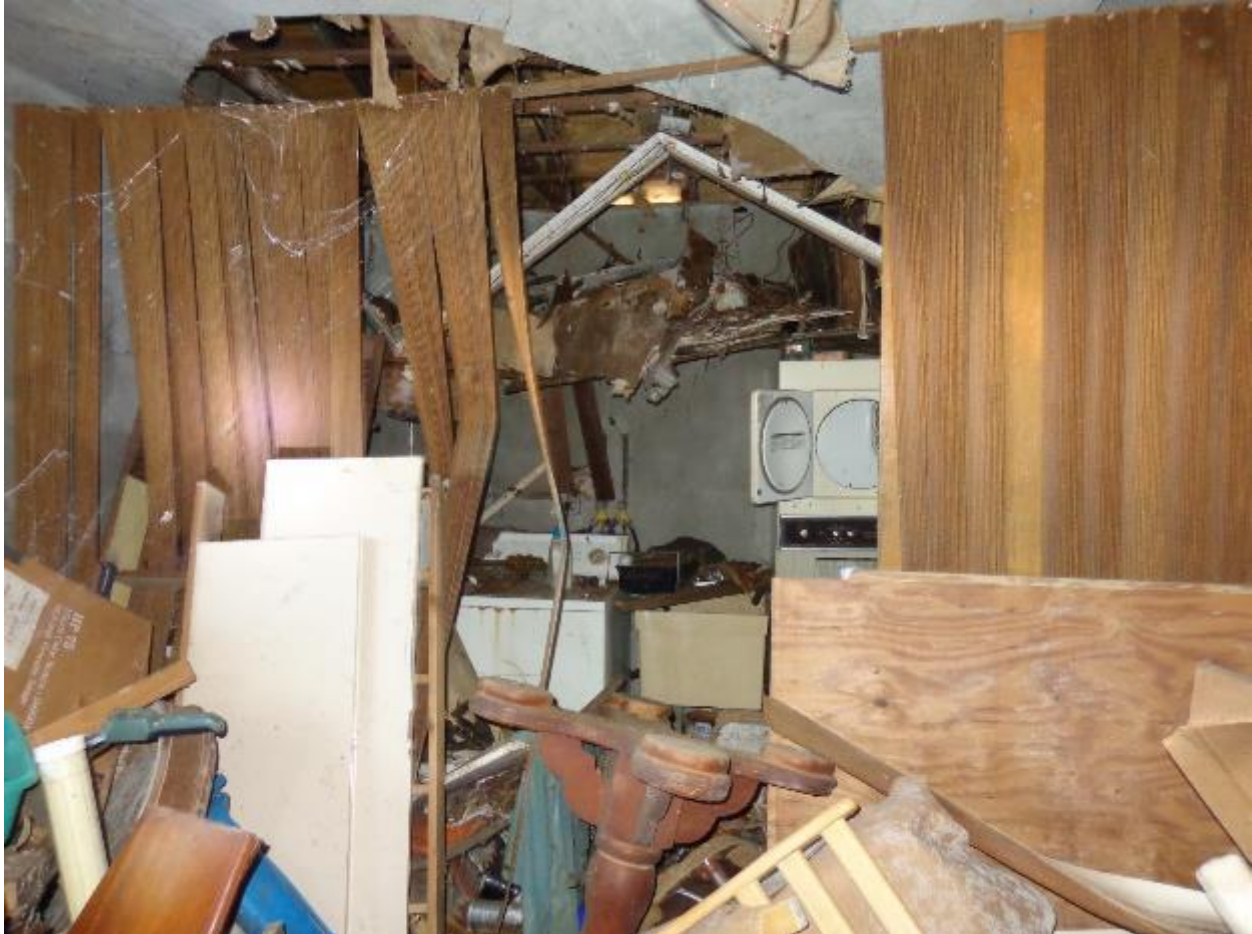
A complete rehabilitation of the interior must be done in order to provide move in conditions. Plumbing, electrical and Ac systems require replacement or repairs. Wood destroying organism active in the property.

Drywall repairs required.

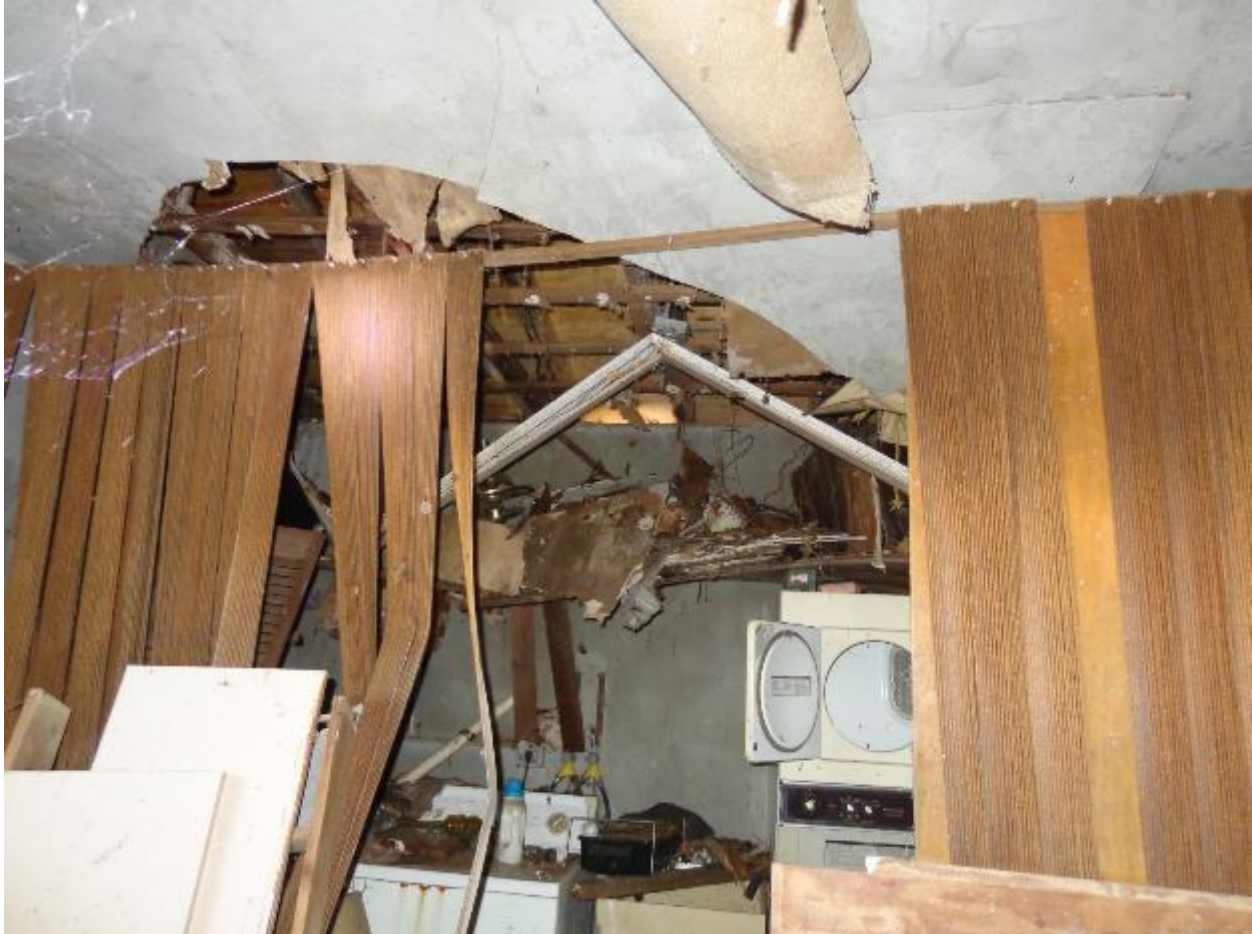
Signs of water infiltration due to roof failure noticed at the habitable space ceiling; allowances must be made for roofing and ceiling repair

Drywall repairs required.

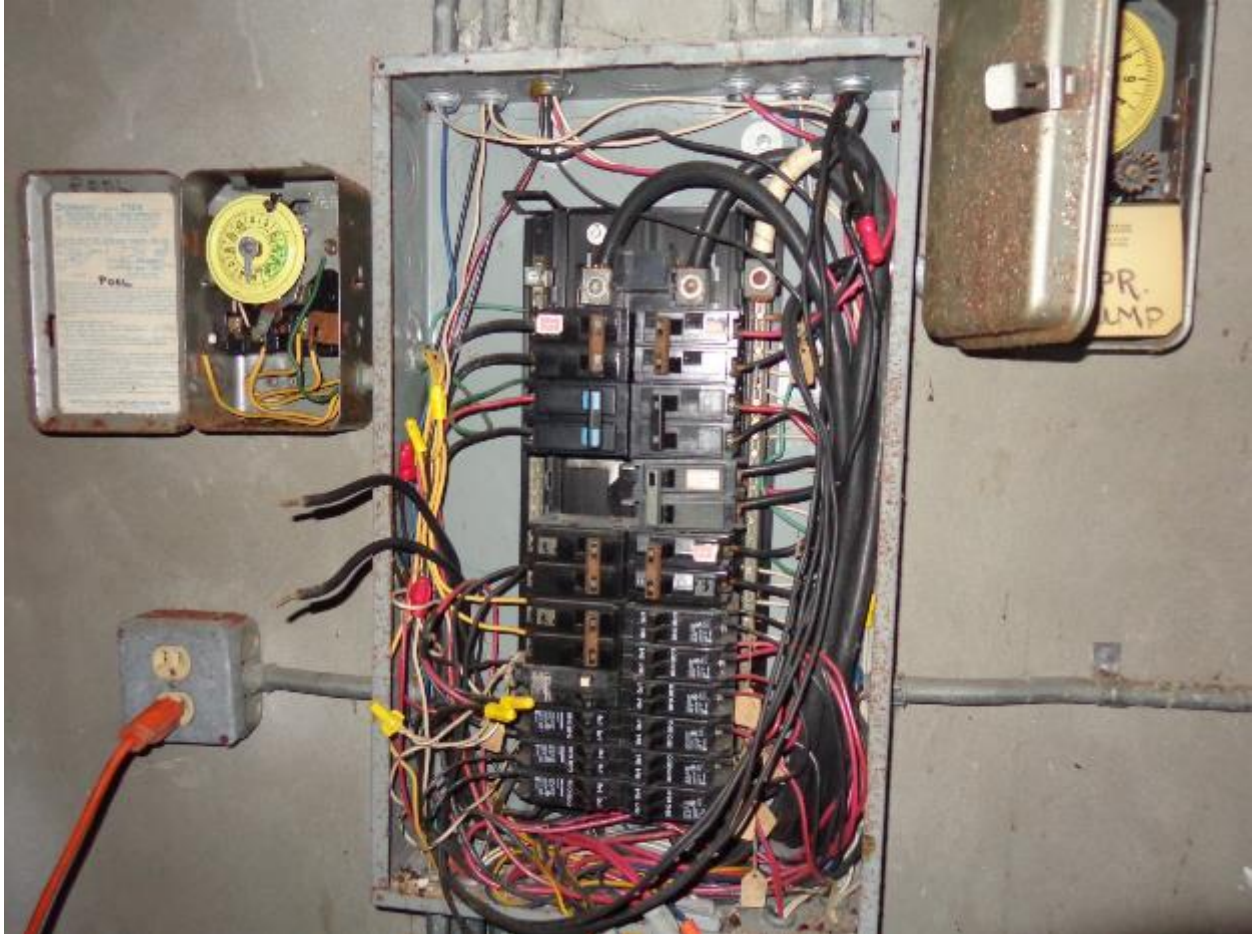
A complete upgrade of the electrical system is recommended including and not limited to GFCI's, smoke detectors, replace outlets and switches and make allowances for replacement of interior and exterior light fixtures. Beware that additional grounding will be required inside the property.

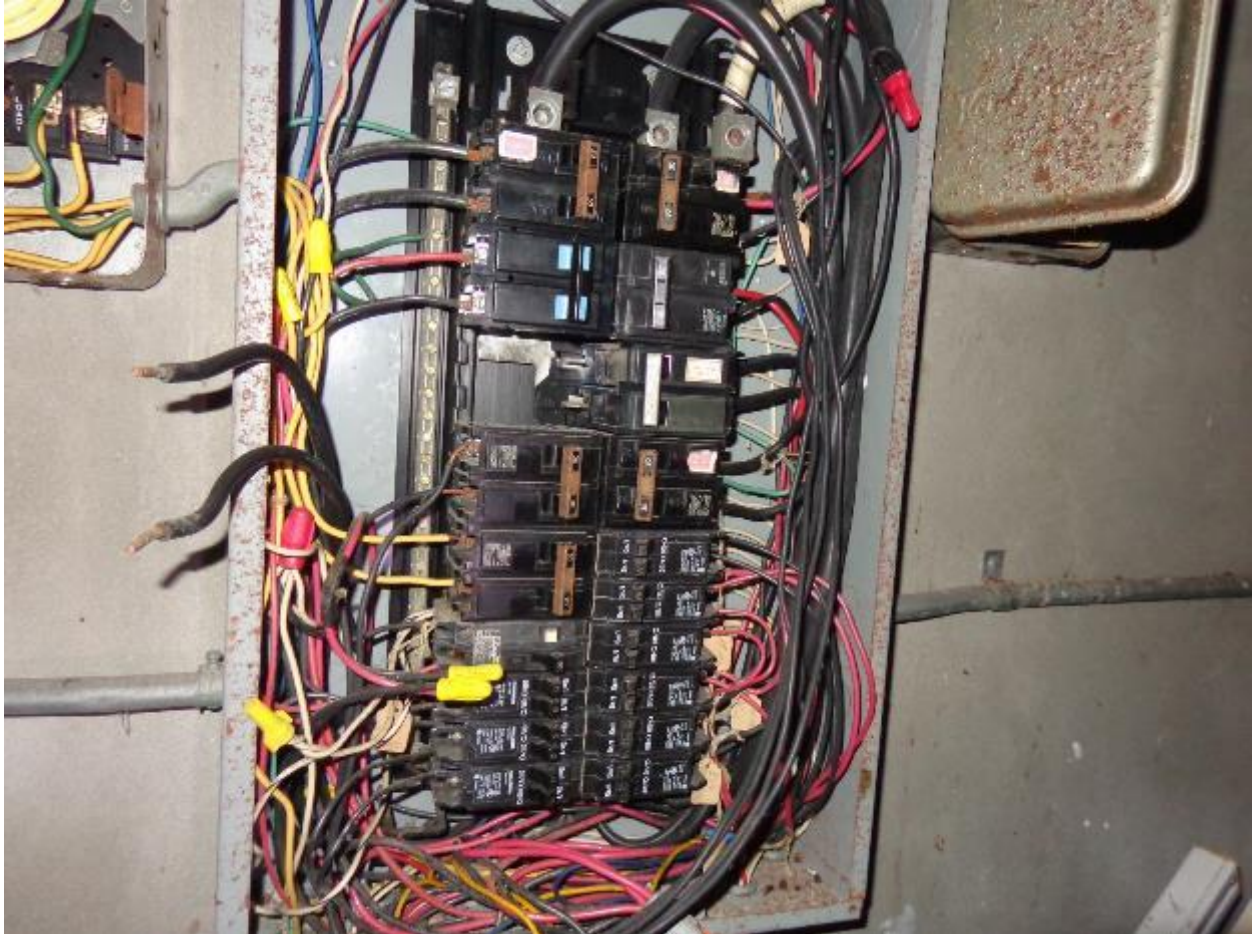
A complete upgrade of the electrical system is recommended including and not limited to GFCI's, smoke detectors, replace outlets and switches and make allowances for replacement of interior and exterior light fixtures. Beware that additional grounding will be required inside the property.

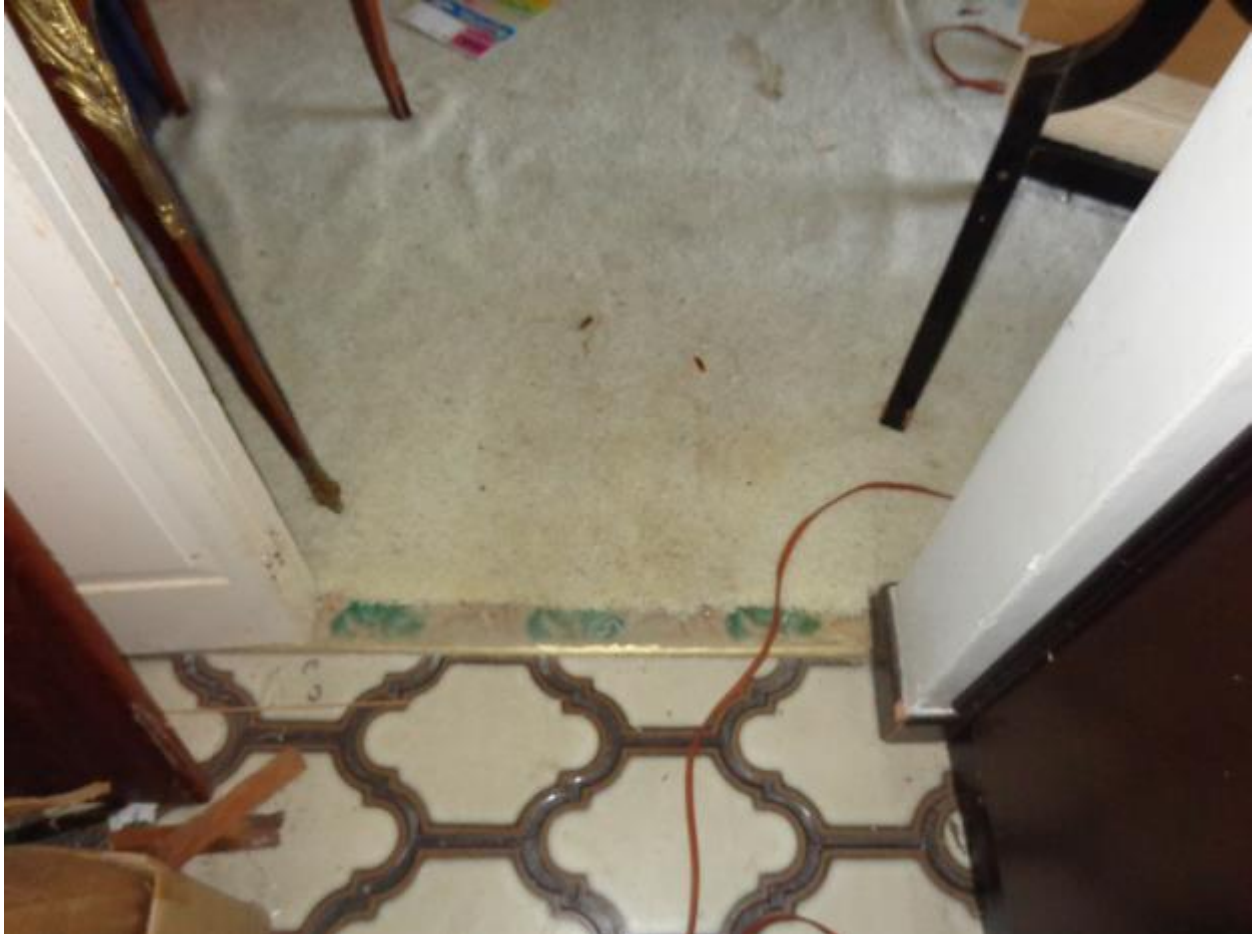
Soiled carpet throughout requires replacement.

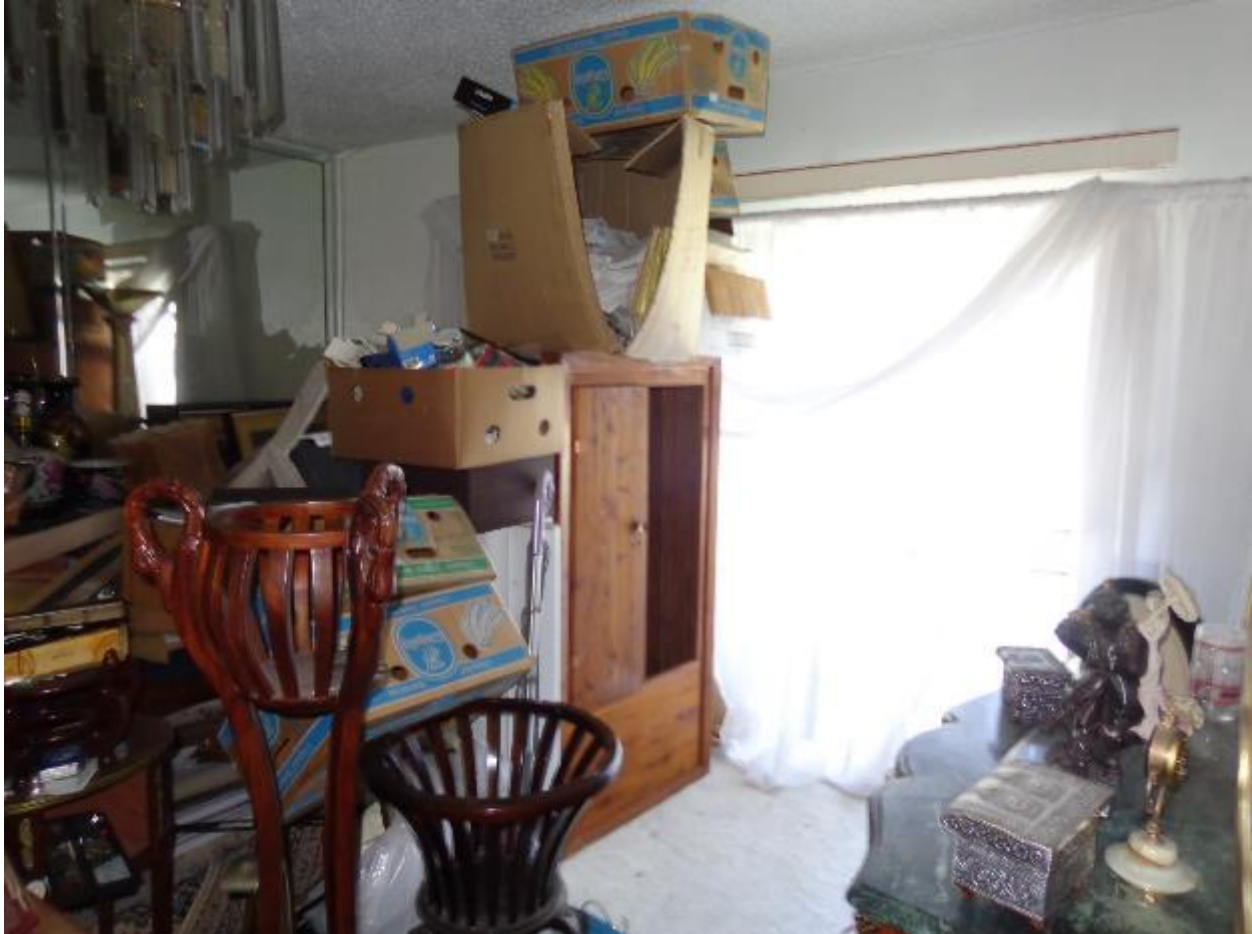
A complete rehabilitation of the interior must be done in order to provide move in conditions. Plumbing, electrical and Ac systems require replacement or repairs. Wood destroying organism active in the property.

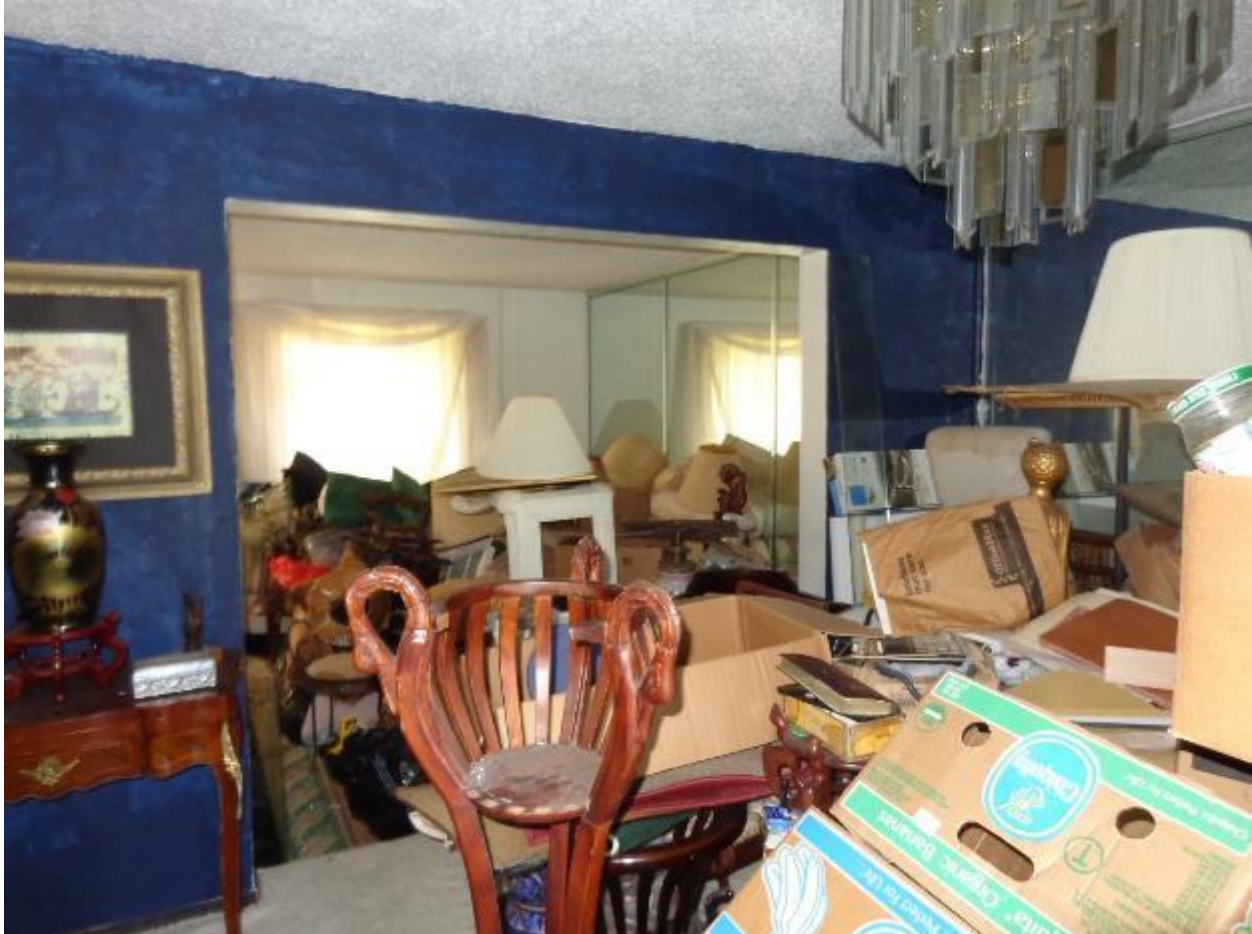
A complete rehabilitation of the interior must be done in order to provide move in conditions. Plumbing, electrical and Ac systems require replacement or repairs. Wood destroying organism active in the property.

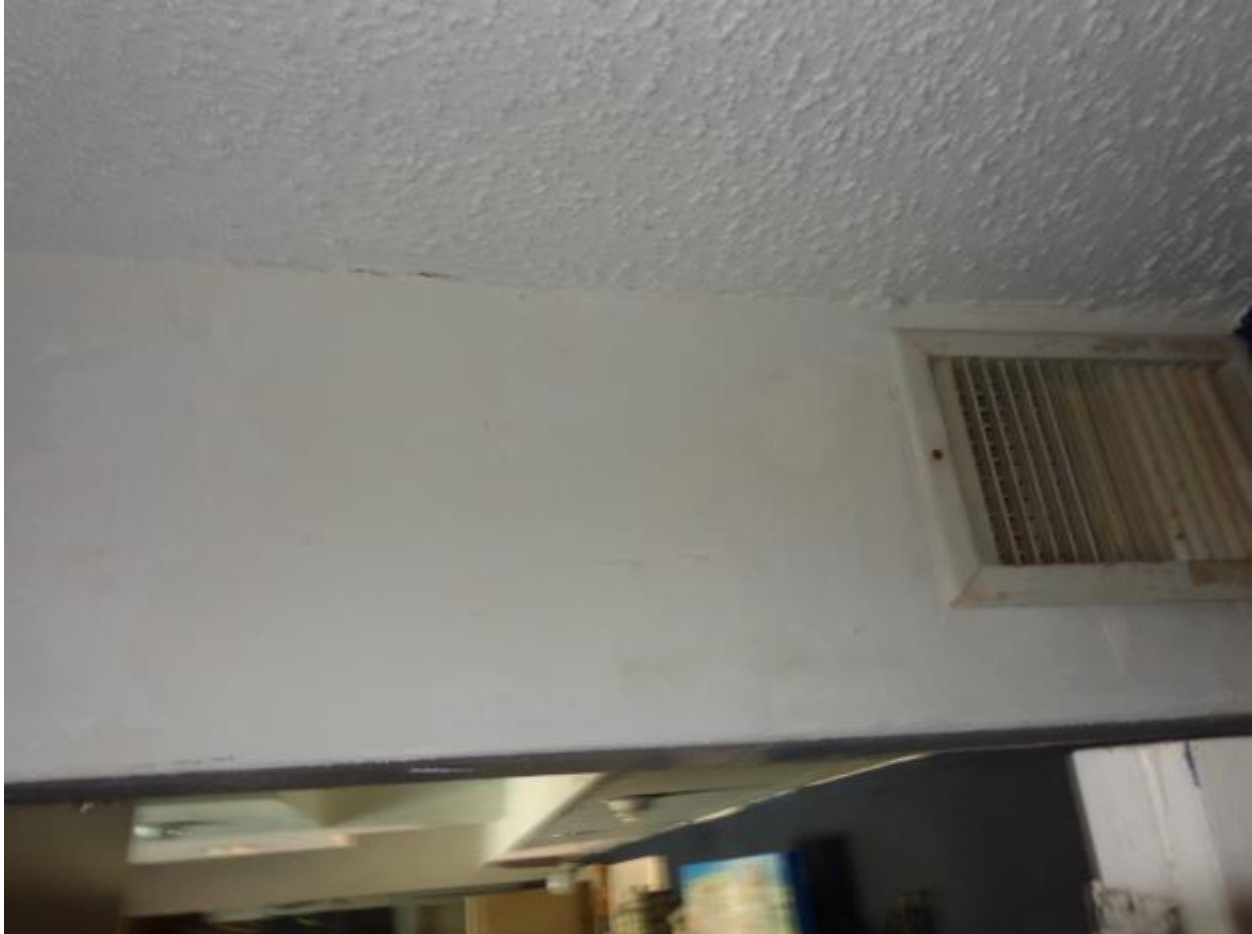
Signs of water infiltration due to roof failure noticed at the habitable space ceiling; allowances must be made for roofing and ceiling repair

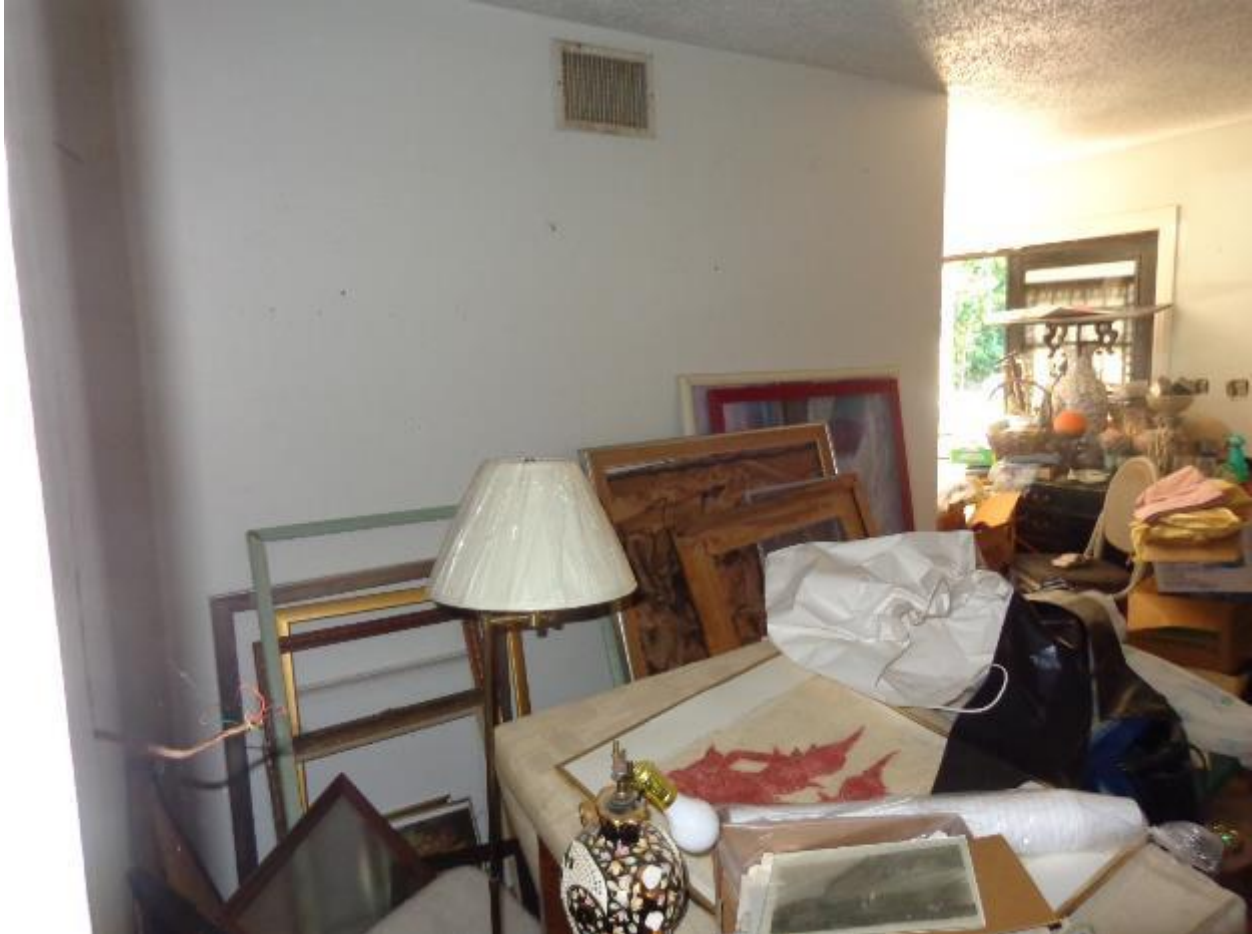
A complete rehabilitation of the interior must be done in order to provide move in conditions. Plumbing, electrical and Ac systems require replacement or repairs. Wood destroying organism active in the property.

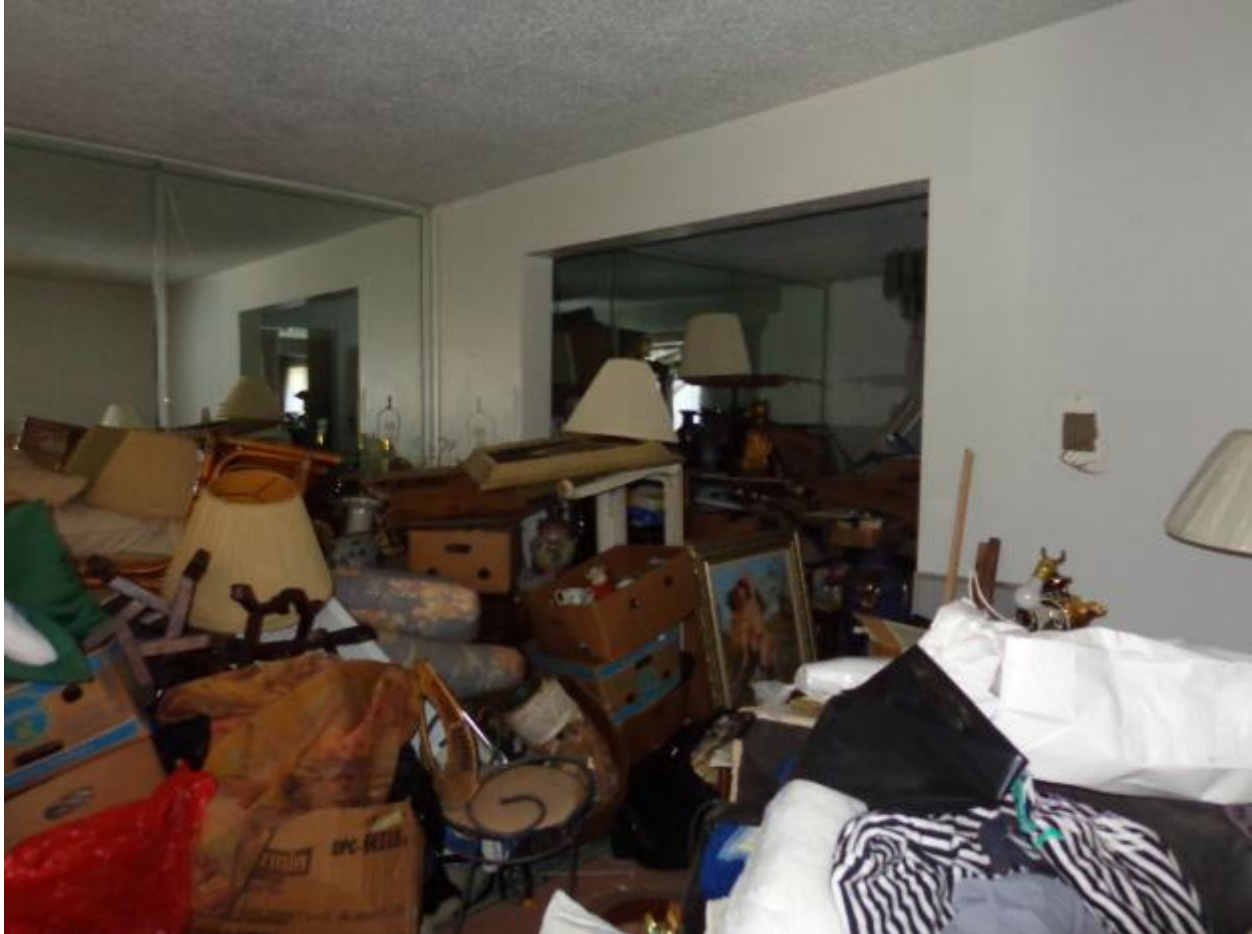
A complete rehabilitation of the interior must be done in order to provide move in conditions. Plumbing, electrical and Ac systems require replacement or repairs. Wood destroying organism active in the property.

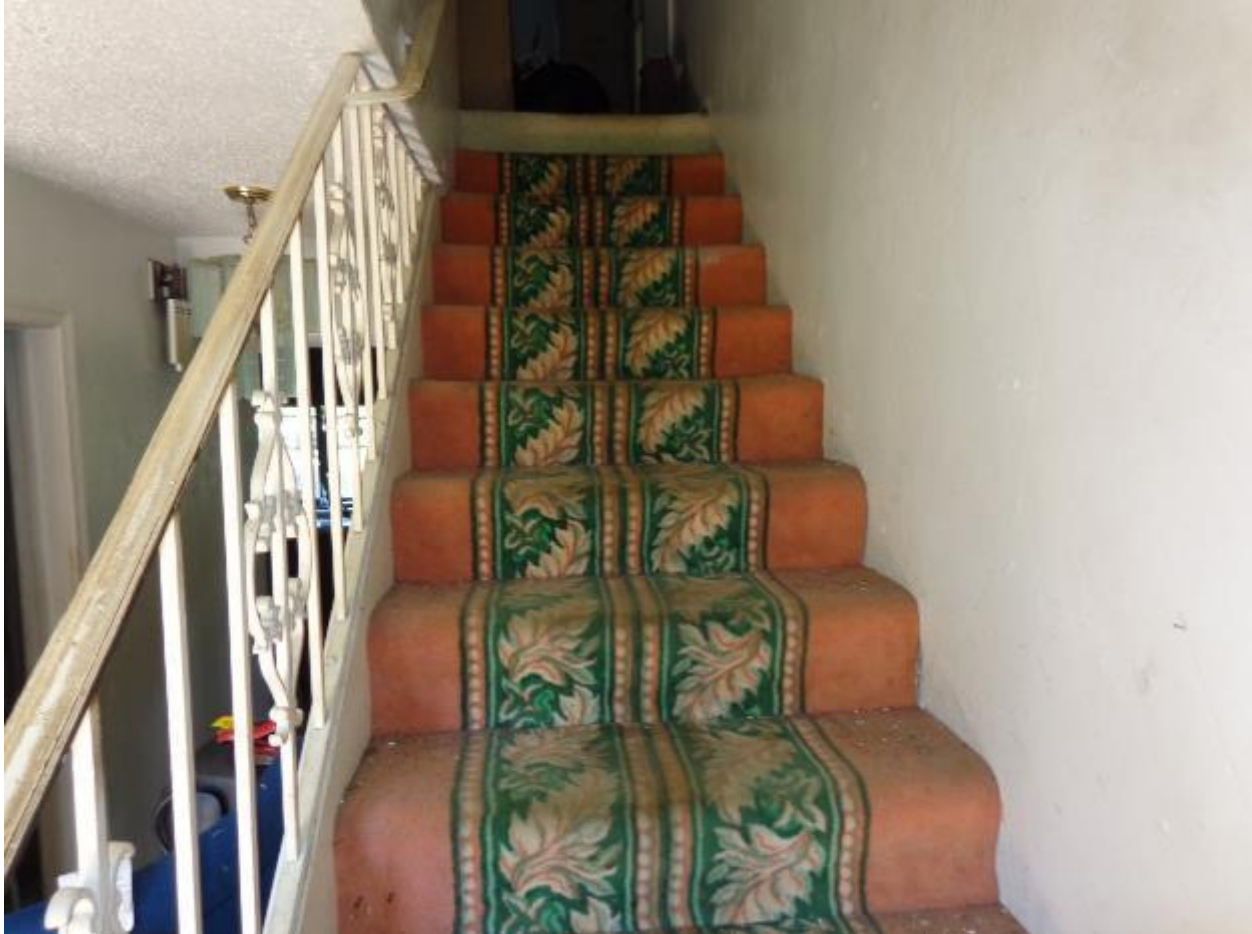
Soiled carpet throughout requires replacement.
