PROPERTY INSPECTION OR ASSESSMENT OF DAMAGES

ADDRESS: Somewhere, FL
CLIENT: GAIA GC
ID No: 2015000
DATE: 12/31/2015

INSPECTION OR ASSESSMENT BY:

GAIA CONSTRUCTION INC.
CGC 1516136 **FLORIDA**
HI-2792 **FLORIDA**
8028867-B2 **INTERNATIONAL CODE COUNCIL**

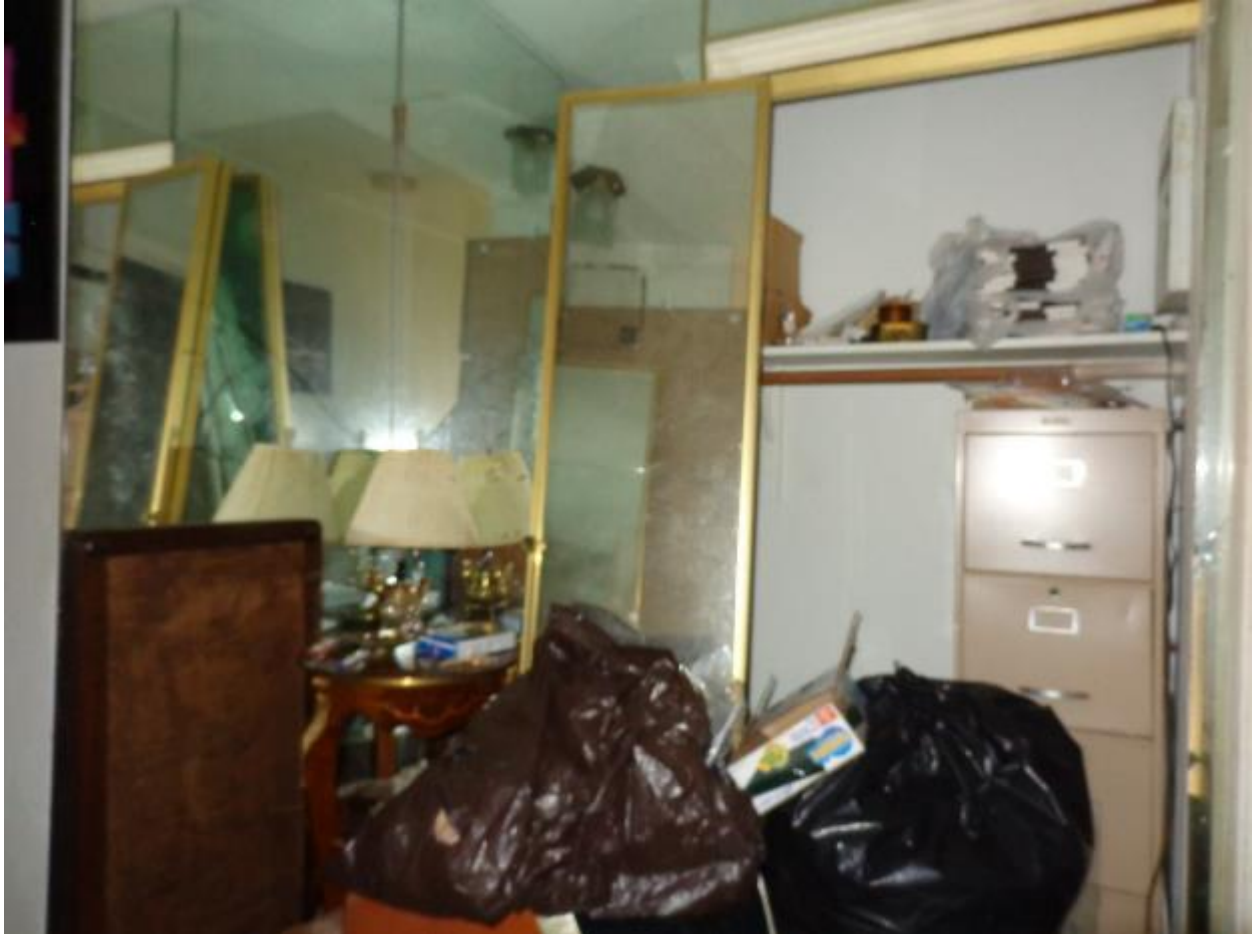
A complete rehabilitation of the interior must be done in order to provide move in conditions. Plumbing, electrical and Ac systems require replacement or repairs. Wood destroying organism active in the property.

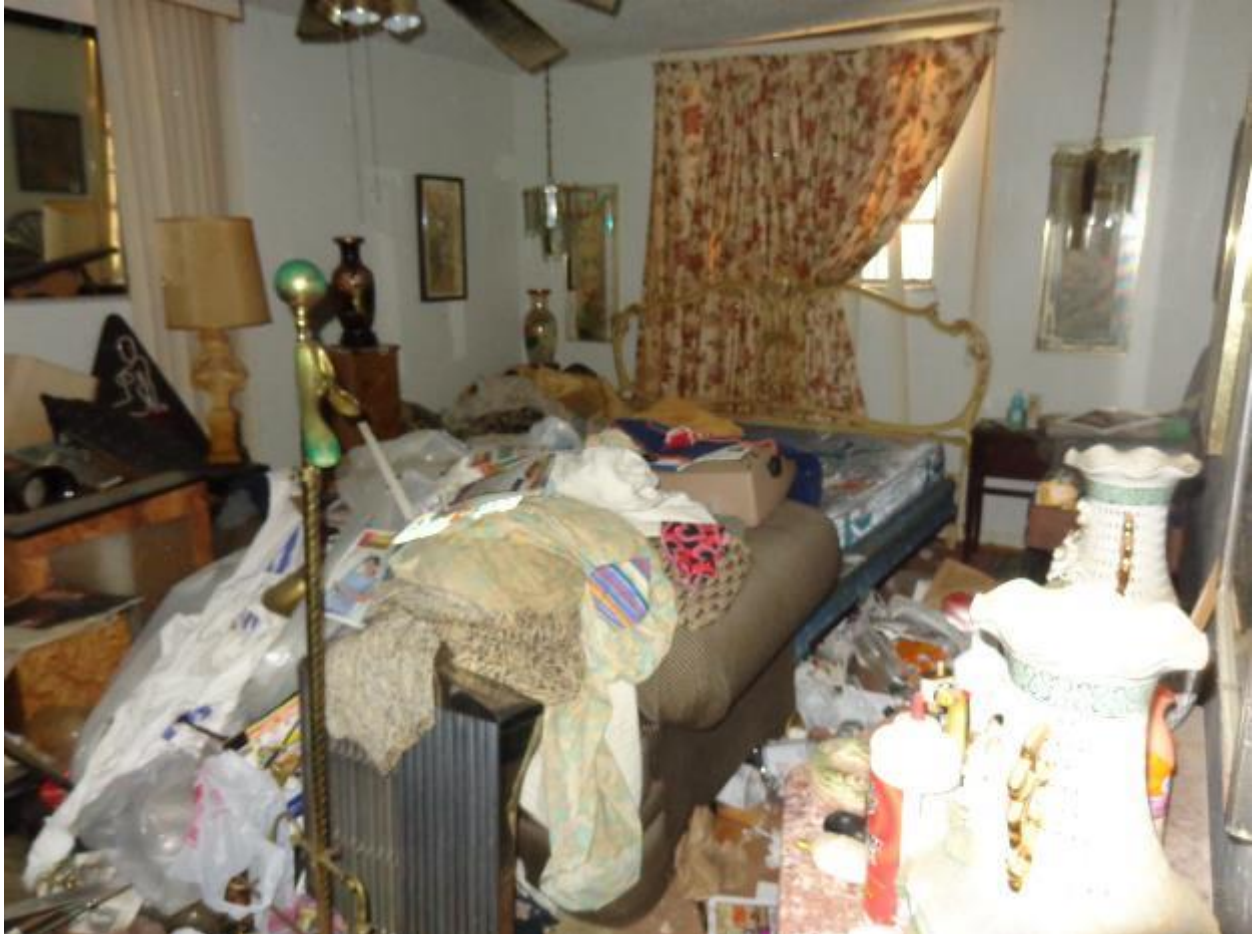
A complete rehabilitation of the interior must be done in order to provide move in conditions. Plumbing, electrical and Ac systems require replacement or repairs. Wood destroying organism active in the property.

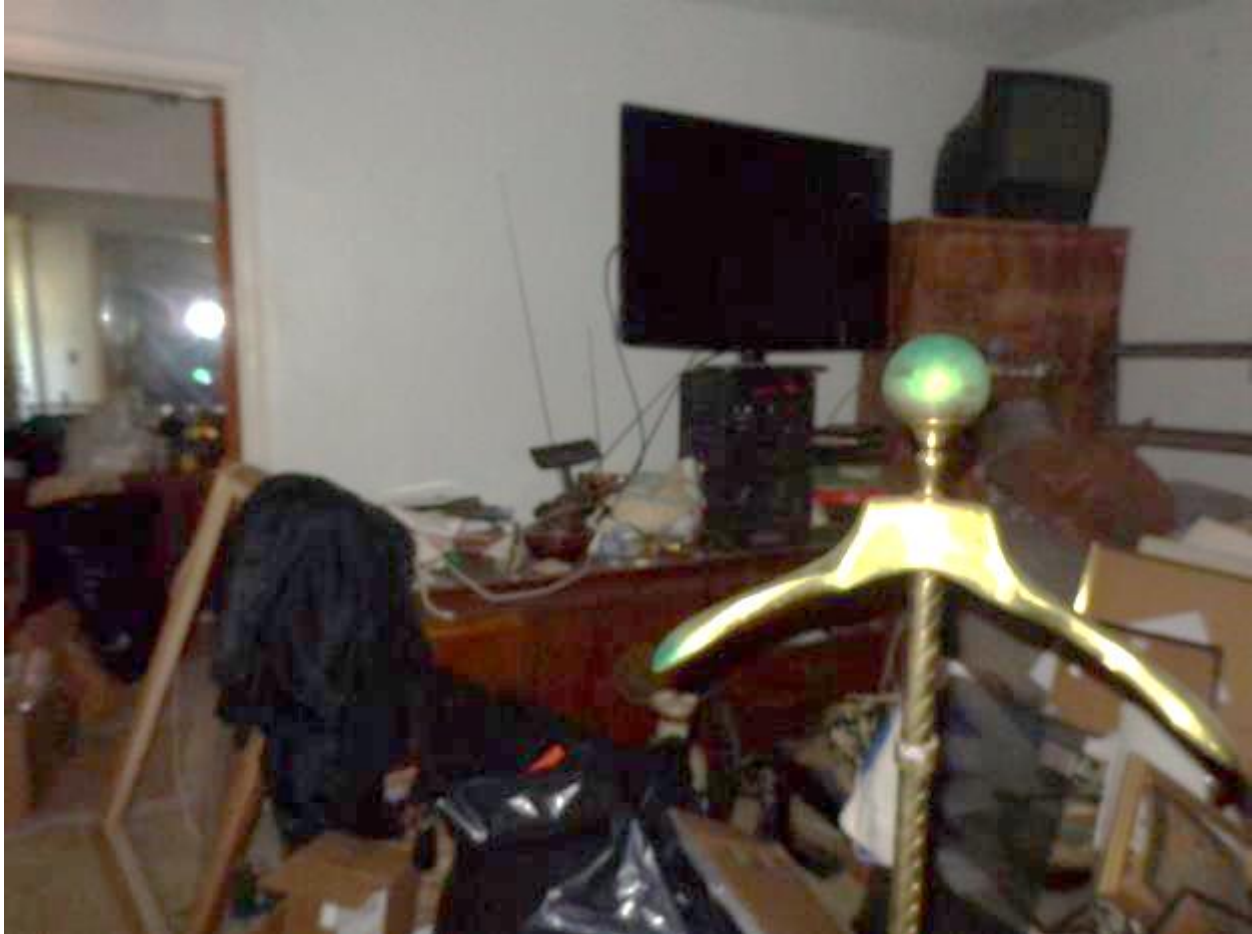
A complete rehabilitation of the interior must be done in order to provide move in conditions. Plumbing, electrical and Ac systems require replacement or repairs. Wood destroying organism active in the property.

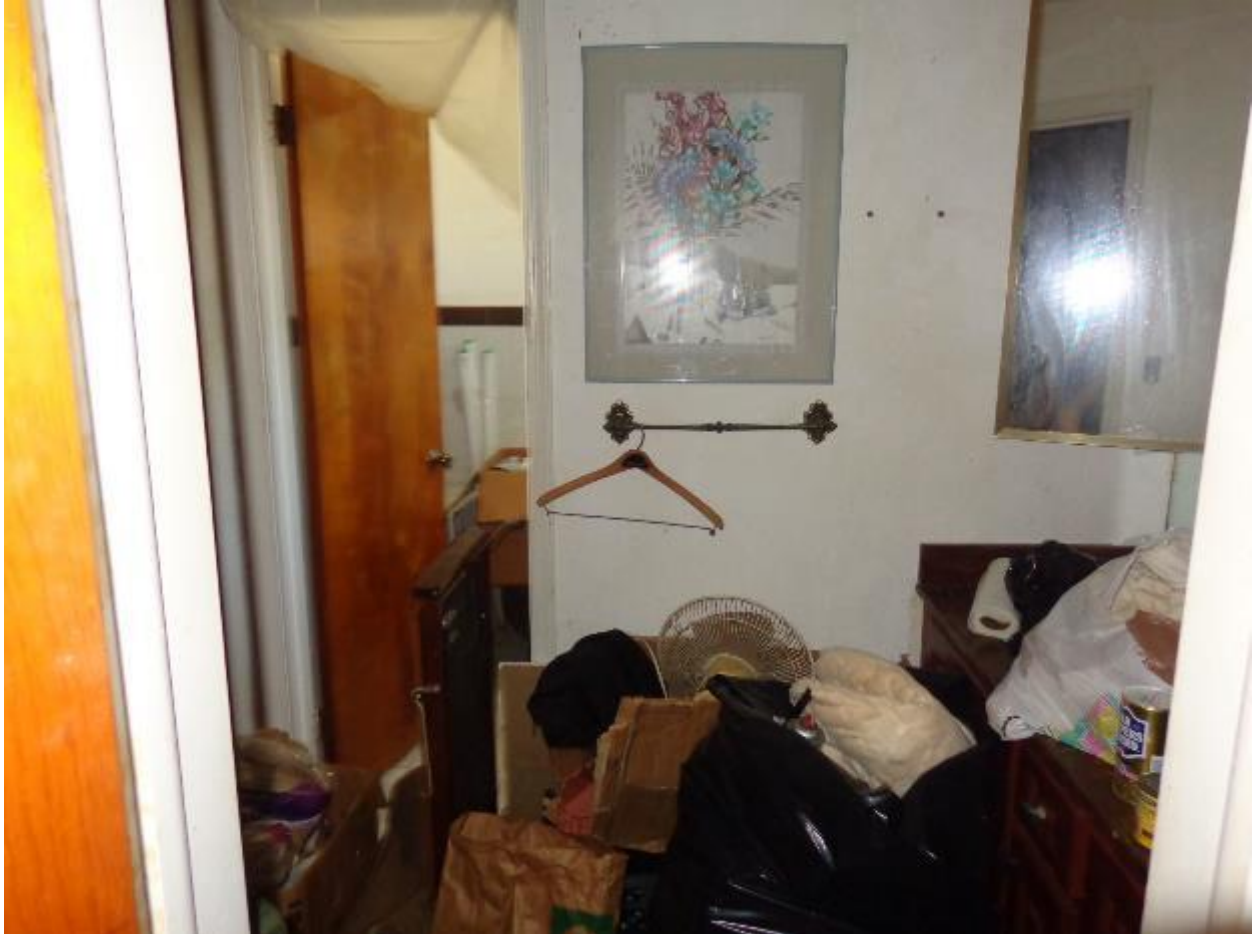
Allowances must be made for the complete upgrade of finishes in bathroom(s).

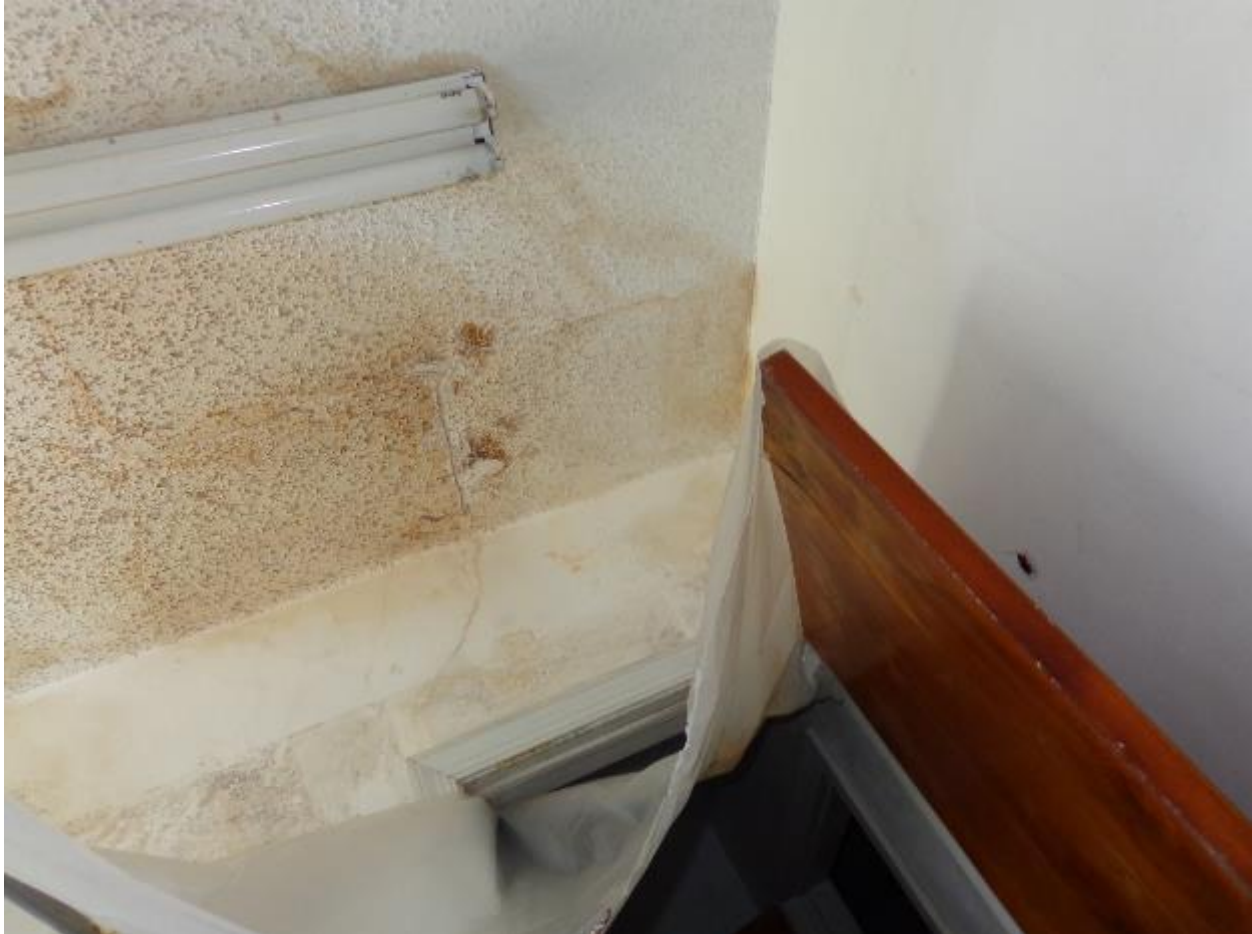
Signs of water infiltration due to roof failure noticed at the habitable space ceiling; allowances must be made for roofing and ceiling repair

Mold growth caused by water damage is visible. Do not attempt to remove damaged surfaces related to Mold growth or with signs of mold growth on your own. Hire only licensed and Insured Mold remediation services.

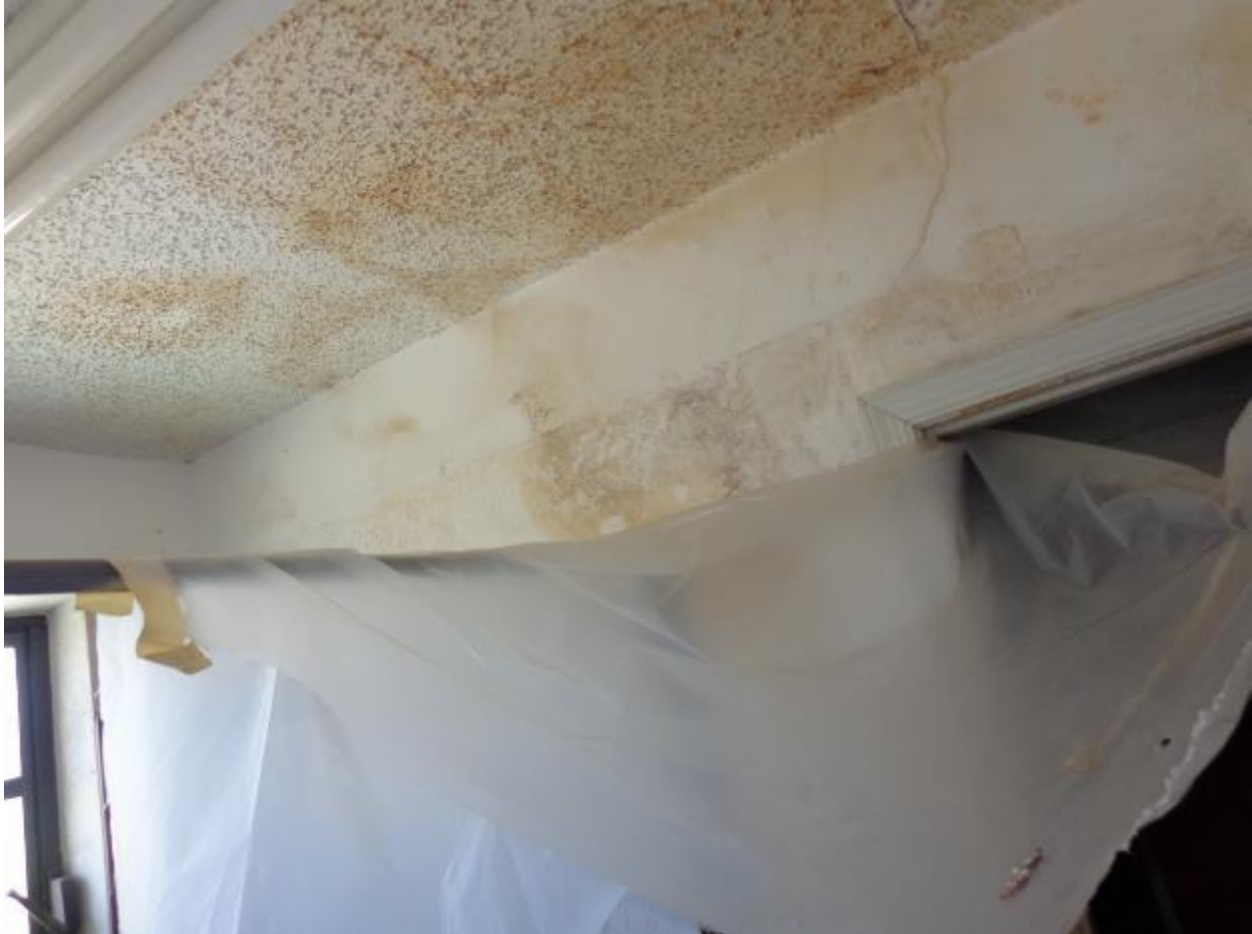
Signs of water infiltration due to roof failure noticed at the habitable space ceiling; allowances must be made for roofing and ceiling repair

Mold growth caused by water damage is visible. Do not attempt to remove damaged surfaces related to Mold growth or with signs of mold growth on your own. Hire only licensed and Insured Mold remediation services.

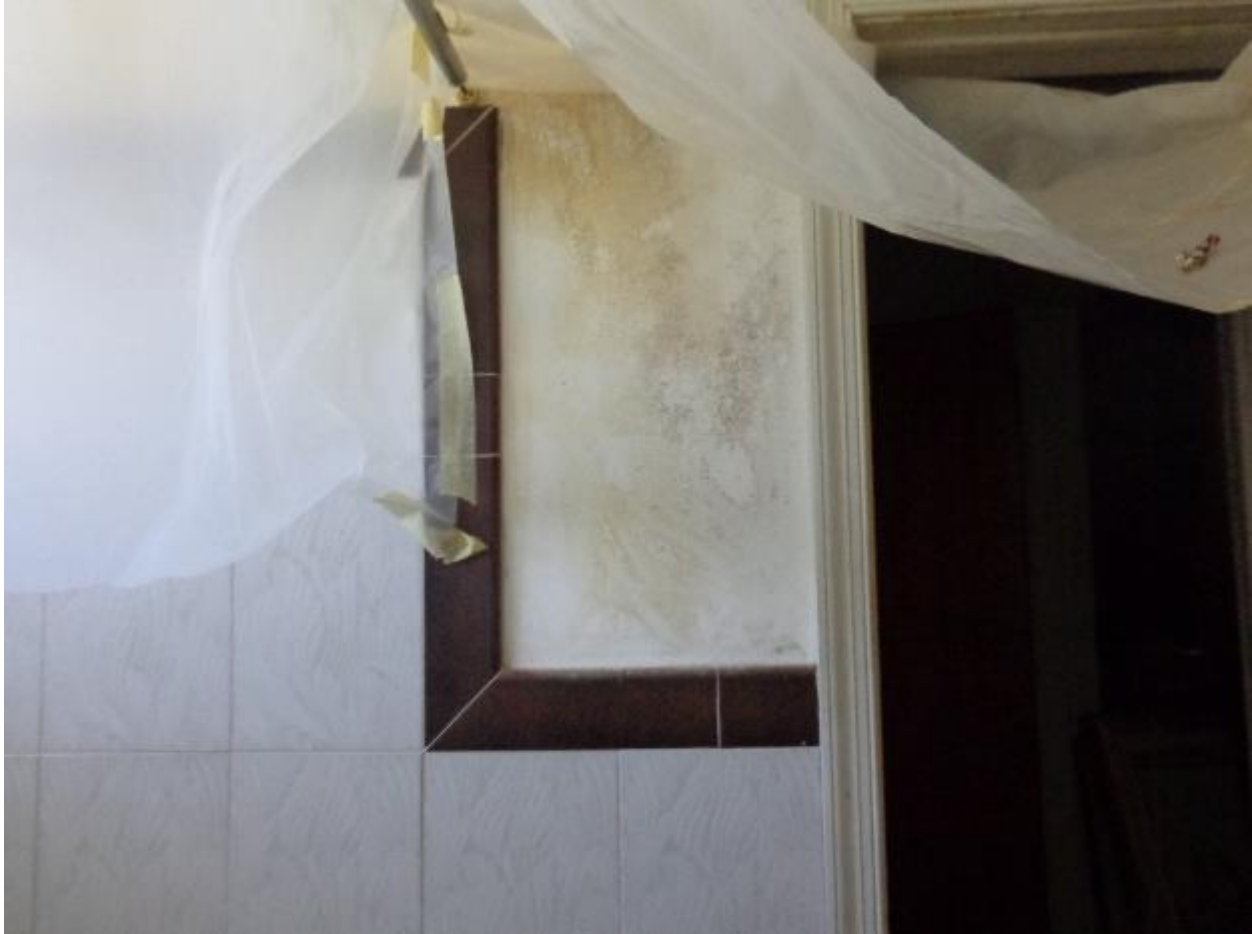
Signs of water infiltration due to roof failure noticed at the habitable space ceiling; allowances must be made for roofing and ceiling repair

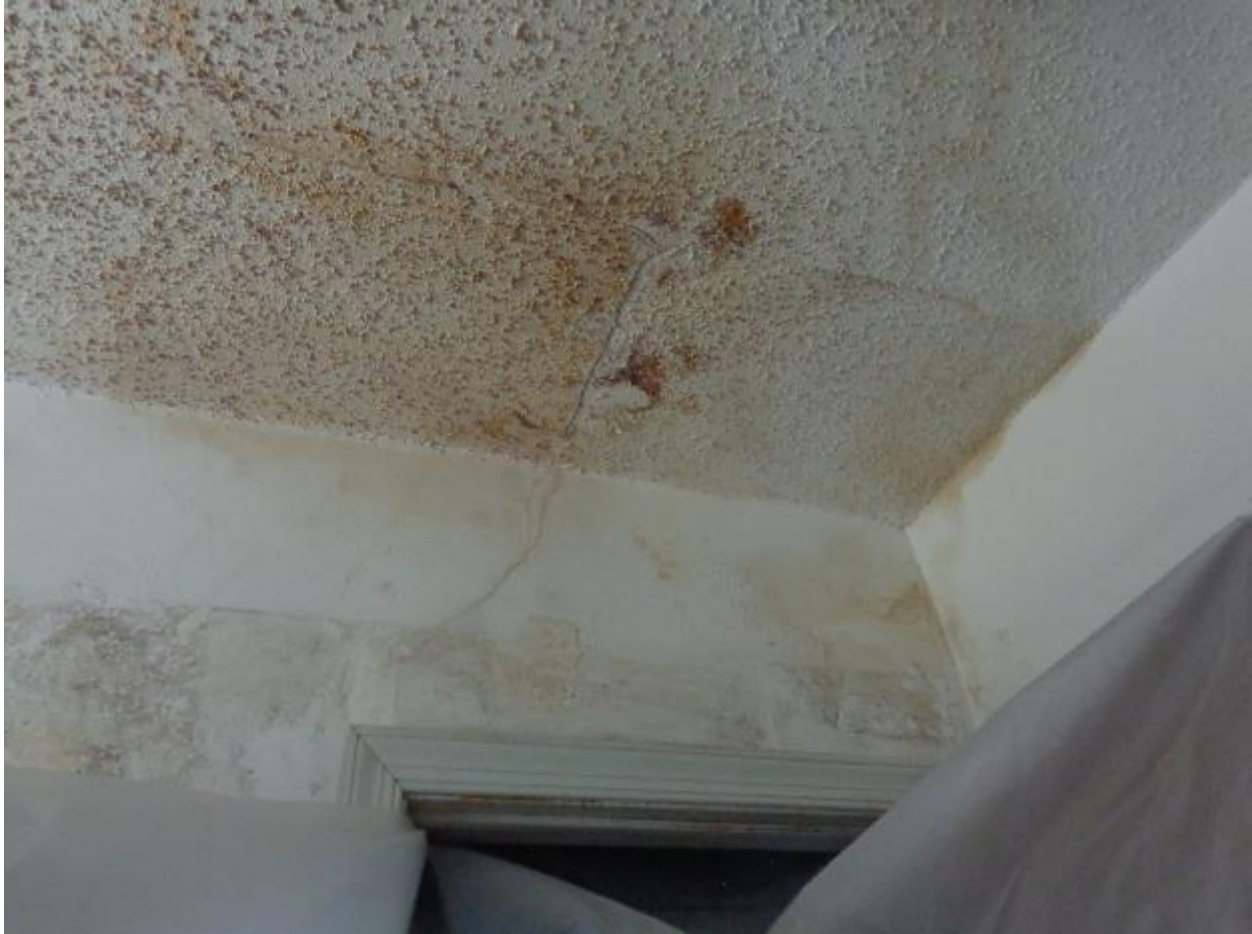
Signs of water infiltration due to roof failure noticed at the habitable space ceiling; allowances must be made for roofing and ceiling repair

Mold growth caused by water damage is visible. Do not attempt to remove damaged surfaces related to Mold growth or with signs of mold growth on your own. Hire only licensed and Insured Mold remediation services.

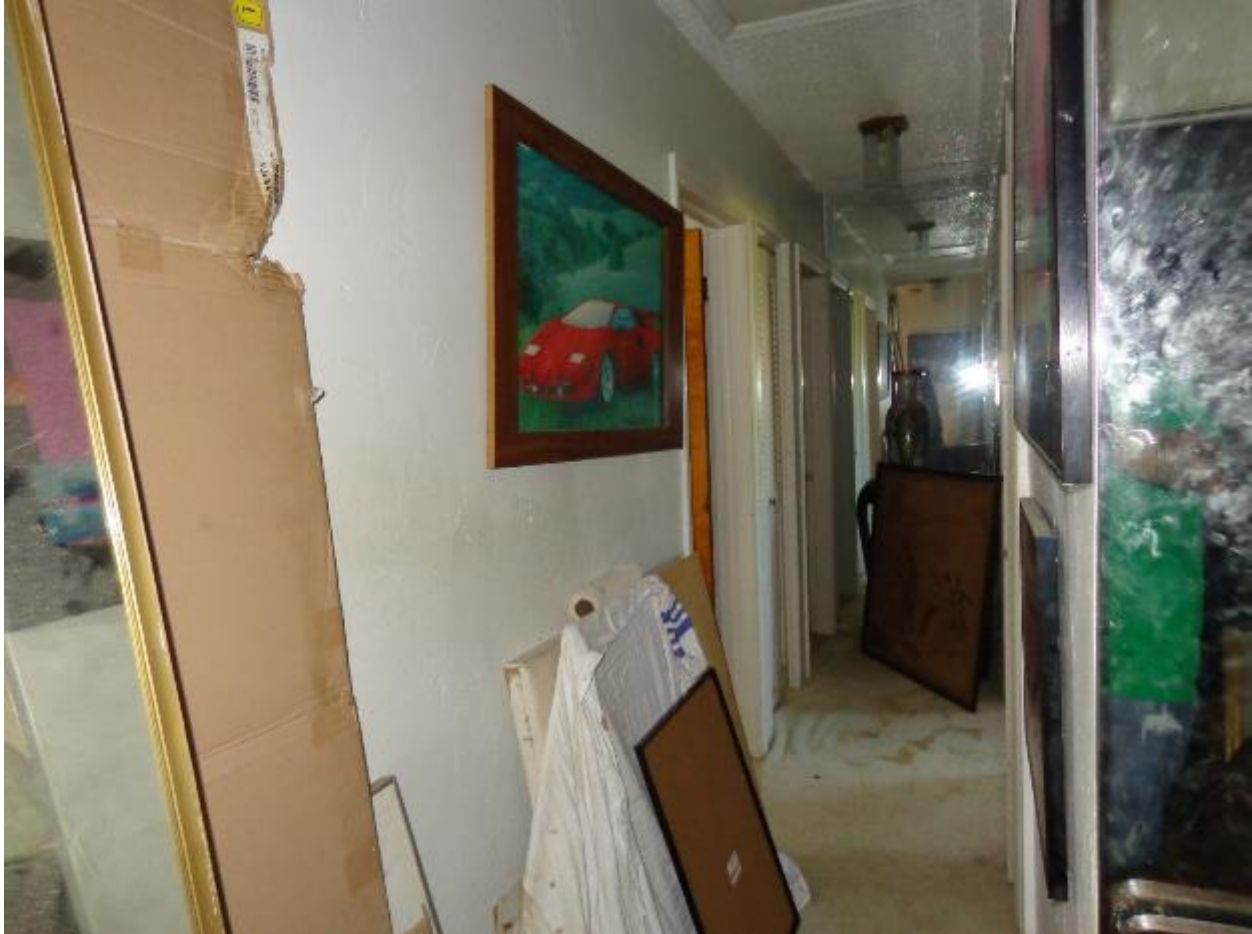
A complete rehabilitation of the interior must be done in order to provide move in conditions. Plumbing, electrical and Ac systems require replacement or repairs. Wood destroying organism active in the property.

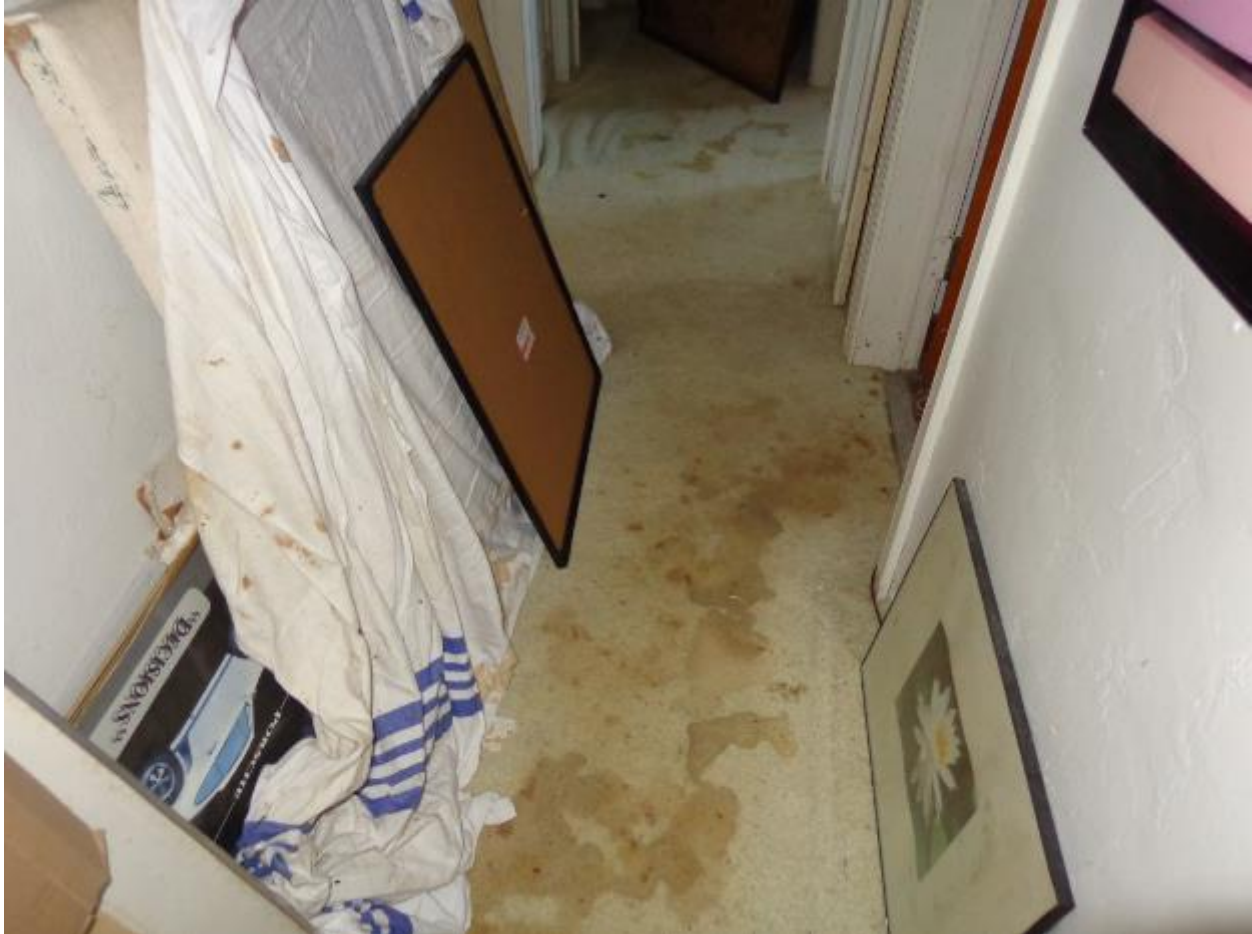
Soiled carpet throughout requires replacement.

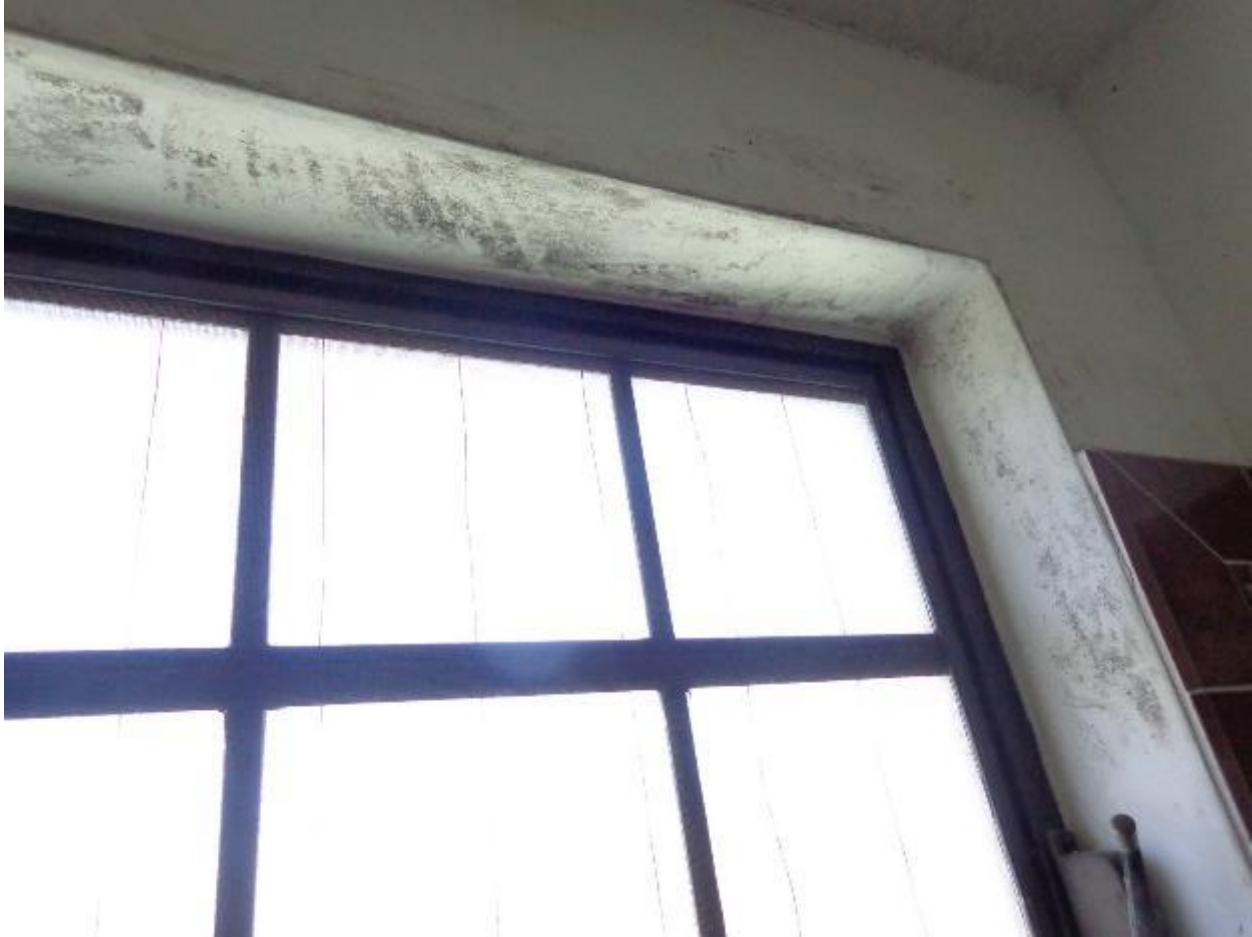
Mold growth caused by water damage is visible. Do not attempt to remove damaged surfaces related to Mold growth or with signs of mold growth on your own. Hire only licensed and Insured Mold remediation services.

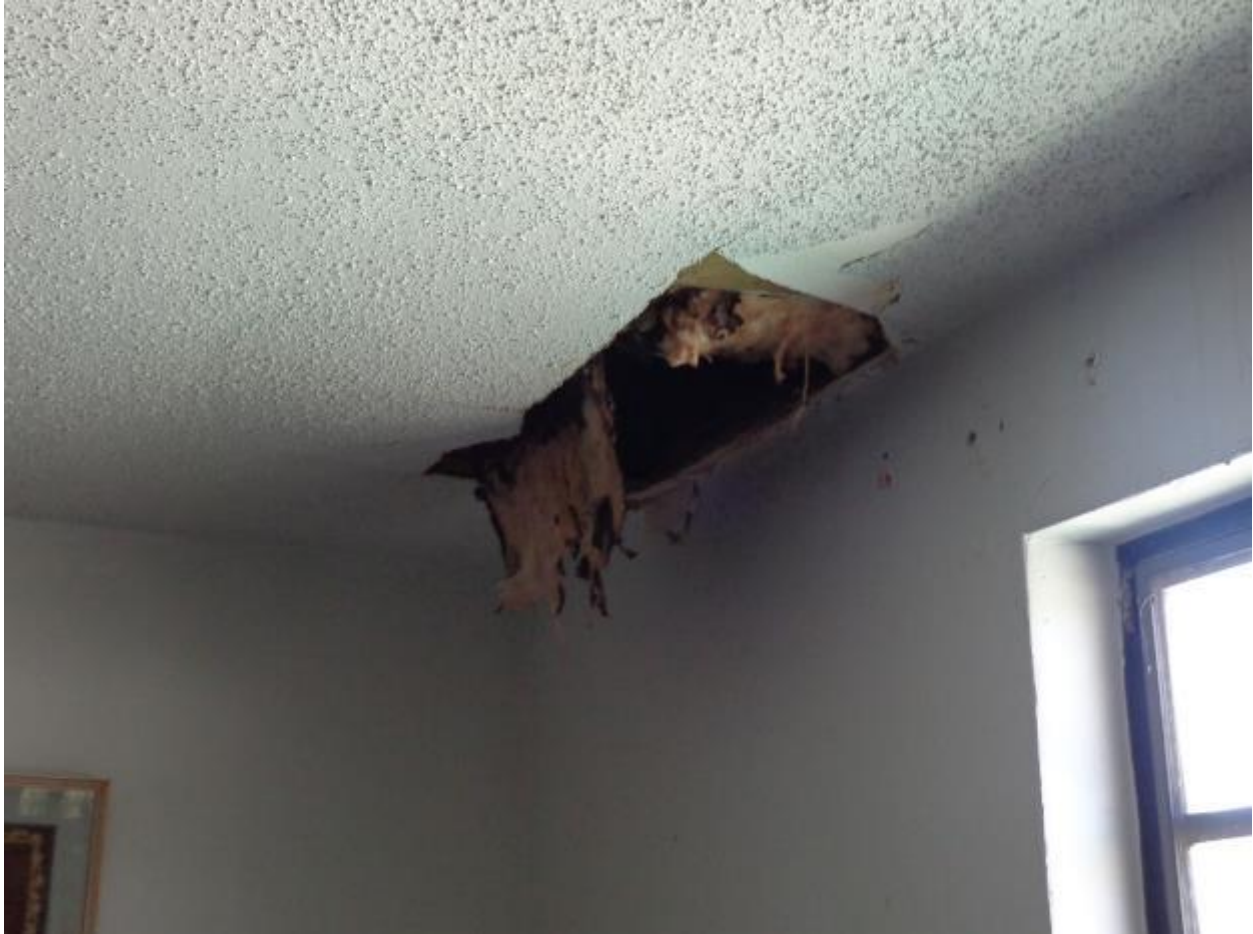
Signs of water infiltration due to roof failure noticed at the habitable space ceiling; allowances must be made for roofing and ceiling repair

Drywall repairs required.

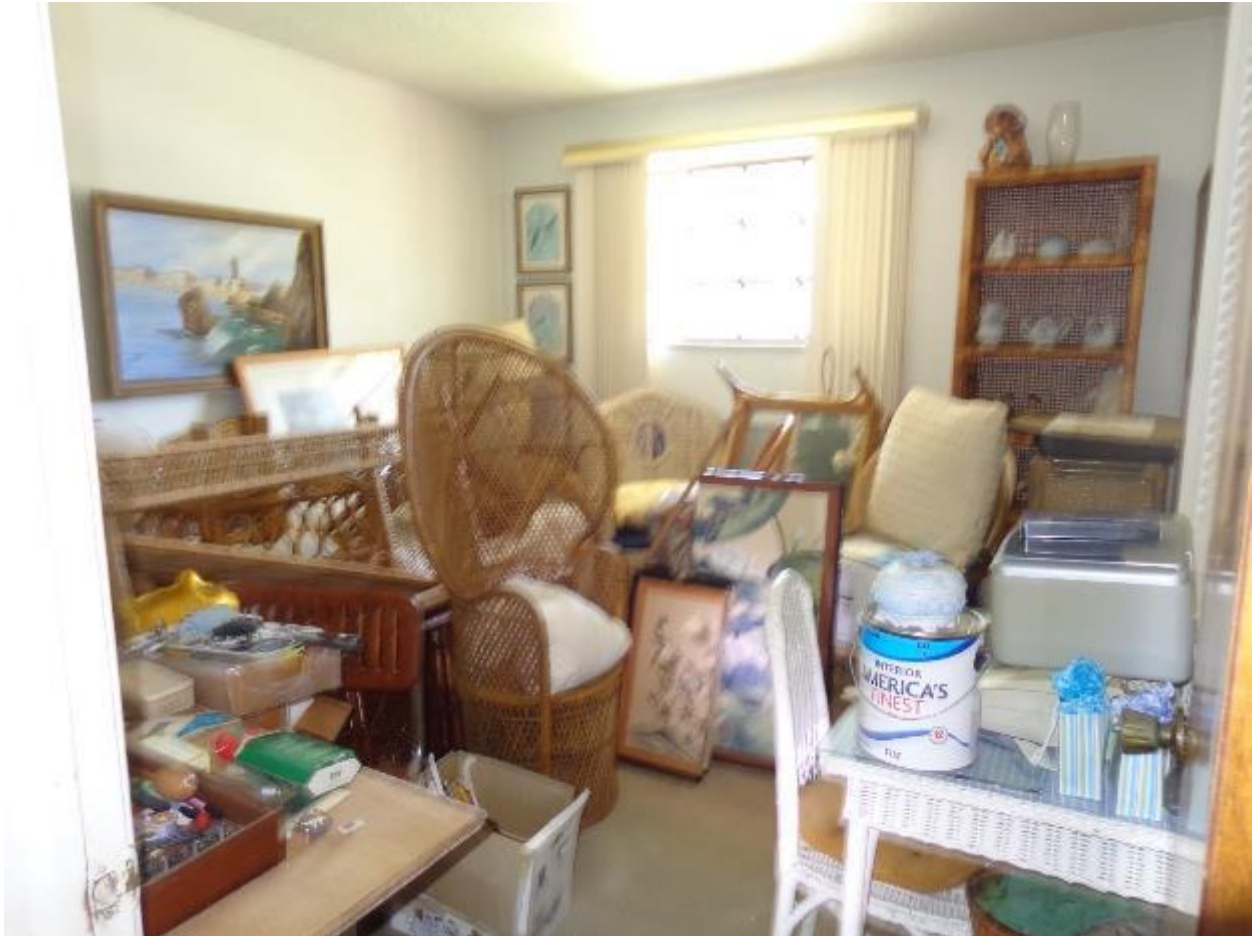
A complete rehabilitation of the interior must be done in order to provide move in conditions. Plumbing, electrical and Ac systems require replacement or repairs. Wood destroying organism active in the property.
