PROPERTY INSPECTION OR ASSESSMENT OF DAMAGES

ADDRESS: xxx NW xx AVE FORT LAUDERDALE, FL
CLIENT: your name here
ID No: 123
DATE: 1/12/xxxx

INSPECTION OR ASSESSMENT BY:

GAIA CONSTRUCTION INC.
CGC 1516136 **FLORIDA**
HI-2792 **FLORIDA**
8028867-B2 **INTERNATIONAL CODE COUNCIL**

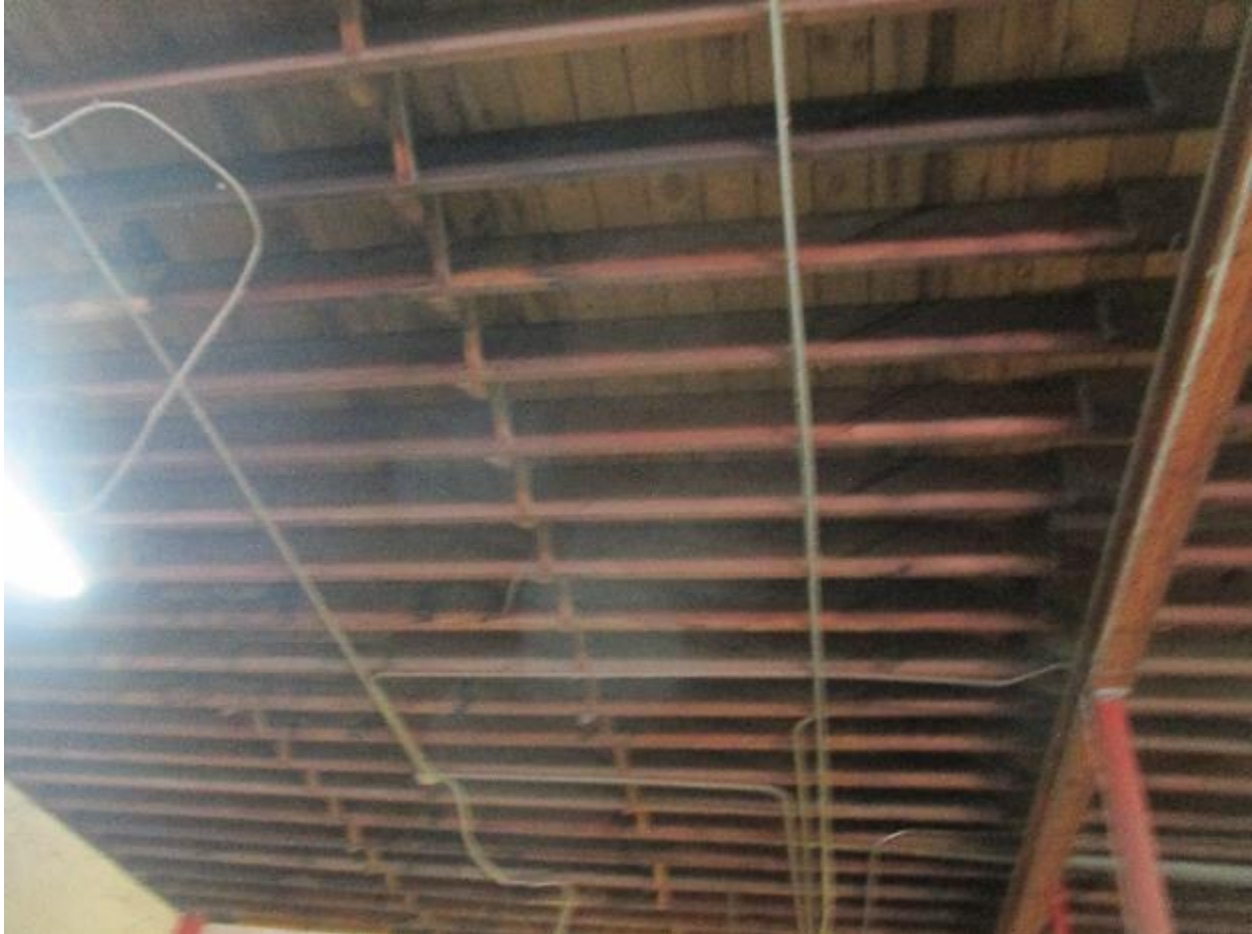
Roof deck repairs required.

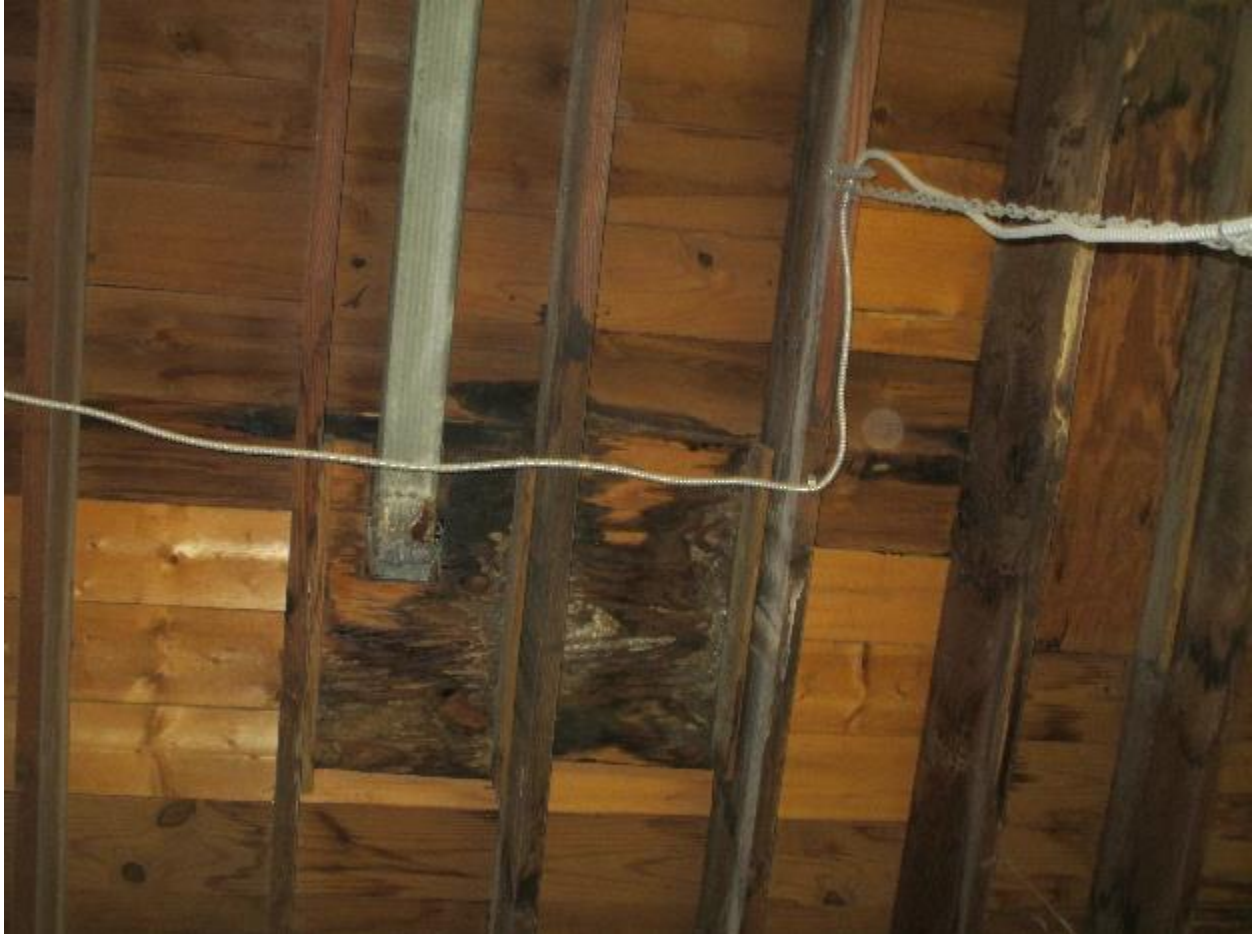
Roof deck repairs required.

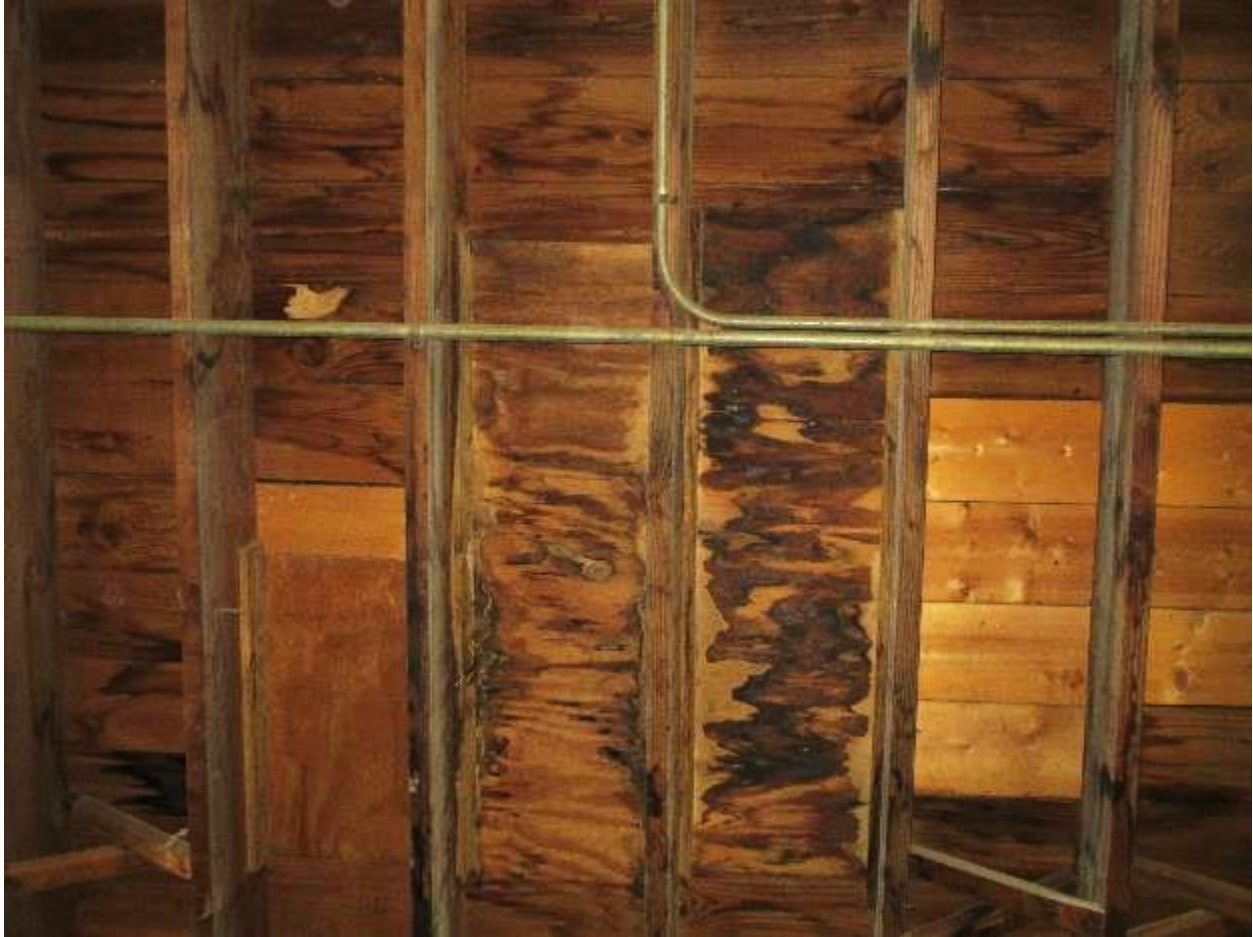
Roof deck repairs required.

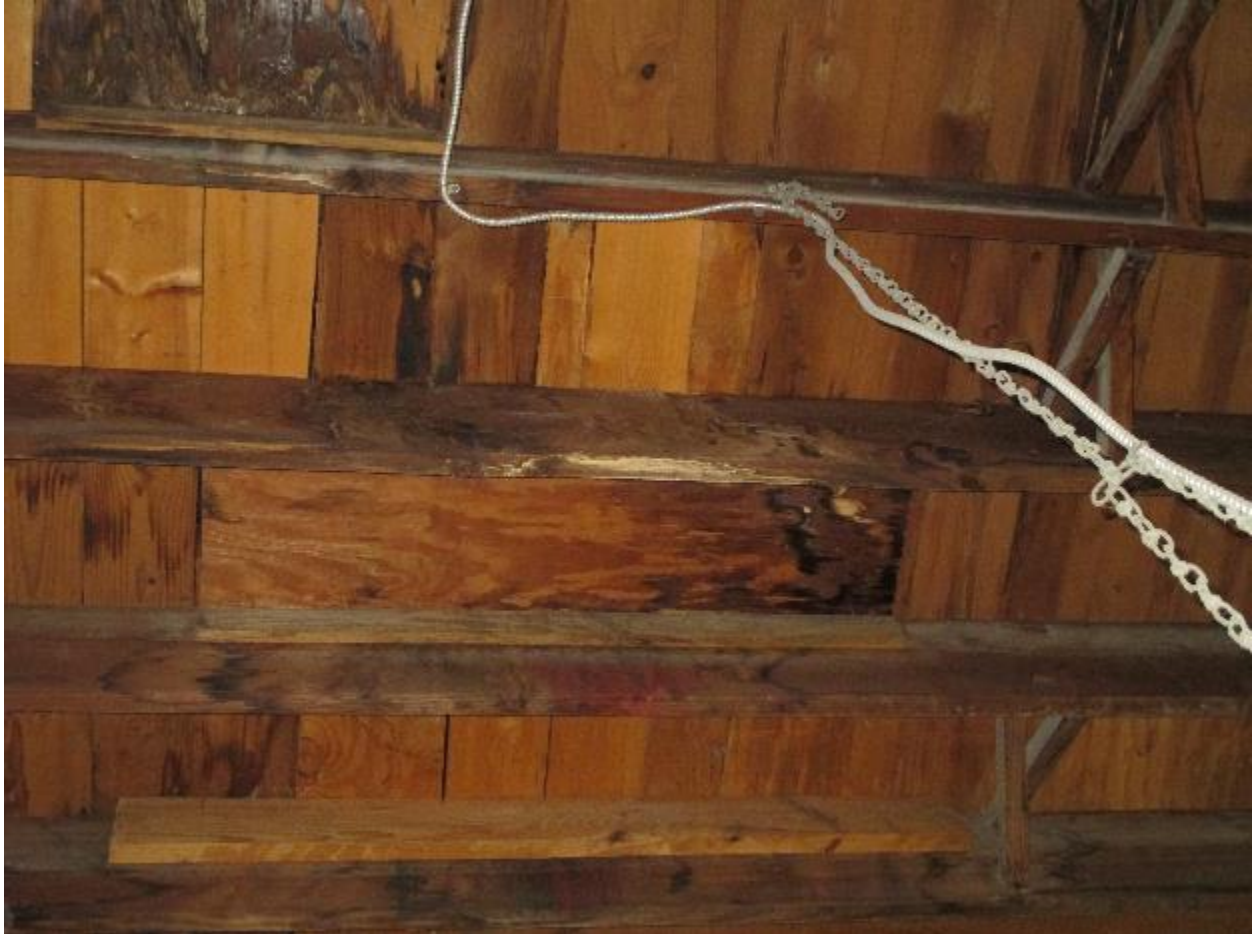
Roof deck repairs required.

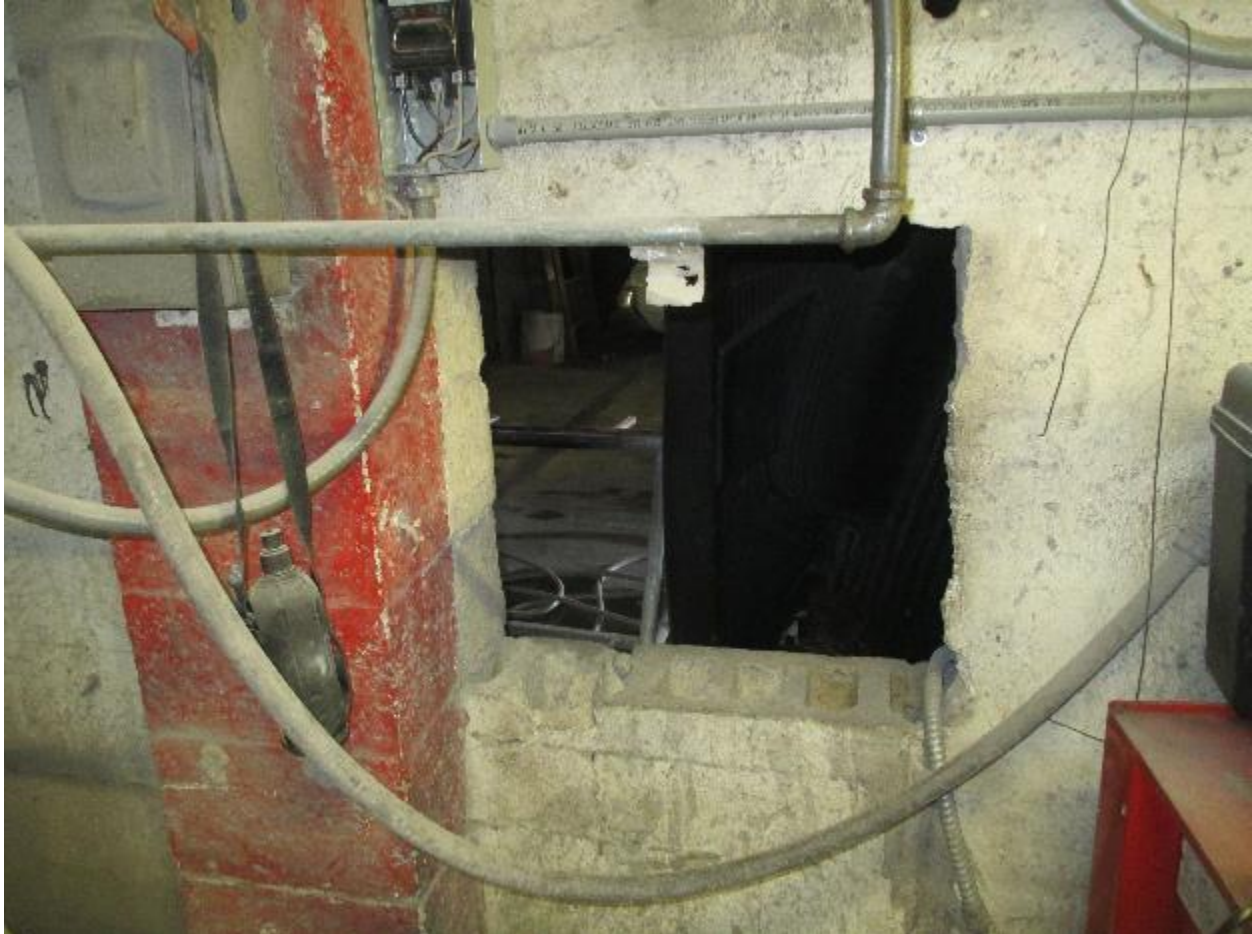
Repairs to interior walls required.

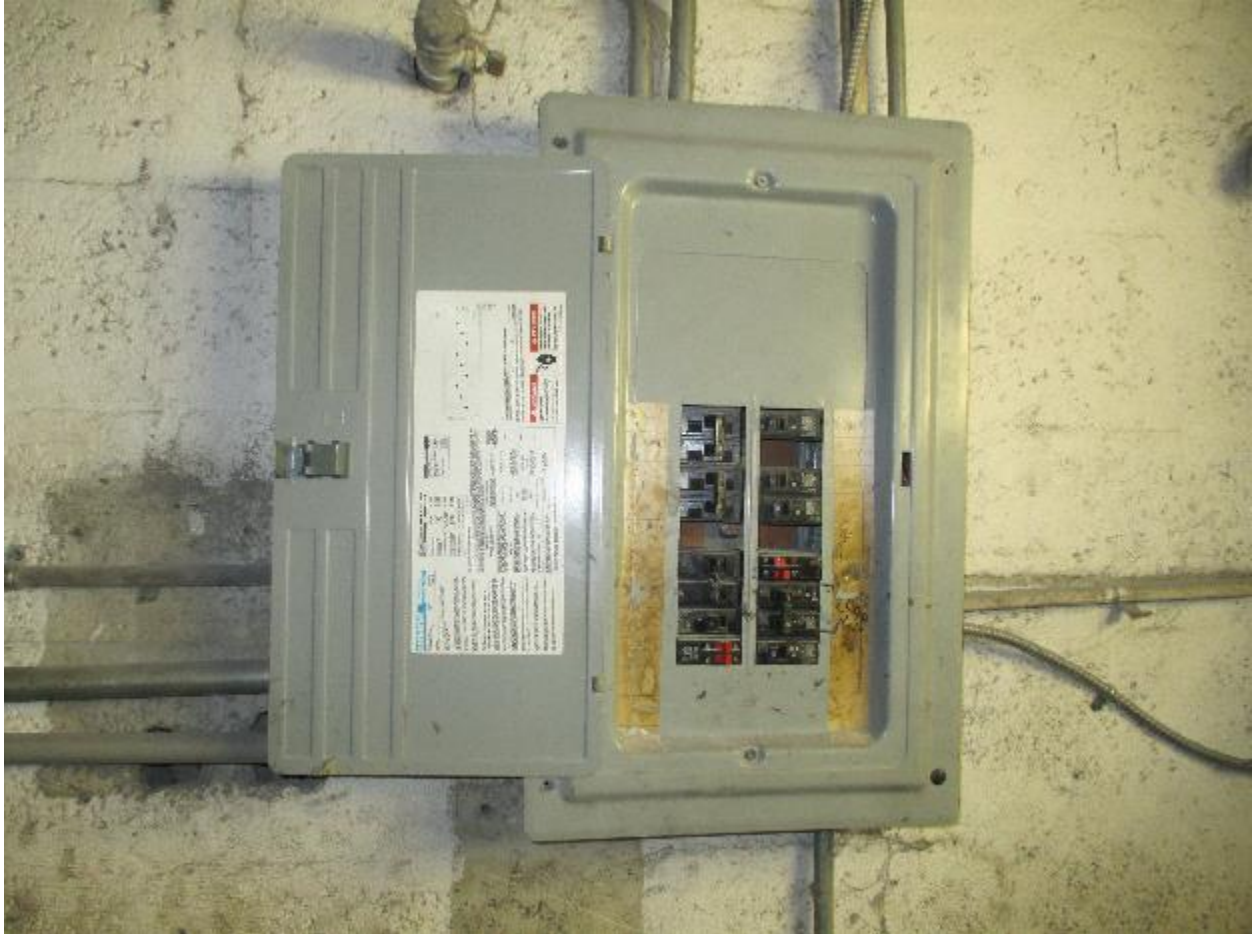
Electrical wires / Breaker panel double tap noted during inspection.

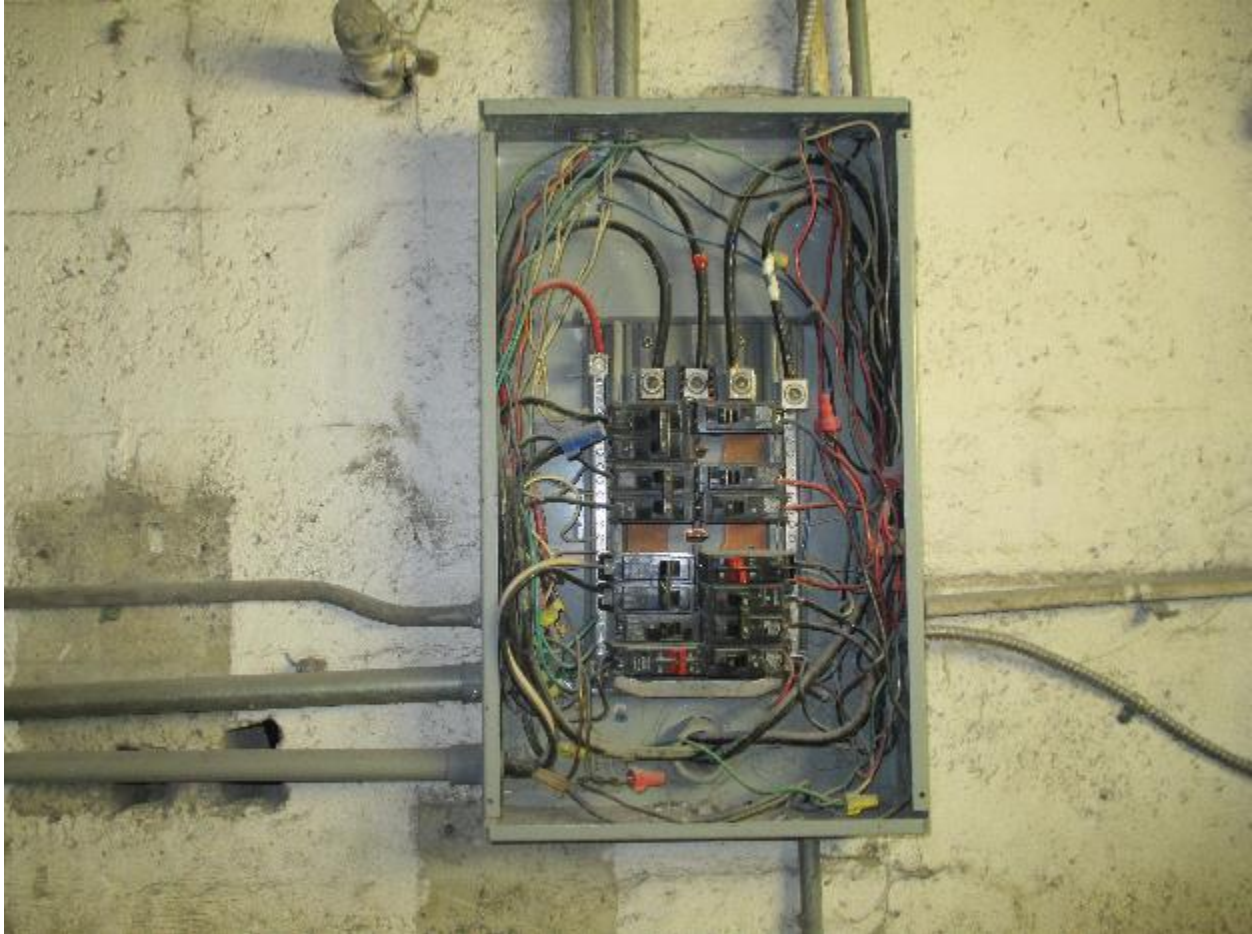
Electrical wires / Breaker panel double tap noted during inspection.

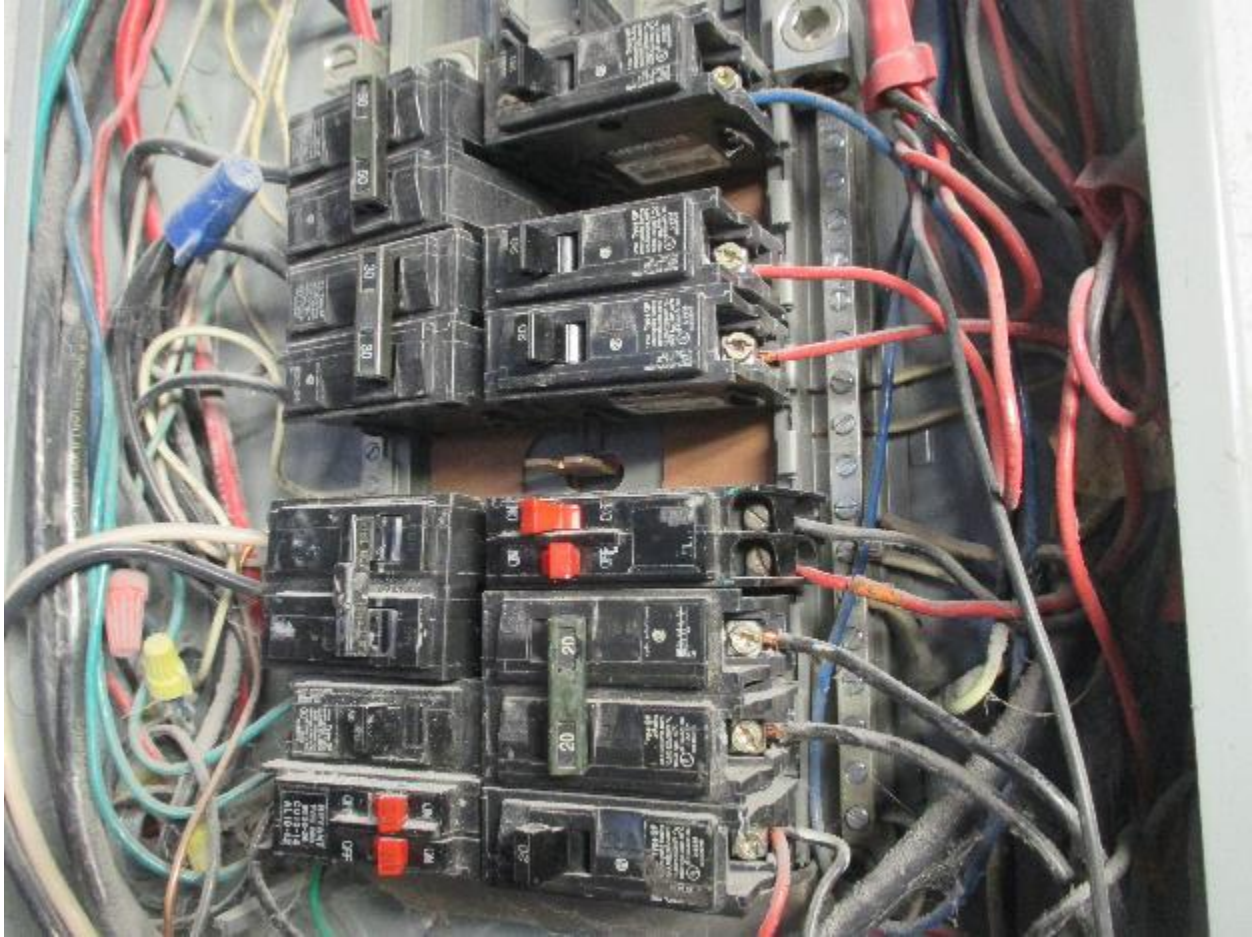
Electrical wires / Breaker panel double tap noted during inspection.

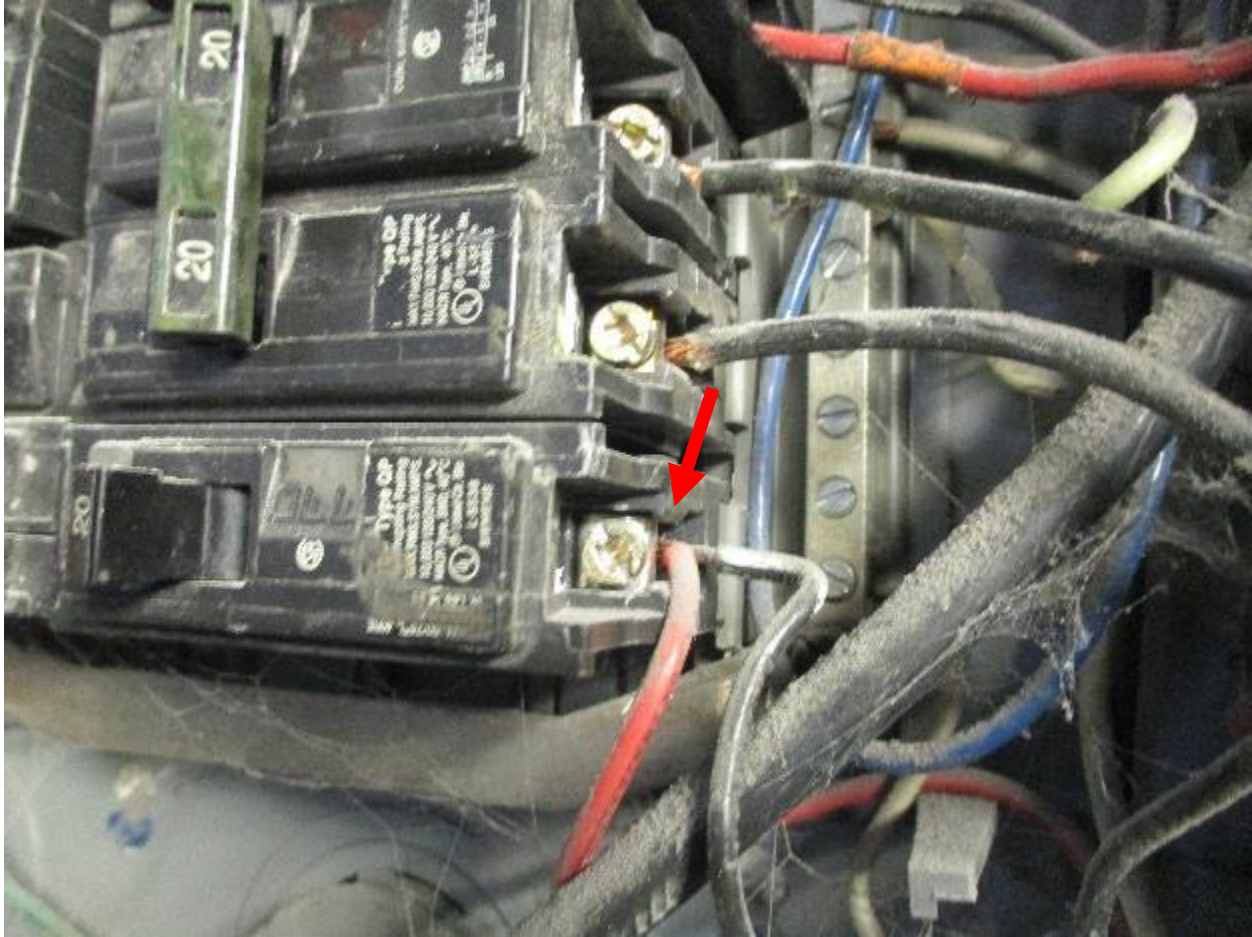
Electrical wires / Breaker panel double tap noted during inspection.

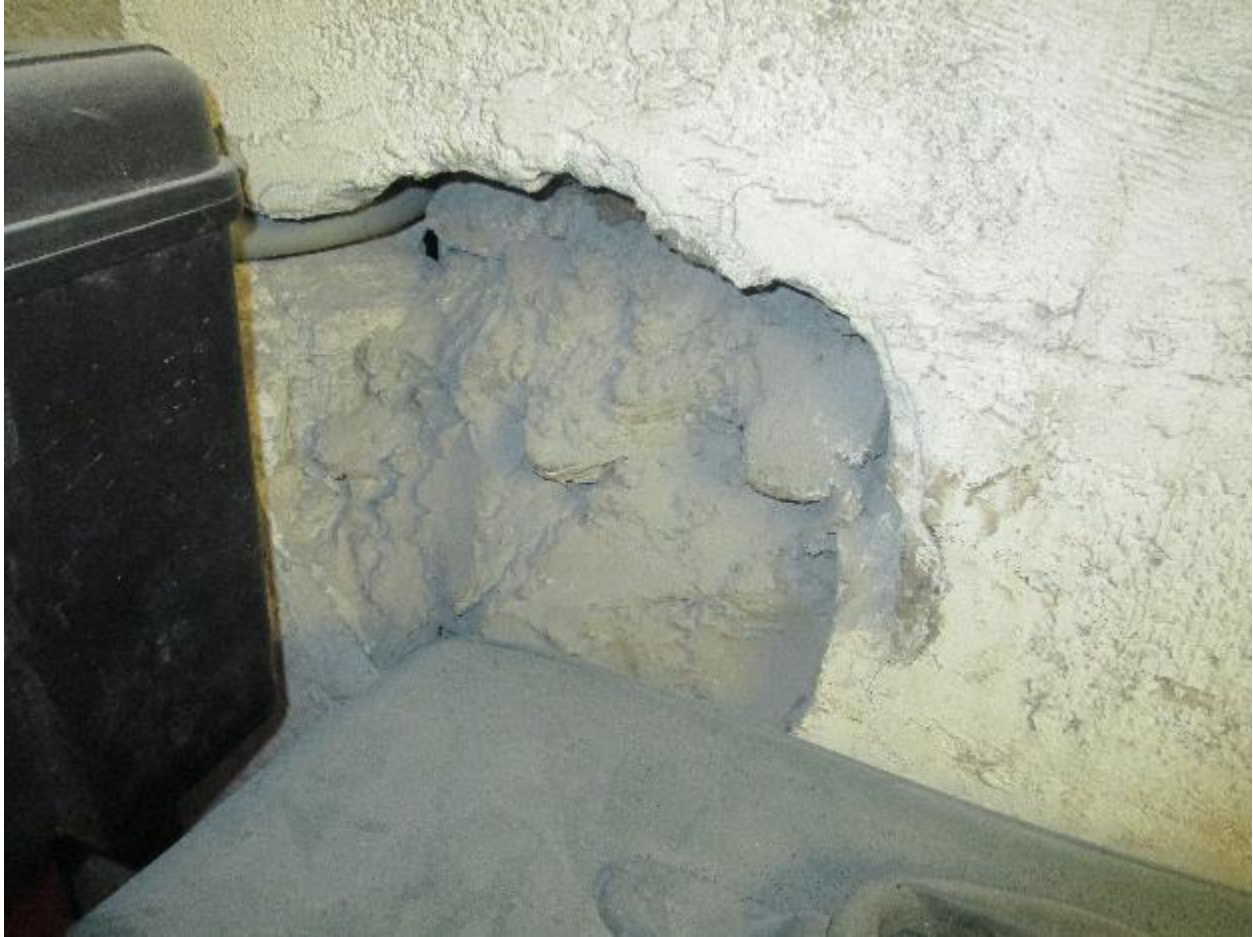
Repairs interior walls.

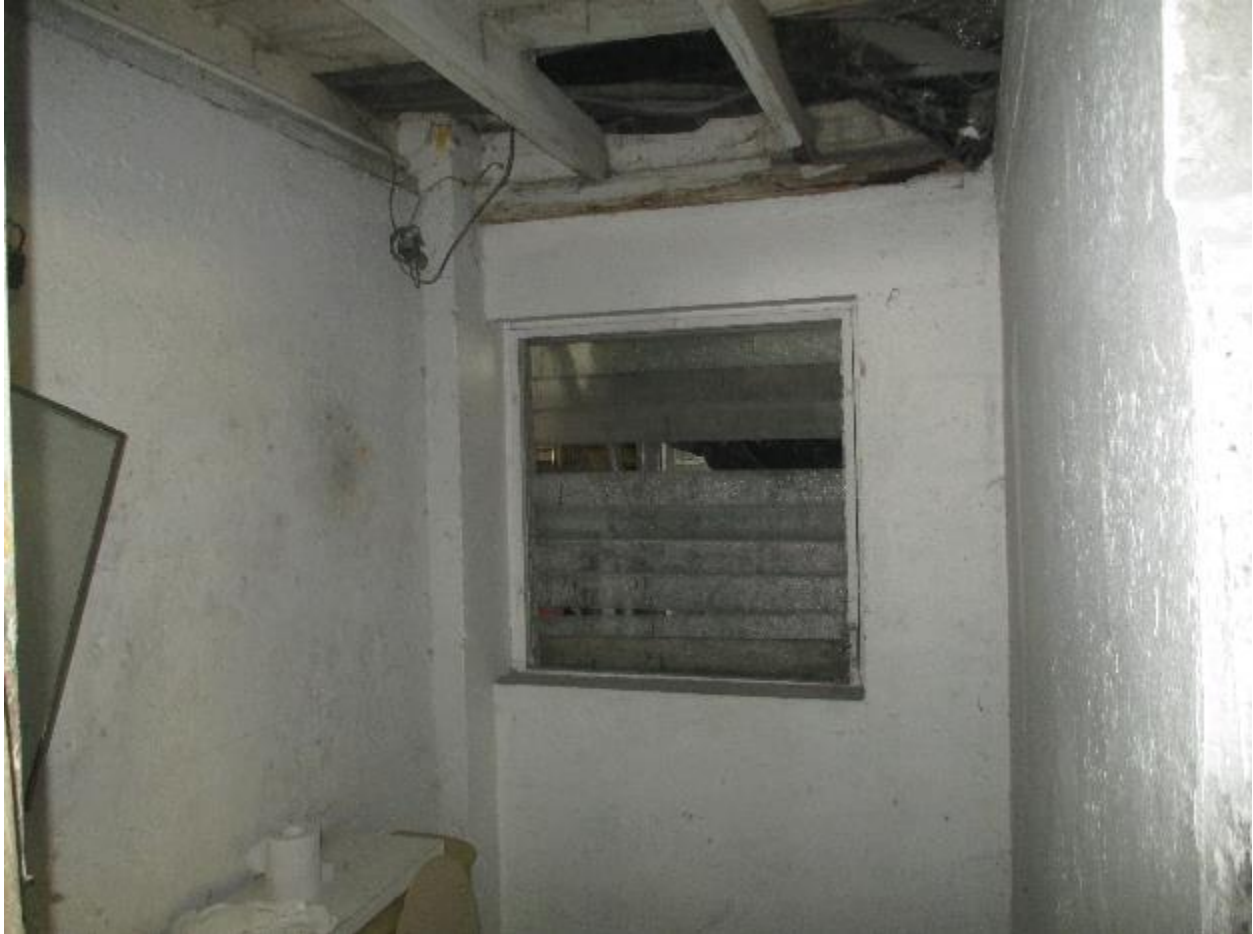
Current window systems are beyond possibilities of repair.

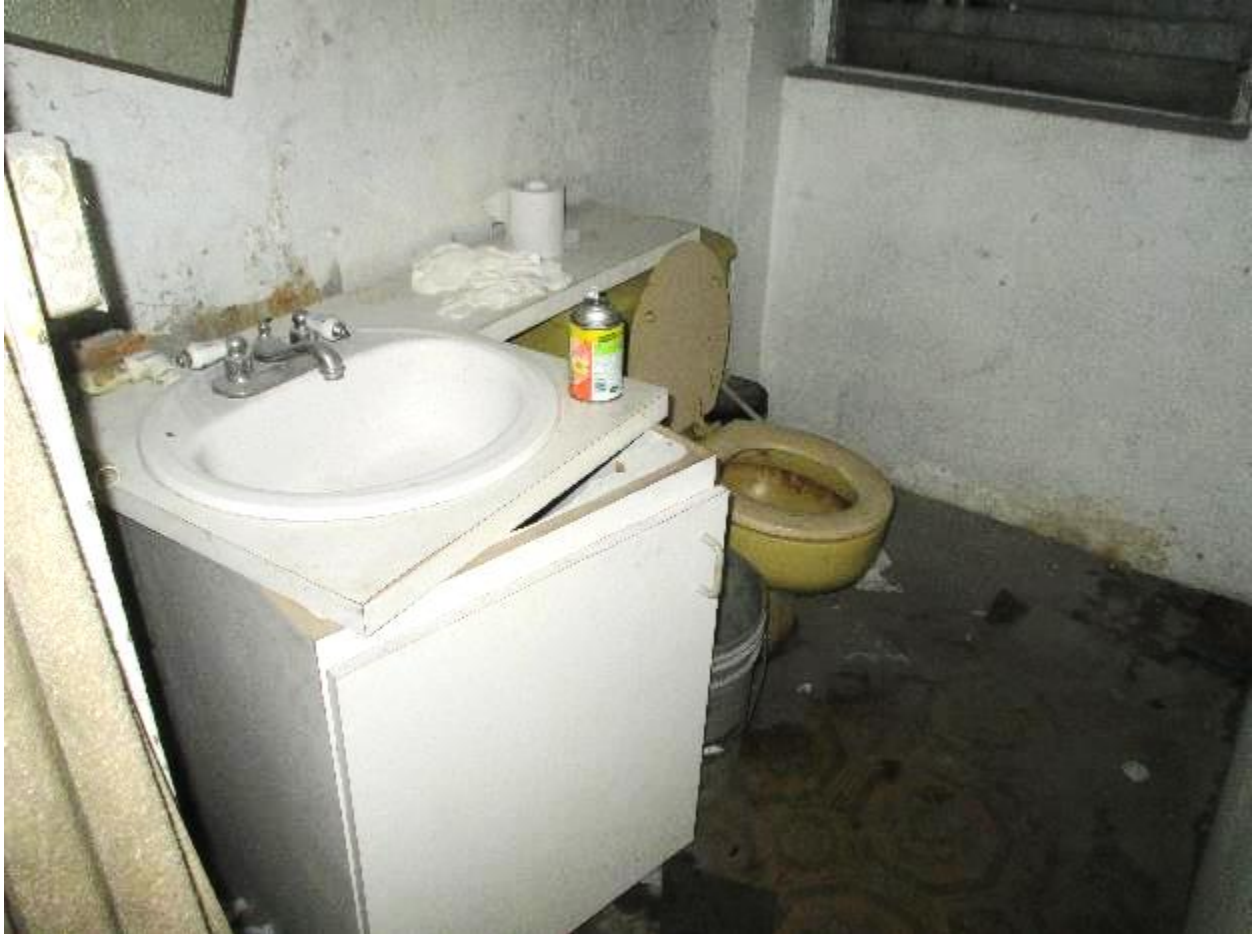
Allowances must be made for the complete upgrade of finishes in bathroom(s).

Not water services at the time of inspection.

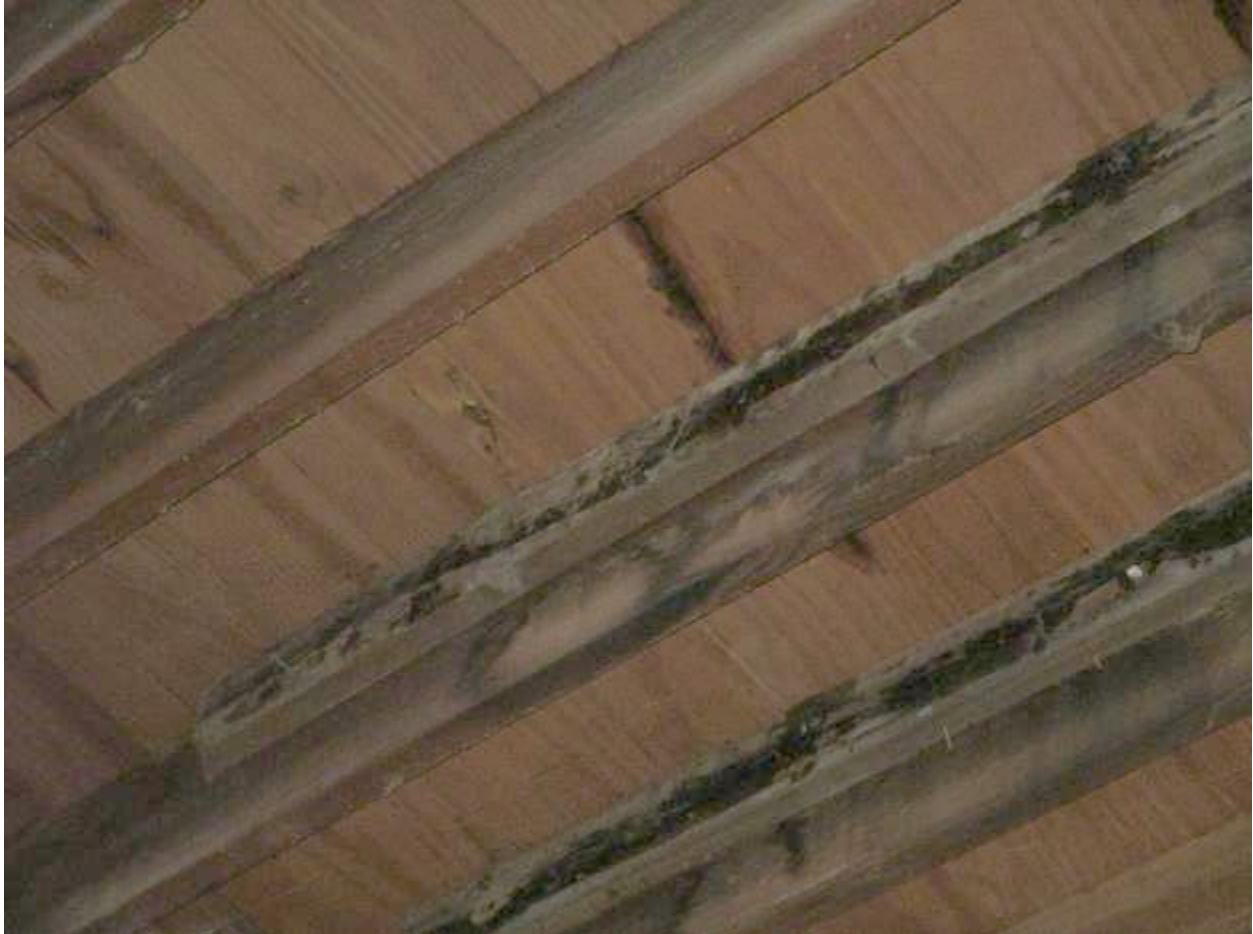
Roof deck repairs required.

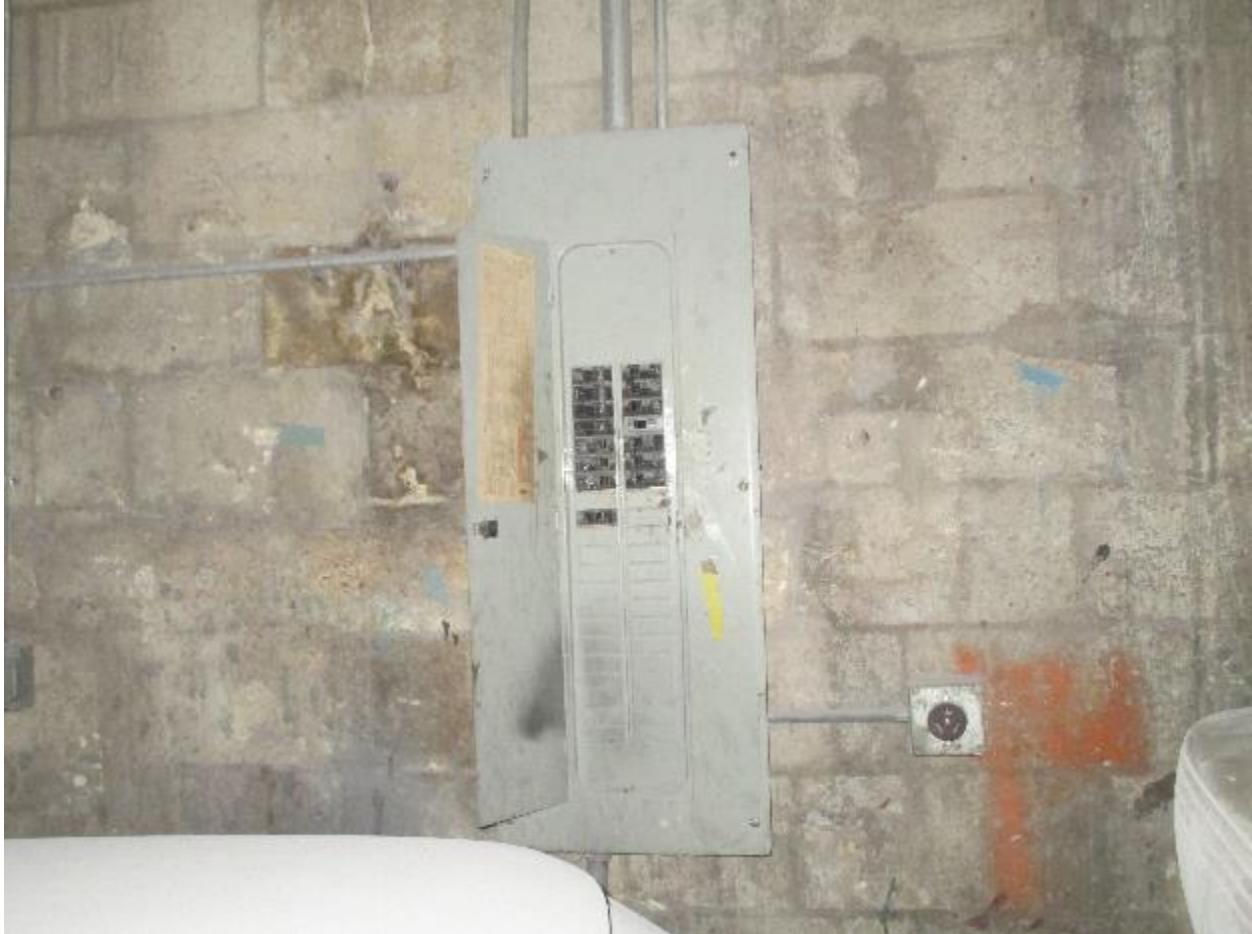
Electrical breaker panel in good condition at the time of inspection.

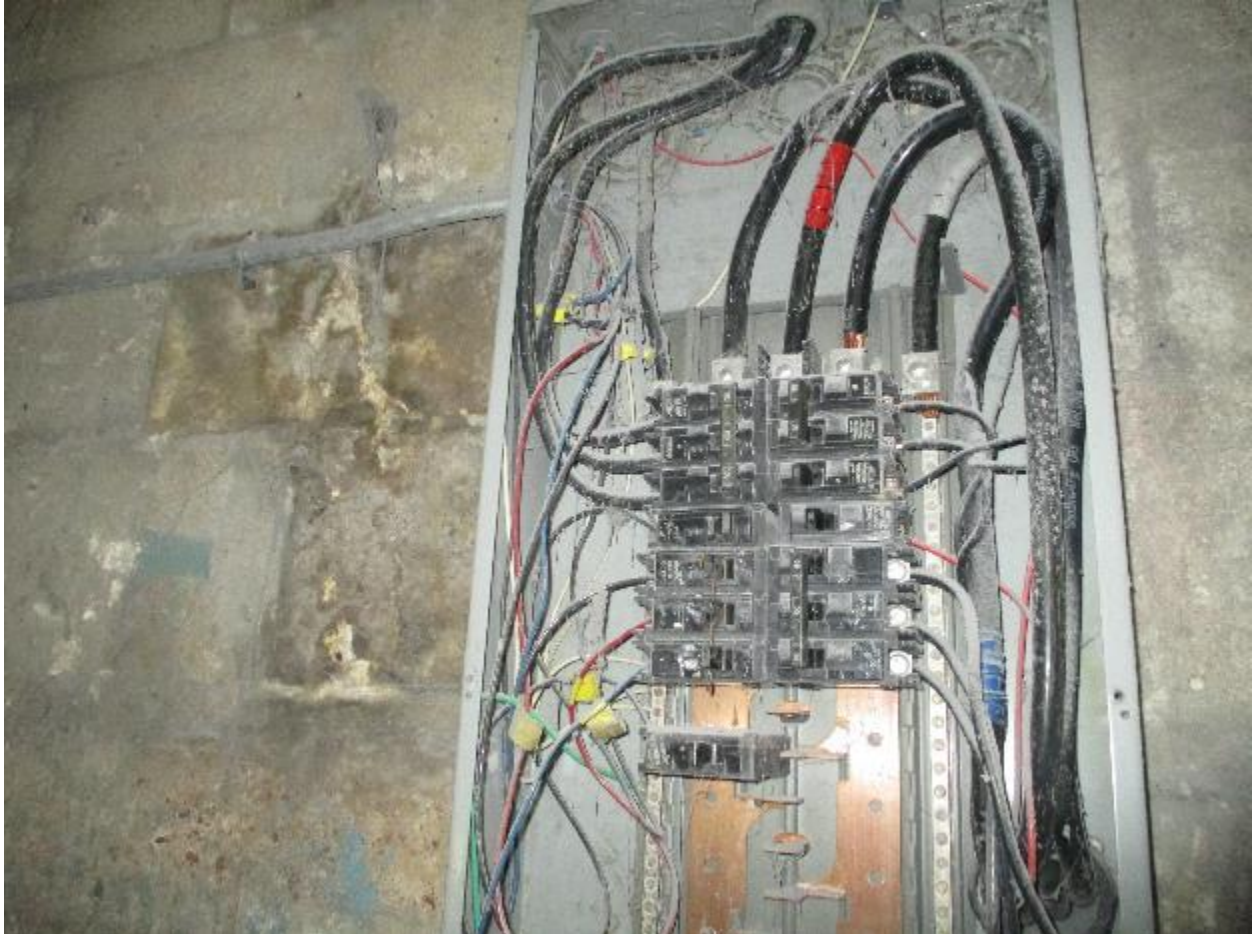
Electrical breaker panel in good condition at the time of inspection.

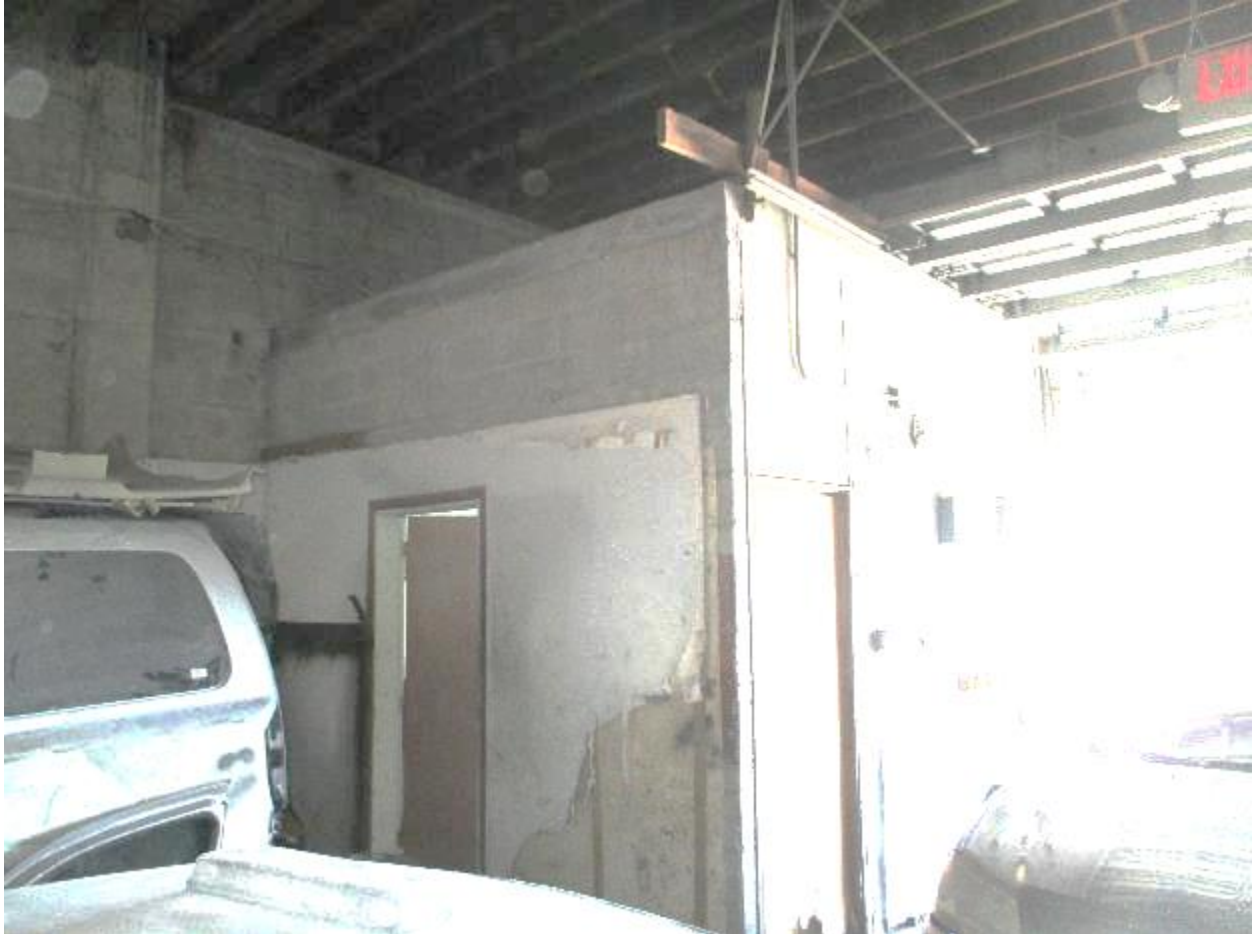
Drywall repairs required.

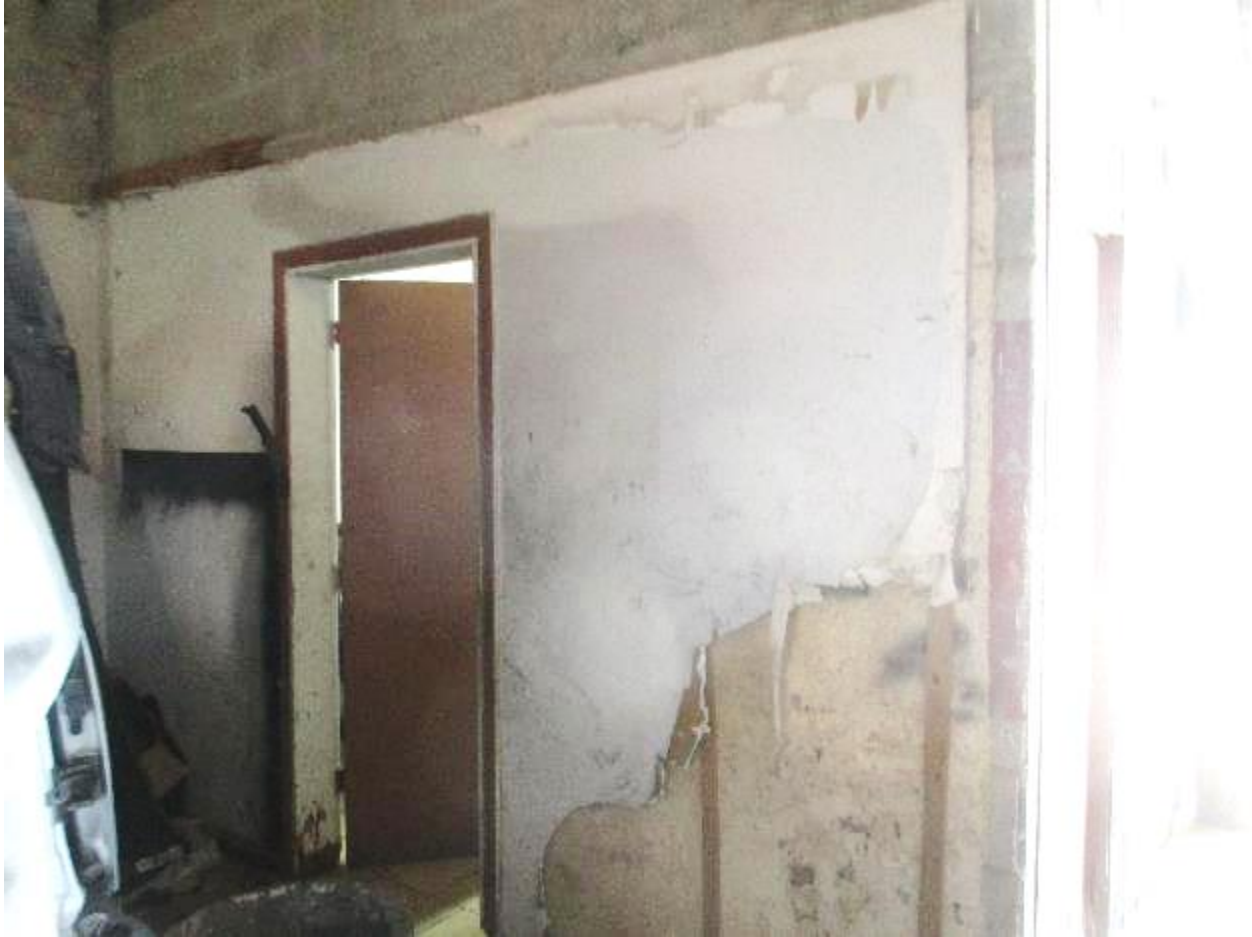
Drywall repairs required.

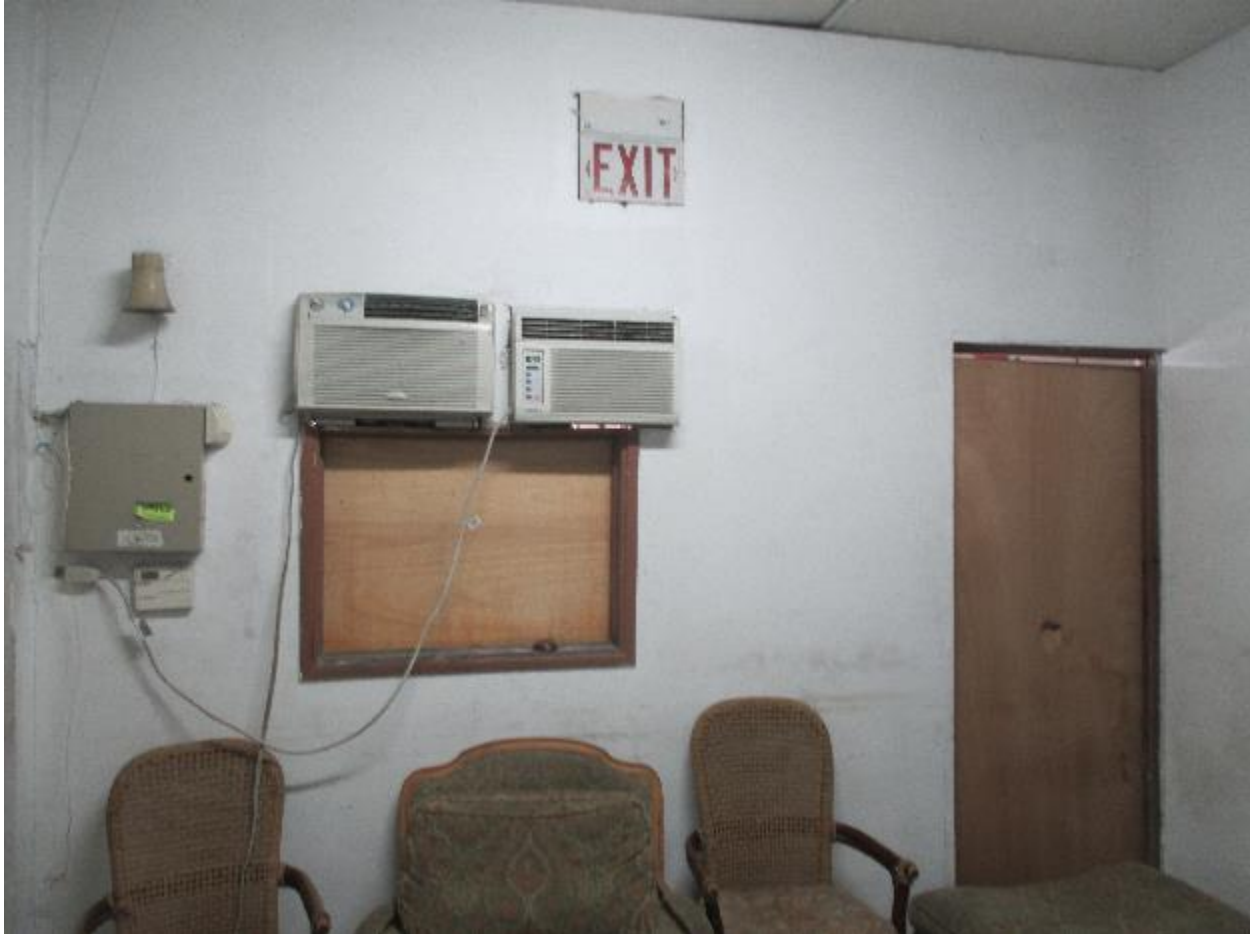
Ac wall and window unit(s) require replacement. Near the end of its useful life.

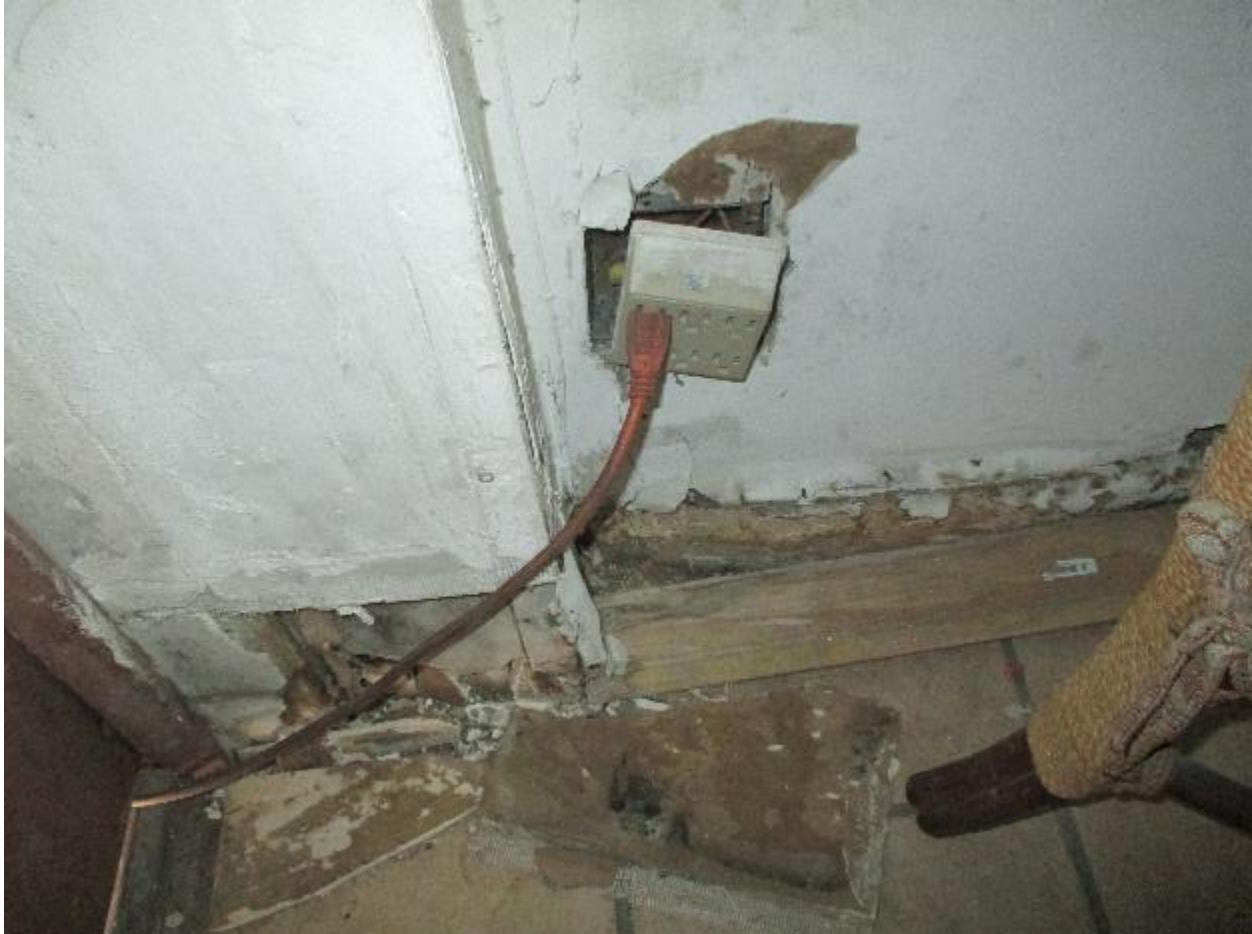
Drywall repairs required.
