PROPERTY INSPECTION OR ASSESSMENT OF DAMAGES

ADDRESS: xxx NW xx AVE FORT LAUDERDALE, FL
CLIENT: your name here
ID No: 123
DATE: 1/12/xxxx

INSPECTION OR ASSESSMENT BY:

GAIA CONSTRUCTION INC.
CGC 1516136 **FLORIDA**
HI-2792 **FLORIDA**
8028867-B2 **INTERNATIONAL CODE COUNCIL**

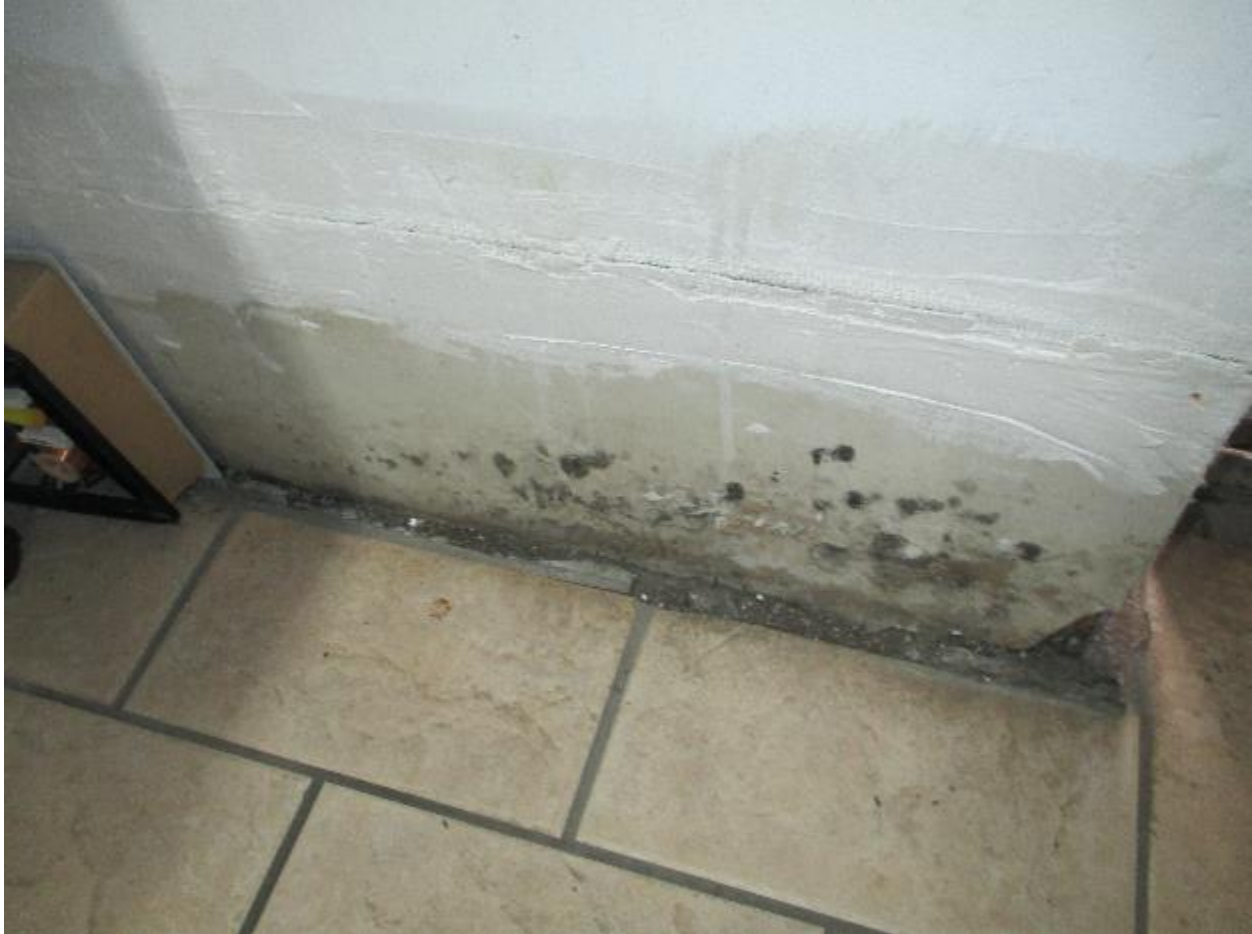
Mold growth caused by water damage is visible. Do not attempt to remove damaged surfaces related to Mold growth or with signs of mold growth on your own. Hire only licensed and Insured Mold remediation services.

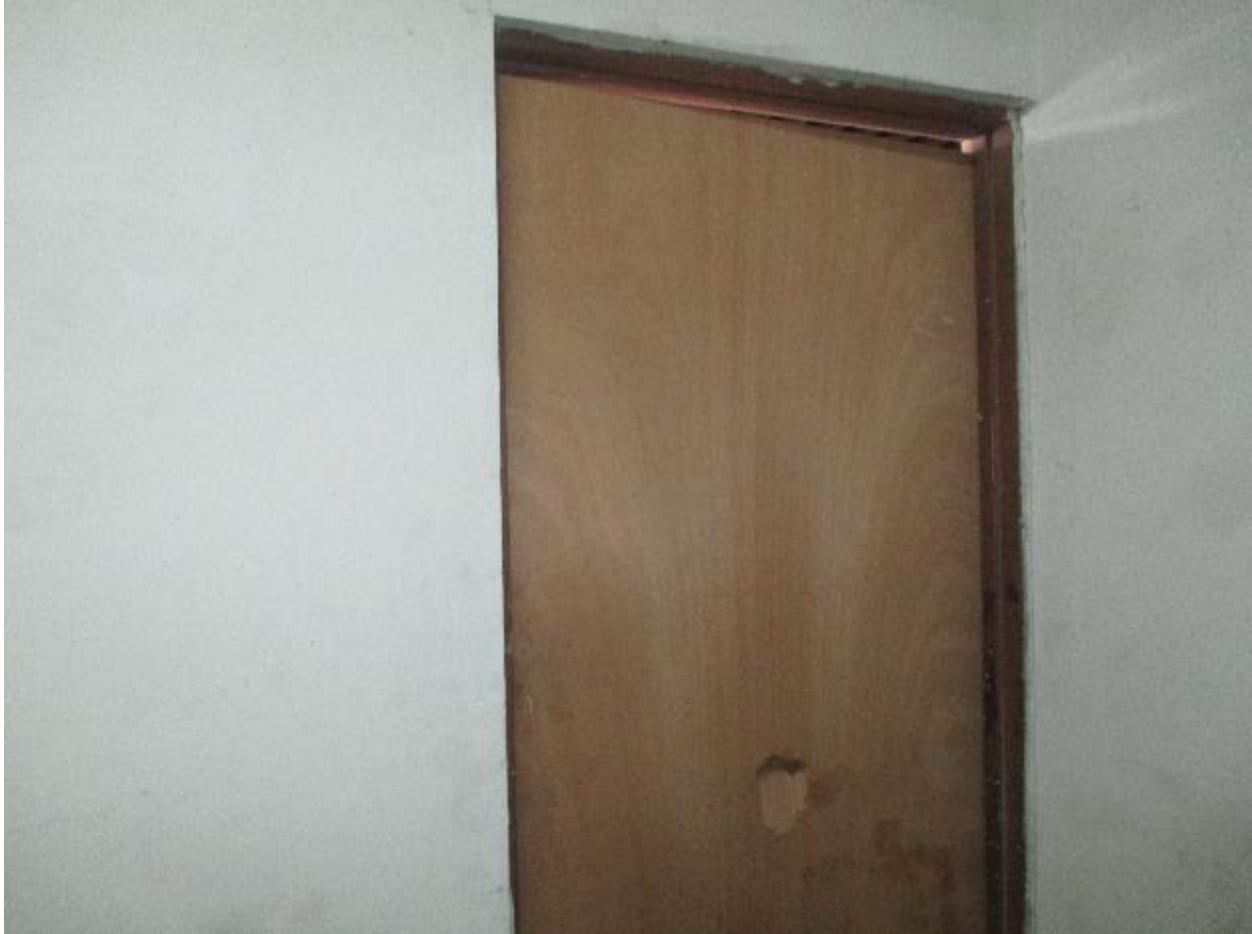
Allowances must be made for the replacement / upgrade of interior doors.

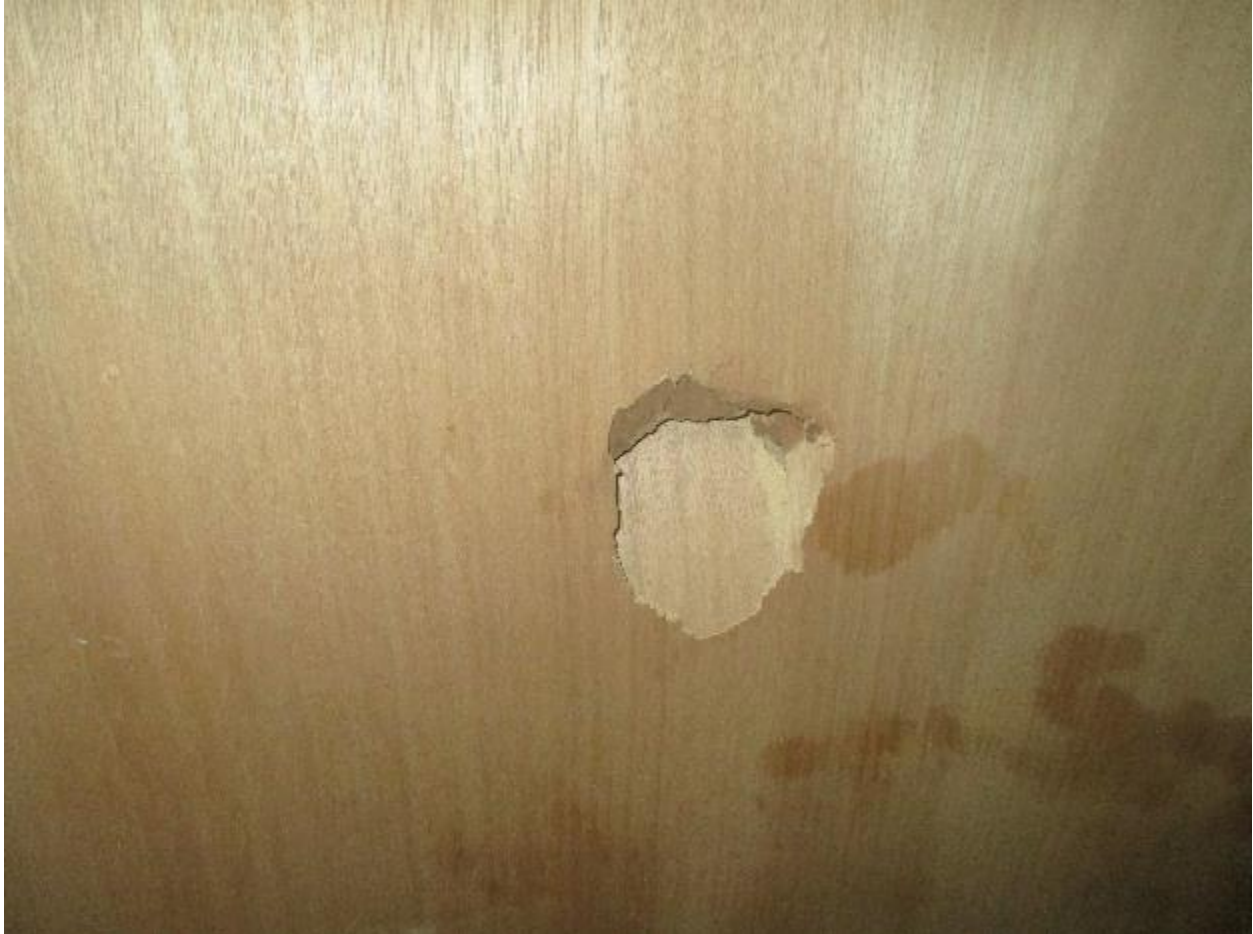
Allowances must be made for the replacement / upgrade of interior doors.

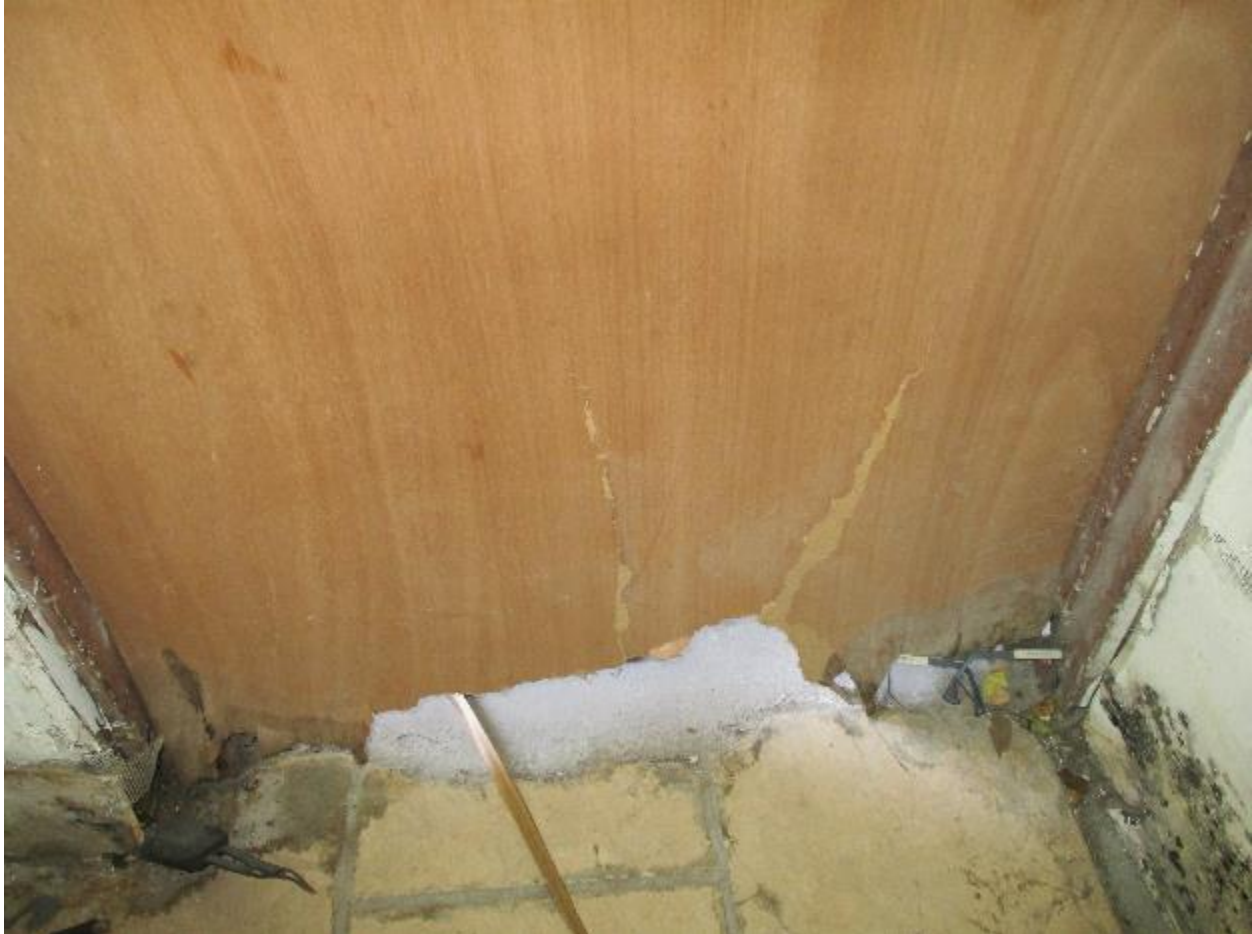
Allowances must be made for the replacement / upgrade of interior doors.

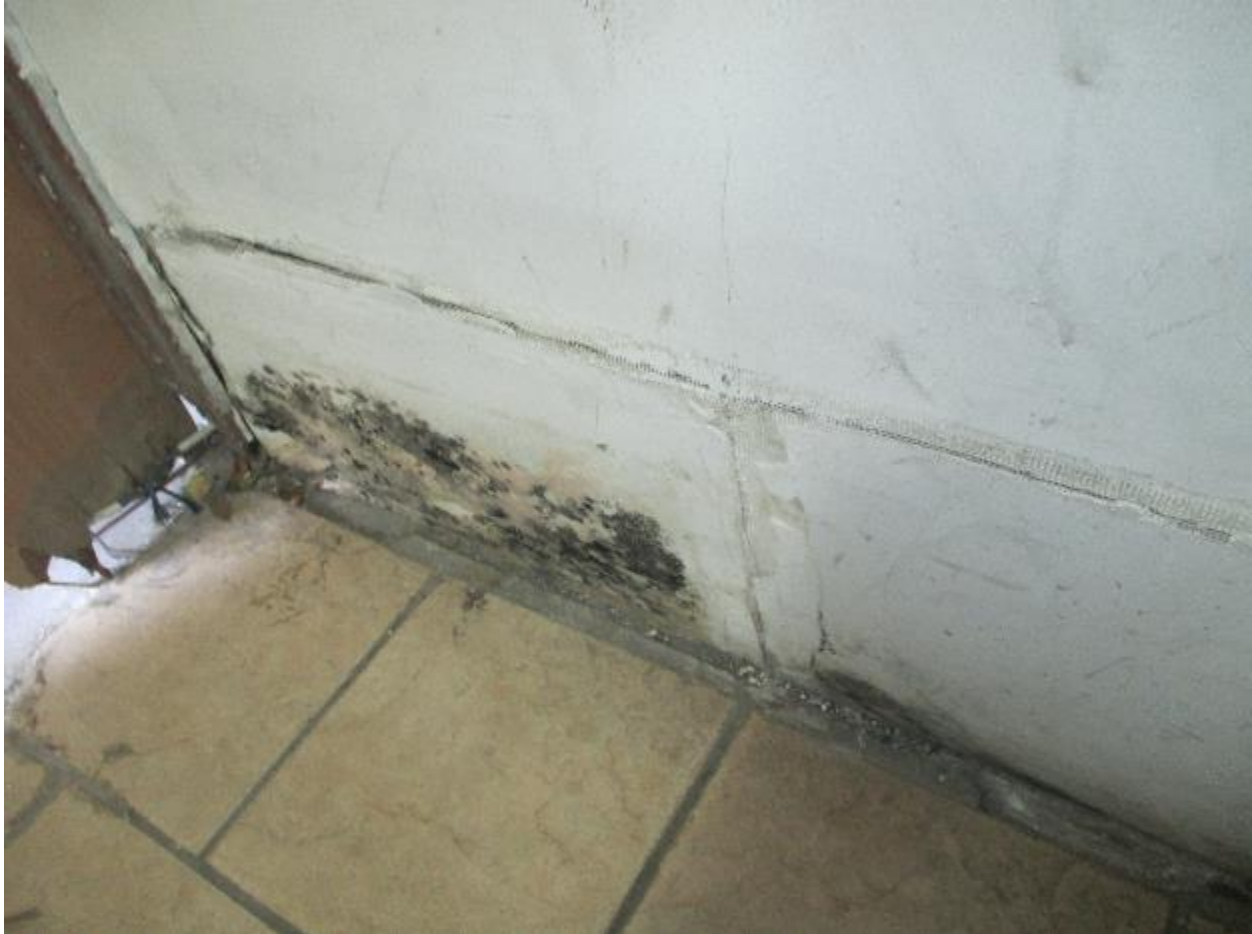
Mold growth caused by water damage is visible. Do not attempt to remove damaged surfaces related to Mold growth or with signs of mold growth on your own. Hire only licensed and Insured Mold remediation services.

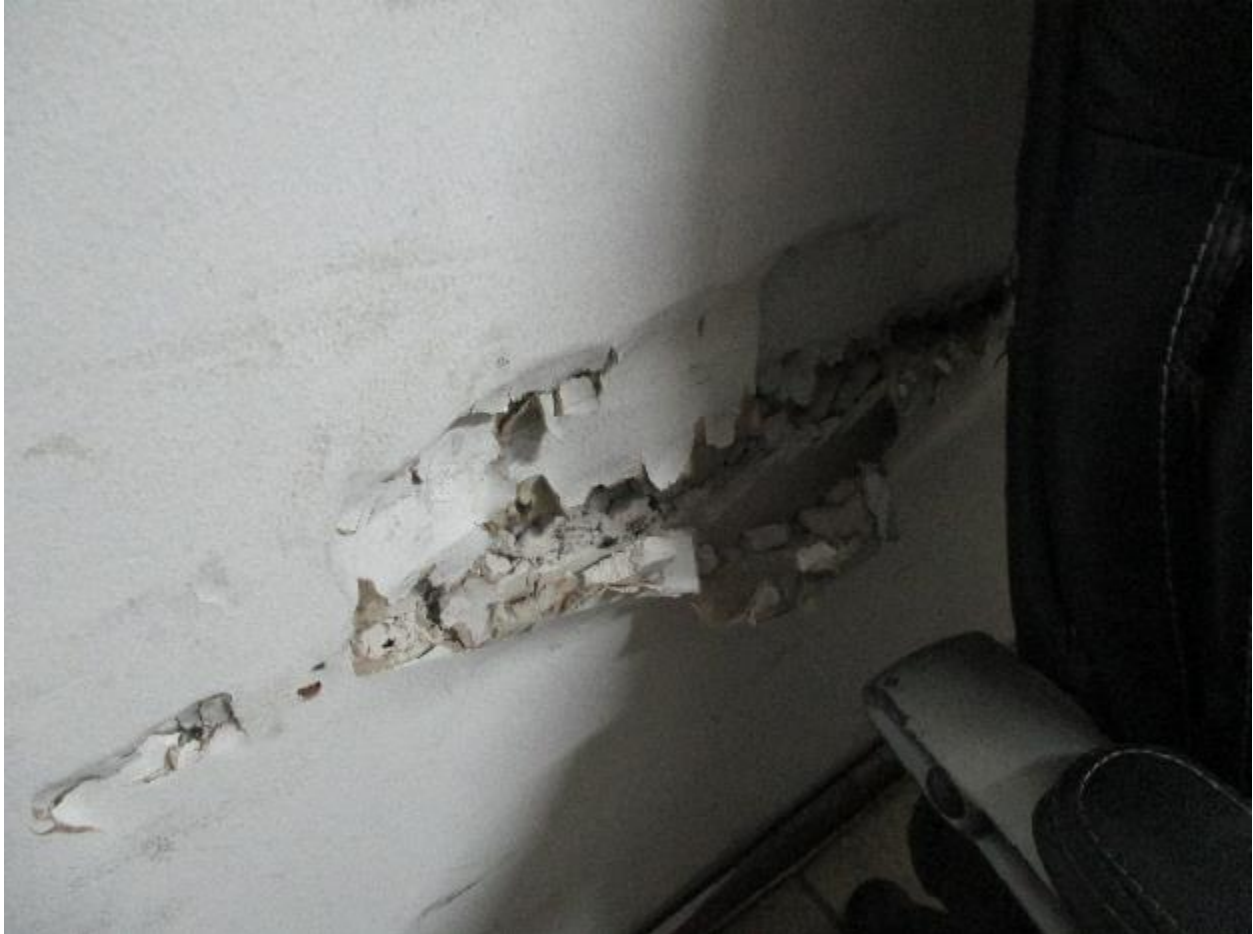
Drywall repairs required.

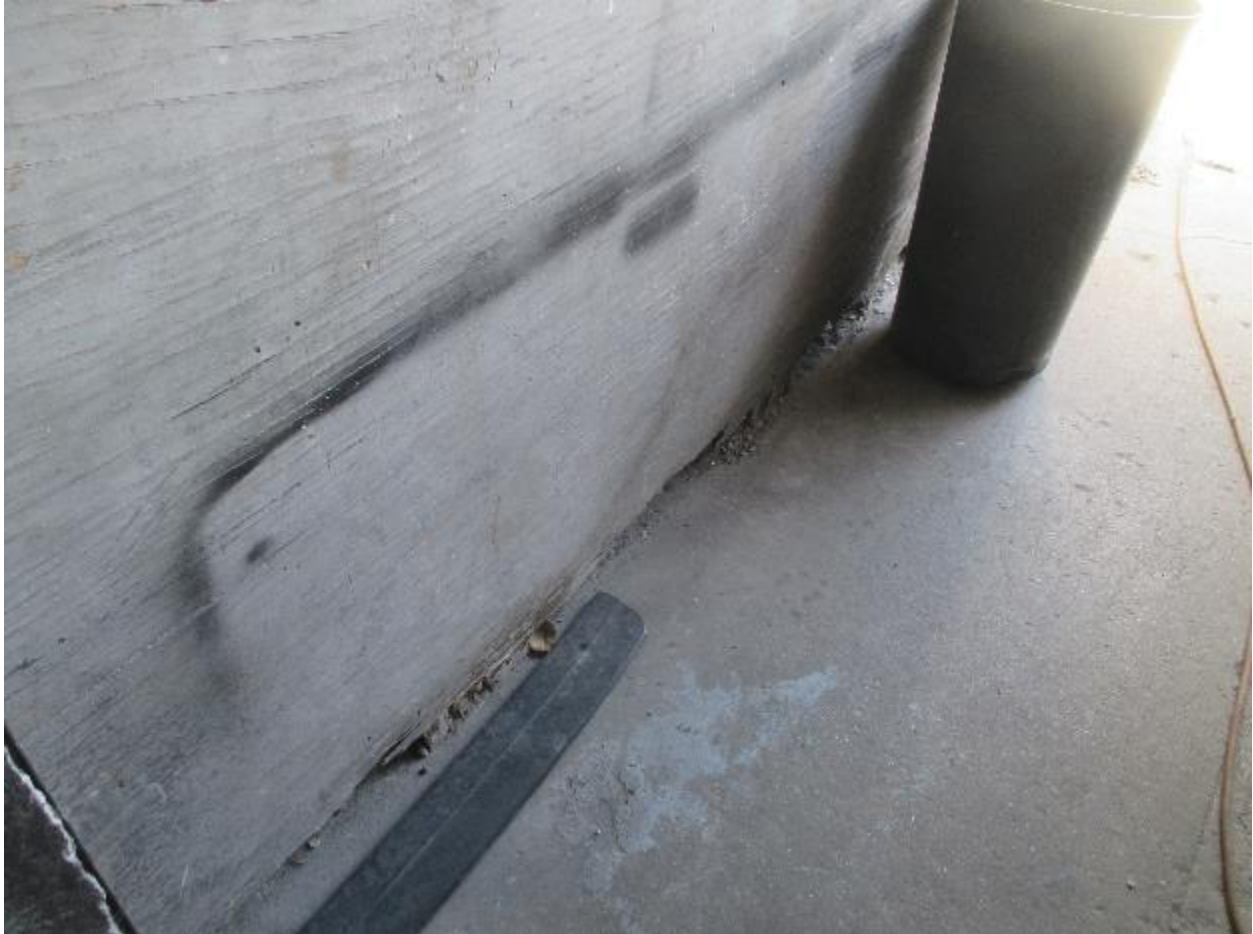
Drywall repairs required.

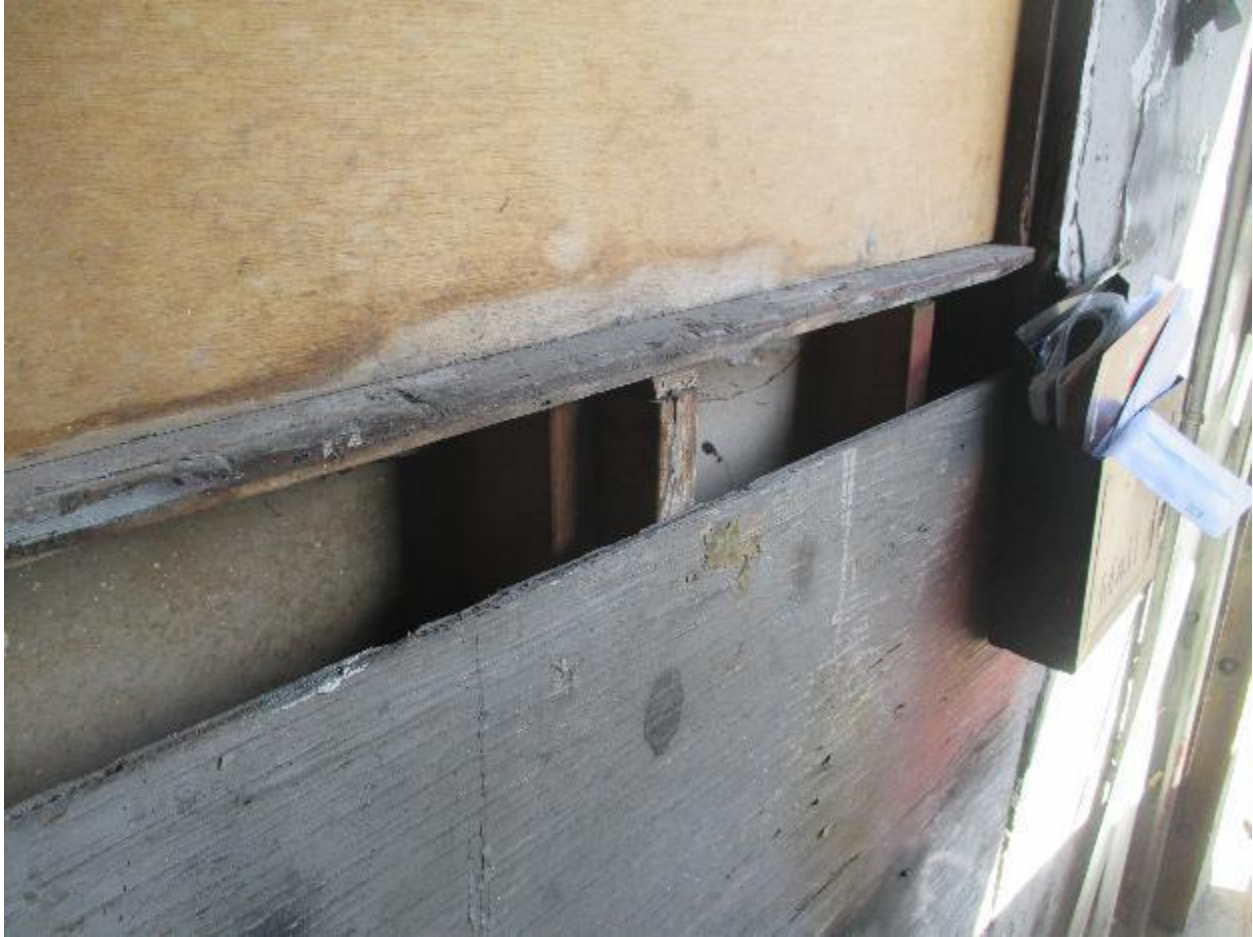
Drywall repairs required.

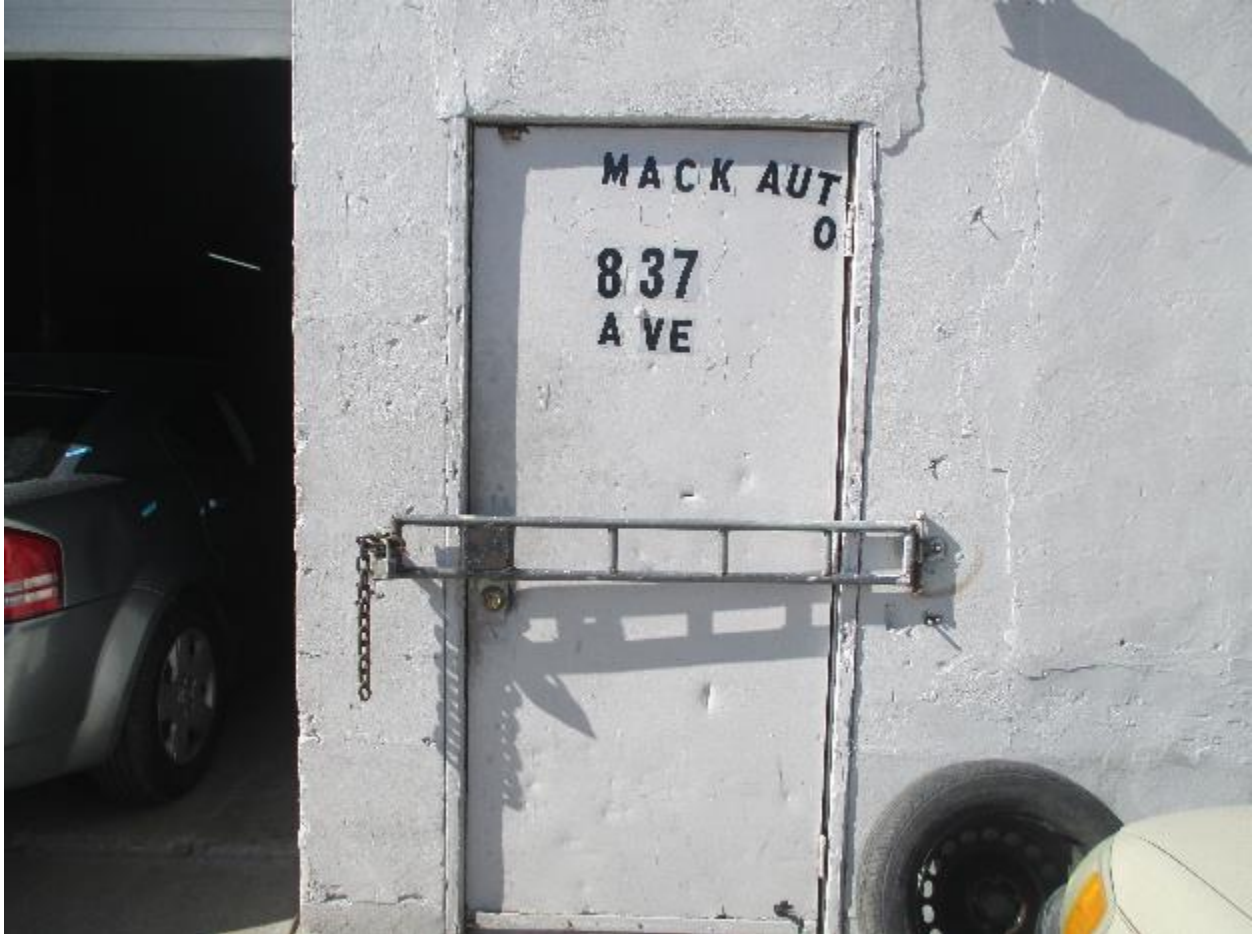
Exterior door(s) require replacement. Currently beyond possibilities of repair.

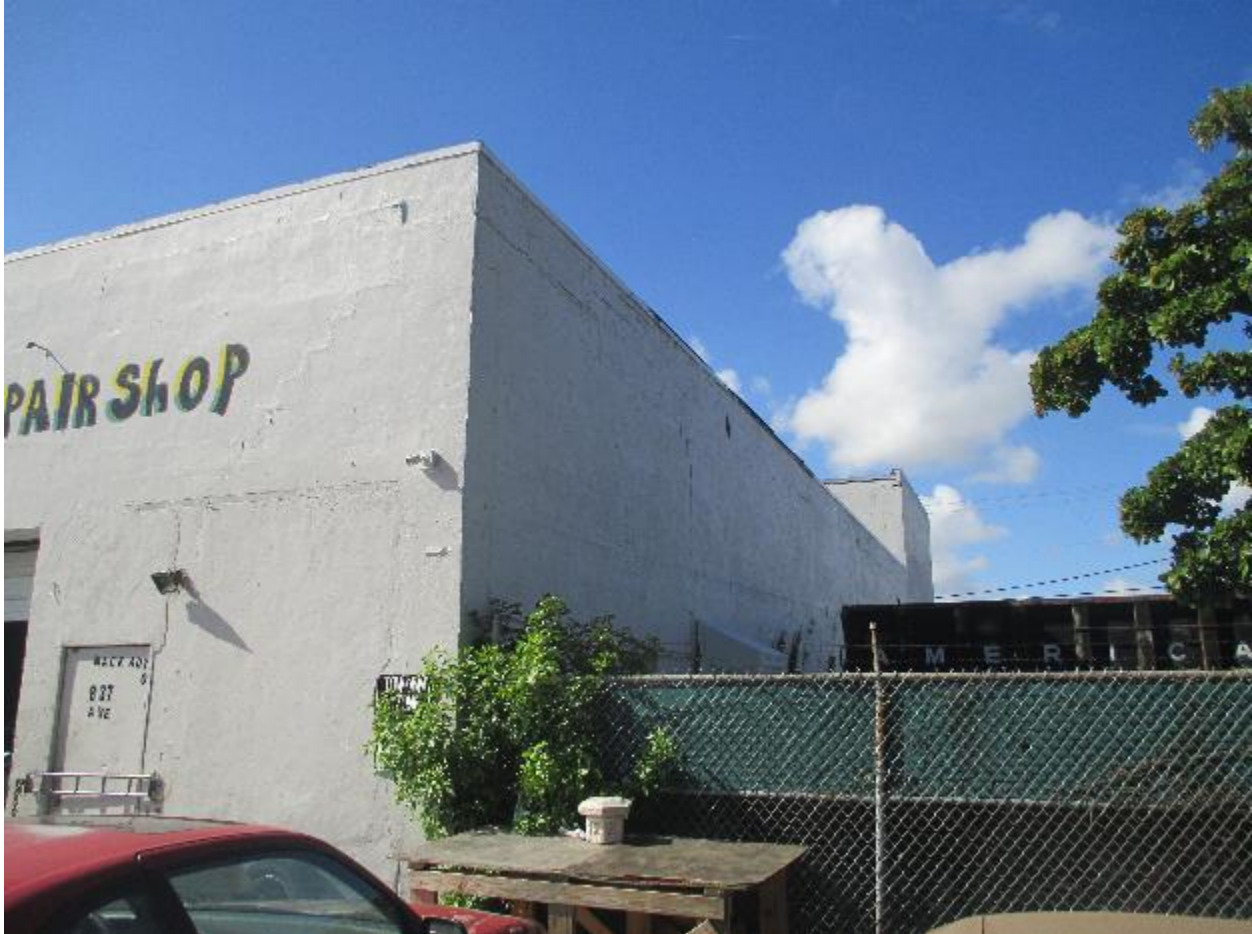
Exterior walls require proper waterproofing application in order to avoid water damage caused by fracture of the stucco work.

Exterior rehabilitation must include and not limited to:

Pressure wash and paint, replace exterior doors, structural repairs required. Refer to attached photographs for details.

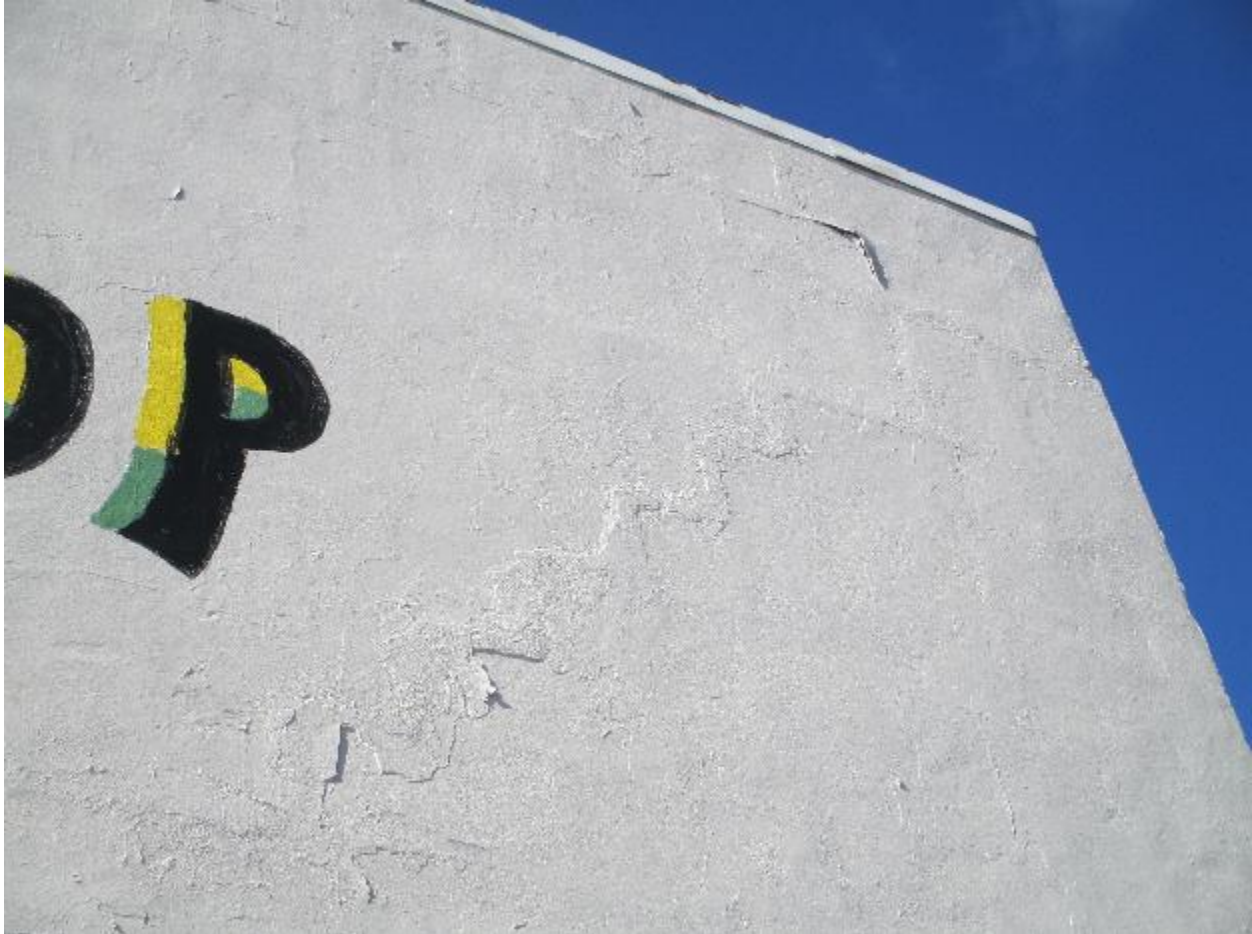
Cracks on vertical planes due to foundation settlement indicating downward and lateral movement. These types of cracks do compromise the ability of the building to function as designed and avoid water intrusion. Structural repair and proper waterproofing treatment are required to avoid further damage to the interior of the building and water infiltration.

Exterior walls require proper waterproofing application in order to avoid water damage caused by fracture of the stucco work.

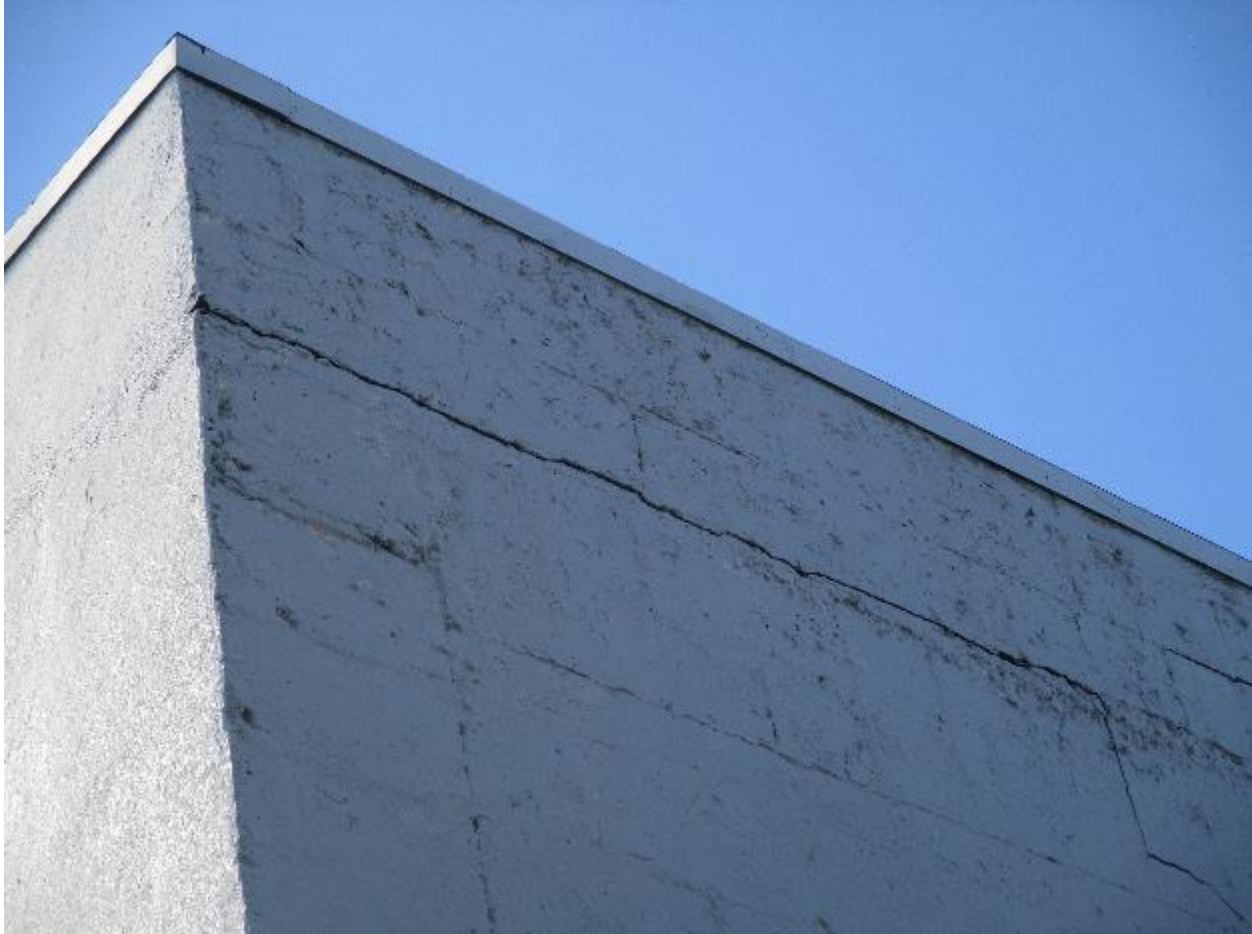
Cracks on vertical planes due to foundation settlement indicating downward and lateral movement. These types of cracks do compromise the ability of the building to function as designed and avoid water intrusion. Structural repair and proper waterproofing treatment are required to avoid further damage to the interior of the building and water infiltration.

Exterior walls require proper waterproofing application in order to avoid water damage caused by fracture of the stucco work.

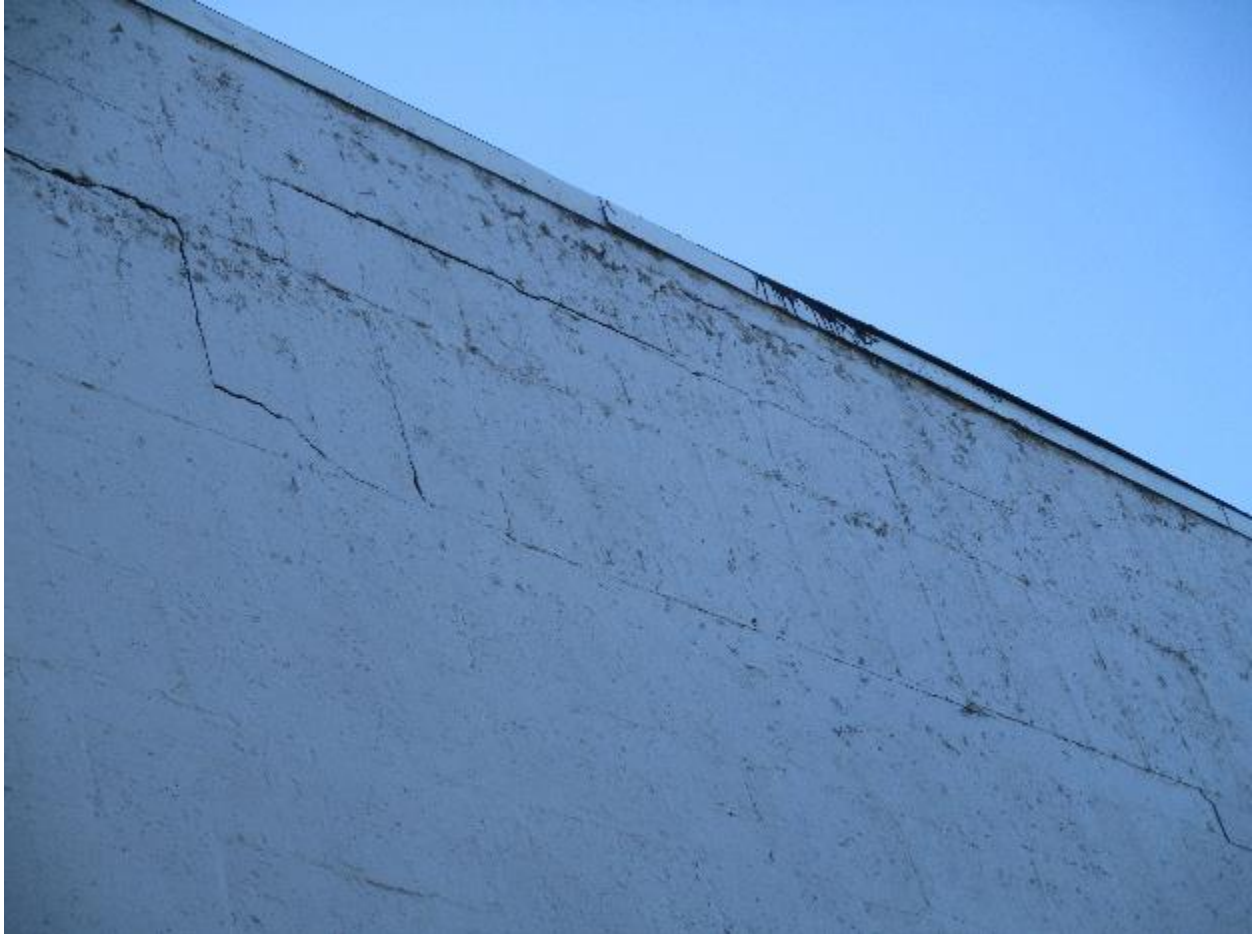
Cracks on vertical planes due to foundation settlement indicating downward and lateral movement. These types of cracks do compromise the ability of the building to function as designed and avoid water intrusion. Structural repair and proper waterproofing treatment are required to avoid further damage to the interior of the building and water infiltration.

Exterior walls require proper waterproofing application in order to avoid water damage caused by fracture of the stucco work.

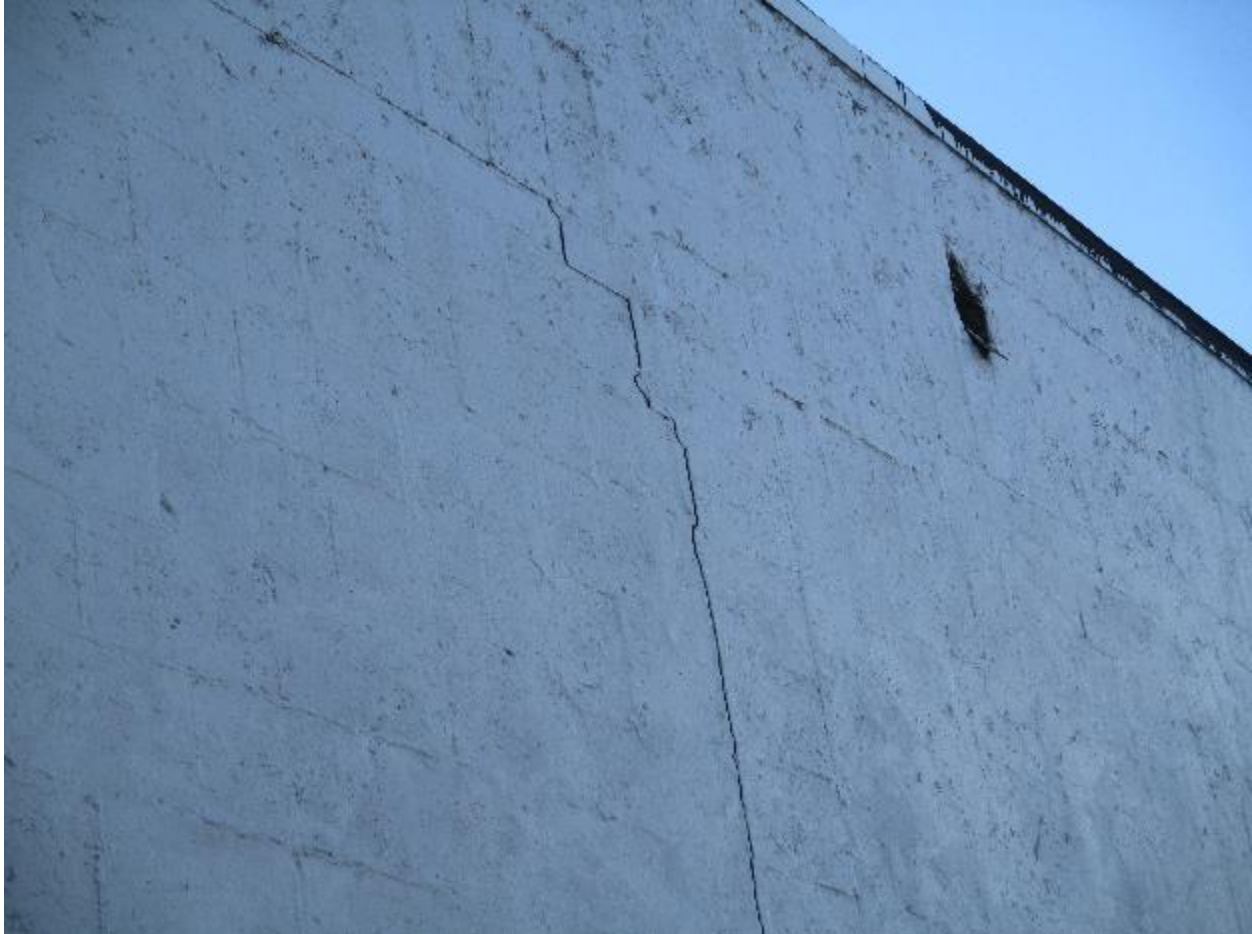
Cracks on vertical planes due to foundation settlement indicating downward and lateral movement. These types of cracks do compromise the ability of the building to function as designed and avoid water intrusion. Structural repair and proper waterproofing treatment are required to avoid further damage to the interior of the building and water infiltration.

Exterior walls require proper waterproofing application to avoid water damage caused by fracture of the stucco work.

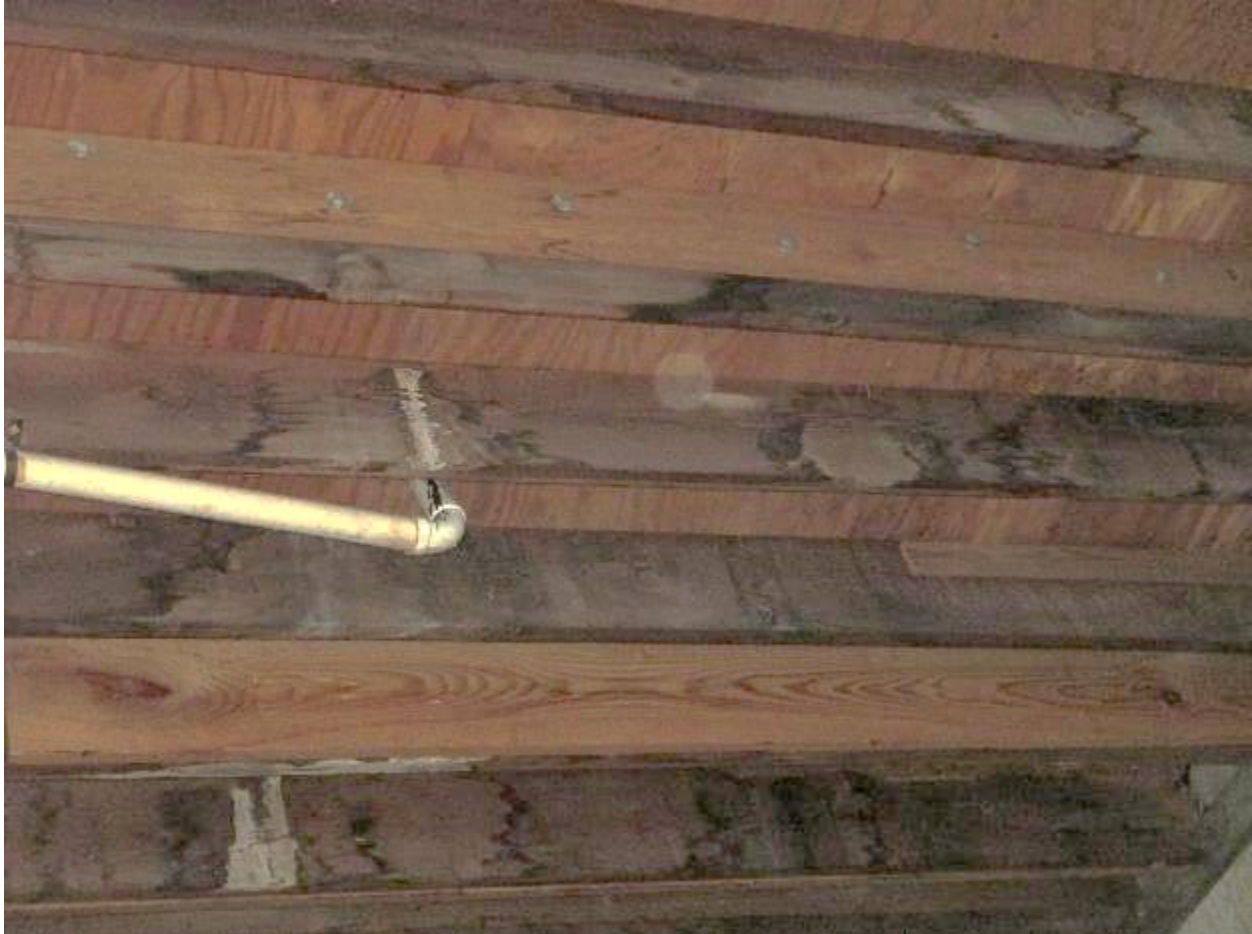
Roof deck repairs required.

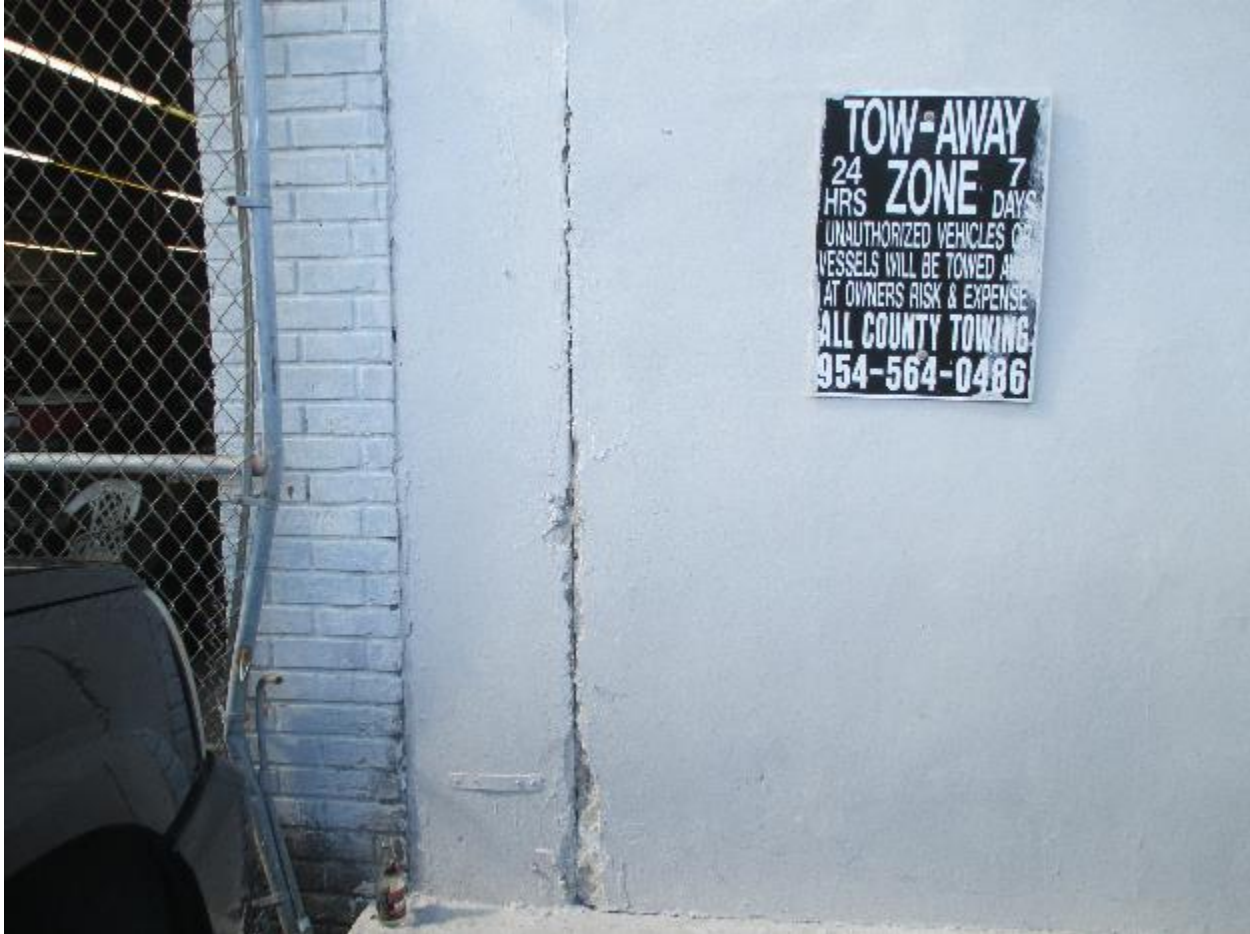
Cracks on vertical planes due to foundation settlement indicating downward and lateral movement. These types of cracks do compromise the ability of the building to function as designed and avoid water intrusion. Structural repair and proper waterproofing treatment are required to avoid further damage to the interior of the building and water infiltration.

Exterior walls require proper waterproofing application to avoid water damage caused by fracture of the stucco work.

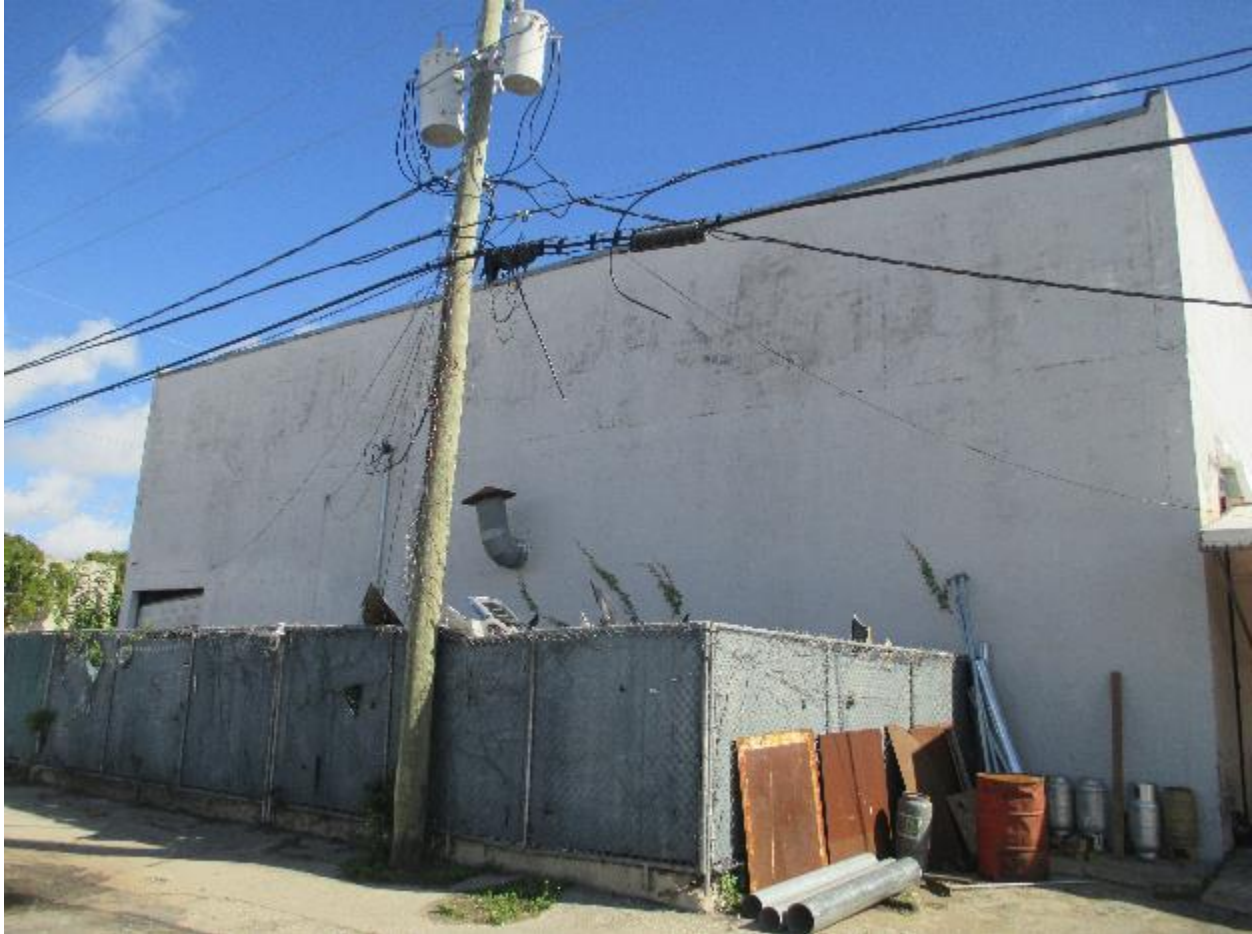
Exterior walls require proper waterproofing application in order to avoid water damage caused by fracture of the stucco work.

Exterior rehabilitation must include and not limited to:

Pressure wash and paint, replace exterior doors, structural repairs required. Refer to attached photographs for details.

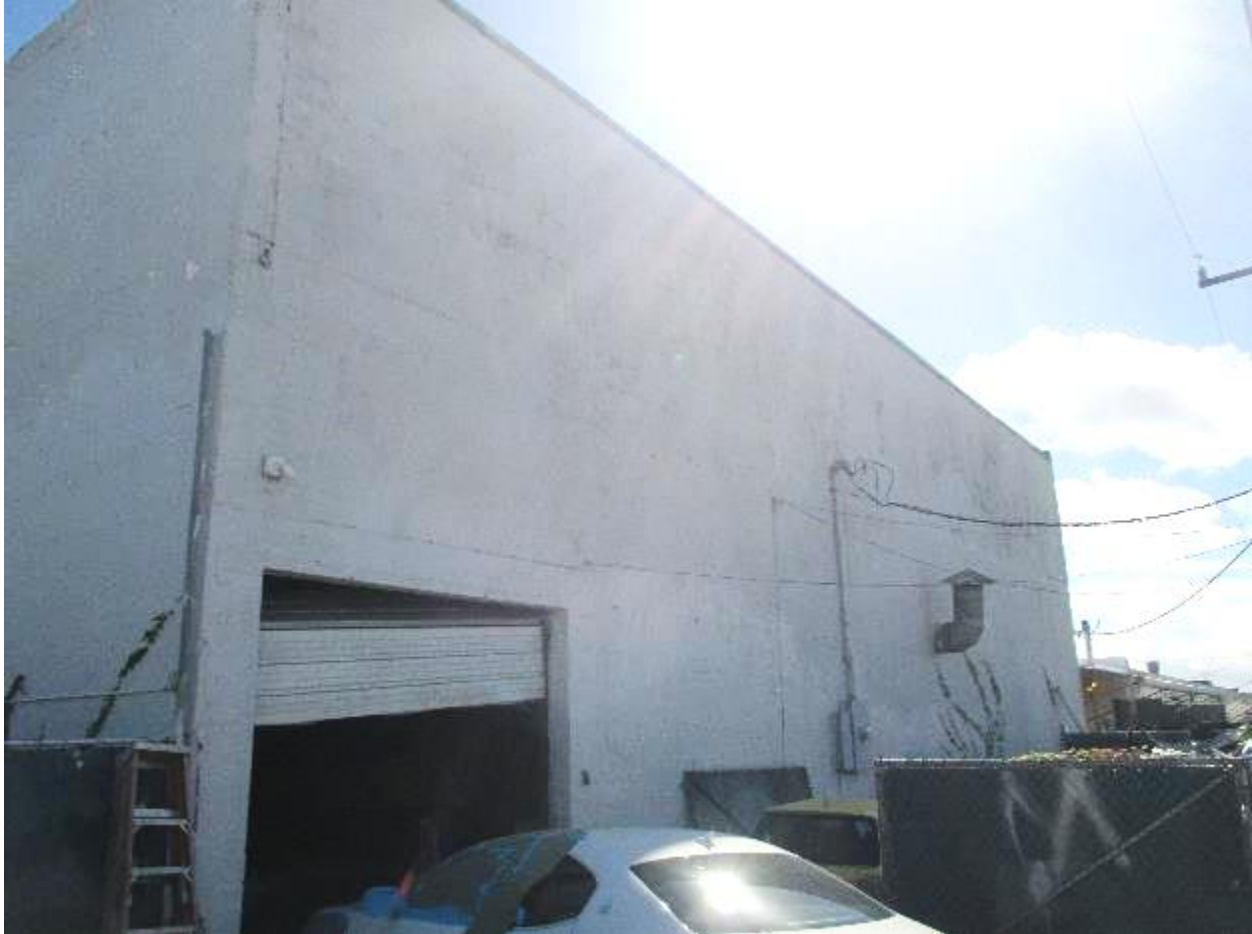
Exterior walls require proper waterproofing application in order to avoid water damage caused by fracture of the stucco work.

Exterior rehabilitation must include and not limited to:

Pressure wash and paint, replace exterior doors, structural repairs required. Refer to attached photographs for details.
