PROPERTY INSPECTION OR ASSESSMENT OF DAMAGES

ADDRESS: xxx NW xx AVE FORT LAUDERDALE, FL
CLIENT: your name here
ID No: 123
DATE: 1/12/xxxx

INSPECTION OR ASSESSMENT BY:

GAIA CONSTRUCTION INC.
CGC 1516136 **FLORIDA**
HI-2792 **FLORIDA**
8028867-B2 **INTERNATIONAL CODE COUNCIL**

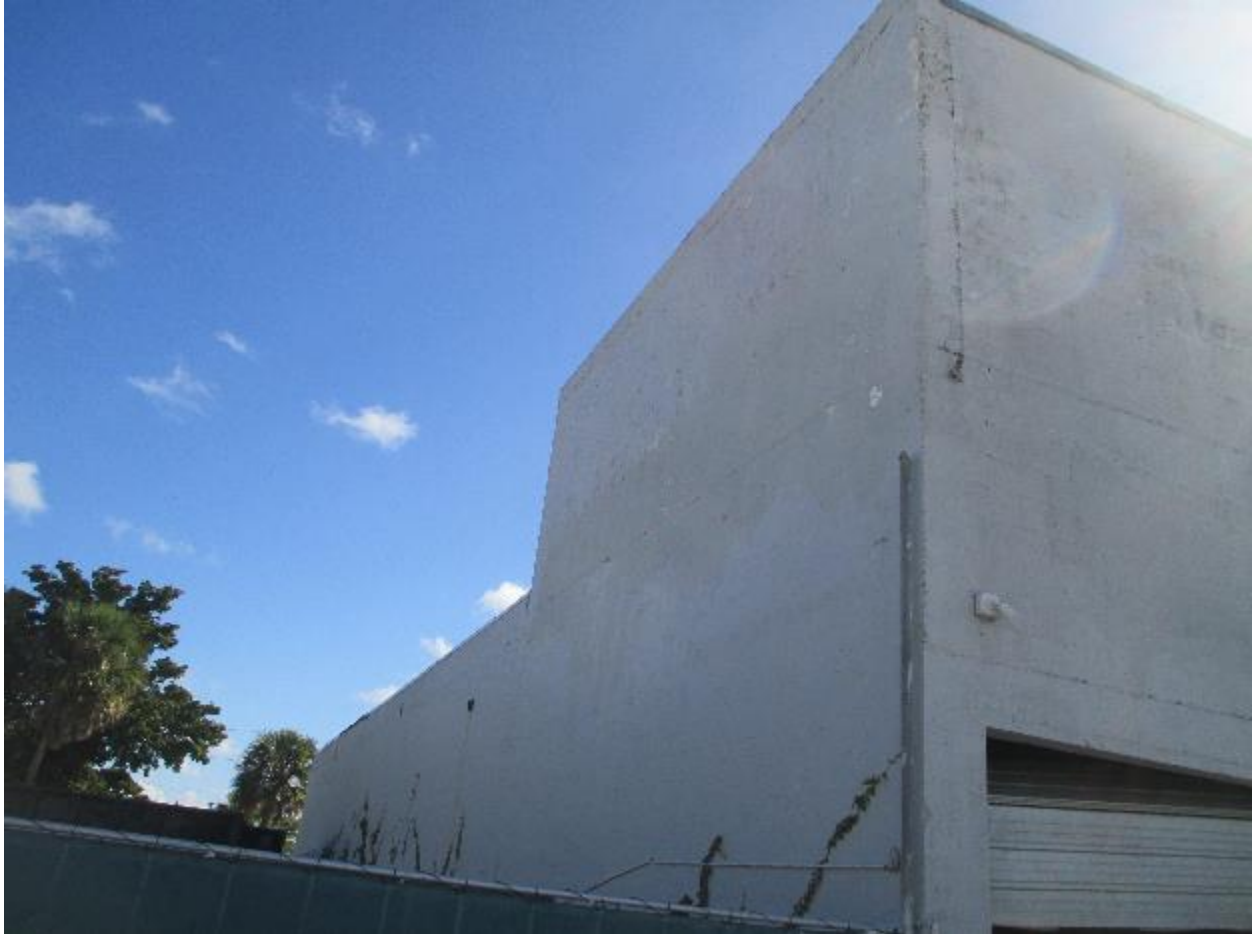
Exterior walls require proper waterproofing application in order to avoid water damage caused by fracture of the stucco work.

Exterior rehabilitation must include and not limited to:

Pressure wash and paint, replace exterior doors, structural repairs required. Refer to attached photographs for details.

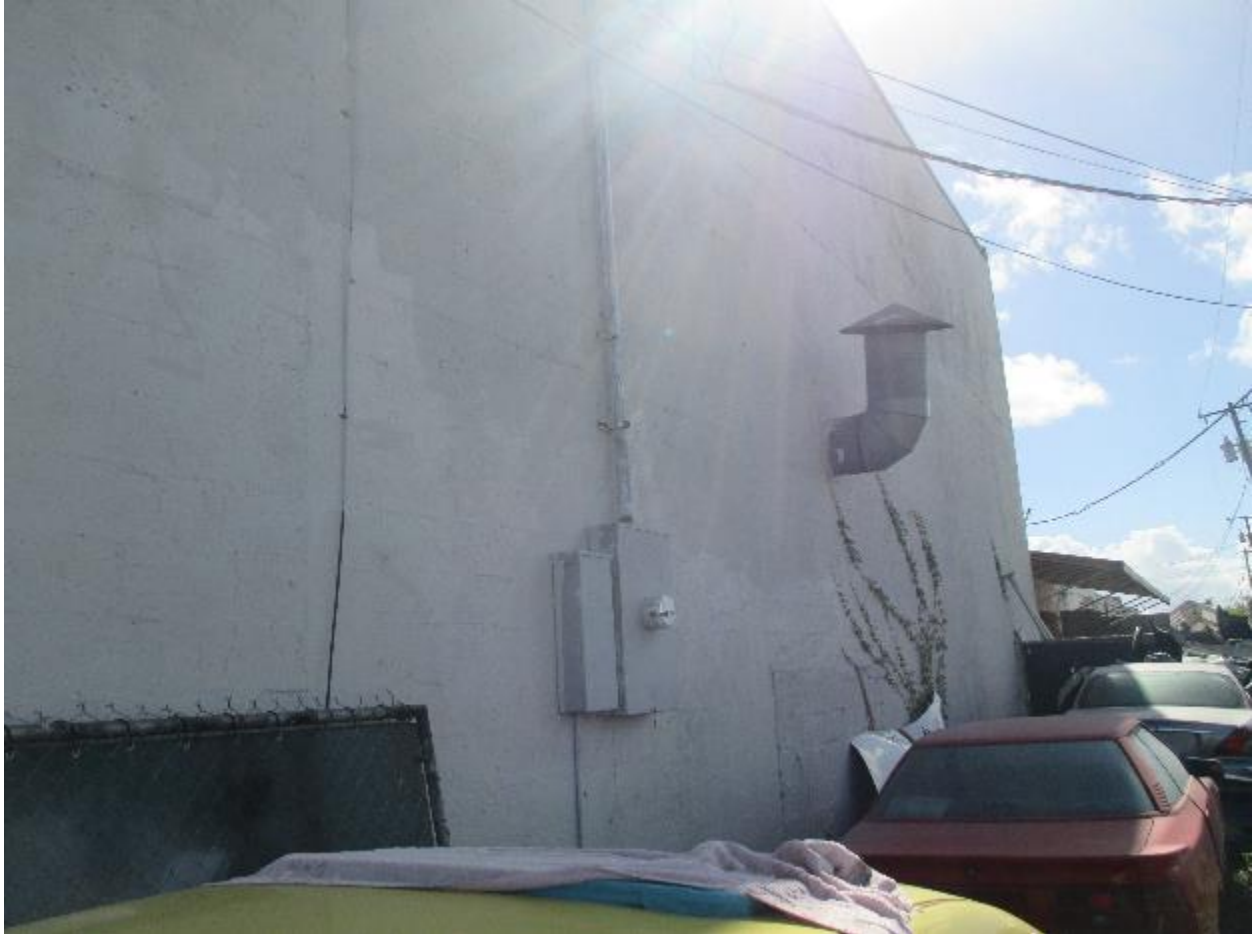
Cracks on vertical planes due to foundation settlement indicating downward and lateral movement. These types of cracks do compromise the ability of the building to function as designed and avoid water intrusion. Structural repair and proper waterproofing treatment are required to avoid further damage to the interior of the building and water infiltration.

Exterior walls require proper waterproofing application to avoid water damage caused by fracture of the stucco work.

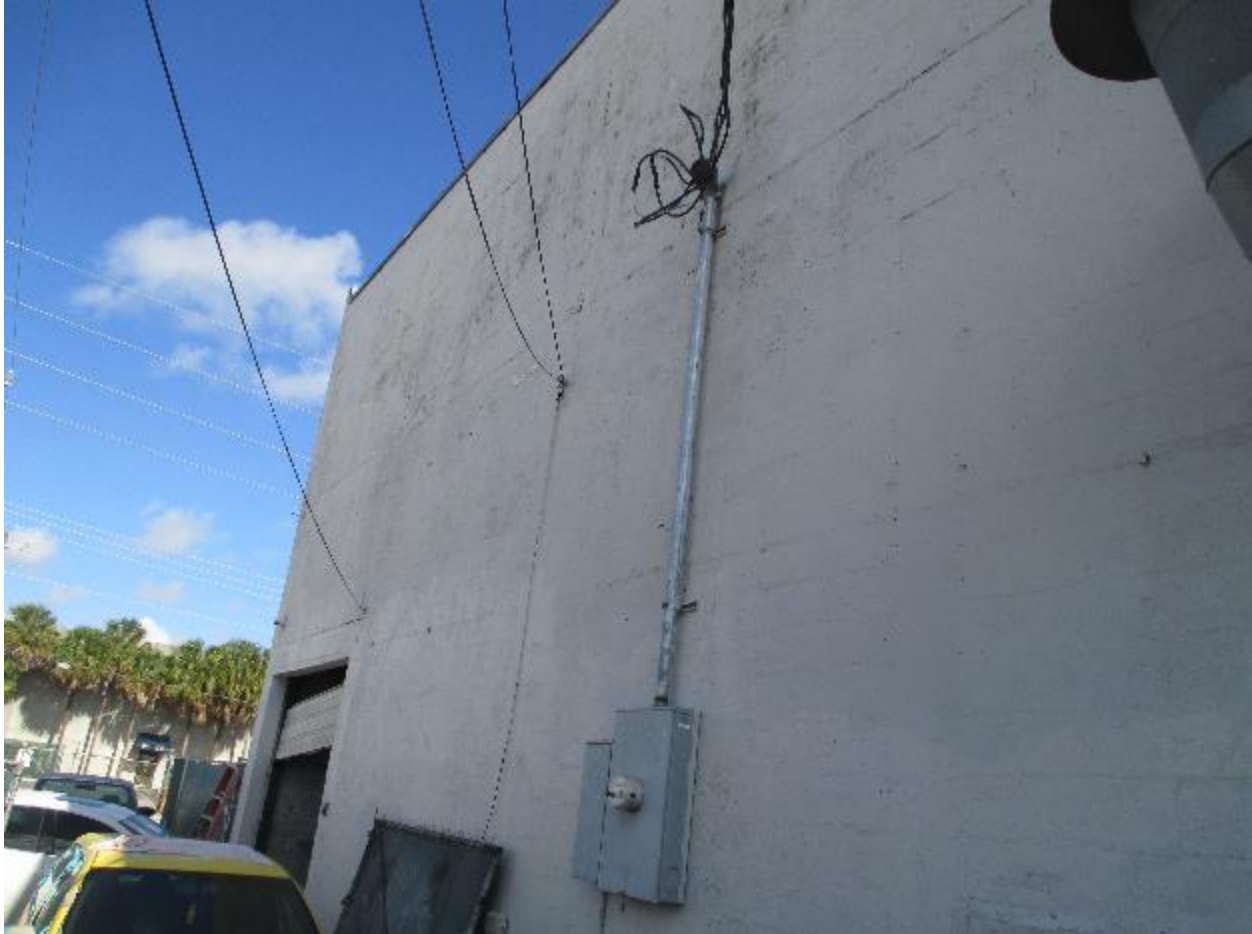
Cracks on vertical planes due to foundation settlement indicating downward and lateral movement. These types of cracks do compromise the ability of the building to function as designed and avoid water intrusion. Structural repair and proper waterproofing treatment are required to avoid further damage to the interior of the building and water infiltration.

Exterior walls require proper waterproofing application to avoid water damage caused by fracture of the stucco work.

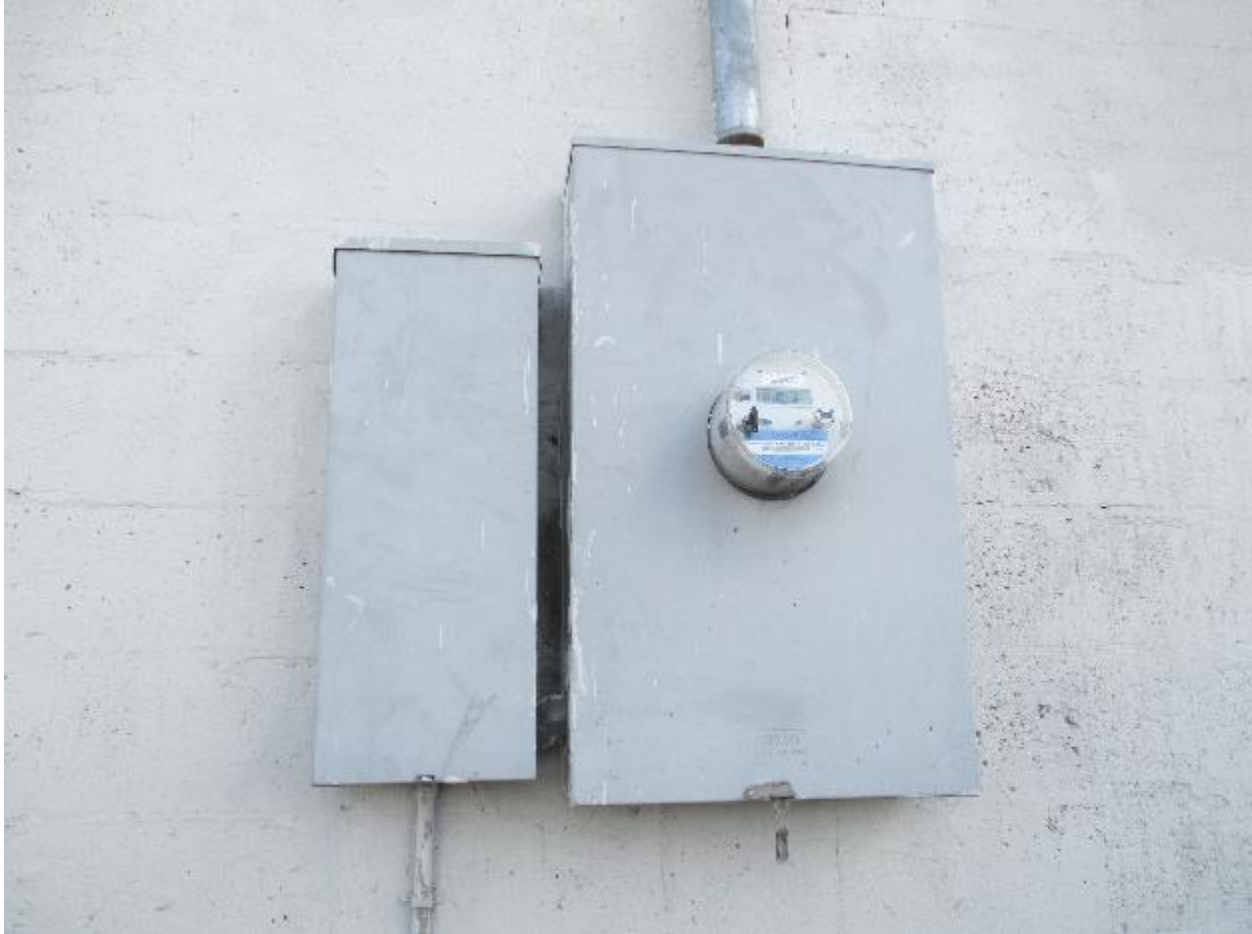
Main disconnect and exterior breaker panel in good condition at the time of inspection.

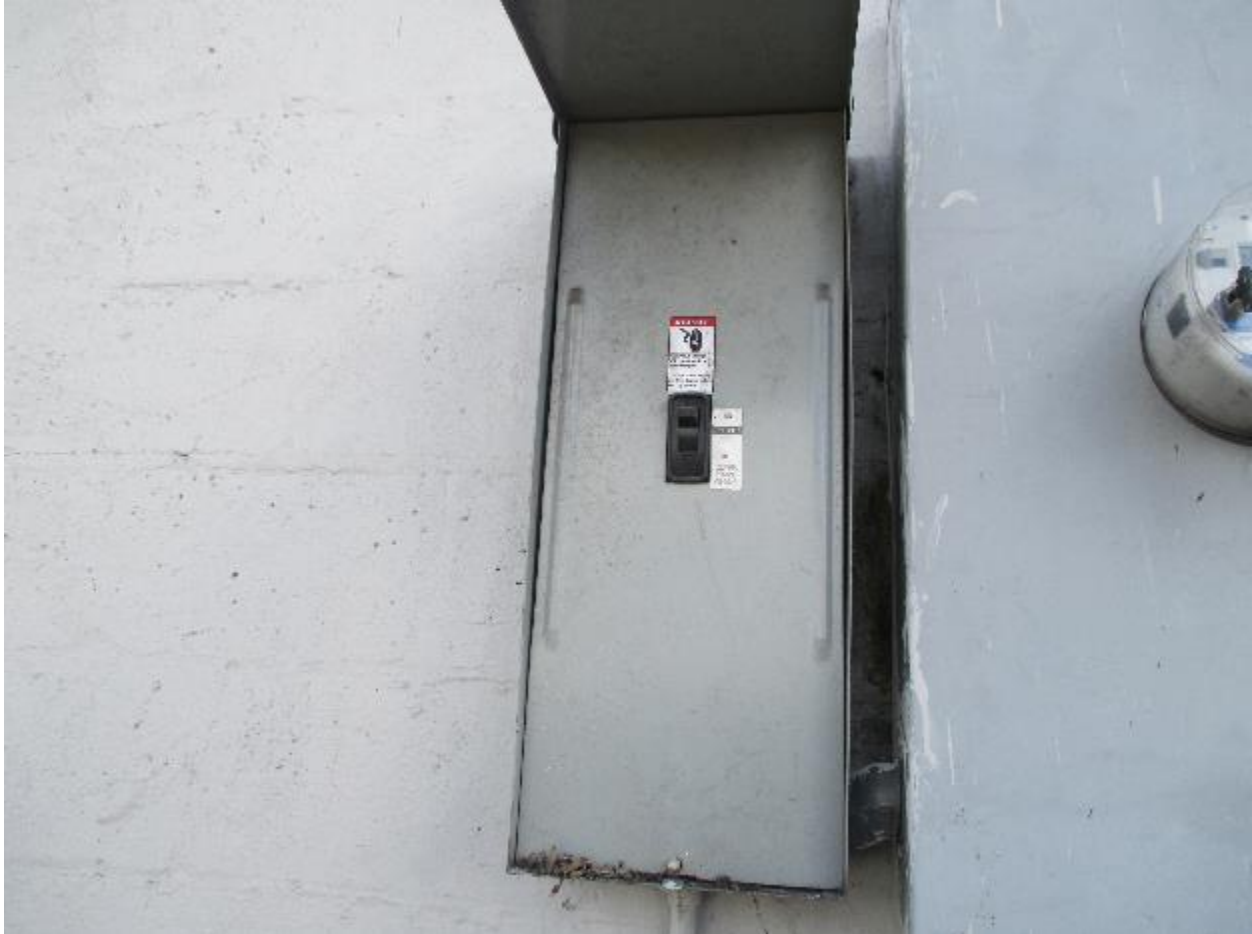
Main disconnect and exterior breaker panel in good condition at the time of inspection.

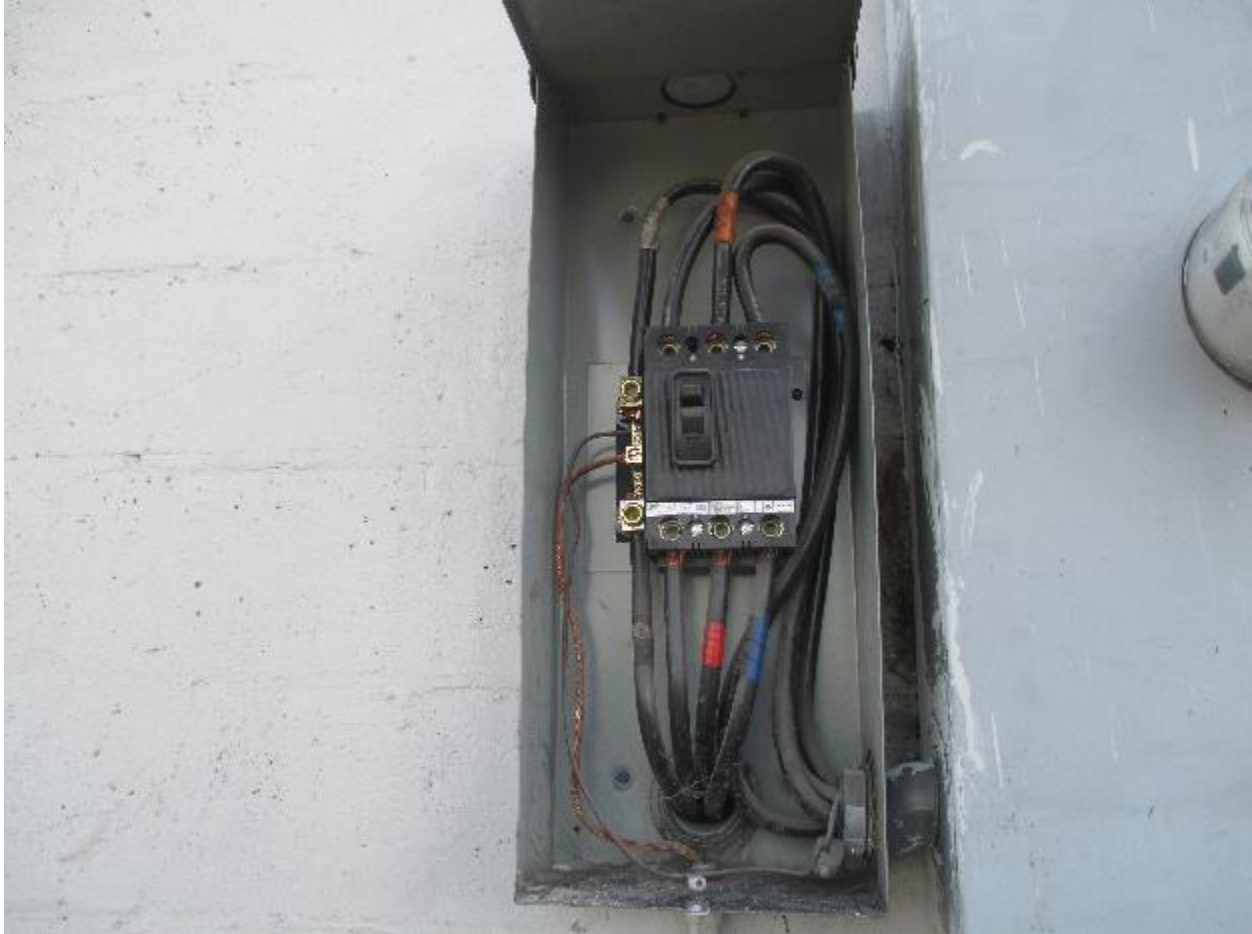
Main disconnect and exterior breaker panel in good condition at the time of inspection.

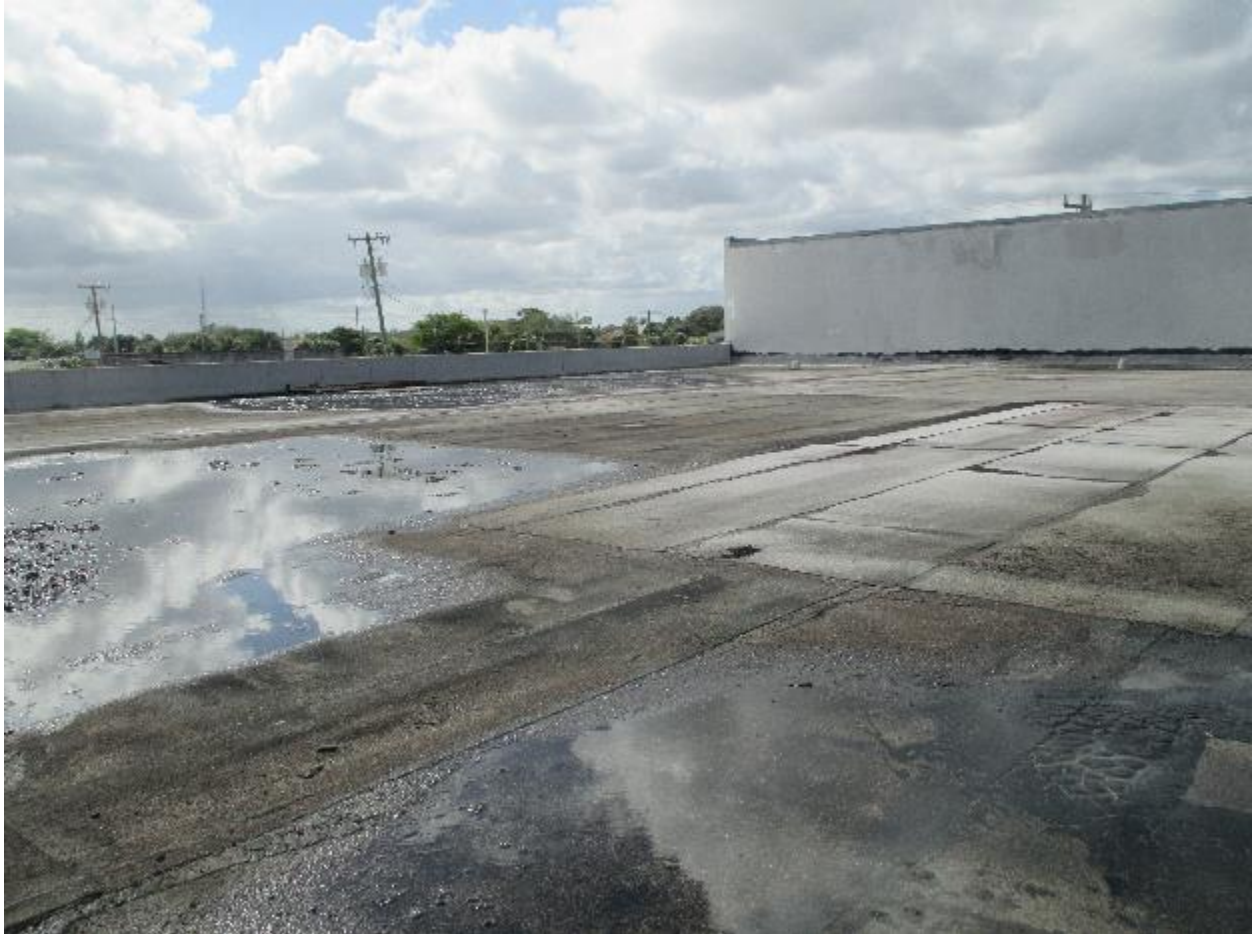
Flat roof not properly sloped; this condition does not allow the water to run over the surface. Replacement required.

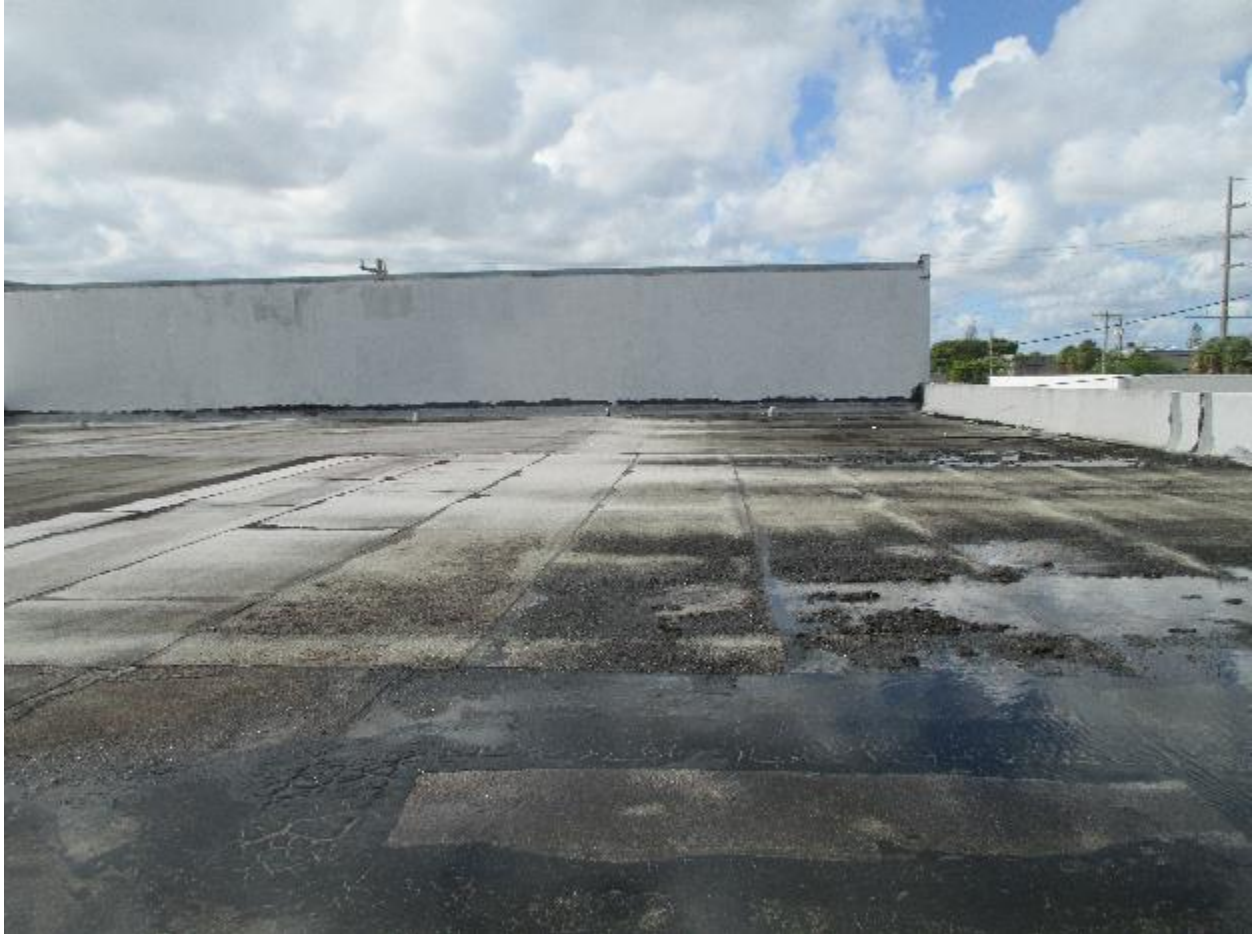
Flat roof not properly sloped; this condition does not allow the water to run over the surface. Replacement required.

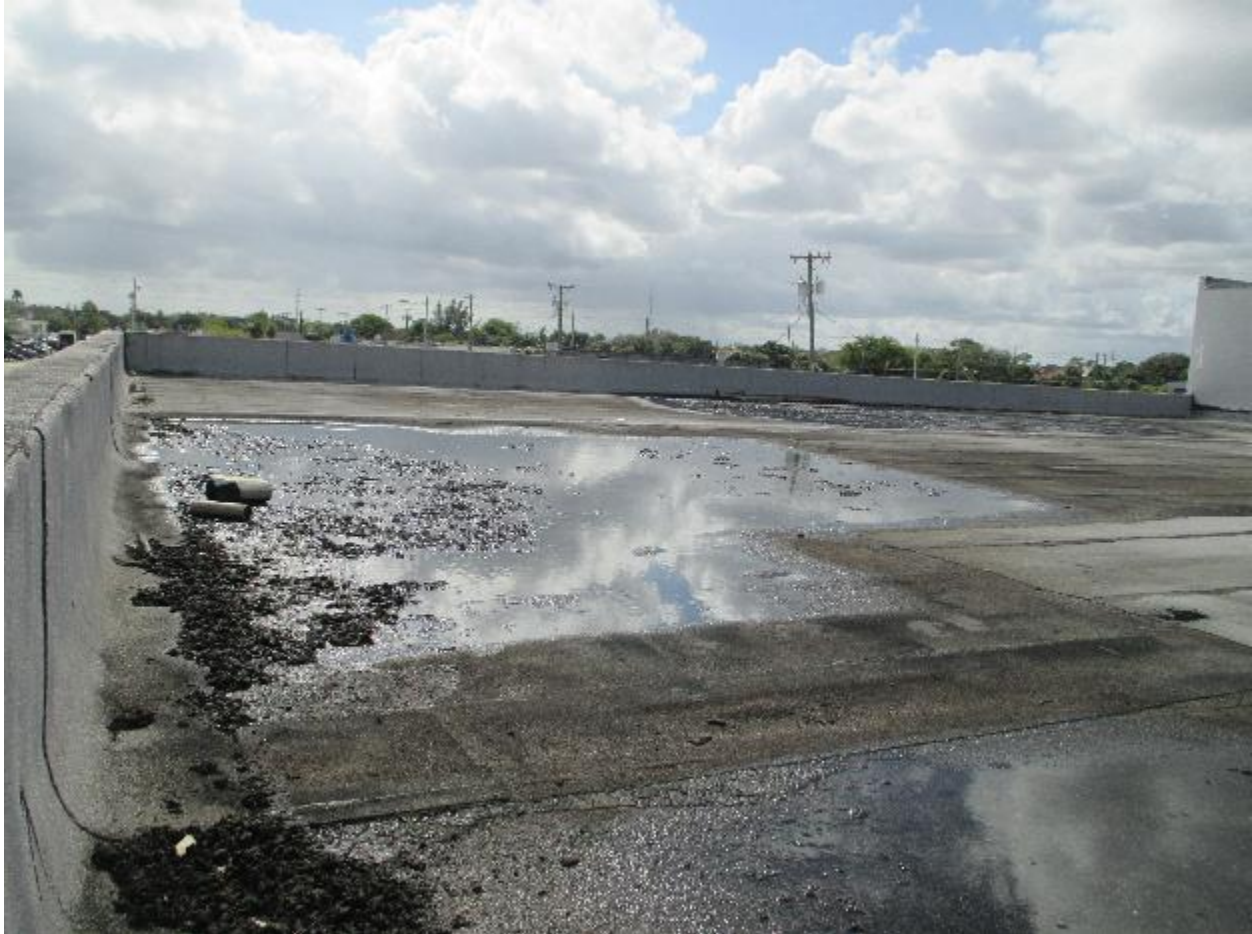
Flat roof not properly sloped; this condition does not allow the water to run over the surface. Replacement required.

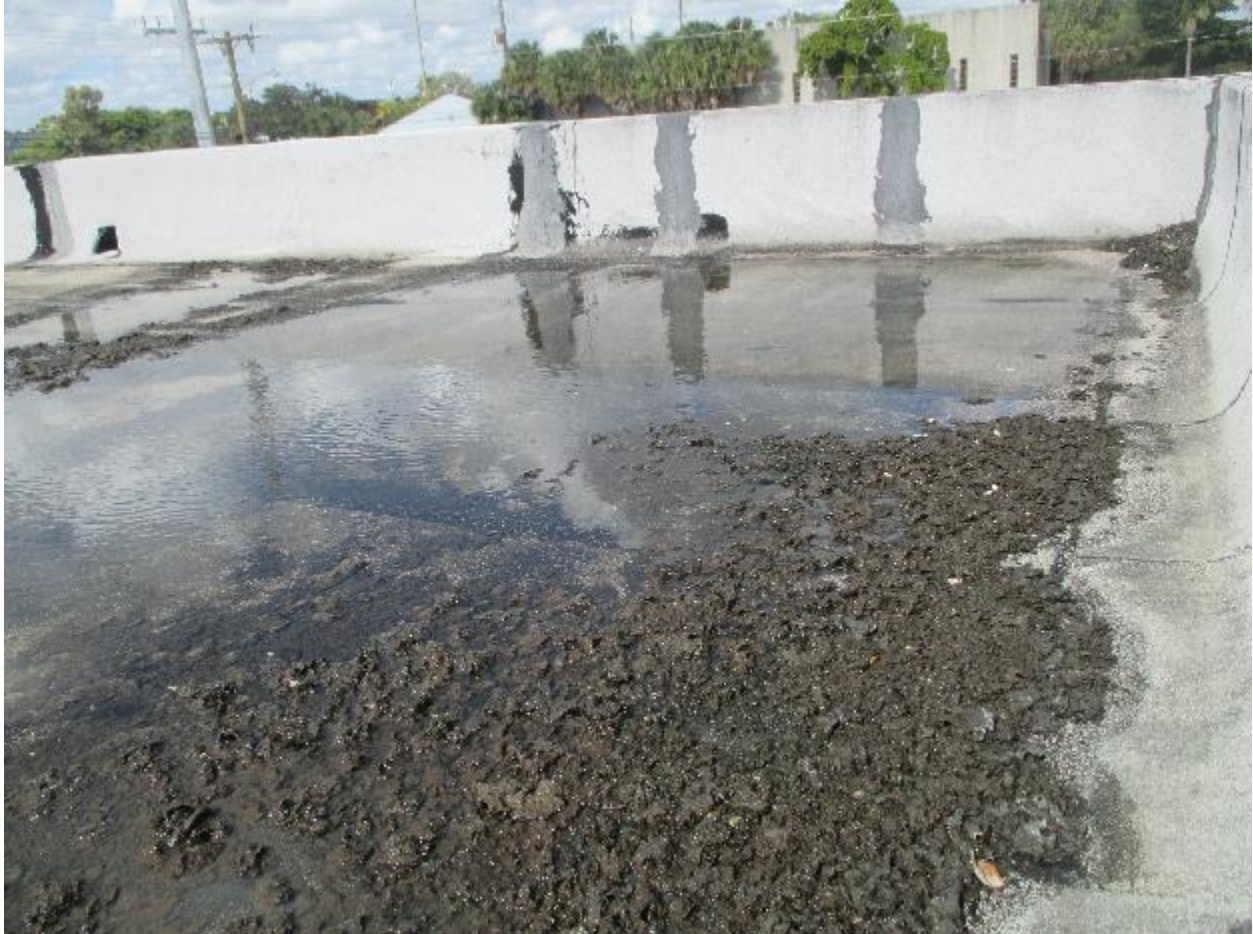
Flat roof not properly sloped; this condition does not allow the water to run over the surface. Replacement required.

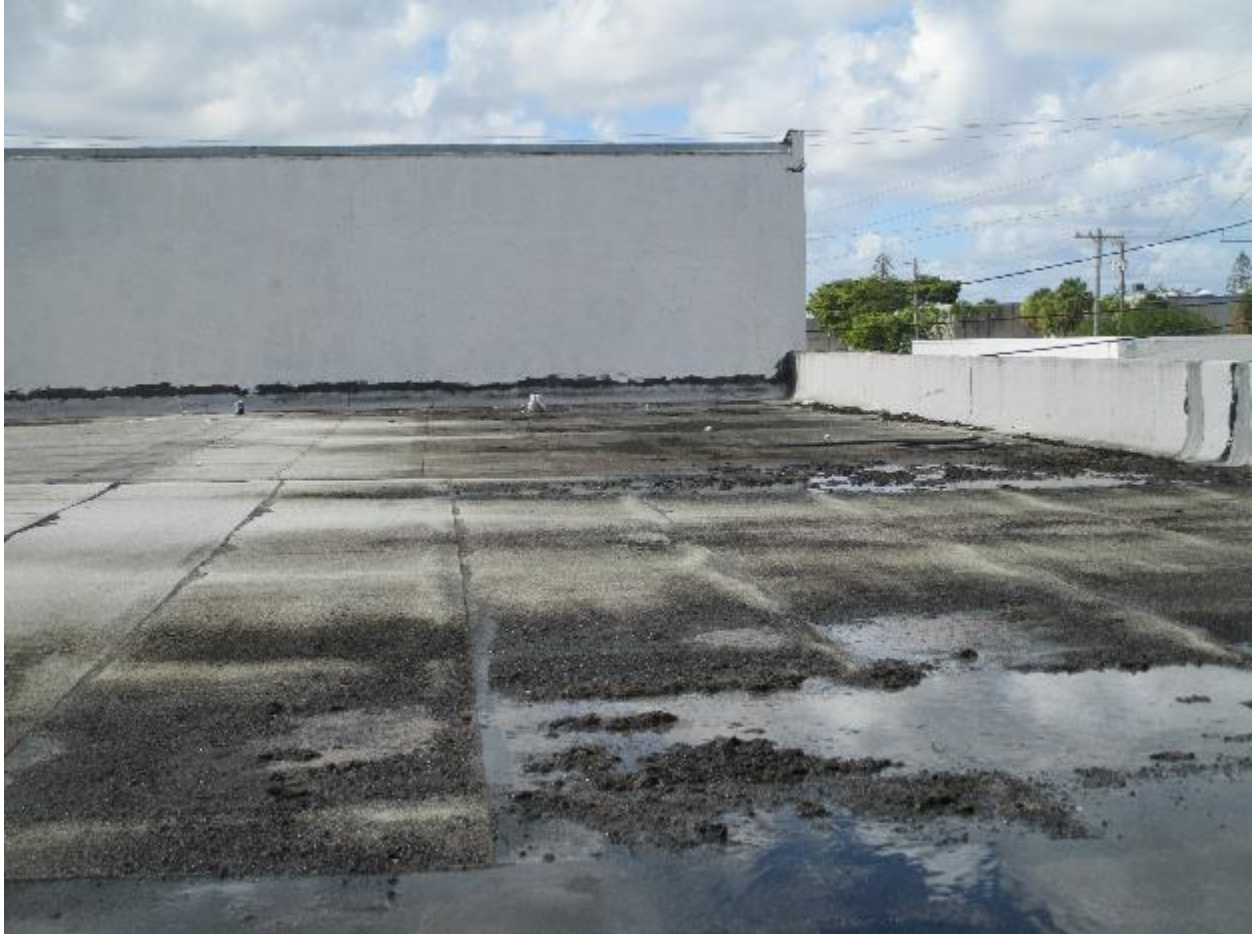
Flat roof not properly sloped; this condition does not allow the water to run over the surface. Replacement required.

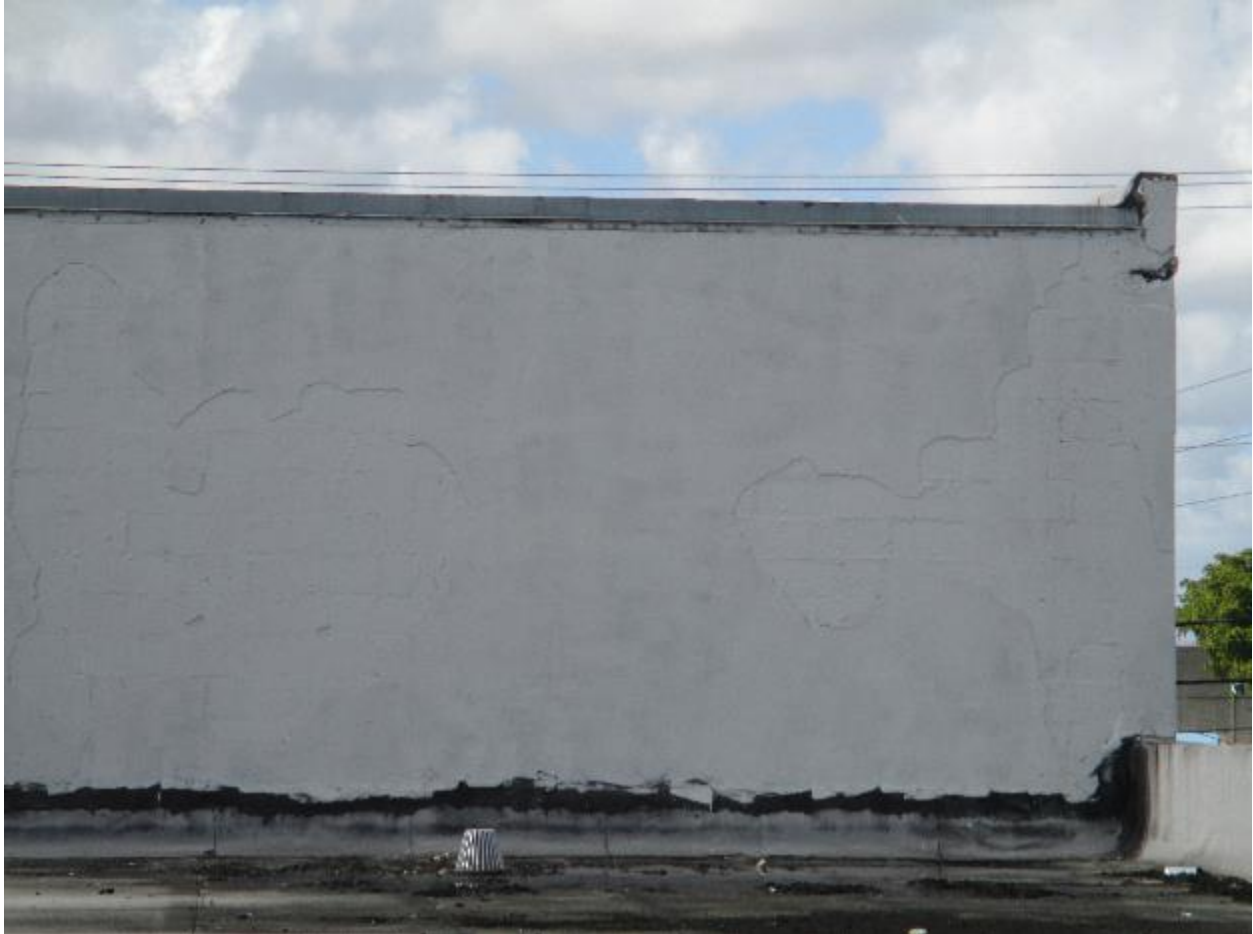
Exterior walls require proper waterproofing application to avoid water damage caused by fracture of the stucco work.

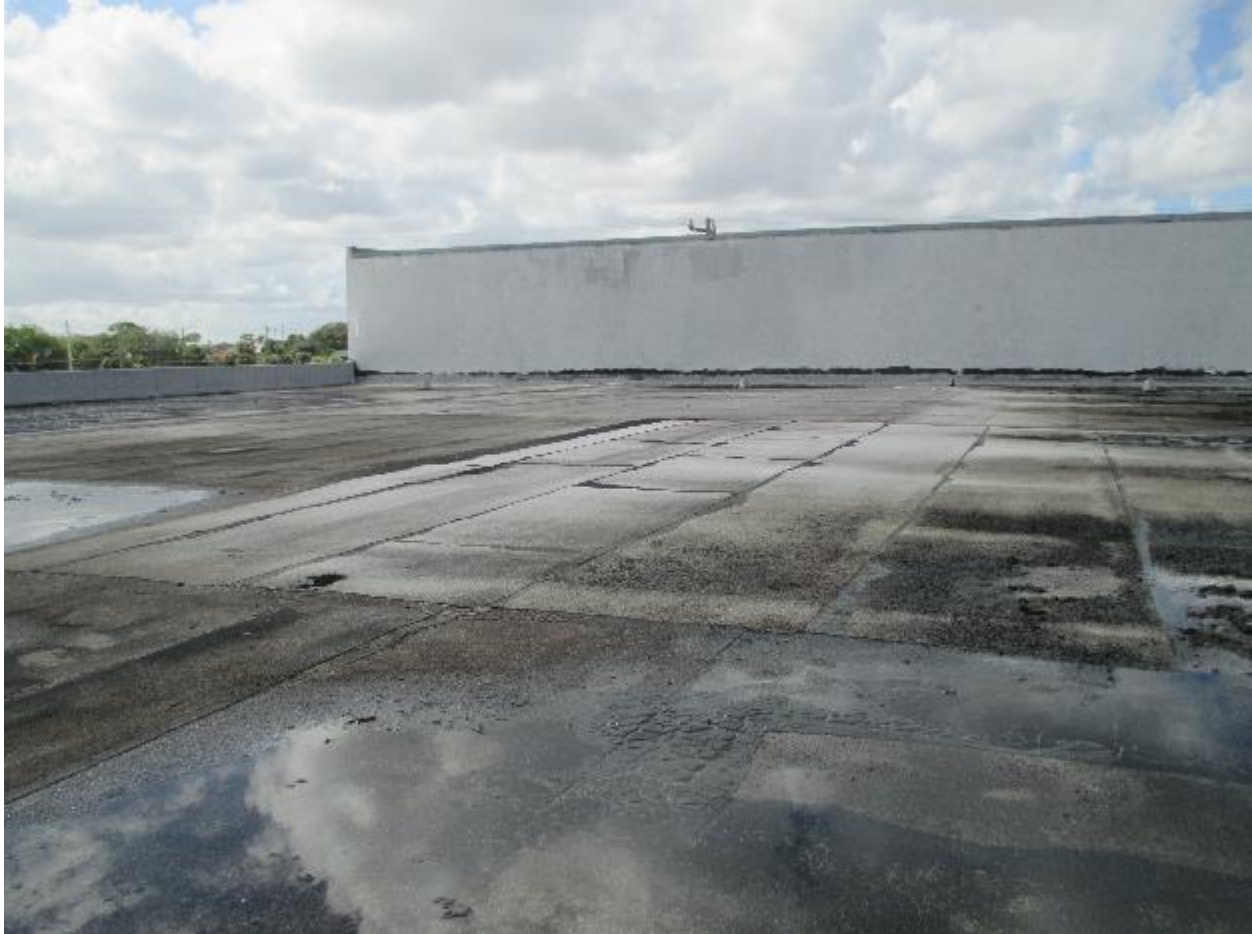
Flat roof not properly sloped; this condition does not allow the water to run over the surface. Replacement required.
