PROPERTY INSPECTION OR ASSESSMENT OF DAMAGES

ADDRESS: **SOMEWHERE , FL**
CLIENT: **GAIA GC**
ID No: **2015000**
DATE: **12/31/xxxx**

GAIA CONSTRUCTION INC.
CGC 1516136 FLORIDA
HI-2792 FLORIDA
8028867-B2 INTERNATIONAL CODE COUNCIL

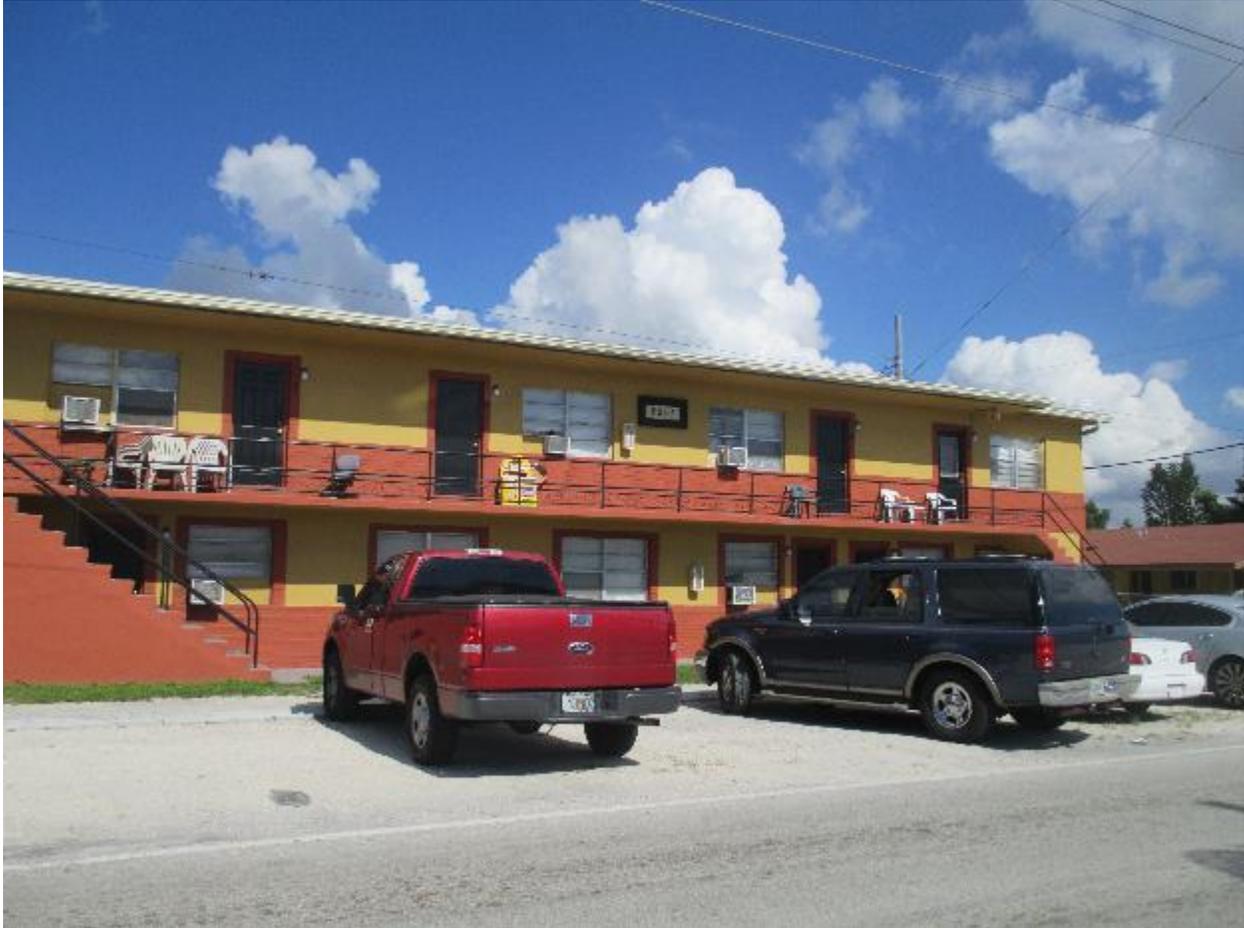
Exterior view.

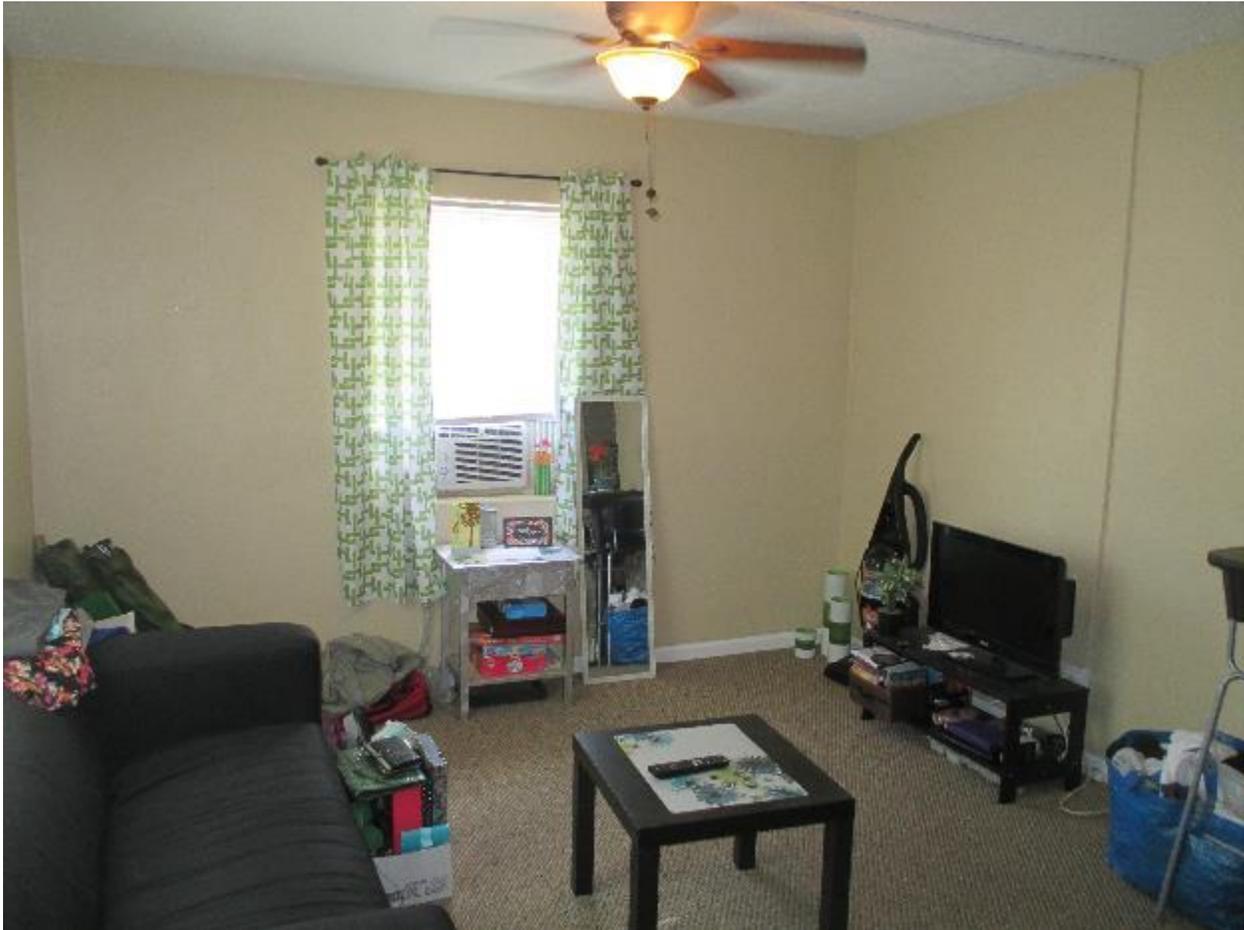
Interior finishes were found in general good condition at the time of inspection with exceptions as noted and shown in photographs.

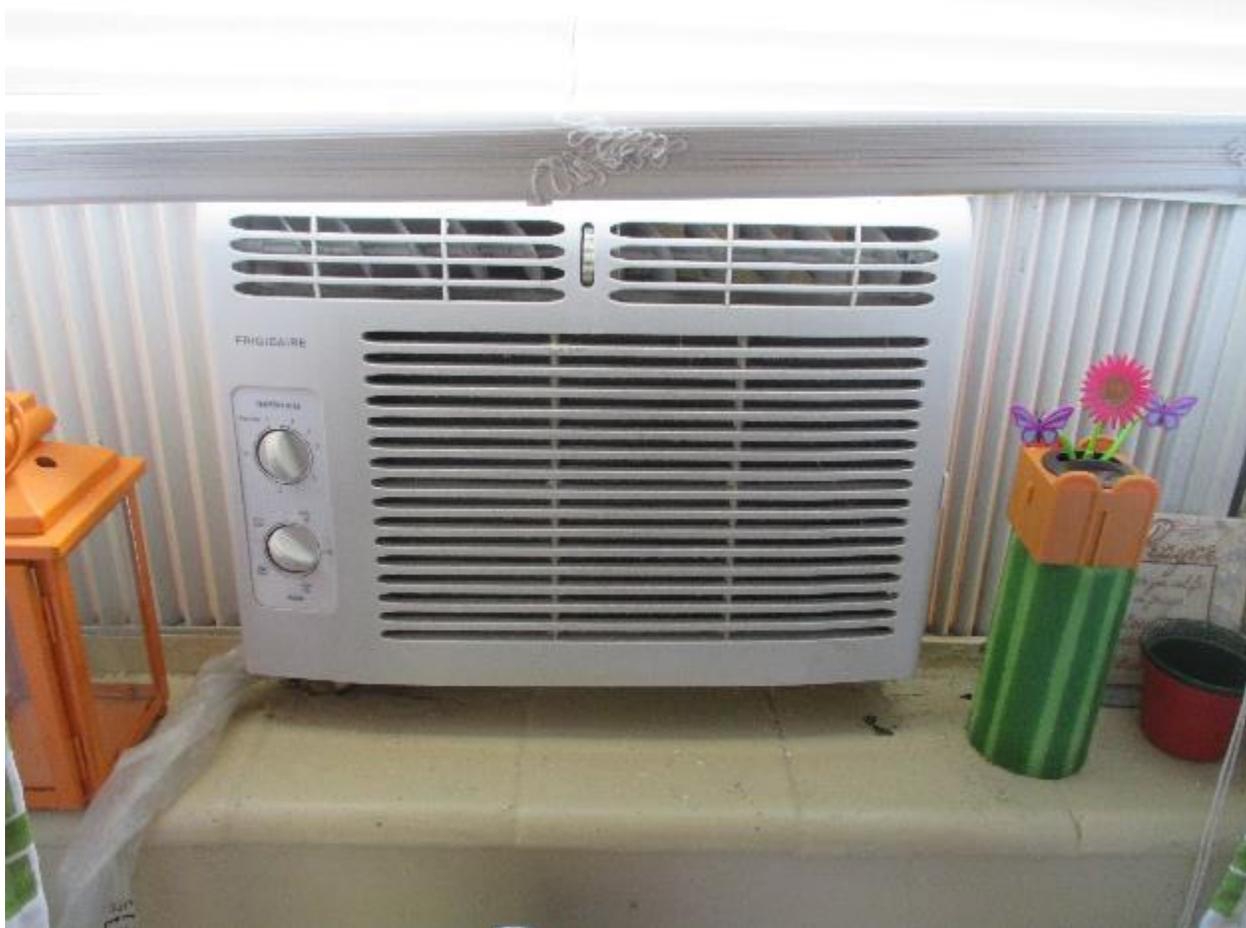
Ac in good working condition at the time of inspection.

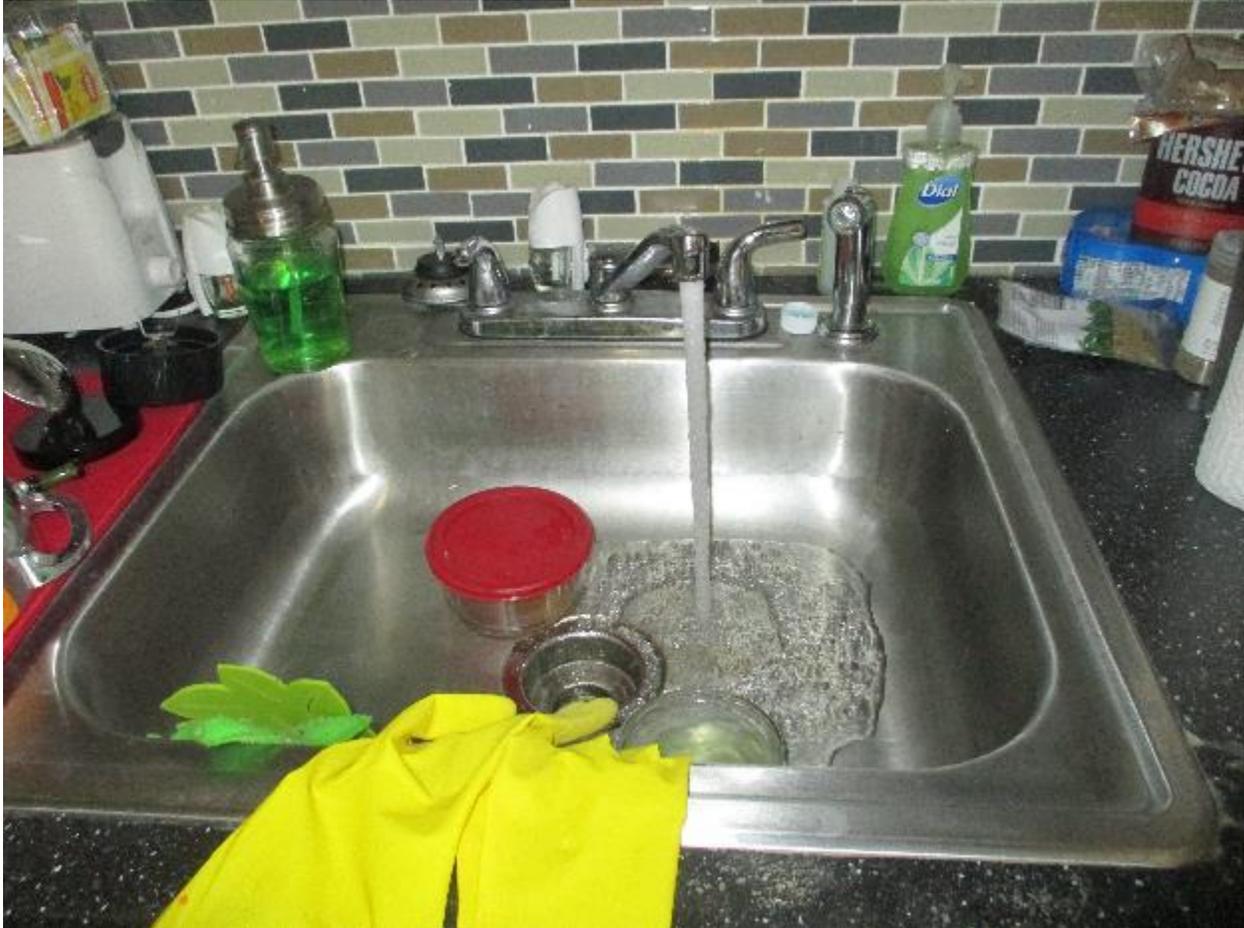
Plumbing systems tested for proper flow. No leaks or deficiencies noted on drain and supply lines.

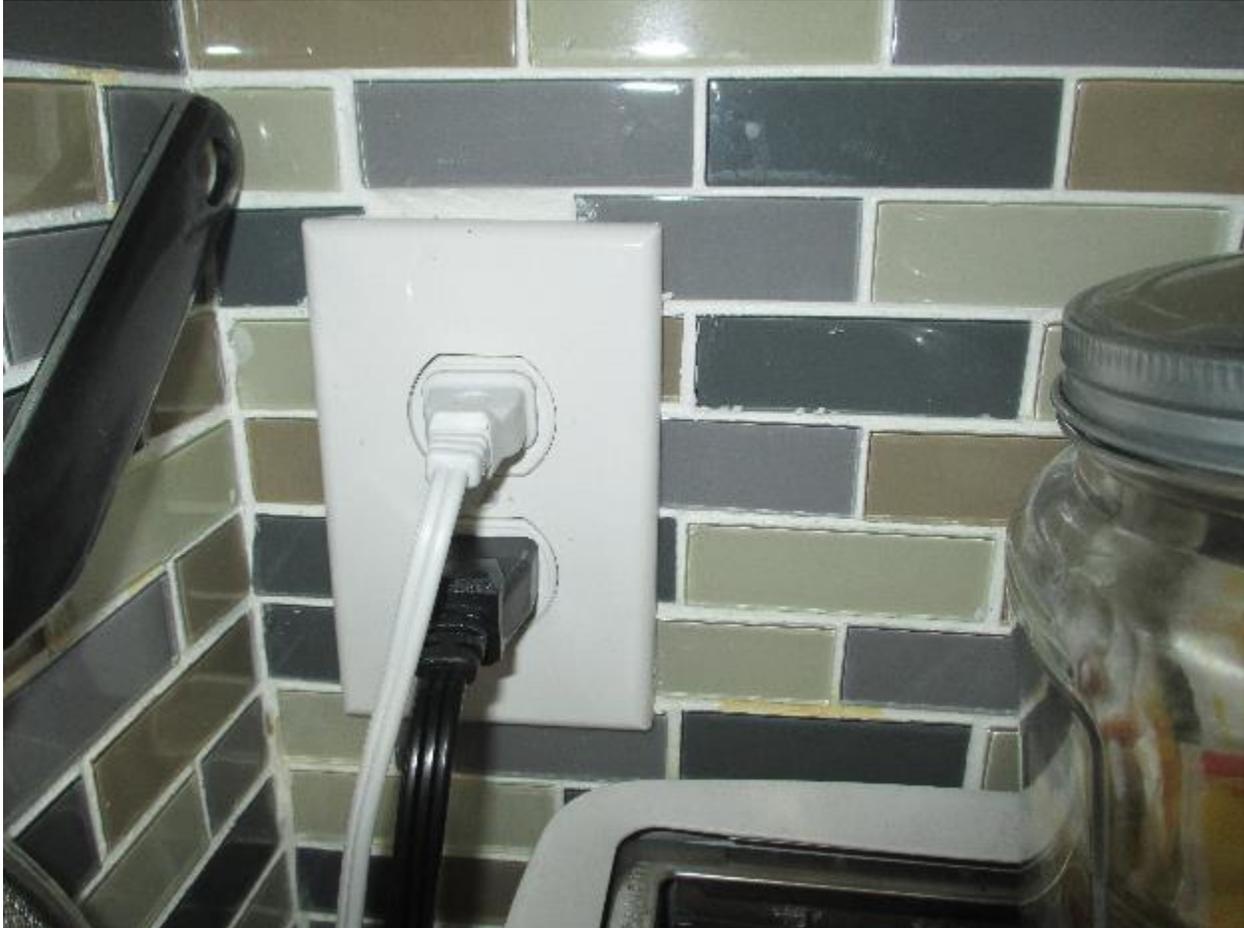
GFCI receptacles installation is required at wet areas such as bathrooms and kitchens.

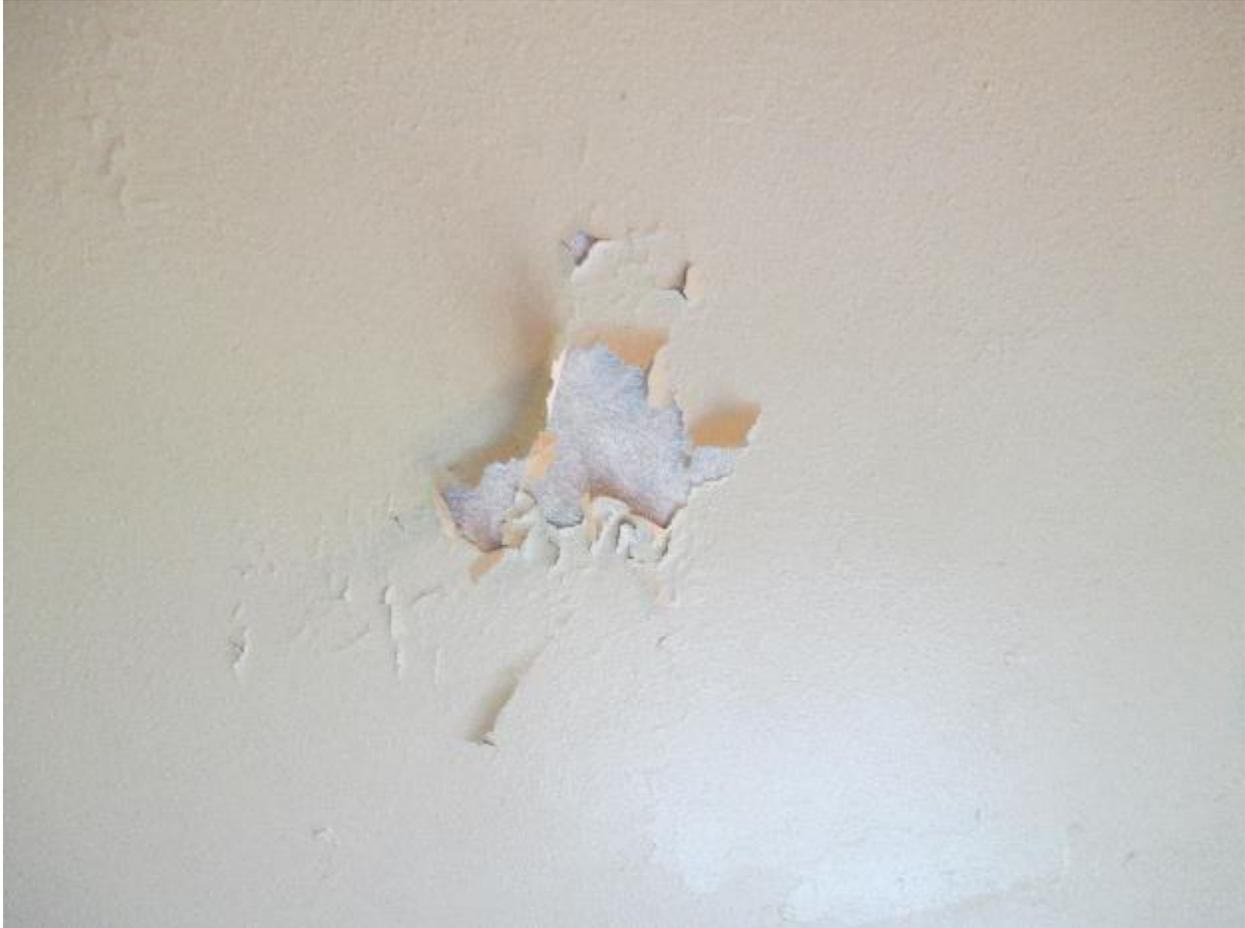
Signs of water infiltration due to roof failure noticed at the habitable space ceiling; allowances must be made for roofing and ceiling repair.

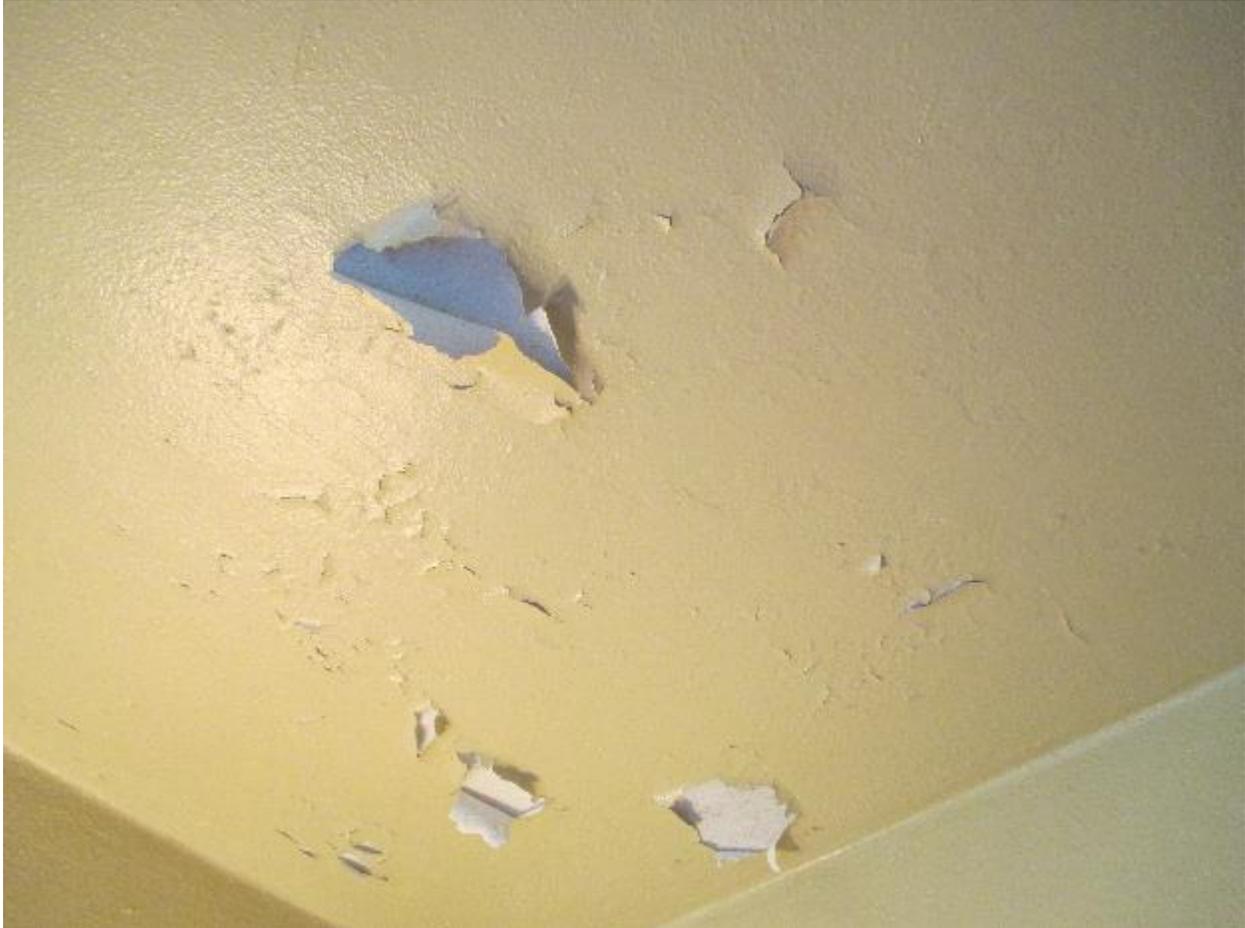
Signs of water infiltration due to roof failure noticed at the habitable space ceiling; allowances must be made for roofing and ceiling repair.

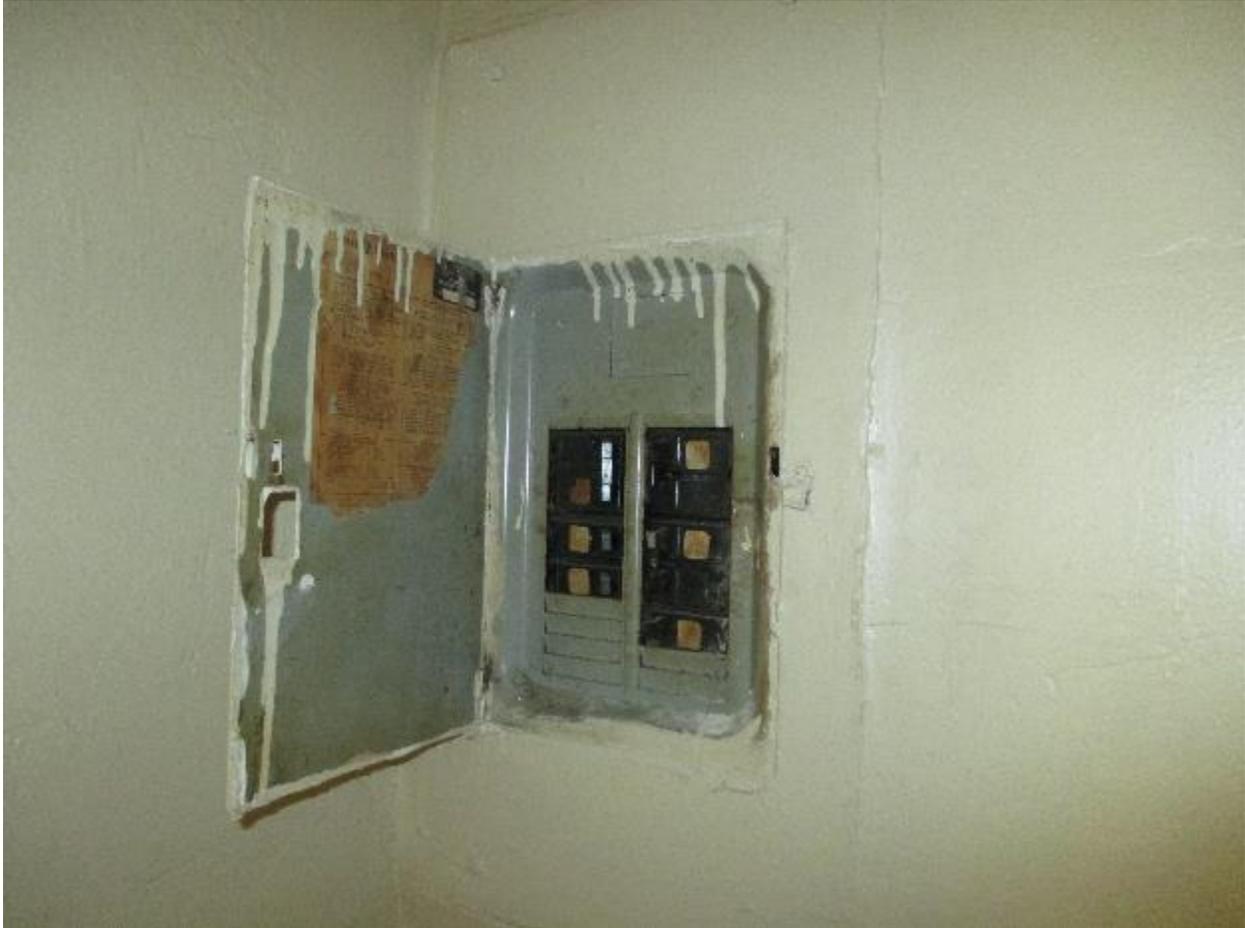
A complete upgrade of the electrical system is recommended including and not limited to GFCI's, smoke detectors, replace outlets and switches and make allowances for replacement of interior and exterior light fixtures. Beware that additional grounding will be required inside the property.

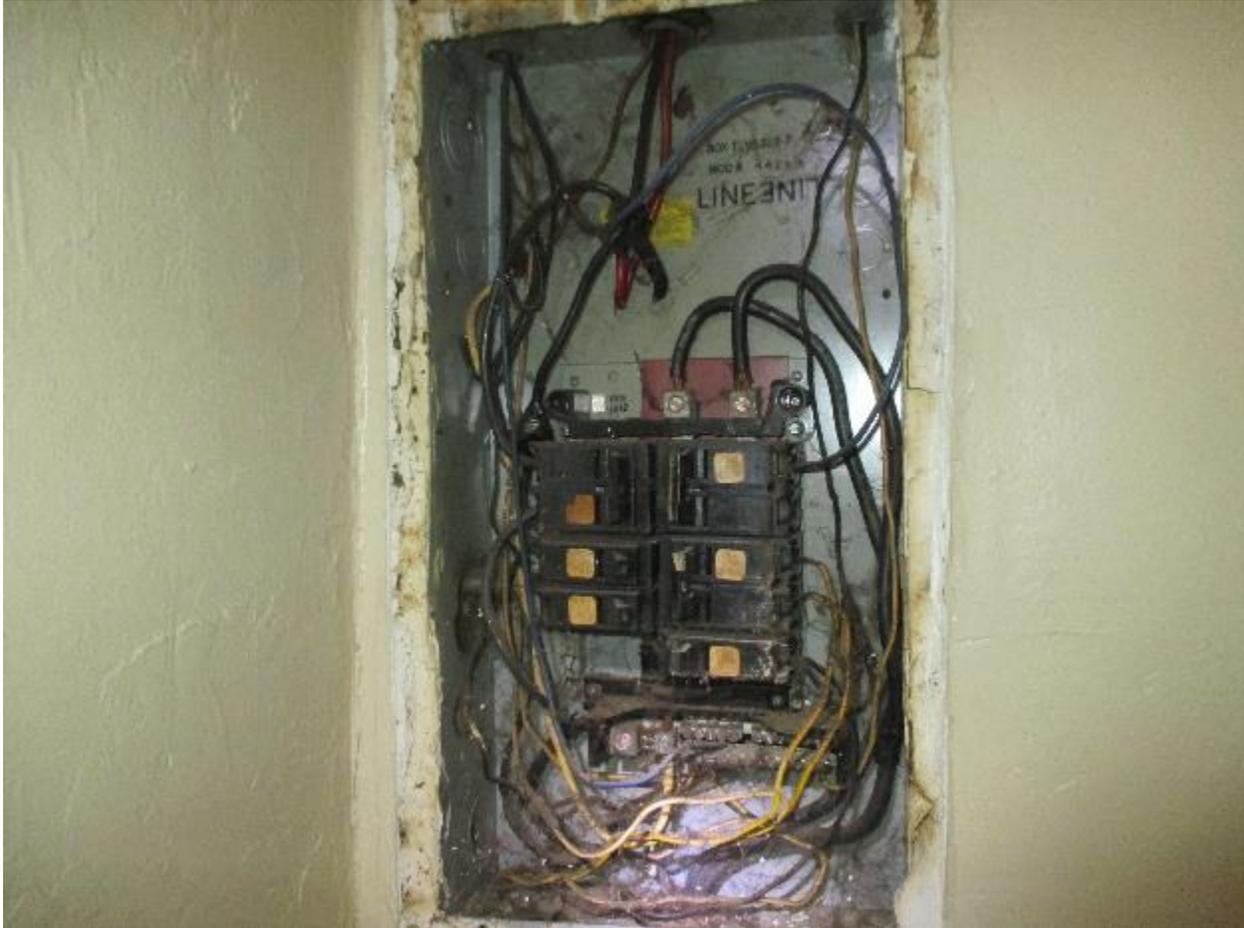
A complete upgrade of the electrical system is recommended including and not limited to GFCI's, smoke detectors, replace outlets and switches and make allowances for replacement of interior and exterior light fixtures. Beware that additional grounding will be required inside the property.

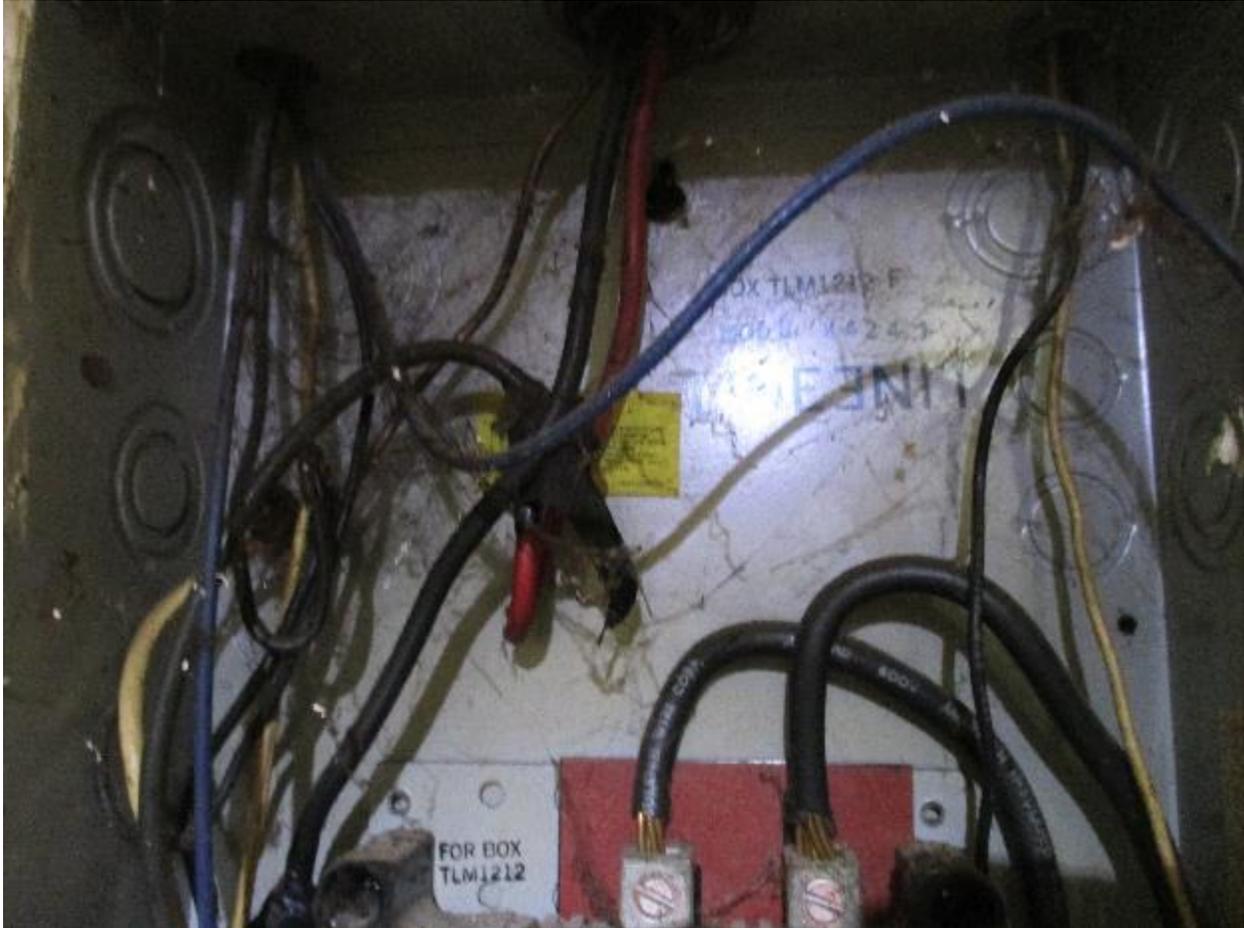
A complete upgrade of the electrical system is recommended including and not limited to GFCI's, smoke detectors, replace outlets and switches and make allowances for replacement of interior and exterior light fixtures. Beware that additional grounding will be required inside the property.

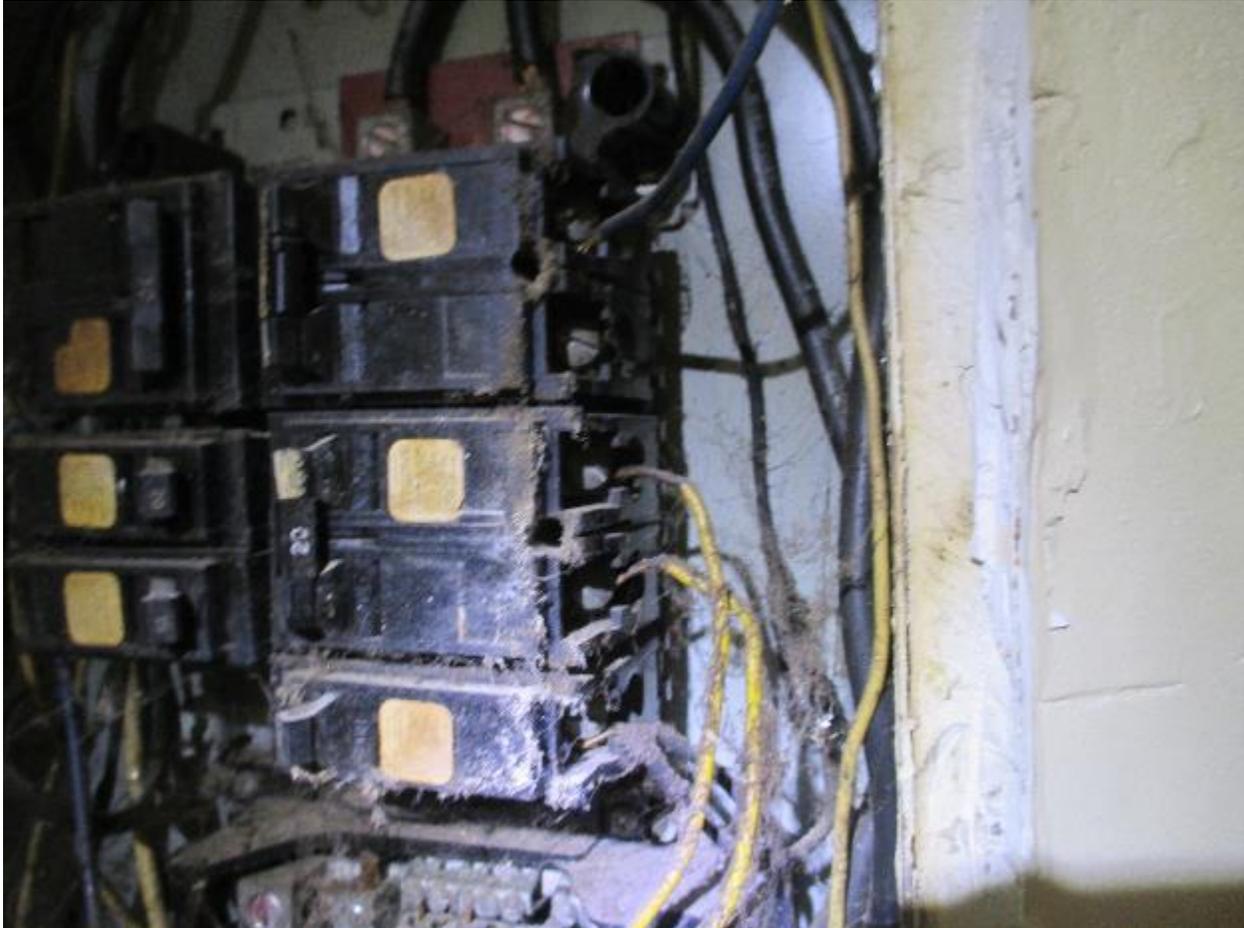
A complete upgrade of the electrical system is recommended including and not limited to GFCI's, smoke detectors, replace outlets and switches and make allowances for replacement of interior and exterior light fixtures. Beware that additional grounding will be required inside the property.

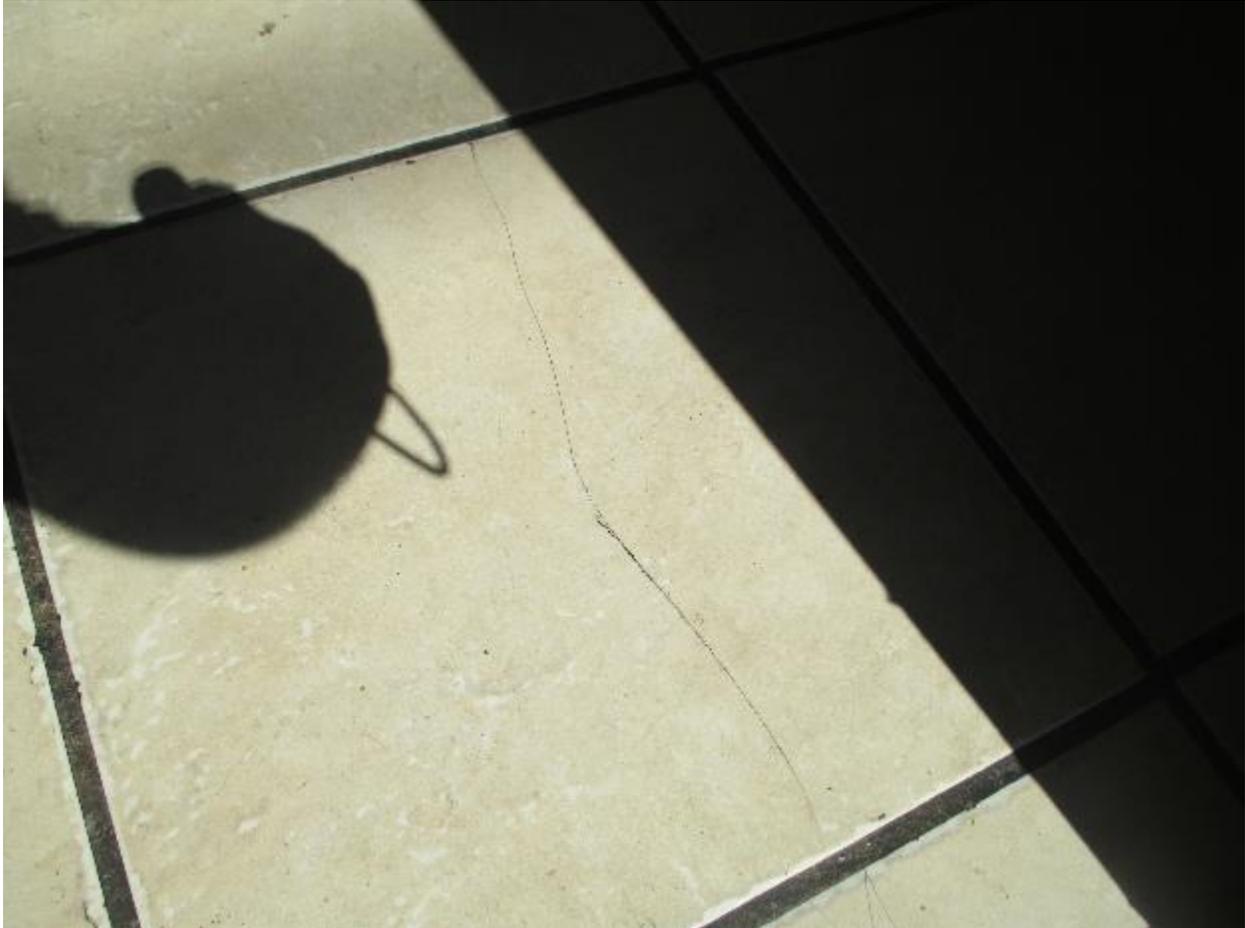
Cracked tiles without possibilities of repair. Complete removal of flooring surfaces must be done in order to provide a finished appearance.

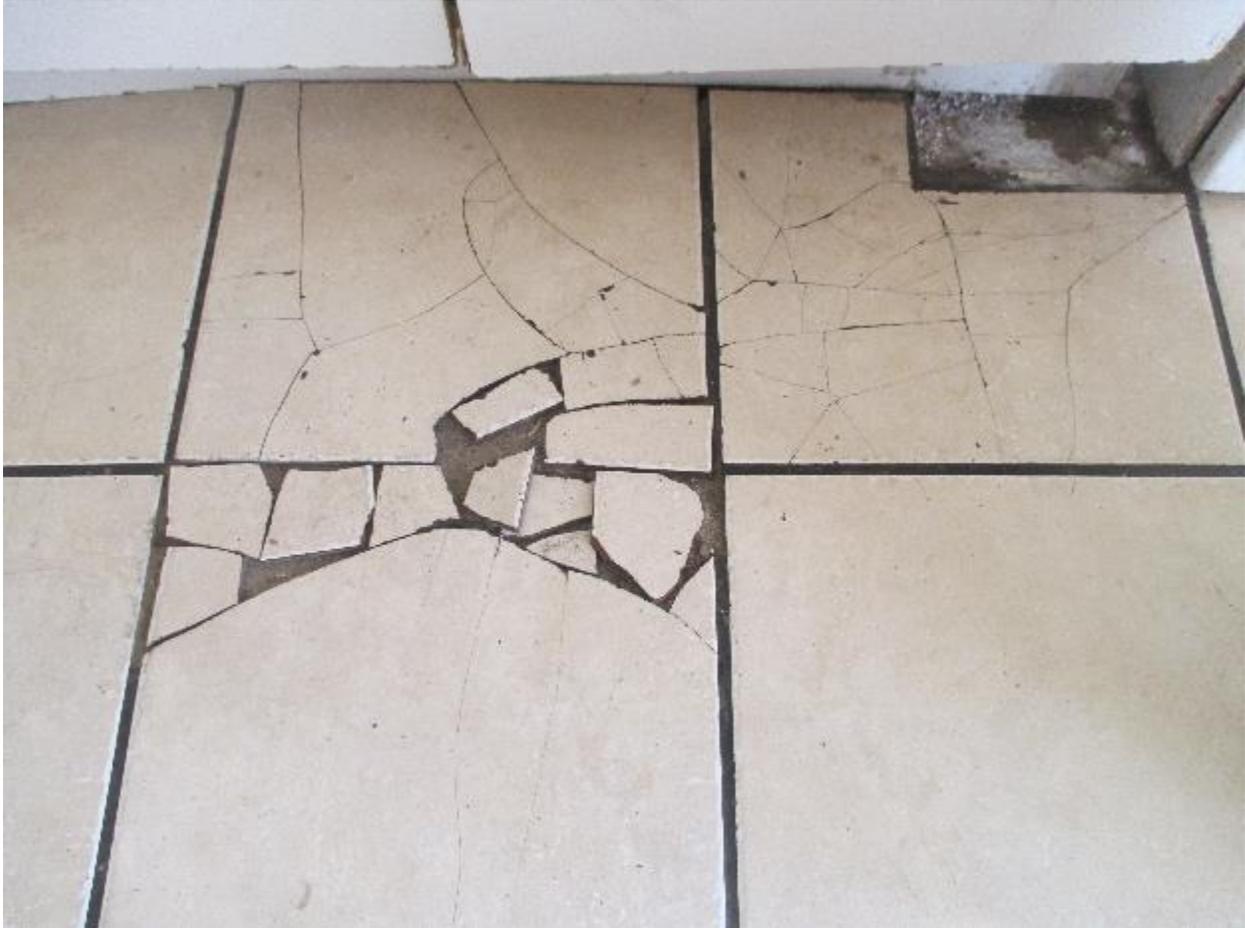
Cracked tiles without possibilities of repair. Complete removal of flooring surfaces must be done in order to provide a finished appearance.

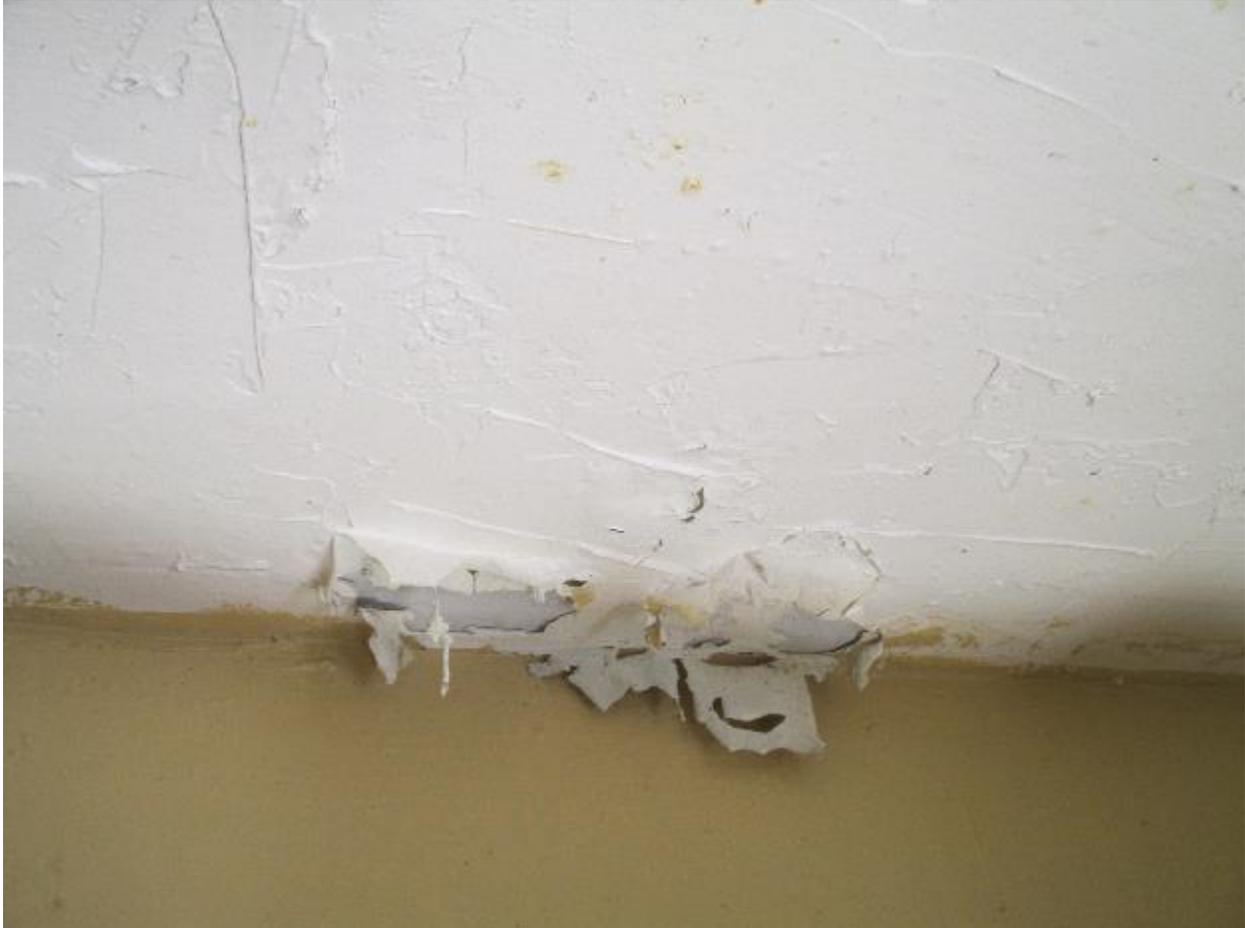
Signs of water infiltration due to roof failure noticed at the habitable space ceiling; allowances must be made for roofing and ceiling repair.

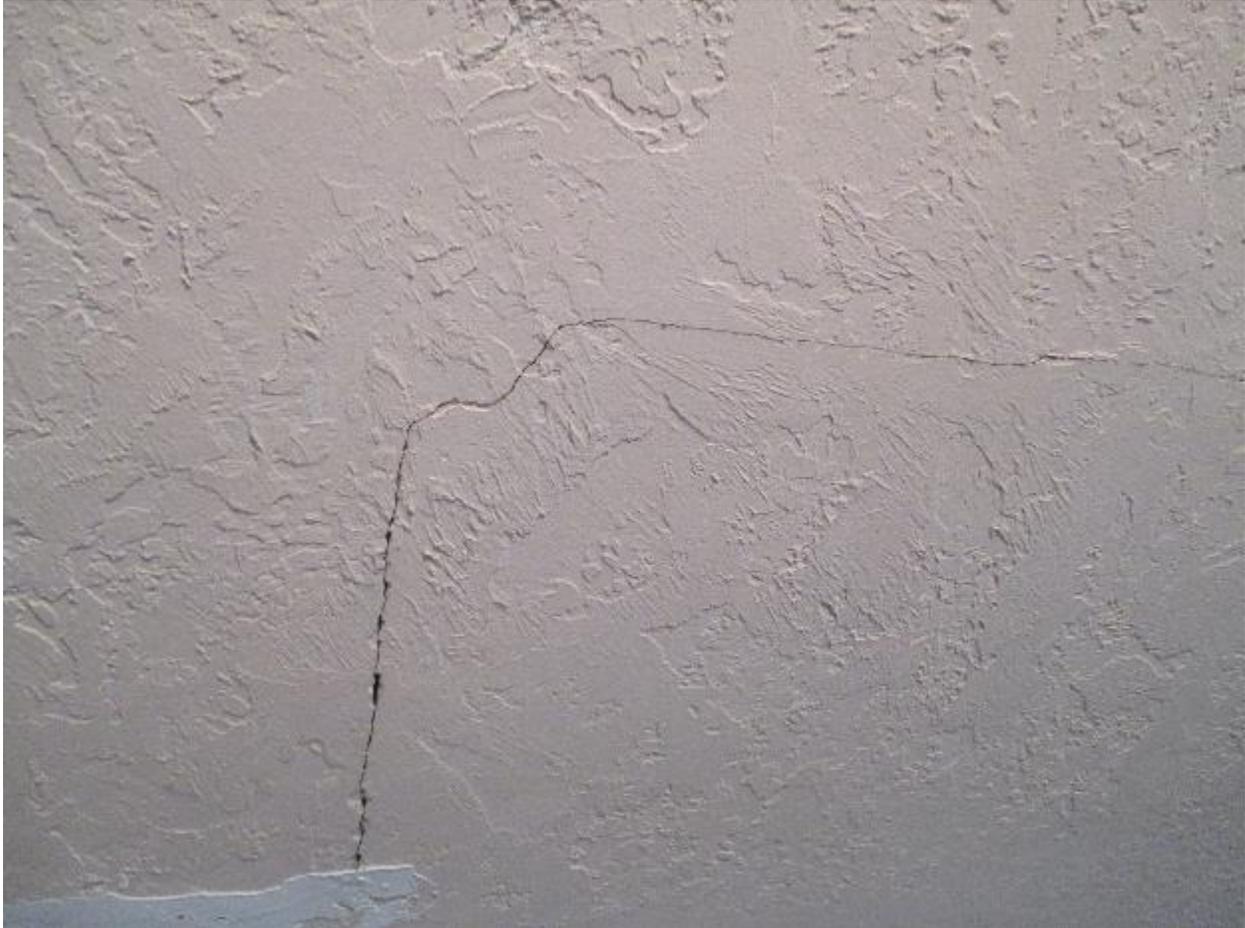
Cracks on ceiling not of structural importance but repairs related to drywall must be performed to secure the loose material.

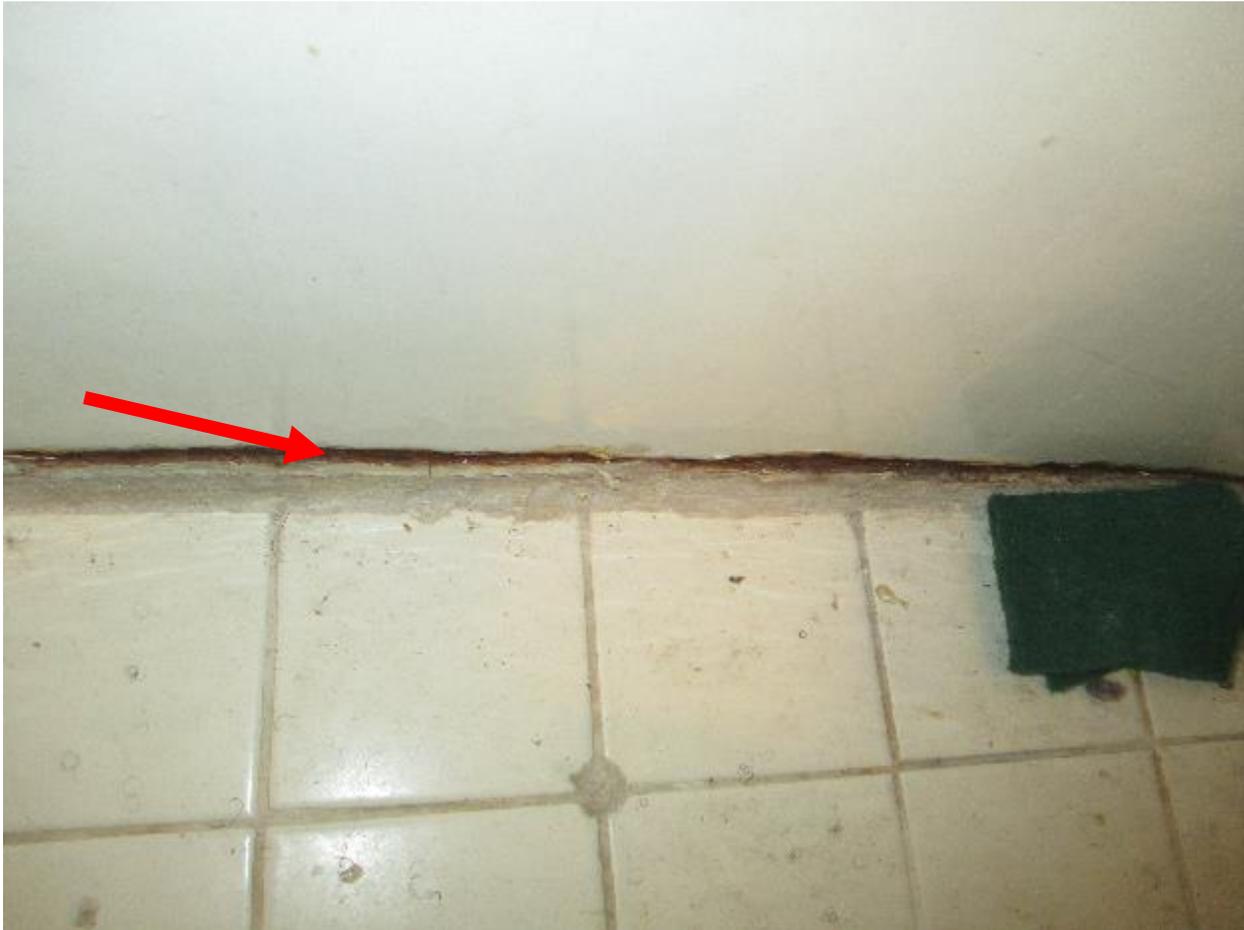
(Rusted bathtub requires replacement).

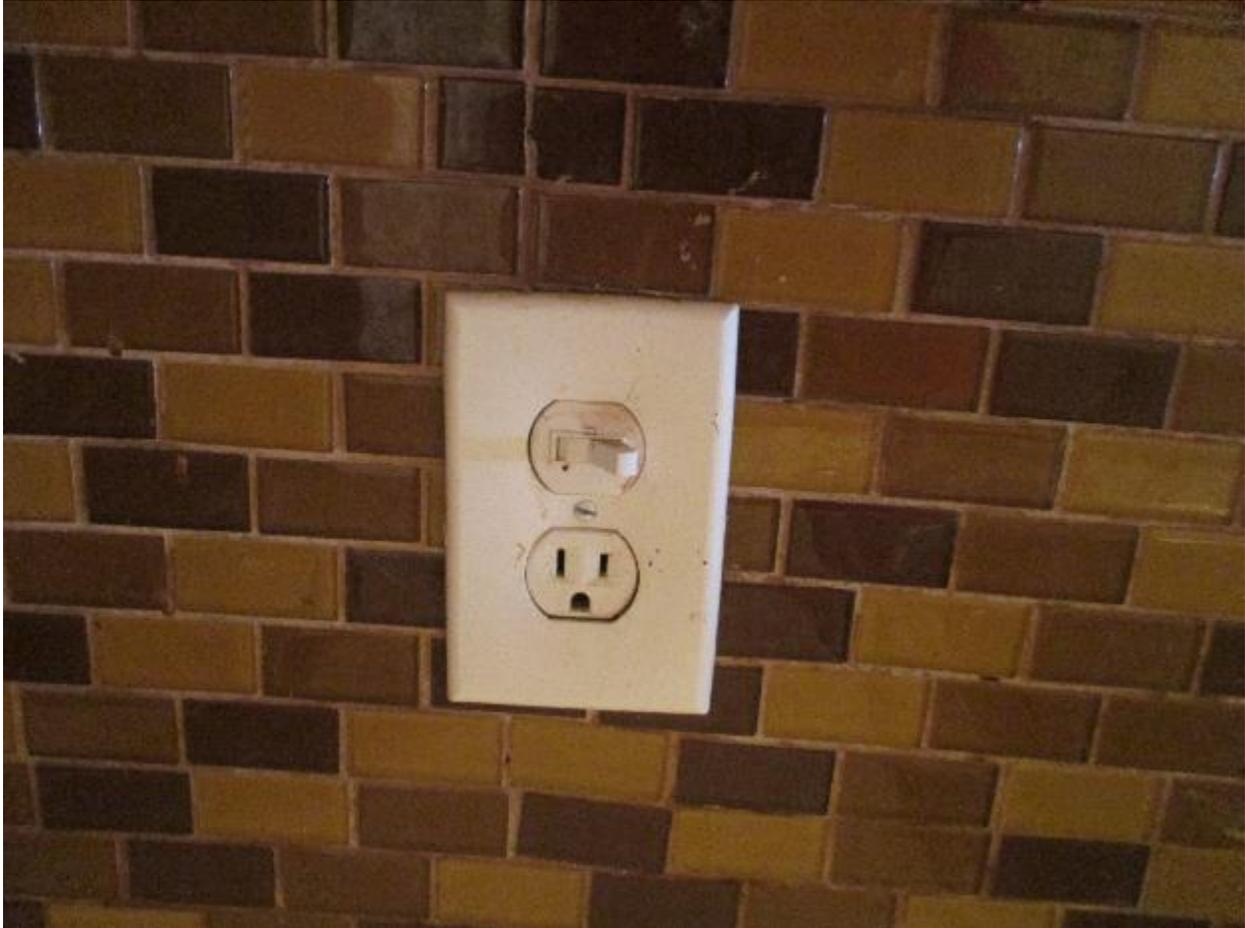
GFCI receptacles installation is required at wet areas such as bathrooms and kitchens.

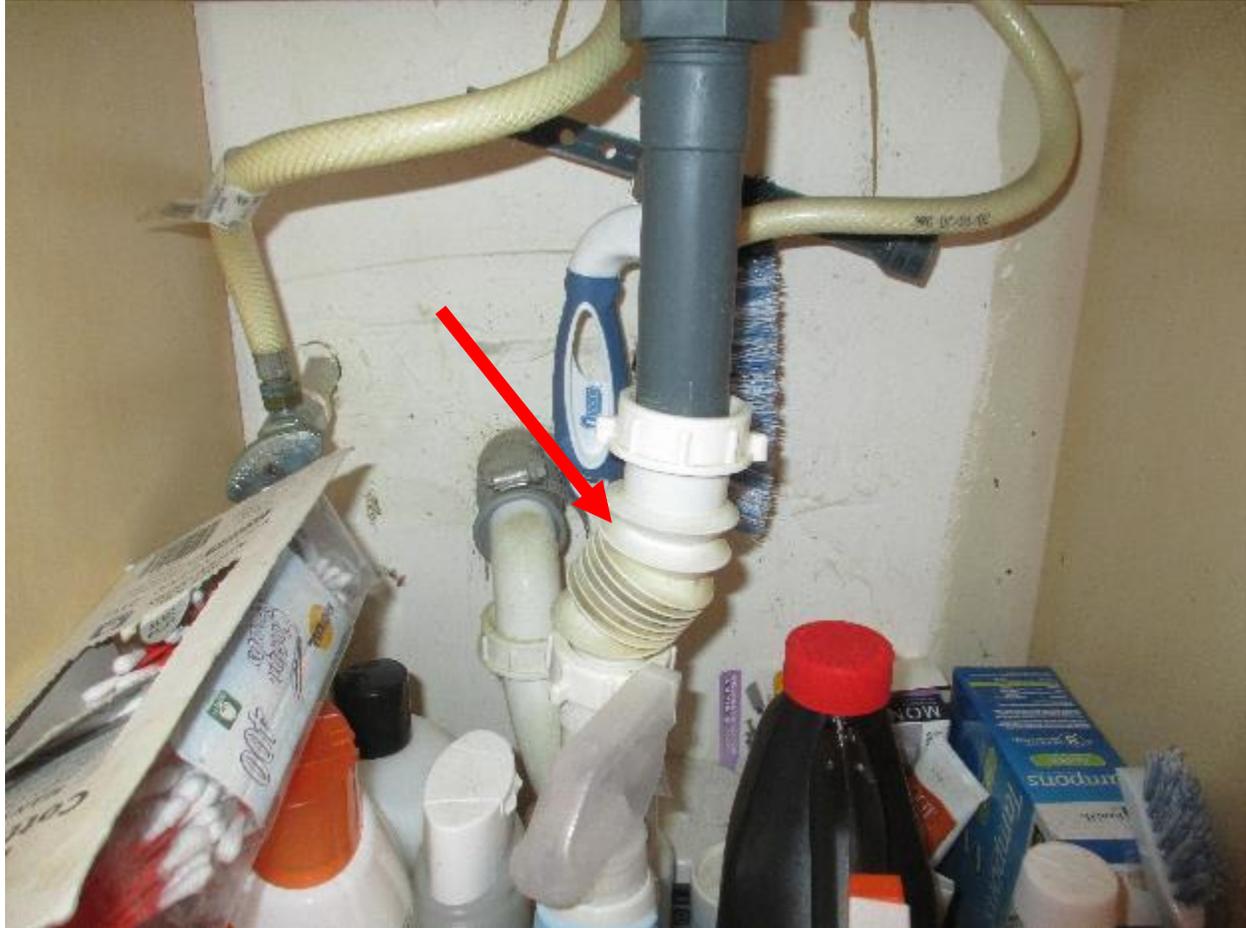
Flexible plumbing system to be replaced, not recommended for insurance purposes. Flexible systems are prone to failure.

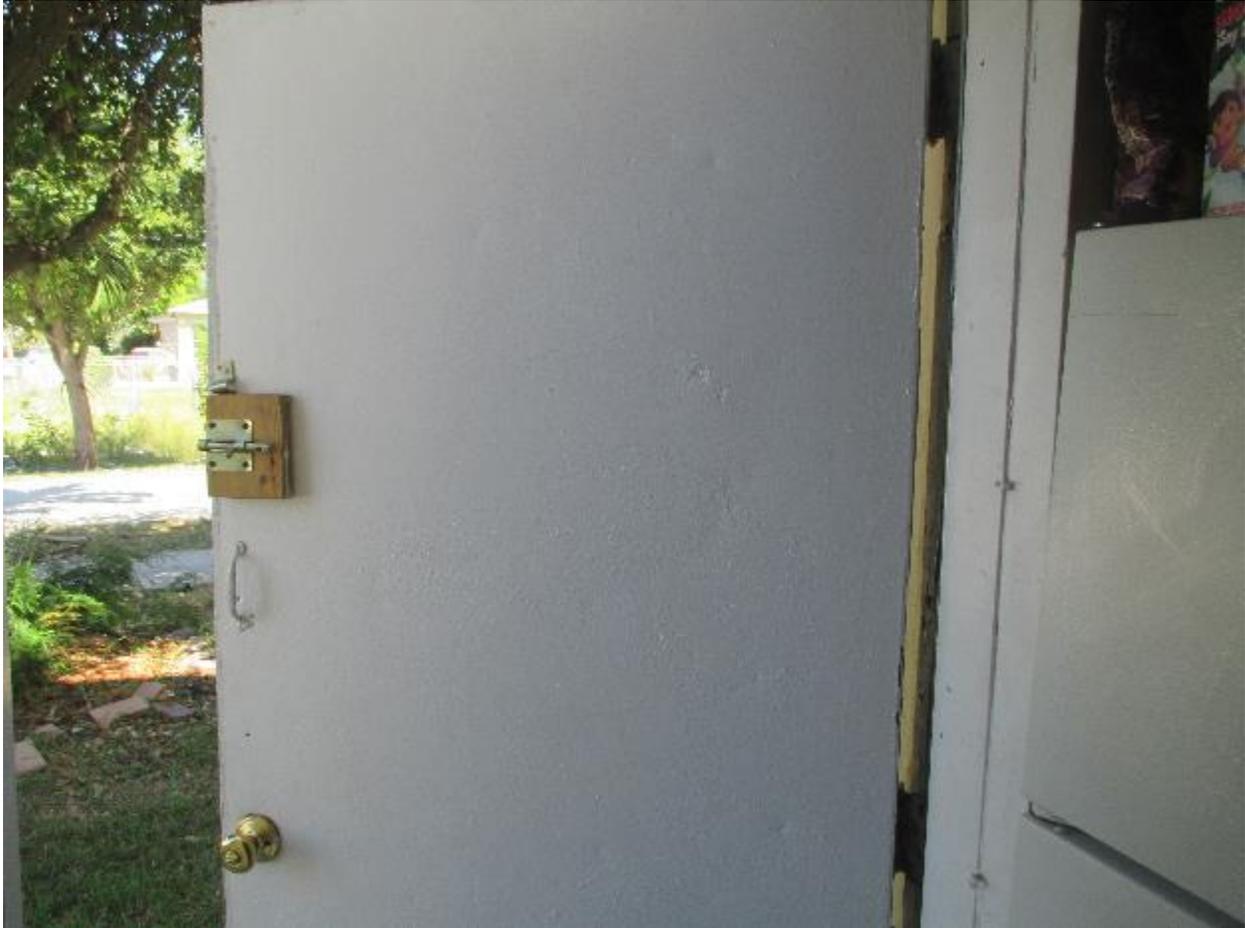
Exterior door(s) require replacement. Currently beyond possibilities of repair.
