PROPERTY INSPECTION OR ASSESSMENT OF DAMAGES

ADDRESS: **SOMEWHERE , FL**
CLIENT: **GAIA GC**
ID No: **2015000**
DATE: **12/31/xxxx**

GAIA CONSTRUCTION INC.
CGC 1516136 FLORIDA
HI-2792 FLORIDA
8028867-B2 INTERNATIONAL CODE COUNCIL

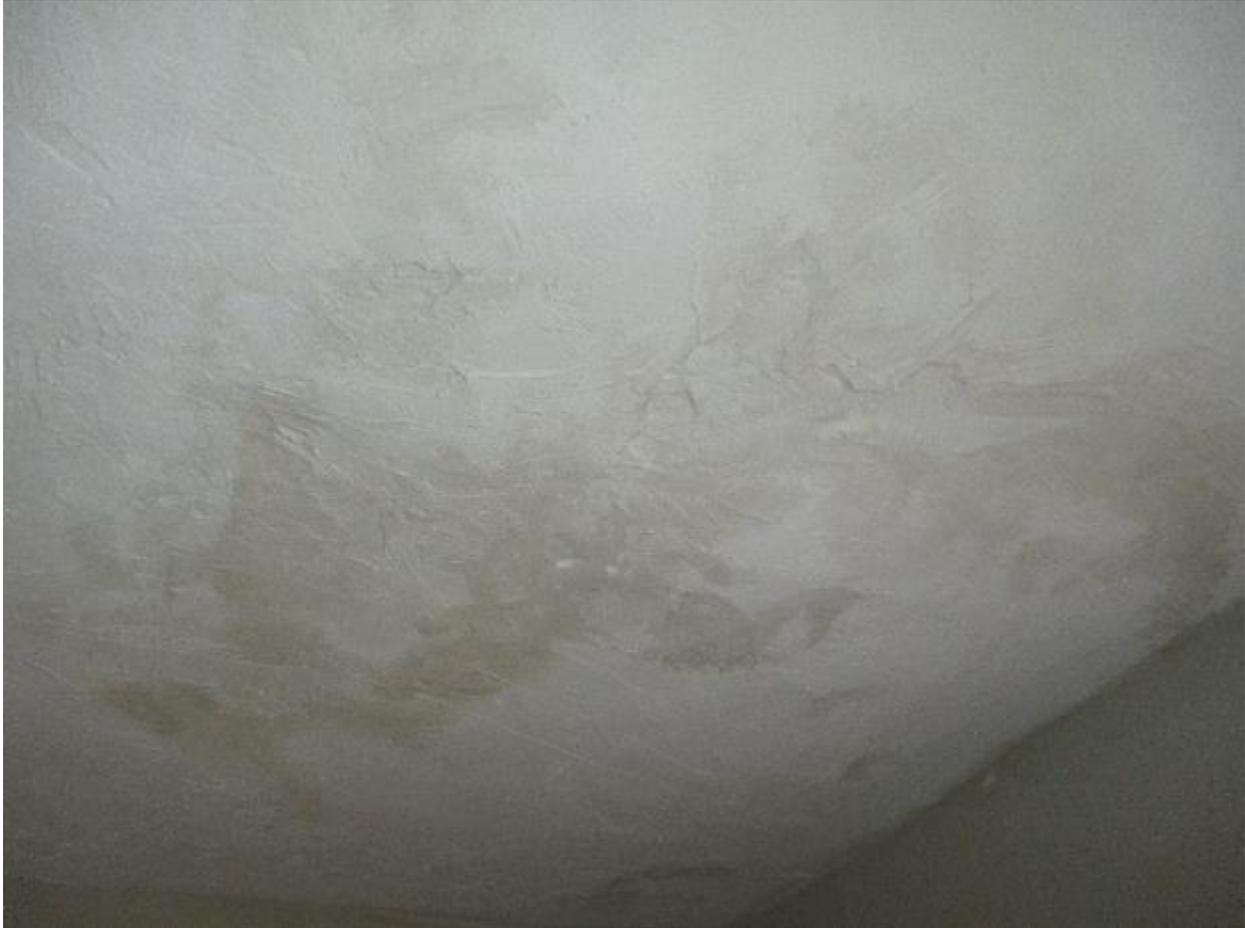
Water damage related to possible plumbing leak in above unit noted.
Allowances must be made for interior repairs.

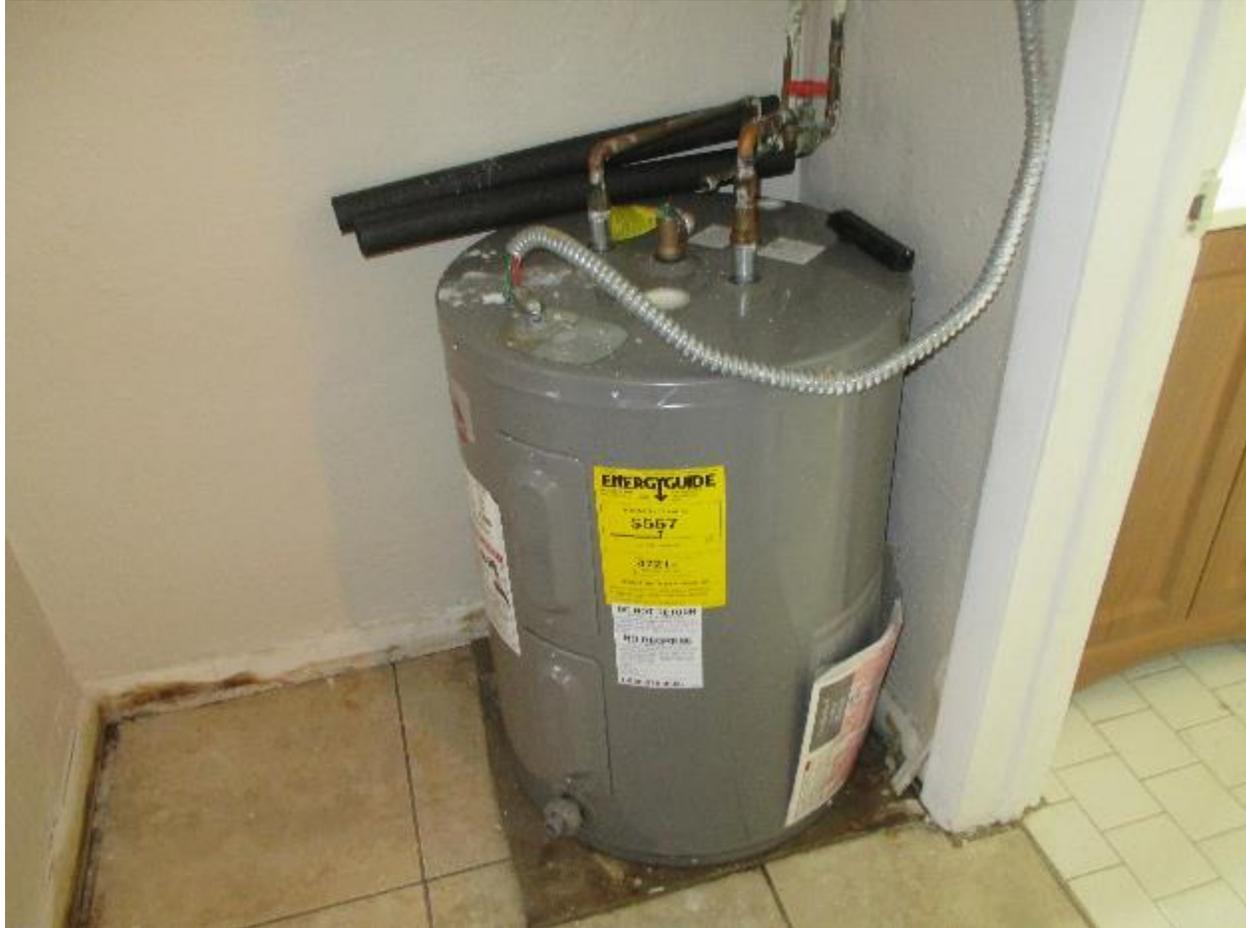
Water heater pressure release valve without release valve / not properly installed.

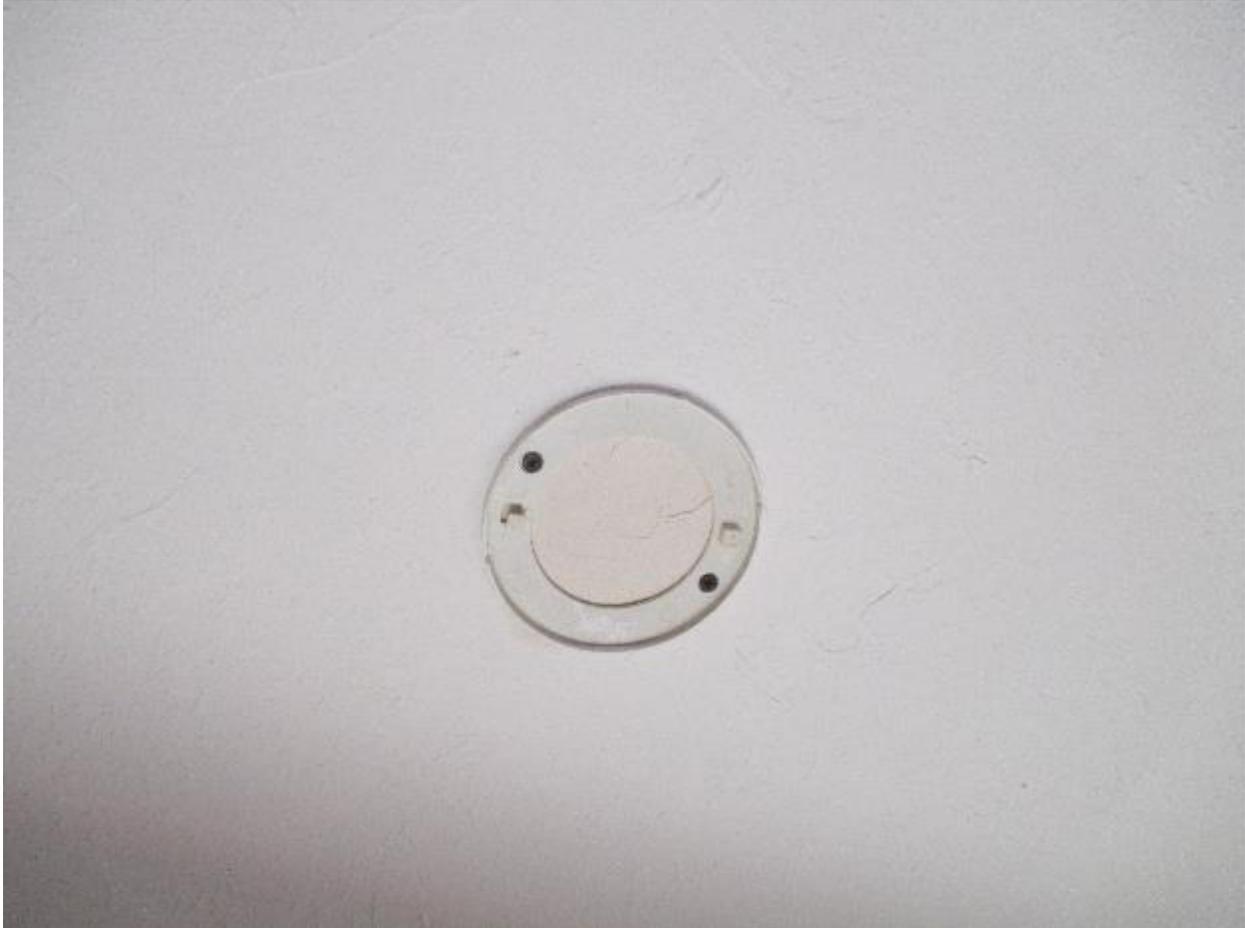
Missing smoke detector.

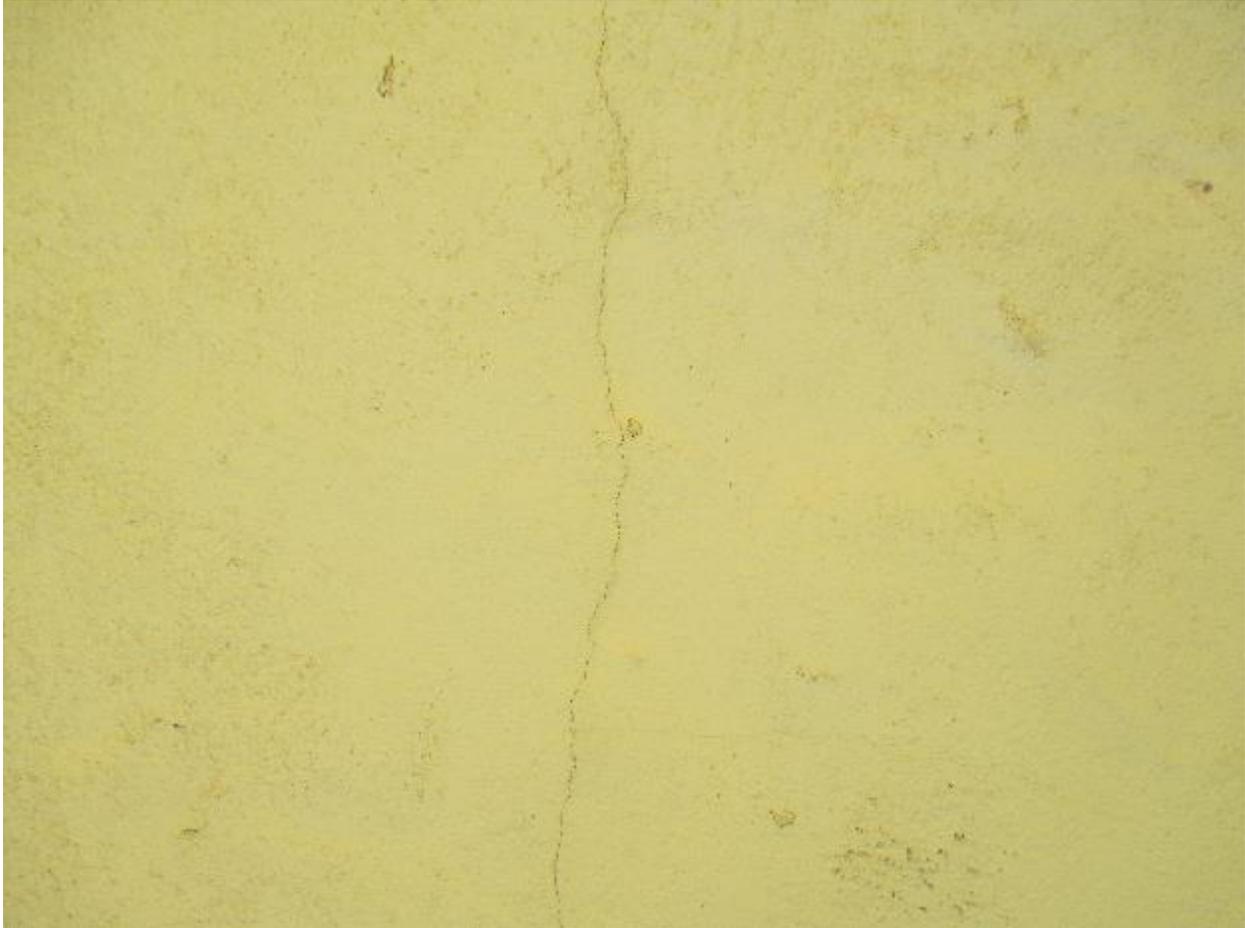
Cracks on vertical planes due to foundation settlement indicating downward and lateral movement. These types of cracks do compromise the ability of the building to function as designed and avoid water intrusion. Structural repair and proper waterproofing treatment are required to avoid further damage to the interior of the building and water infiltration.

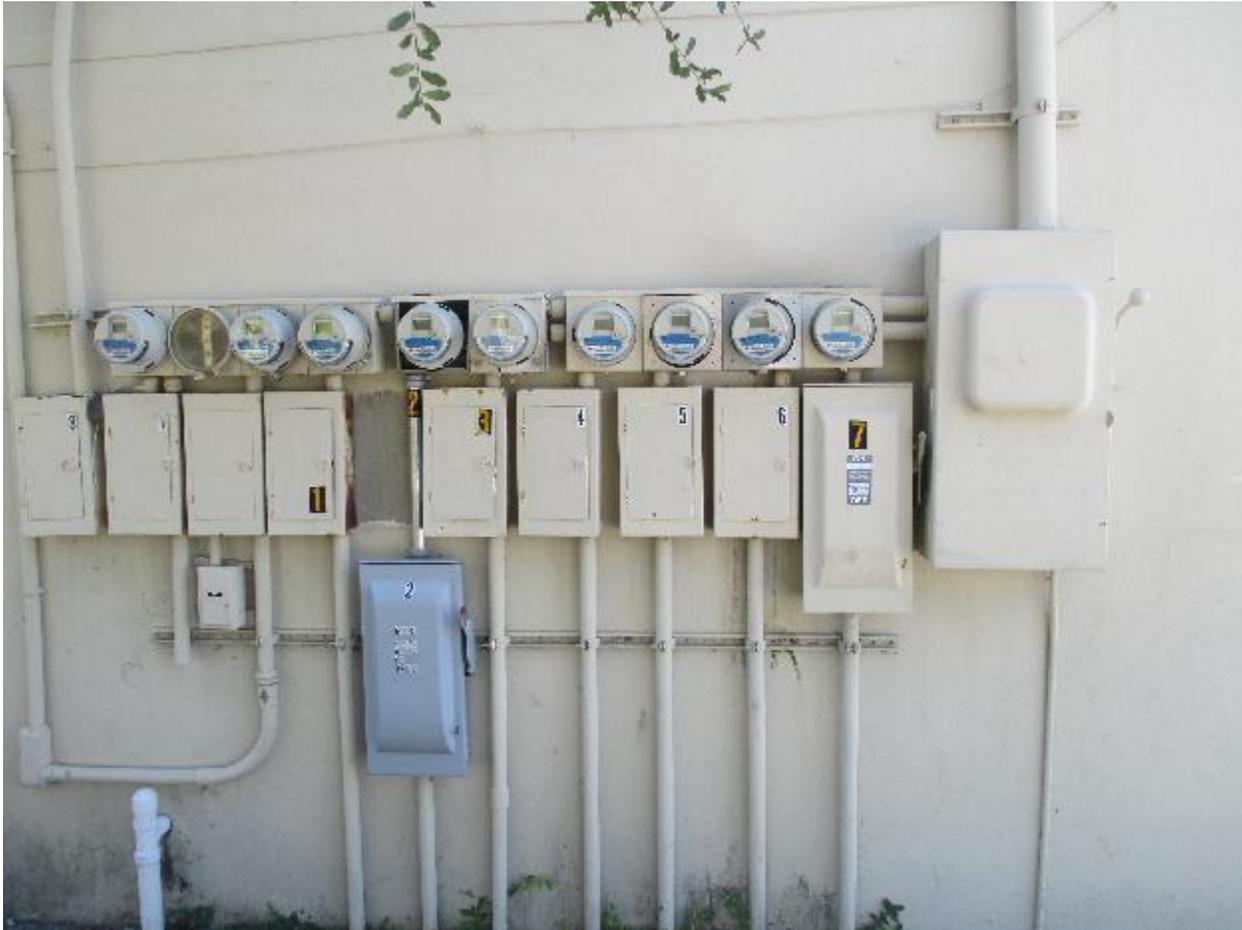
A complete upgrade of the electrical system is recommended including and not limited to GFCI's, smoke detectors, replace outlets and switches and make allowances for replacement of interior and exterior light fixtures. Beware that additional grounding will be required inside the property.

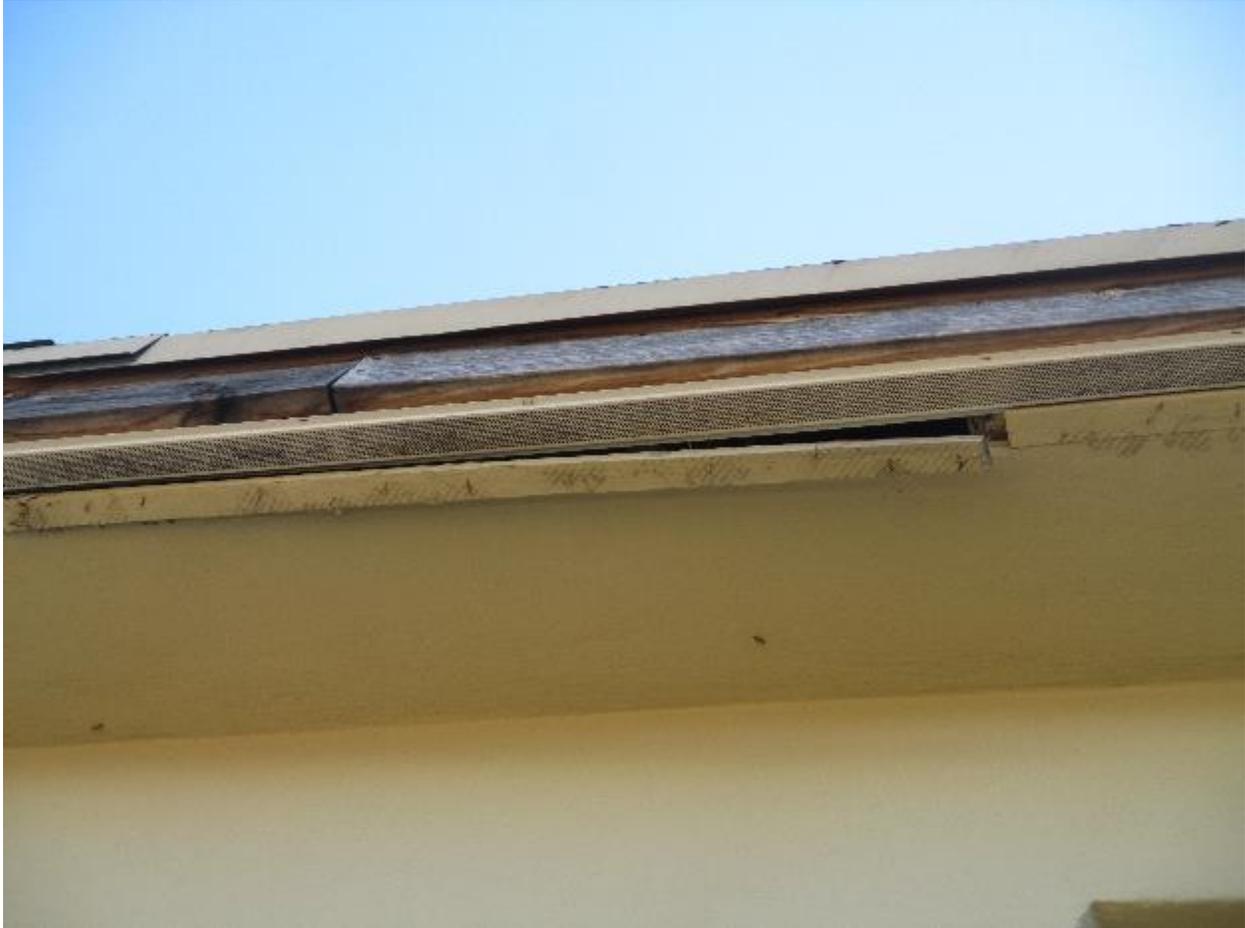
Fascia and soffit deteriorated wood requires replacement.

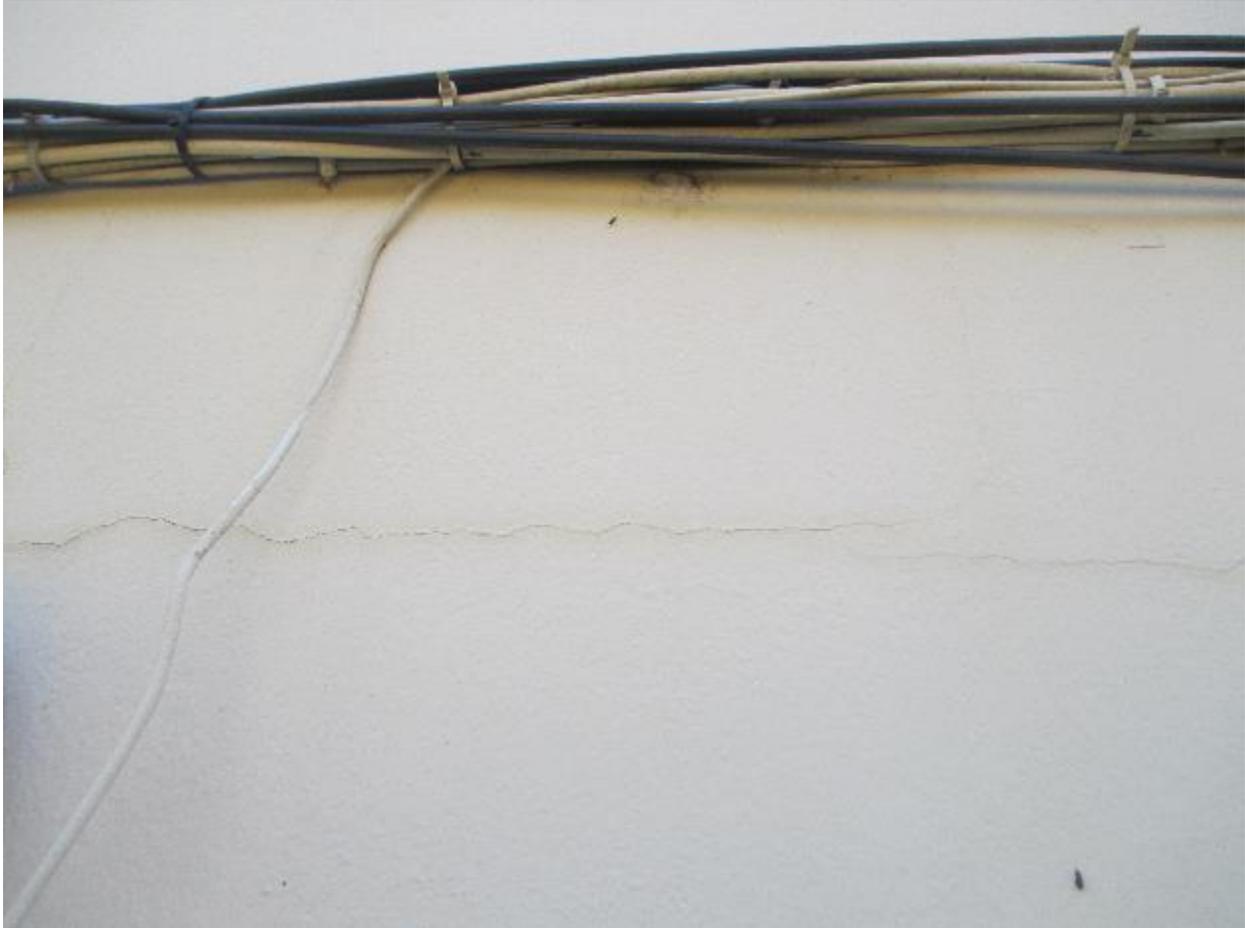
Cracks on vertical planes due to foundation settlement indicating downward and lateral movement. These types of cracks do compromise the ability of the building to function as designed and avoid water intrusion. Structural repair and proper waterproofing treatment are required to avoid further damage to the interior of the building and water infiltration.

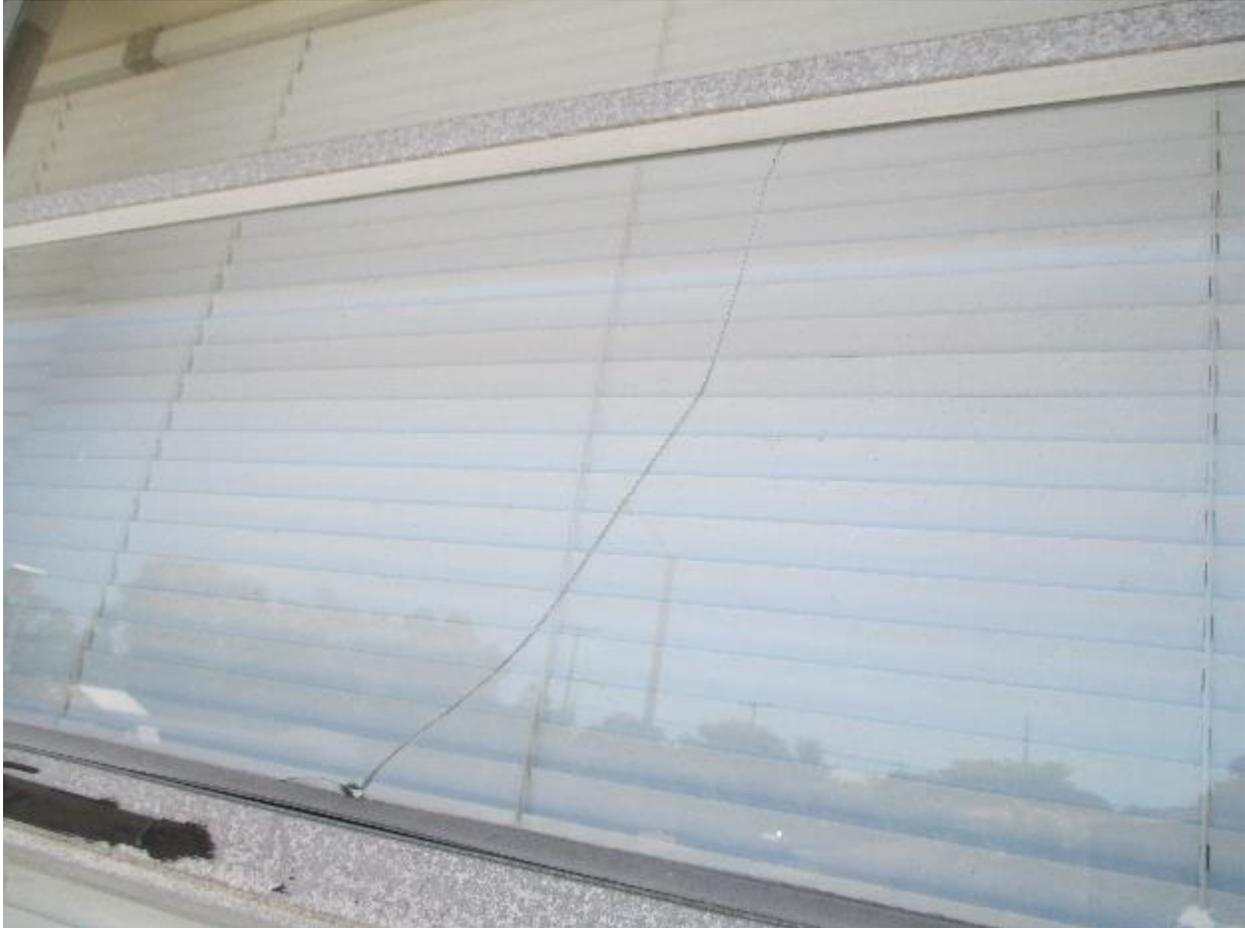
Broken glass.

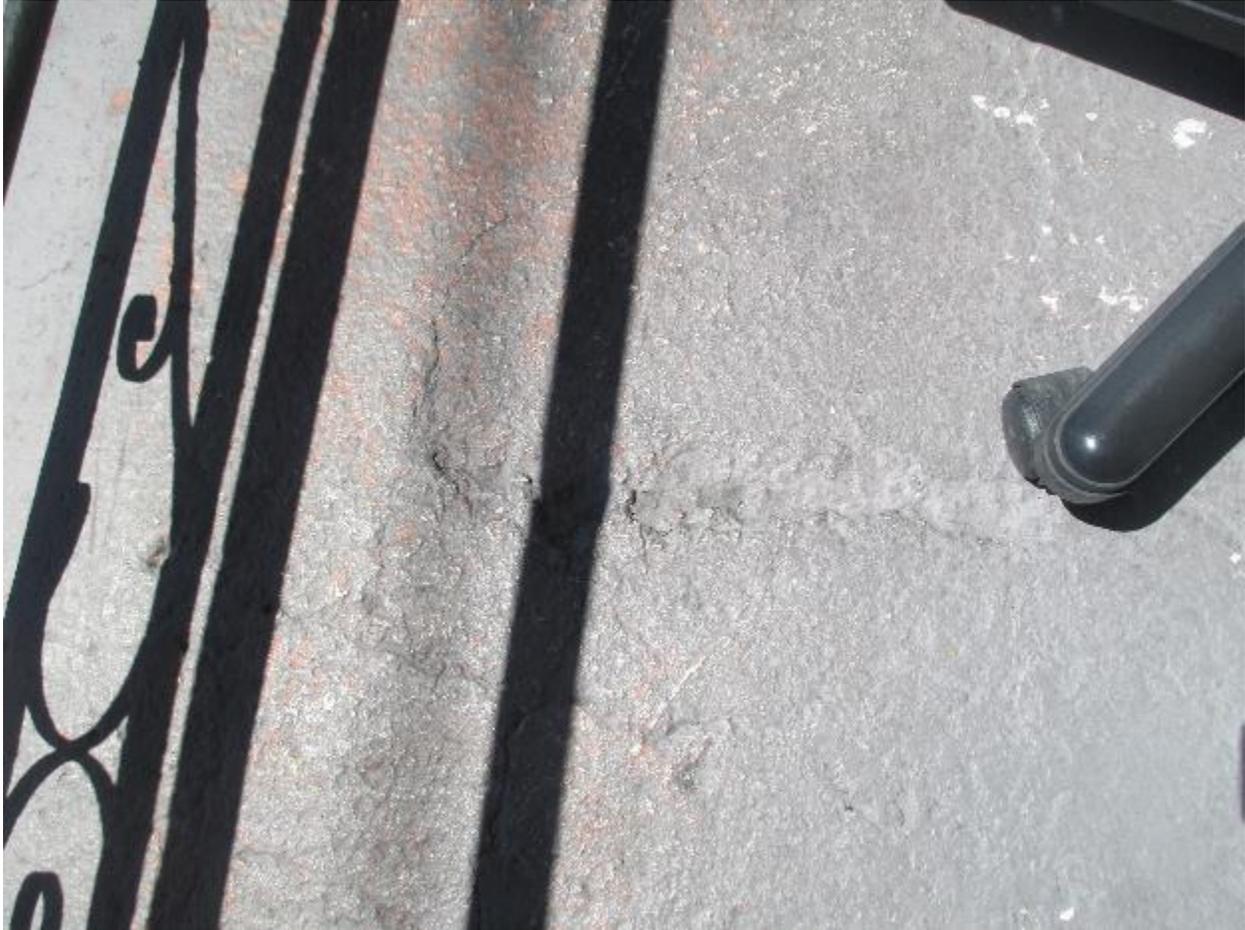
Cracks in slab.

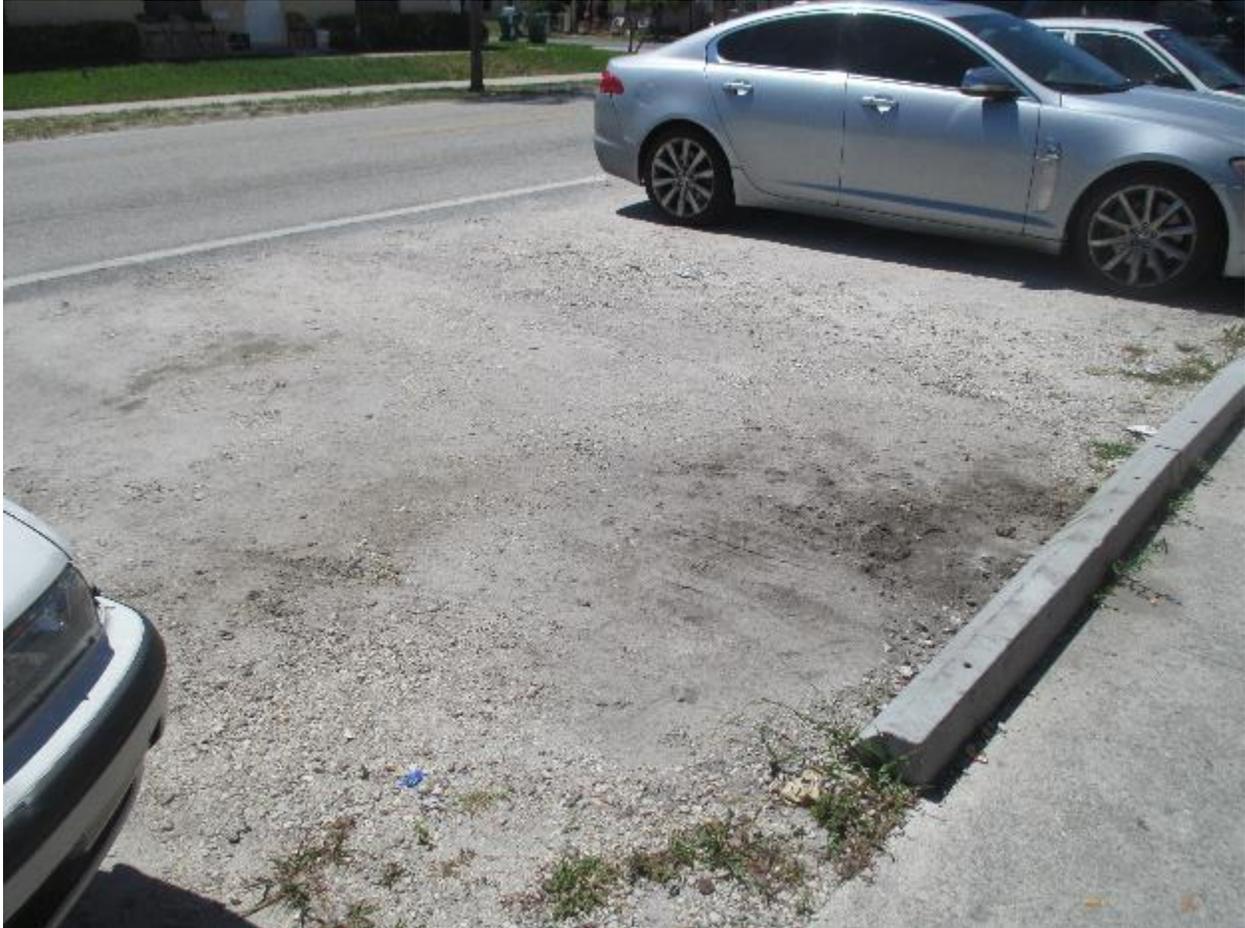
Missing driveway surface.

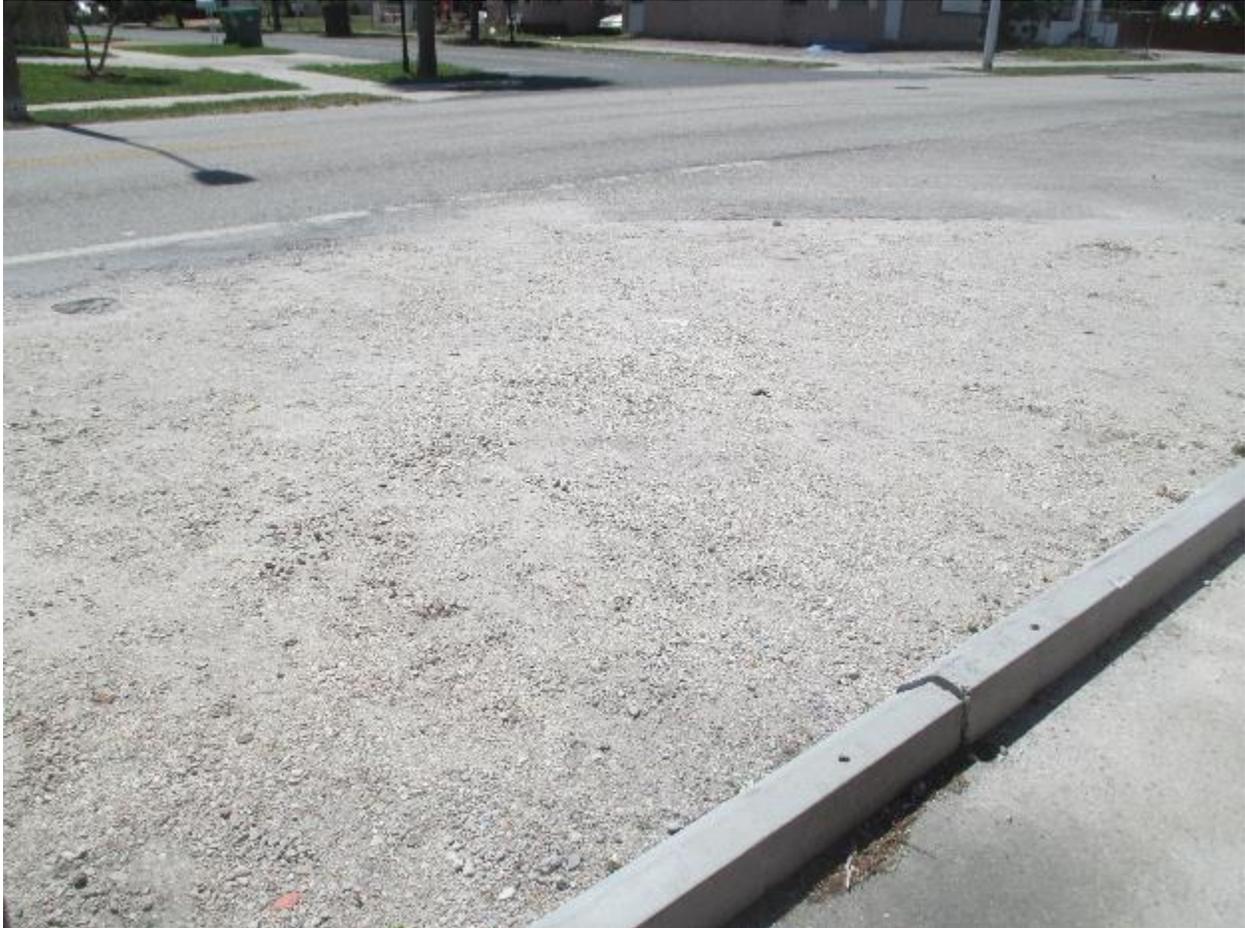
Missing driveway surface.
