PROPERTY INSPECTION OR ASSESSMENT OF DAMAGES

ADDRESS: Somewhere, FL
CLIENT: GAIA GC
ID No: 2015000
DATE: 12/31/2015

INSPECTION OR ASSESSMENT BY:

GAIA CONSTRUCTION INC.
CGC 1516136 **FLORIDA**
HI-2792 **FLORIDA**
8028867-B2 **INTERNATIONAL CODE COUNCIL**

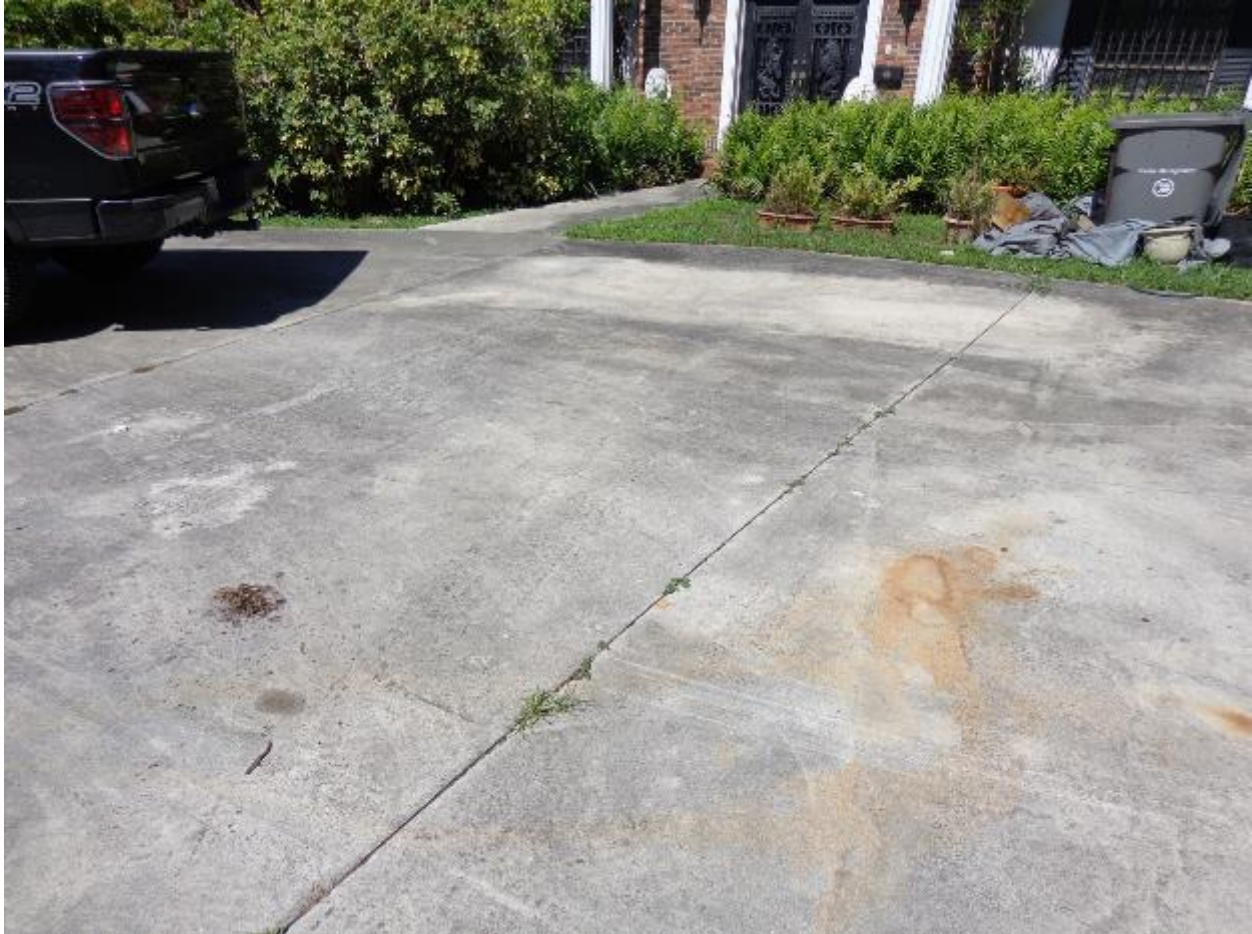
Driveway requires pressure wash.

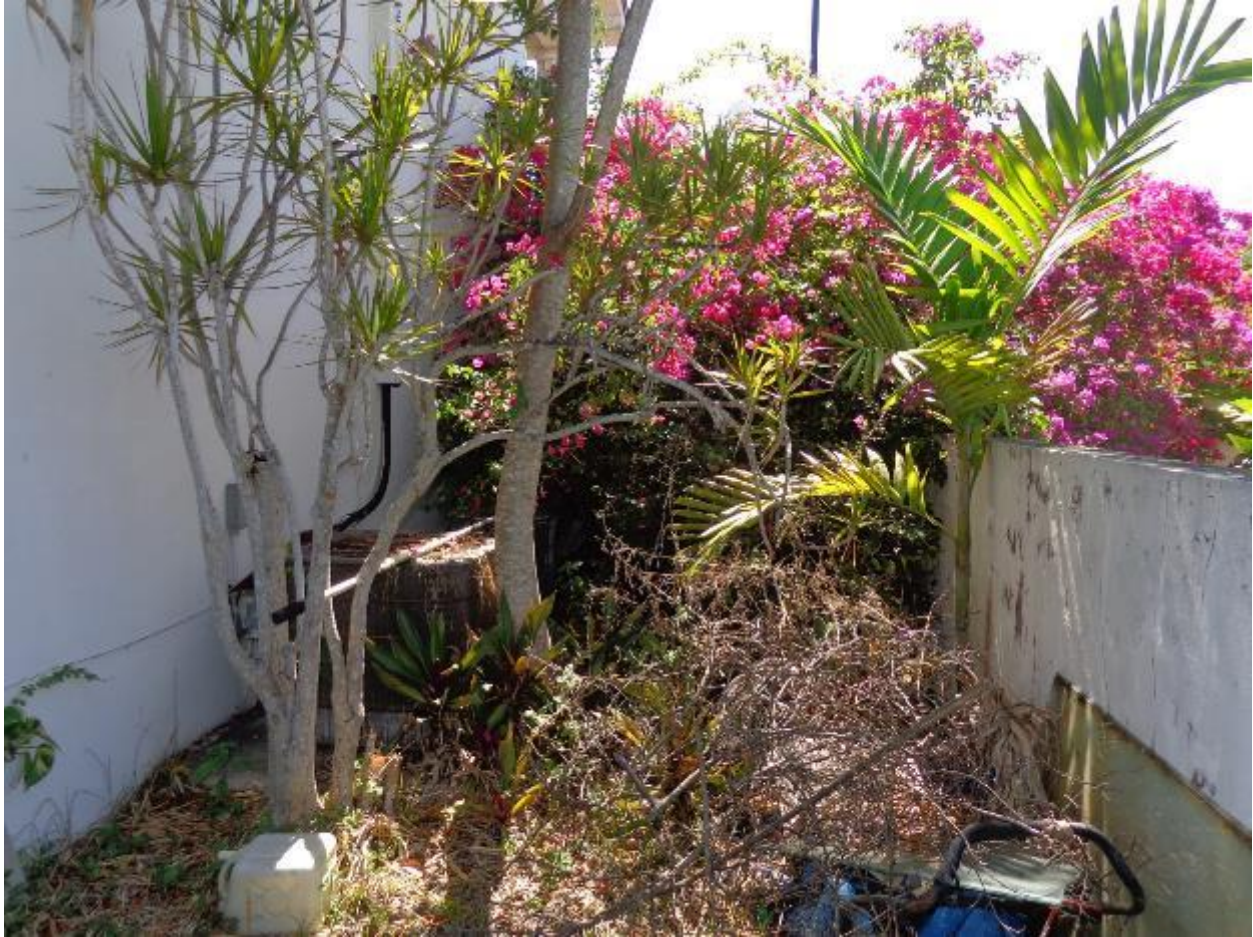
Allowances must be made for the removal of overgrown vegetation.

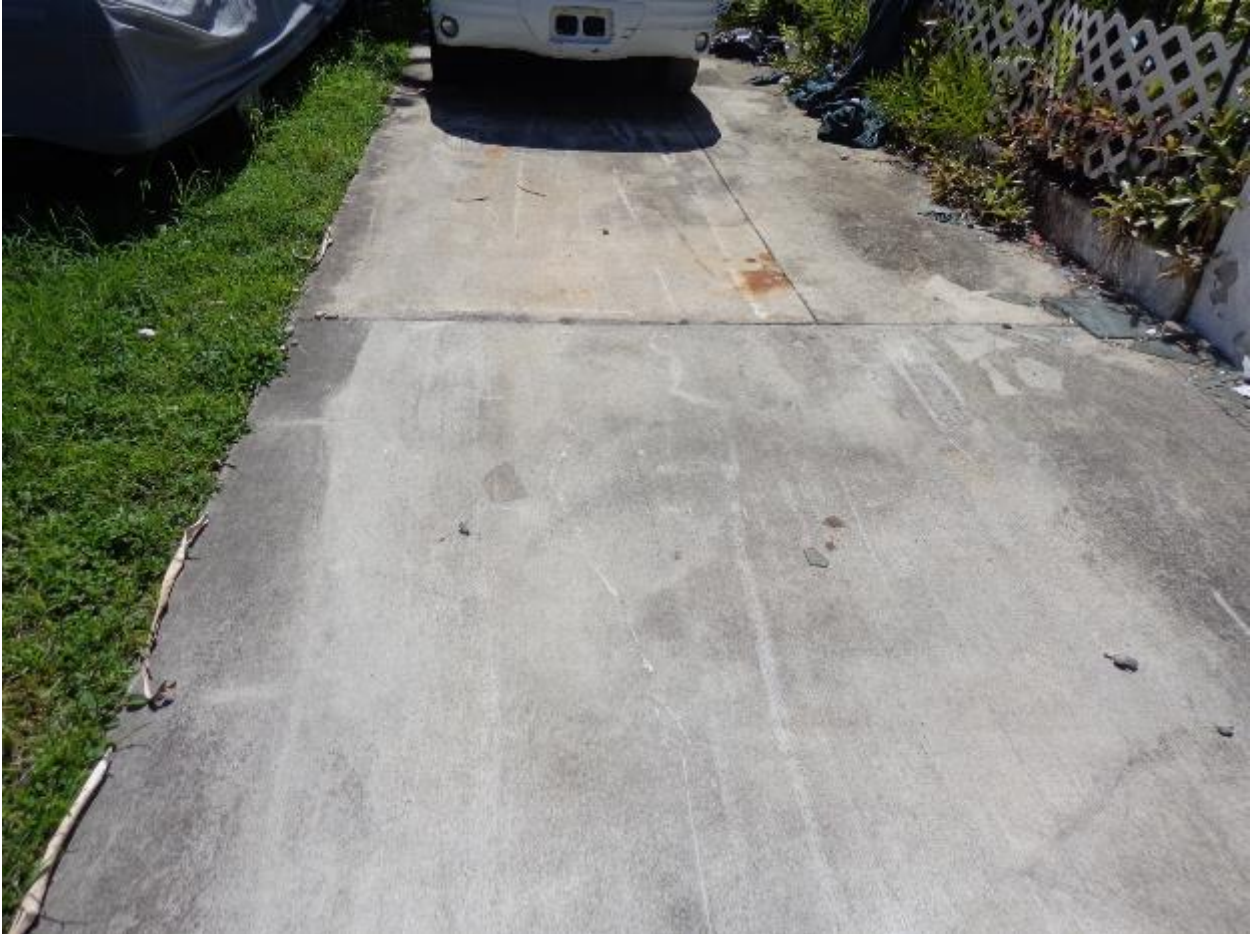
Driveway requires pressure wash.

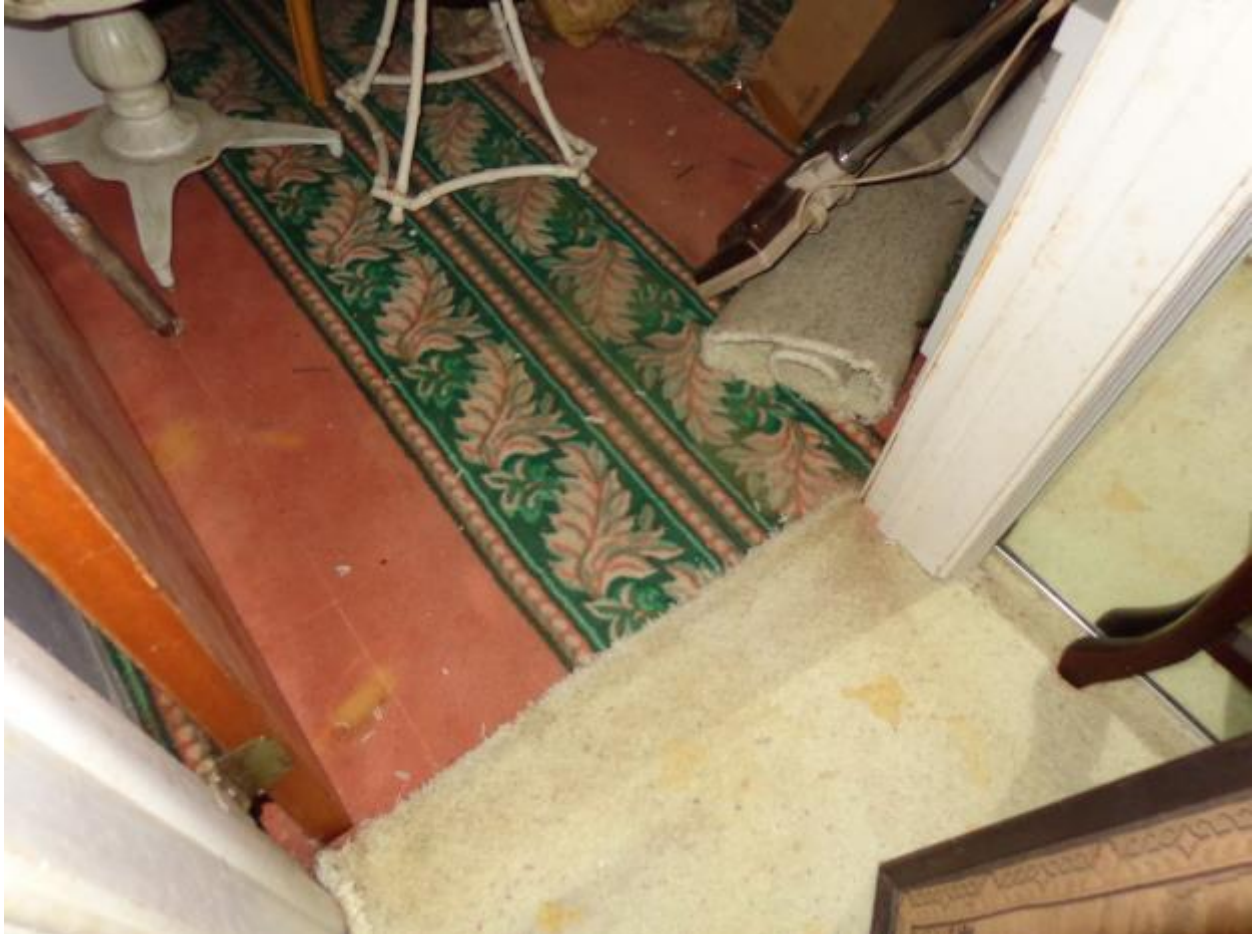
Soiled carpet throughout requires replacement.
