PROPERTY INSPECTION OR ASSESSMENT OF DAMAGES

ADDRESS: xxx NW xx AVE FORT LAUDERDALE, FL
CLIENT: your name here
ID No: 123
DATE: 1/12/xxxx

INSPECTION OR ASSESSMENT BY:

GAIA CONSTRUCTION INC.
CGC 1516136 **FLORIDA**
HI-2792 **FLORIDA**
8028867-B2 **INTERNATIONAL CODE COUNCIL**

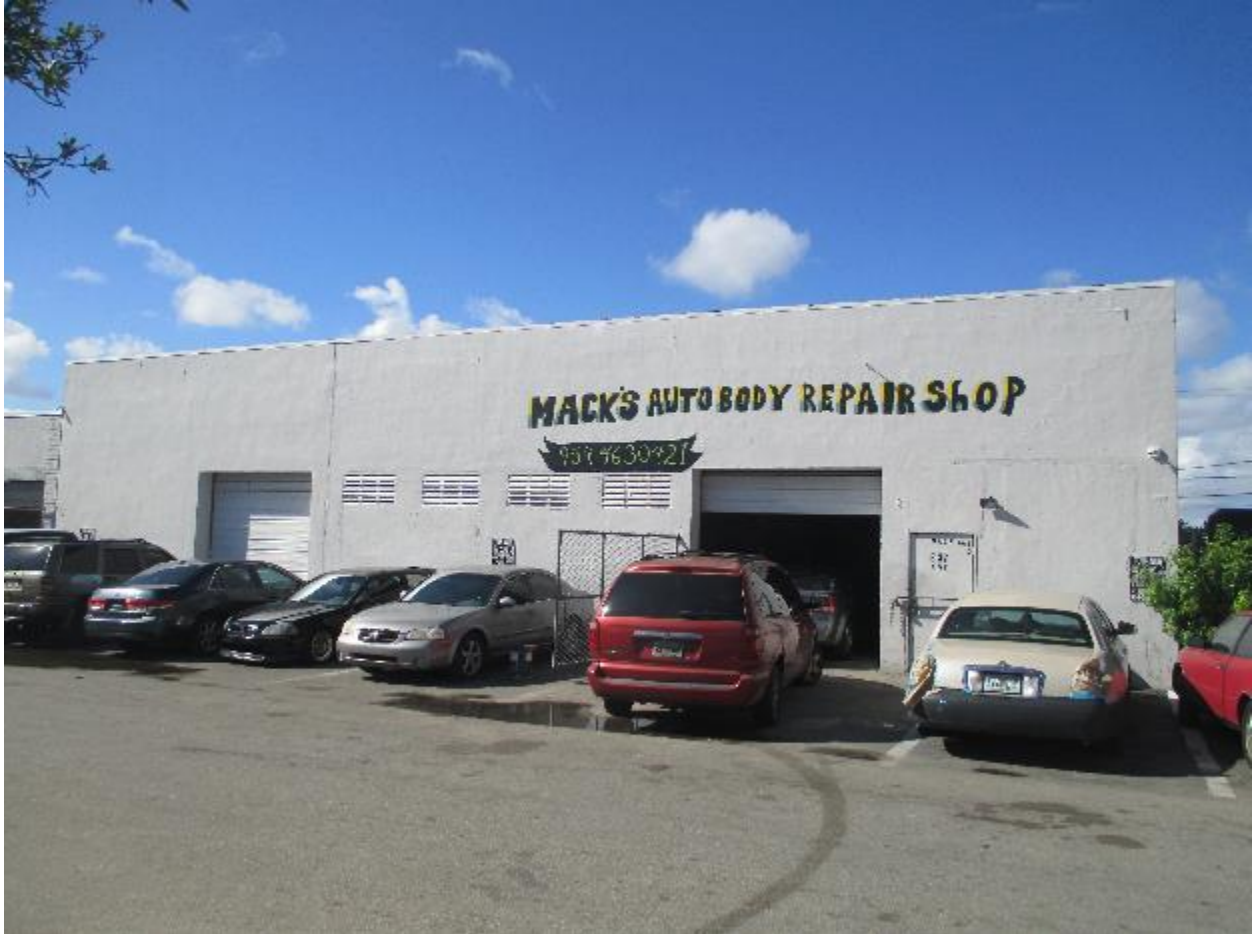
Exterior view.

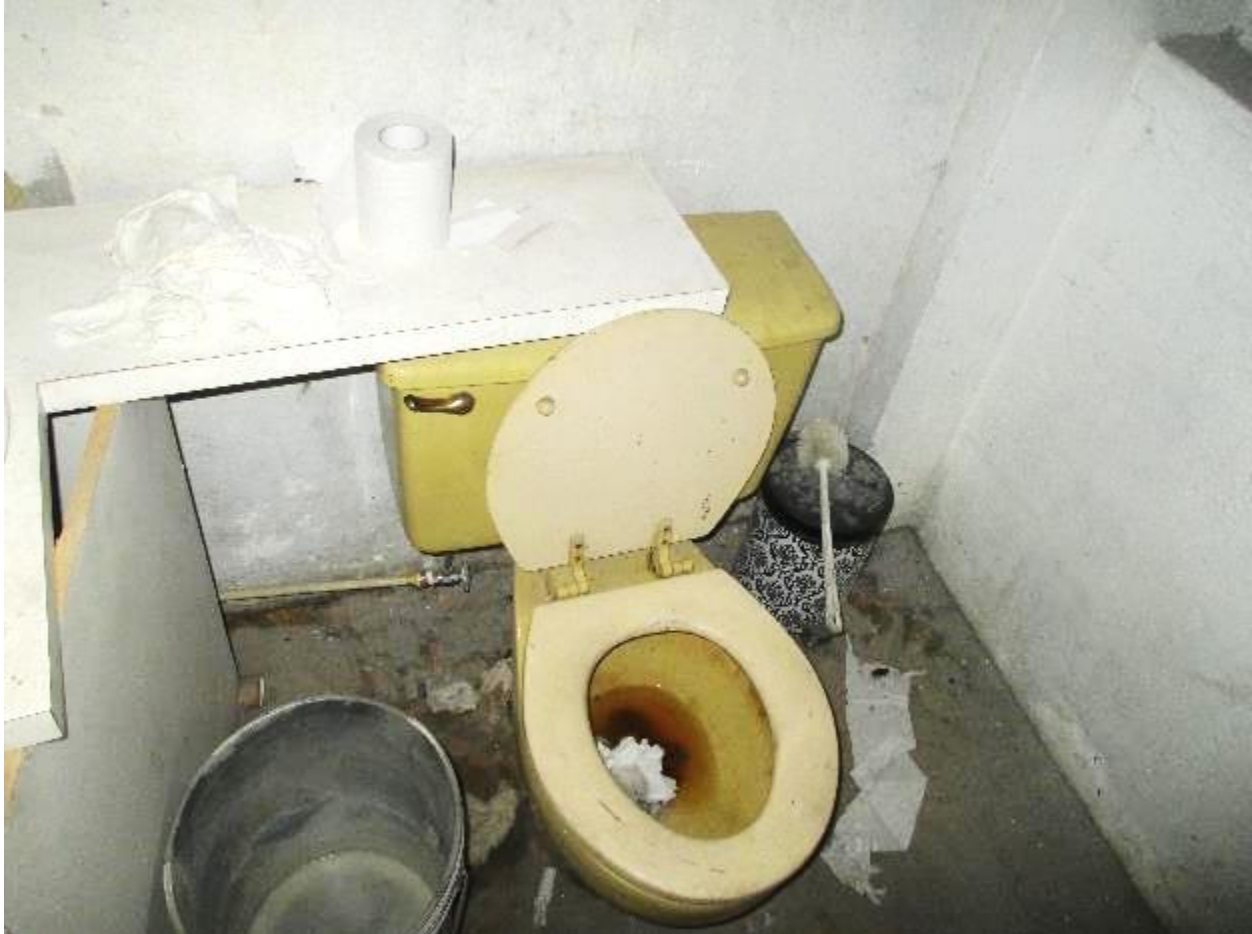
Not water services at the time of inspection.

Allowances must be made for the complete upgrade of finishes in bathroom(s).
