PROPERTY INSPECTION OR ASSESSMENT OF DAMAGES

ADDRESS: **SOMEWHERE , FL**
CLIENT: **GAIA GC**
ID No: **2015000**
DATE: **12/31/xxxx**

GAIA CONSTRUCTION INC.
CGC 1516136 FLORIDA
HI-2792 FLORIDA
8028867-B2 INTERNATIONAL CODE COUNCIL

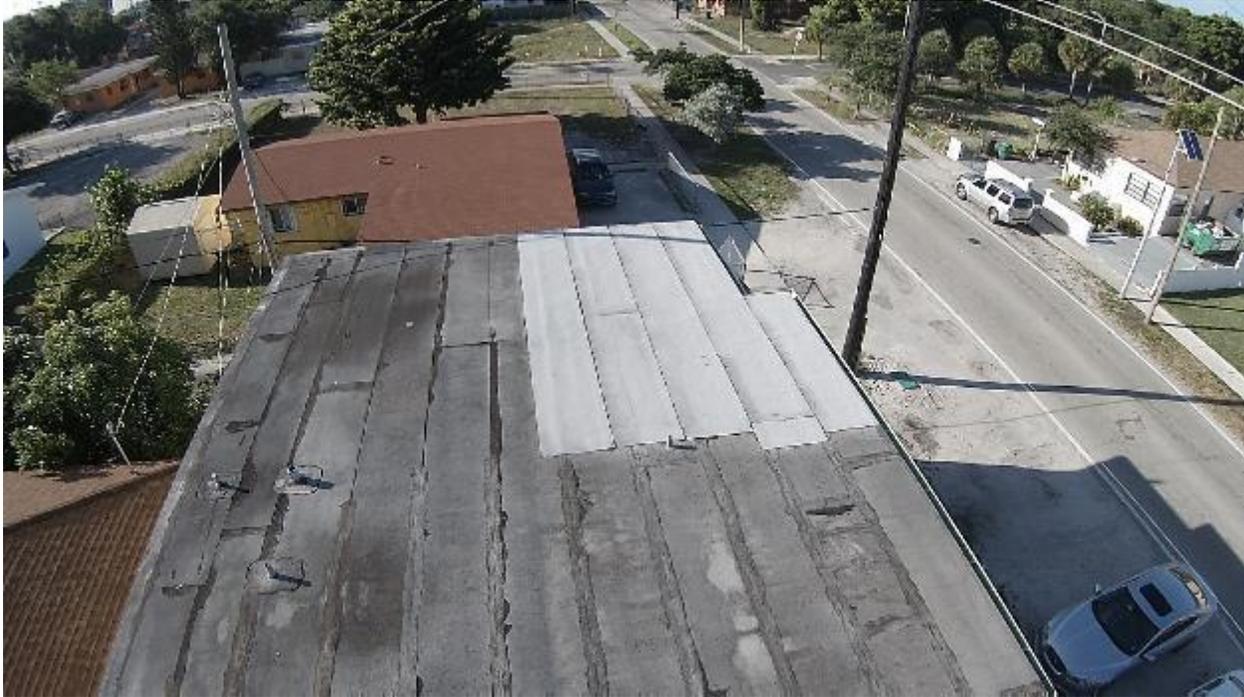
Roof signs of recent repairs and a large patches are visible on the NE section of the roof and the center of the roof. All west section is deteriorated.

No active leaks noted during inspection and we estimate this roof to maintain its waterproofing properties for a maximum of 1 year without requiring additional repairs. Proper maintenance required.

This roof must be replaced as this property becomes uninsurable after issuing this report.

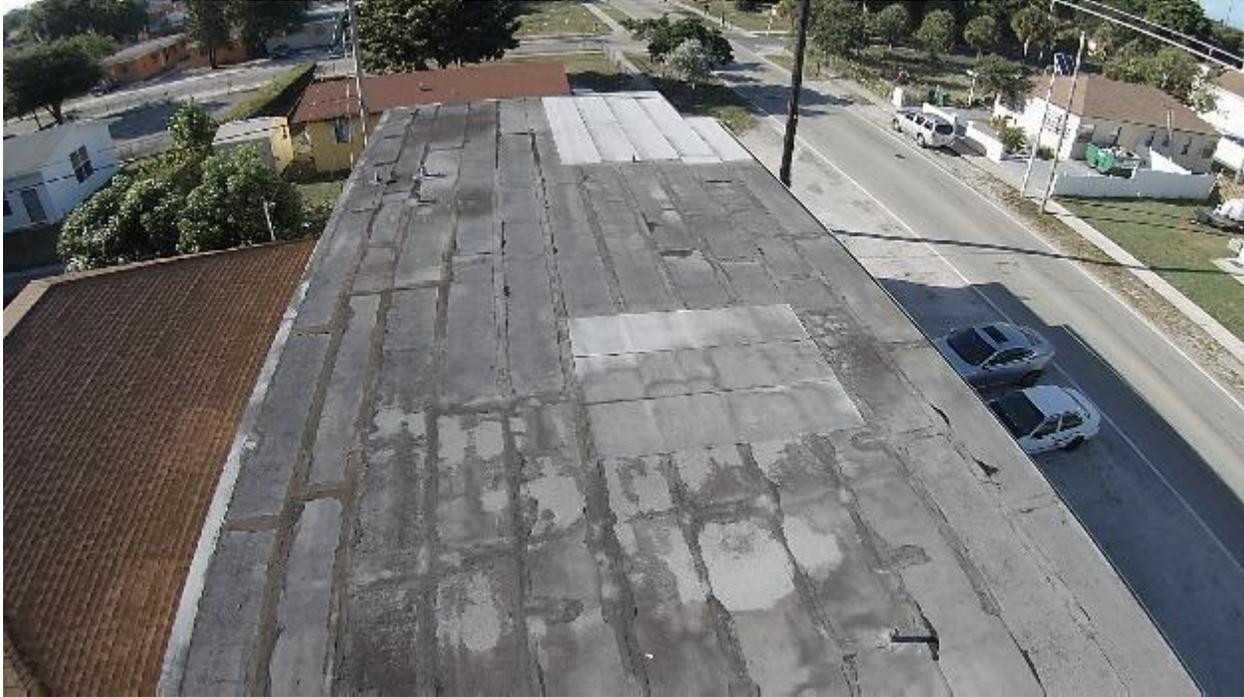
Roof signs of recent repairs and a large patches are visible on the NE section of the roof and the center of the roof. All west section is deteriorated.

No active leaks noted during inspection and we estimate this roof to maintain its waterproofing properties for a maximum of 1 year without requiring additional repairs. Proper maintenance required.

This roof must be replaced as this property becomes uninsurable after issuing this report.

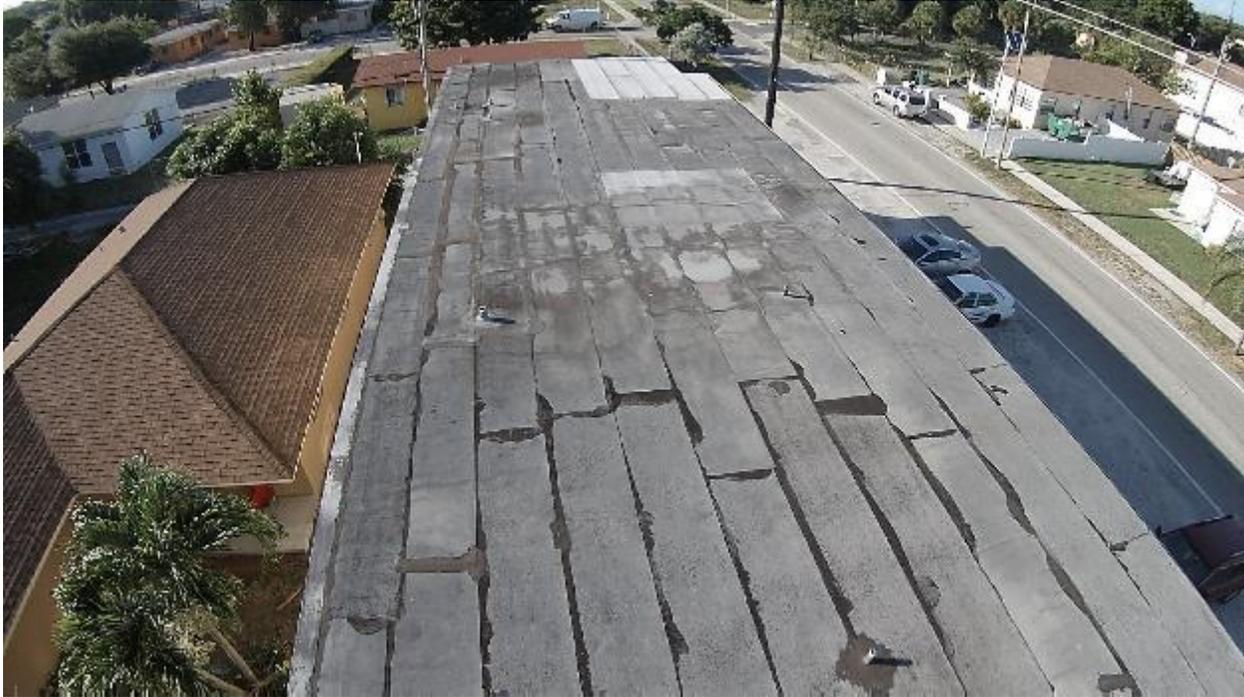
Roof signs of recent repairs and a large patches are visible on the NE section of the roof and the center of the roof. All west section is deteriorated.

No active leaks noted during inspection and we estimate this roof to maintain its waterproofing properties for a maximum of 1 year without requiring additional repairs. Proper maintenance required.

This roof must be replaced as this property becomes uninsurable after issuing this report.

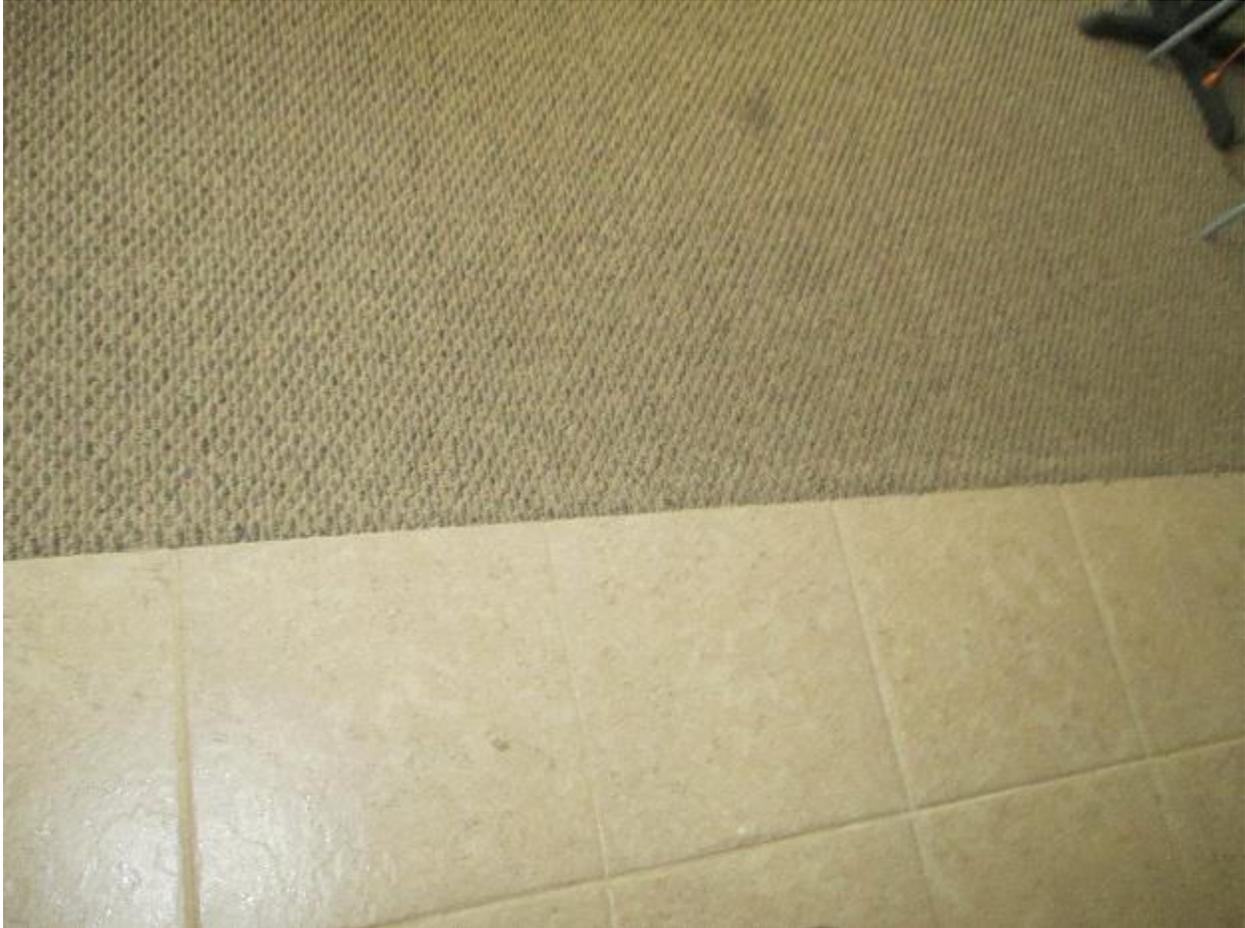
Interior finishes were found in general good condition at the time of inspection with exceptions as noted and shown in photographs.

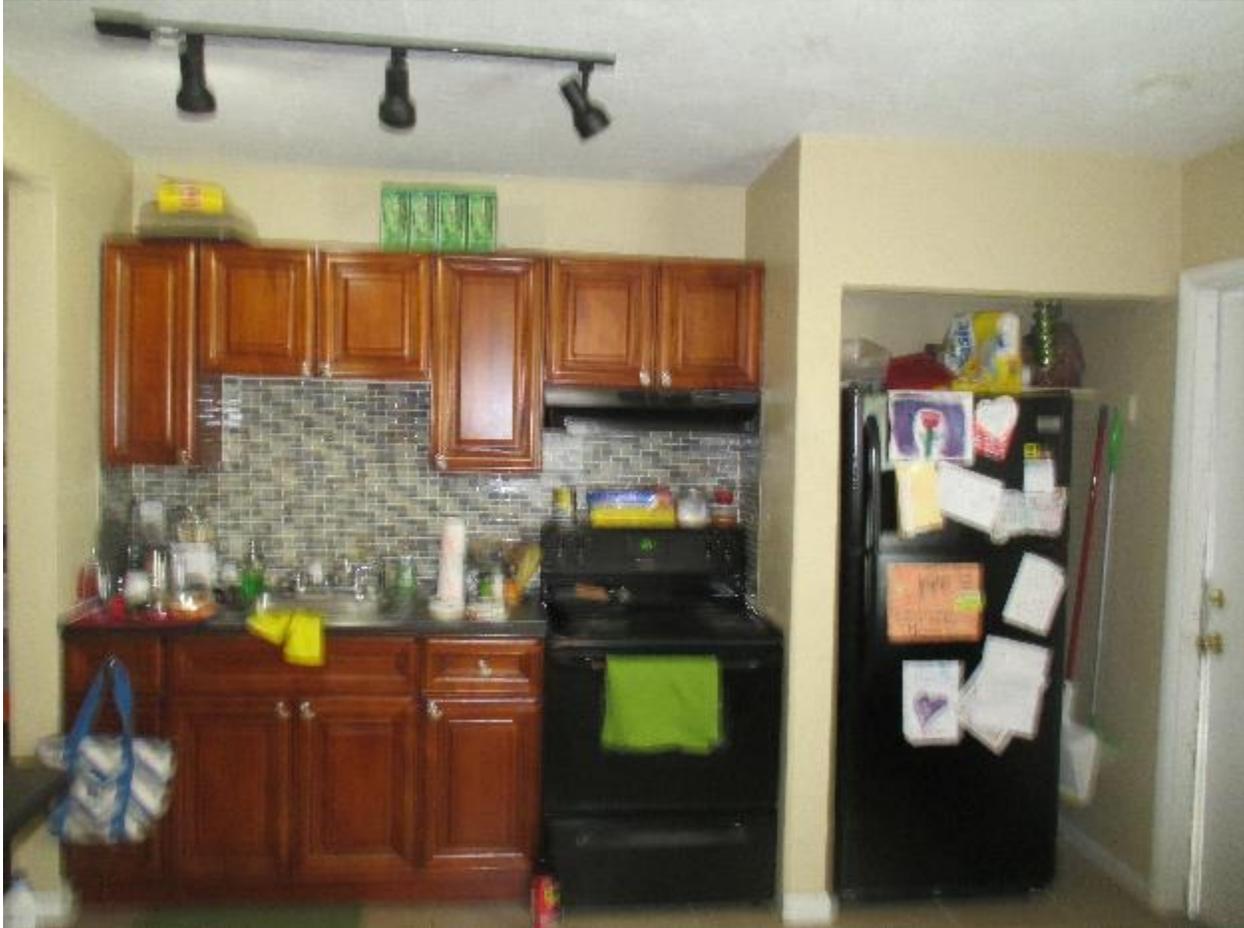
Interior finishes were found in general good condition at the time of inspection with exceptions as noted and shown in photographs.

No warranties or guarantees expressed on used appliances. Appliances found in working condition at the time of inspection.

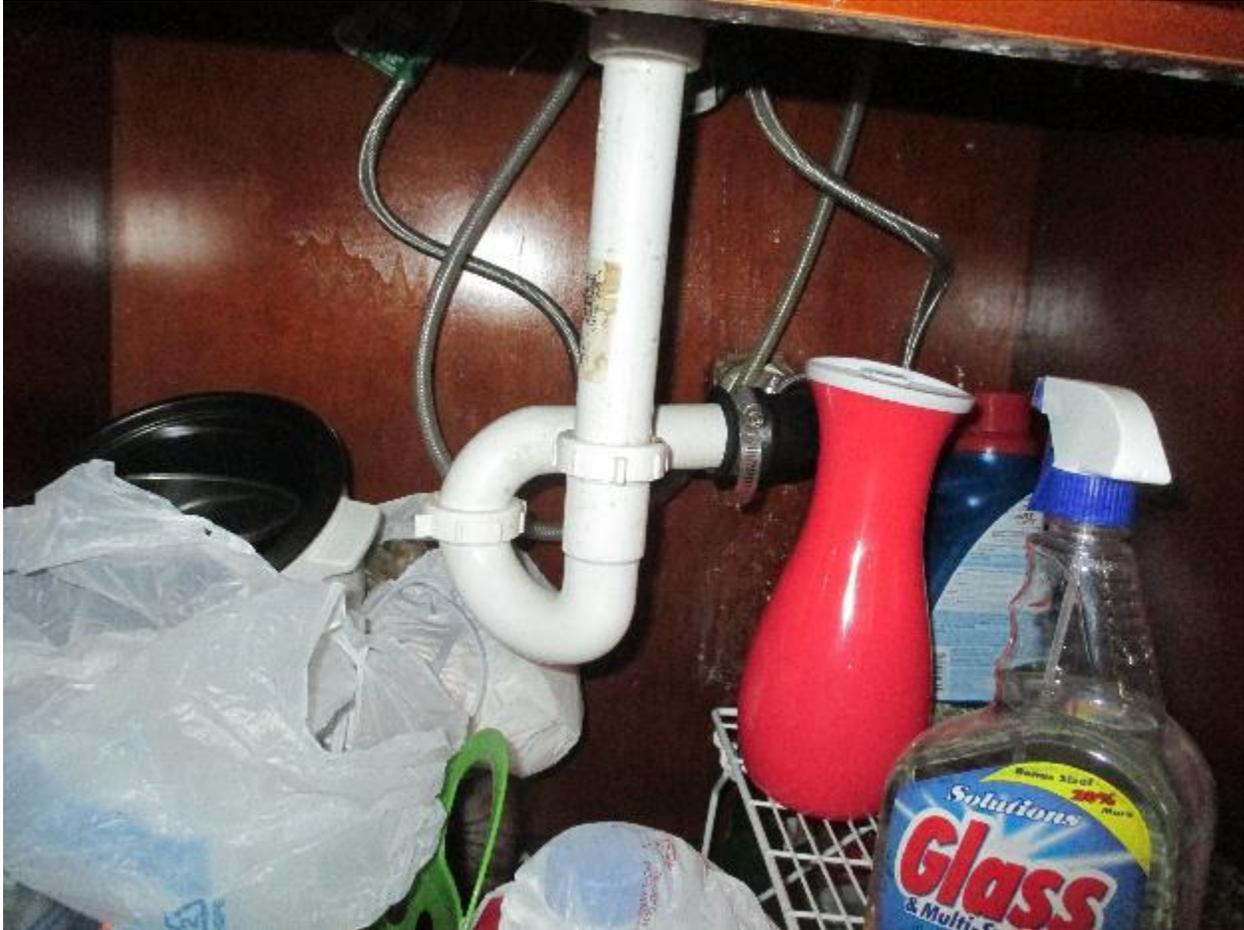
Plumbing systems tested for proper flow. No leaks or deficiencies noted on drain and supply lines.

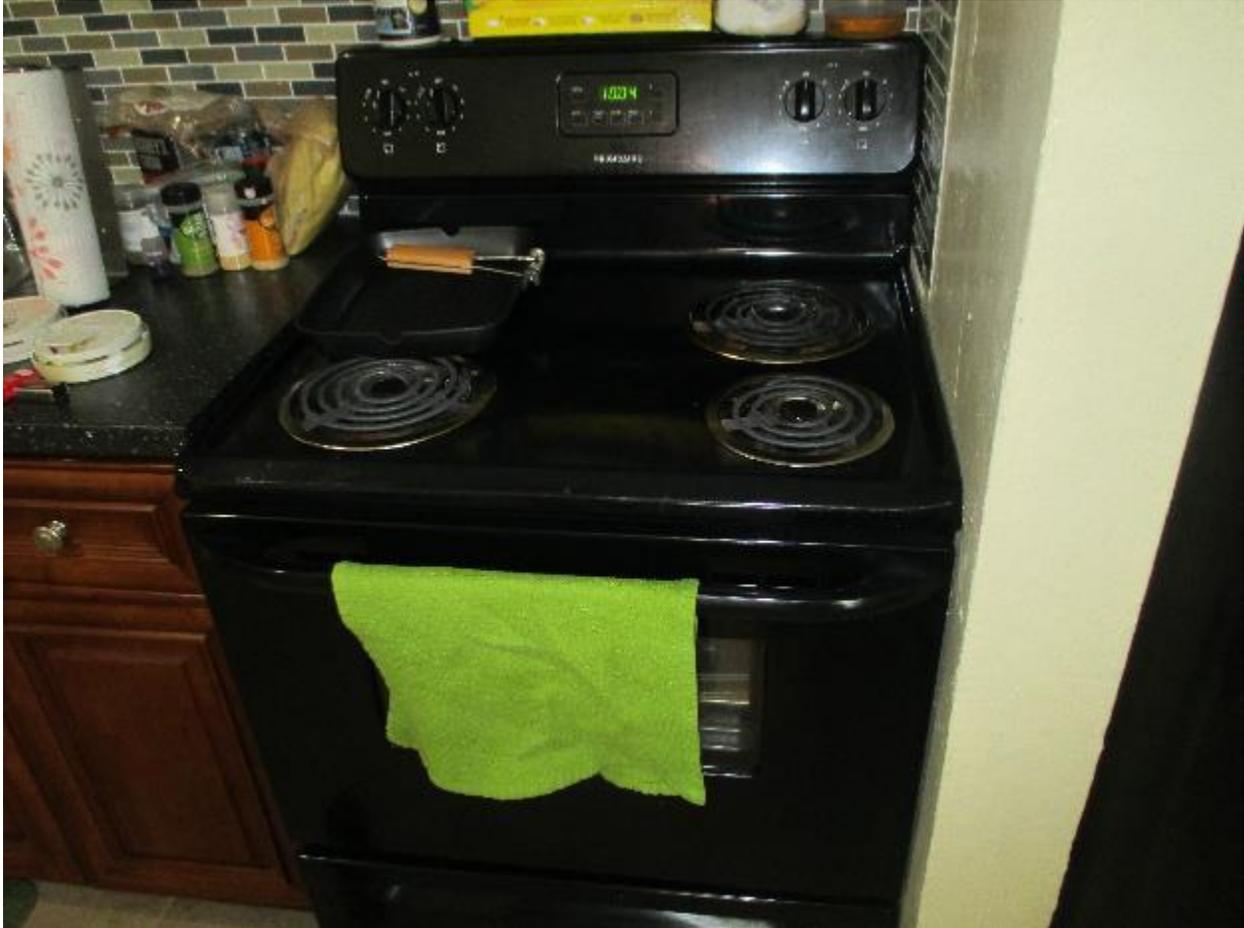
No warranties or guarantees expressed on used appliances. Appliances found in working condition at the time of inspection.

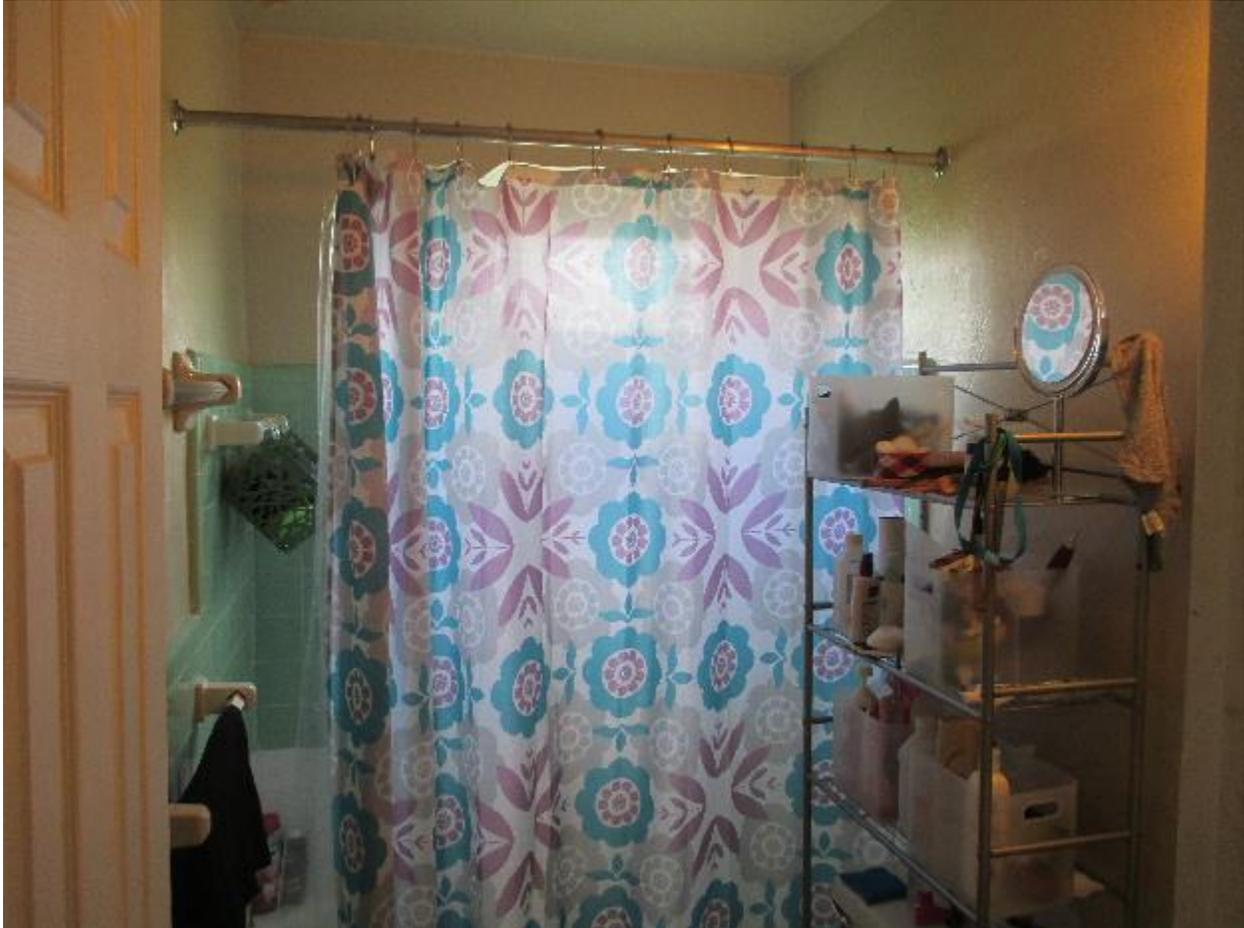
Interior finishes were found in general good condition at the time of inspection with exceptions as noted and shown in photographs.

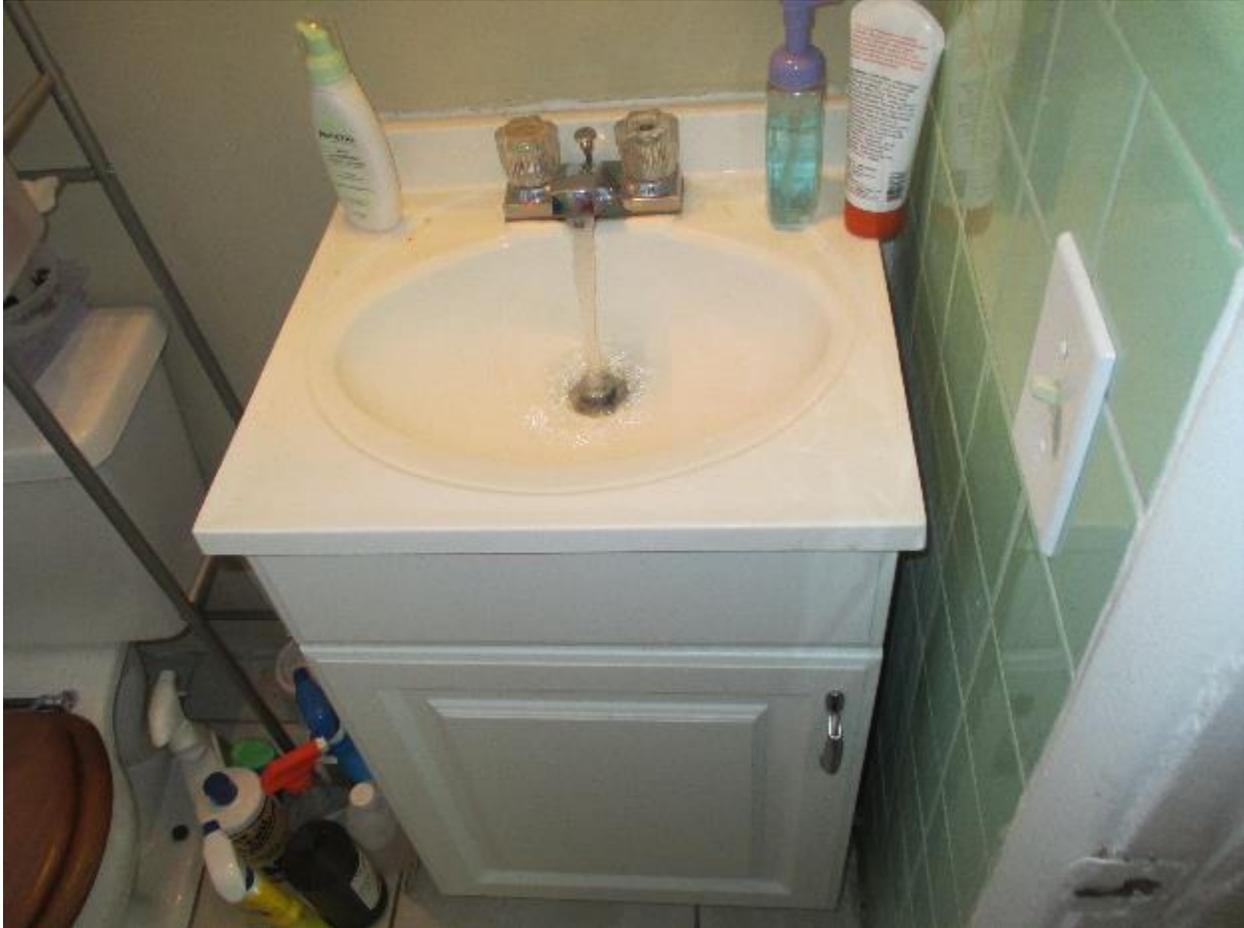
Plumbing systems tested for proper flow. No leaks or deficiencies noted on drain and supply lines.

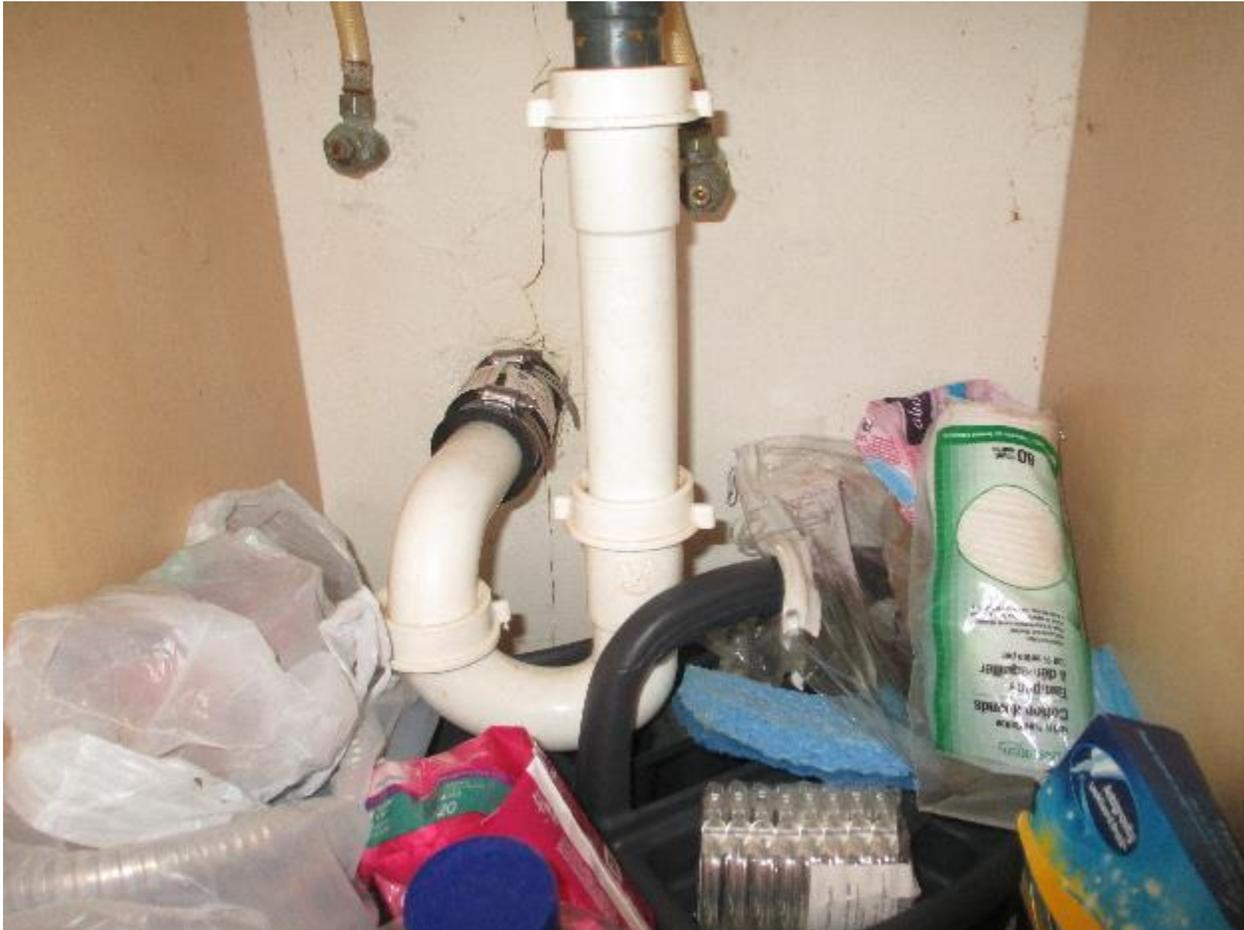
Plumbing systems tested for proper flow. No leaks or deficiencies noted on drain and supply lines.

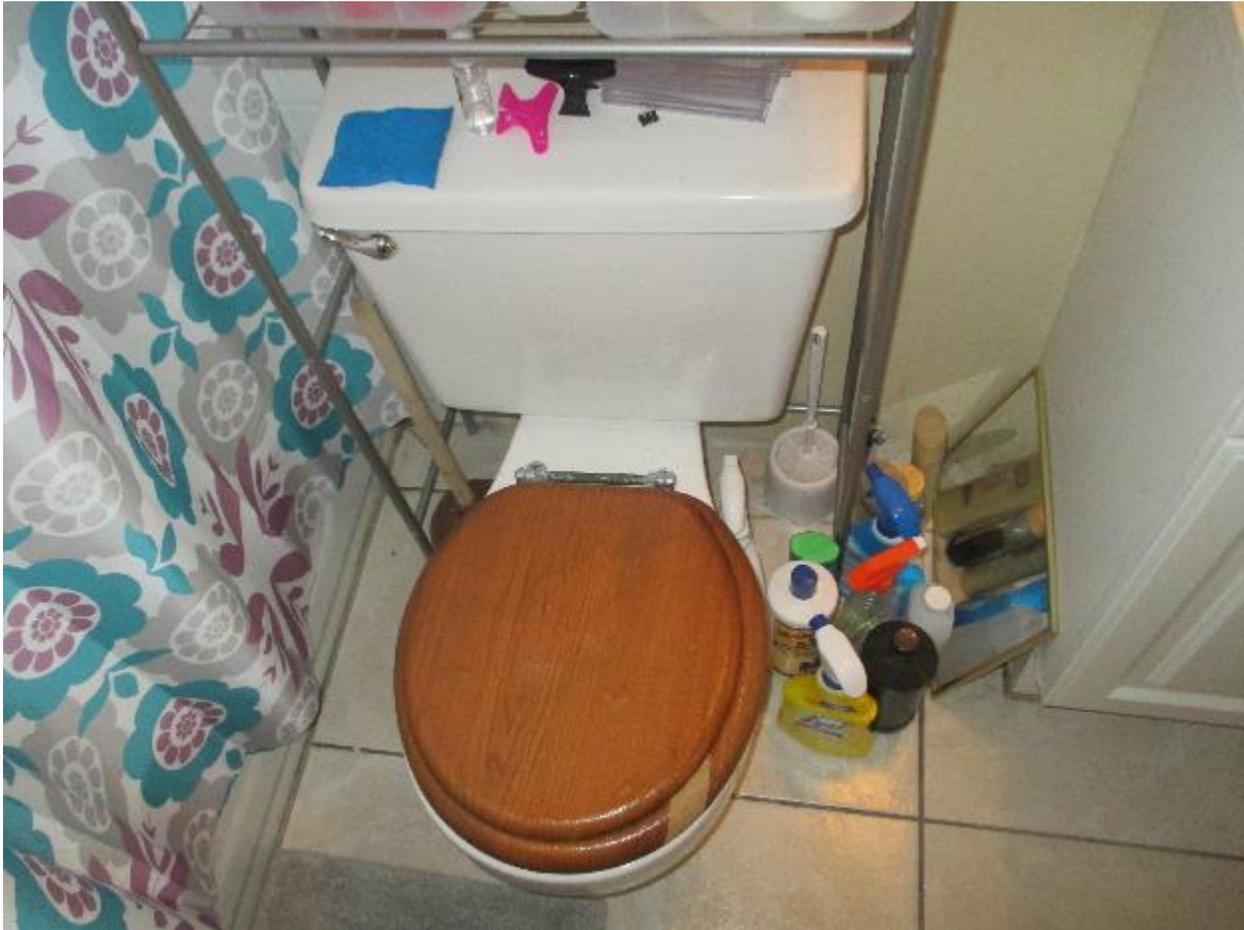
Interior finishes were found in general good condition at the time of inspection with exceptions as noted and shown in photographs.

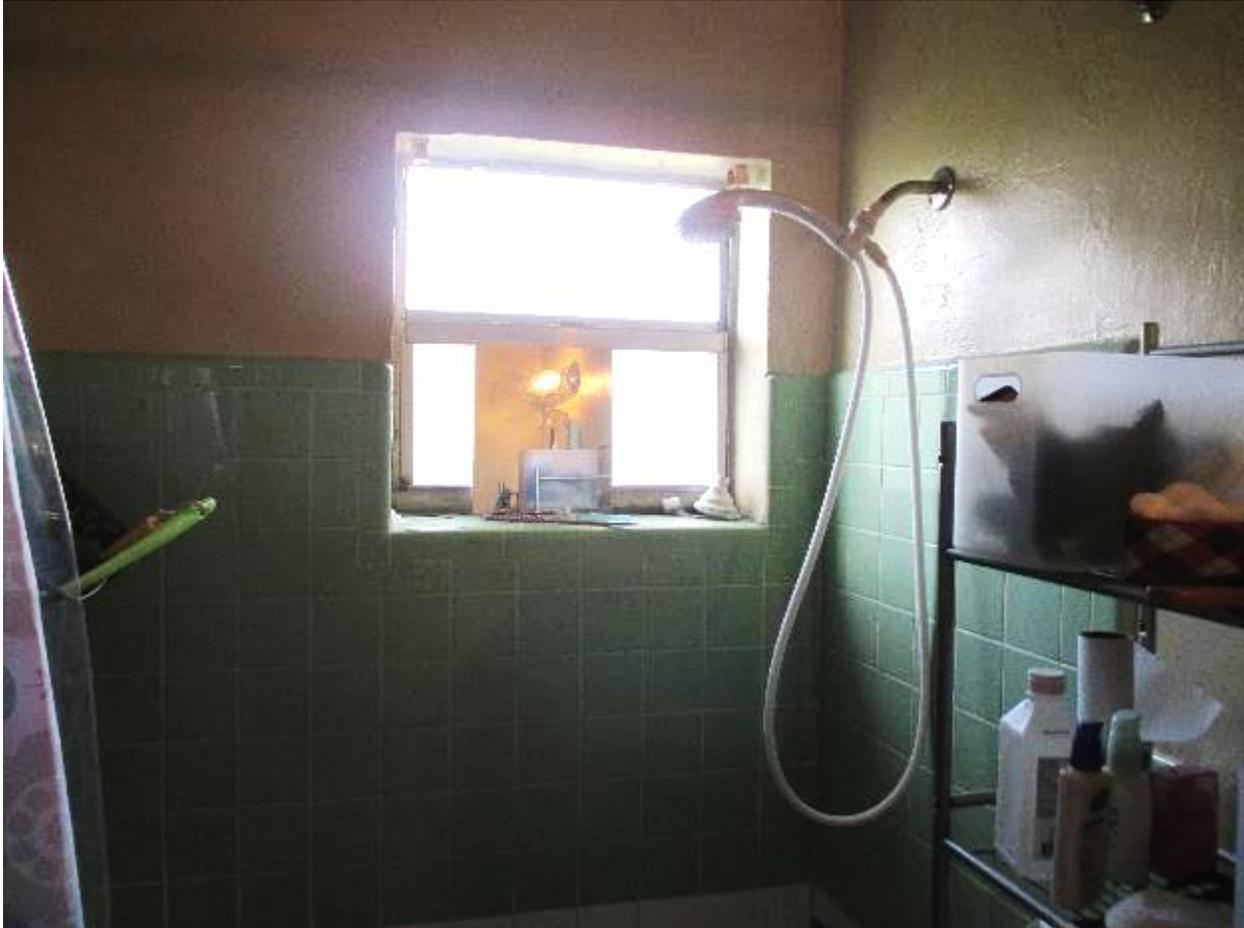
Interior finishes were found in general good condition at the time of inspection with exceptions as noted and shown in photographs.

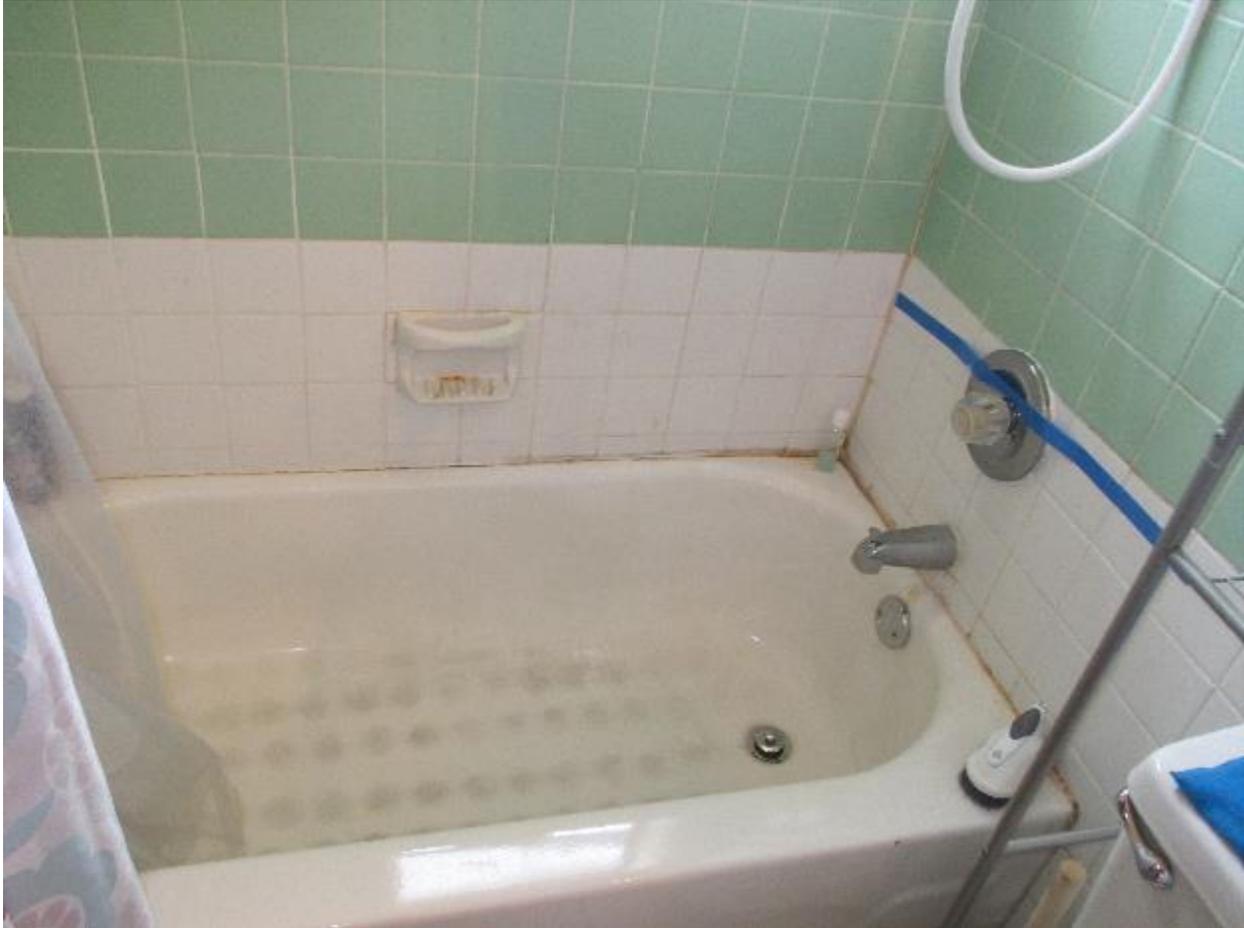
Interior finishes were found in general good condition at the time of inspection with exceptions as noted and shown in photographs.

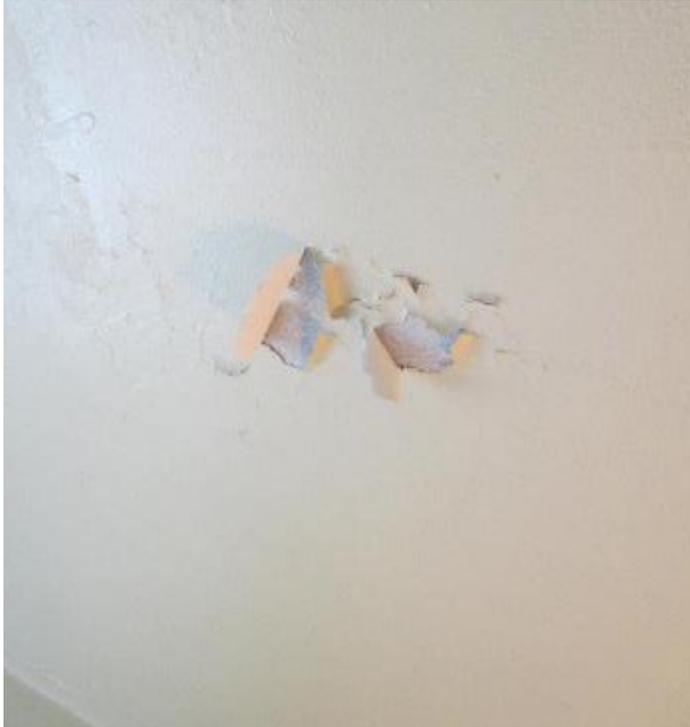
Signs of water infiltration due to roof failure noticed at the habitable space ceiling; allowances must be made for roofing and ceiling repair.

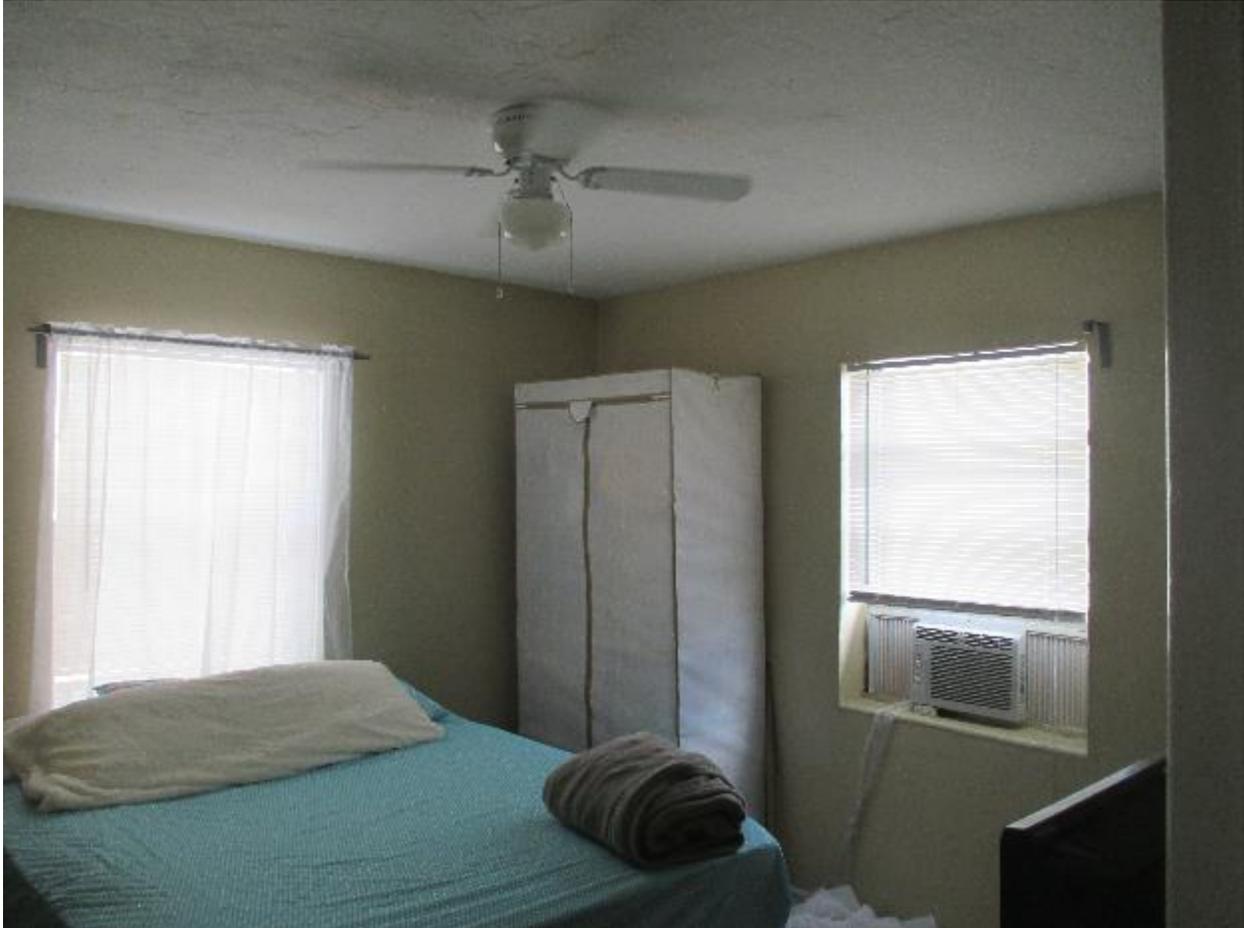
Interior finishes were found in general good condition at the time of inspection with exceptions as noted and shown in photographs.

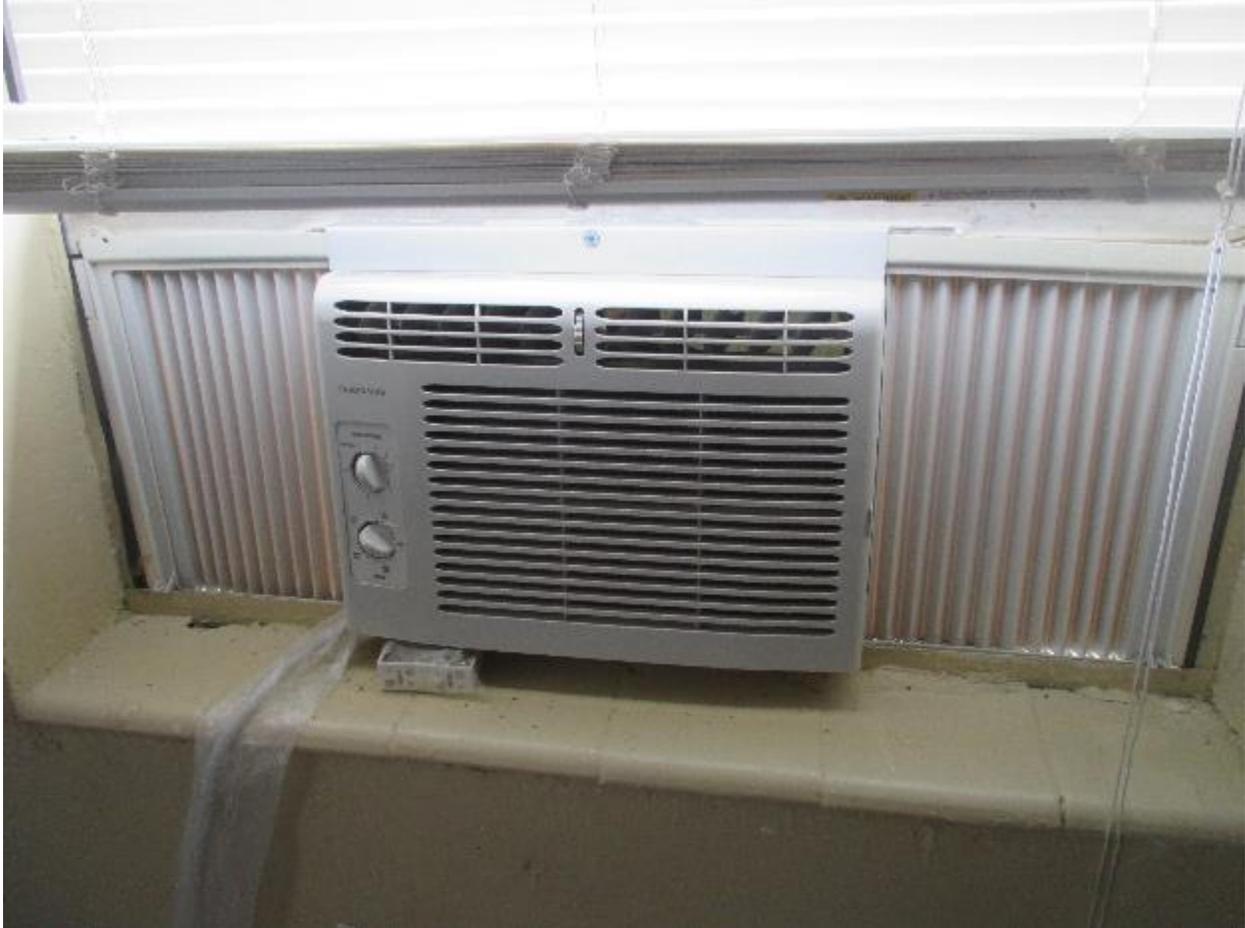
Ac in good working condition at the time of inspection.

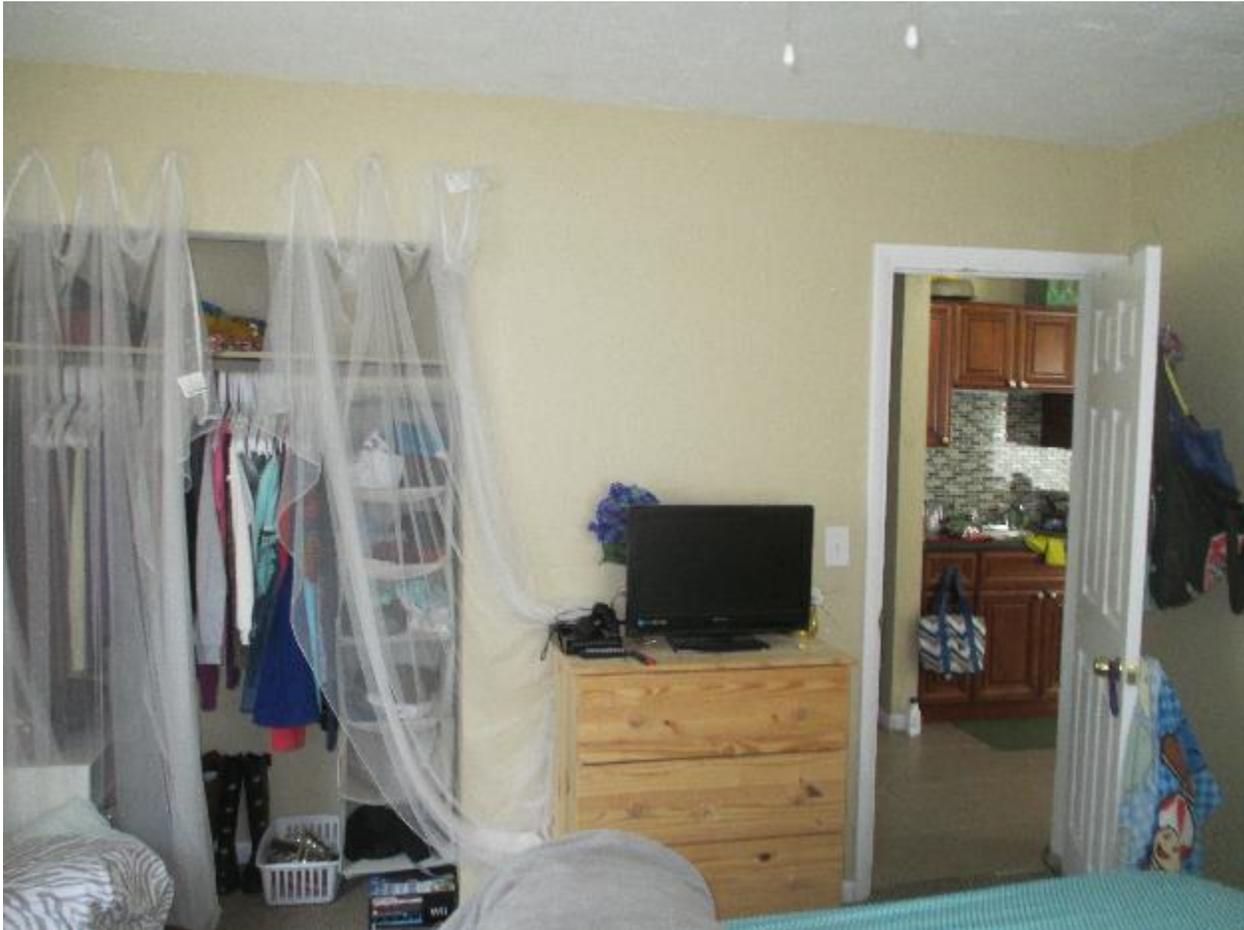
Interior finishes were found in general good condition at the time of inspection with exceptions as noted and shown in photographs.

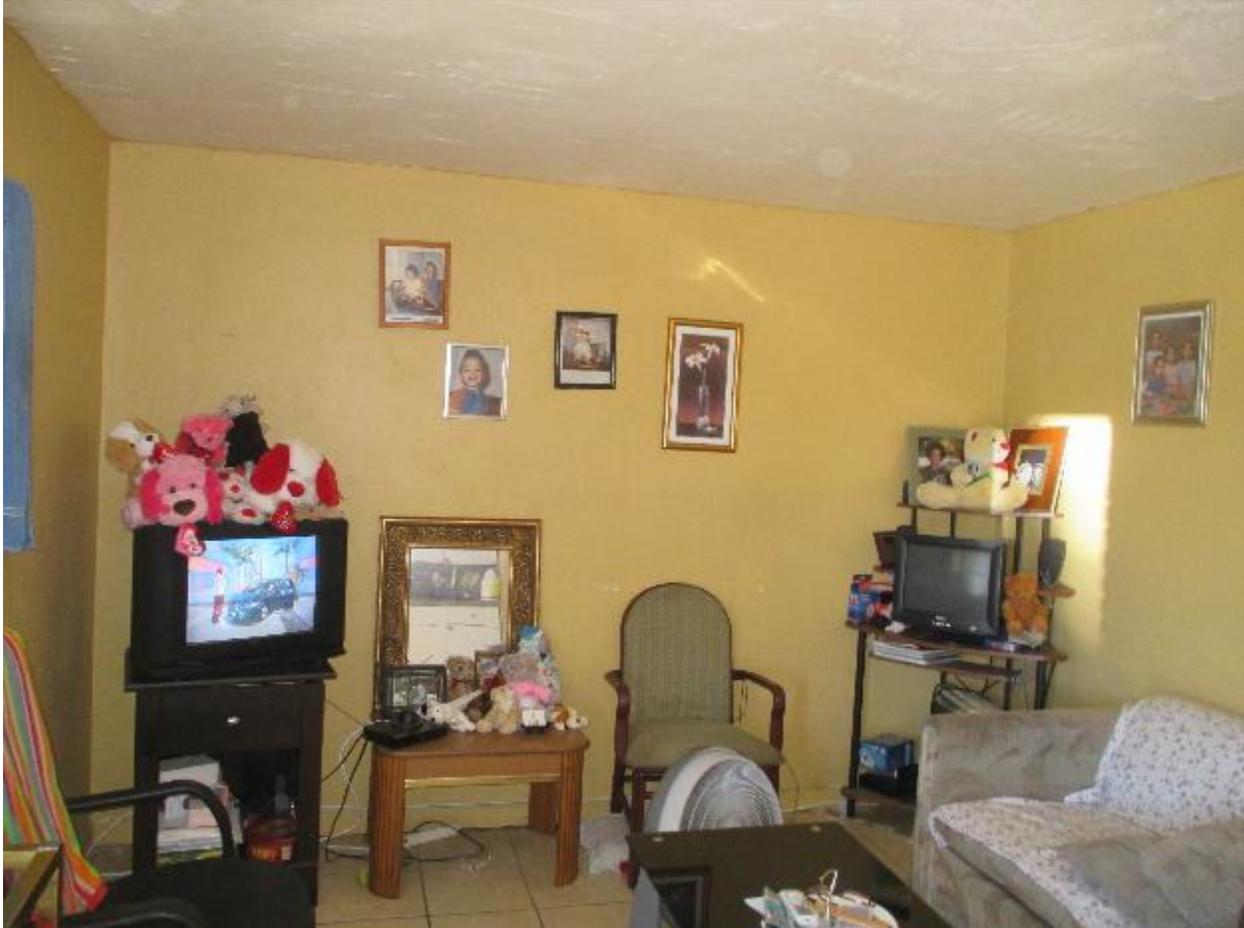
Interior finishes were found in general good condition at the time of inspection with exceptions as noted and shown in photographs.

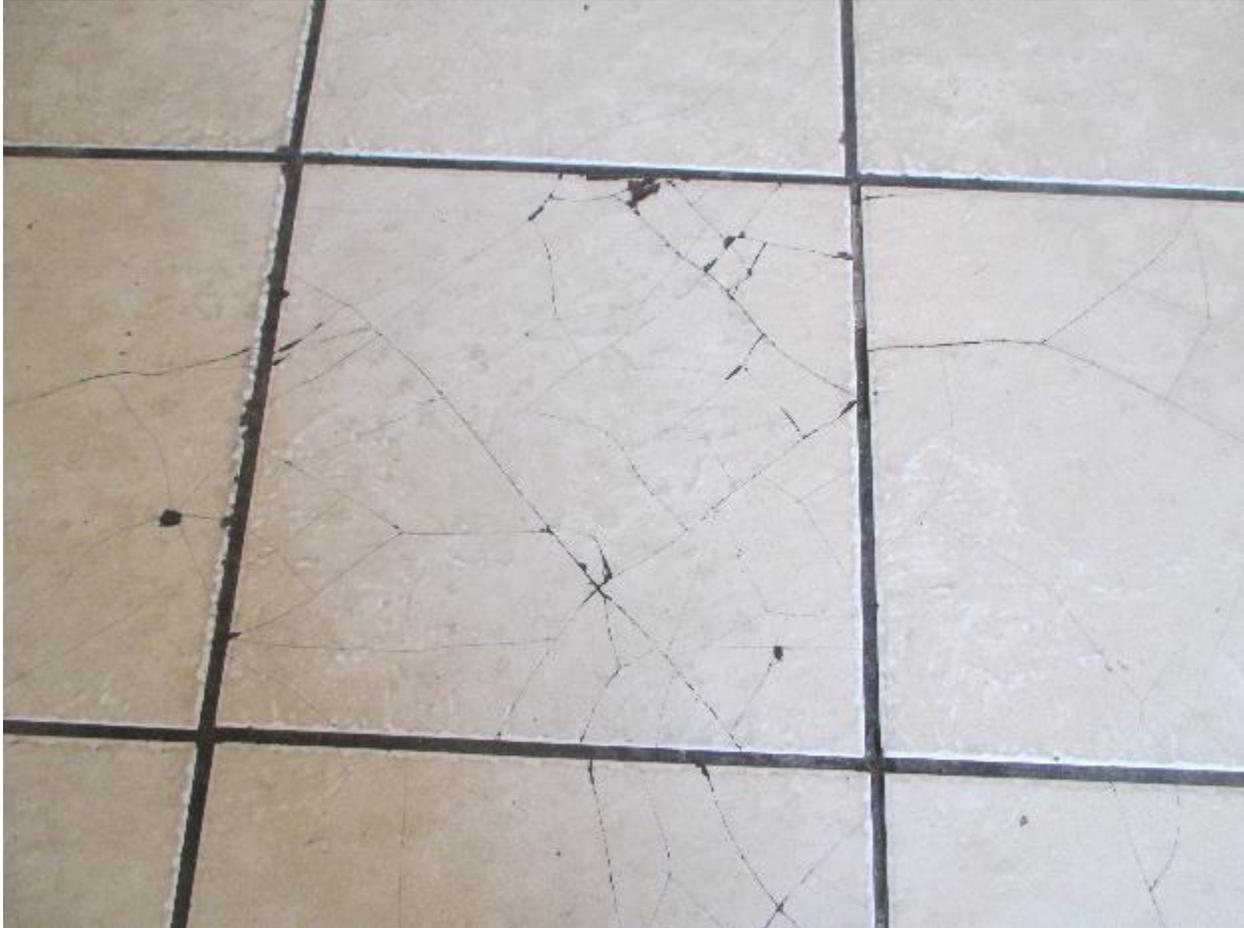
Cracked tiles without possibilities of repair. Complete removal of flooring surfaces must be done in order to provide a finished appearance.

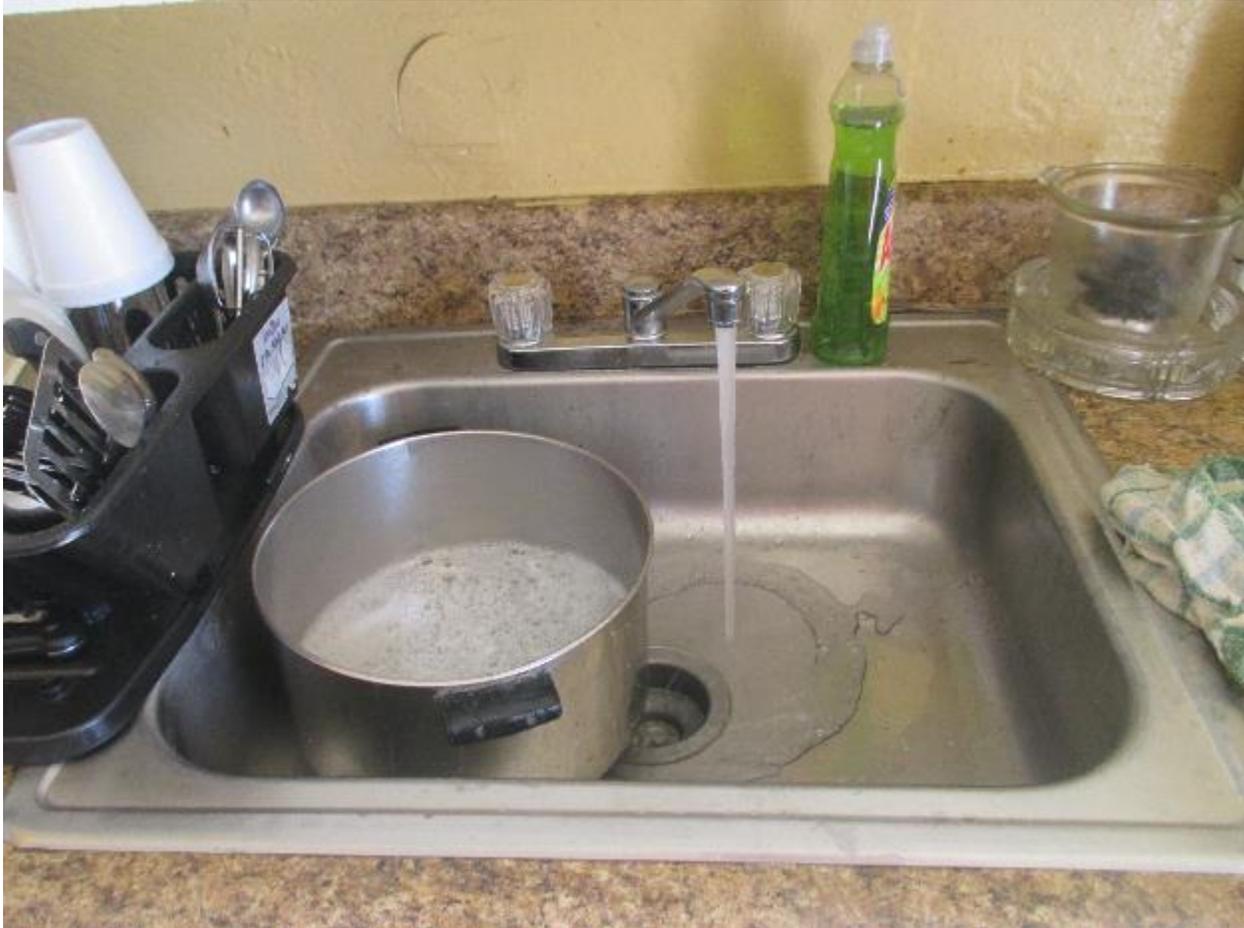
Plumbing systems tested for proper flow. No leaks or deficiencies noted on drain and supply lines.
