PROPERTY INSPECTION OR ASSESSMENT OF DAMAGES

ADDRESS: **SOMEWHERE , FL**
CLIENT: **GAIA GC**
ID No: **2015000**
DATE: **12/31/xxxx**

GAIA CONSTRUCTION INC.
CGC 1516136 FLORIDA
HI-2792 FLORIDA
8028867-B2 INTERNATIONAL CODE COUNCIL

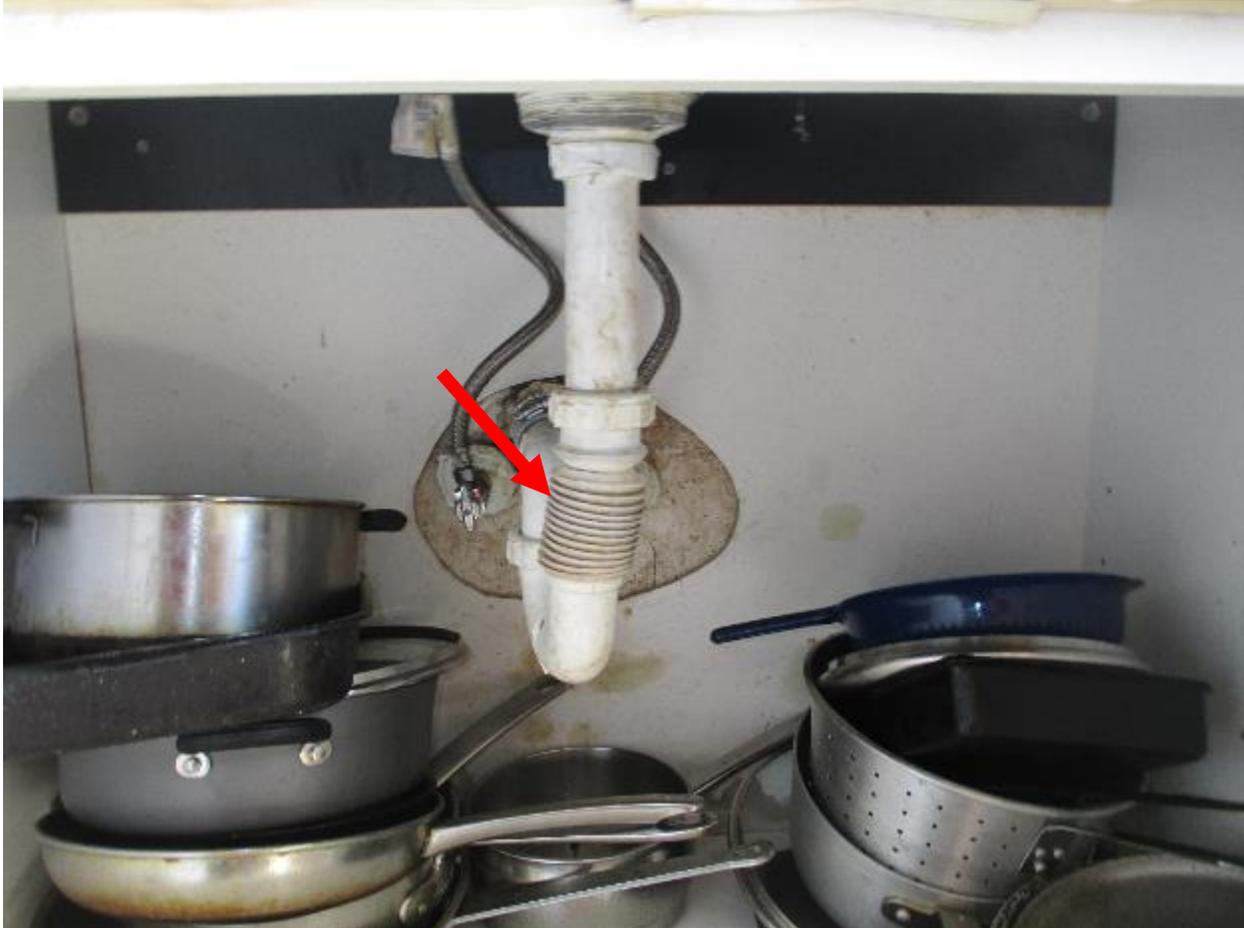
Flexible plumbing system to be replaced, not recommended for insurance purposes. Flexible systems are prone to failure.

Active leak.

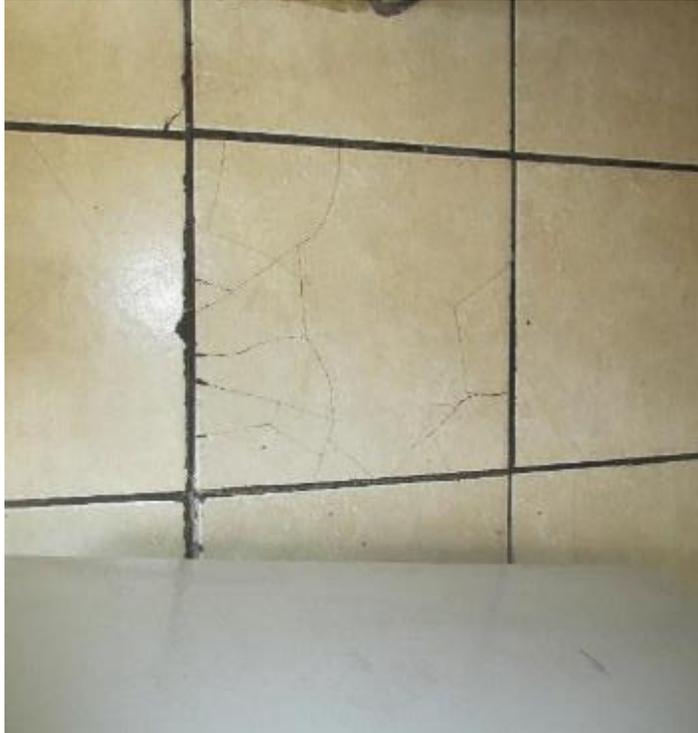
Cracked tiles without possibilities of repair. Complete removal of flooring surfaces must be done in order to provide a finished appearance.

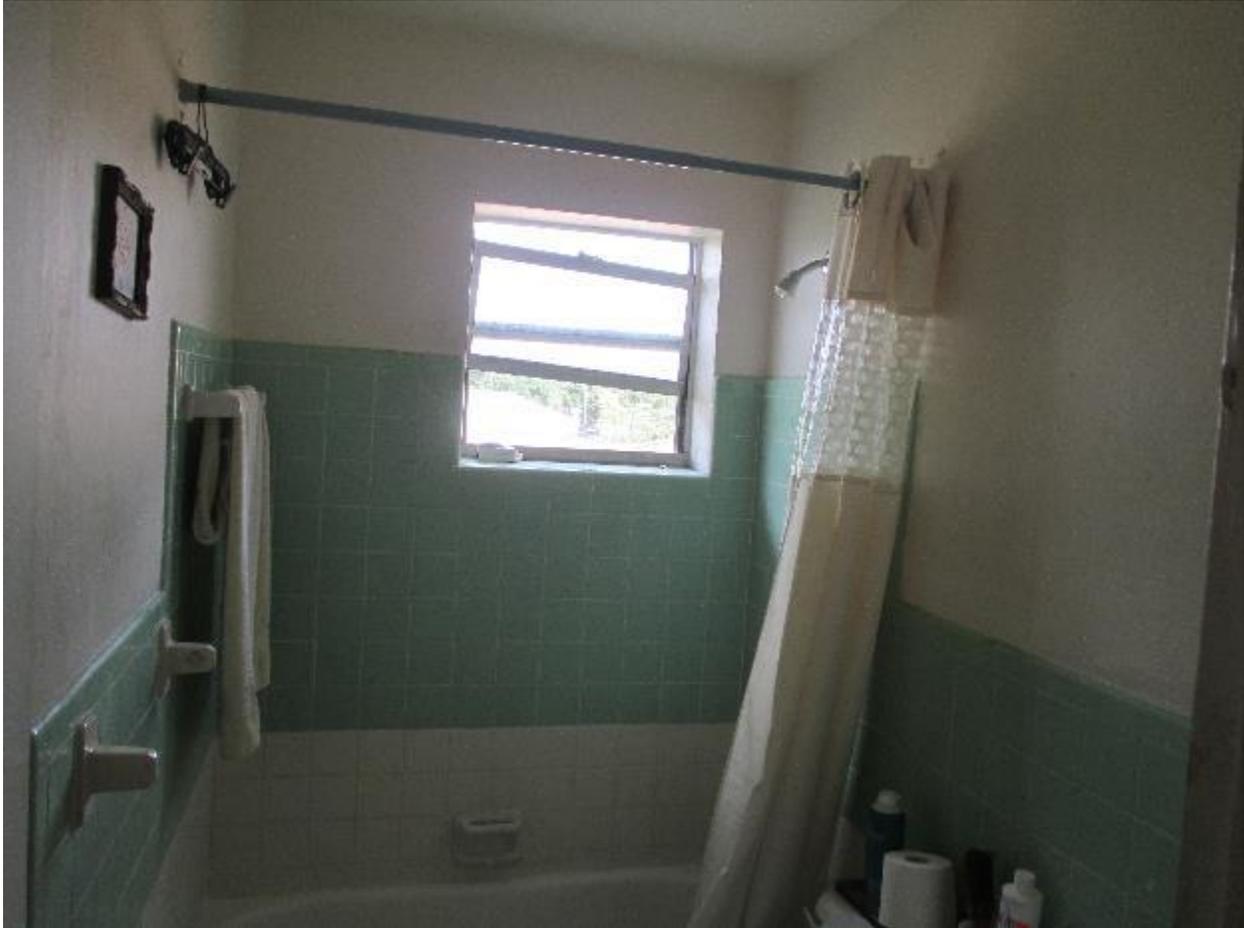
Interior finishes were found in general good condition at the time of inspection with exceptions as noted and shown in photographs.

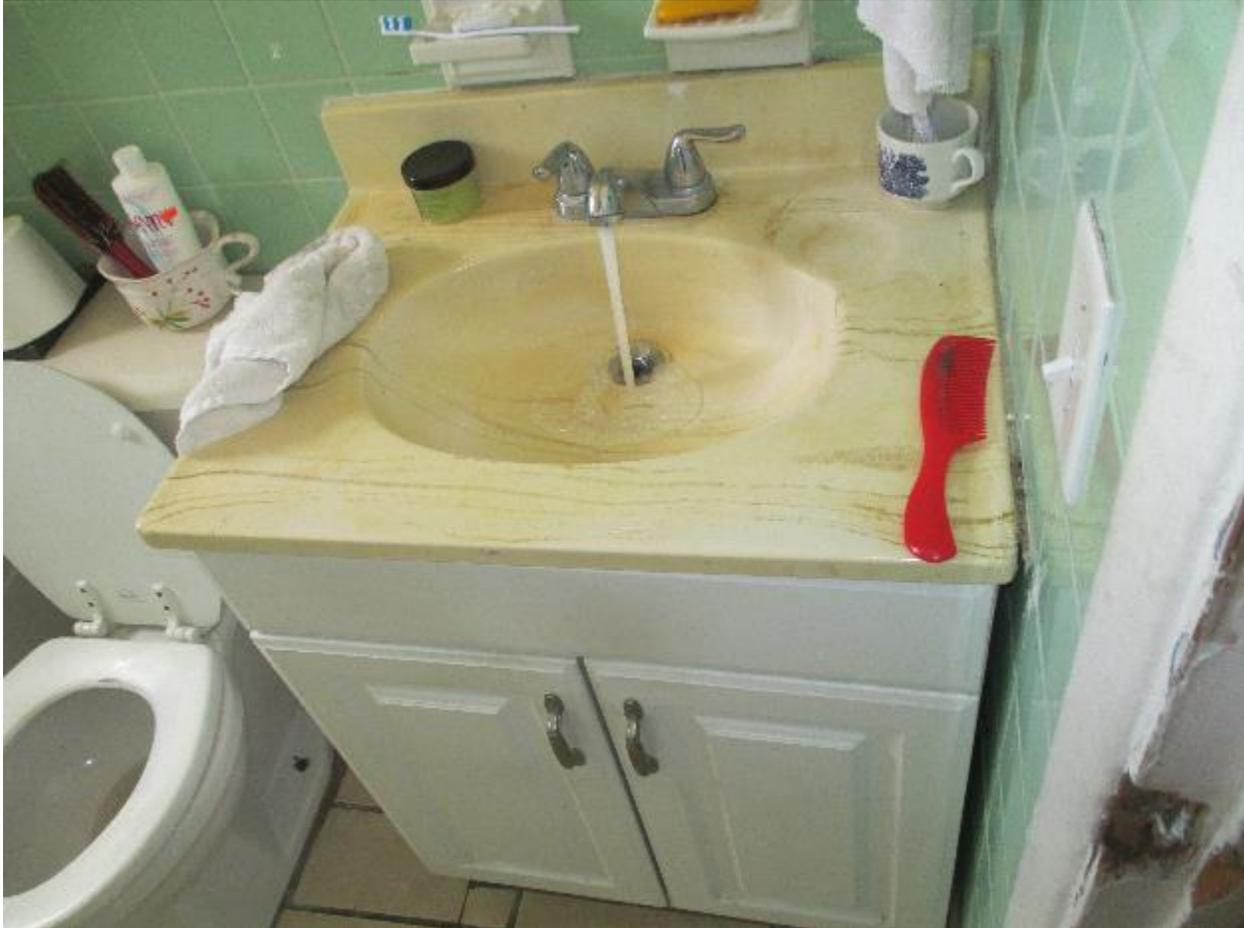
Plumbing systems tested for proper flow. No leaks or deficiencies noted on drain and supply lines.

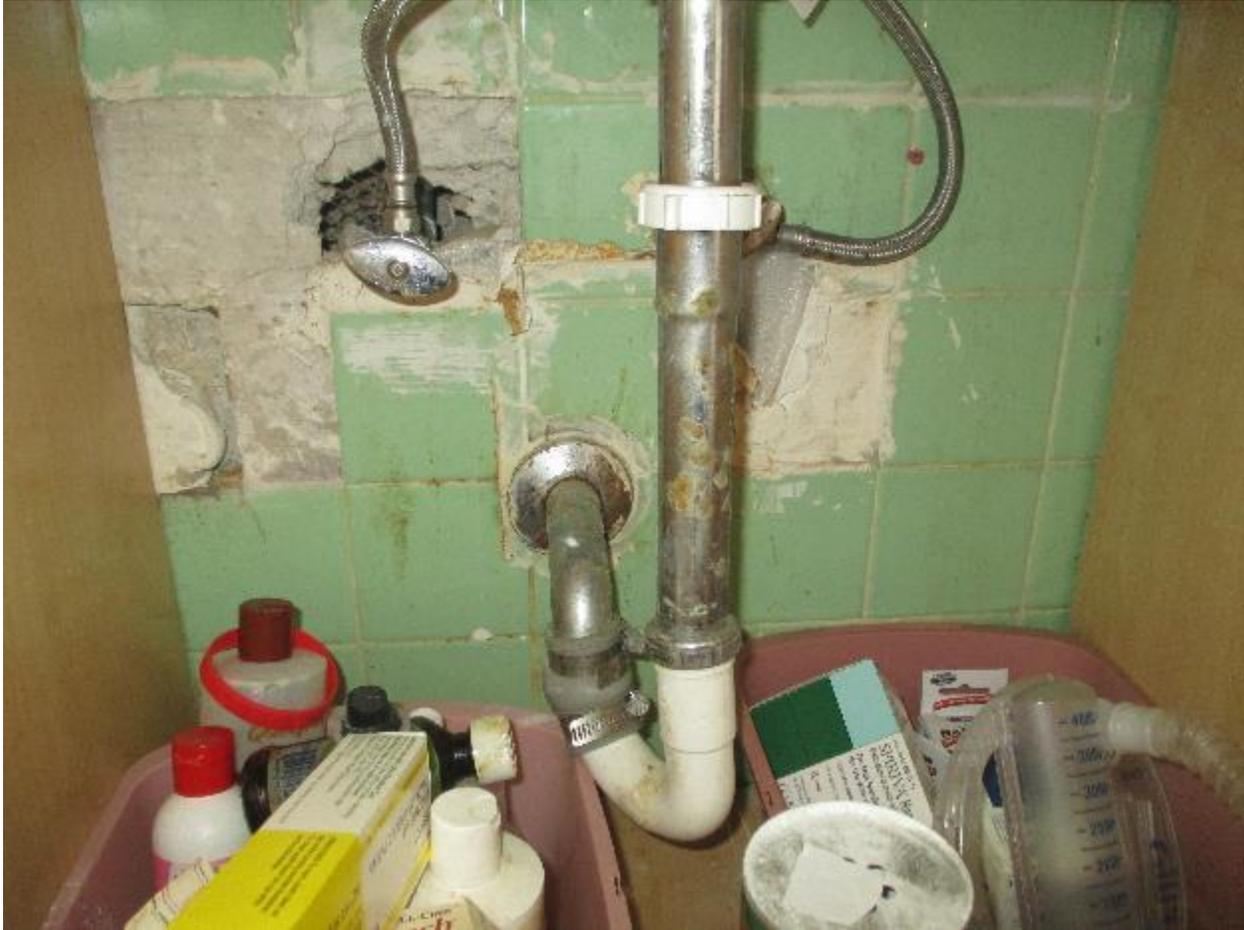
Plumbing systems tested for proper flow. No leaks or deficiencies noted on drain and supply lines.

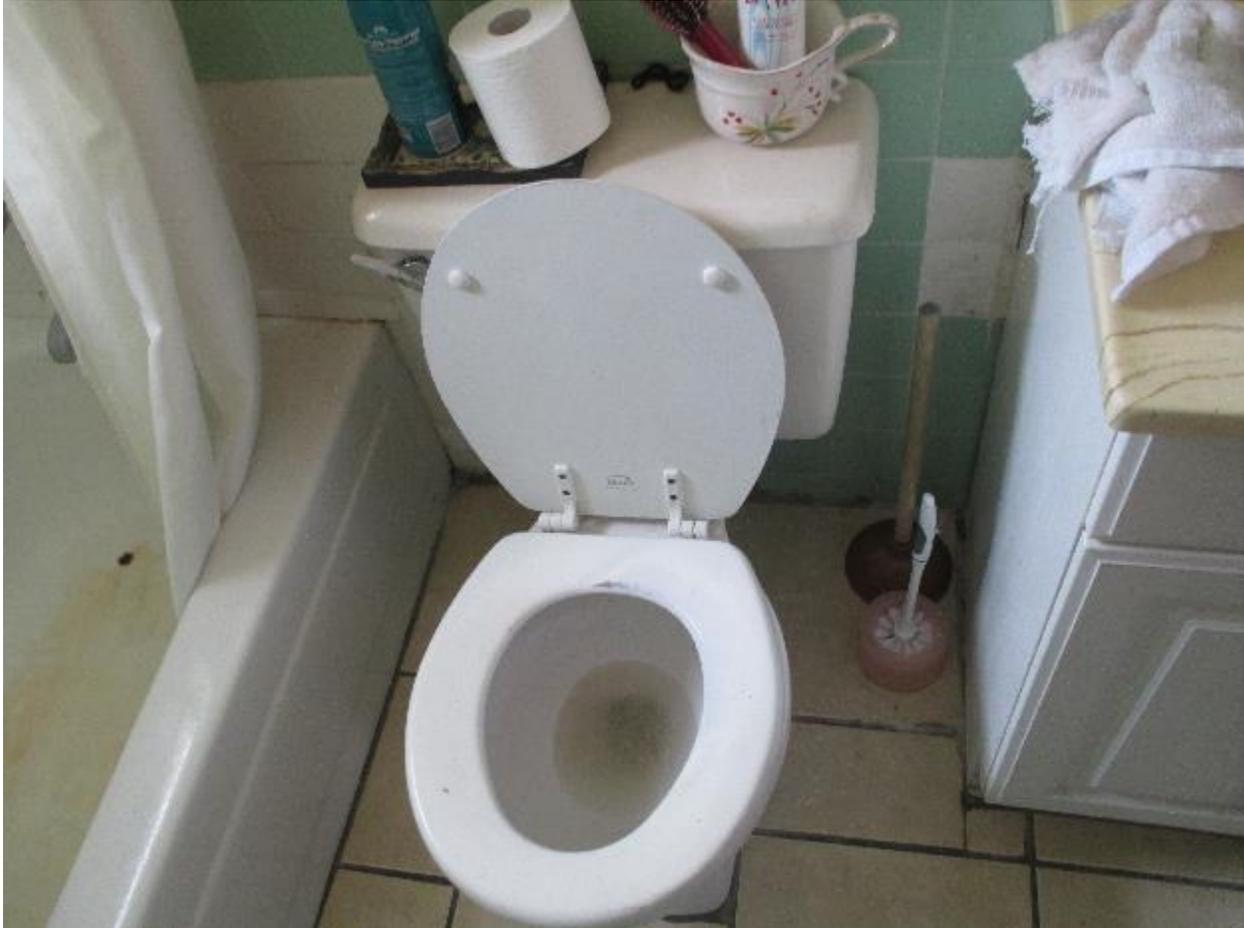
Interior finishes were found in general good condition at the time of inspection with exceptions as noted and shown in photographs.

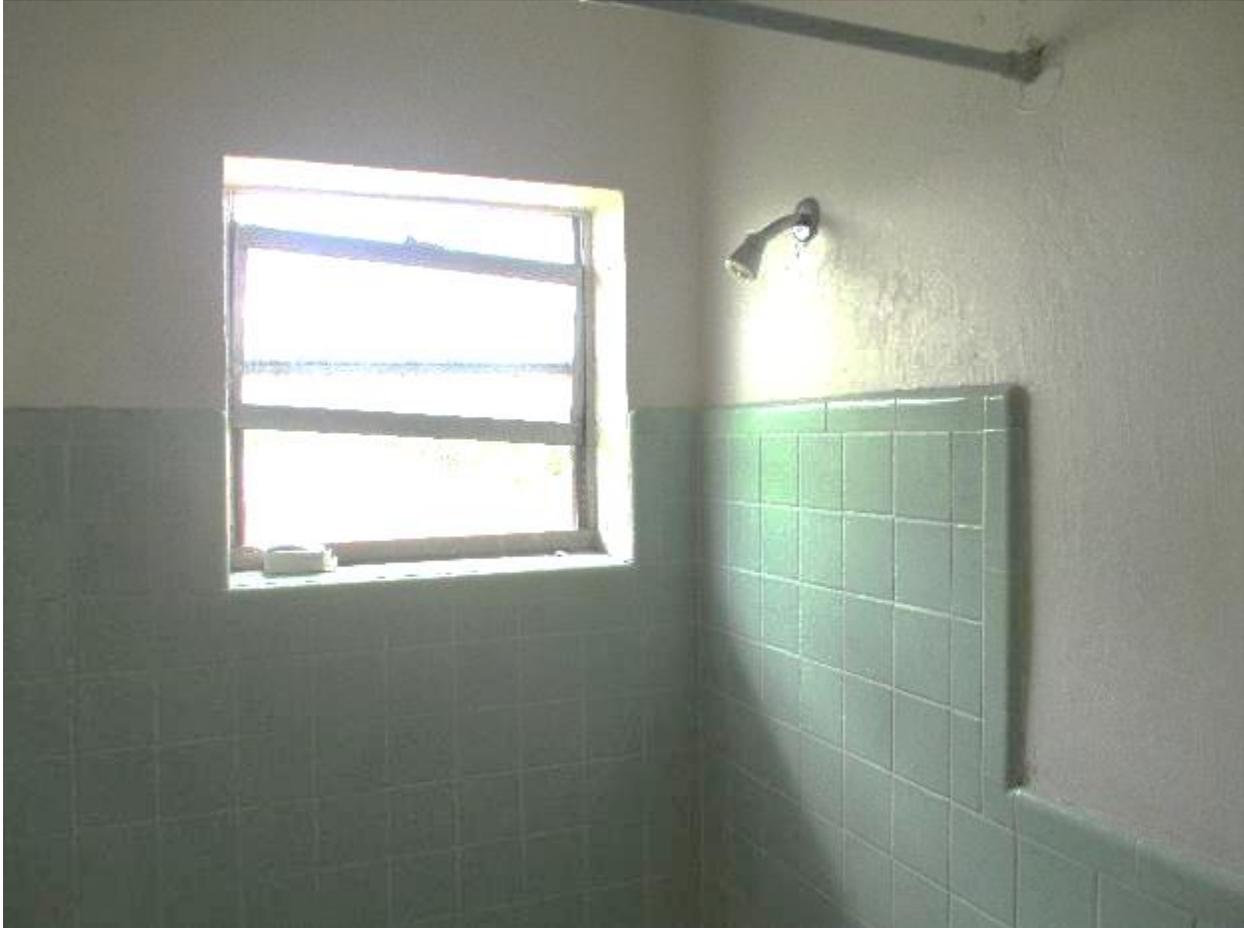
Interior finishes were found in general good condition at the time of inspection with exceptions as noted and shown in photographs.

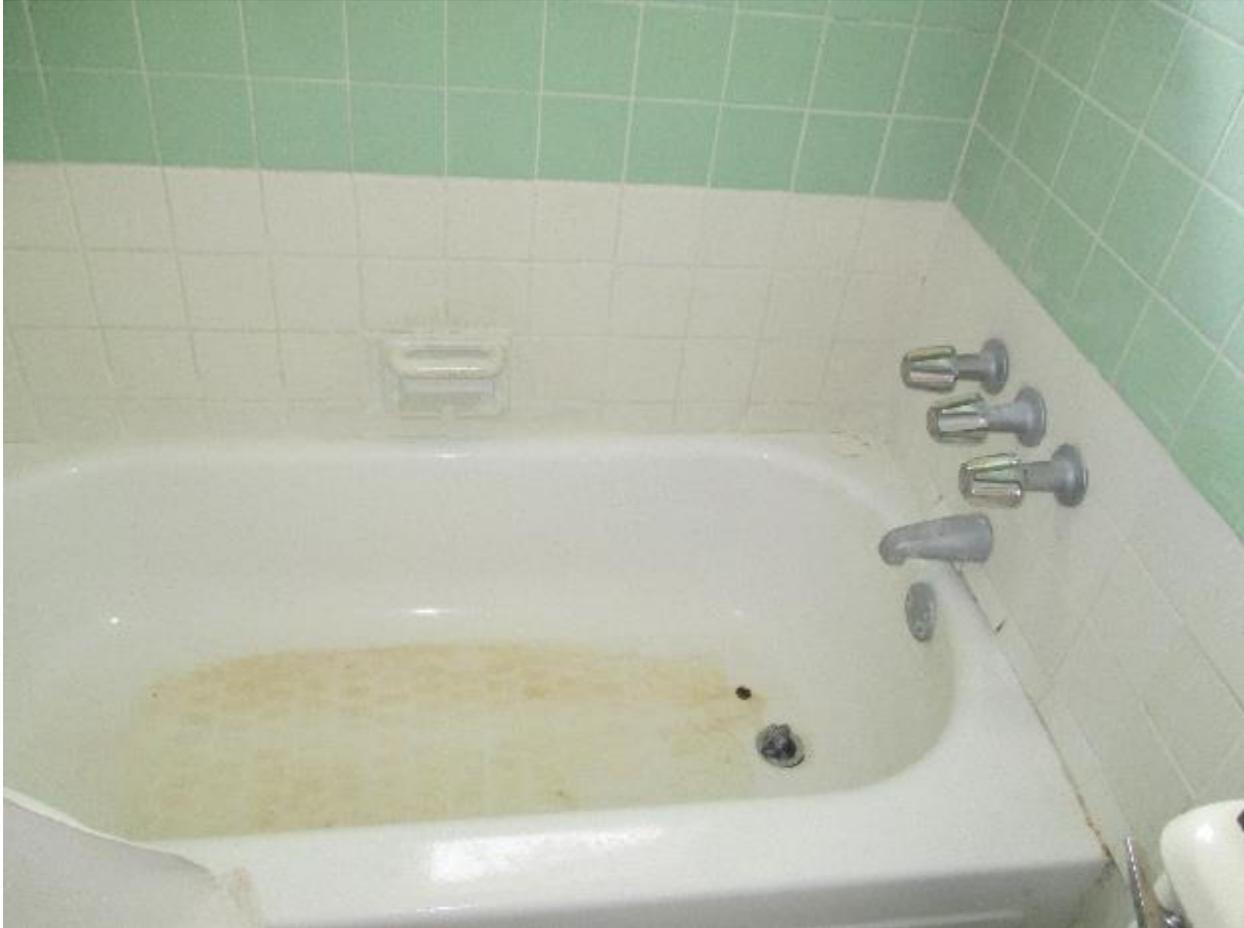
Interior finishes were found in general good condition at the time of inspection with exceptions as noted and shown in photographs.

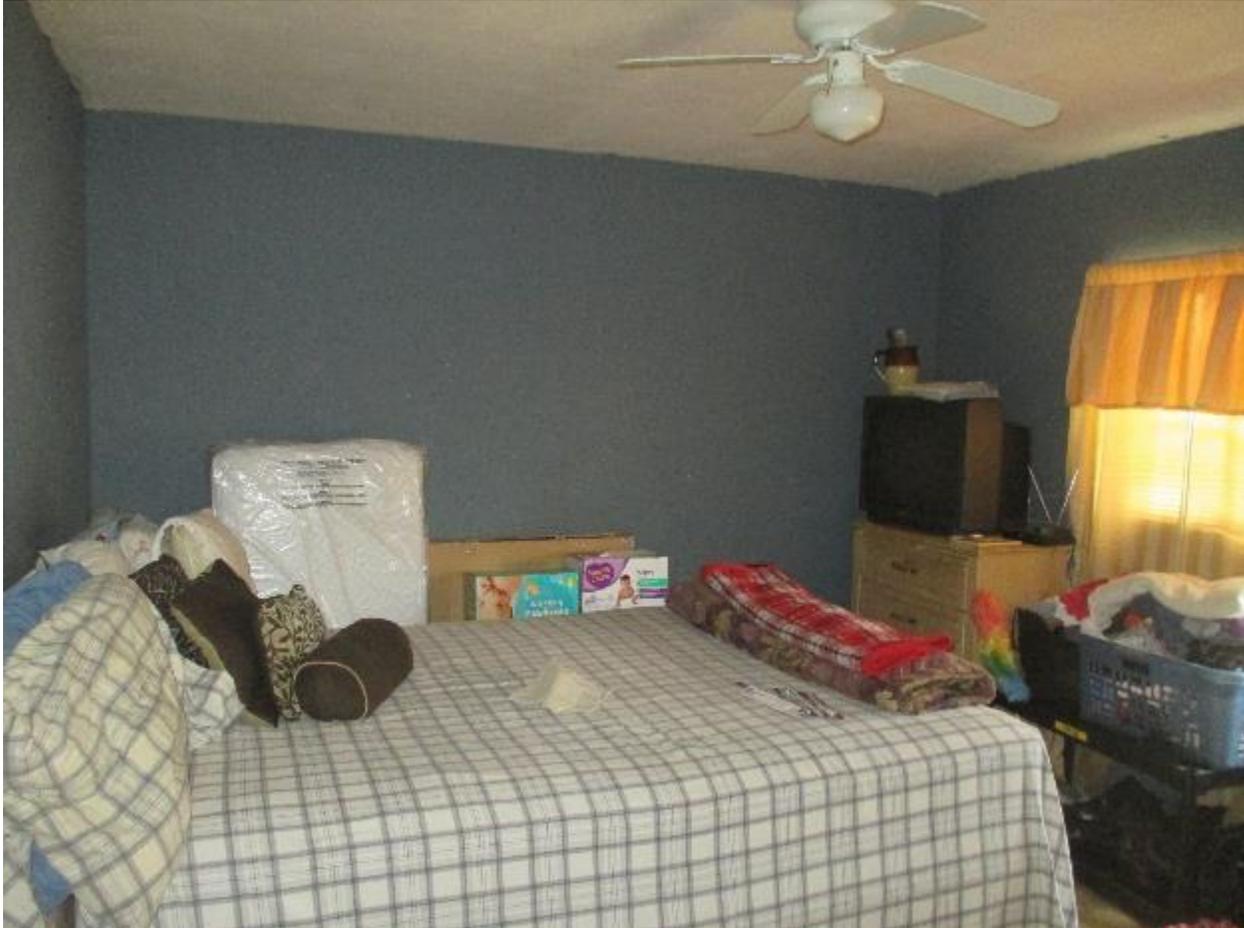
Interior finishes were found in general good condition at the time of inspection with exceptions as noted and shown in photographs.

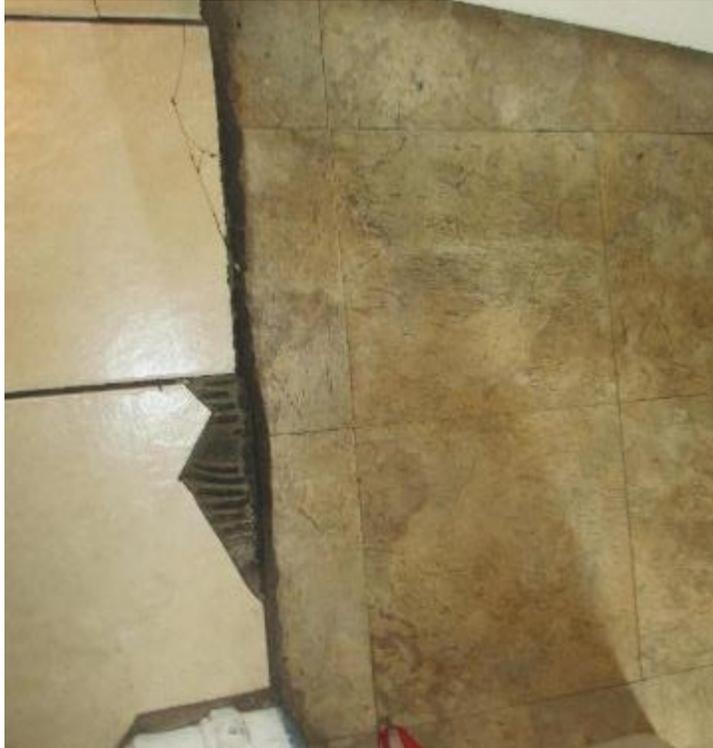
Dissimilar material on floors to be considered for removal and replacement for a uniform look.

Cracked tiles without possibilities of repair. Complete removal of flooring surfaces must be done in order to provide a finished appearance.

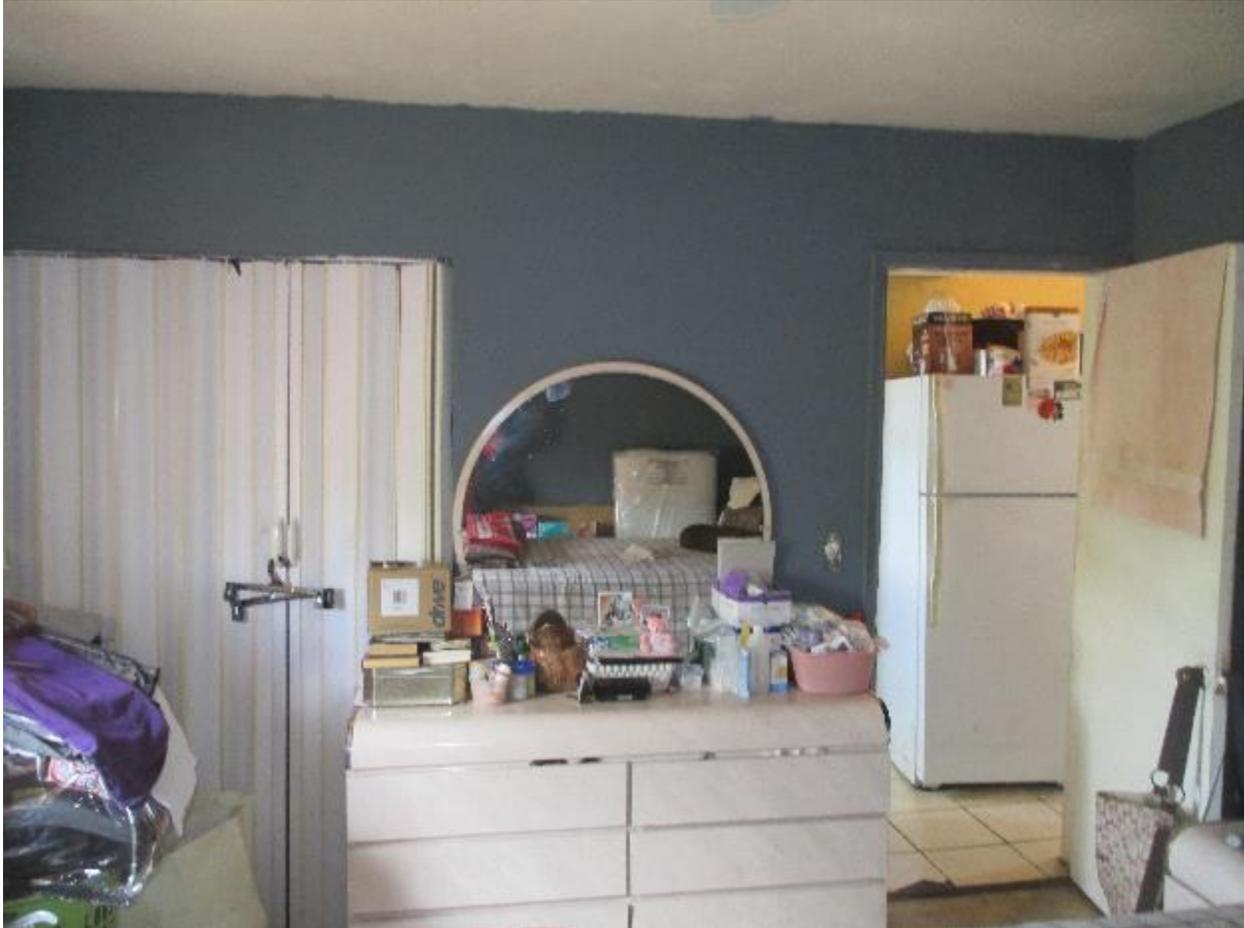
Interior finishes were found in general good condition at the time of inspection with exceptions as noted and shown in photographs.

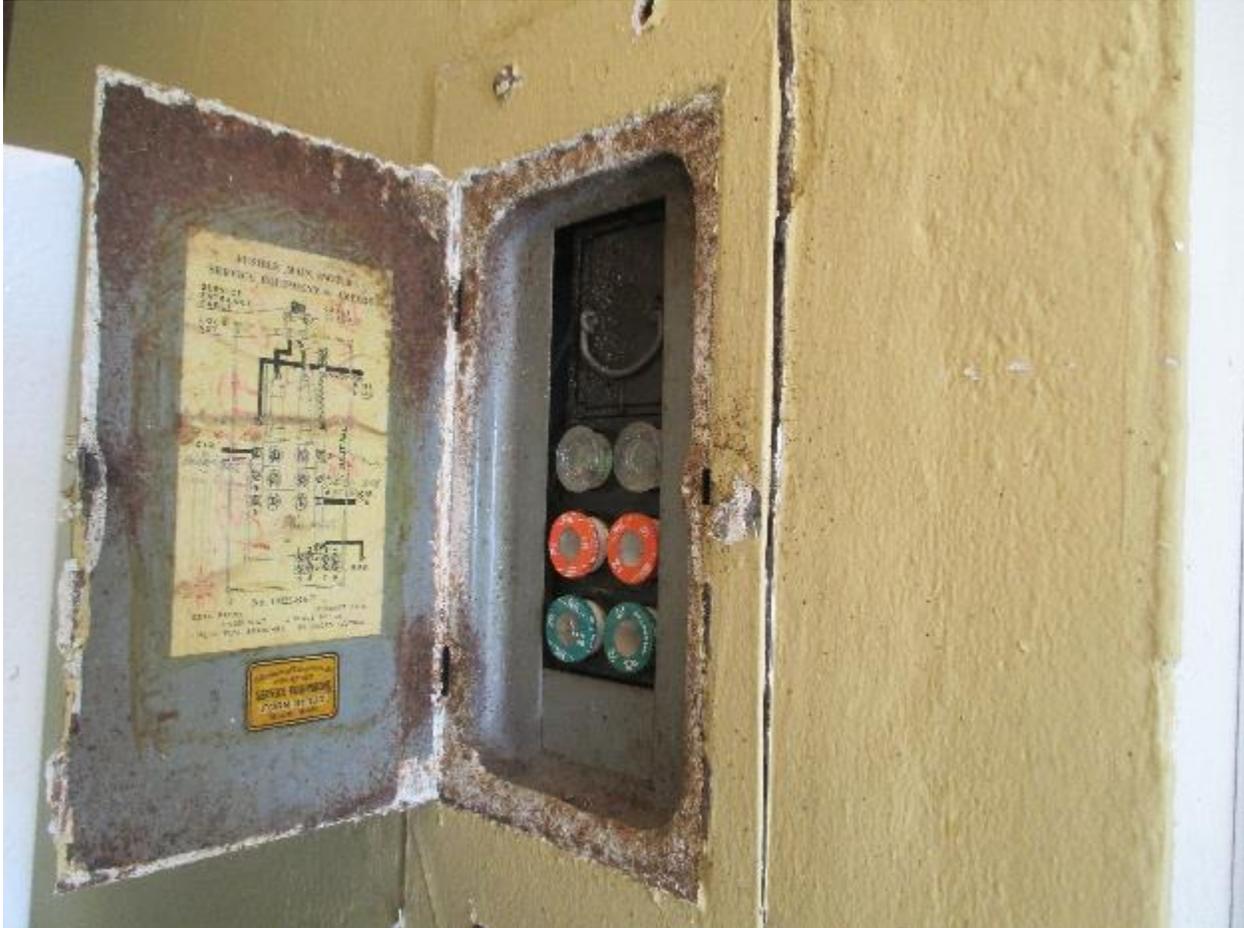
A complete upgrade of the electrical system is recommended including and not limited to GFCI's, smoke detectors, replace outlets and switches and make allowances for replacement of interior and exterior light fixtures. Beware that additional grounding will be required inside the property.

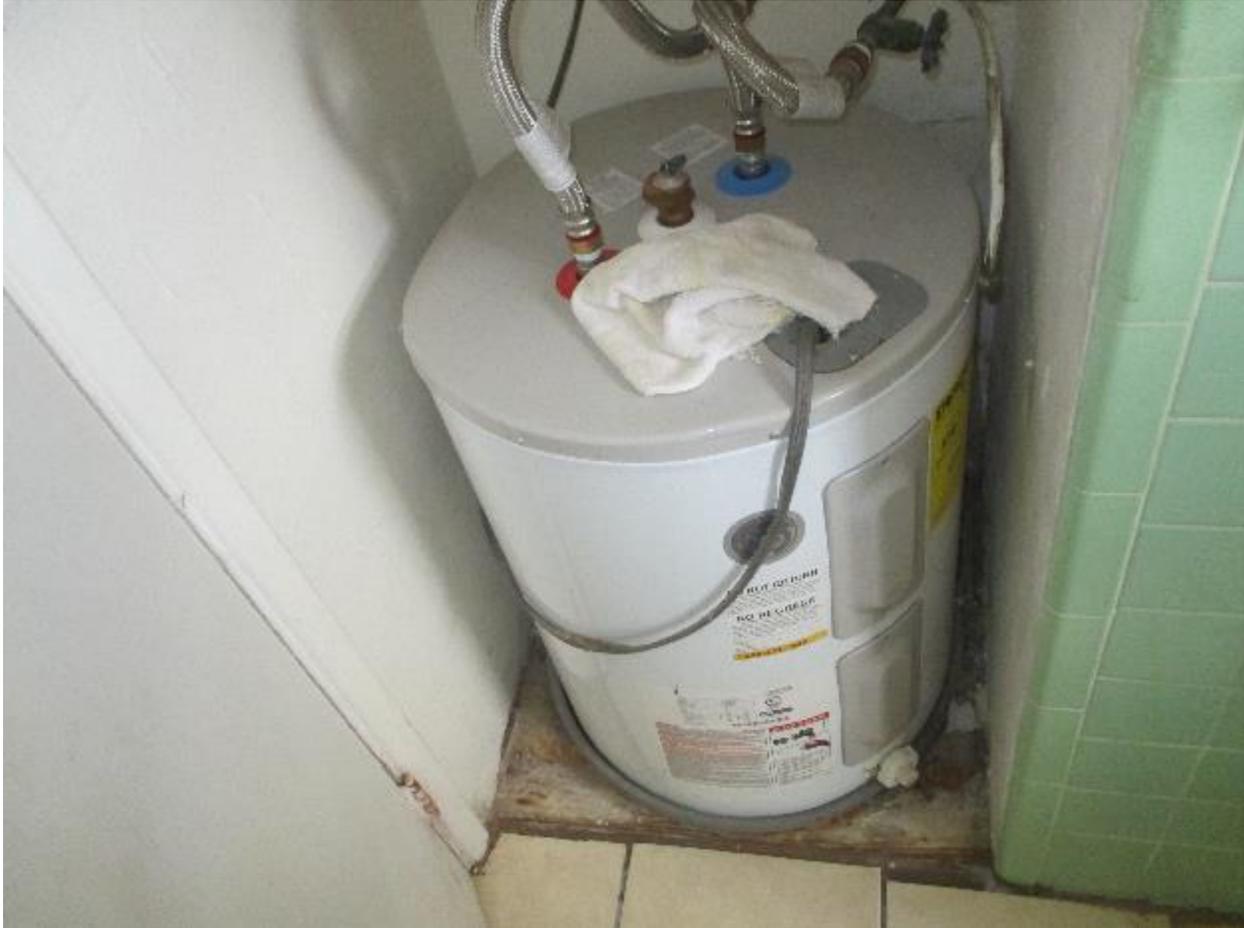
Water heater pressure release valve without release valve / not properly installed.

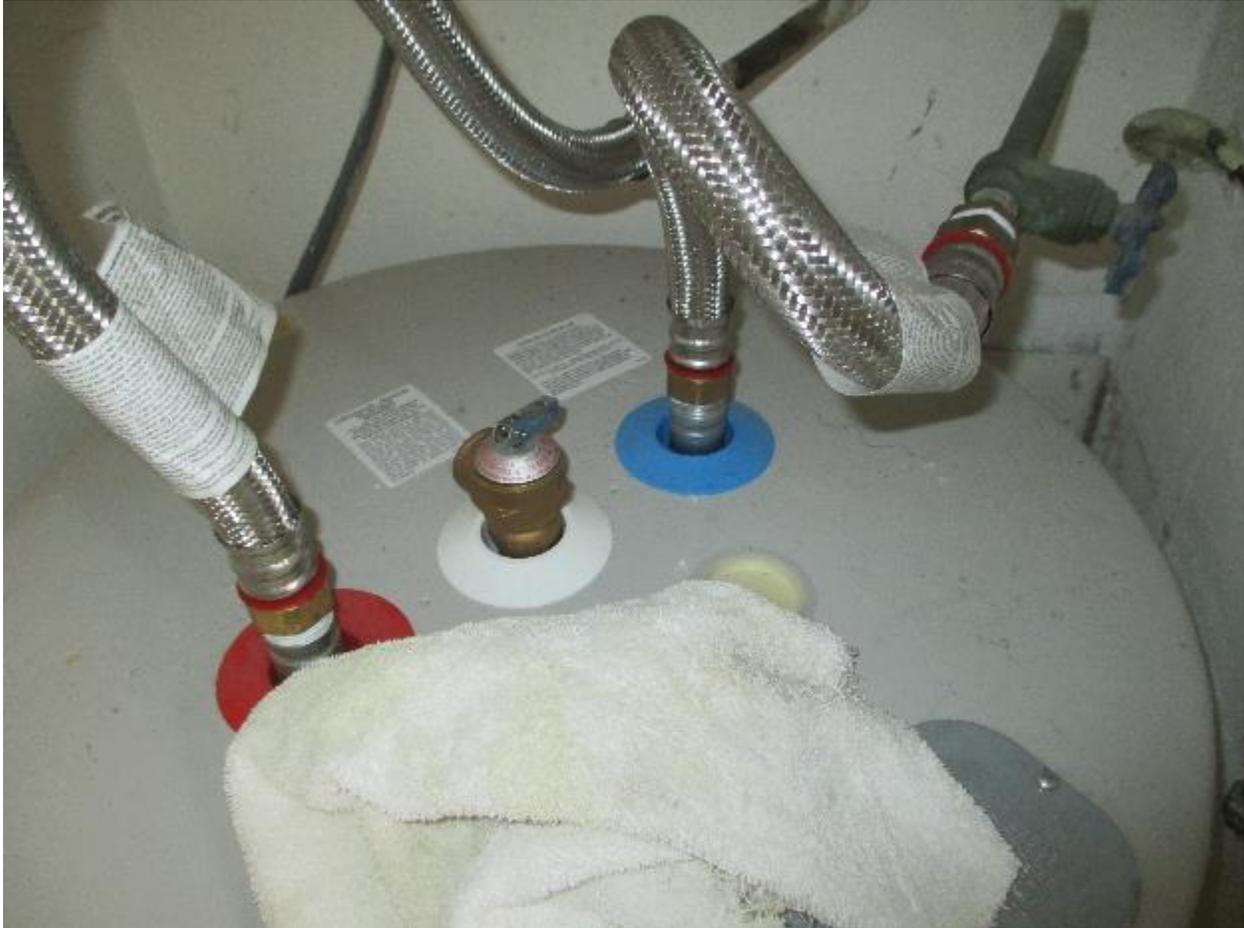
Water heater pressure release valve without release valve / not properly installed.

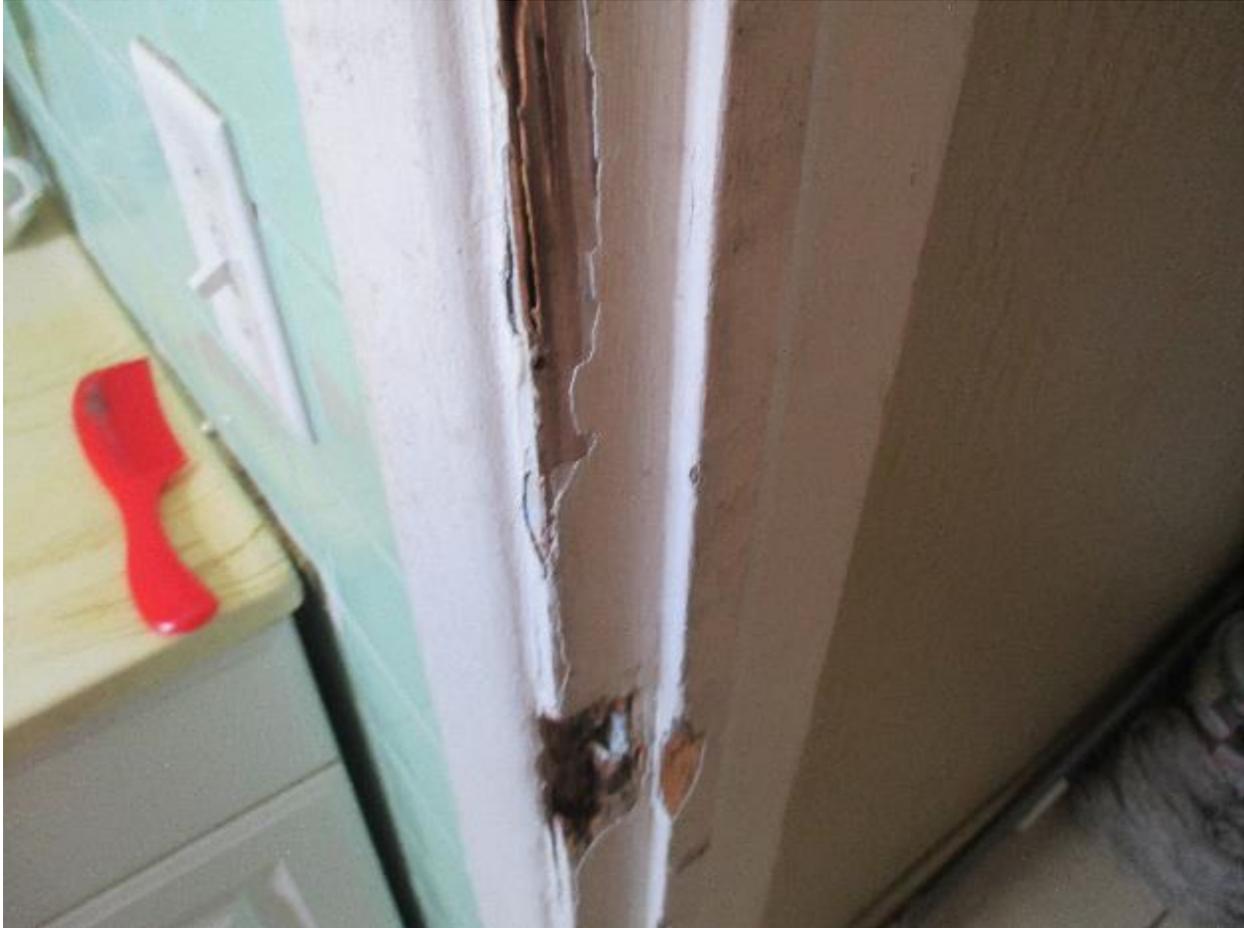
Allowances must be made for the replacement / upgrade of interior doors.

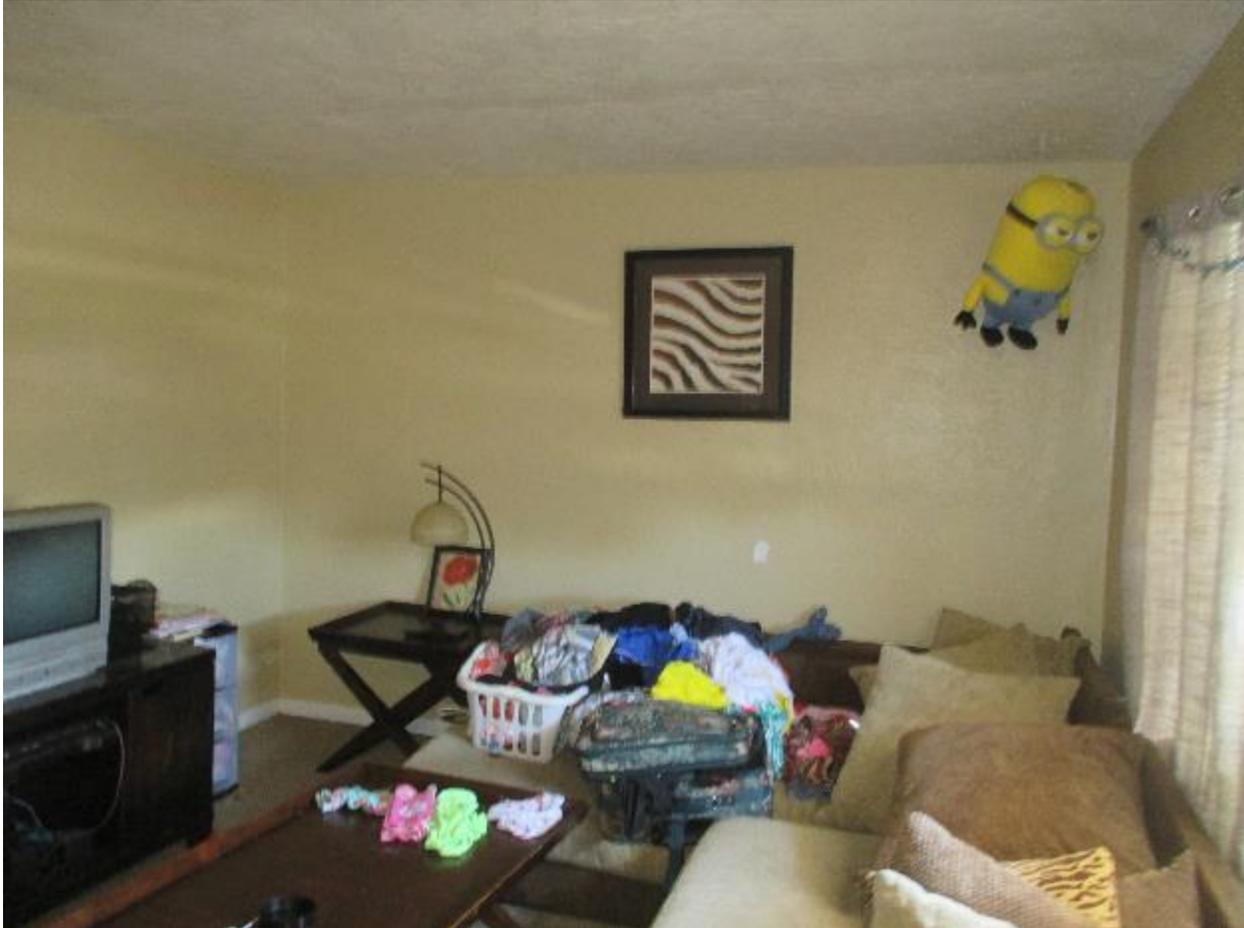
Interior finishes were found in general good condition at the time of inspection with exceptions as noted and shown in photographs.

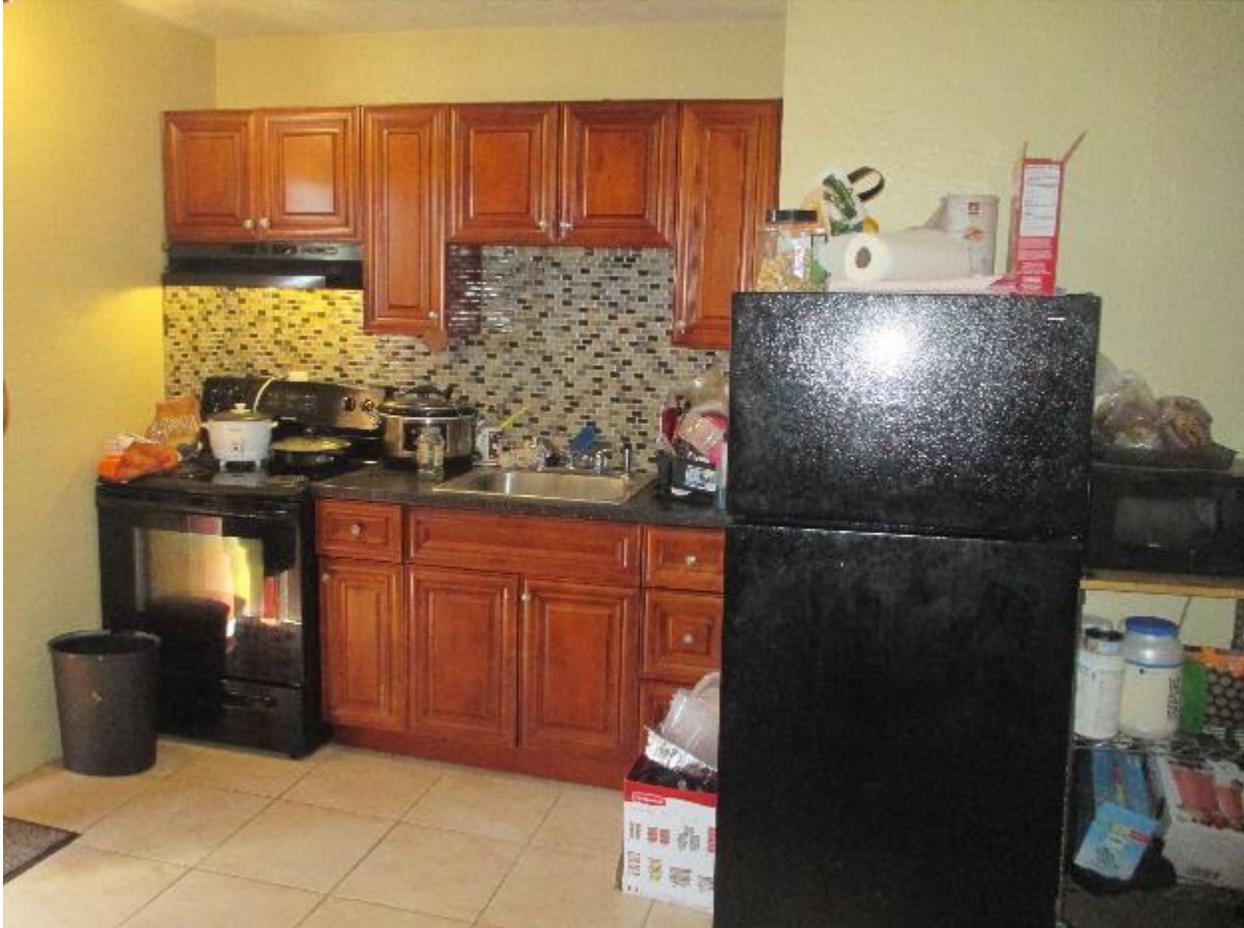
Interior finishes were found in general good condition at the time of inspection with exceptions as noted and shown in photographs.

No warranties or guarantees expressed on used appliances. Appliances found in working condition at the time of inspection.

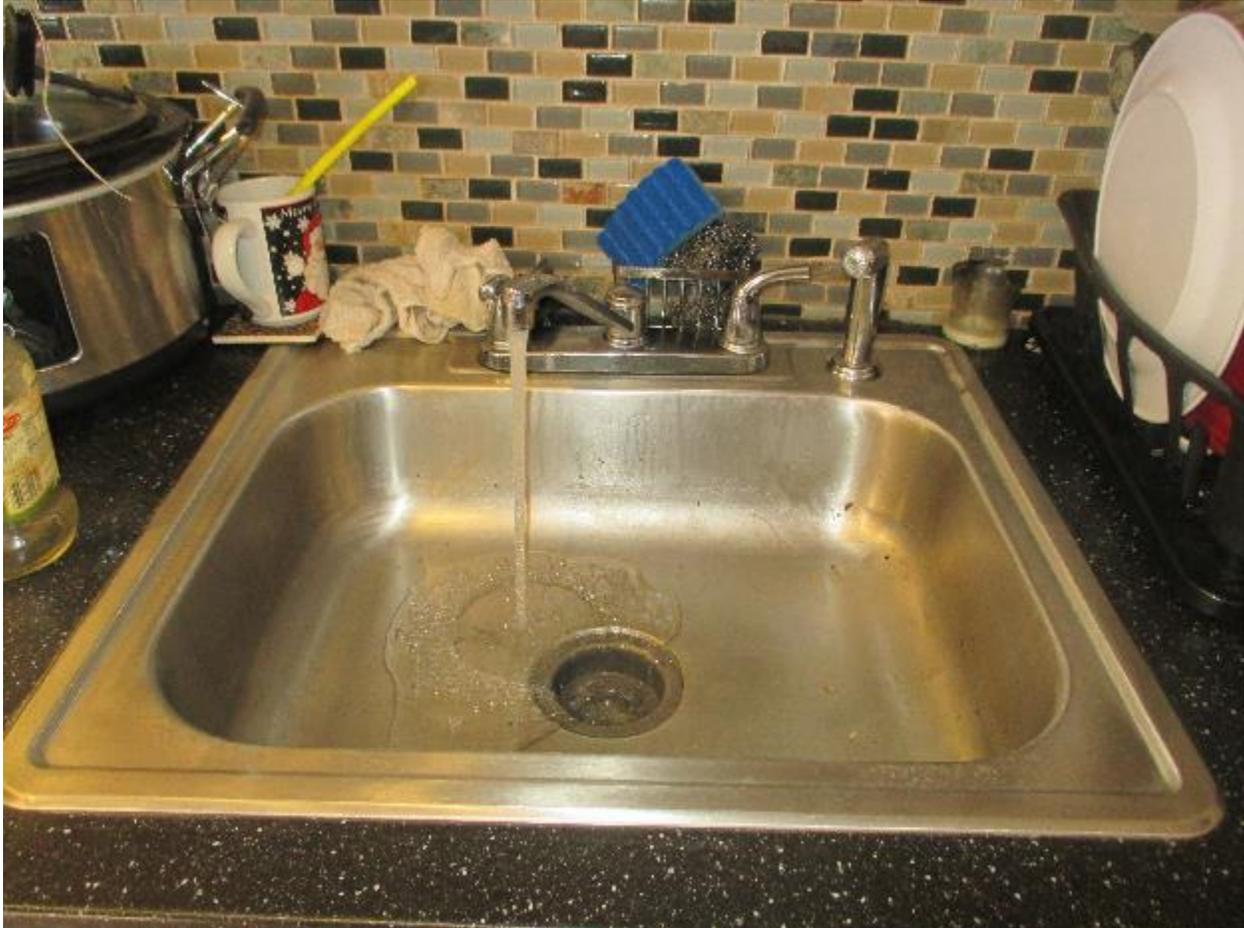
Plumbing systems tested for proper flow. No leaks or deficiencies noted on drain and supply lines.

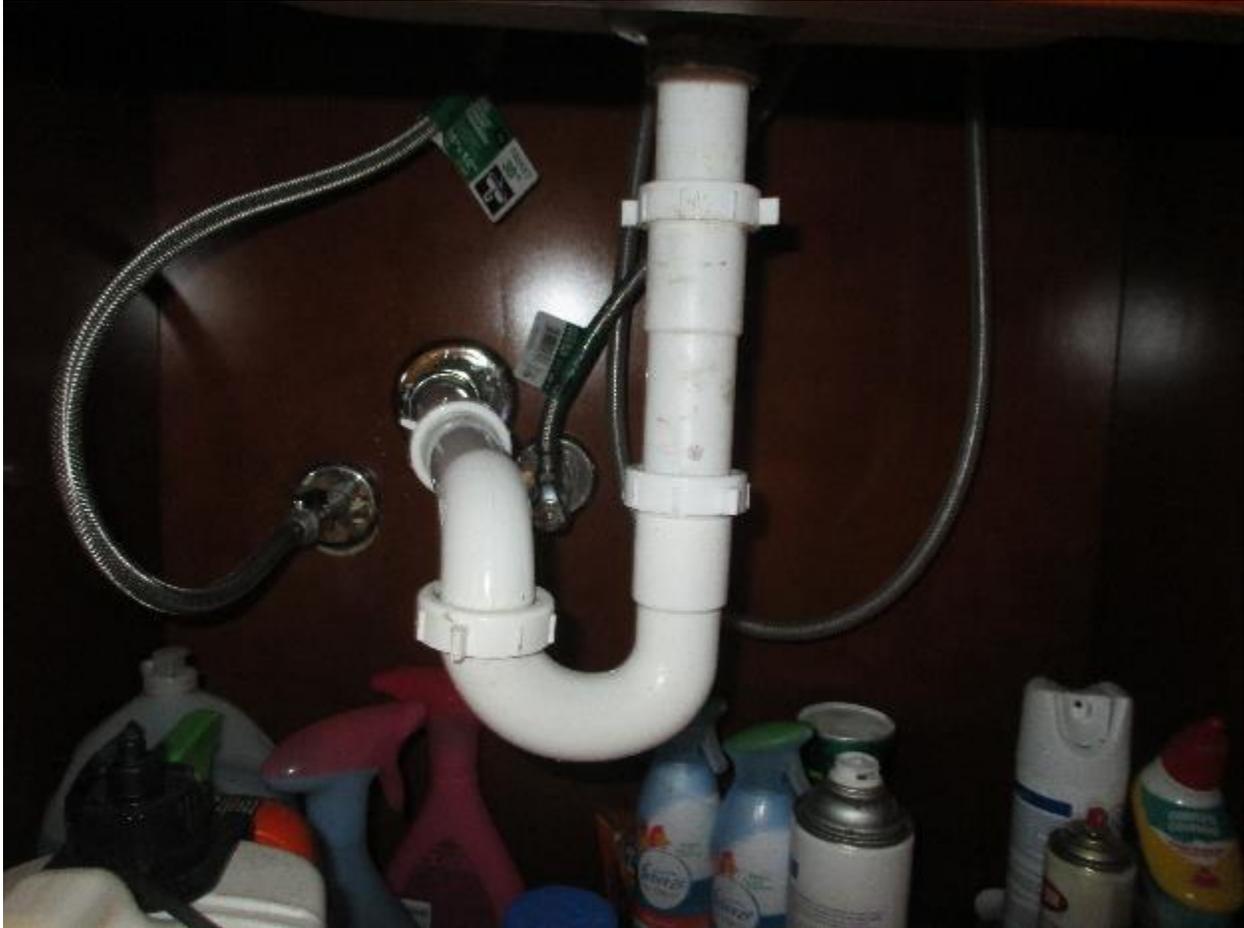
Plumbing systems tested for proper flow. No leaks or deficiencies noted on drain and supply lines.

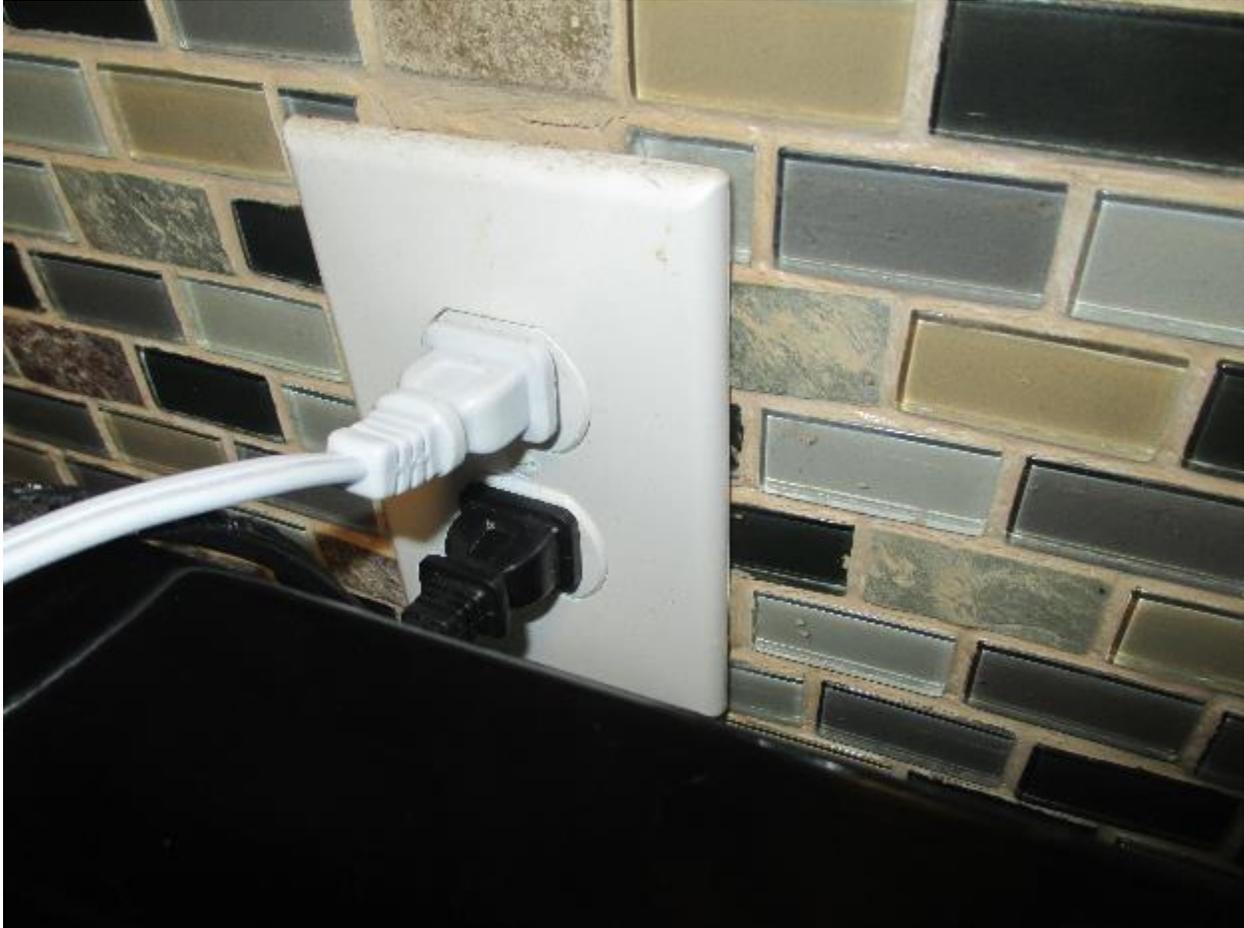
GFCI receptacles installation is required at wet areas such as bathrooms and kitchens.
