PROPERTY INSPECTION OR ASSESSMENT OF DAMAGES

ADDRESS: **SOMEWHERE , FL**
CLIENT: **GAIA GC**
ID No: **2015000**
DATE: **12/31/xxxx**

GAIA CONSTRUCTION INC.
CGC 1516136 FLORIDA
HI-2792 FLORIDA
8028867-B2 INTERNATIONAL CODE COUNCIL

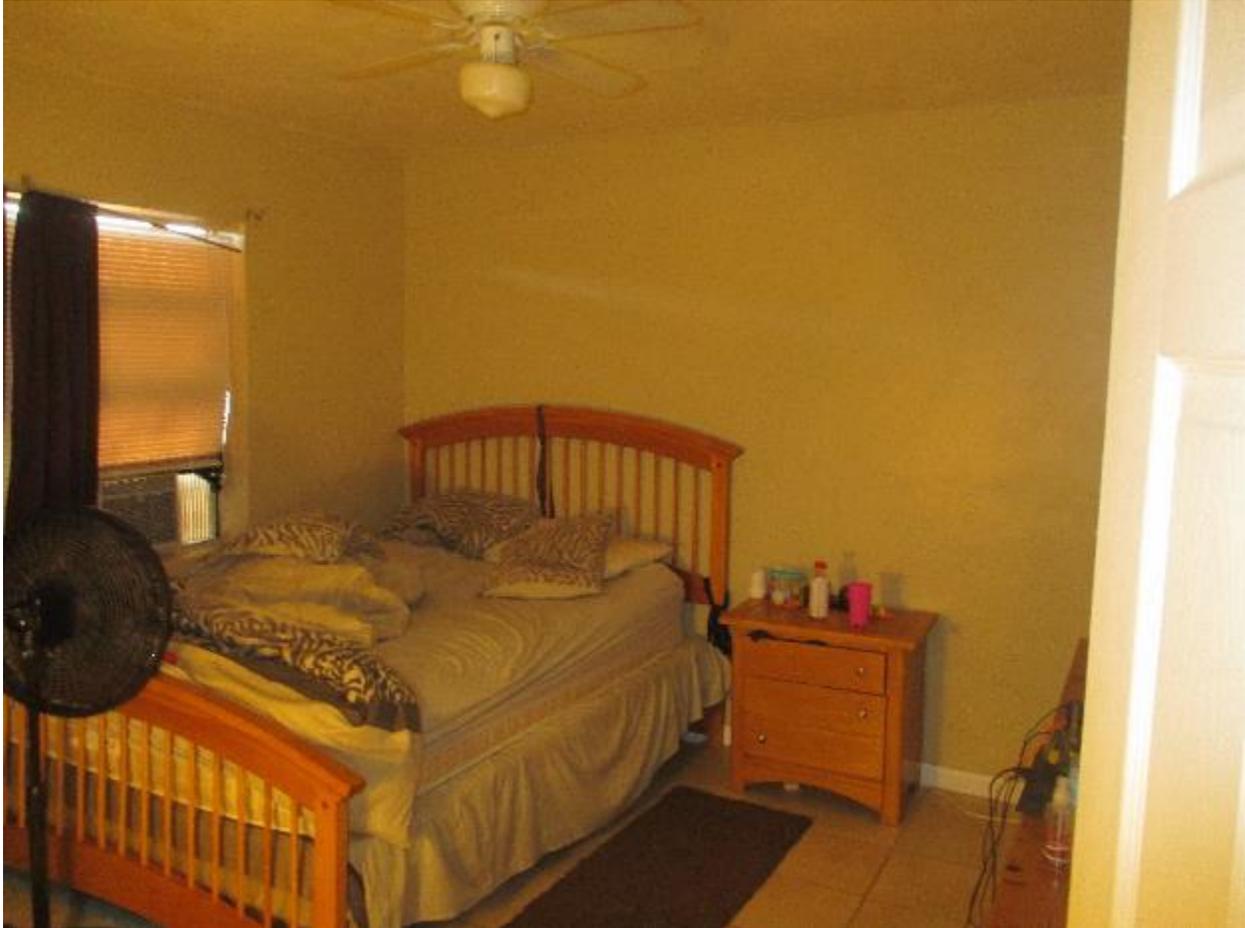
Interior finishes were found in general good condition at the time of inspection with exceptions as noted and shown in photographs.

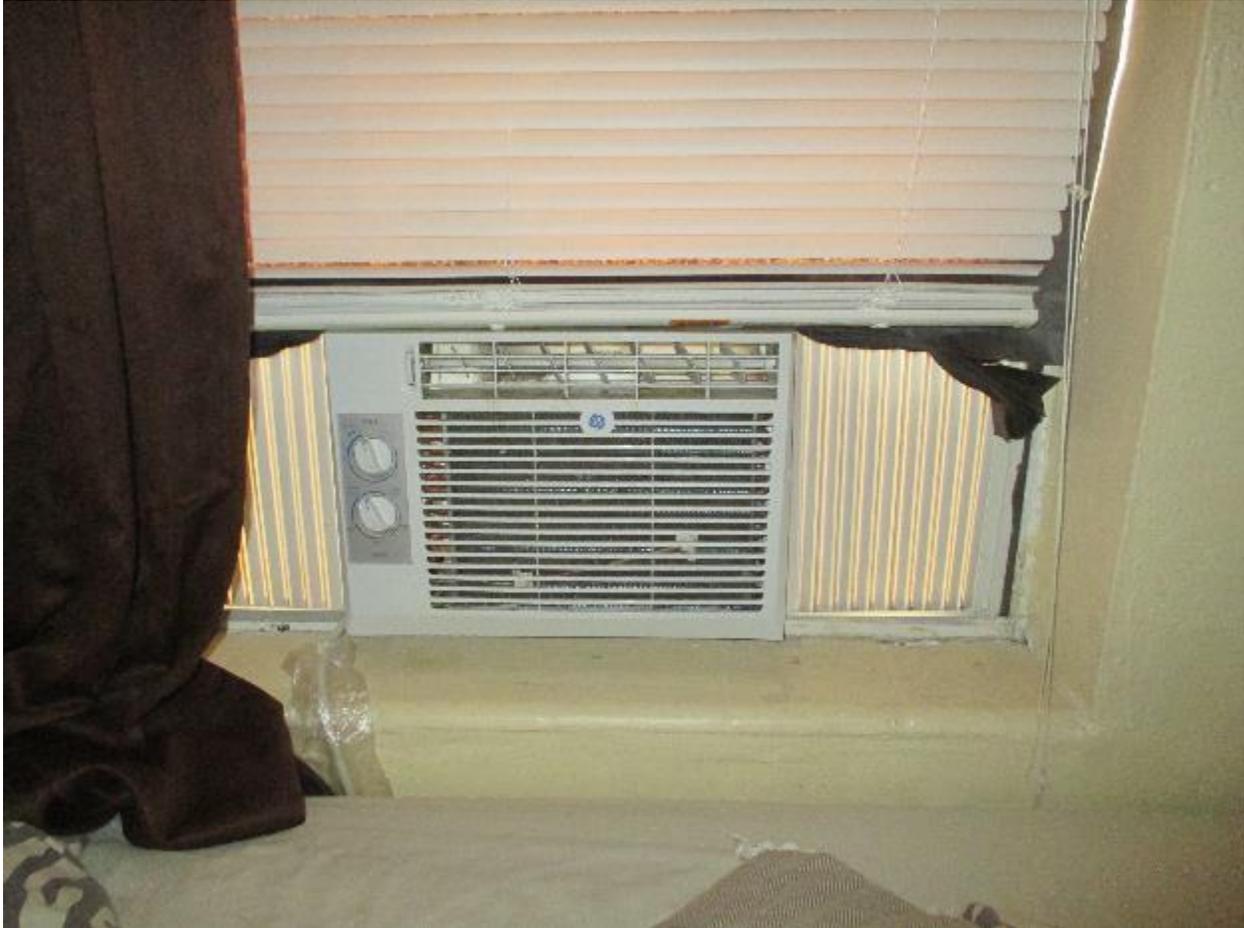
Ac in good working condition at the time of inspection.

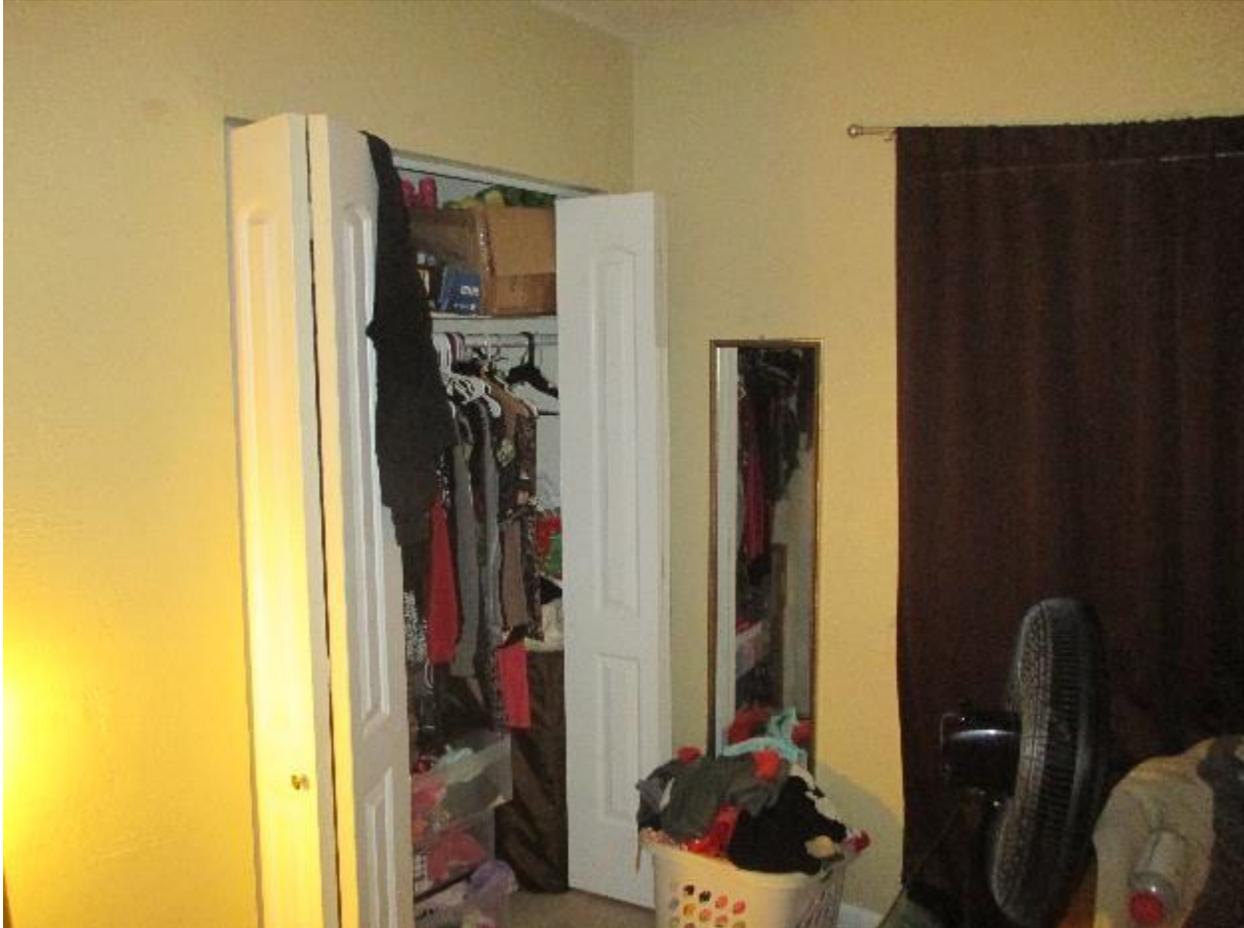
Interior finishes were found in general good condition at the time of inspection with exceptions as noted and shown in photographs.

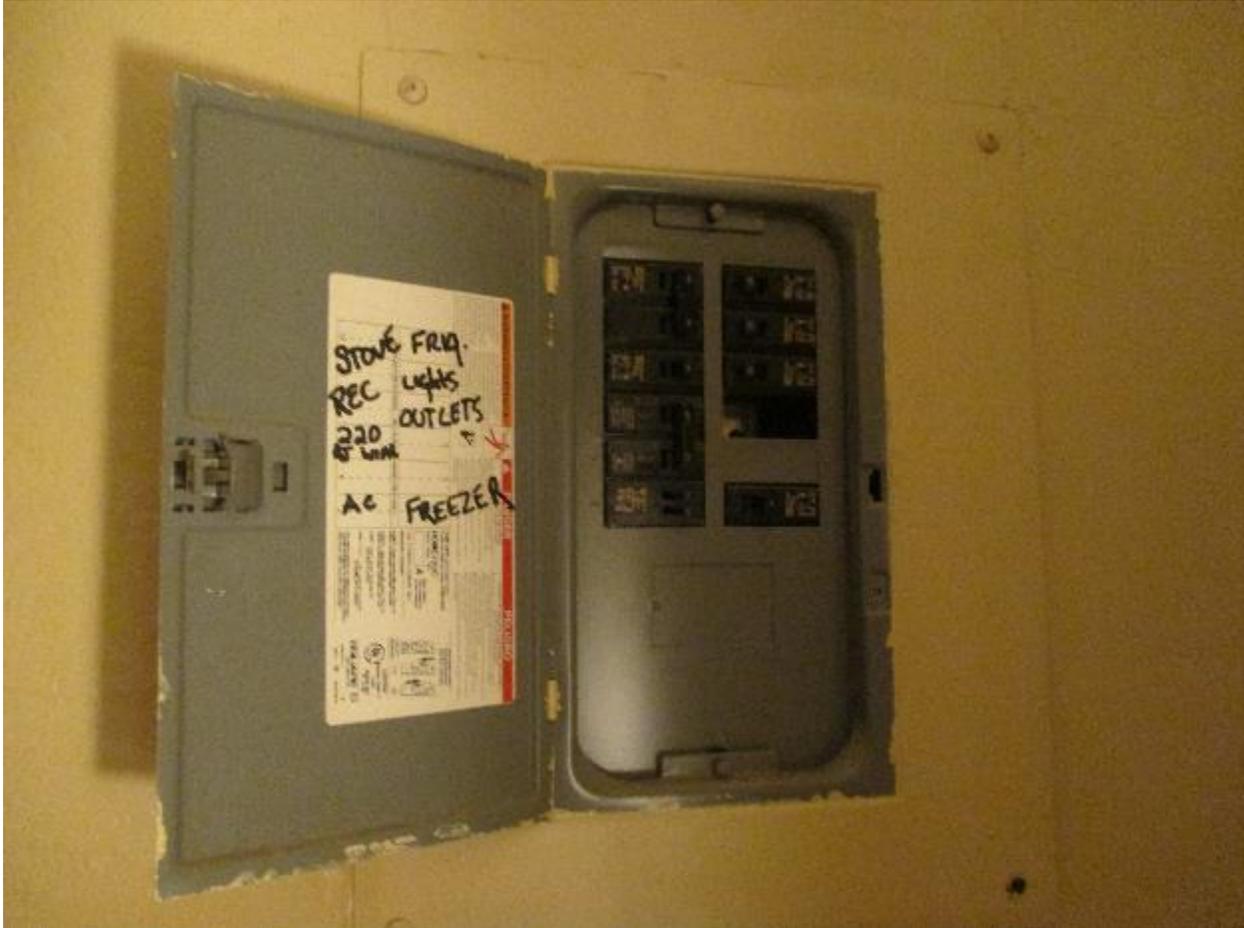
Electrical breaker panel in good condition at the time of inspection.

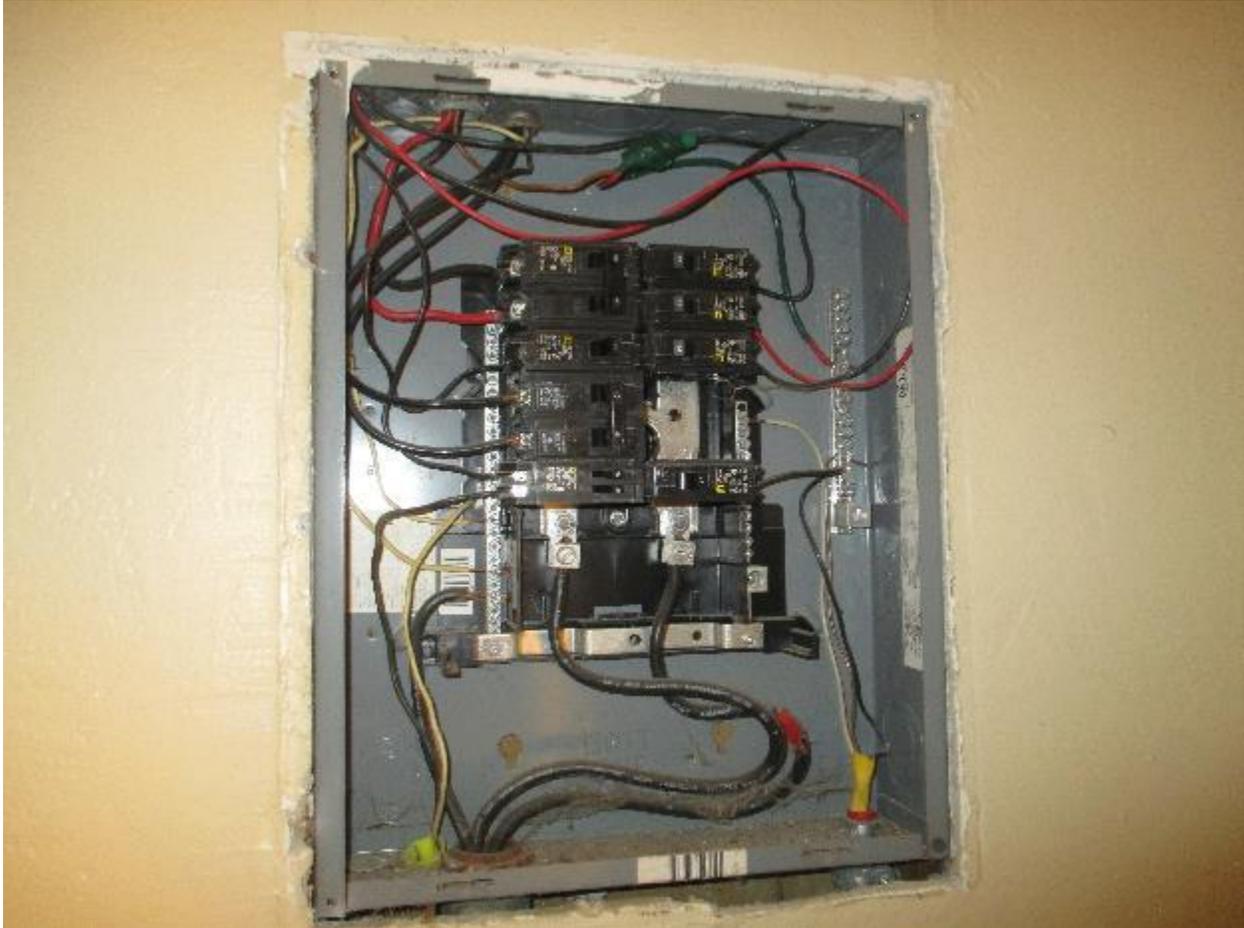
Electrical breaker panel in good condition at the time of inspection.

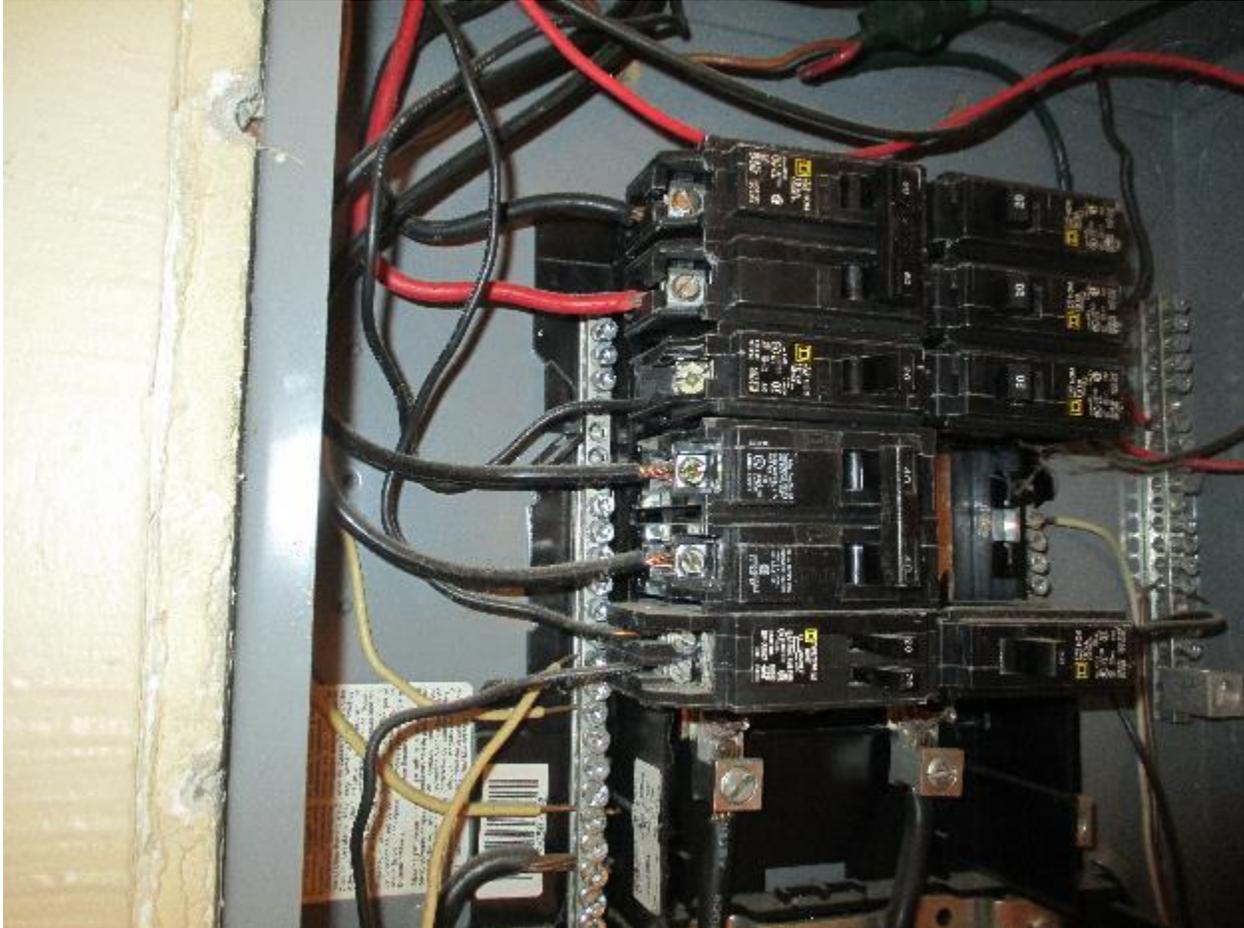
Electrical breaker panel in good condition at the time of inspection.

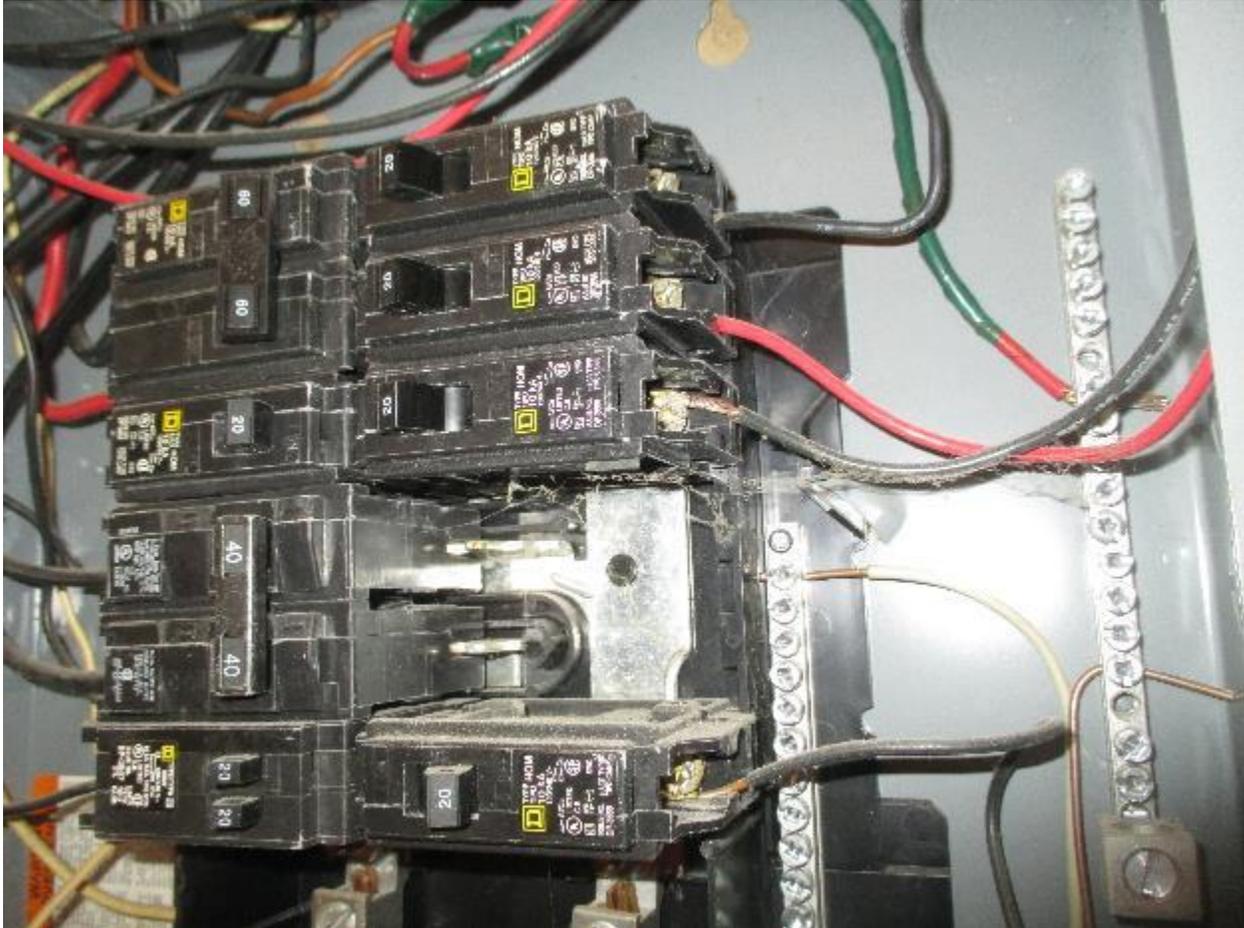
Electrical breaker panel in good condition at the time of inspection.

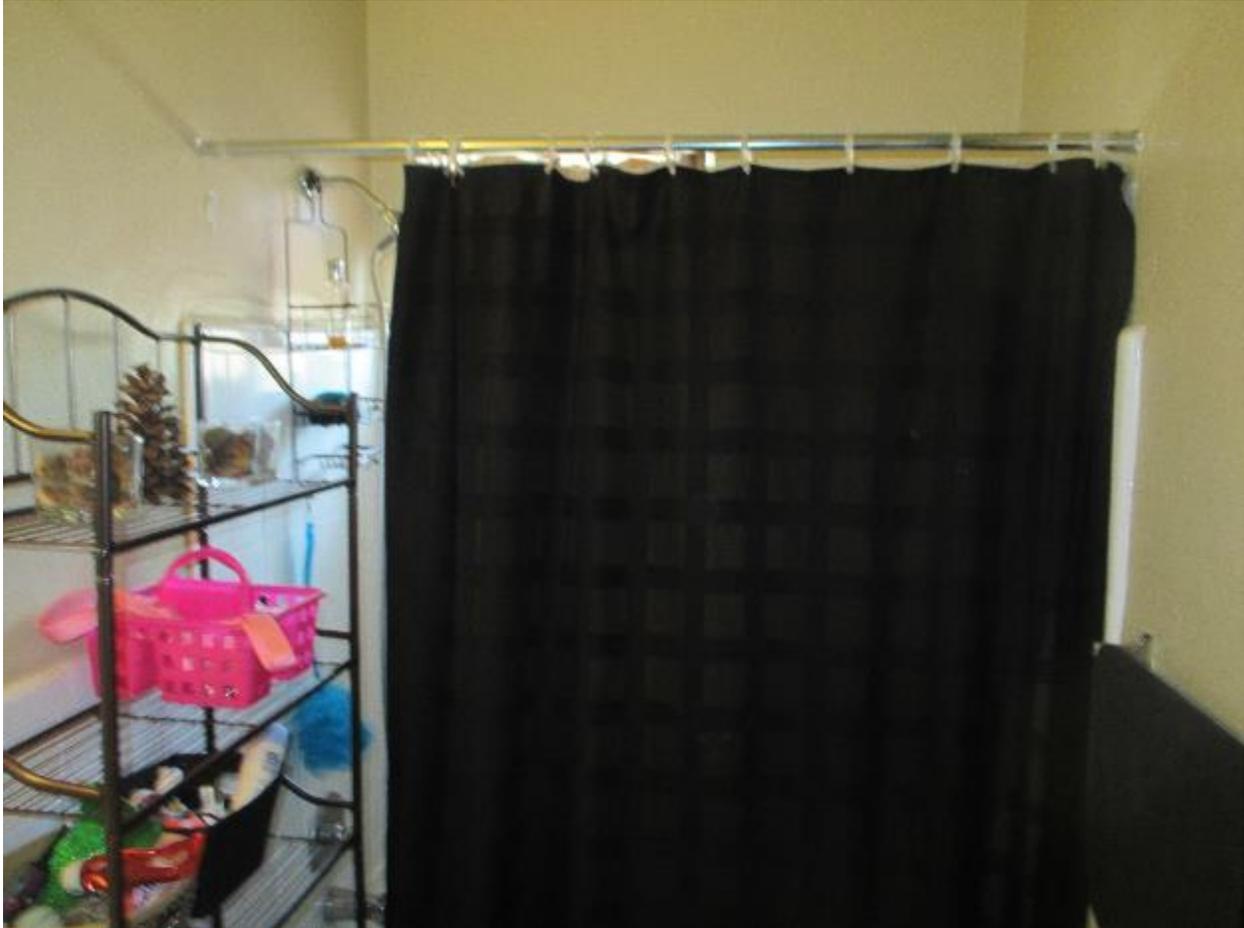
Interior finishes were found in general good condition at the time of inspection with exceptions as noted and shown in photographs.

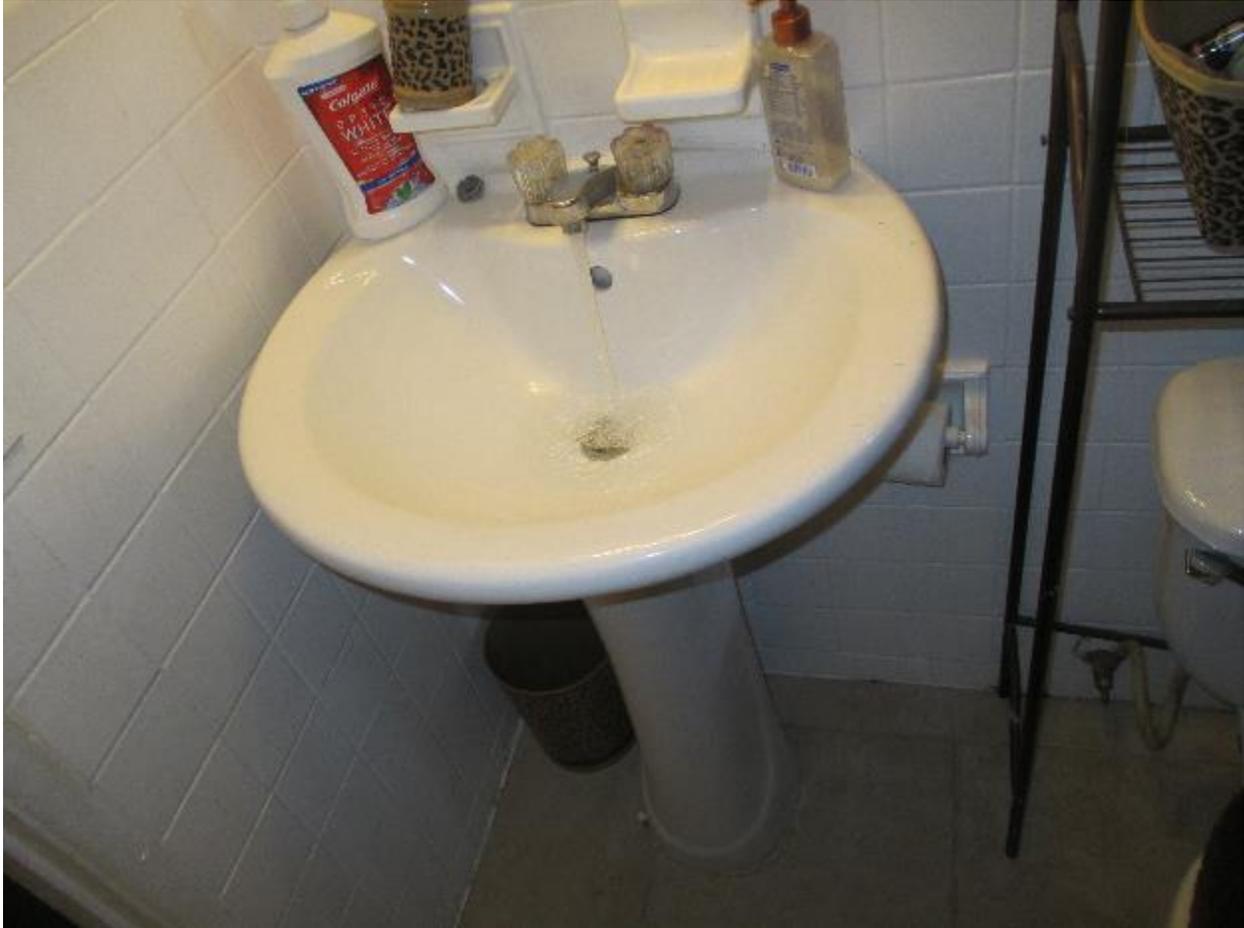
Plumbing systems tested for proper flow. No leaks or deficiencies noted on drain and supply lines.

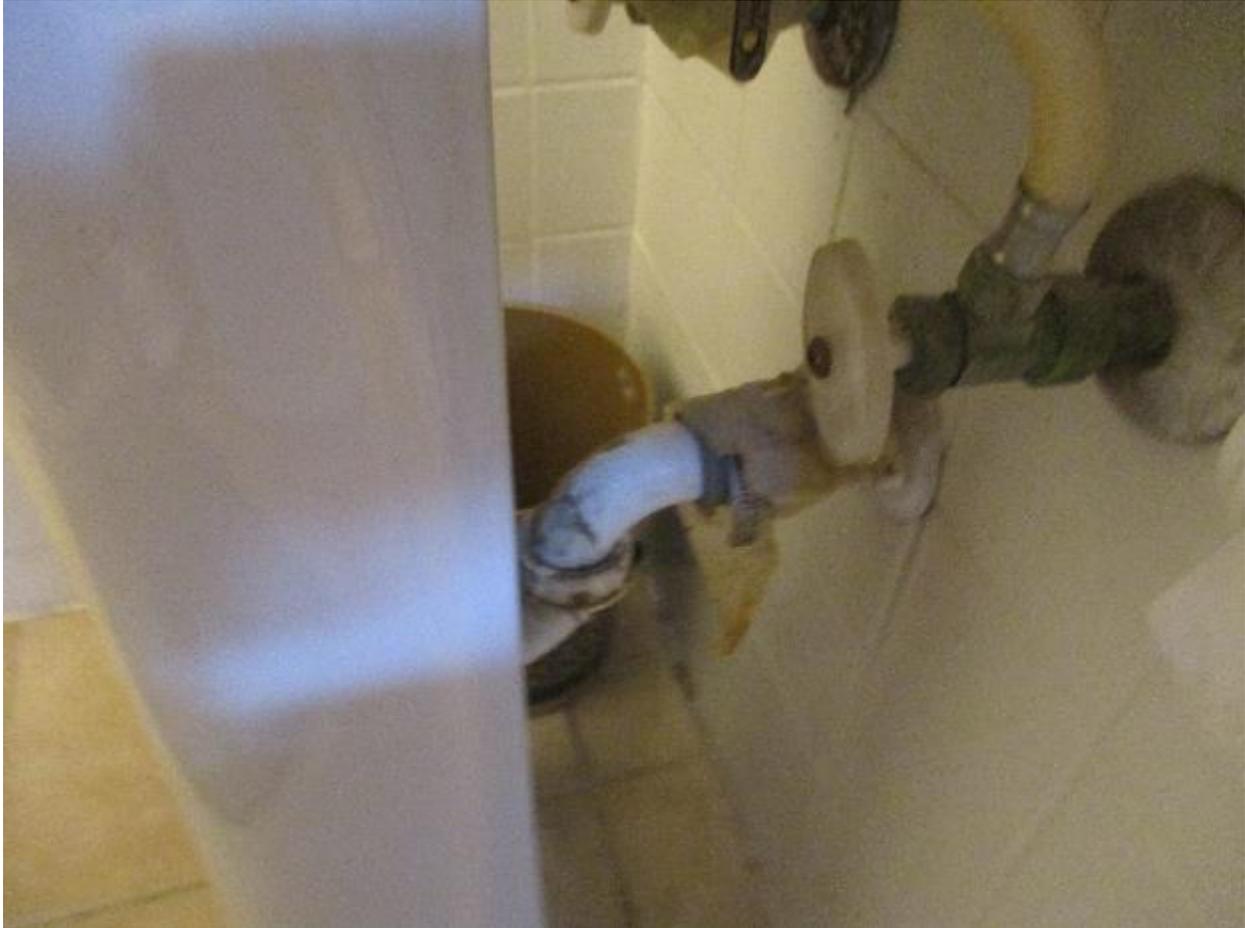
Plumbing systems tested for proper flow. No leaks or deficiencies noted on drain and supply lines.

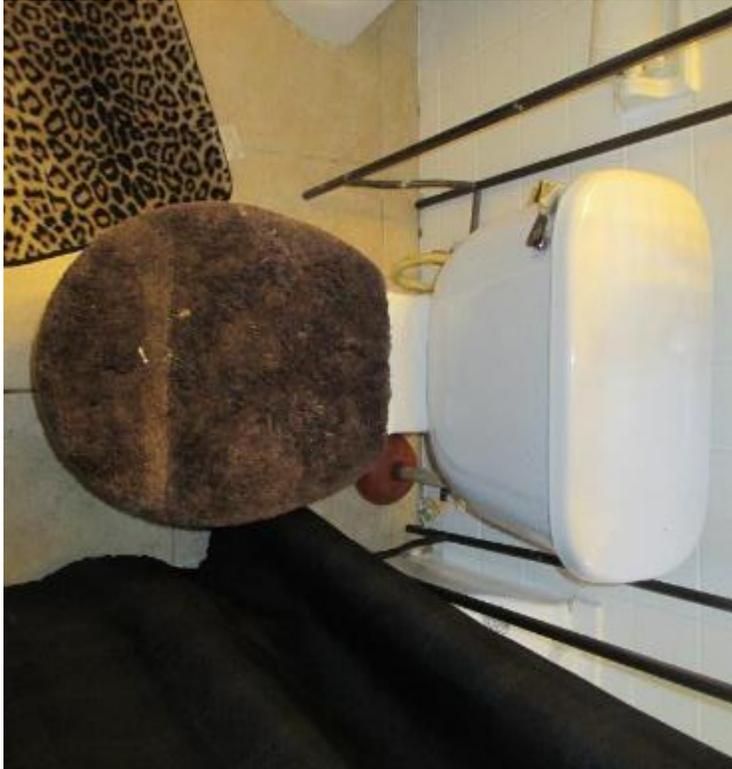
Interior finishes were found in general good condition at the time of inspection with exceptions as noted and shown in photographs.

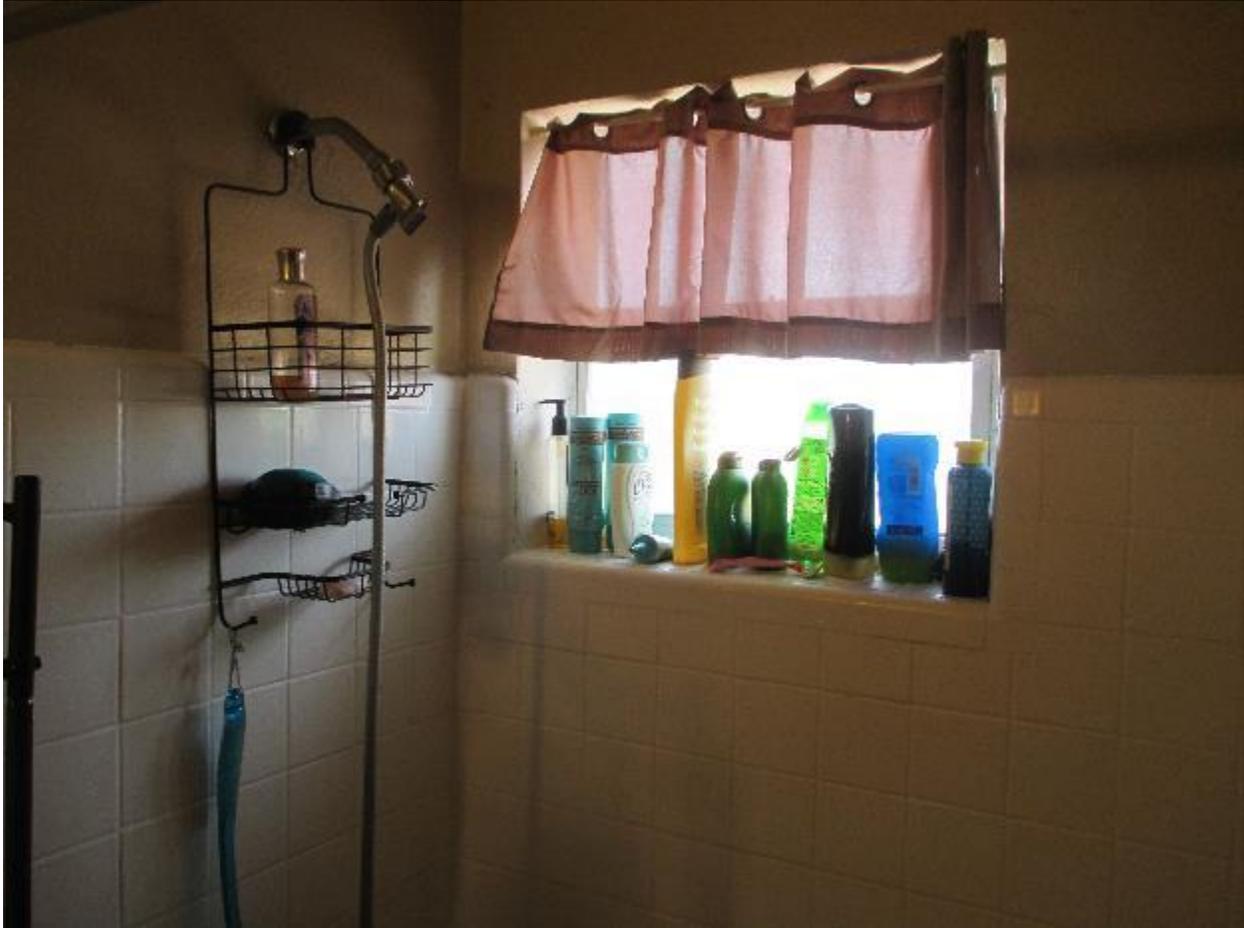
Interior finishes were found in general good condition at the time of inspection with exceptions as noted and shown in photographs.

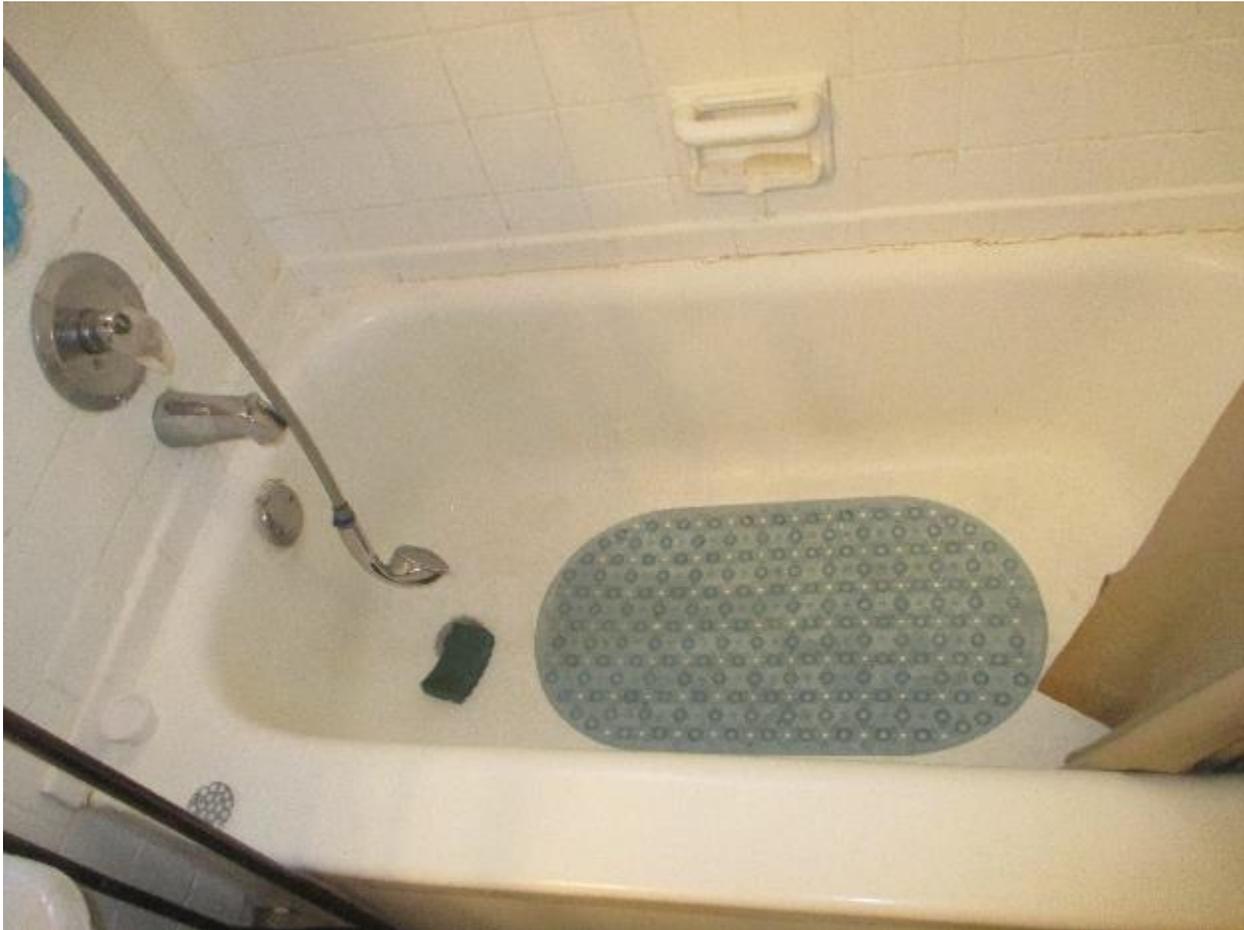
Interior finishes were found in general good condition at the time of inspection with exceptions as noted and shown in photographs.

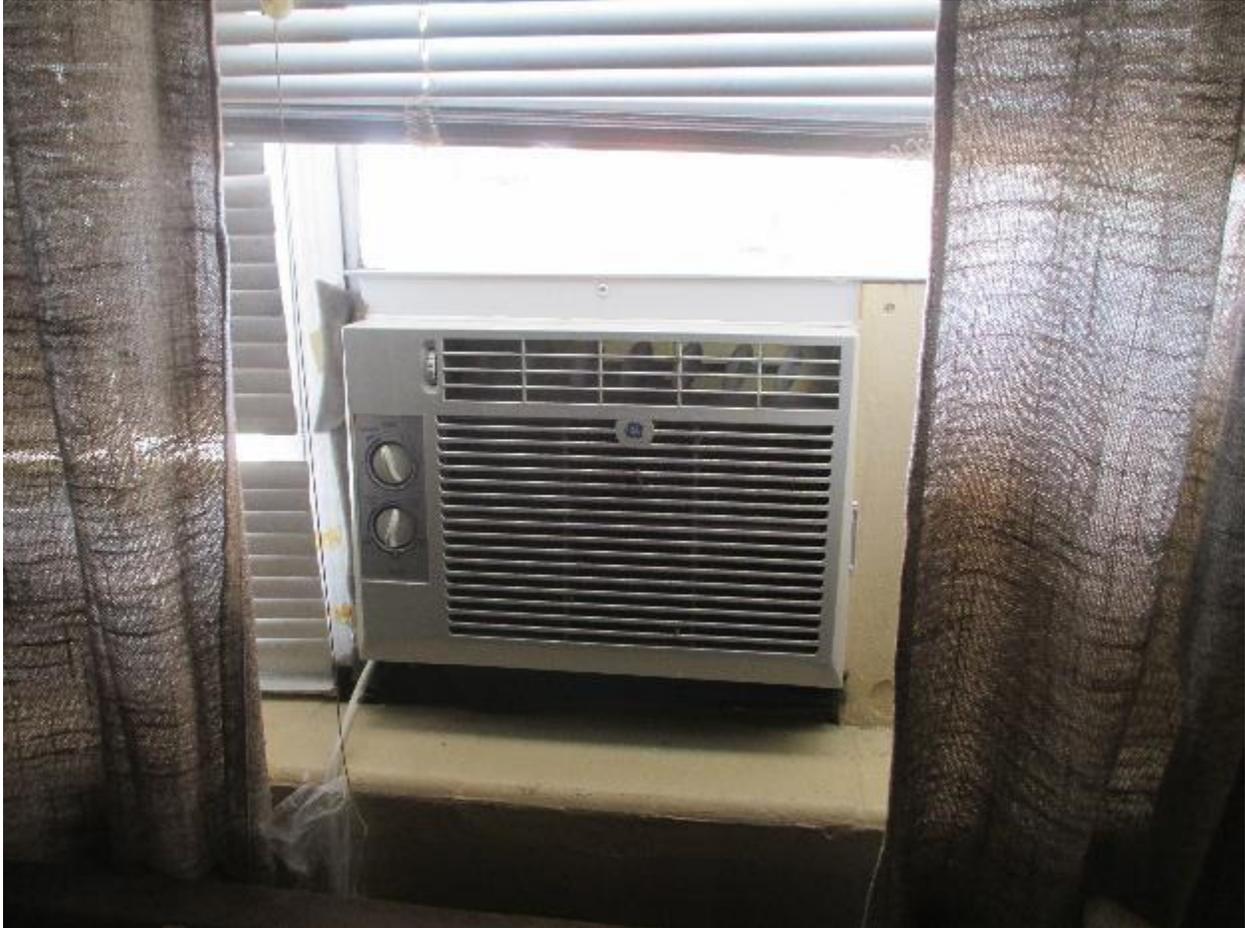
Ac in good working condition at the time of inspection.

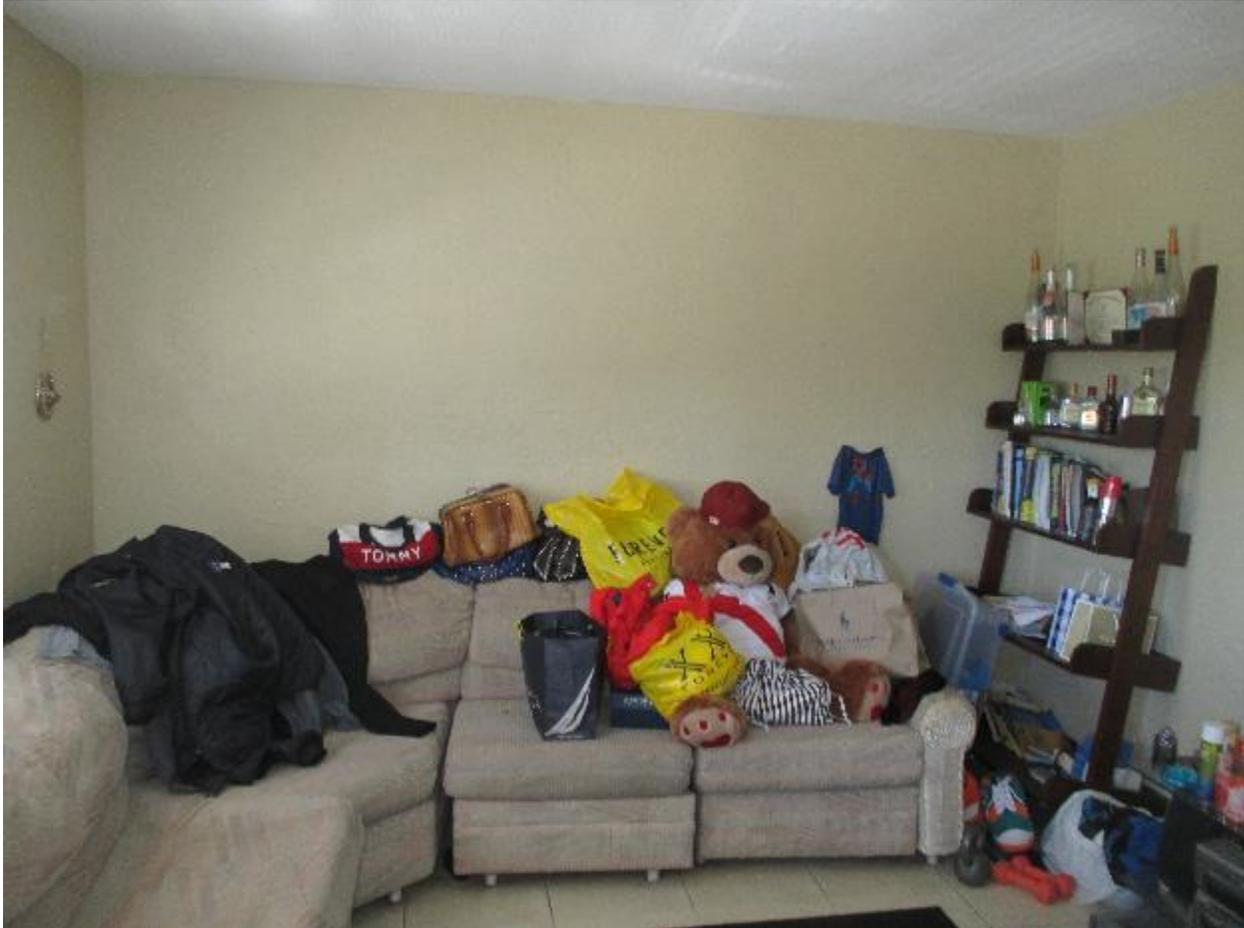
Interior finishes were found in general good condition at the time of inspection with exceptions as noted and shown in photographs.

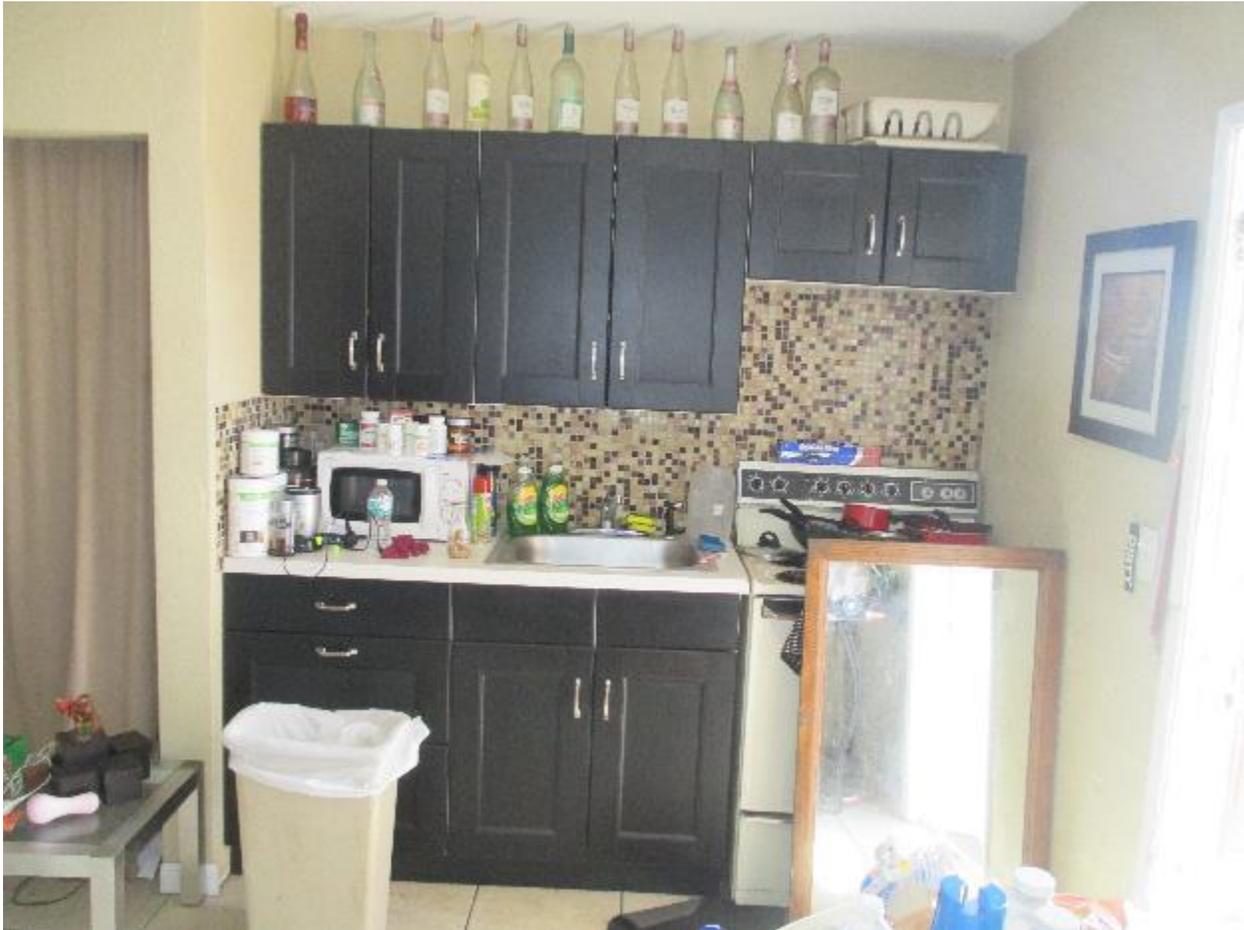
Interior finishes were found in general good condition at the time of inspection with exceptions as noted and shown in photographs.

No warranties or guarantees expressed on used appliances. Appliances found in working condition at the time of inspection.

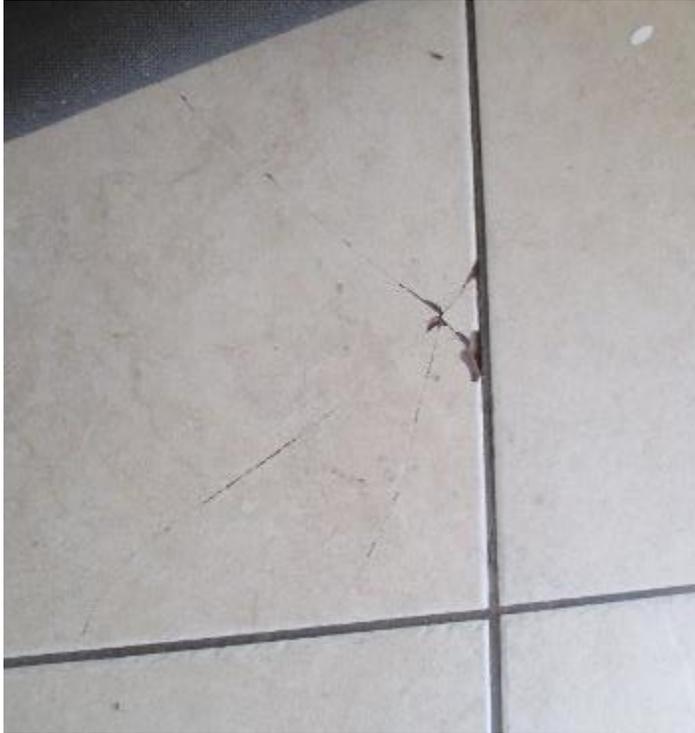
Cracked tiles without possibilities of repair. Complete removal of flooring surfaces must be done in order to provide a finished appearance.

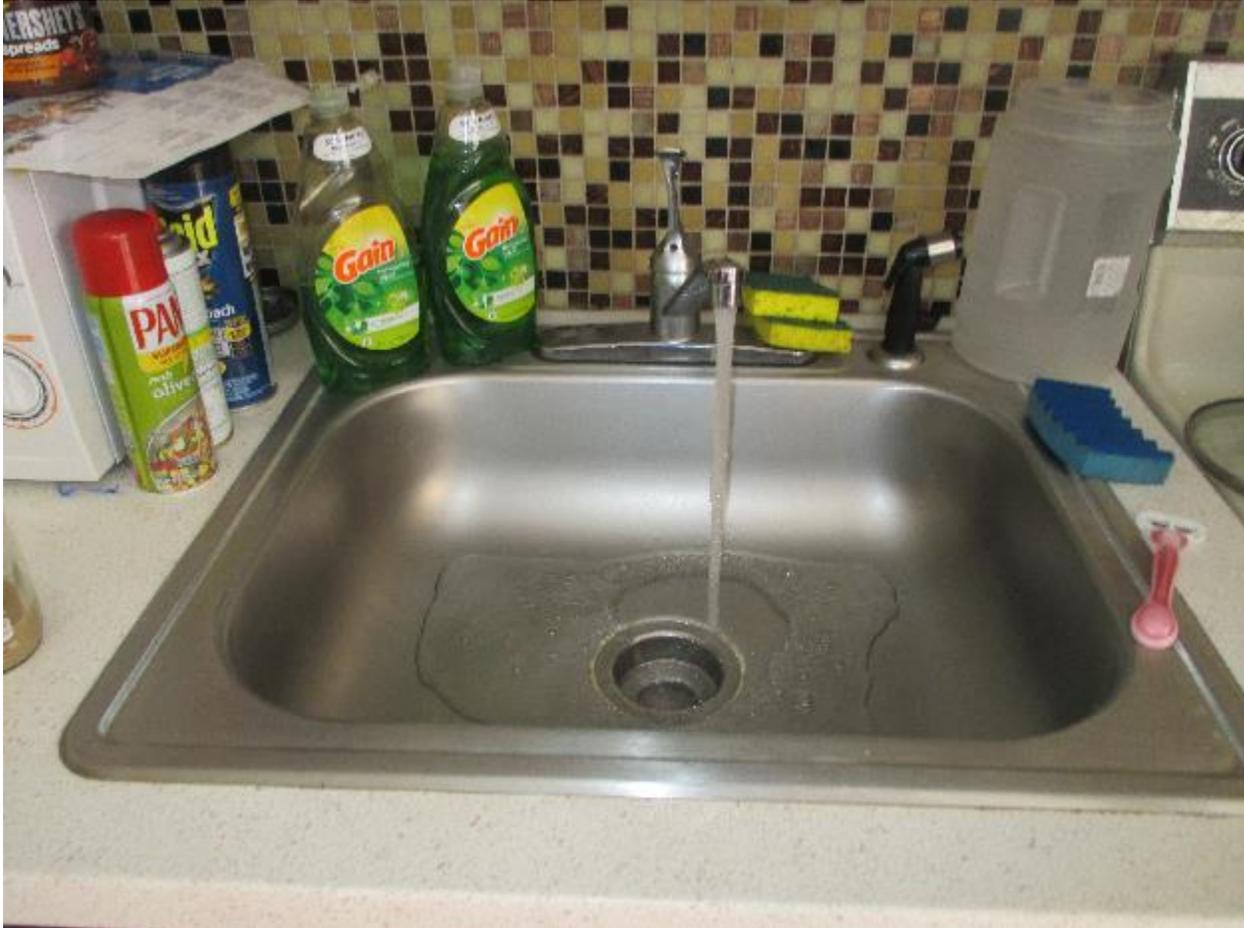
Plumbing systems tested for proper flow. No leaks or deficiencies noted on drain and supply lines.

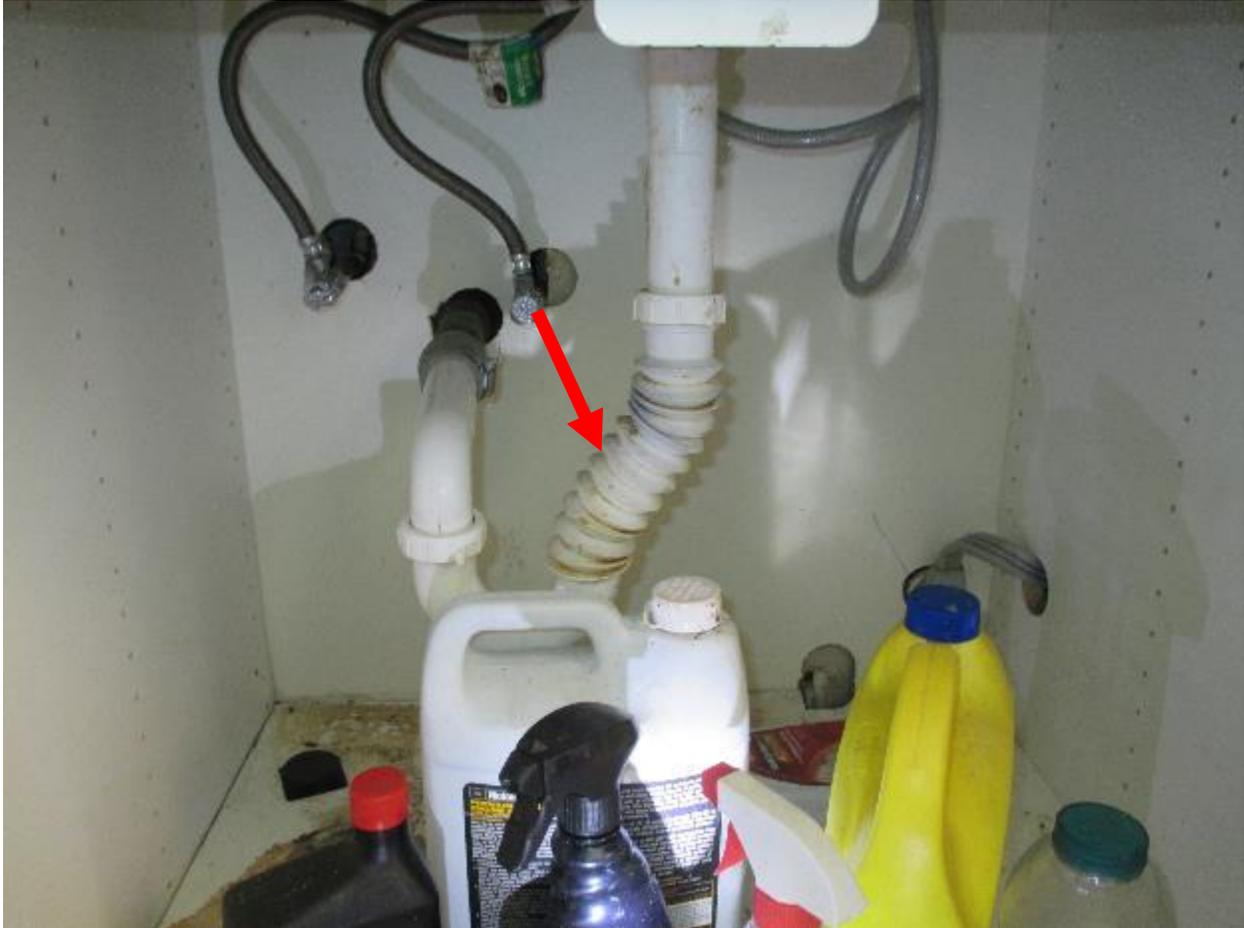
Flexible plumbing system to be replaced, not recommended for insurance purposes. Flexible systems are prone to failure.

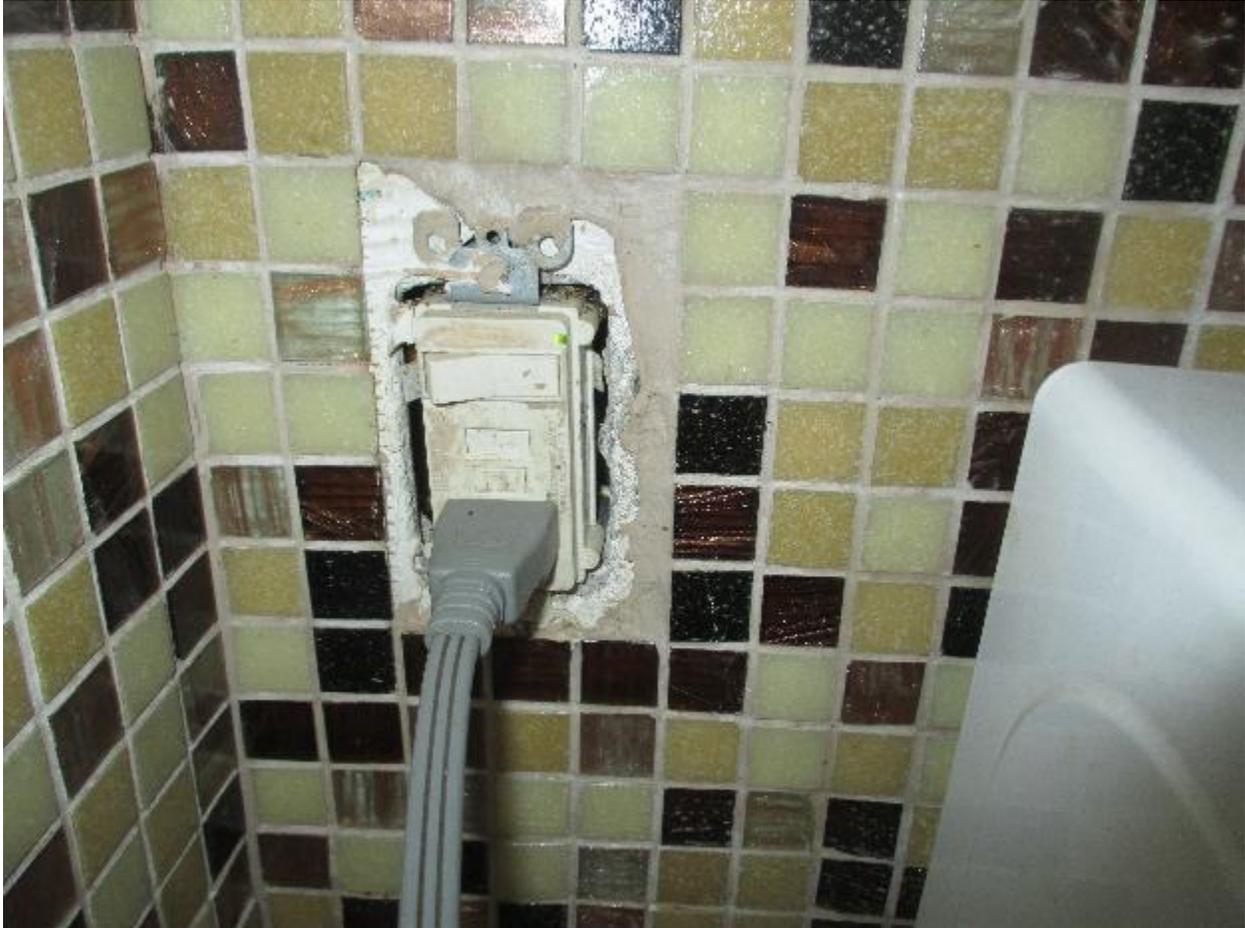
GFCI receptacles installation is required at wet areas such as bathrooms and kitchens.
