PROPERTY INSPECTION OR ASSESSMENT OF DAMAGES

ADDRESS: **SOMEWHERE , FL**
CLIENT: **GAIA GC**
ID No: **2015000**
DATE: **12/31/xxxx**

GAIA CONSTRUCTION INC.
CGC 1516136 FLORIDA
HI-2792 FLORIDA
8028867-B2 INTERNATIONAL CODE COUNCIL

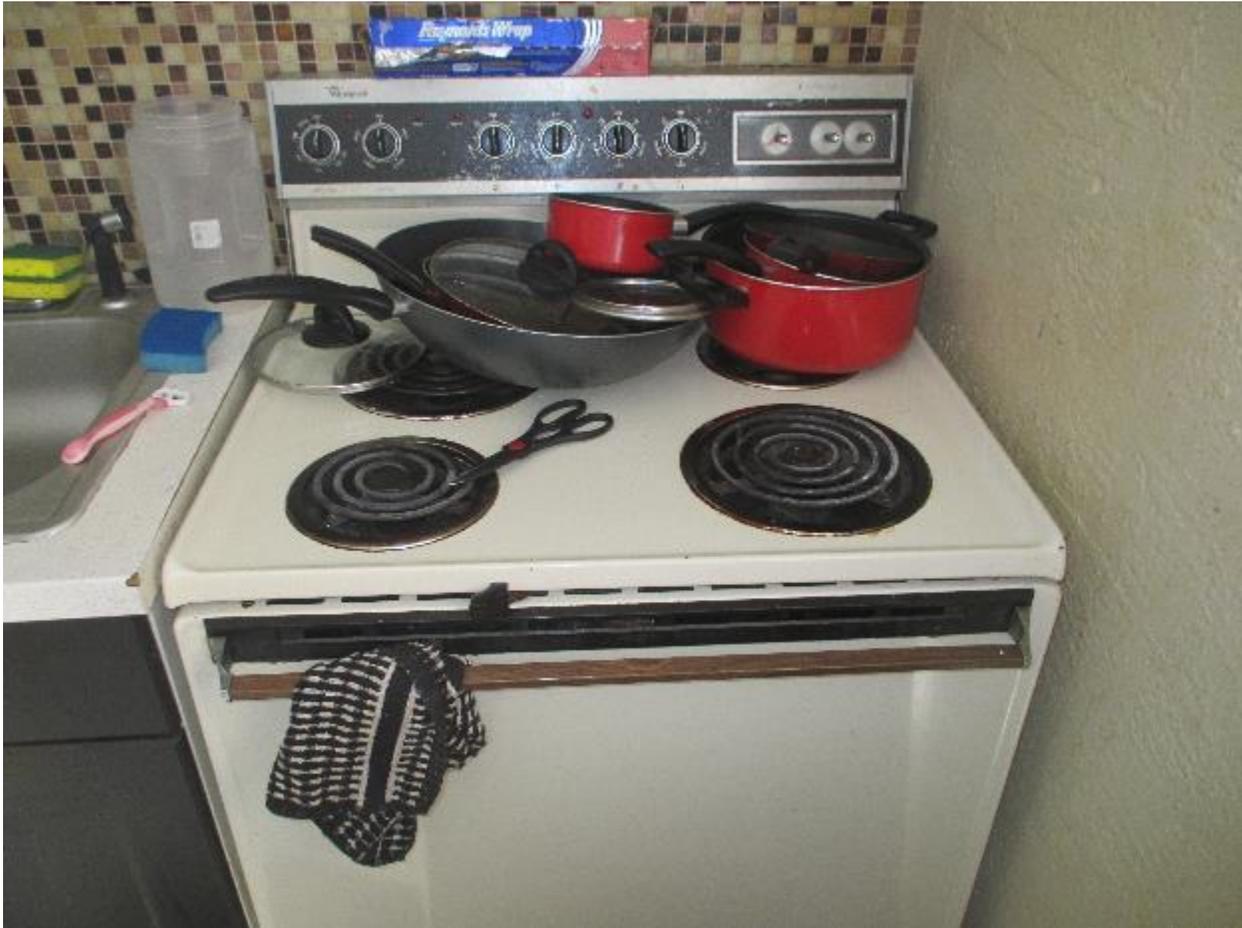
No warranties or guarantees expressed on used appliances. Appliances found in working condition at the time of inspection.

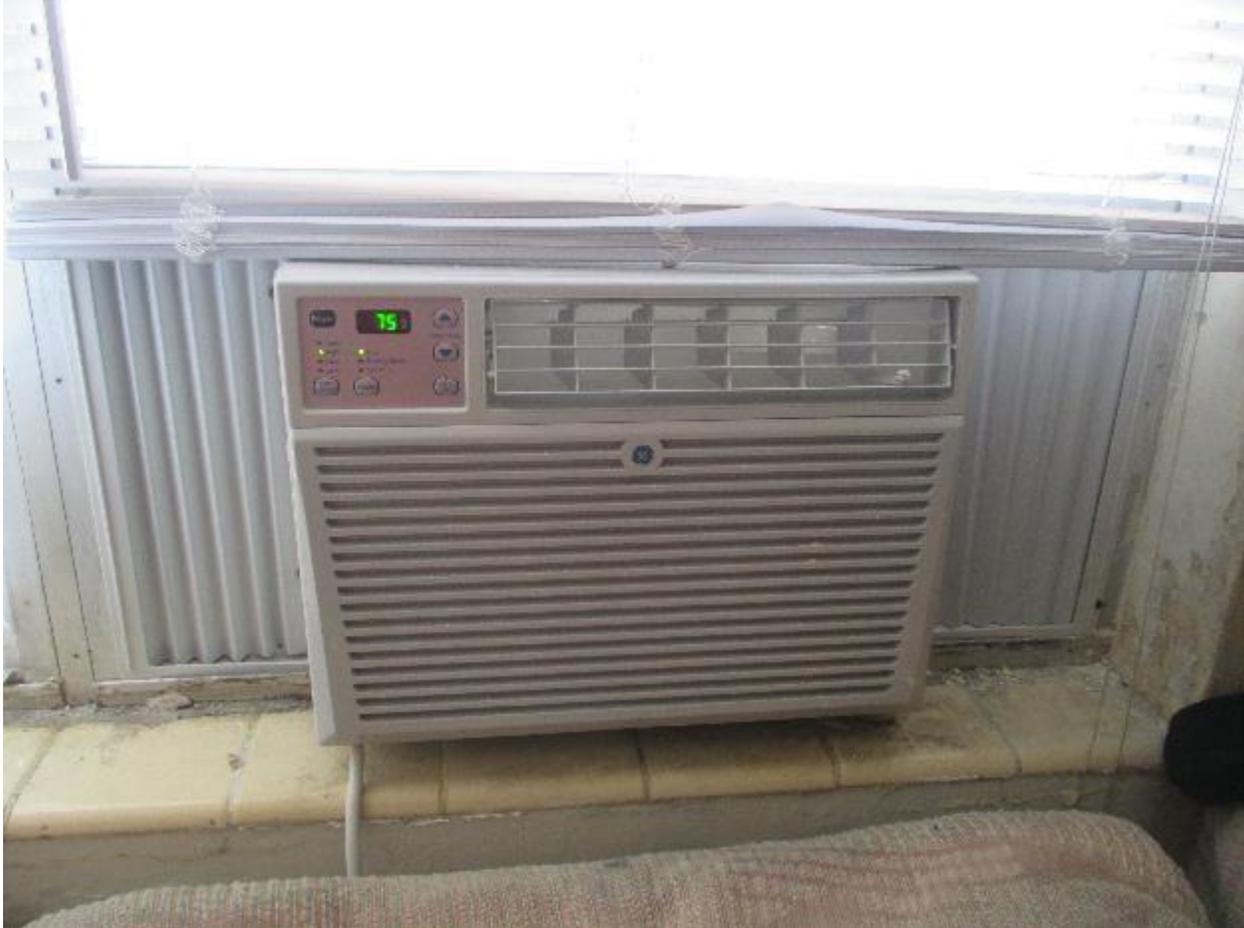
Ac in good working condition at the time of inspection.

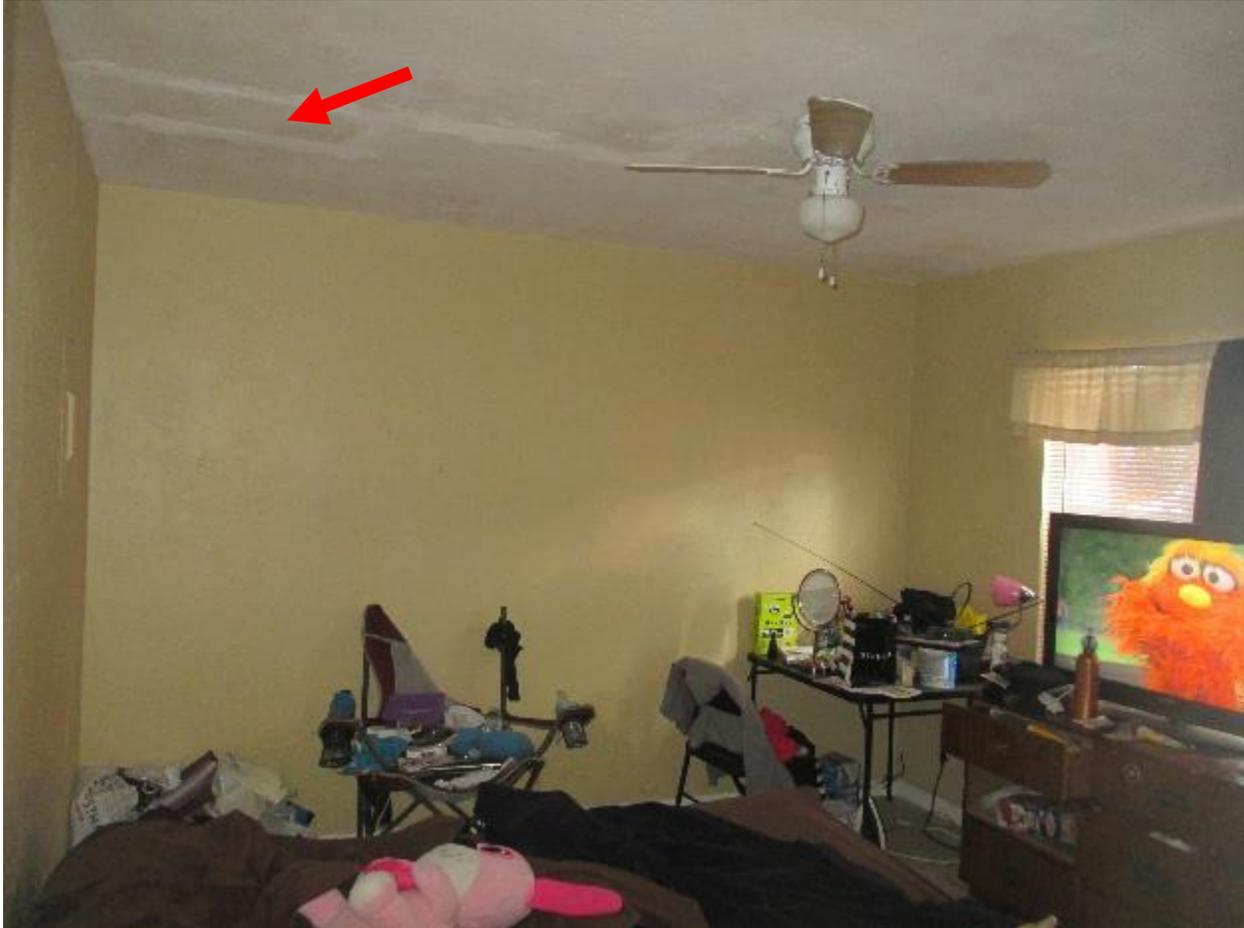
Cracks on ceiling not of structural importance but repairs related to drywall must be performed to secure the loose material.

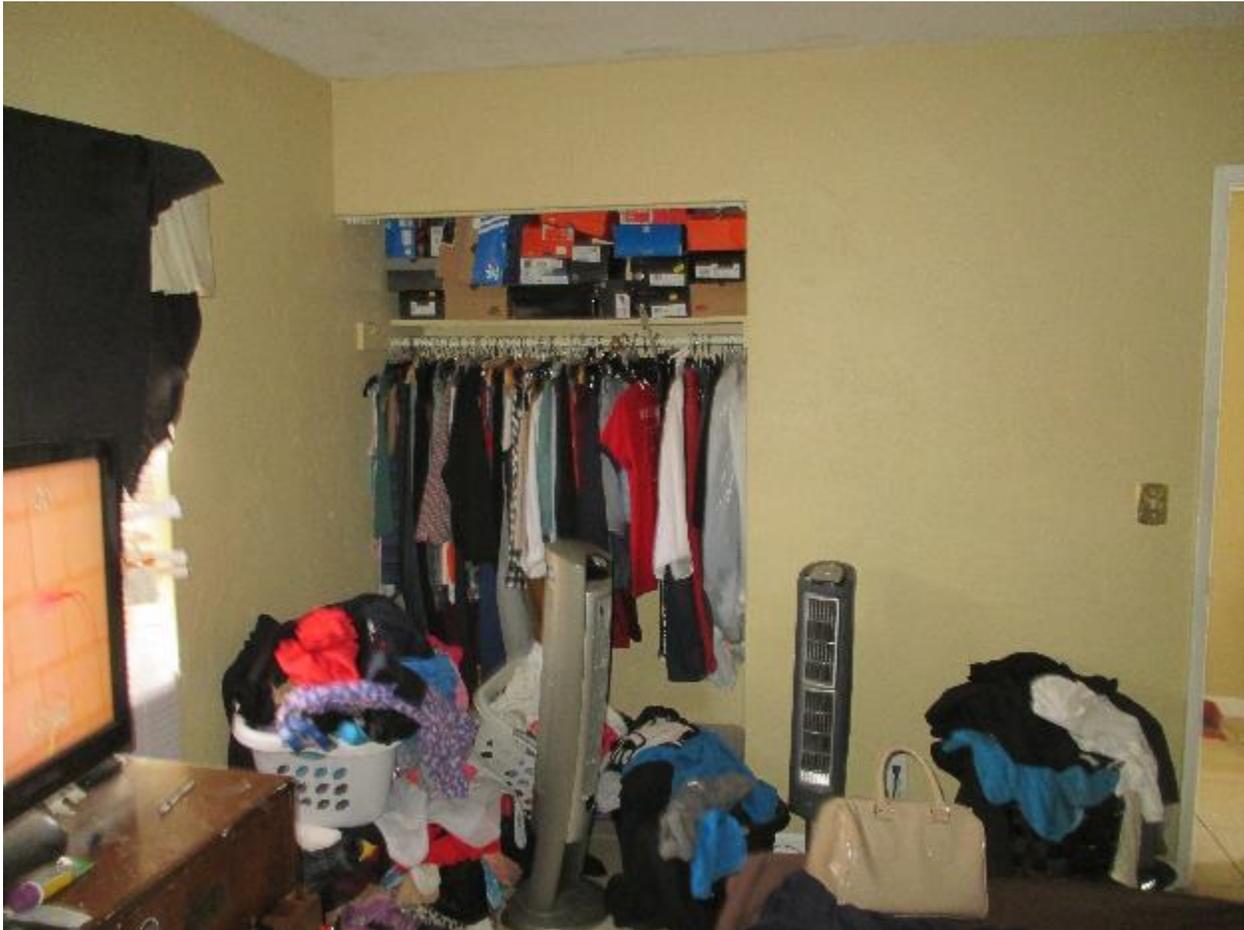
Interior finishes were found in general good condition at the time of inspection with exceptions as noted and shown in photographs.

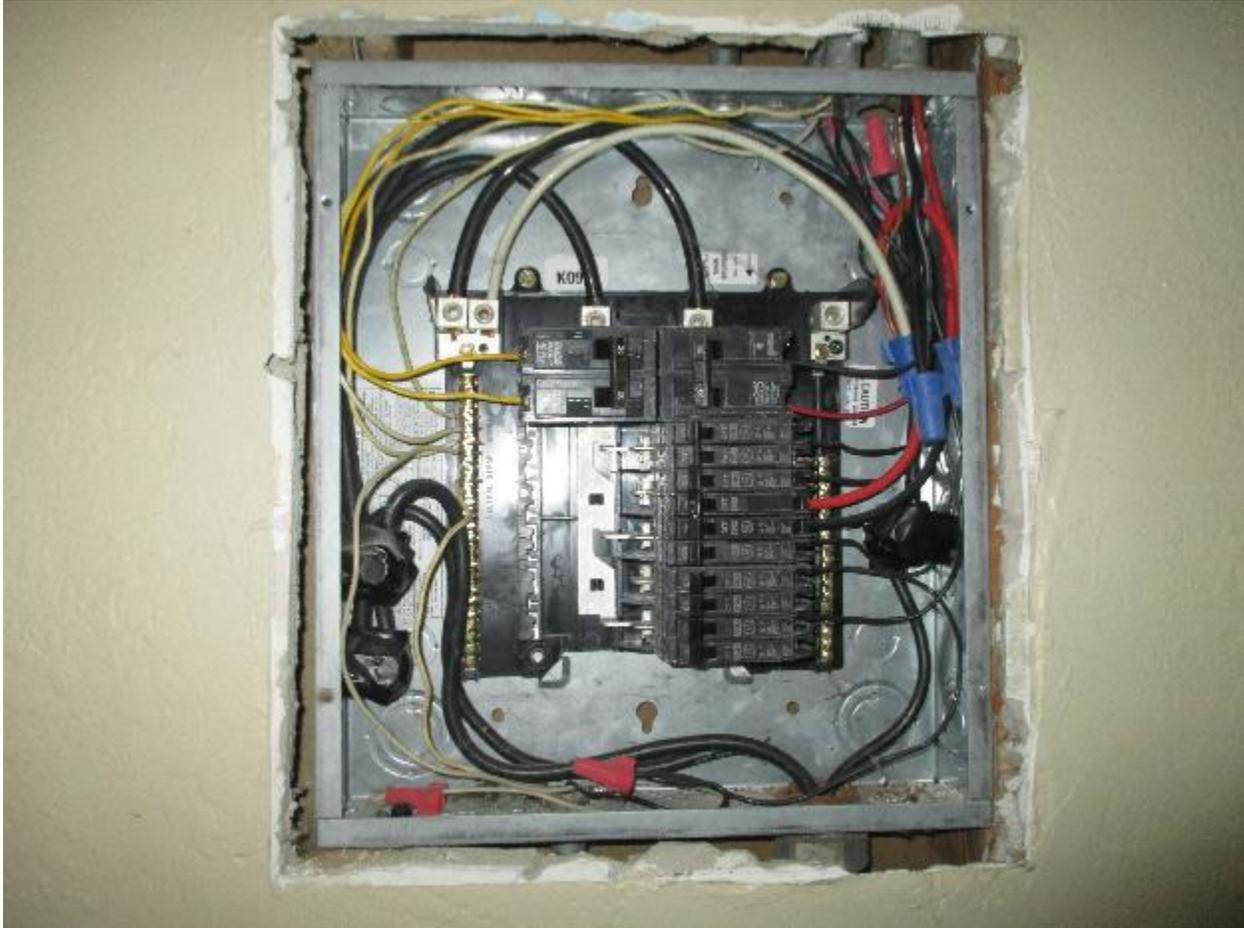
Electrical breaker panel in good condition at the time of inspection.

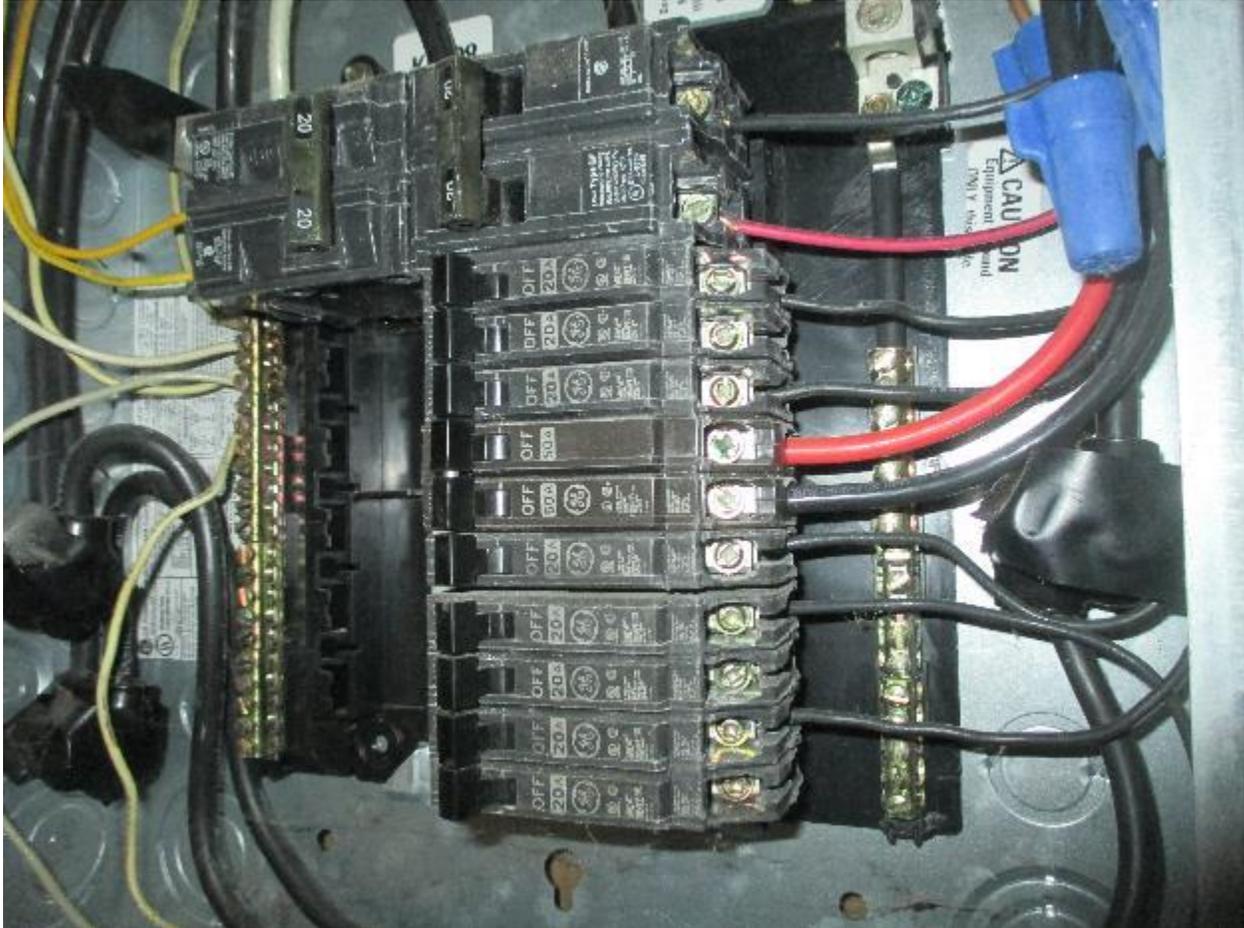
Electrical breaker panel in good condition at the time of inspection.

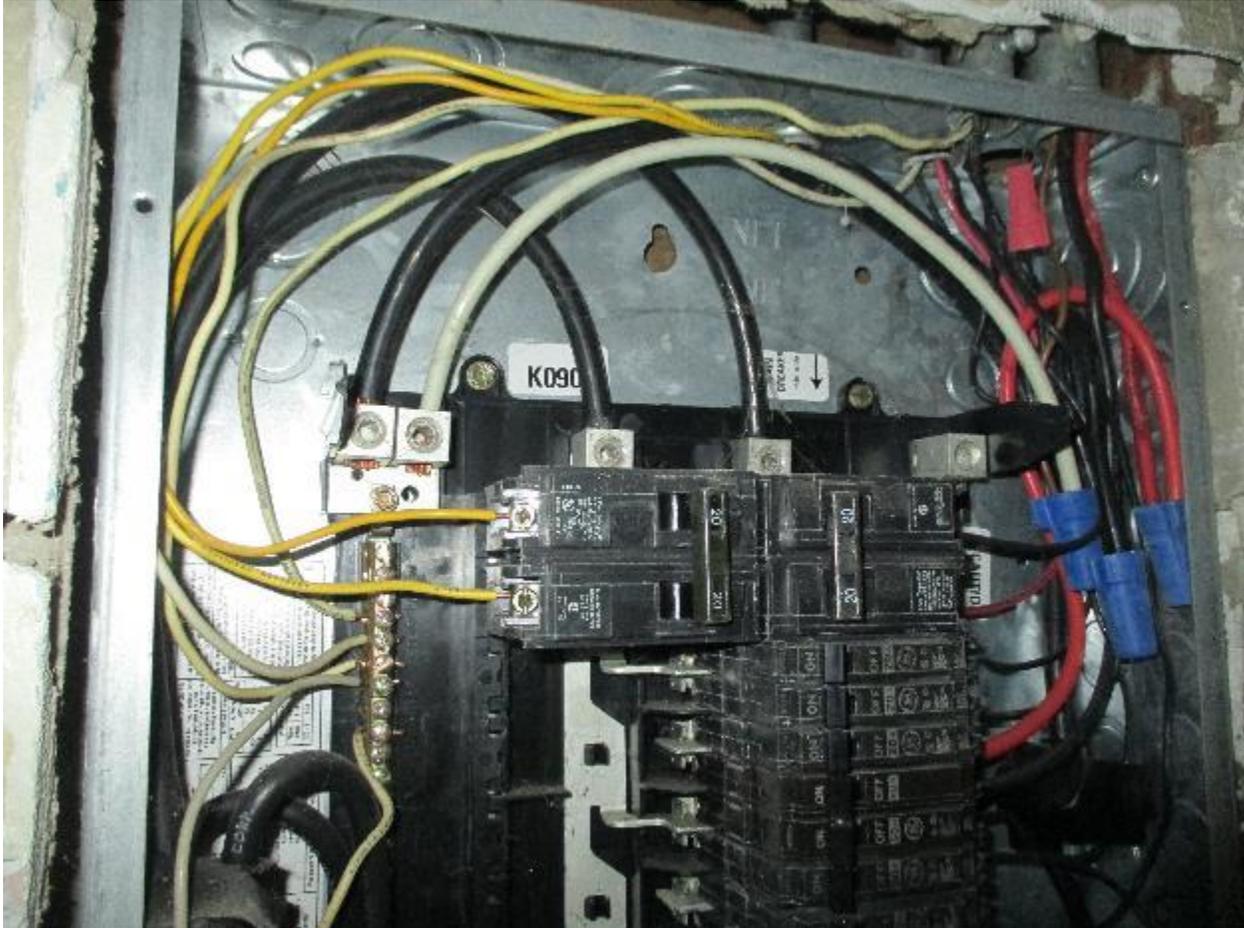
Electrical breaker panel in good condition at the time of inspection.

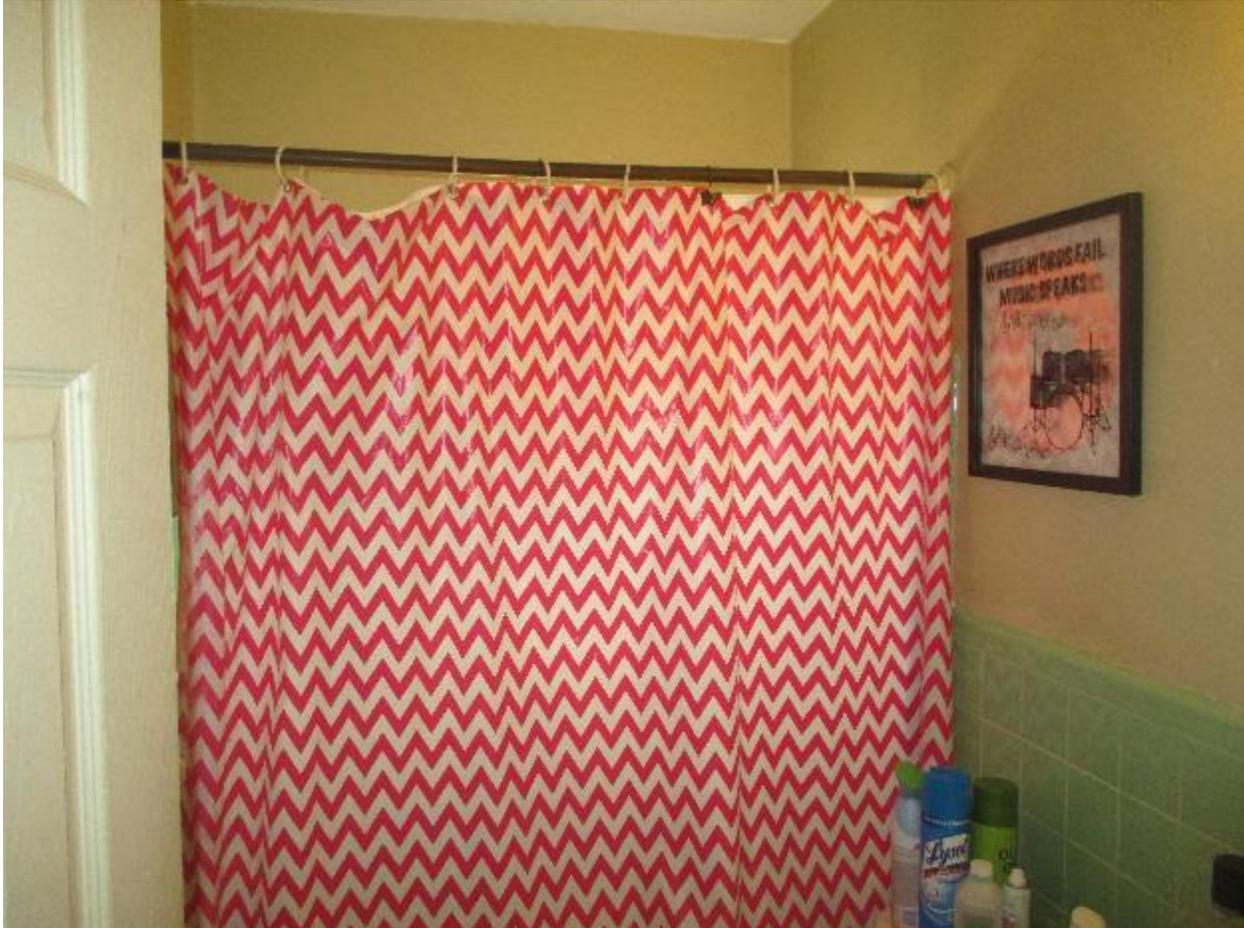
Interior finishes were found in general good condition at the time of inspection with exceptions as noted and shown in photographs.

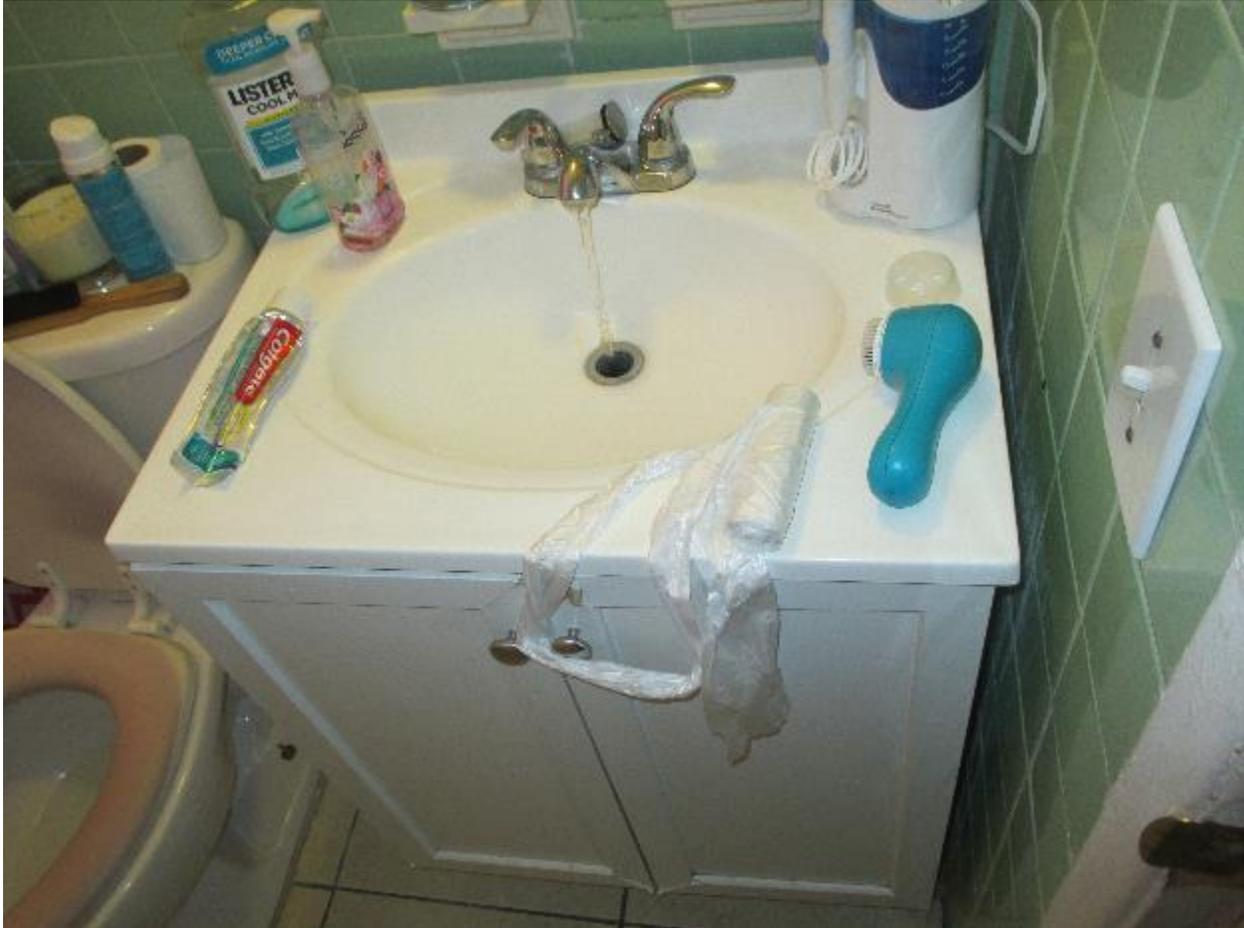
Plumbing systems tested for proper flow. No leaks or deficiencies noted on drain and supply lines.

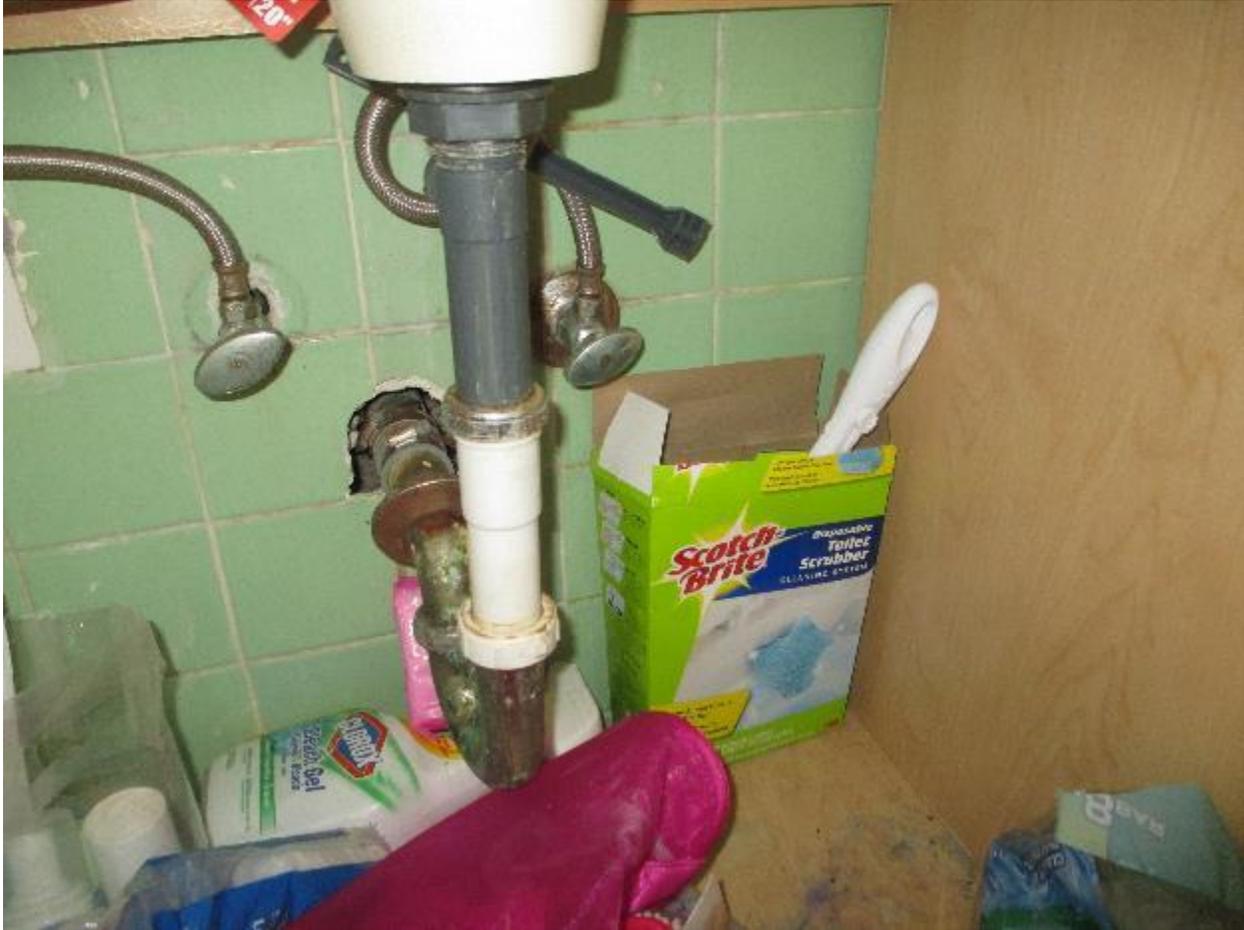
Plumbing systems tested for proper flow. No leaks or deficiencies noted on drain and supply lines.

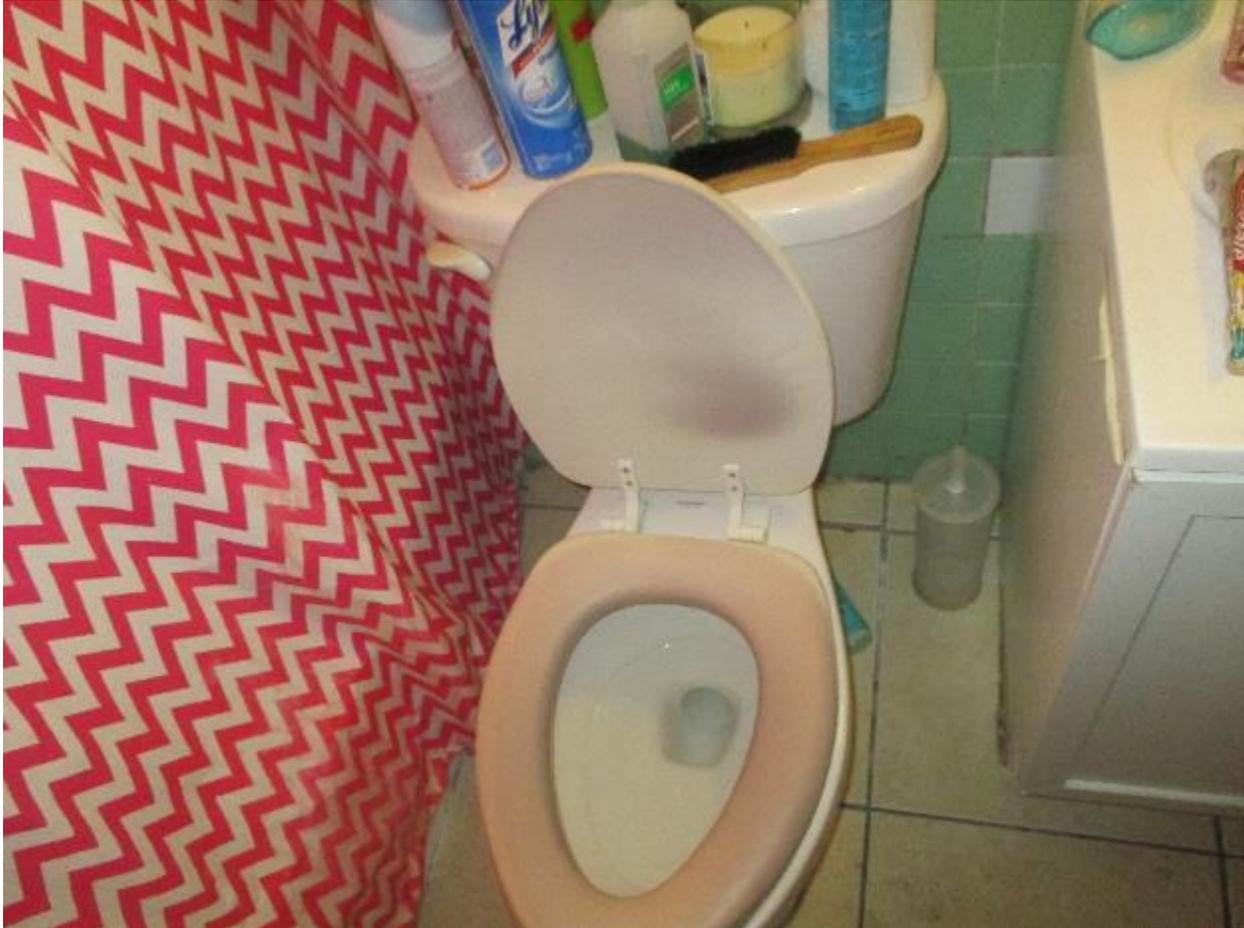
Interior finishes were found in general good condition at the time of inspection with exceptions as noted and shown in photographs.

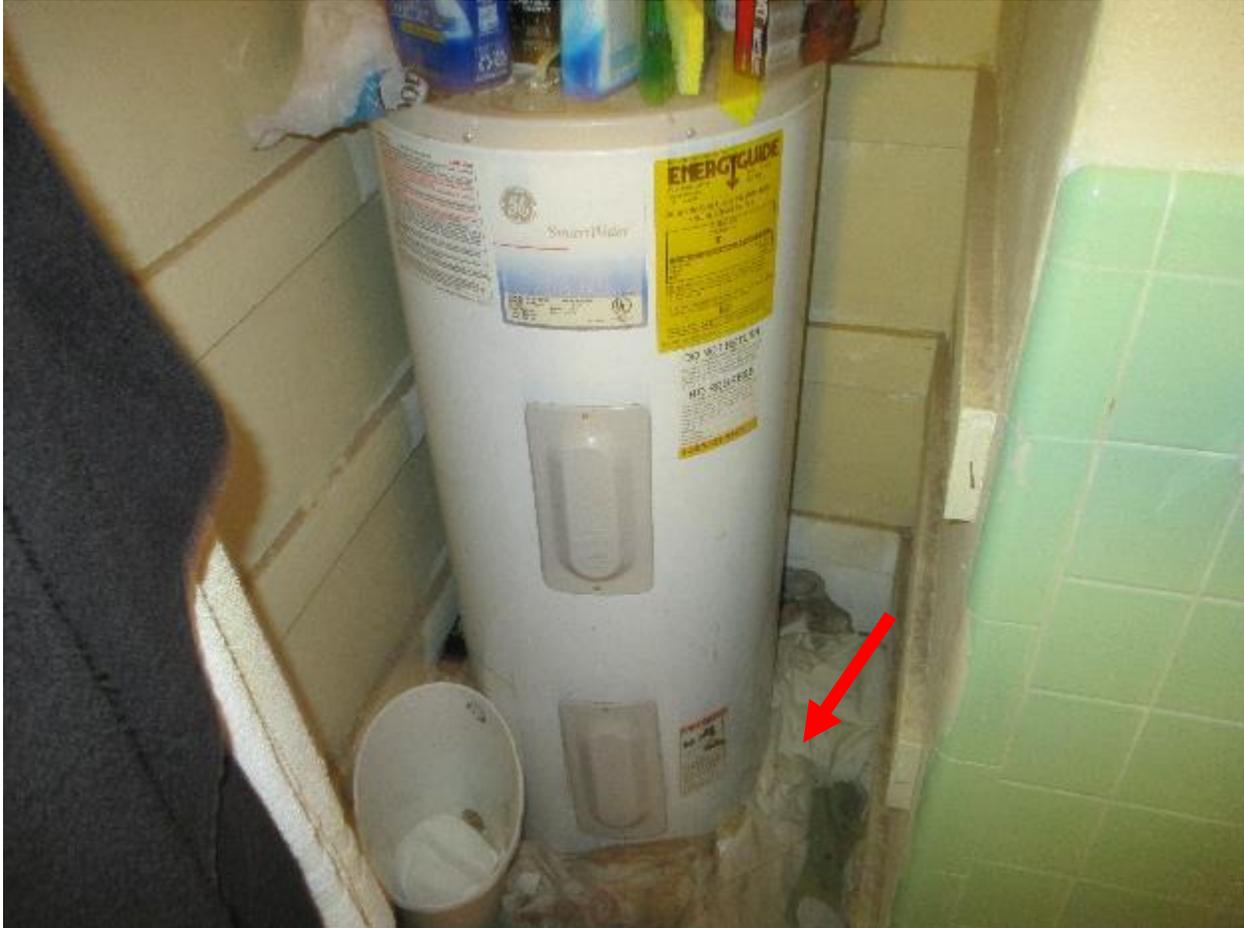
Water heater requires secondary drip pan.

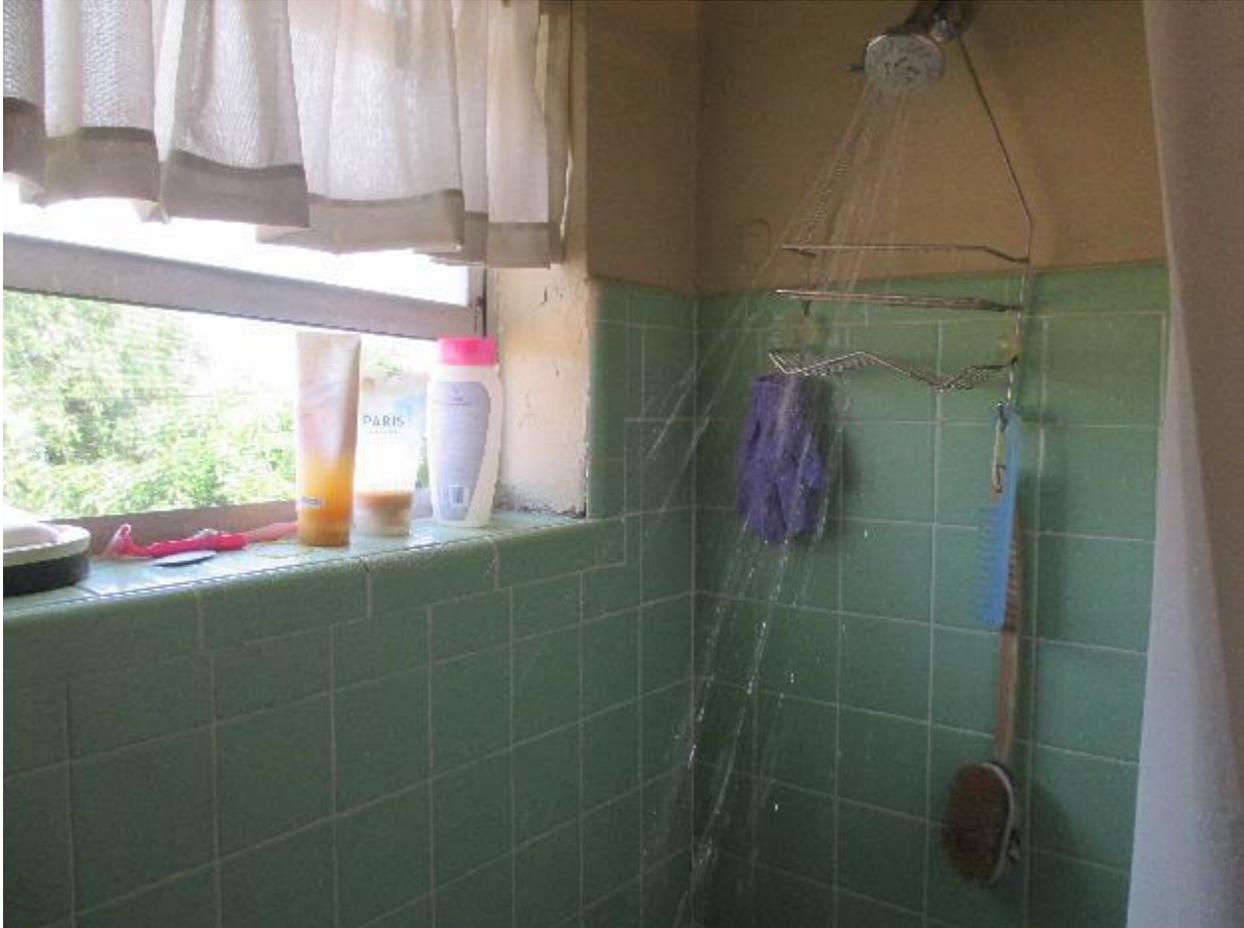
Interior finishes were found in general good condition at the time of inspection with exceptions as noted and shown in photographs.

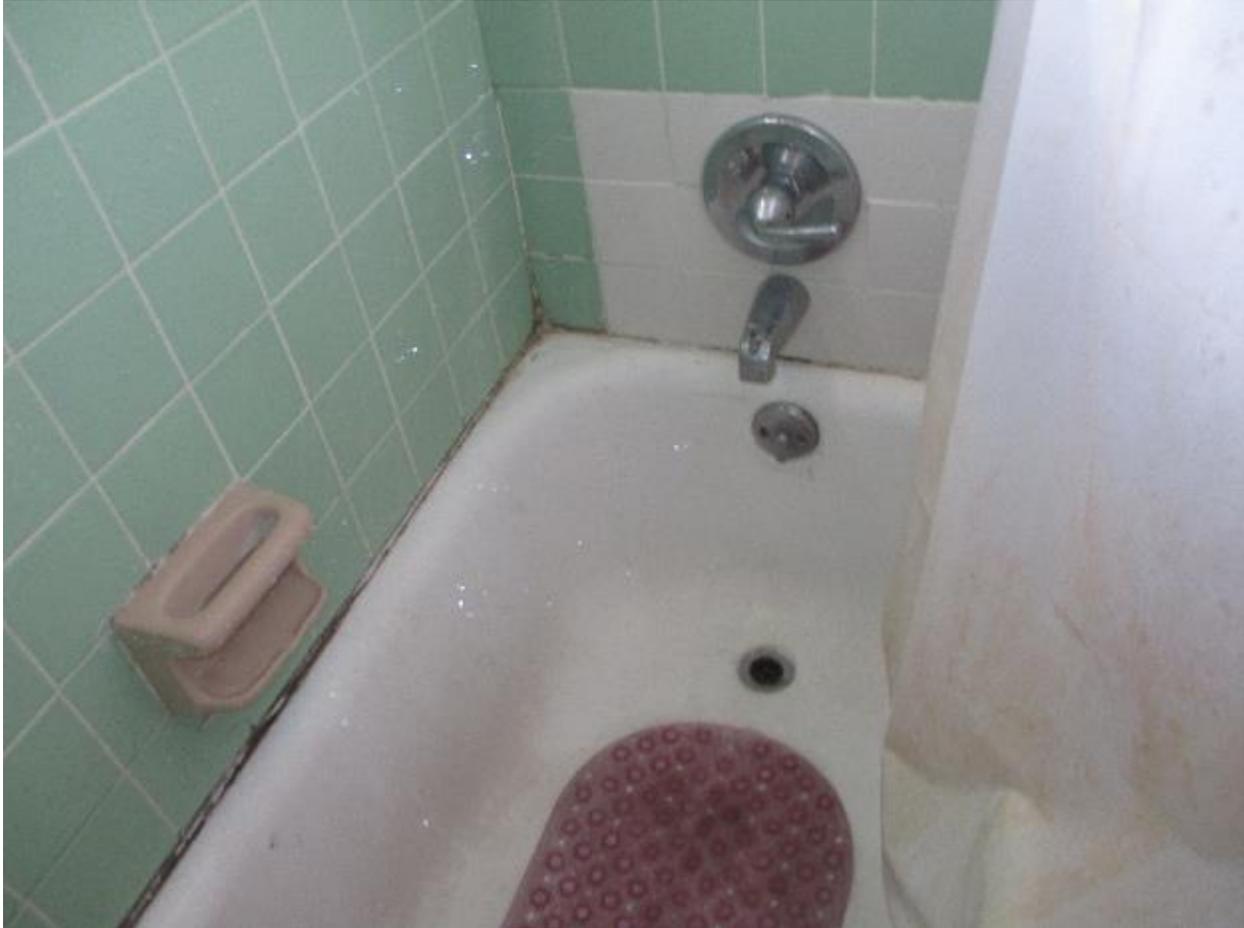
Interior finishes were found in general good condition at the time of inspection with exceptions as noted and shown in photographs.

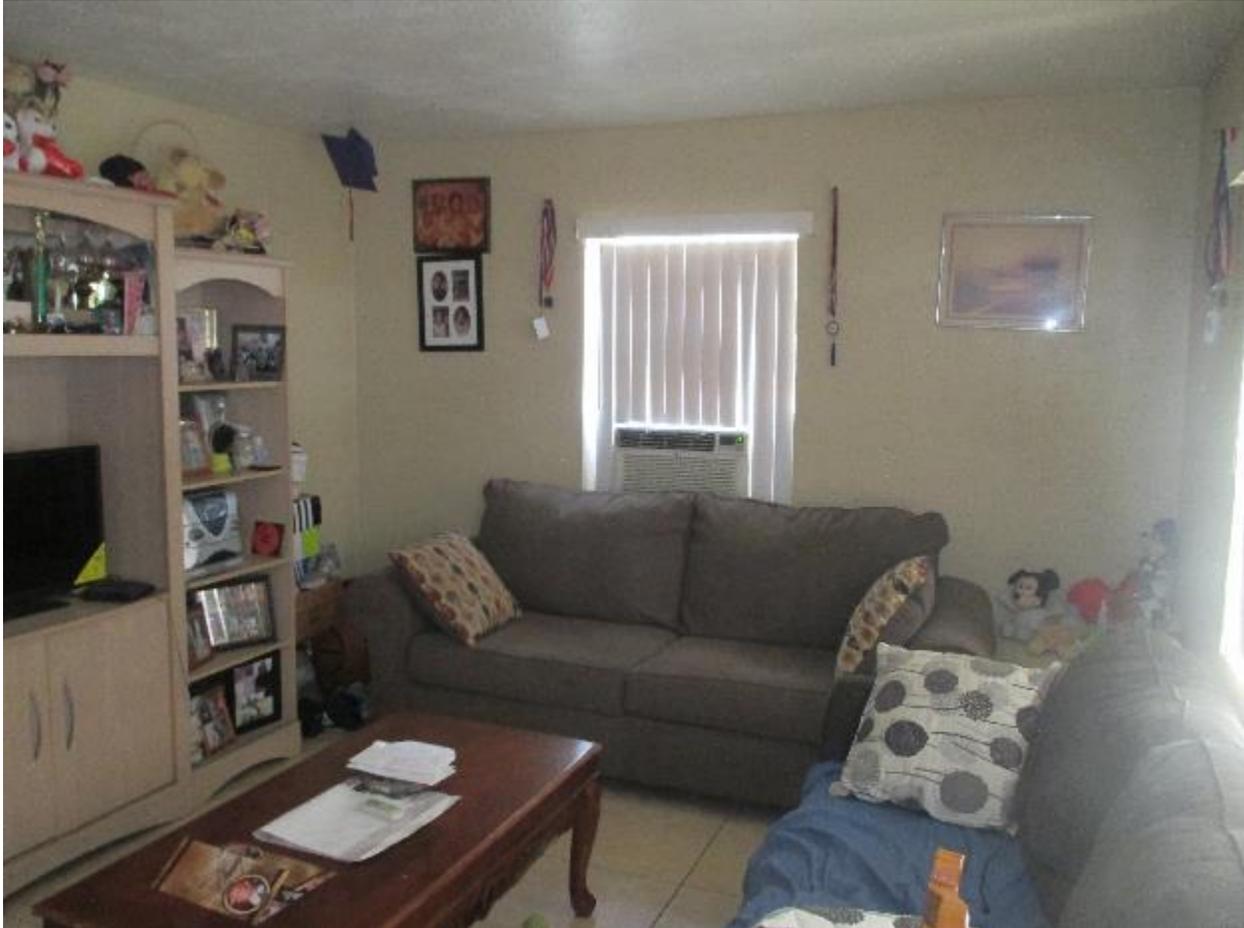
Interior finishes were found in general good condition at the time of inspection with exceptions as noted and shown in photographs.

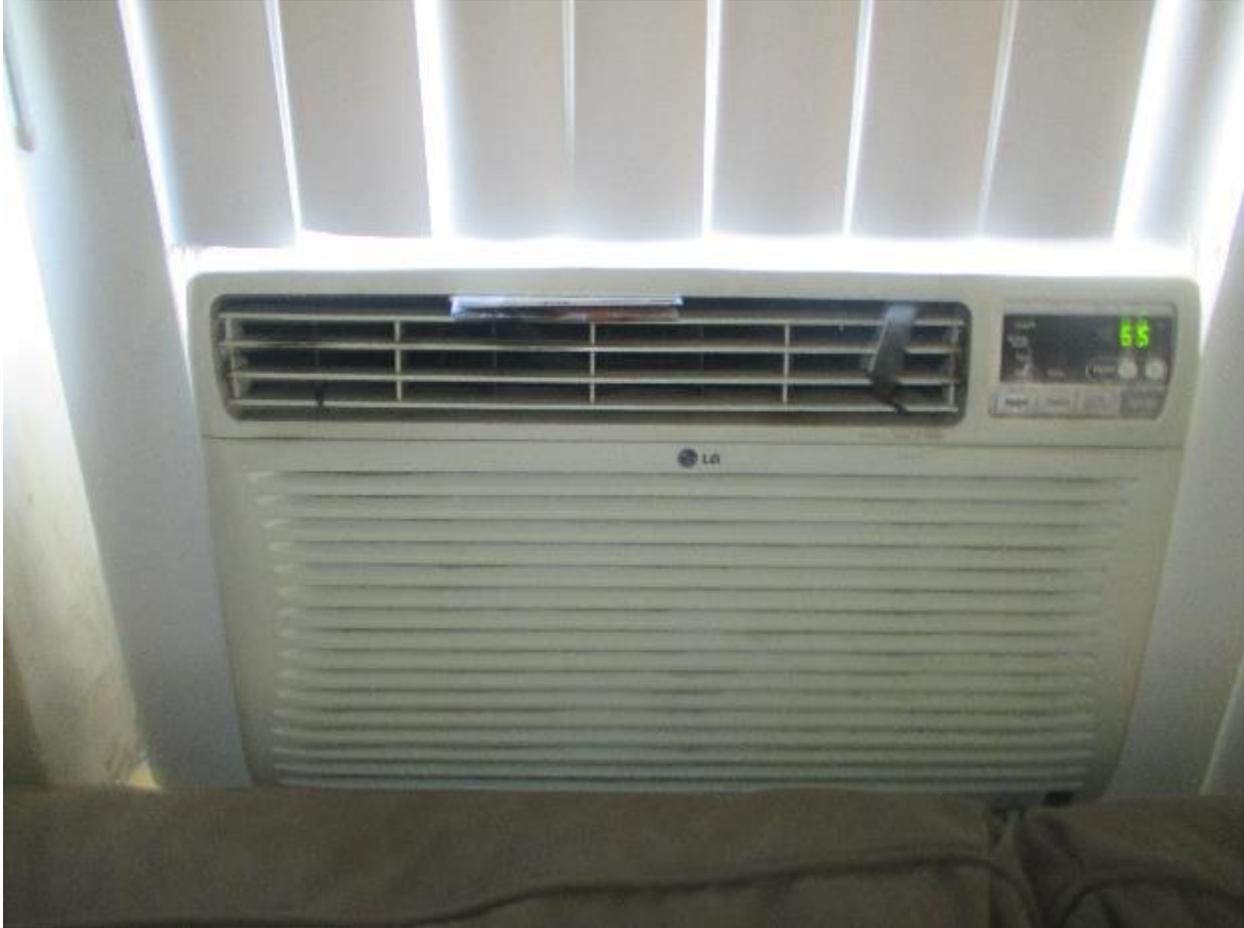
Ac in good working condition at the time of inspection.

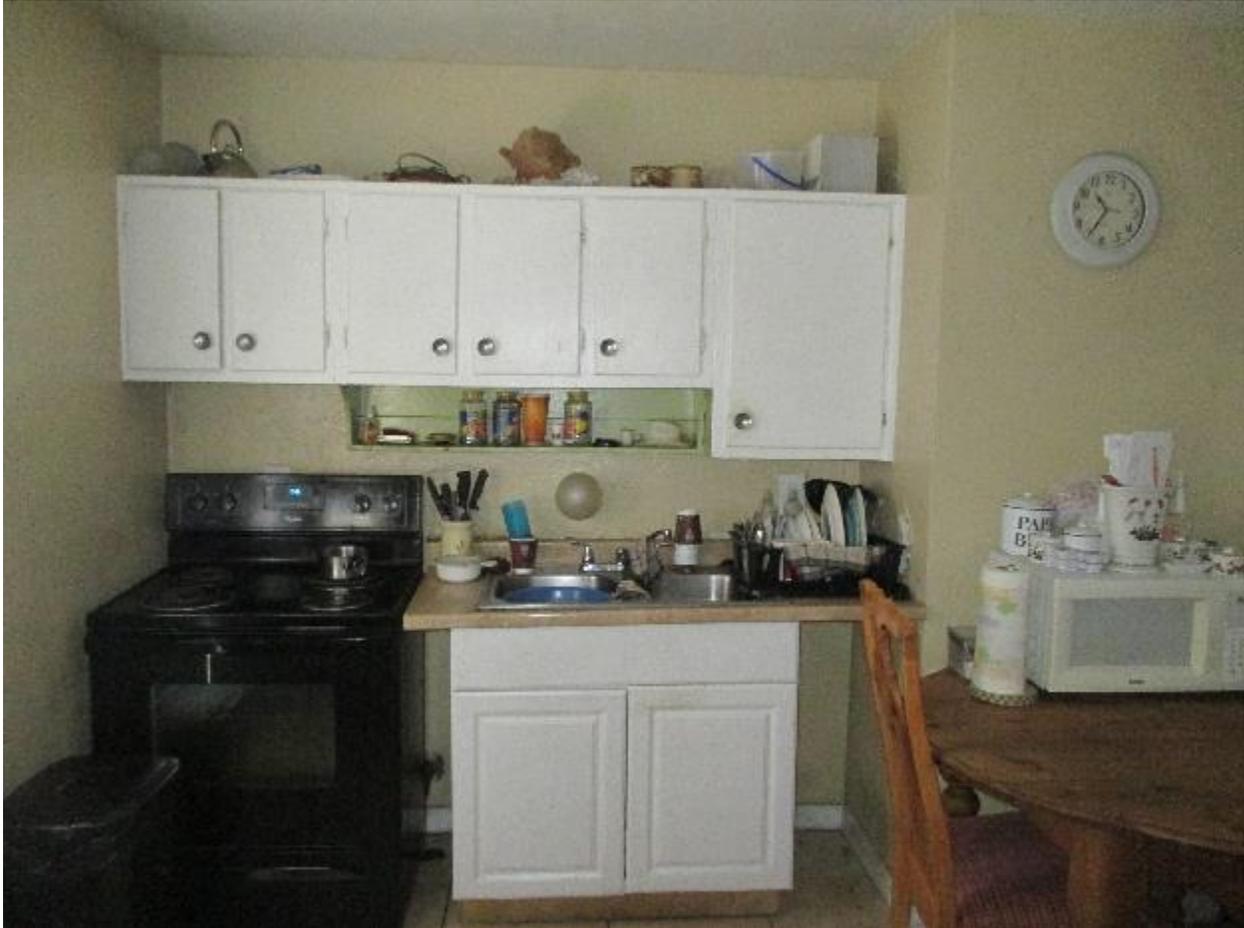
Interior finishes were found in general good condition at the time of inspection with exceptions as noted and shown in photographs.

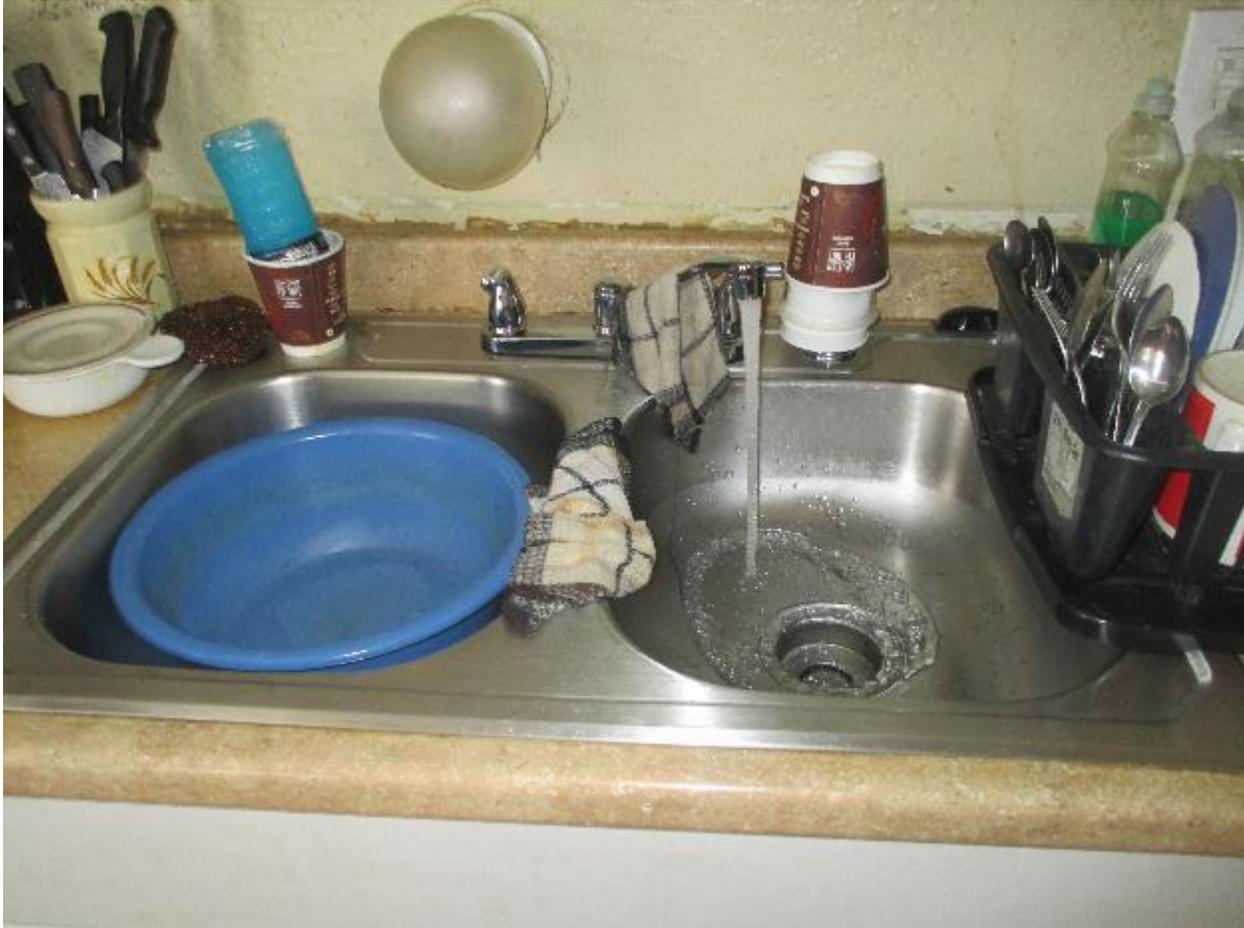
Plumbing systems tested for proper flow. No leaks or deficiencies noted on drain and supply lines.

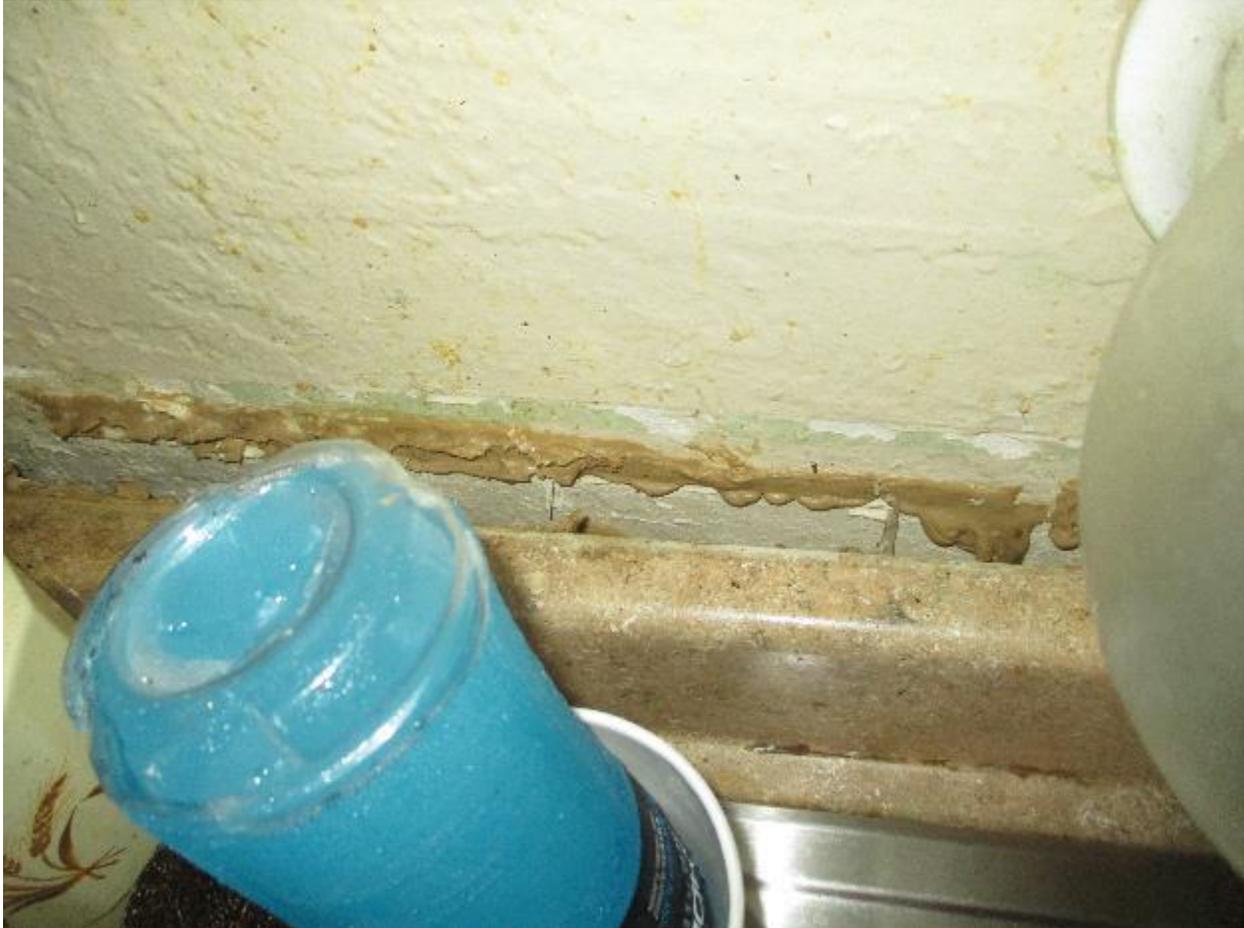
Proper installation of kitchen cabinets are required.
