PROPERTY INSPECTION OR ASSESSMENT OF DAMAGES

ADDRESS: **SOMEWHERE , FL**
CLIENT: **GAIA GC**
ID No: **2015000**
DATE: **12/31/xxxx**

GAIA CONSTRUCTION INC.
CGC 1516136 FLORIDA
HI-2792 FLORIDA
8028867-B2 INTERNATIONAL CODE COUNCIL

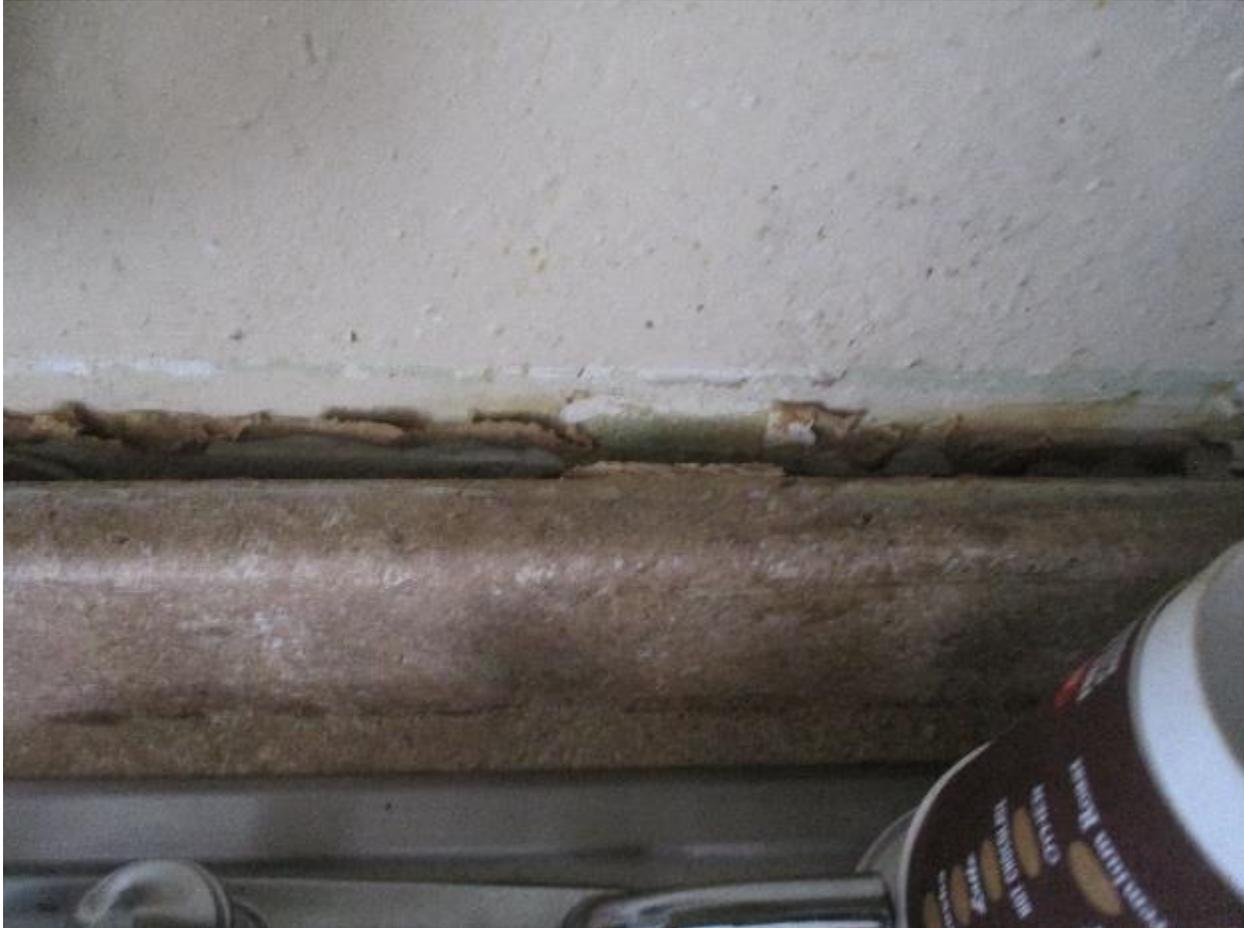
Proper installation of kitchen cabinets are required.

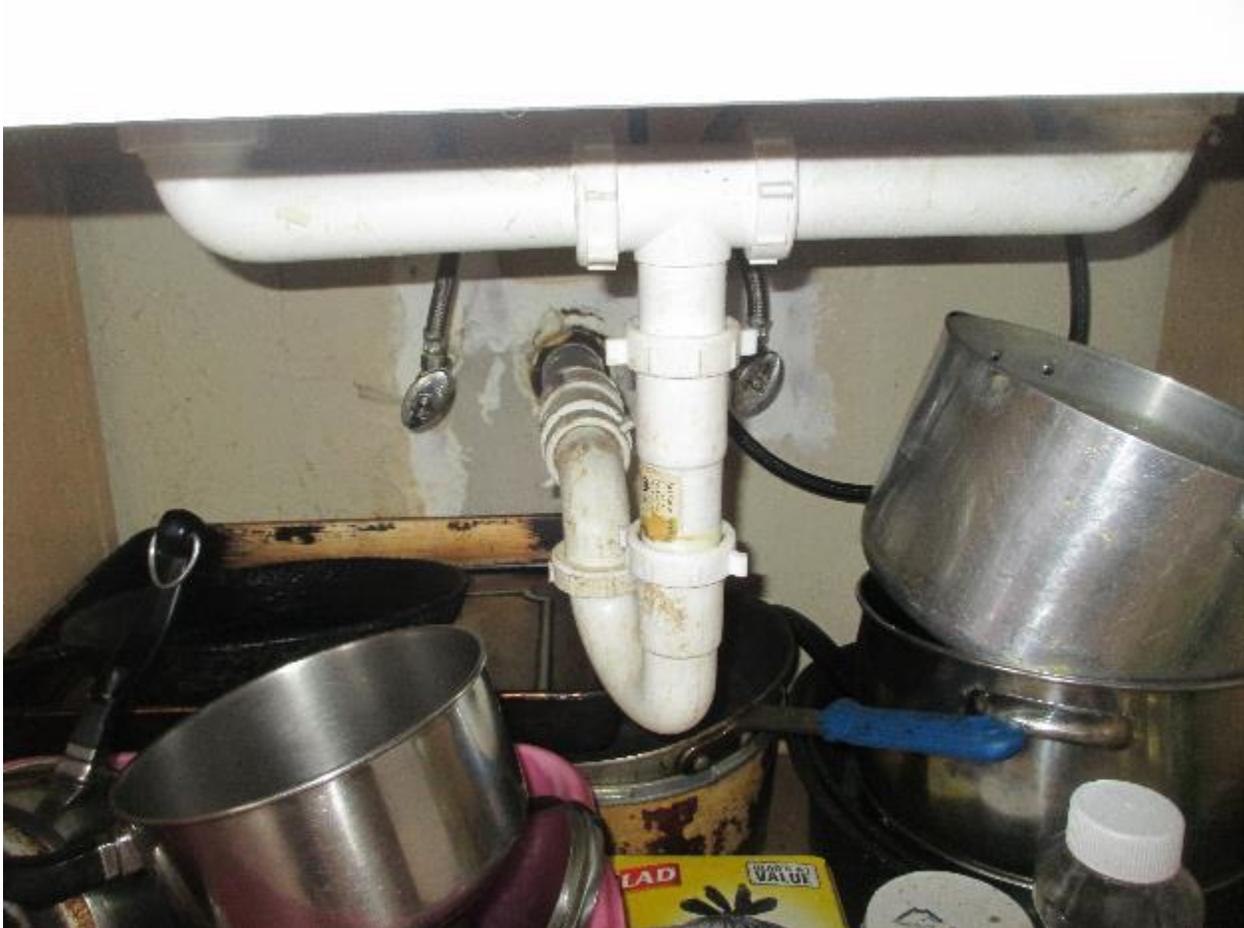
Plumbing systems tested for proper flow. No leaks or deficiencies noted on drain and supply lines.

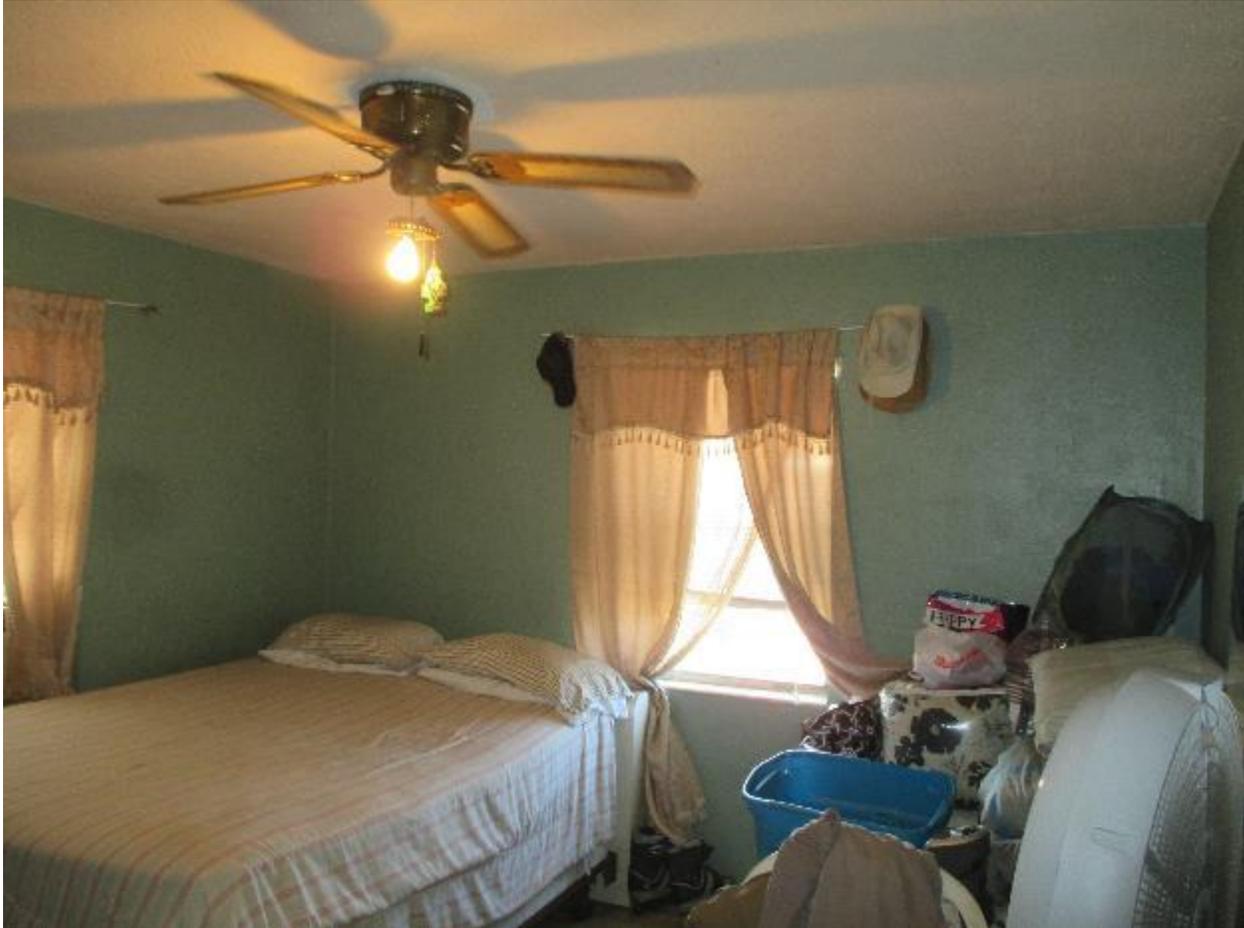
Interior finishes were found in general good condition at the time of inspection with exceptions as noted and shown in photographs.

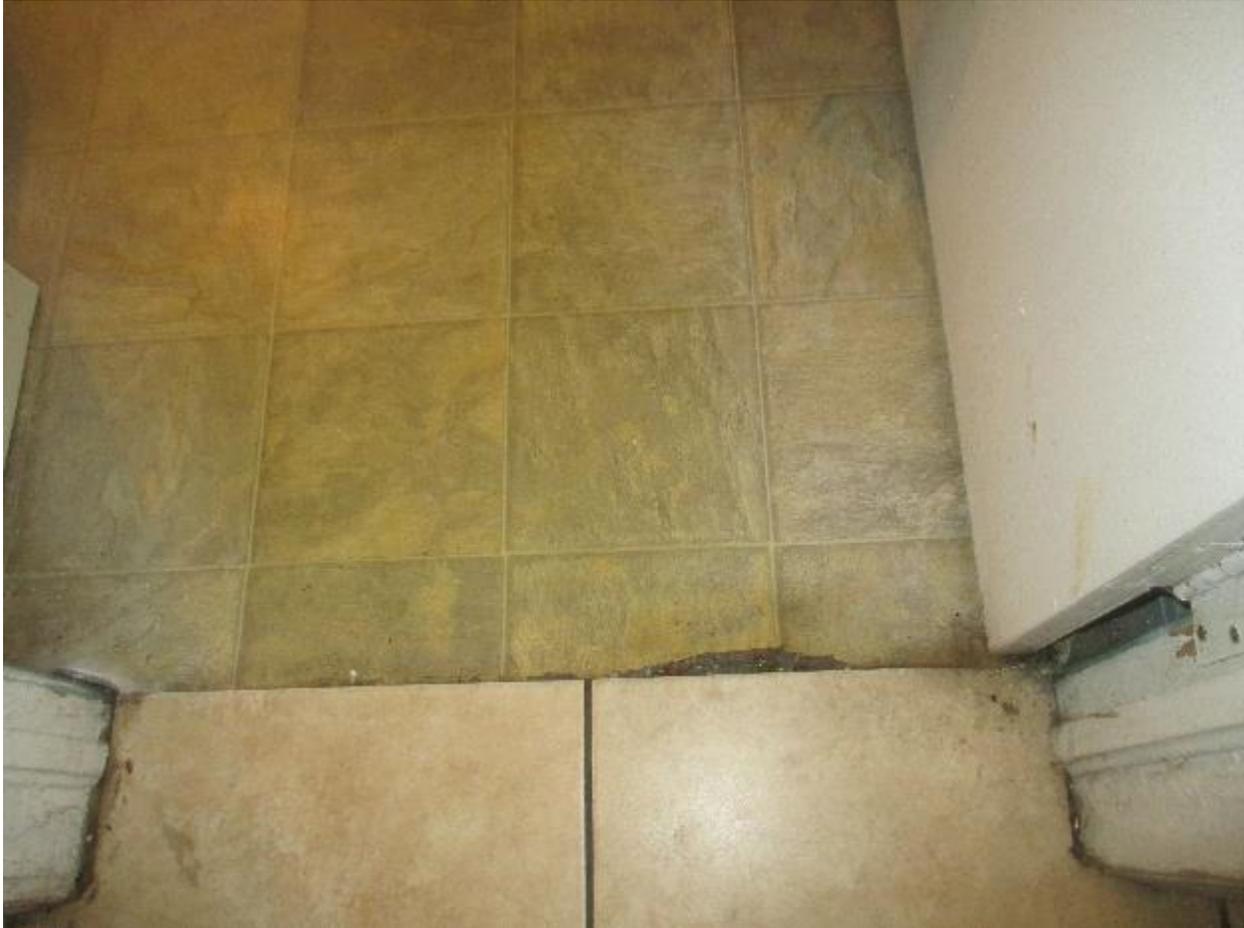
Dissimilar material on floors to be considered for removal and replacement for a uniform look.

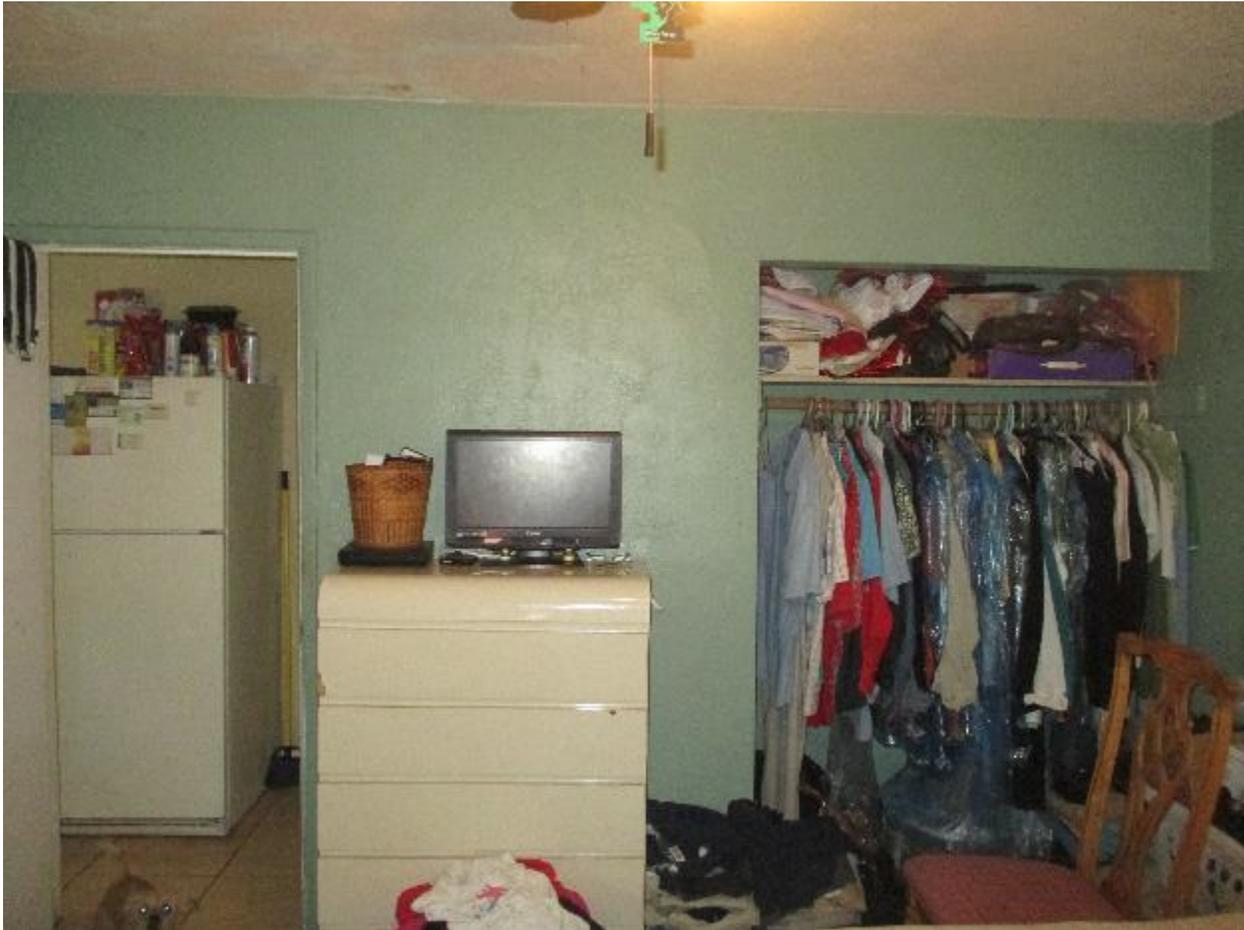
Interior finishes were found in general good condition at the time of inspection with exceptions as noted and shown in photographs.

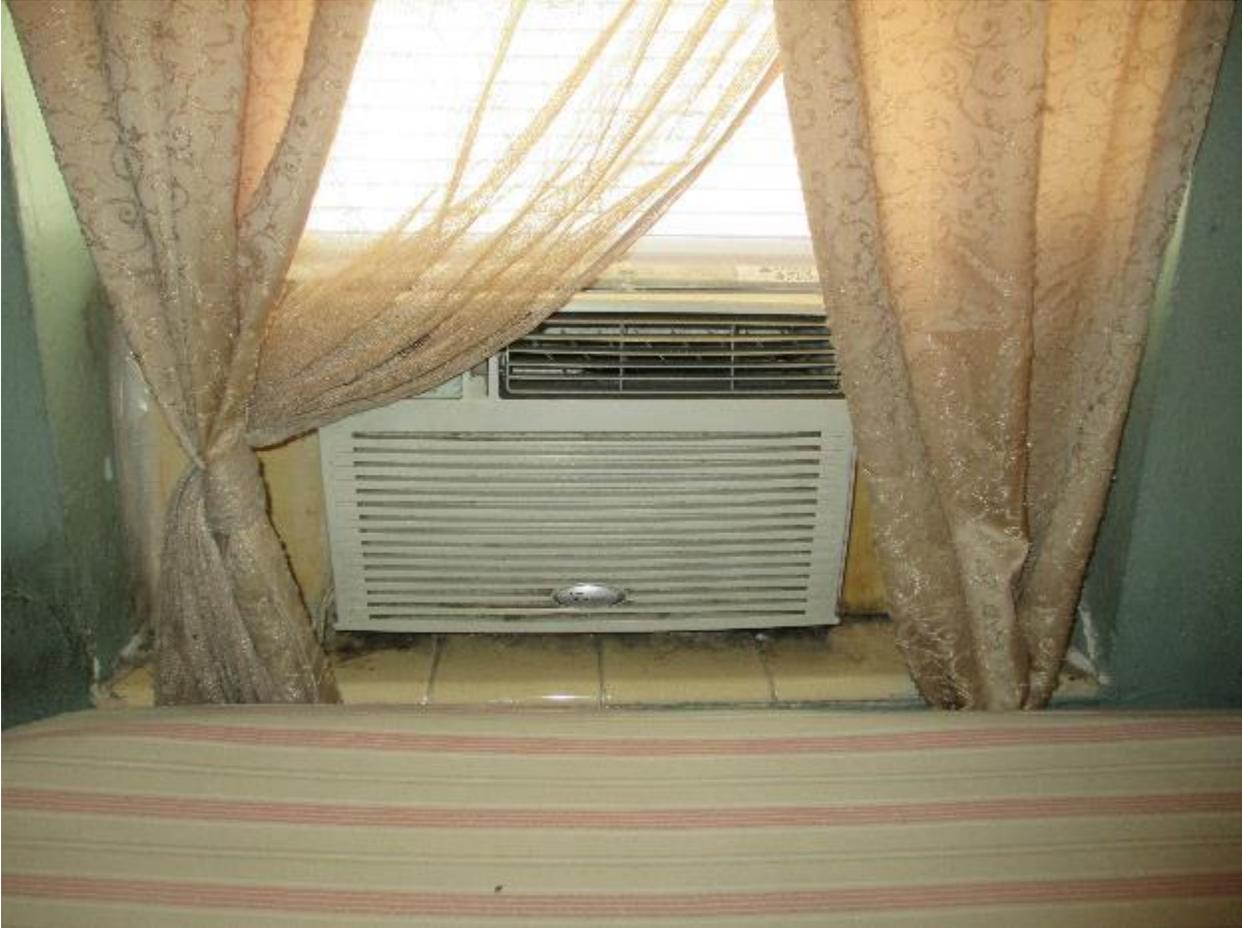
Ac in good working condition at the time of inspection.

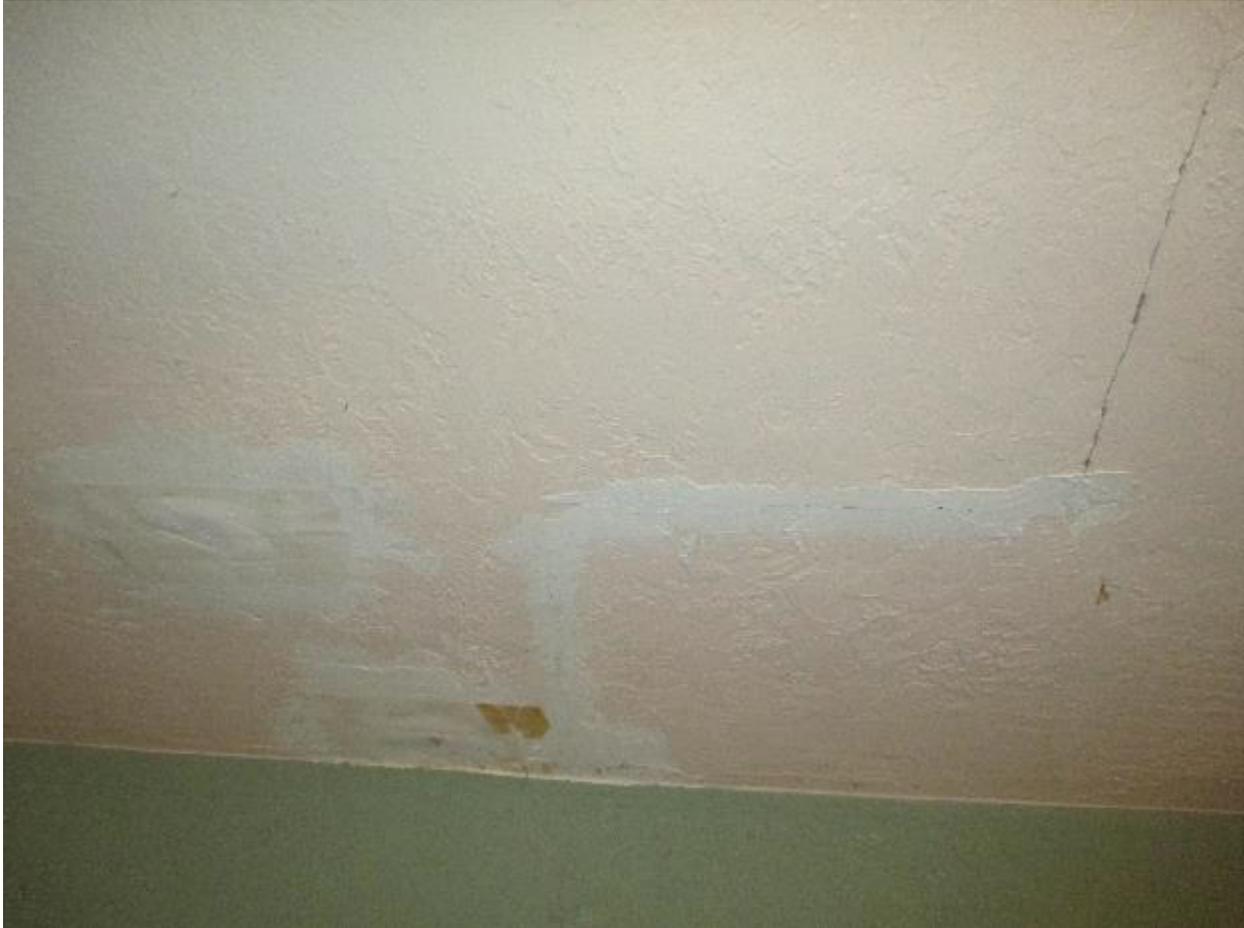
Cracks on ceiling not of structural importance but repairs related to drywall must be performed to secure the loose material.

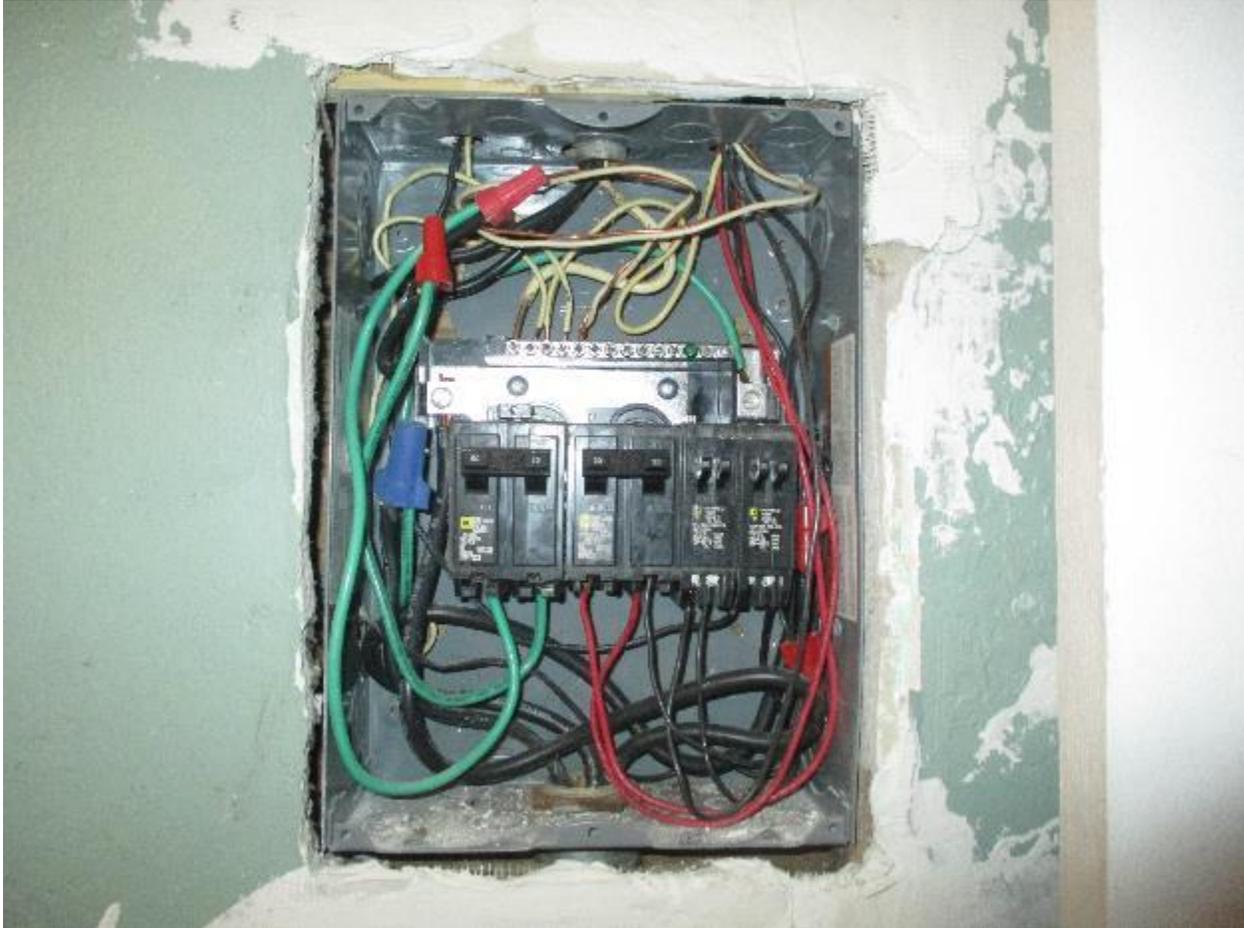
Electrical breaker panel in good condition at the time of inspection.

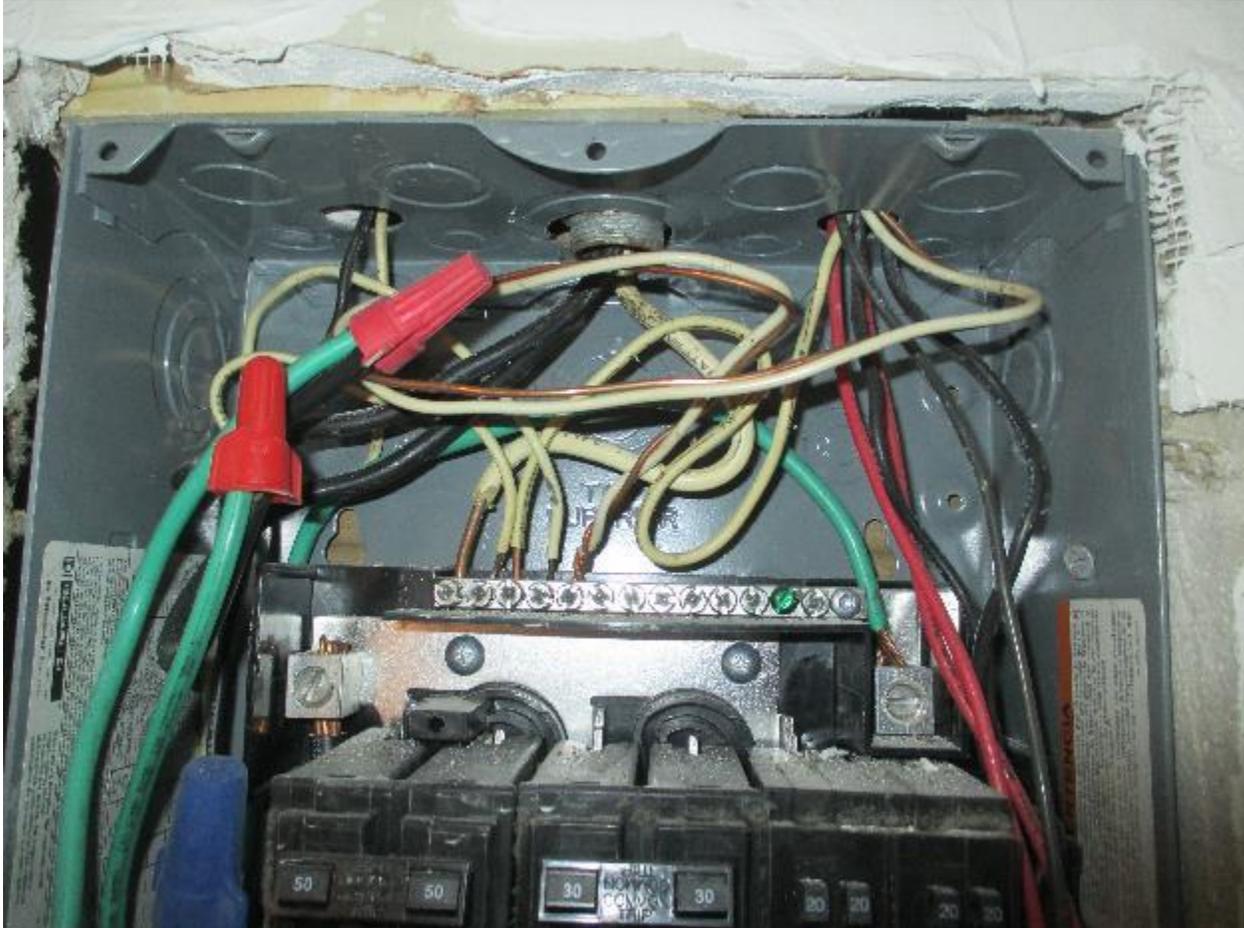
Electrical breaker panel in good condition at the time of inspection.

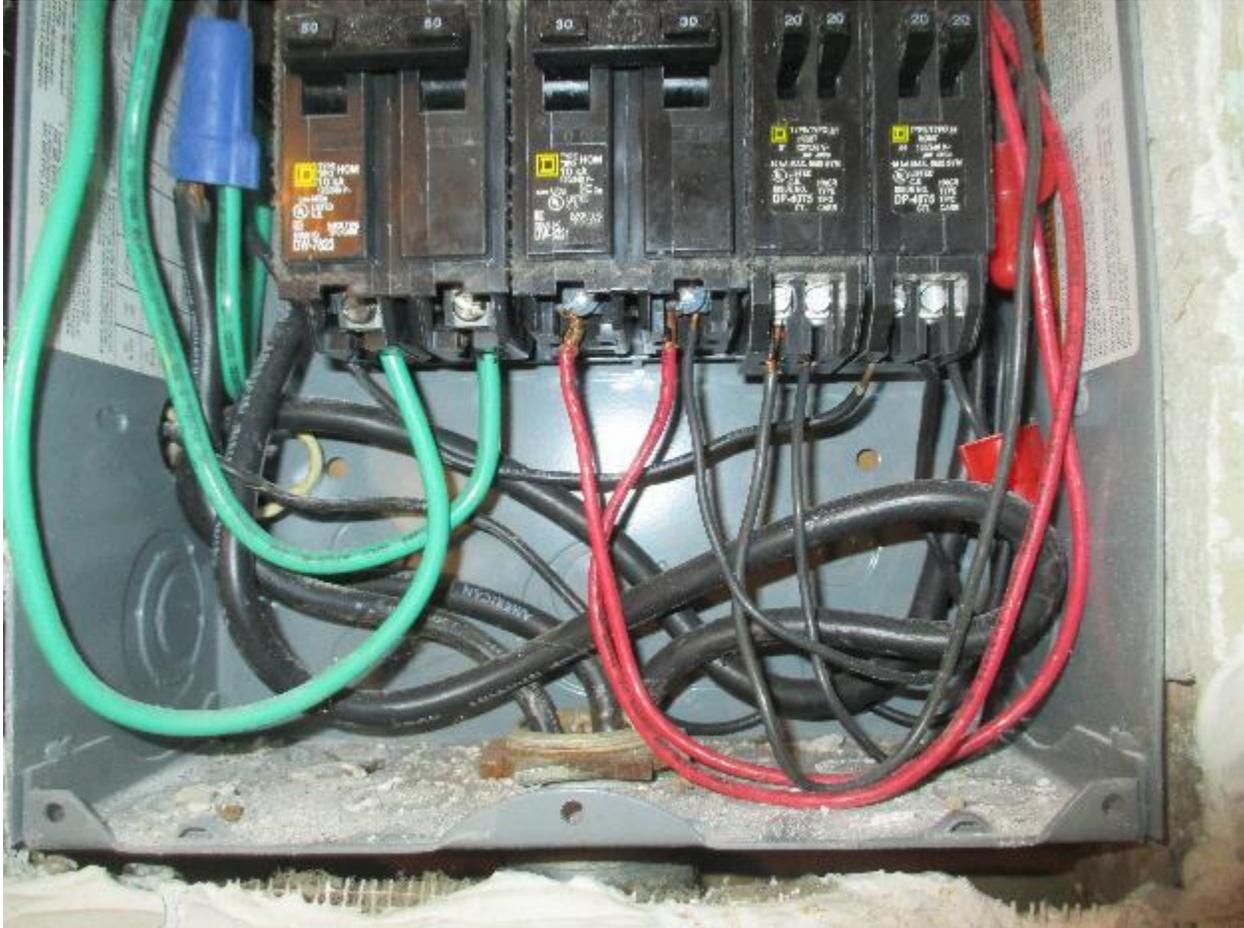
Electrical breaker panel in good condition at the time of inspection.

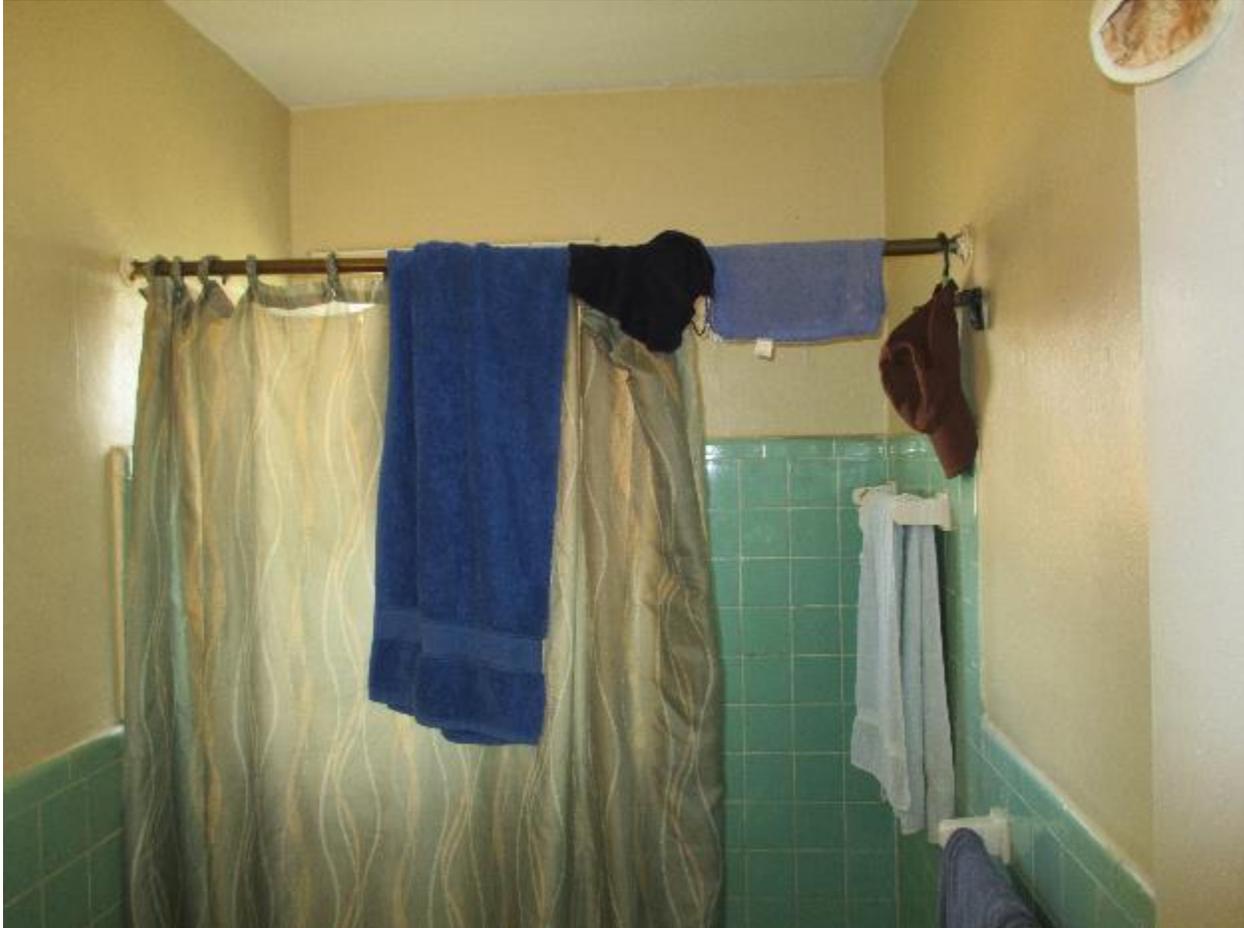
Allowances must be made for the complete upgrade of finishes in bathroom(s).

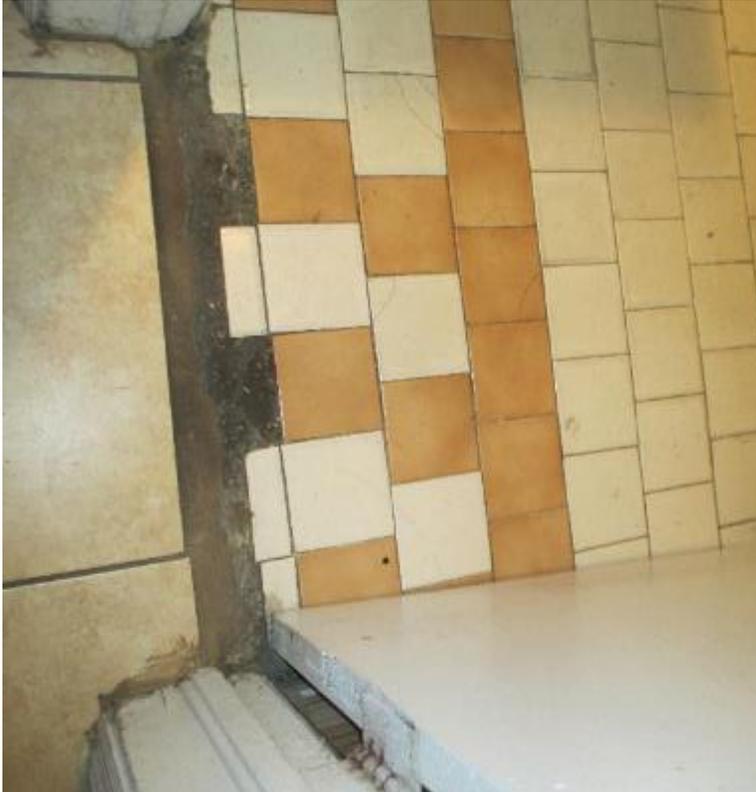
Allowances must be made for the complete upgrade of finishes in bathroom(s).

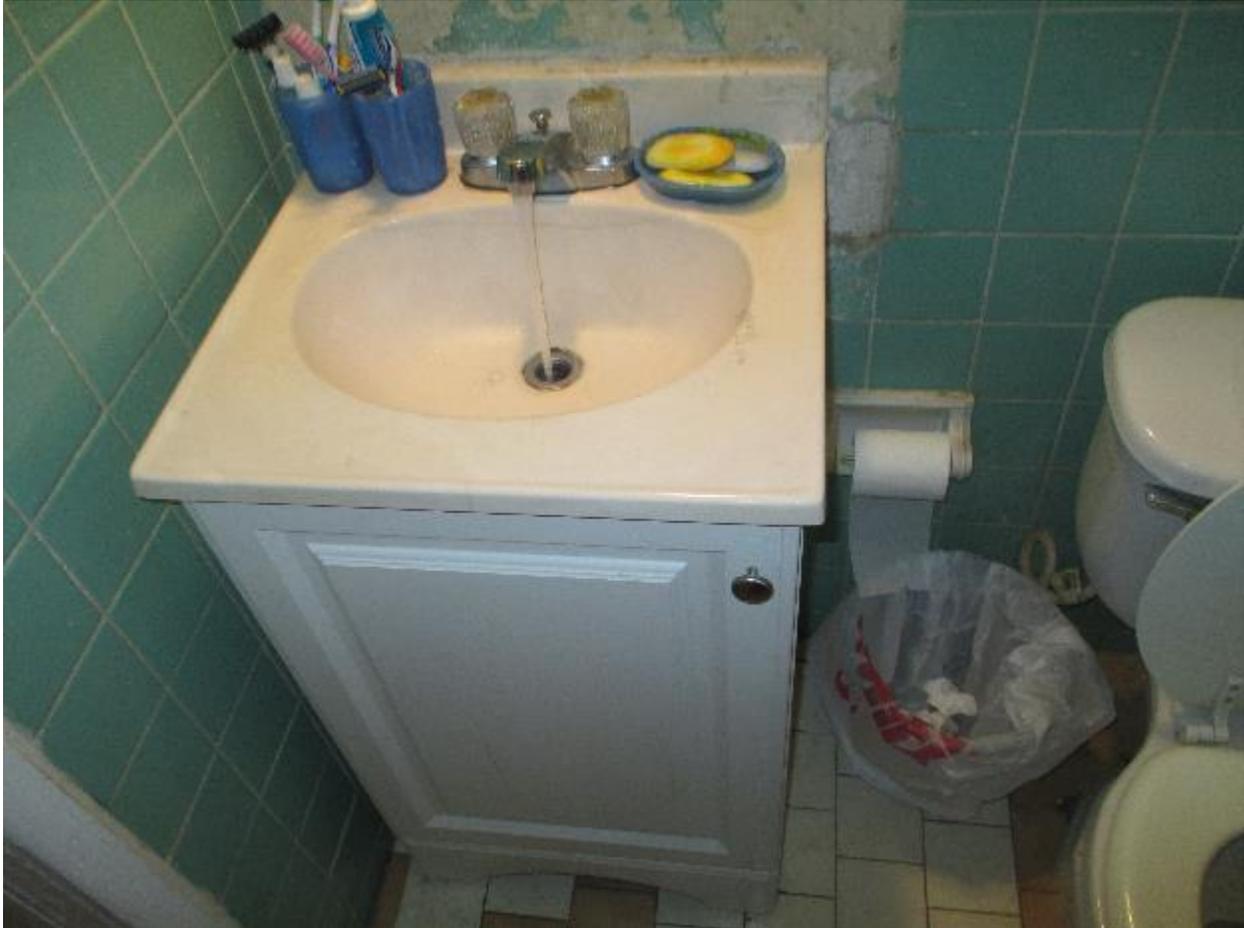
Plumbing systems tested for proper flow. No leaks or deficiencies noted on drain and supply lines.

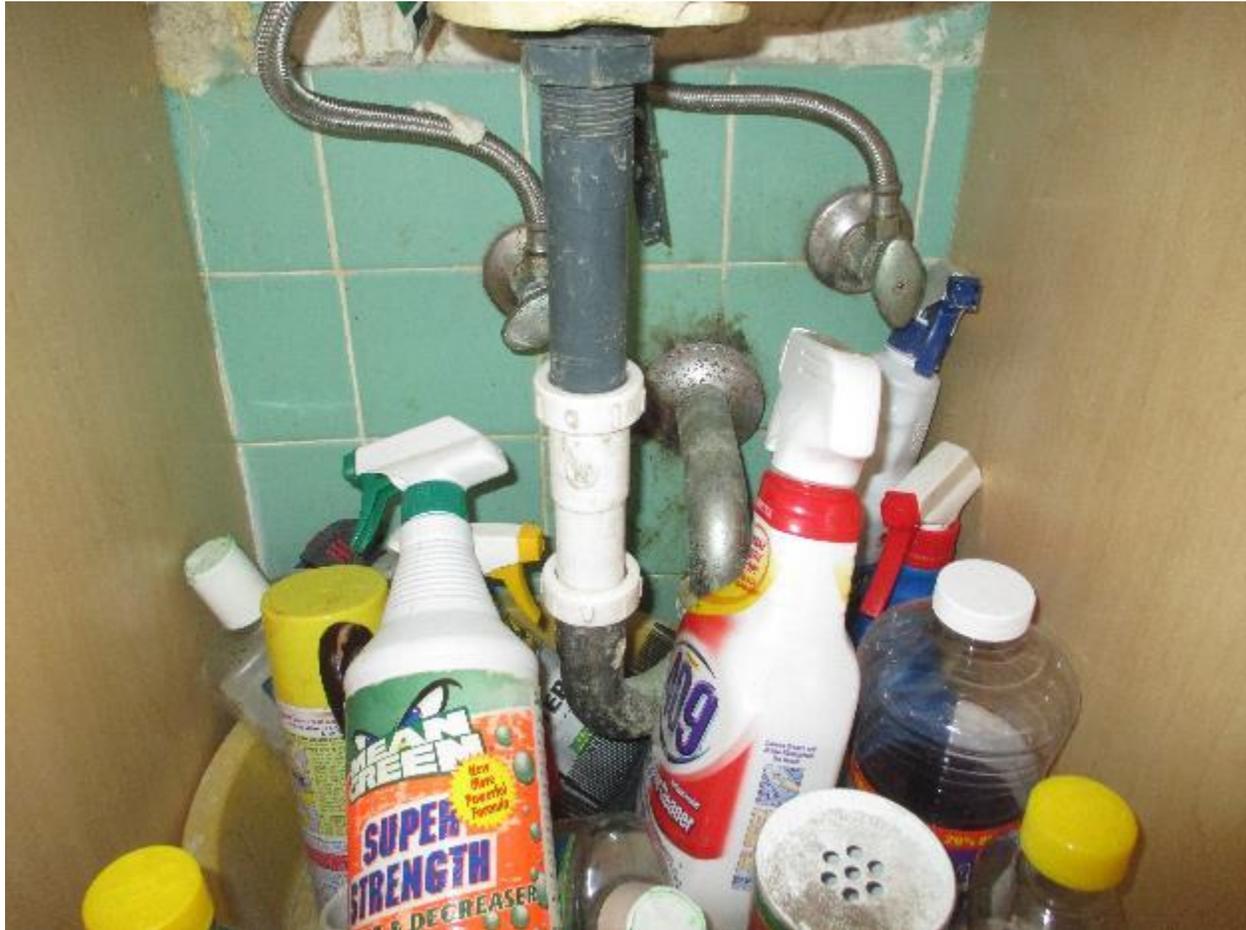
Plumbing systems tested for proper flow. No leaks or deficiencies noted on drain and supply lines.

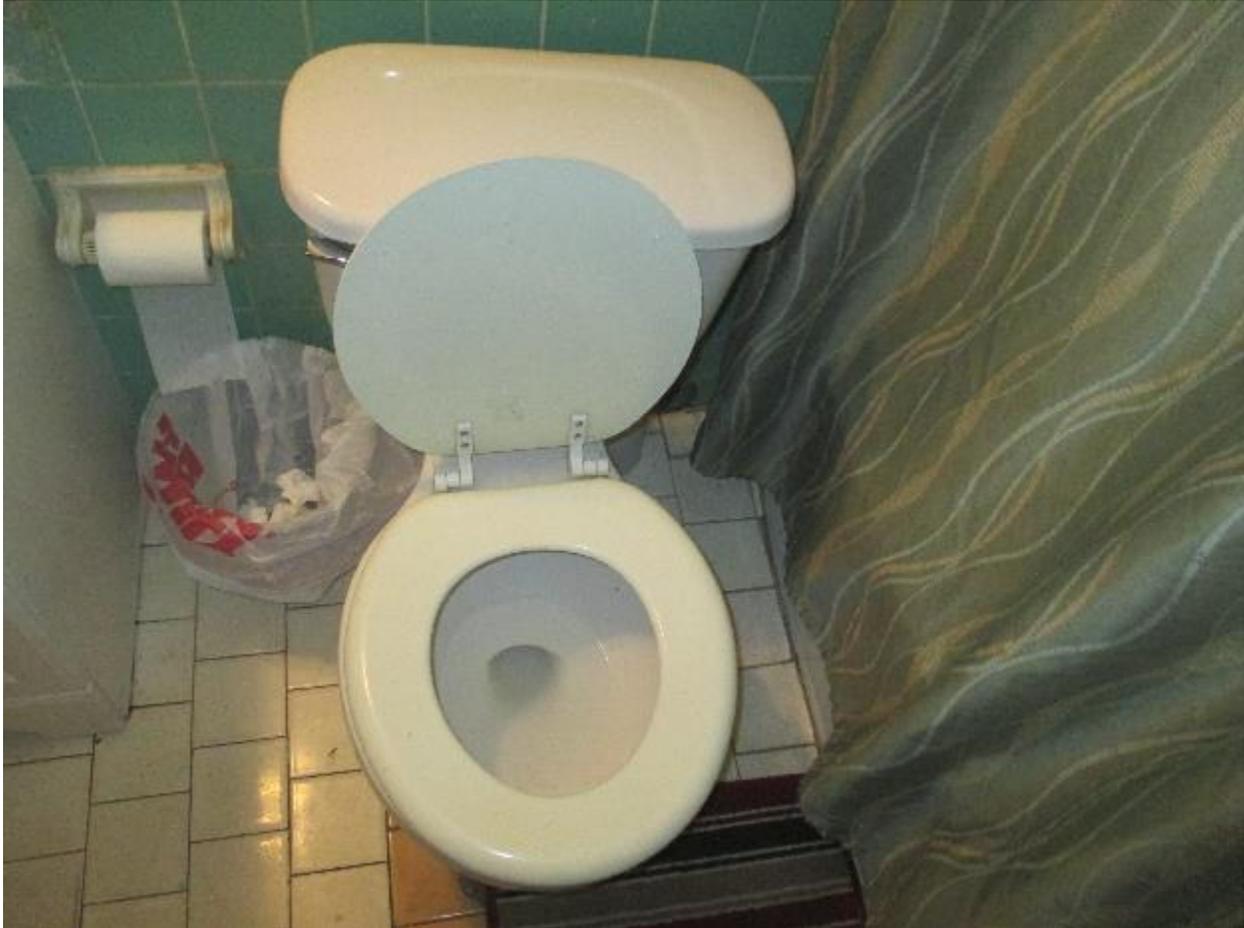
Allowances must be made for the complete upgrade of finishes in bathroom(s).

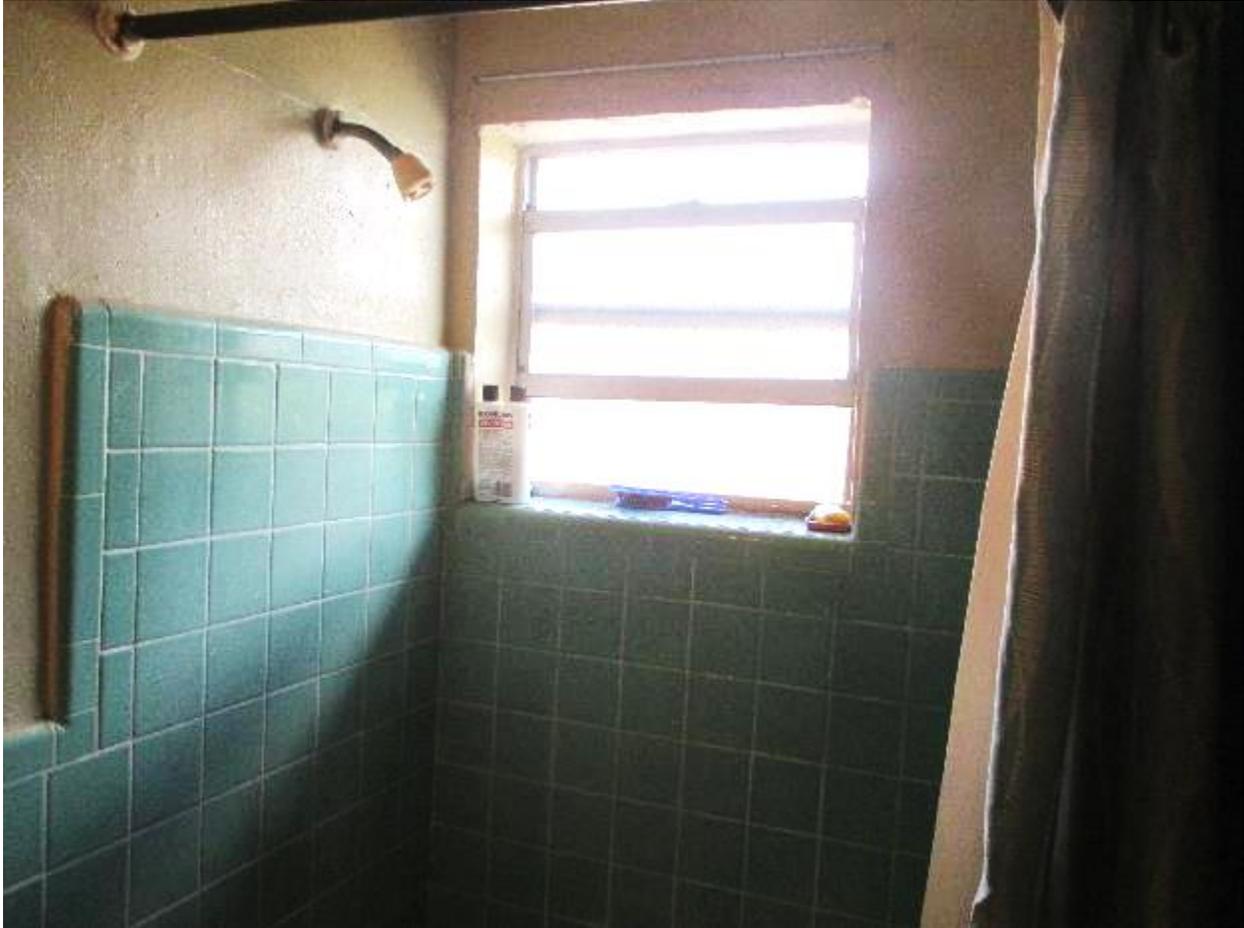
Allowances must be made for the complete upgrade of finishes in bathroom(s).

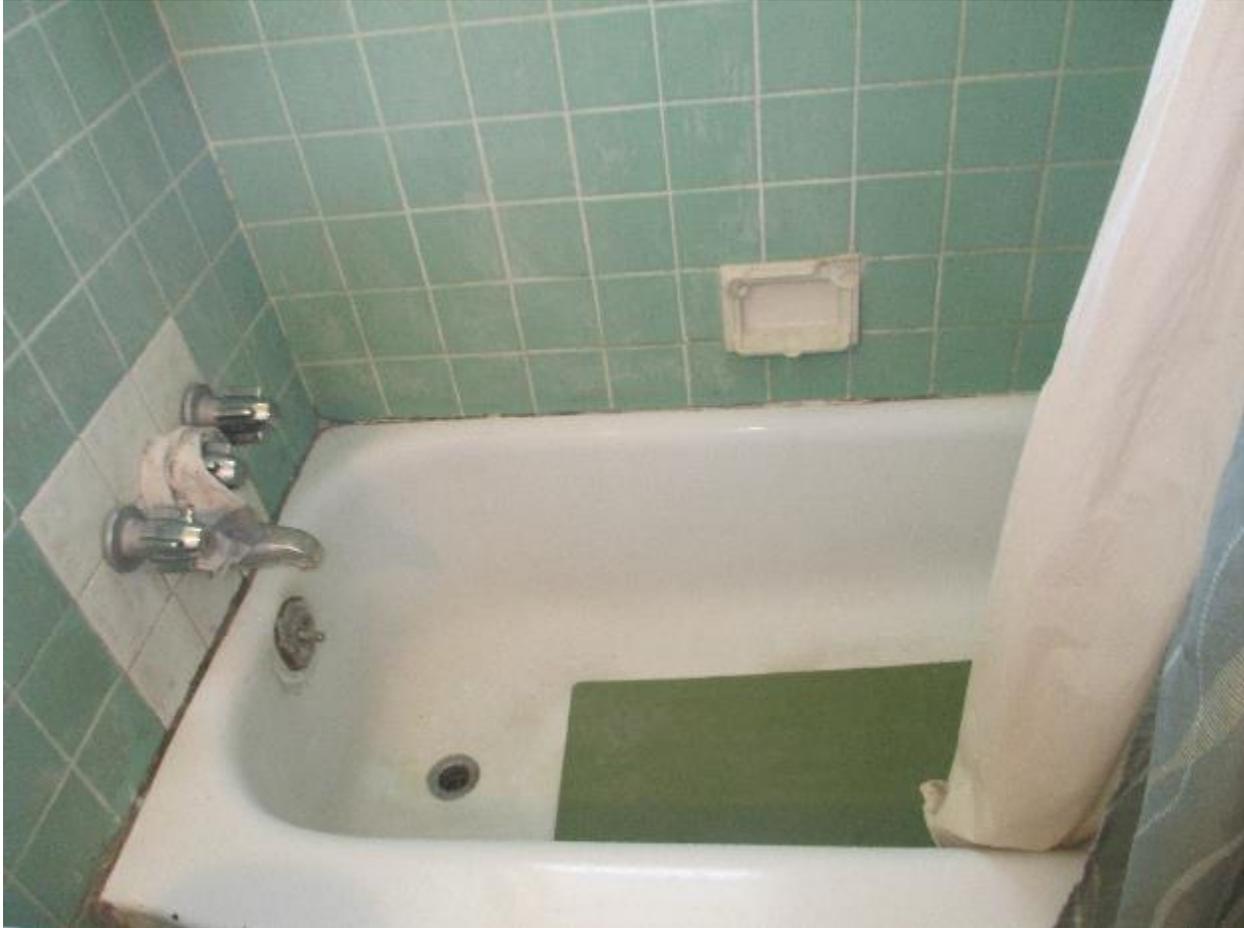
Allowances must be made for the complete upgrade of finishes in bathroom(s).

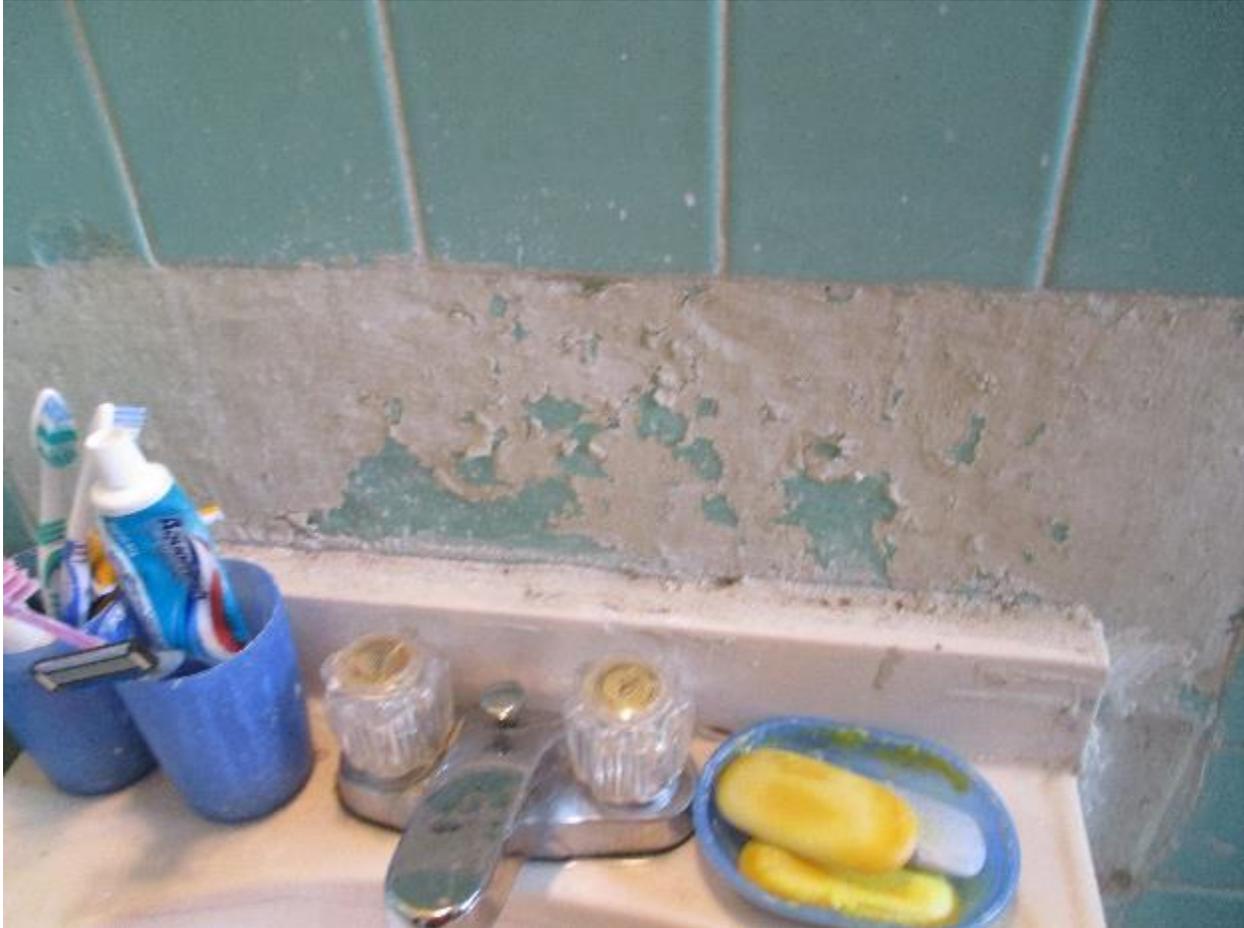
Allowances must be made for the complete upgrade of finishes in bathroom(s).

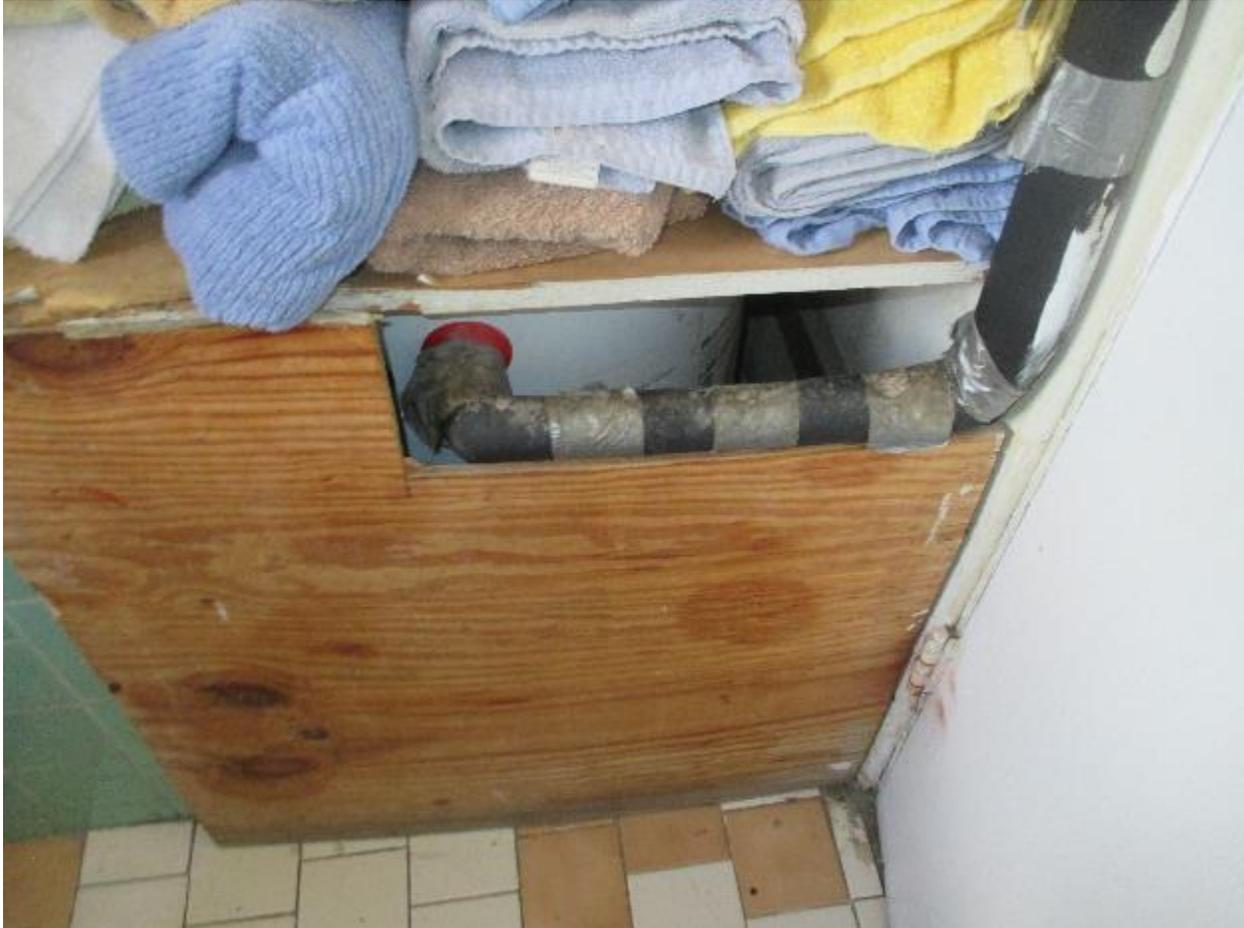
Water heater pressure release valve without release valve / not properly installed.

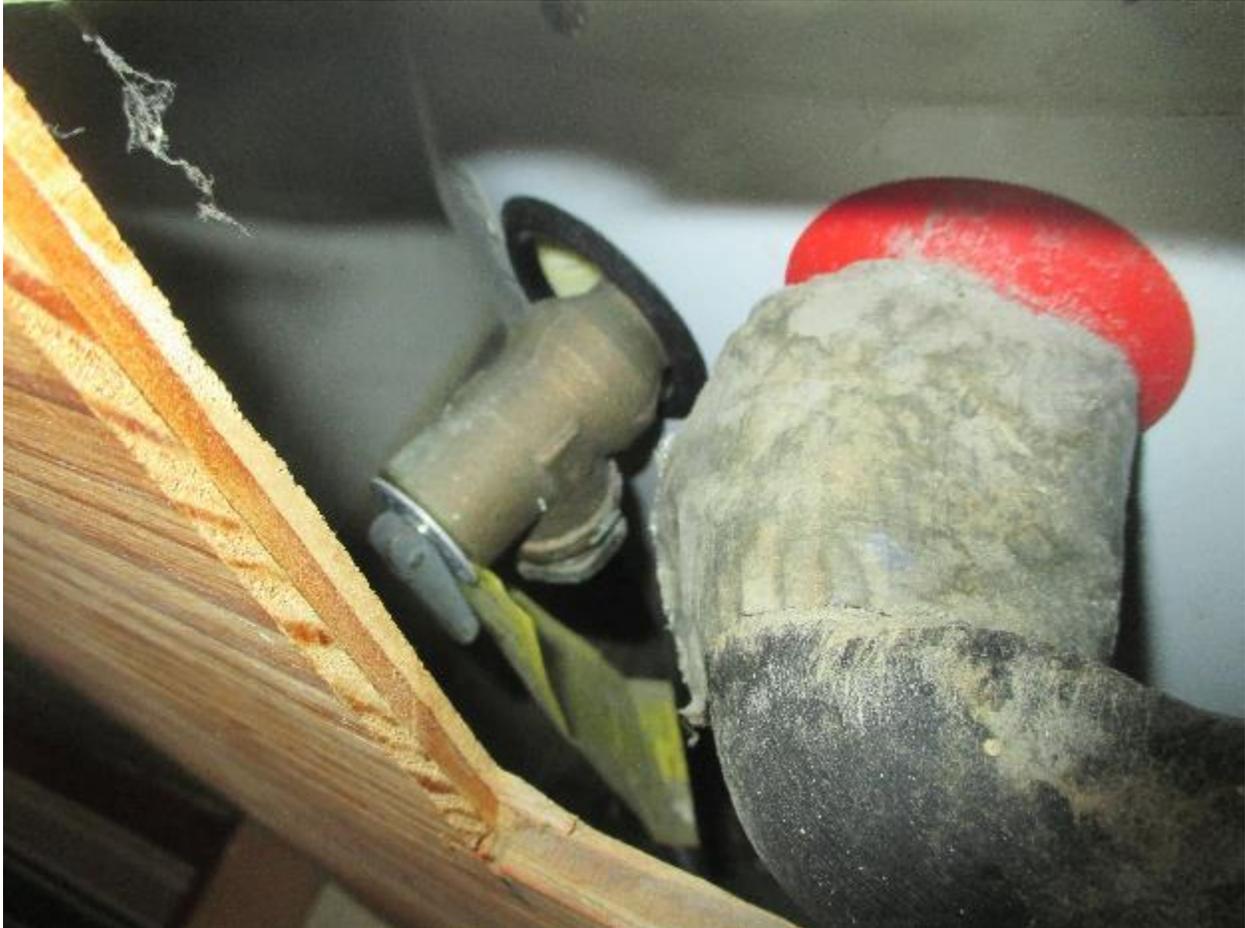
Water heater pressure release valve without release valve / not properly installed.
