PROPERTY INSPECTION OR ASSESSMENT OF DAMAGES

ADDRESS: **SOMEWHERE , FL**
CLIENT: **GAIA GC**
ID No: **2015000**
DATE: **12/31/xxxx**

GAIA CONSTRUCTION INC.
CGC 1516136 FLORIDA
HI-2792 FLORIDA
8028867-B2 INTERNATIONAL CODE COUNCIL

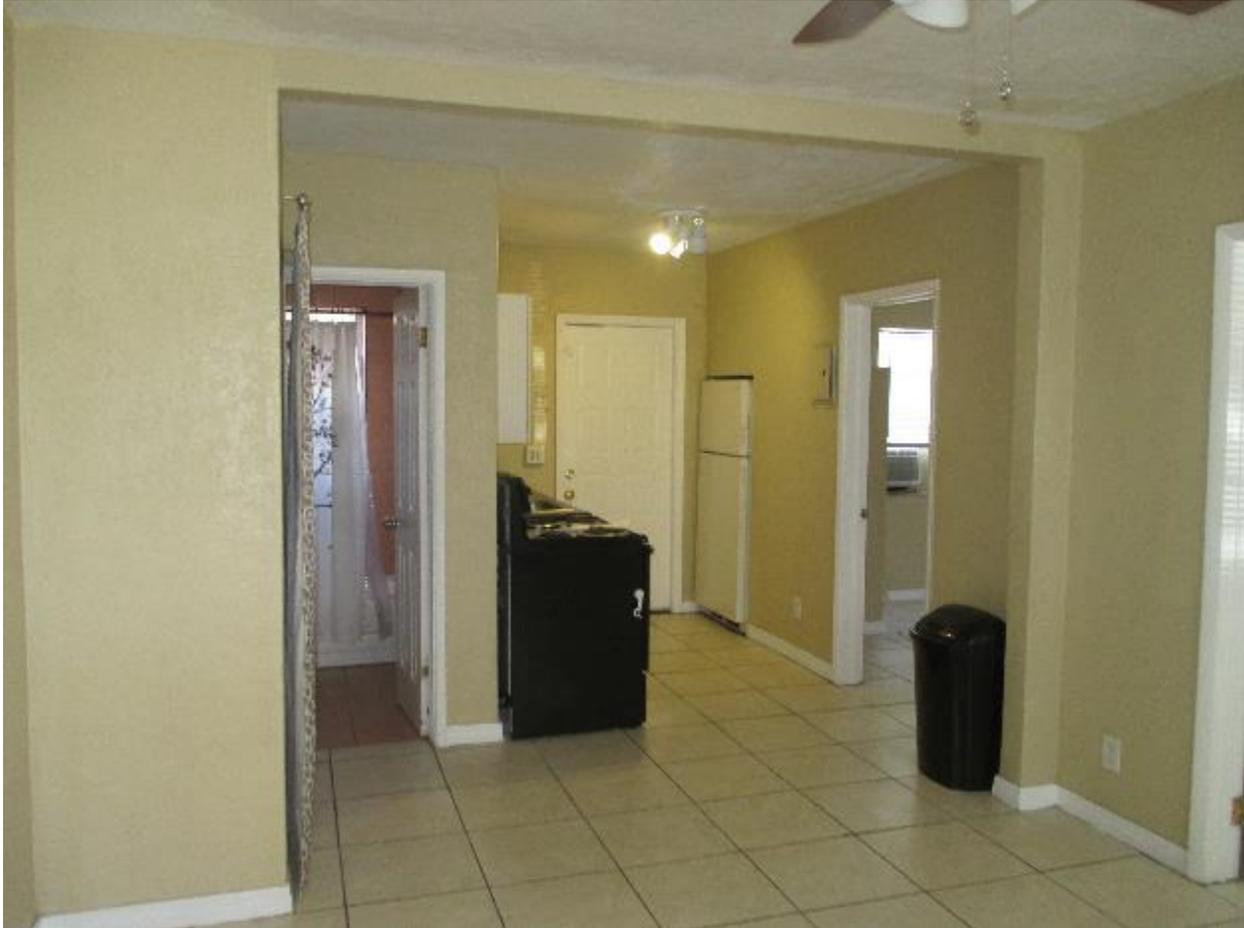
Interior finishes were found in general good condition at the time of inspection with exceptions as noted and shown in photographs.

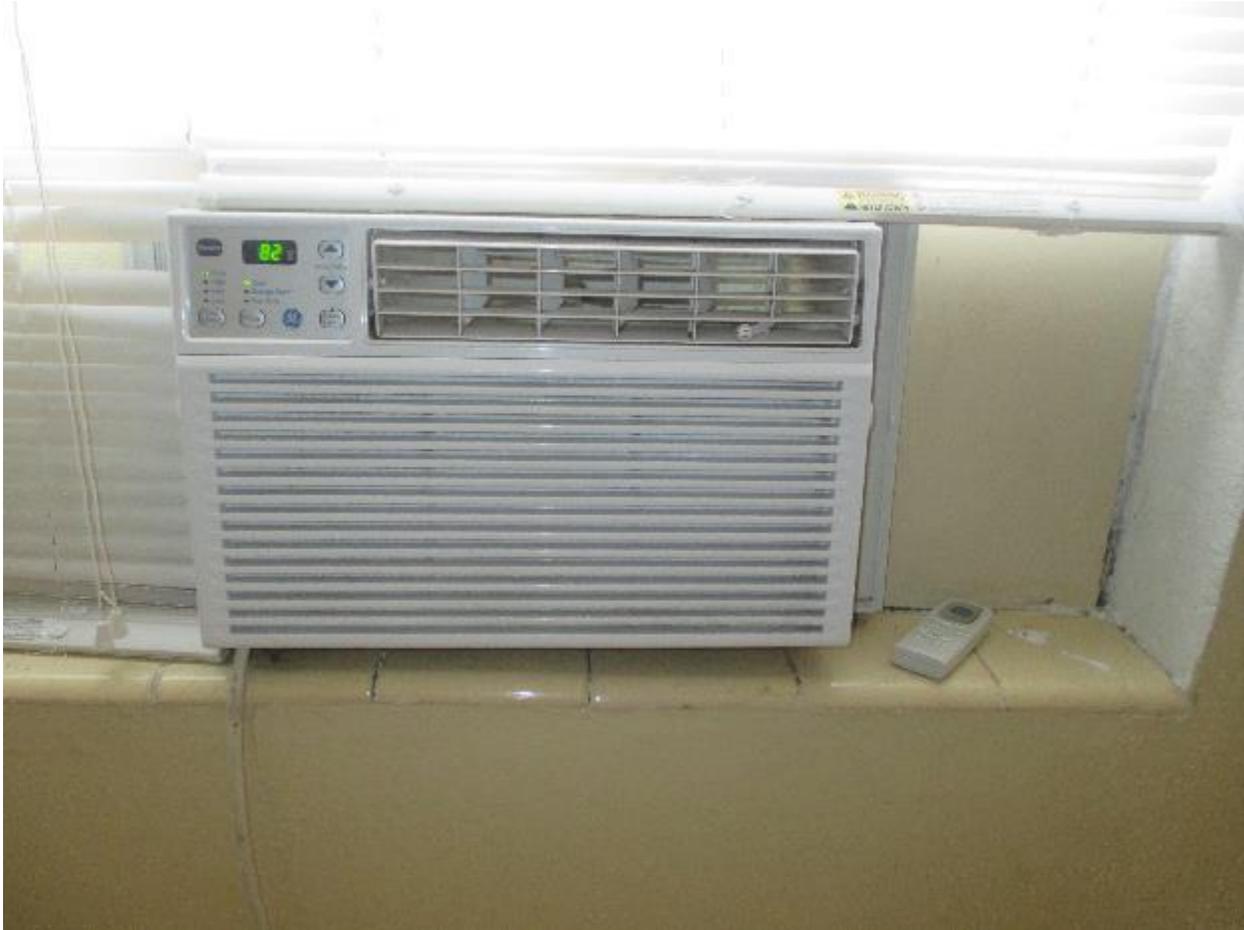
Ac in good working condition at the time of inspection.

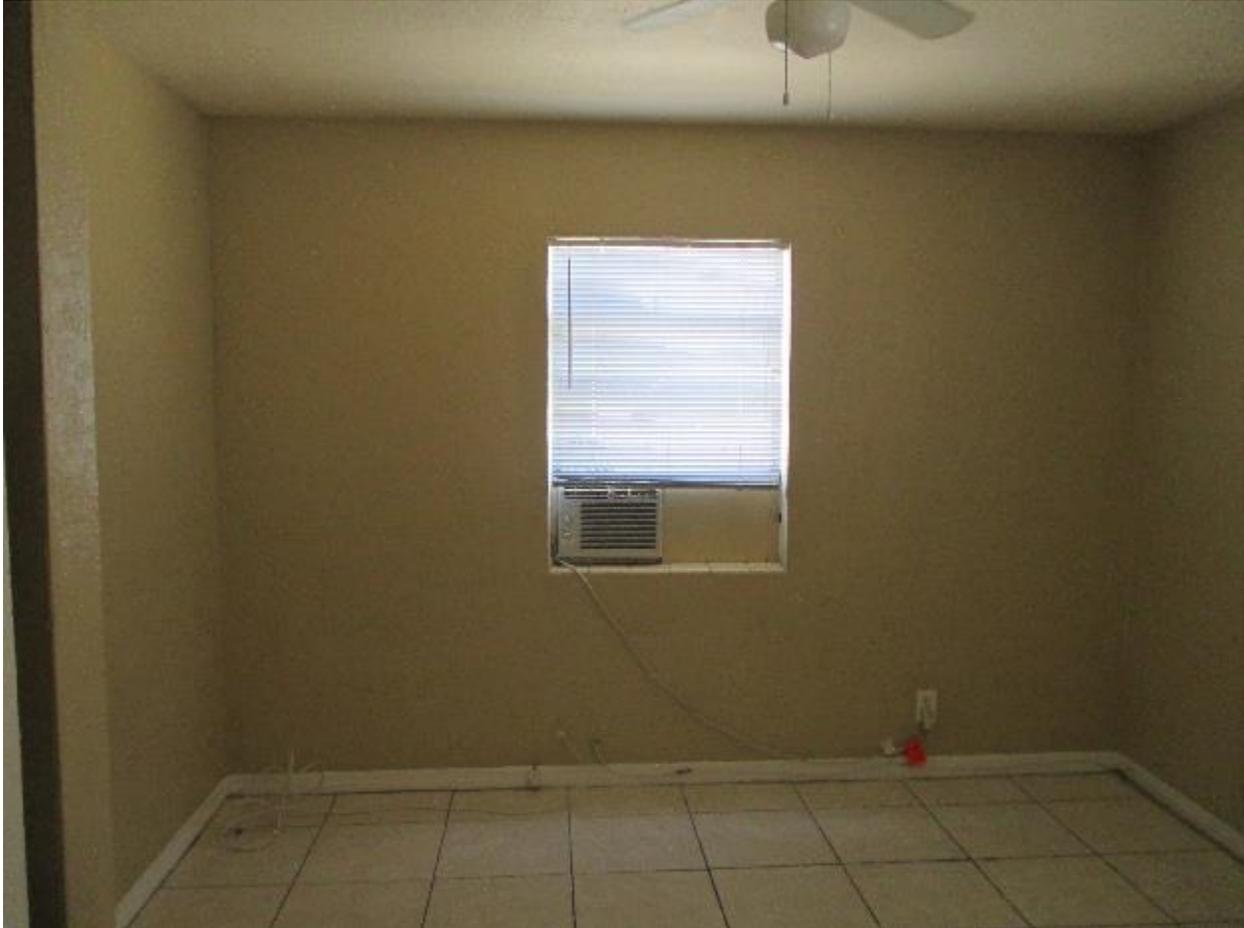
Interior finishes were found in general good condition at the time of inspection with exceptions as noted and shown in photographs.

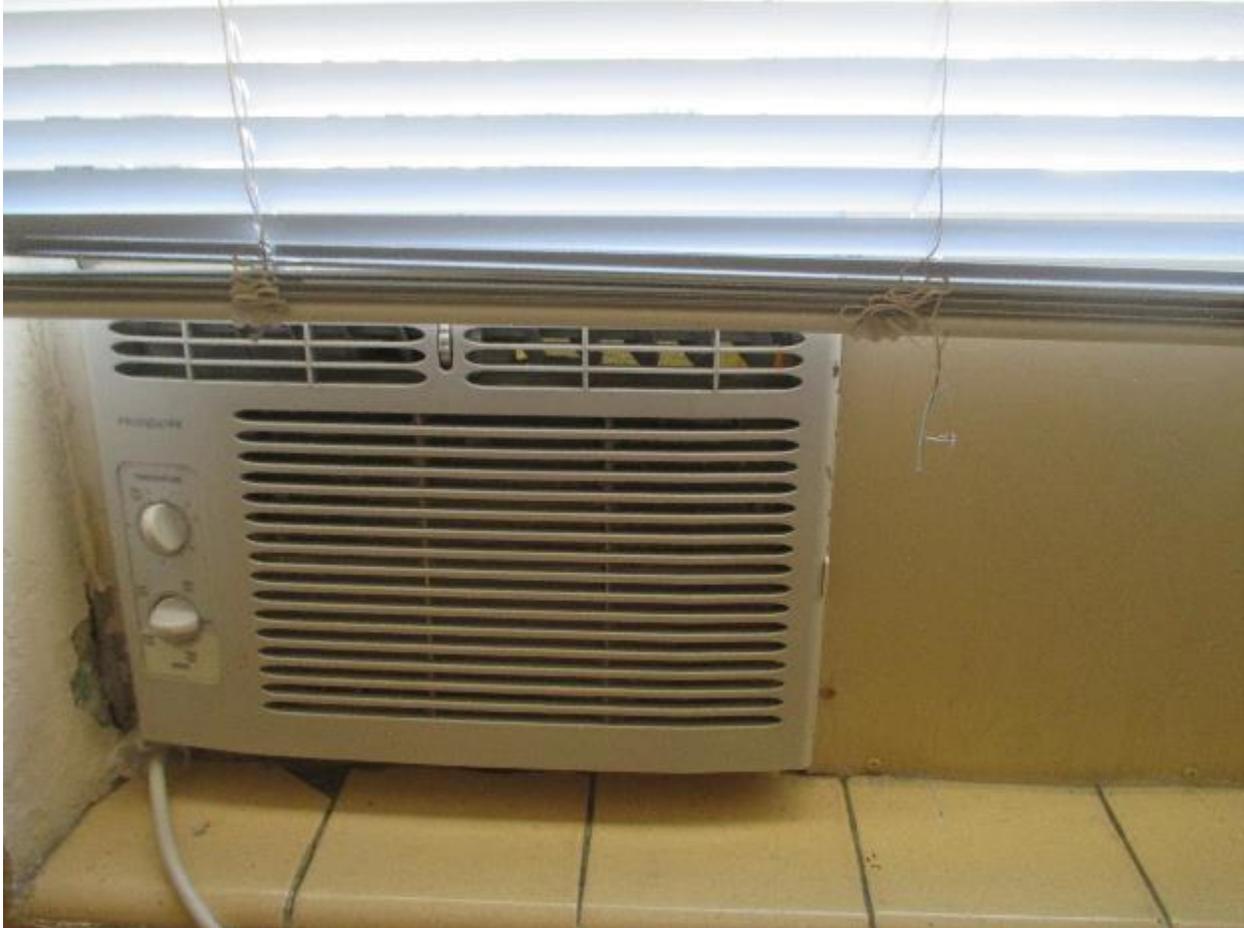
Ac in good working condition at the time of inspection.

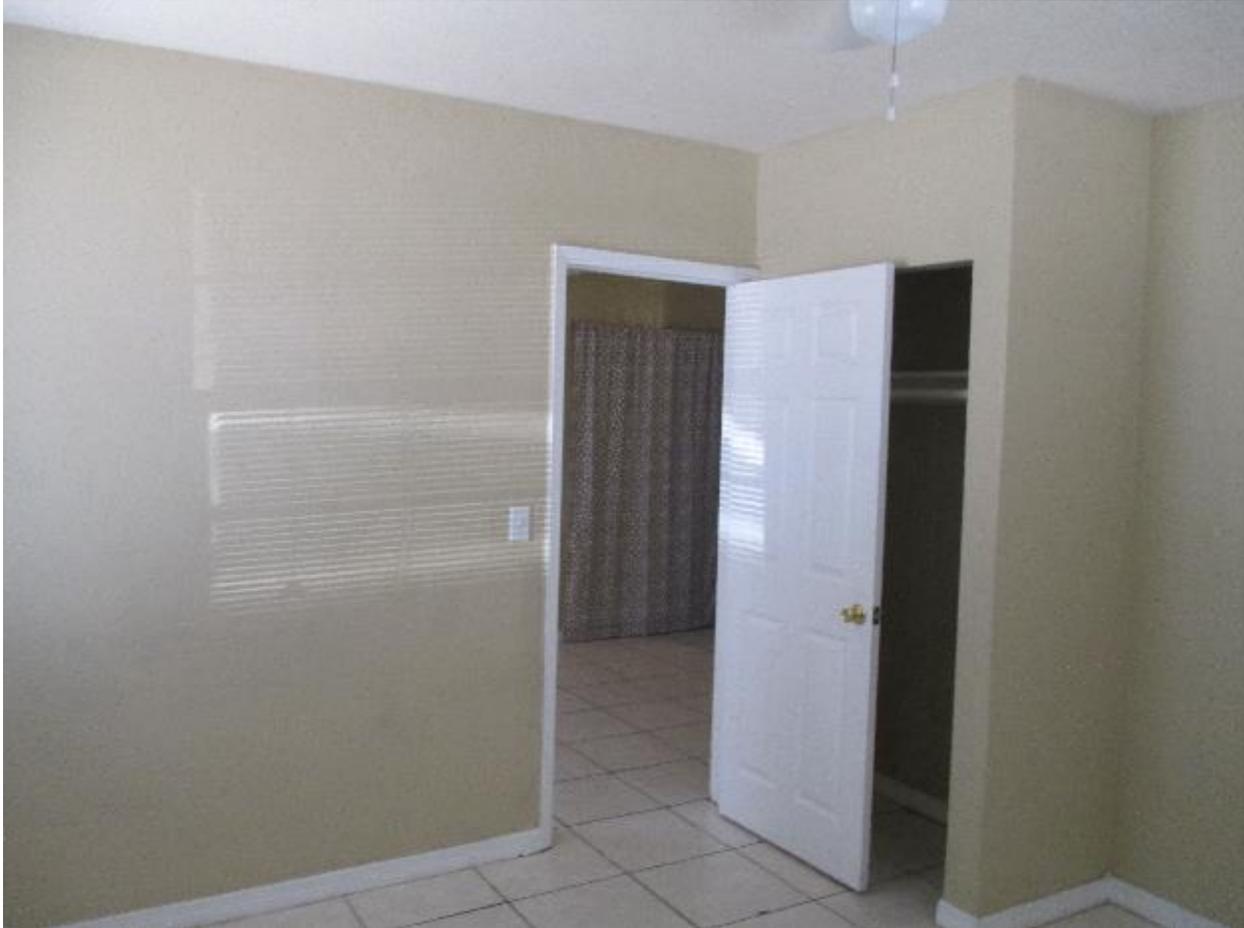
Interior finishes were found in general good condition at the time of inspection with exceptions as noted and shown in photographs.

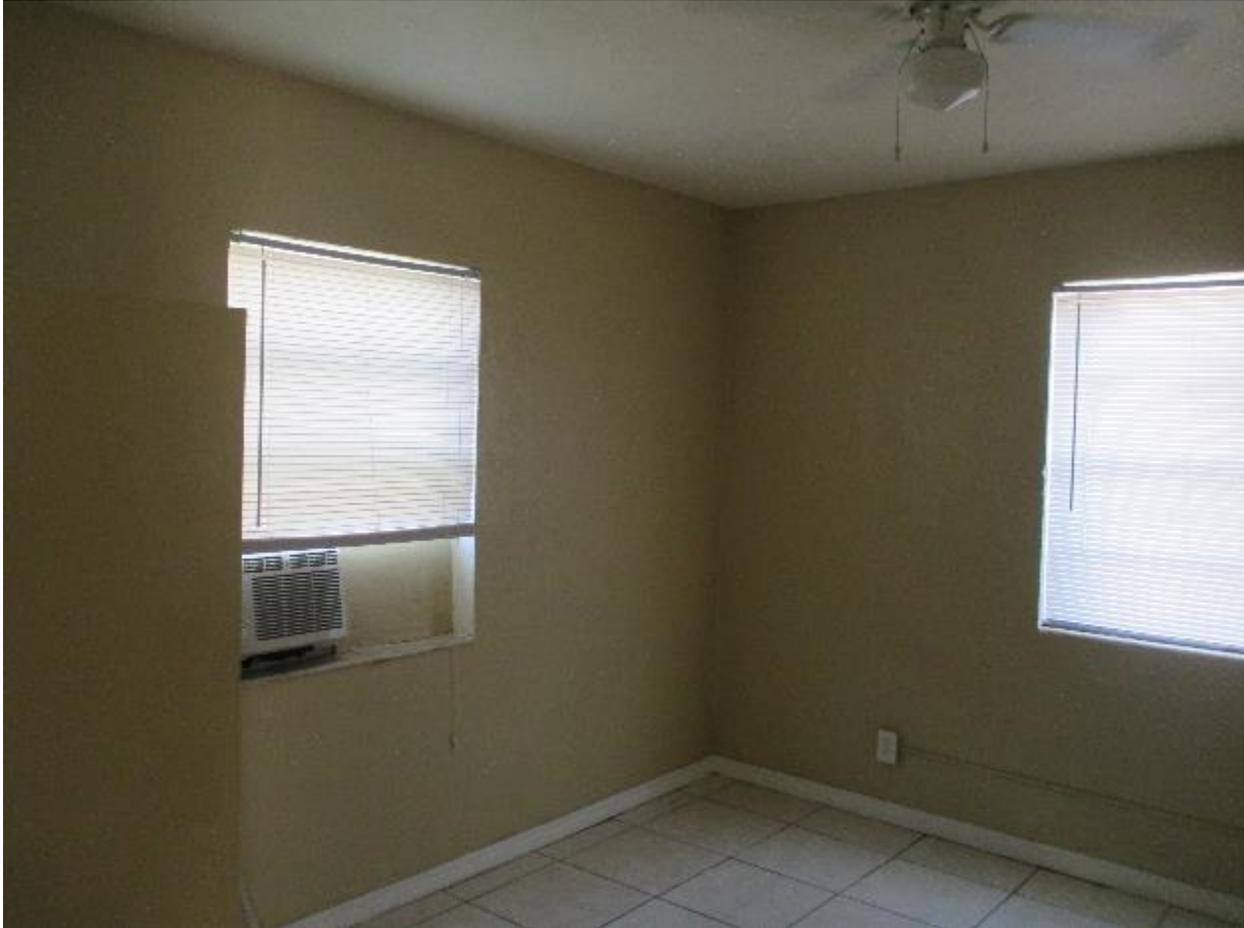
Interior finishes were found in general good condition at the time of inspection with exceptions as noted and shown in photographs.

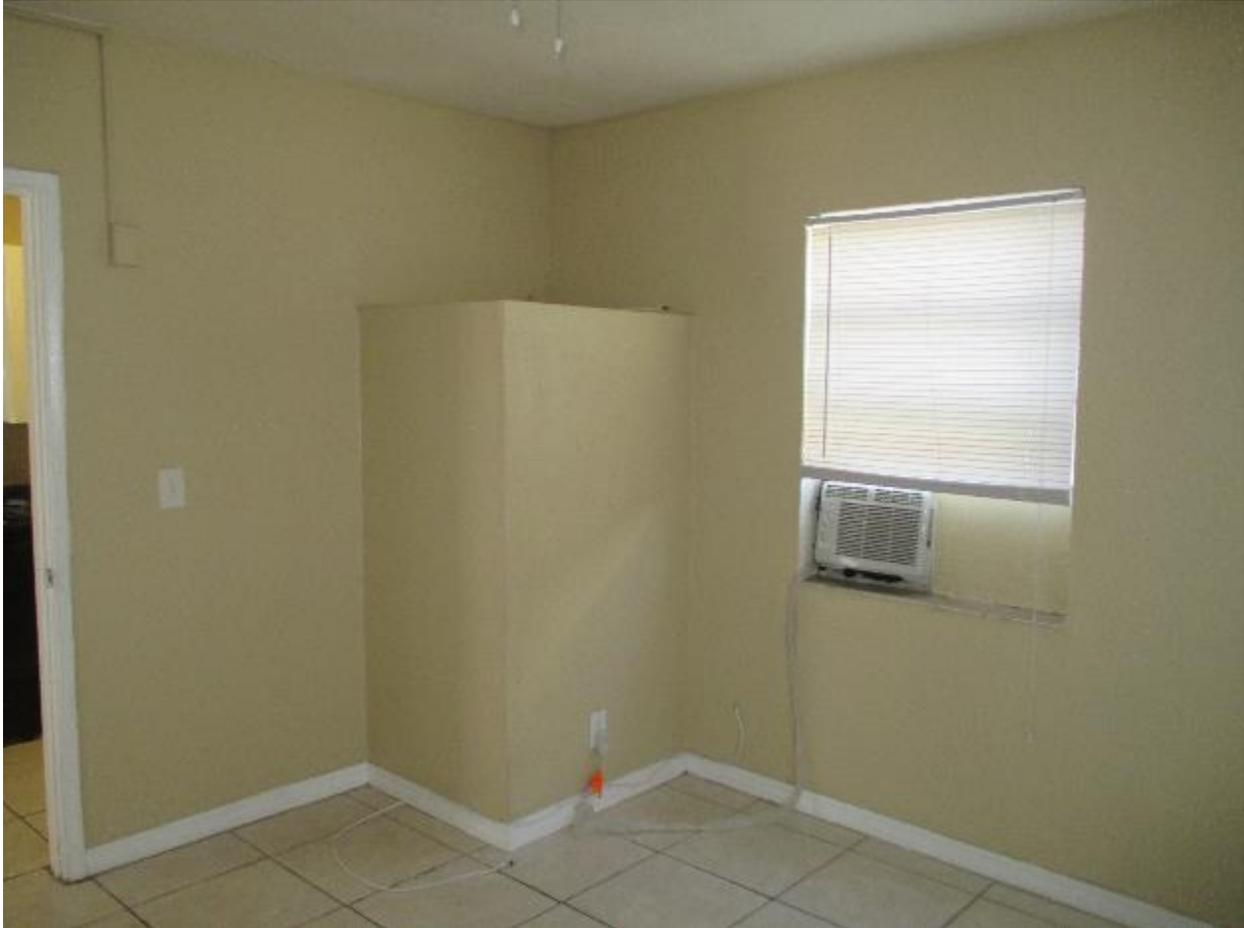
Interior finishes were found in general good condition at the time of inspection with exceptions as noted and shown in photographs.

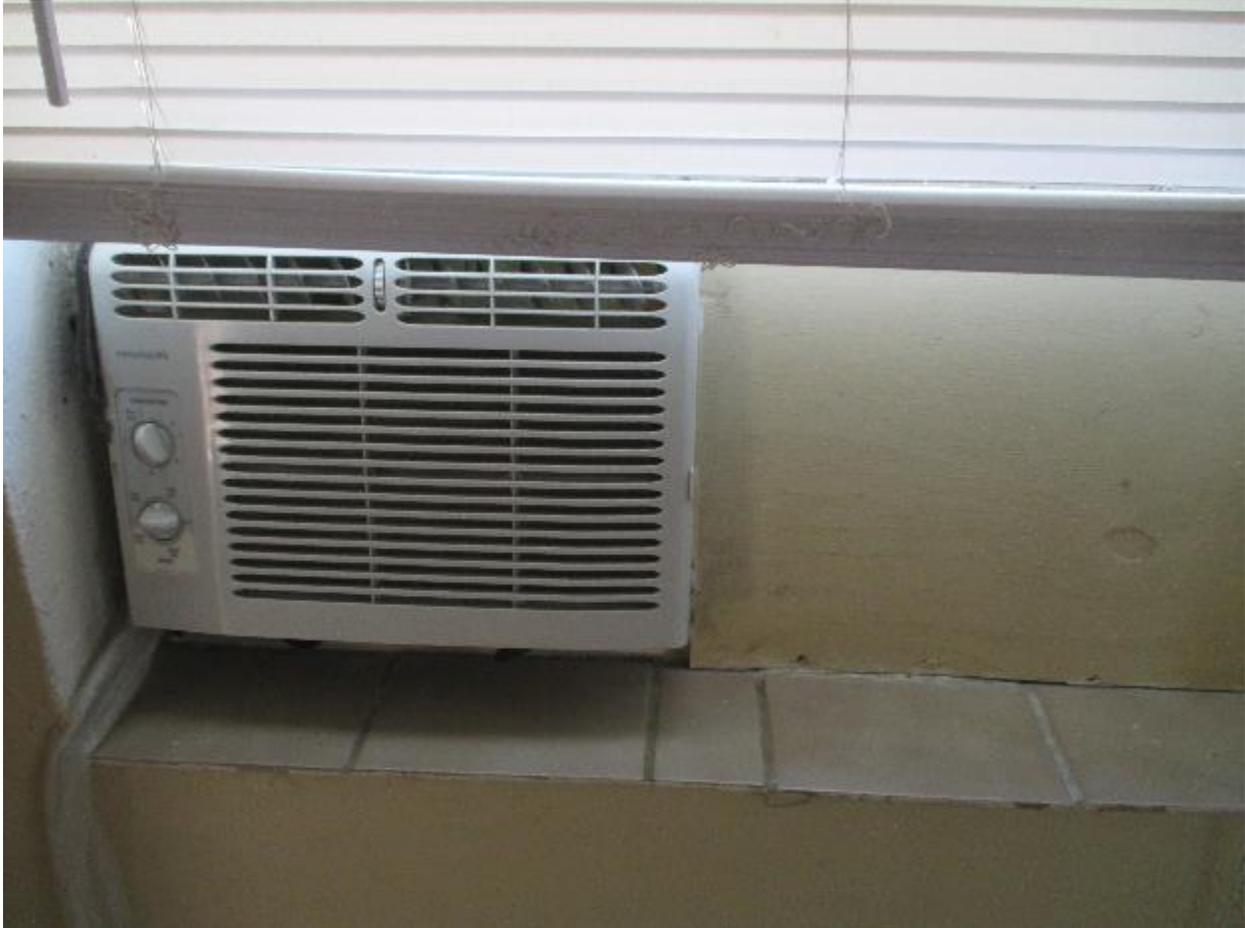
Ac in good working condition at the time of inspection.

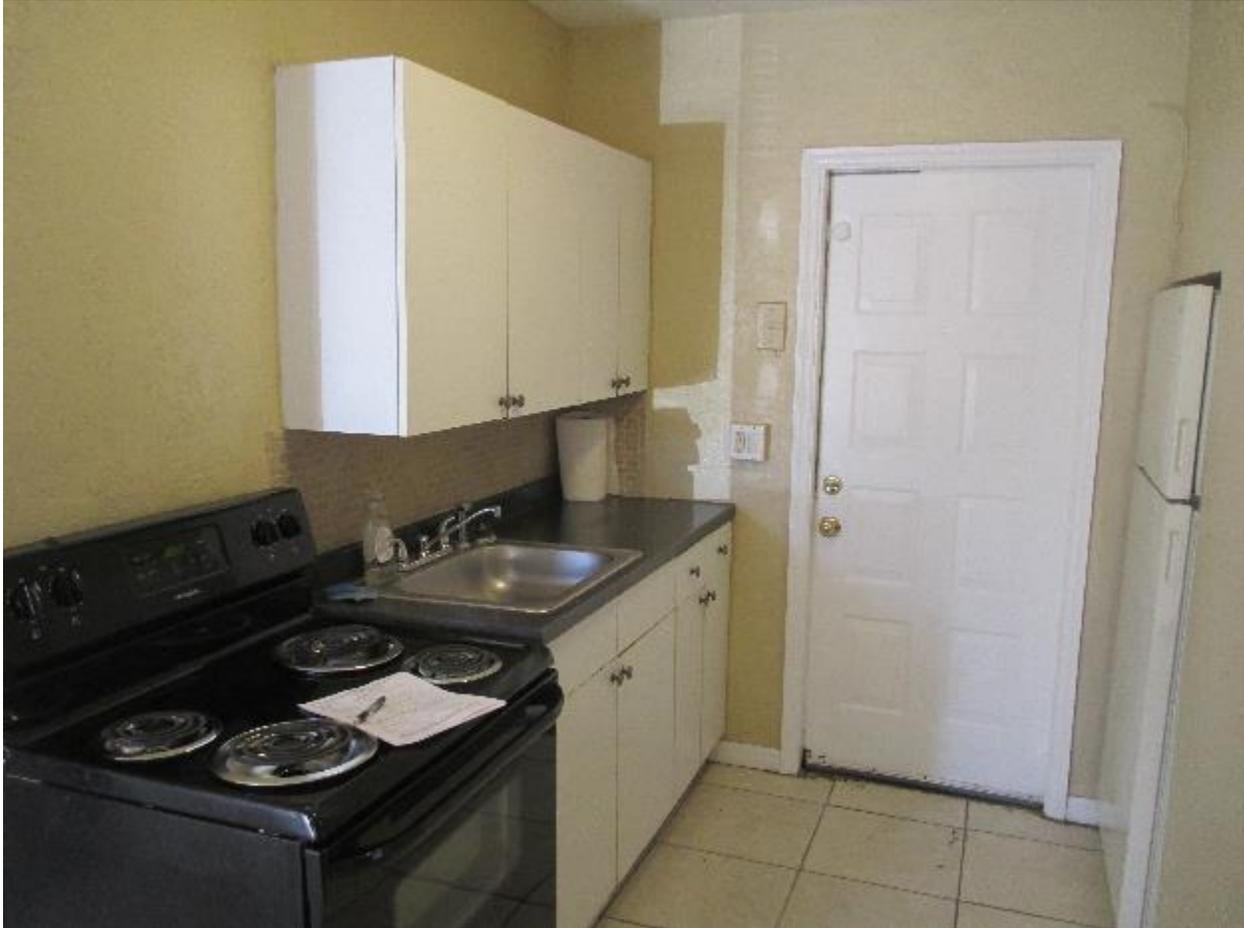
Interior finishes were found in general good condition at the time of inspection with exceptions as noted and shown in photographs.

No warranties or guarantees expressed on used appliances. Appliances found in working condition at the time of inspection.

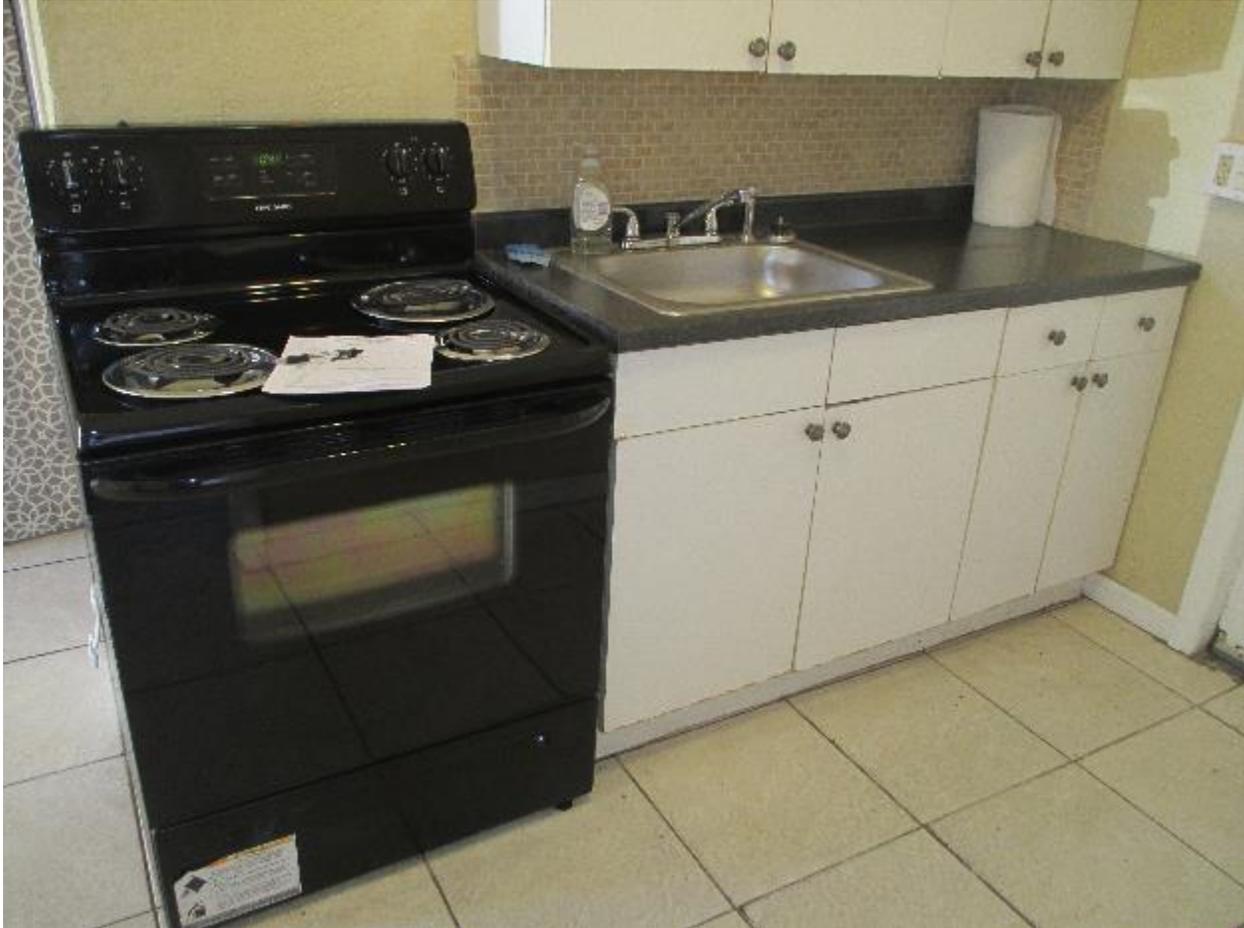
Interior finishes were found in general good condition at the time of inspection with exceptions as noted and shown in photographs.

No warranties or guarantees expressed on used appliances. Appliances found in working condition at the time of inspection.

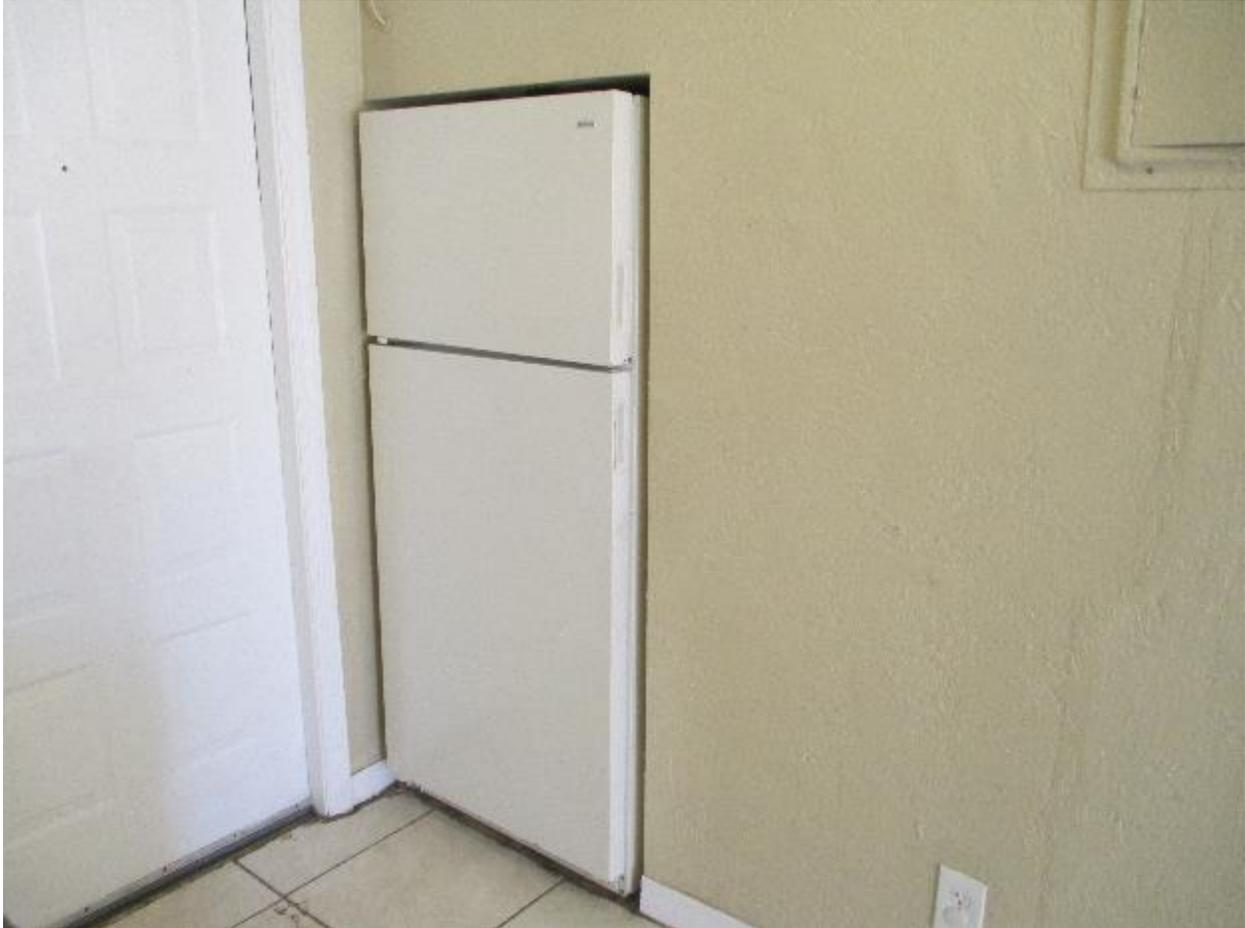
Interior finishes were found in general good condition at the time of inspection with exceptions as noted and shown in photographs.

No warranties or guarantees expressed on used appliances. Appliances found in working condition at the time of inspection.

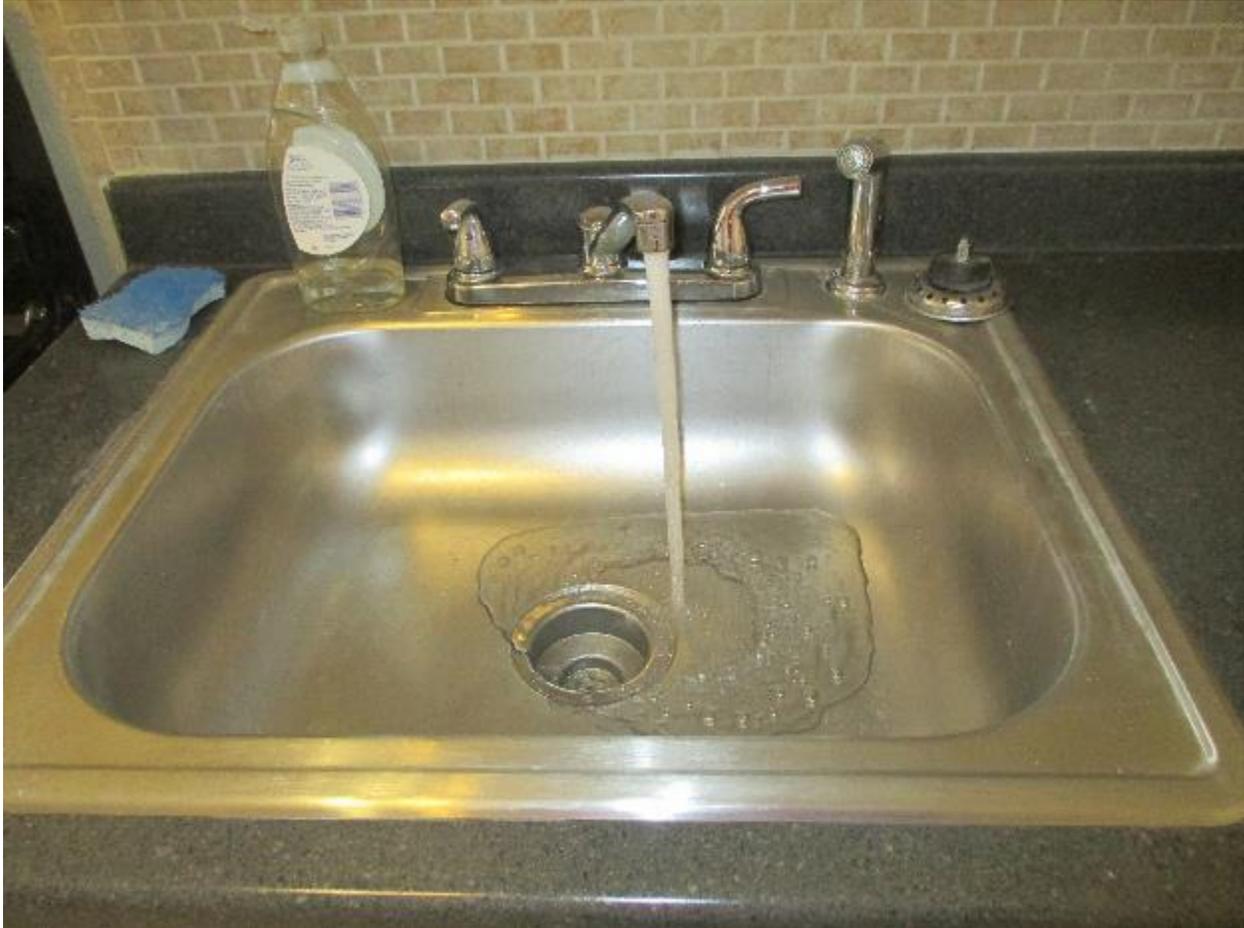
Plumbing systems tested for proper flow. No leaks or deficiencies noted on drain and supply lines.

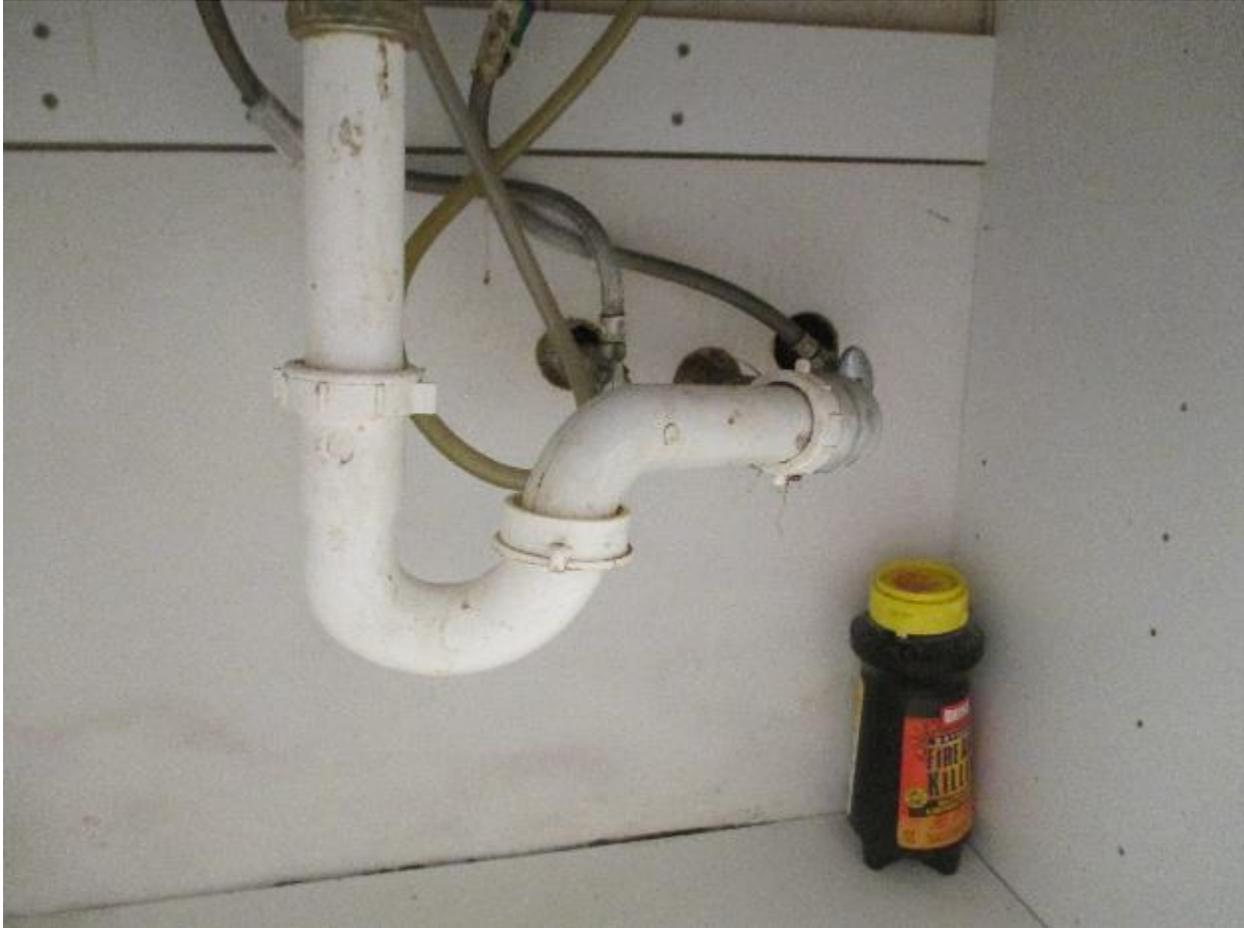
Plumbing systems tested for proper flow. No leaks or deficiencies noted on drain and supply lines.

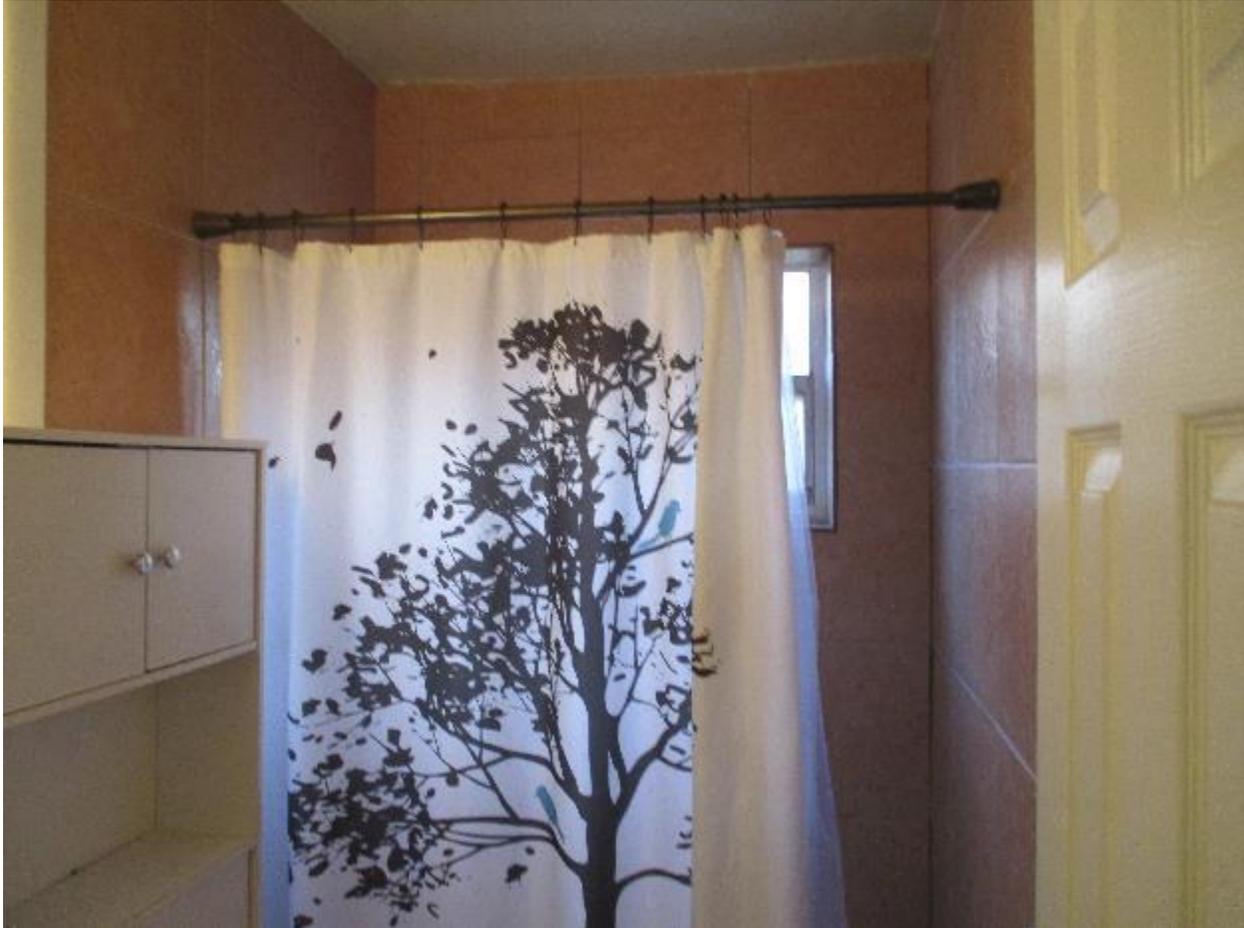
Interior finishes were found in general good condition at the time of inspection with exceptions as noted and shown in photographs.

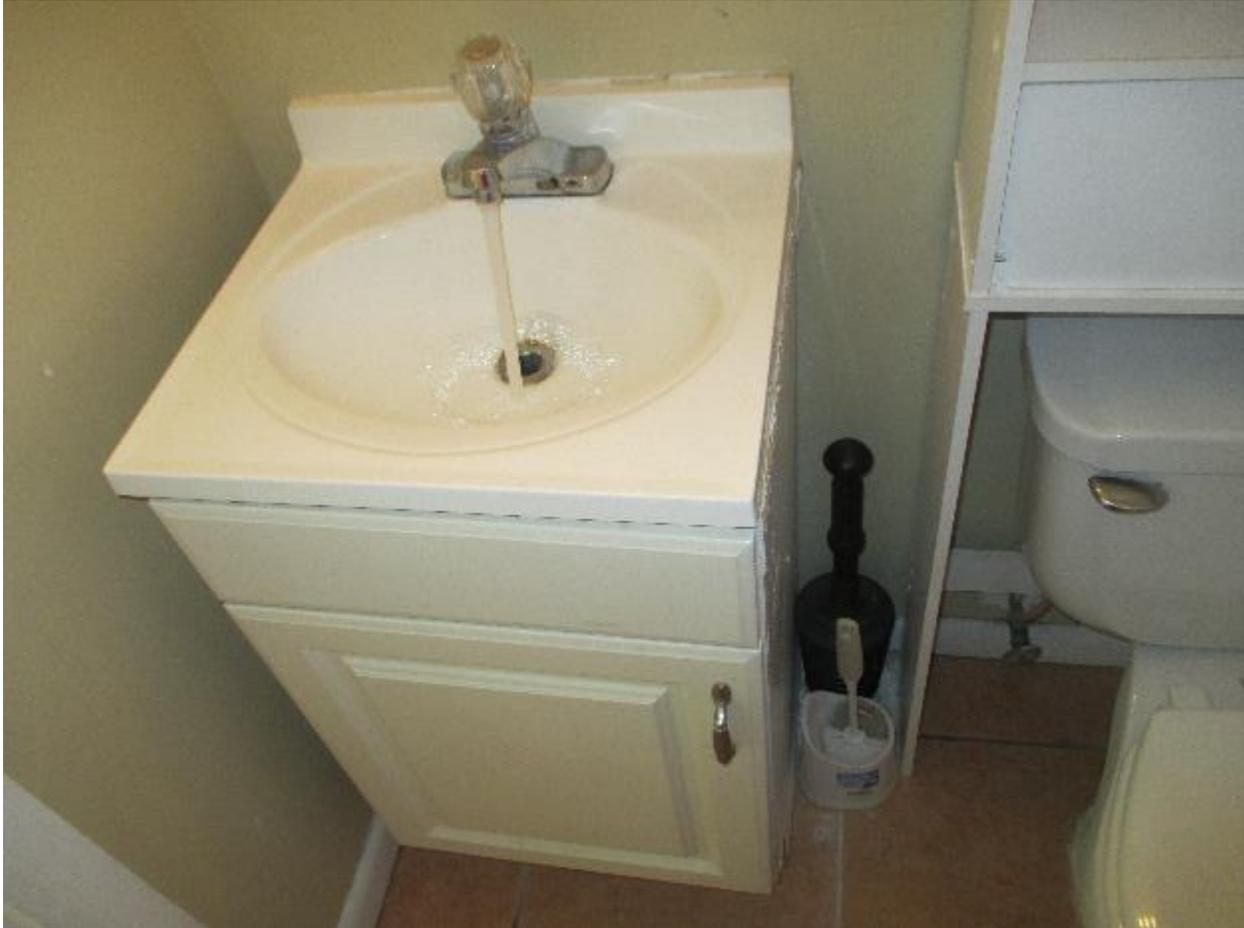
Plumbing systems tested for proper flow. No leaks or deficiencies noted on drain and supply lines.

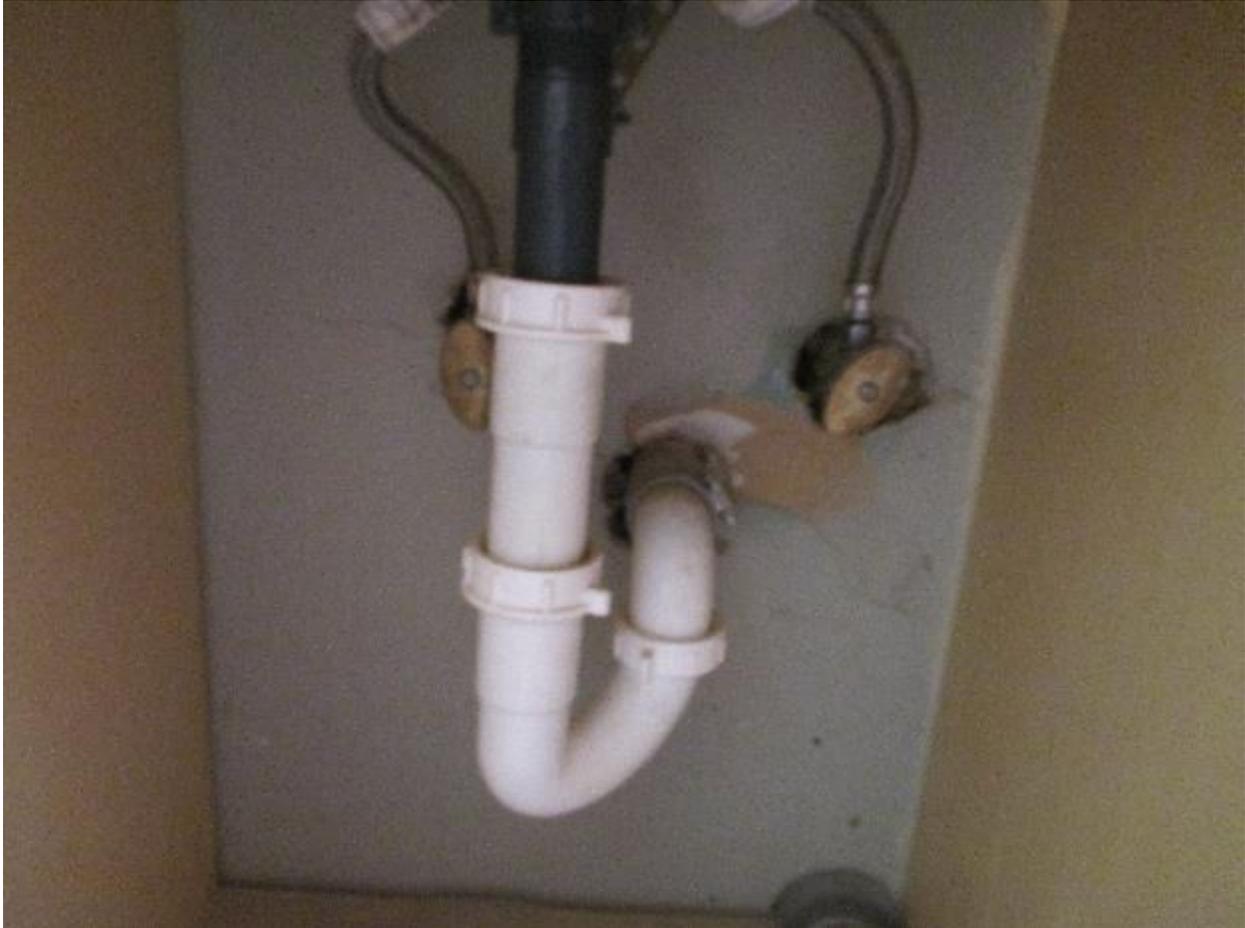
Plumbing systems tested for proper flow. No leaks or deficiencies noted on drain and supply lines.

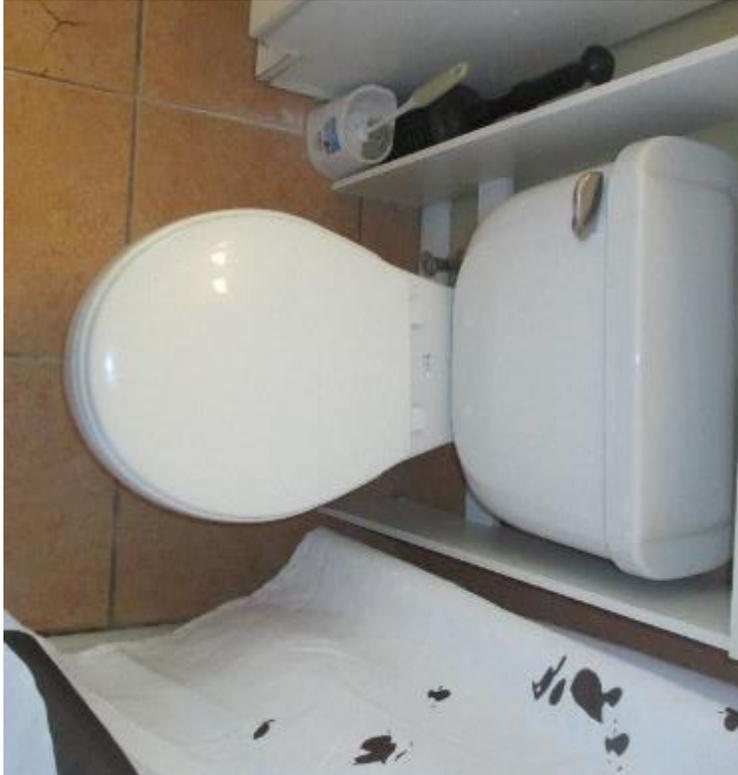
Interior finishes were found in general good condition at the time of inspection with exceptions as noted and shown in photographs.

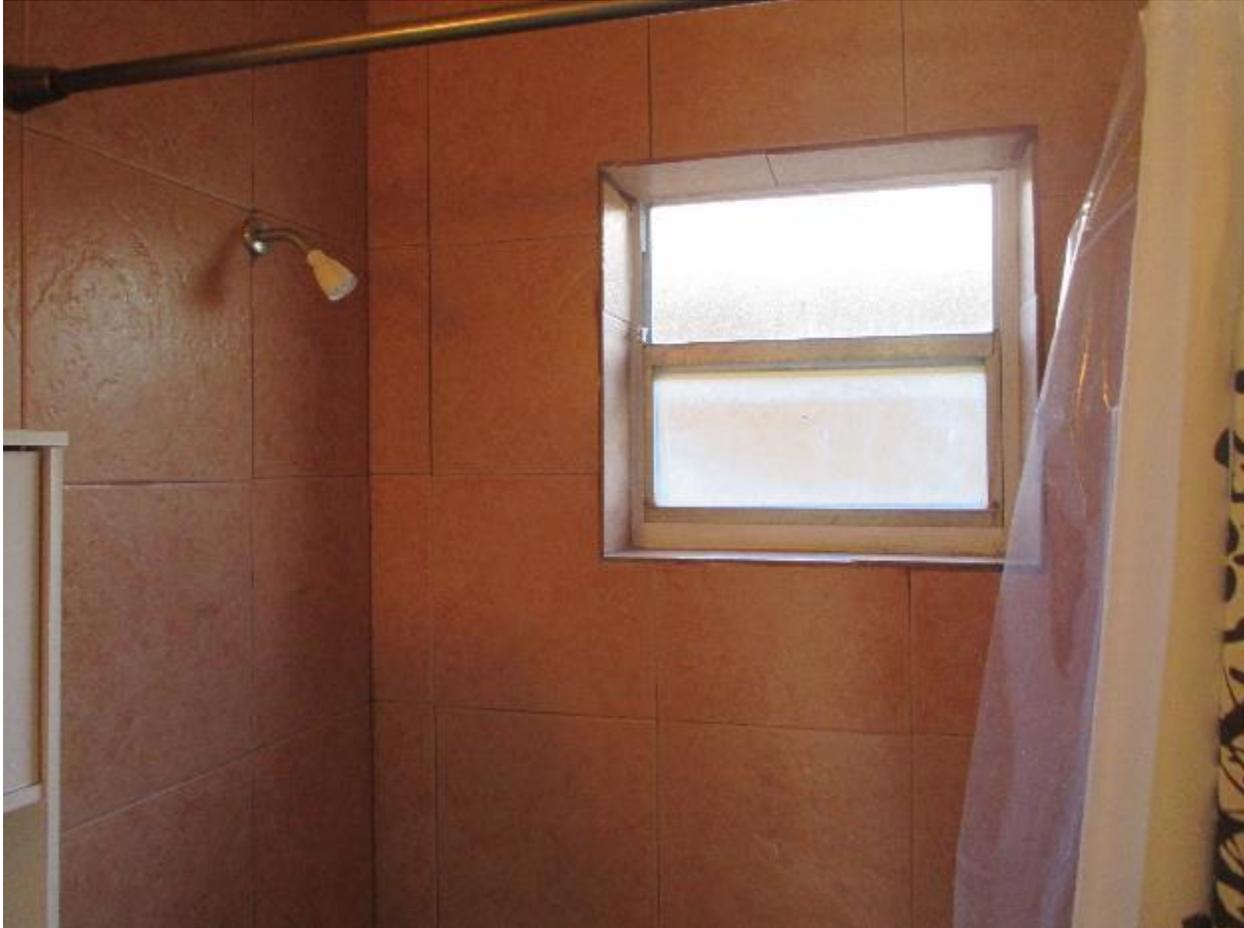
Interior finishes were found in general good condition at the time of inspection with exceptions as noted and shown in photographs.

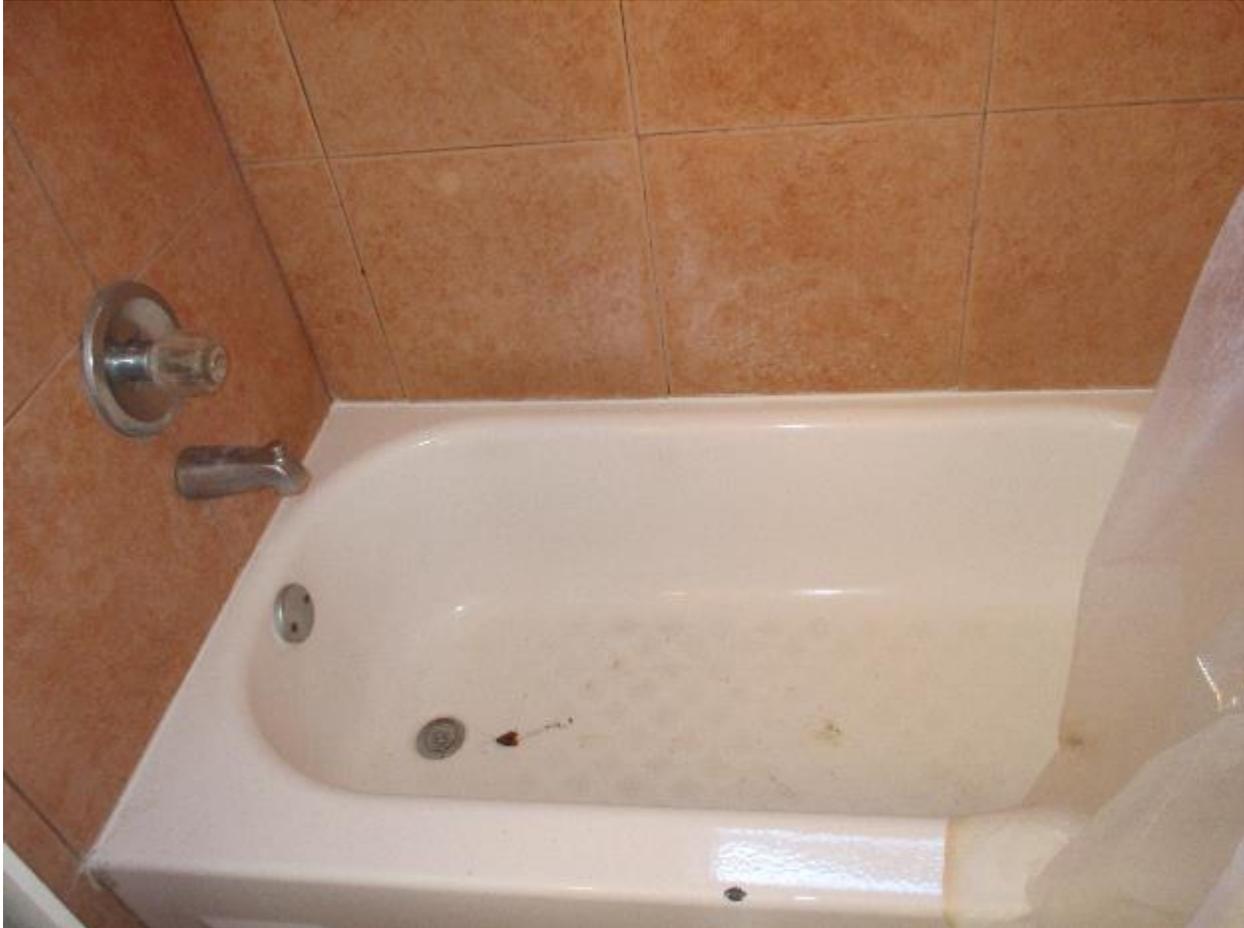
Interior finishes were found in general good condition at the time of inspection with exceptions as noted and shown in photographs.

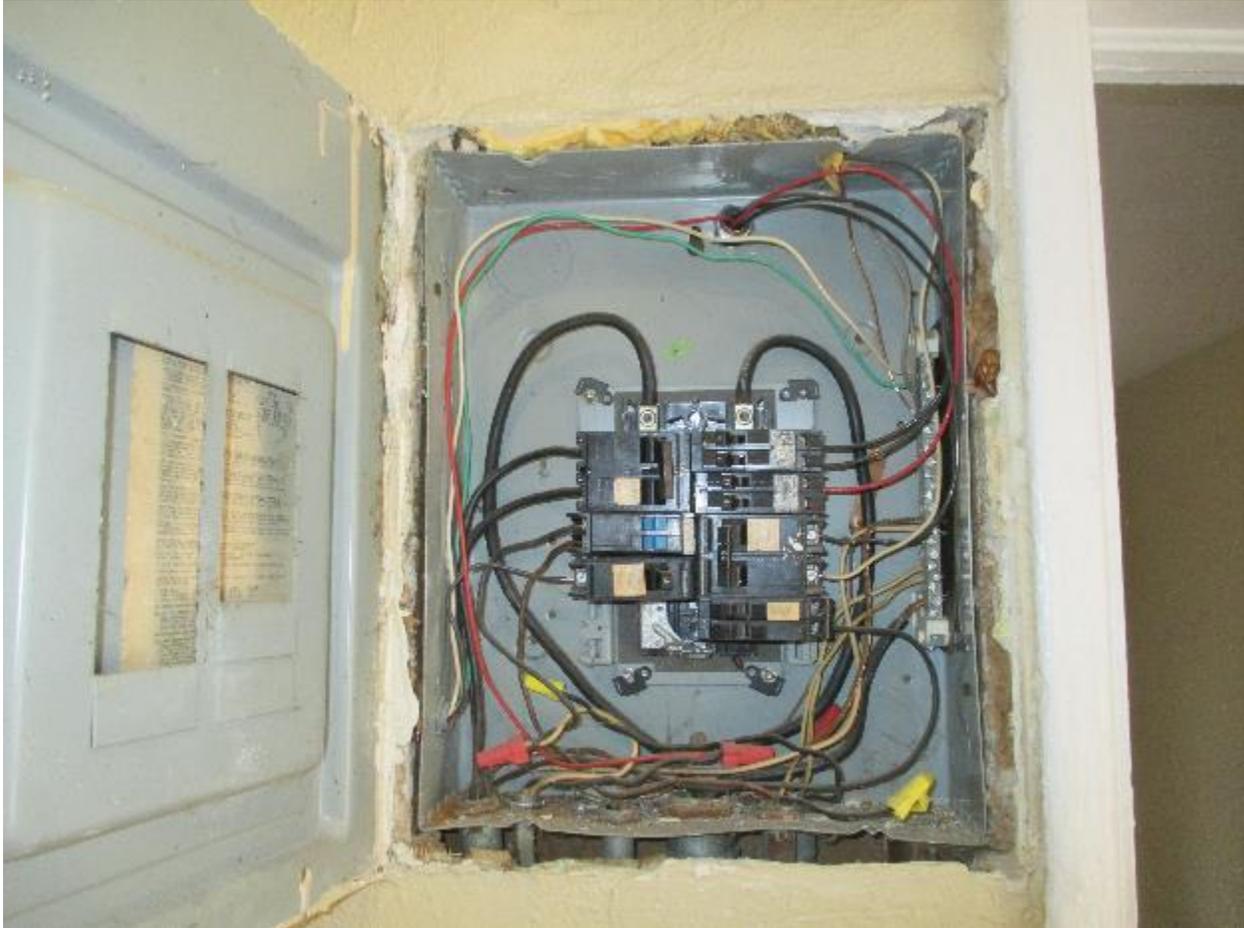
Electrical breaker panel in good condition at the time of inspection.
