PROPERTY INSPECTION OR ASSESSMENT OF DAMAGES

ADDRESS: **SOMEWHERE , FL**
CLIENT: **GAIA GC**
ID No: **2015000**
DATE: **12/31/xxxx**

GAIA CONSTRUCTION INC.
CGC 1516136 FLORIDA
HI-2792 FLORIDA
8028867-B2 INTERNATIONAL CODE COUNCIL

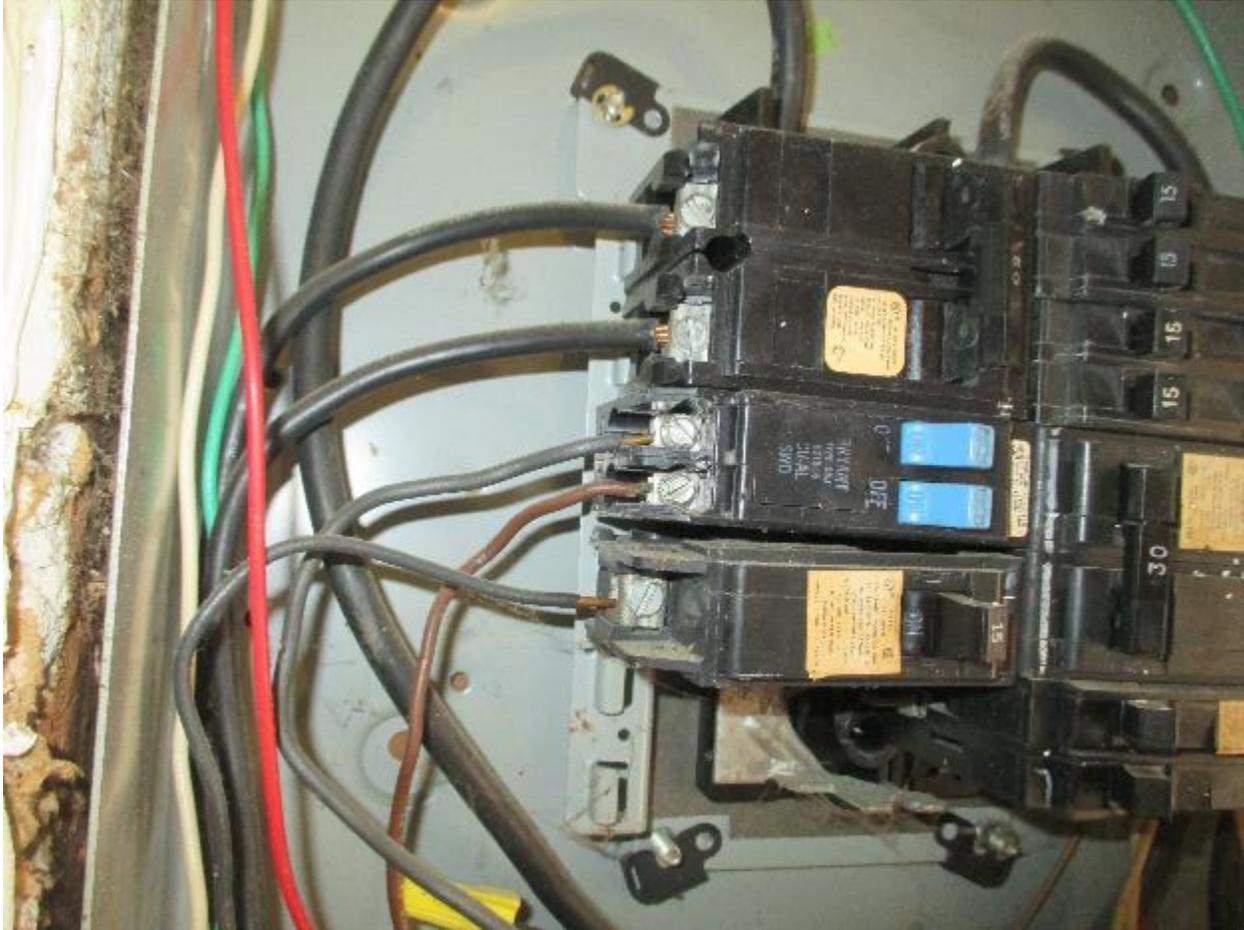
Electrical breaker panel in good condition at the time of inspection.

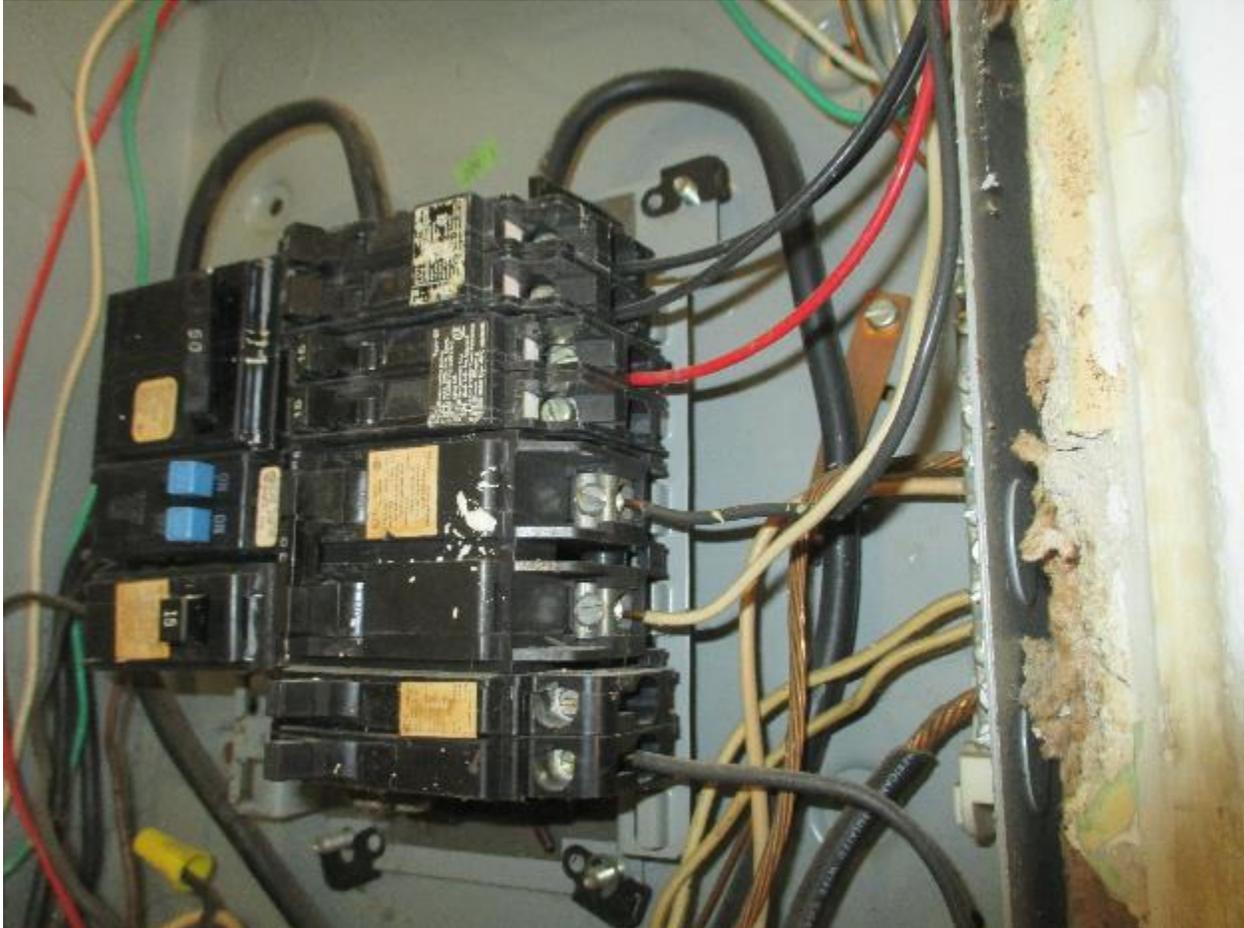
Electrical breaker panel in good condition at the time of inspection.

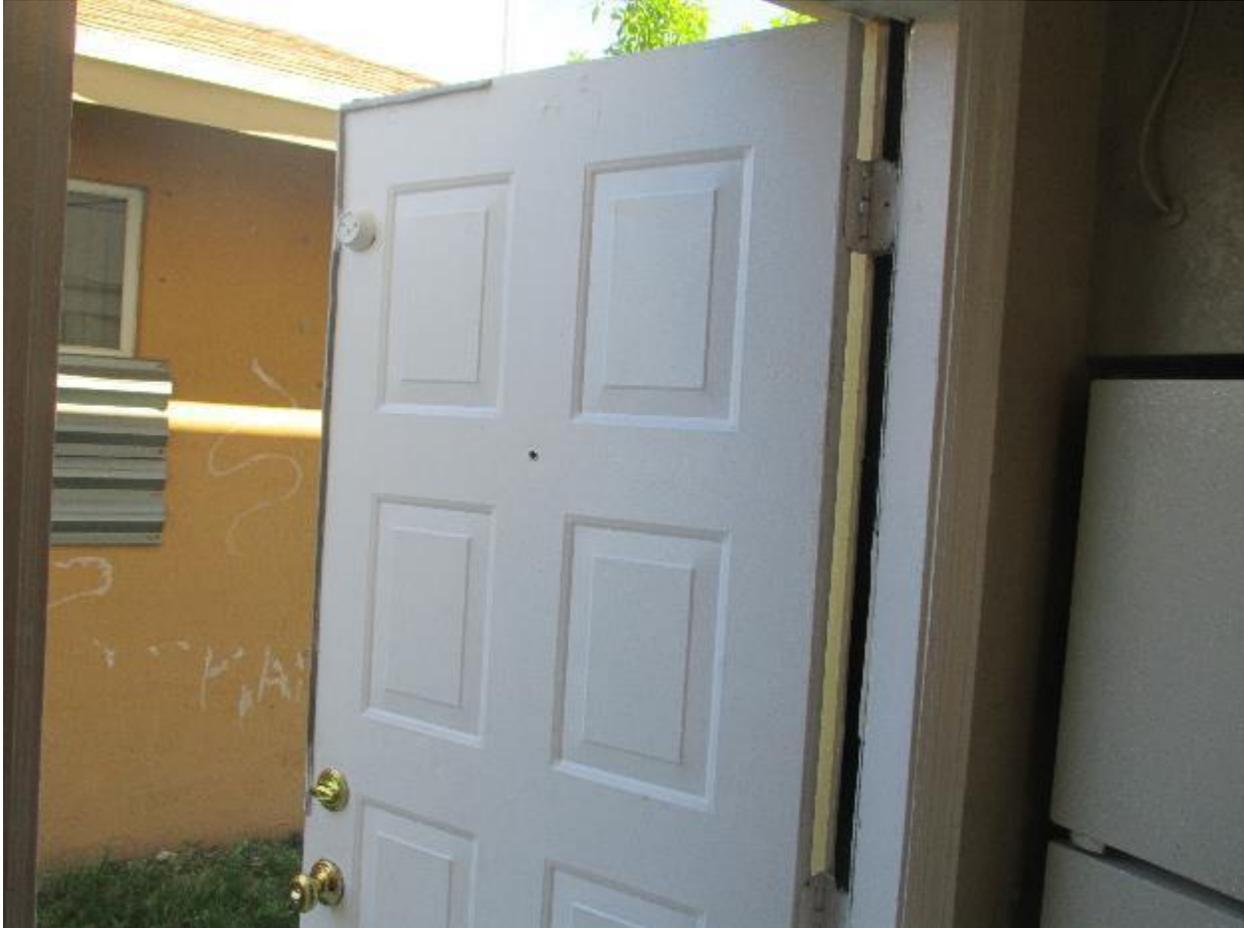
Exterior door(s) require replacement. Currently beyond possibilities of repair.

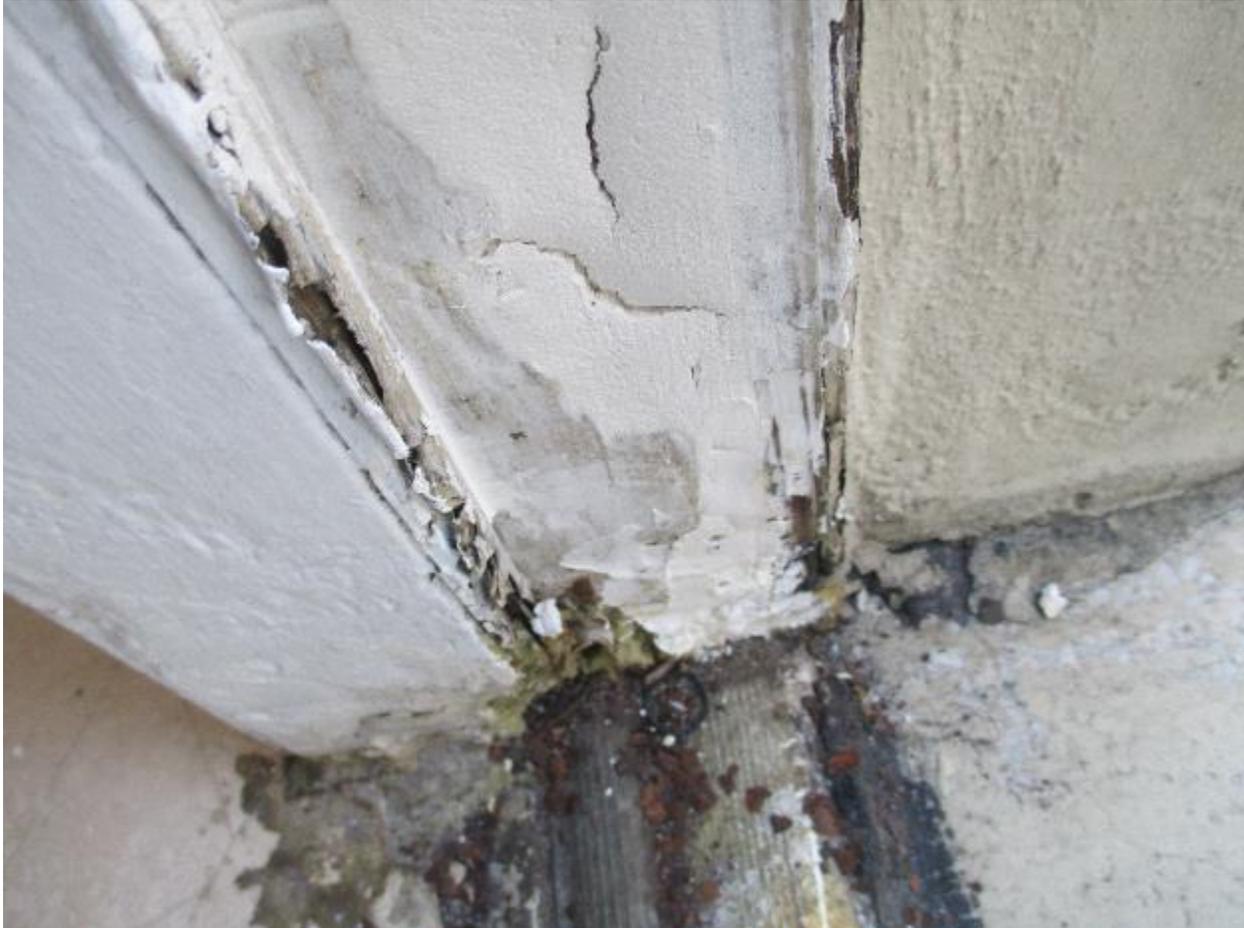
Exterior door(s) require replacement. Currently beyond possibilities of repair.

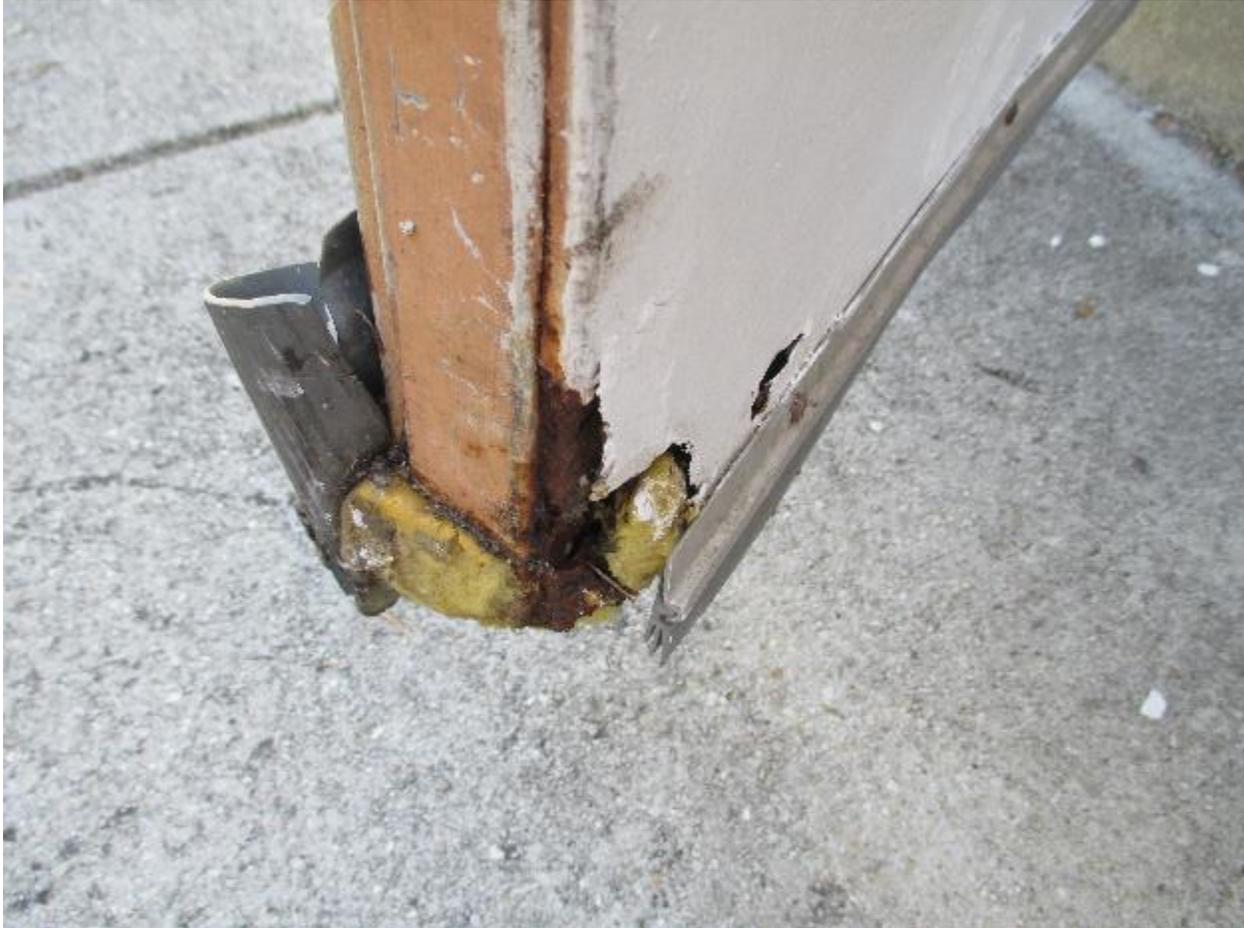
Exterior door(s) require replacement. Currently beyond possibilities of repair.

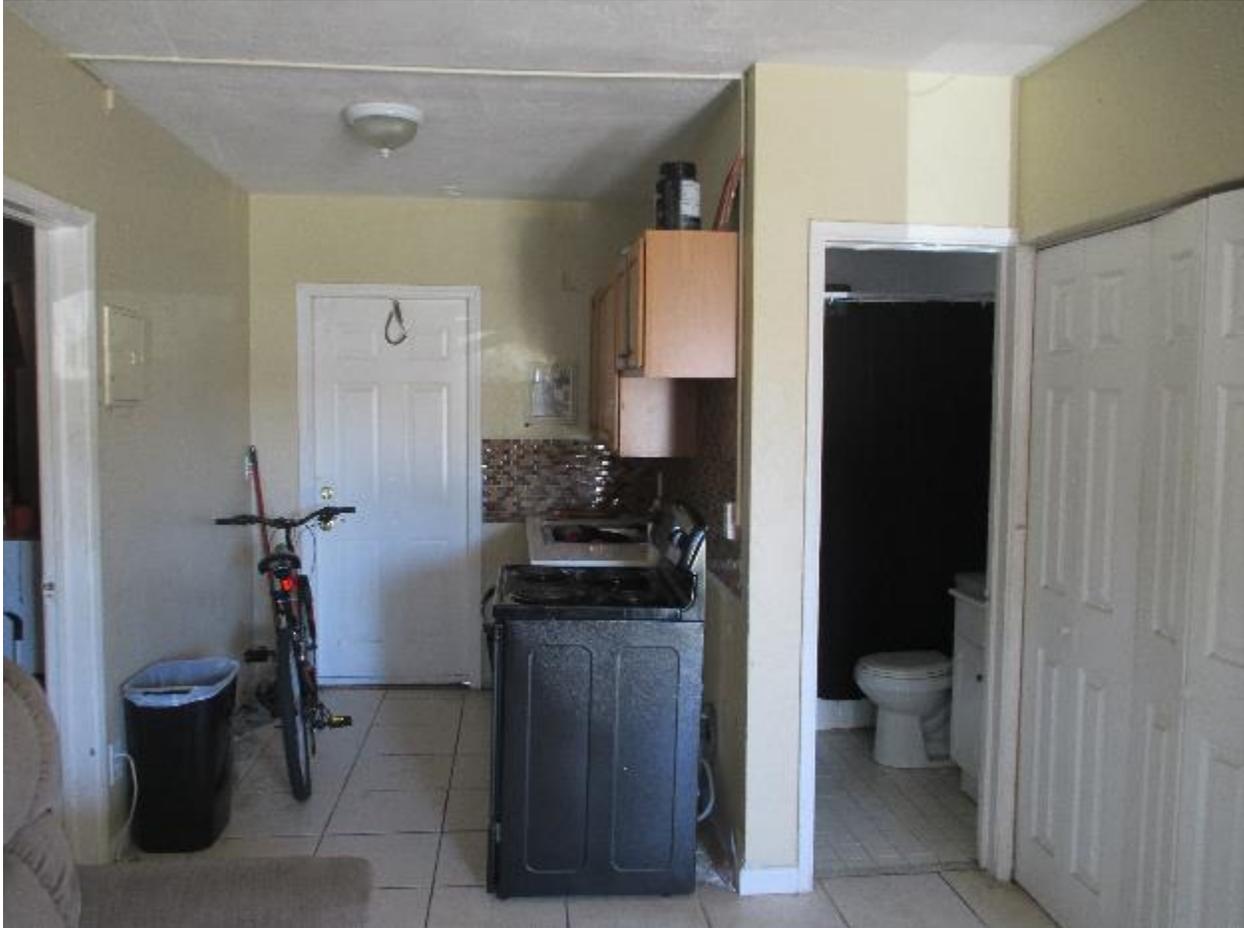
Interior finishes were found in general good condition at the time of inspection with exceptions as noted and shown in photographs.

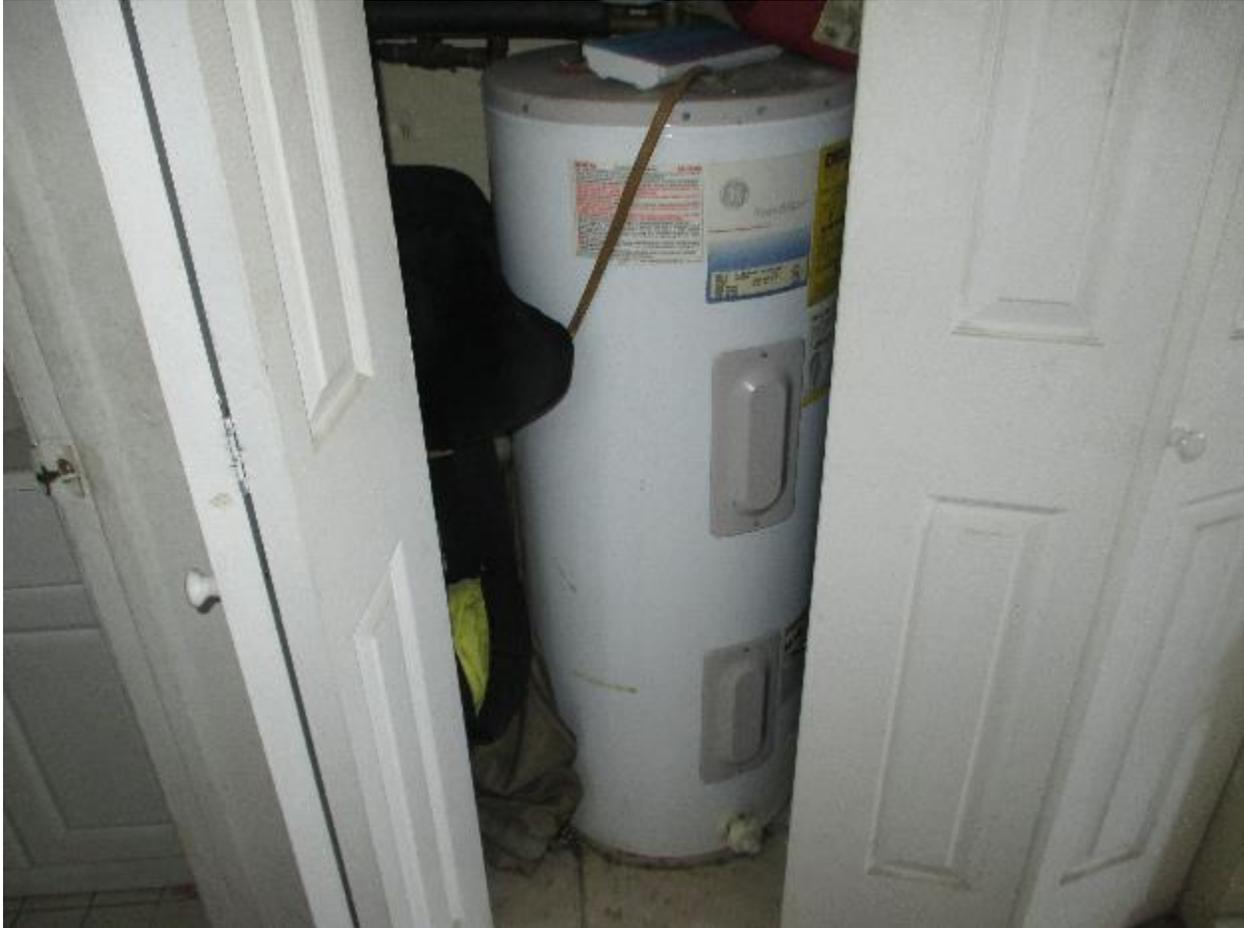
Water heater pressure release valve without release valve / not properly installed.

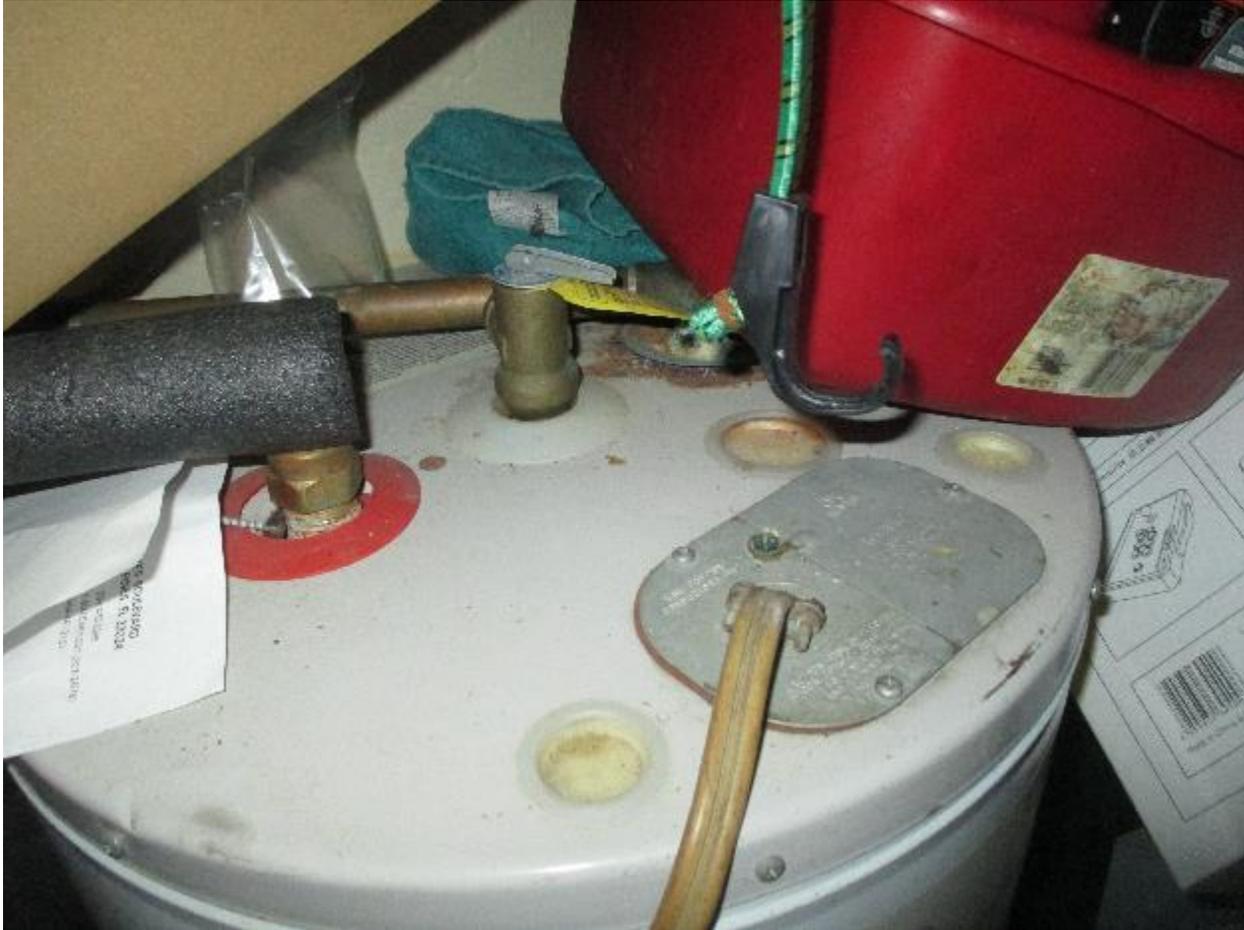
Water heater pressure release valve without release valve / not properly installed.

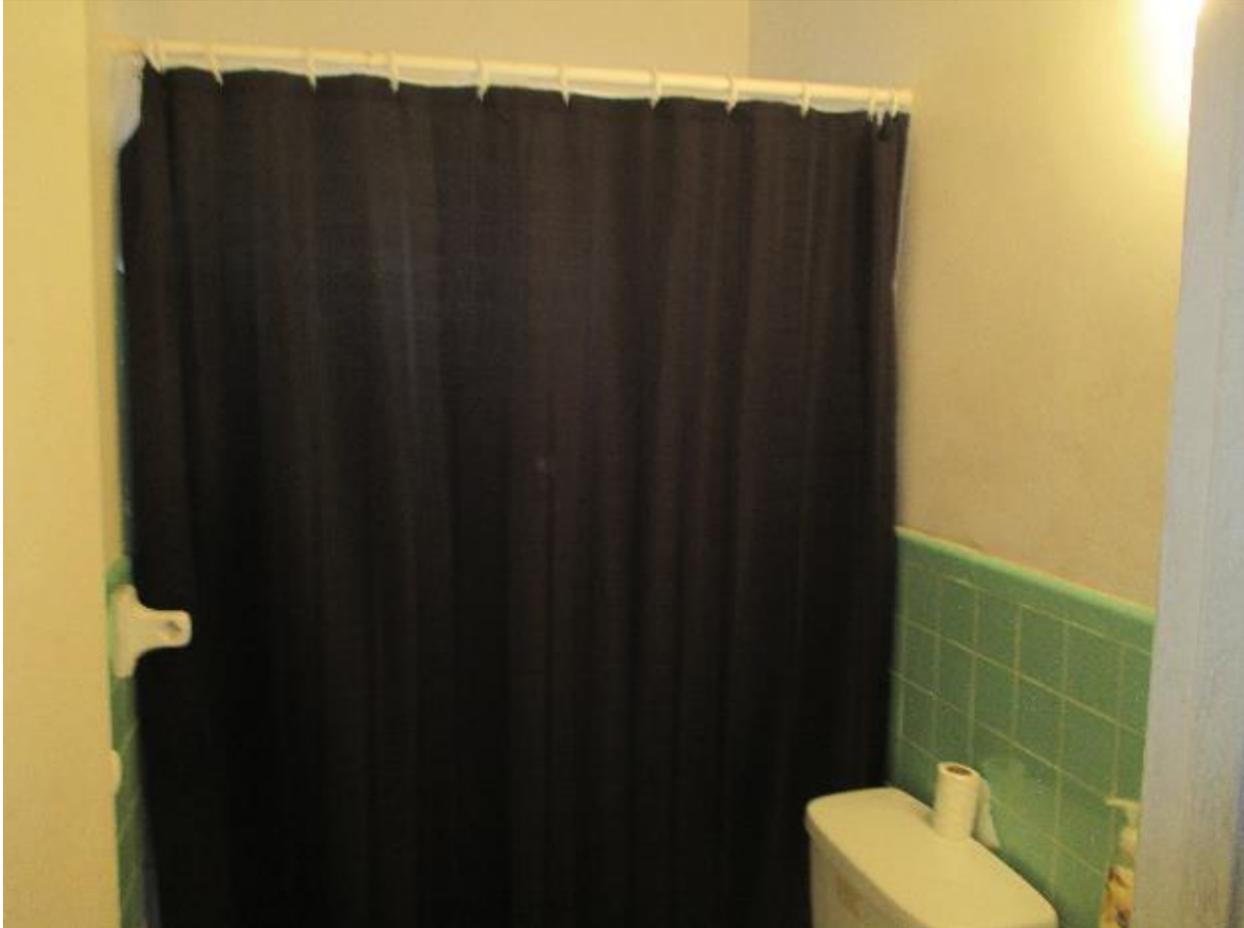
Allowances must be made for the complete upgrade of finishes in bathroom(s).

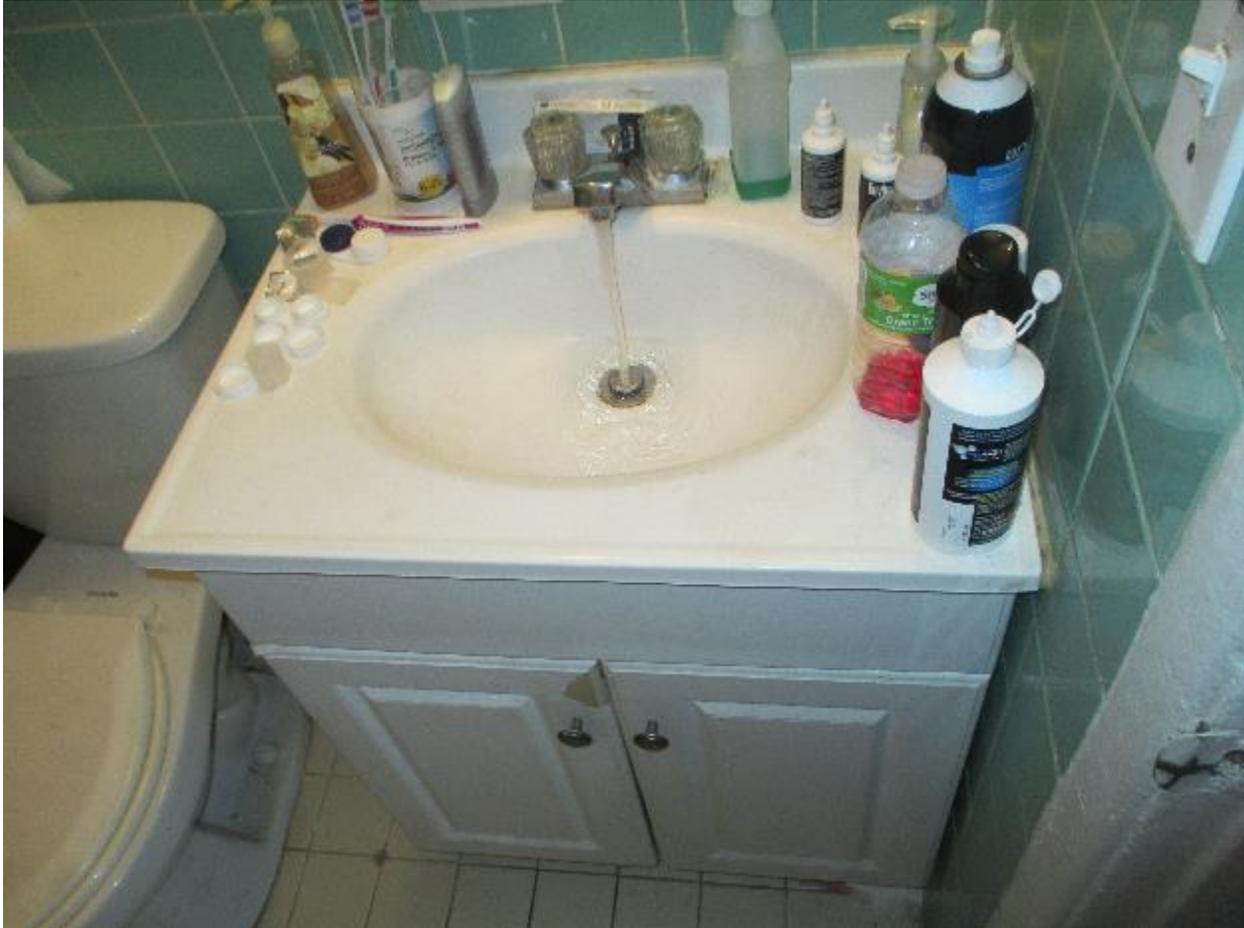
Plumbing systems tested for proper flow. No leaks or deficiencies noted on drain and supply lines.

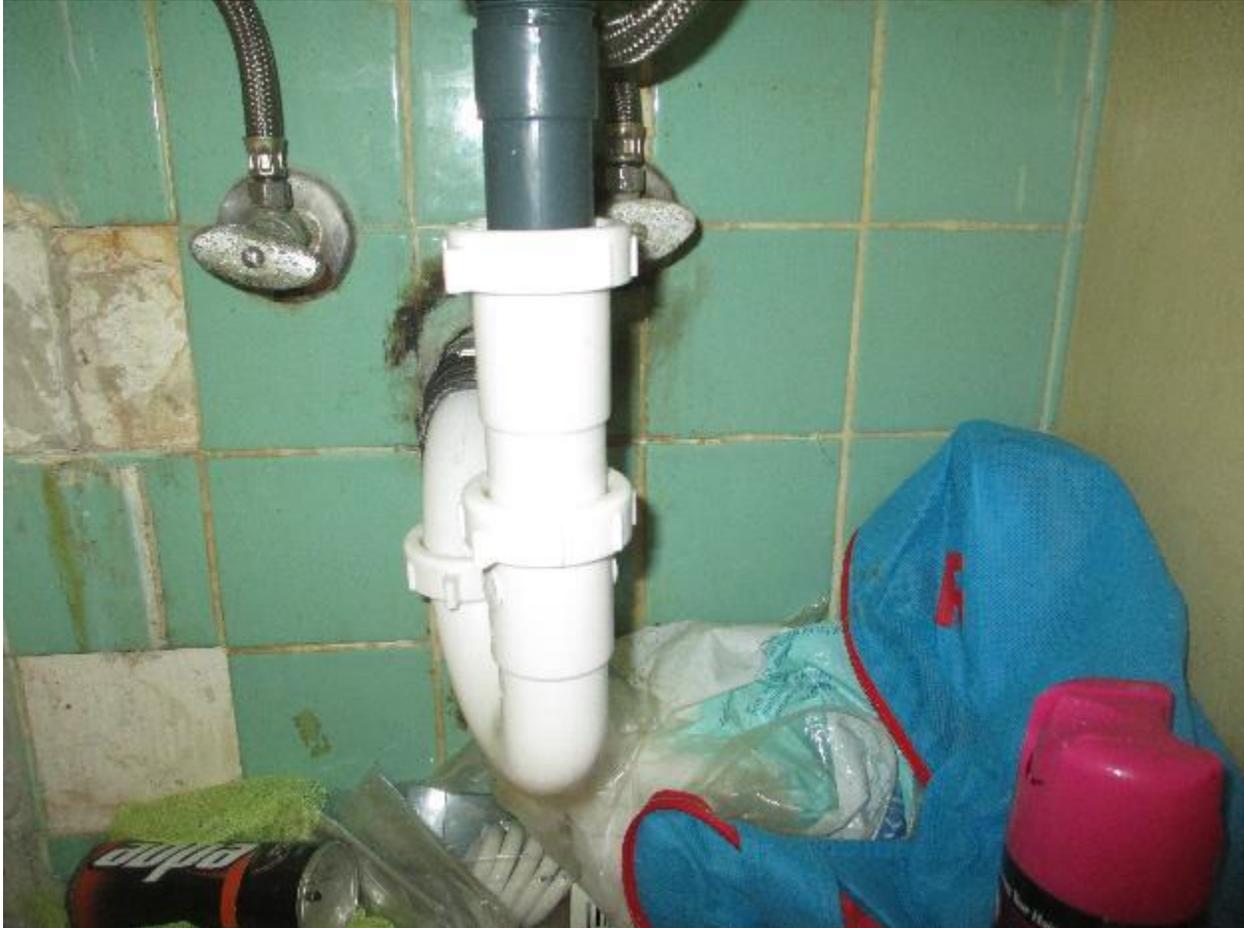
Plumbing systems tested for proper flow. No leaks or deficiencies noted on drain and supply lines.

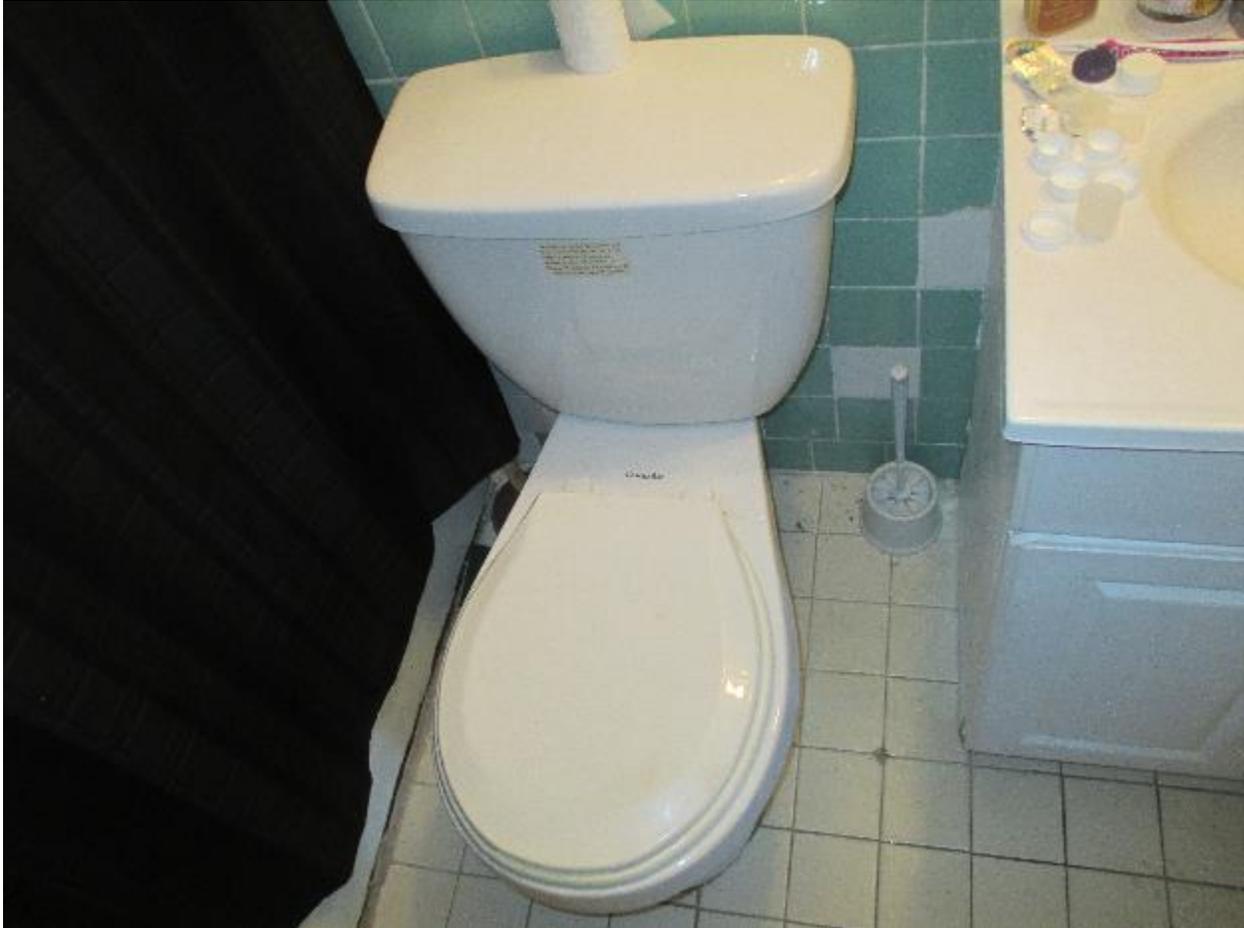
Allowances must be made for the complete upgrade of finishes in bathroom(s).

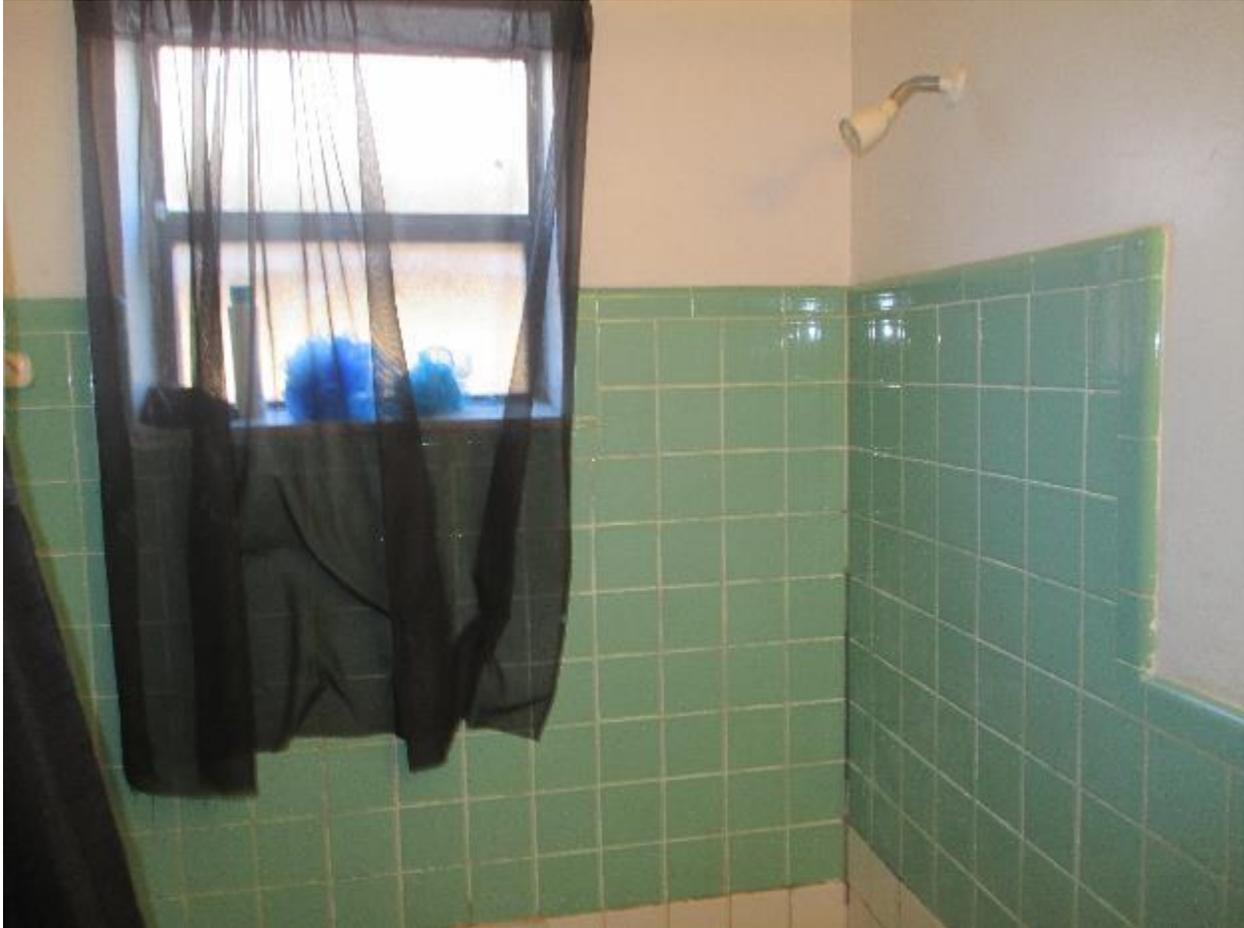
Allowances must be made for the complete upgrade of finishes in bathroom(s).

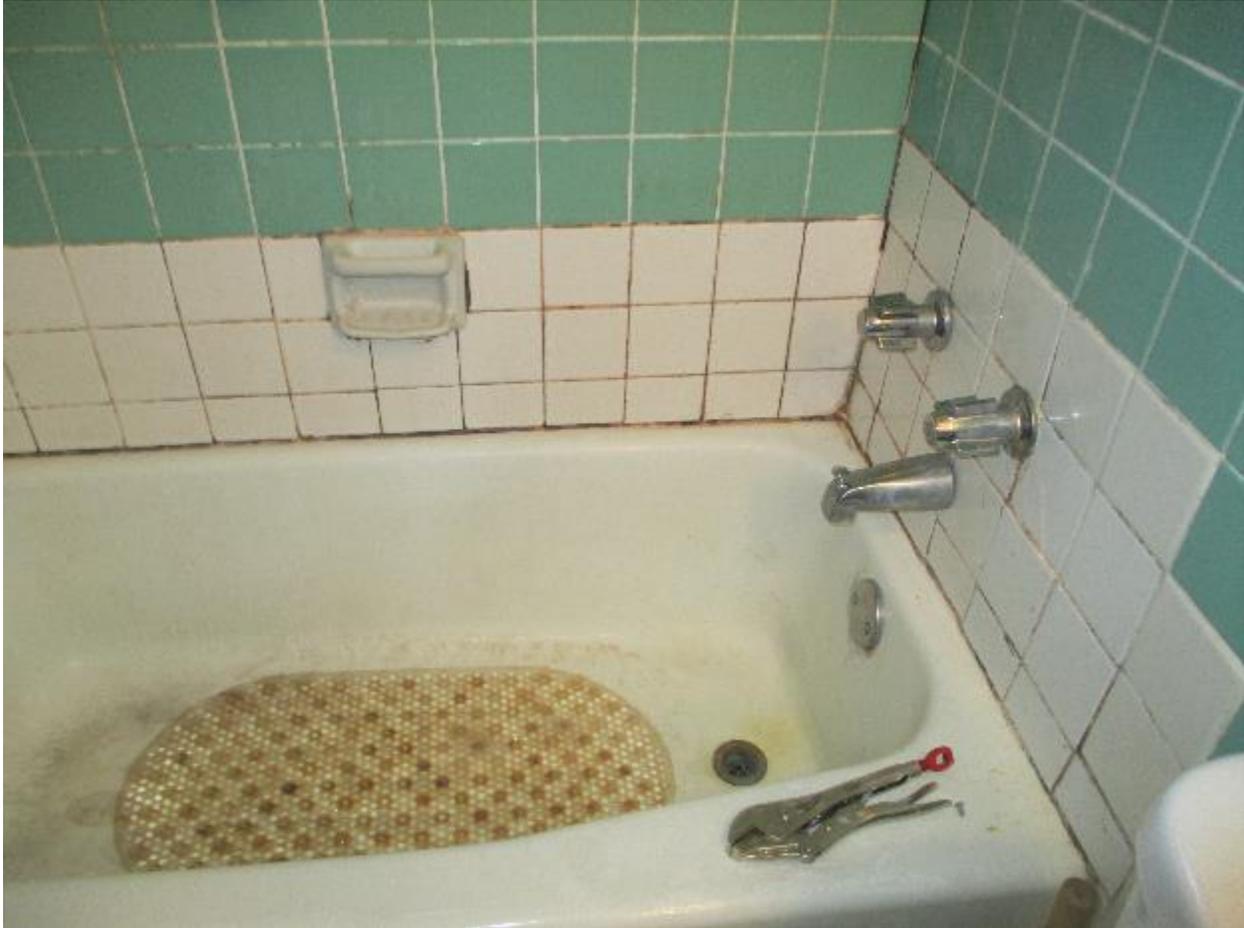
Allowances must be made for the complete upgrade of finishes in bathroom(s).

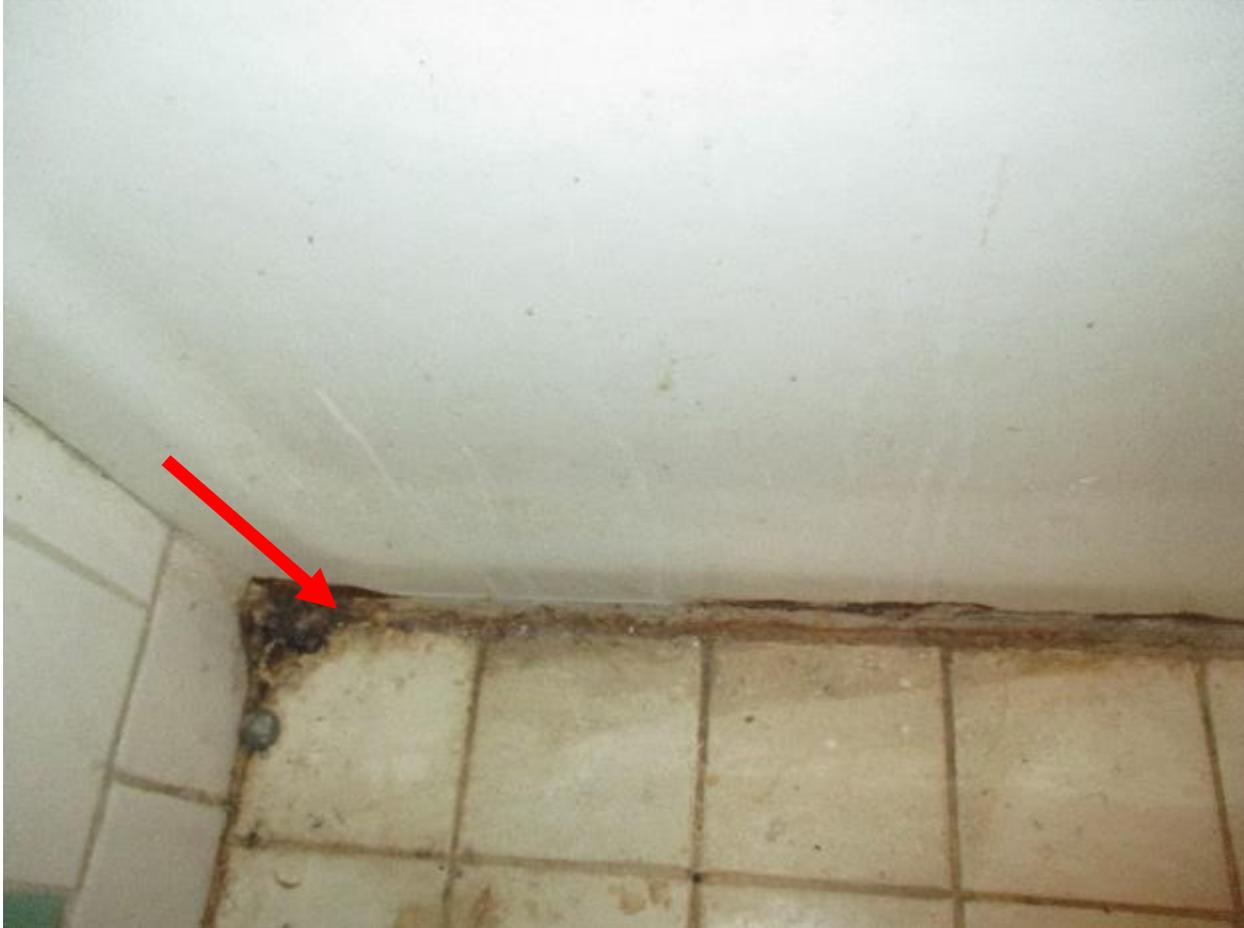
(Rusted bathtub requires replacement).

Allowances must be made for the complete upgrade of finishes in bathroom(s).

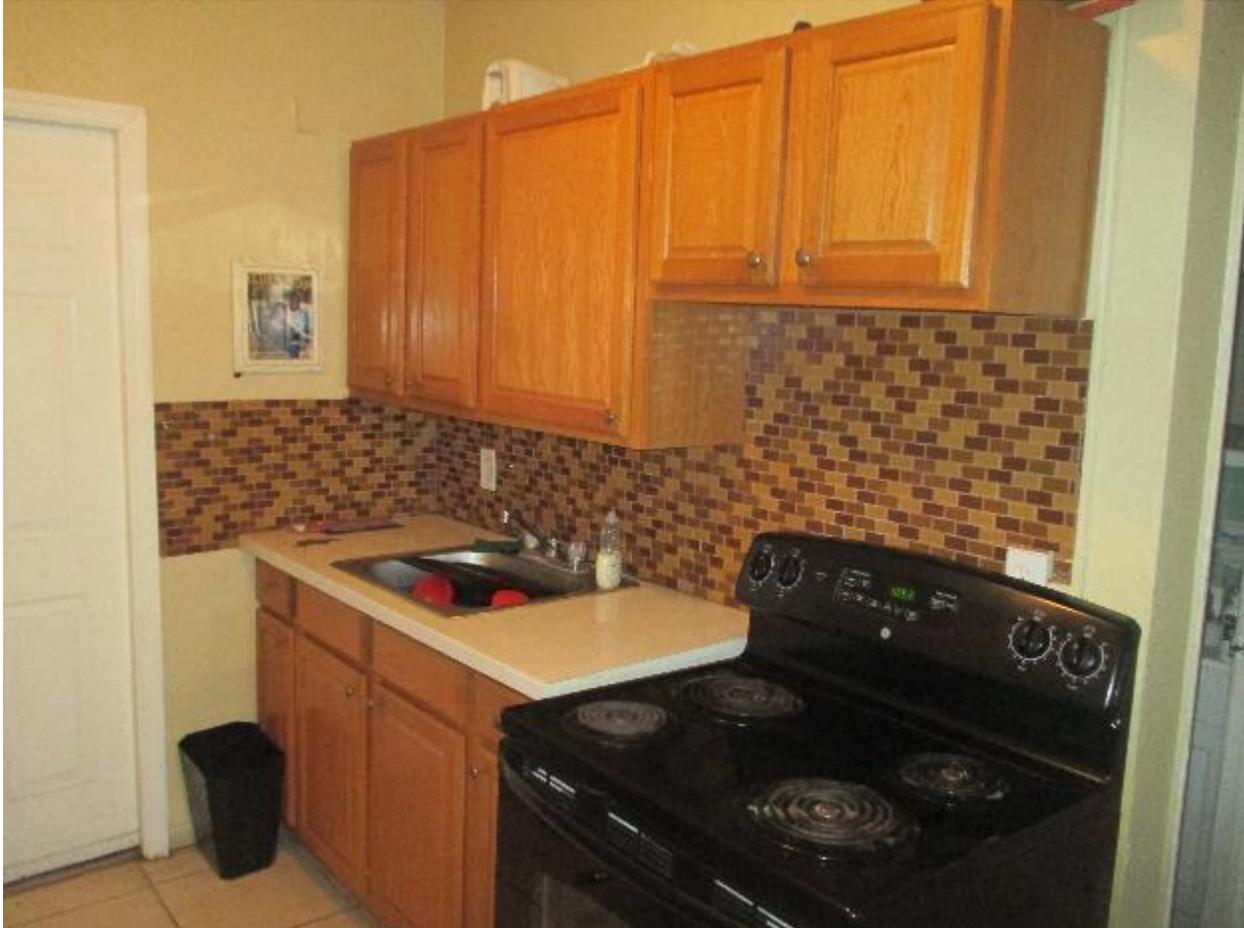
Interior finishes were found in general good condition at the time of inspection with exceptions as noted and shown in photographs.

No warranties or guarantees expressed on used appliances. Appliances found in working condition at the time of inspection.

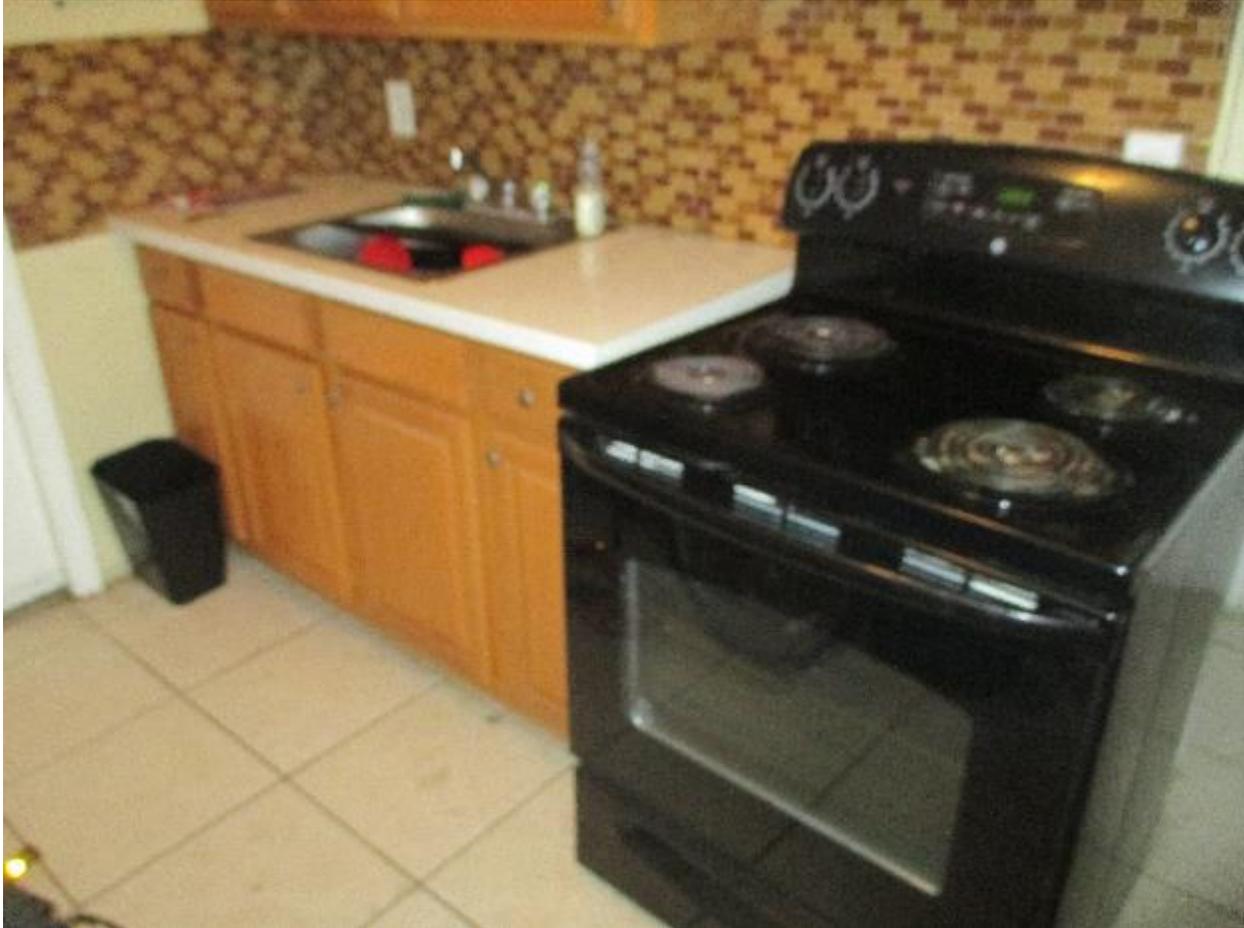
Interior finishes were found in general good condition at the time of inspection with exceptions as noted and shown in photographs.

No warranties or guarantees expressed on used appliances. Appliances found in working condition at the time of inspection.

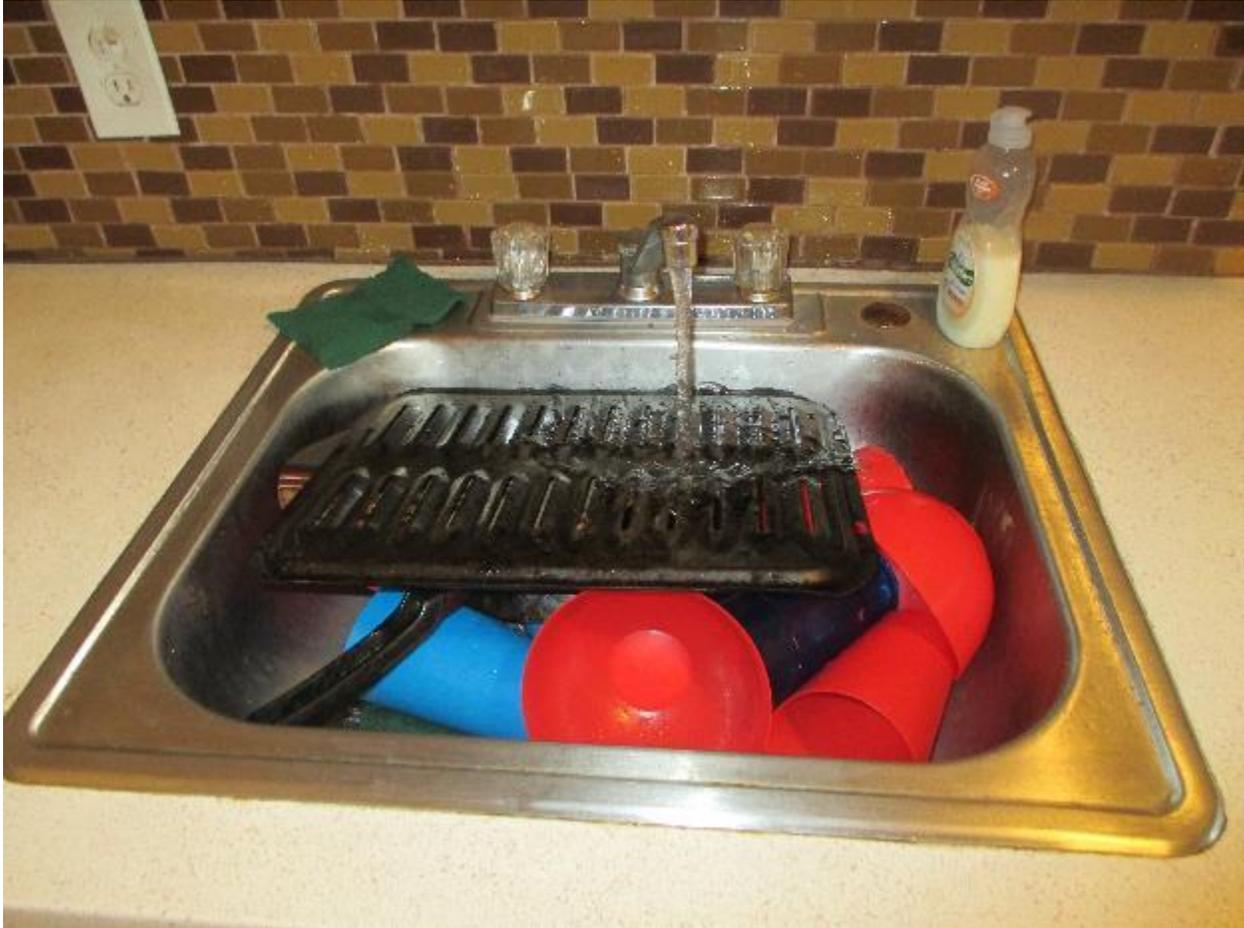
Plumbing systems tested for proper flow. No leaks or deficiencies noted on drain and supply lines.

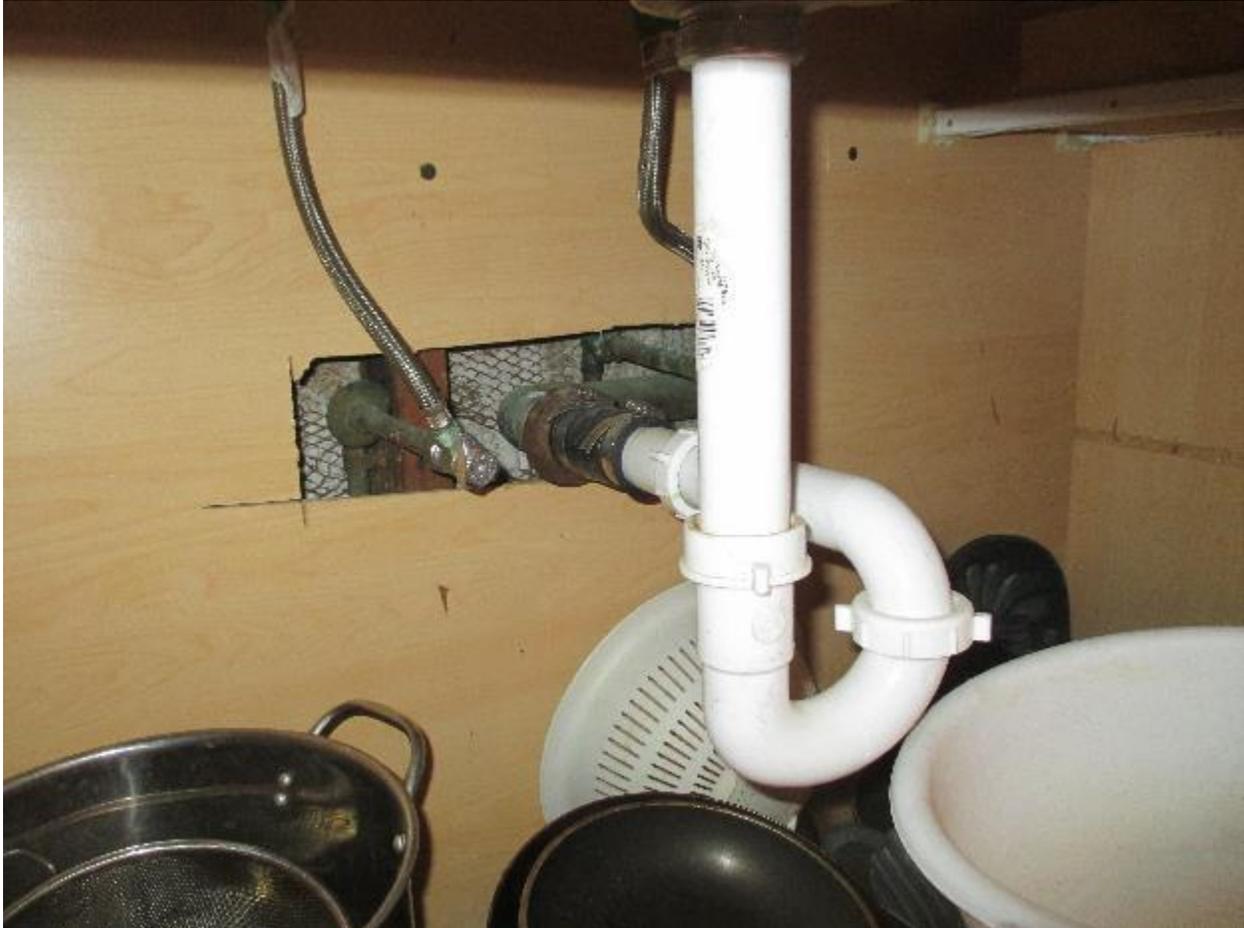
Plumbing systems tested for proper flow. No leaks or deficiencies noted on drain and supply lines.
