PROPERTY INSPECTION OR ASSESSMENT OF DAMAGES

ADDRESS: **SOMEWHERE , FL**
CLIENT: **GAIA GC**
ID No: **2015000**
DATE: **12/31/xxxx**

GAIA CONSTRUCTION INC.
CGC 1516136 FLORIDA
HI-2792 FLORIDA
8028867-B2 INTERNATIONAL CODE COUNCIL

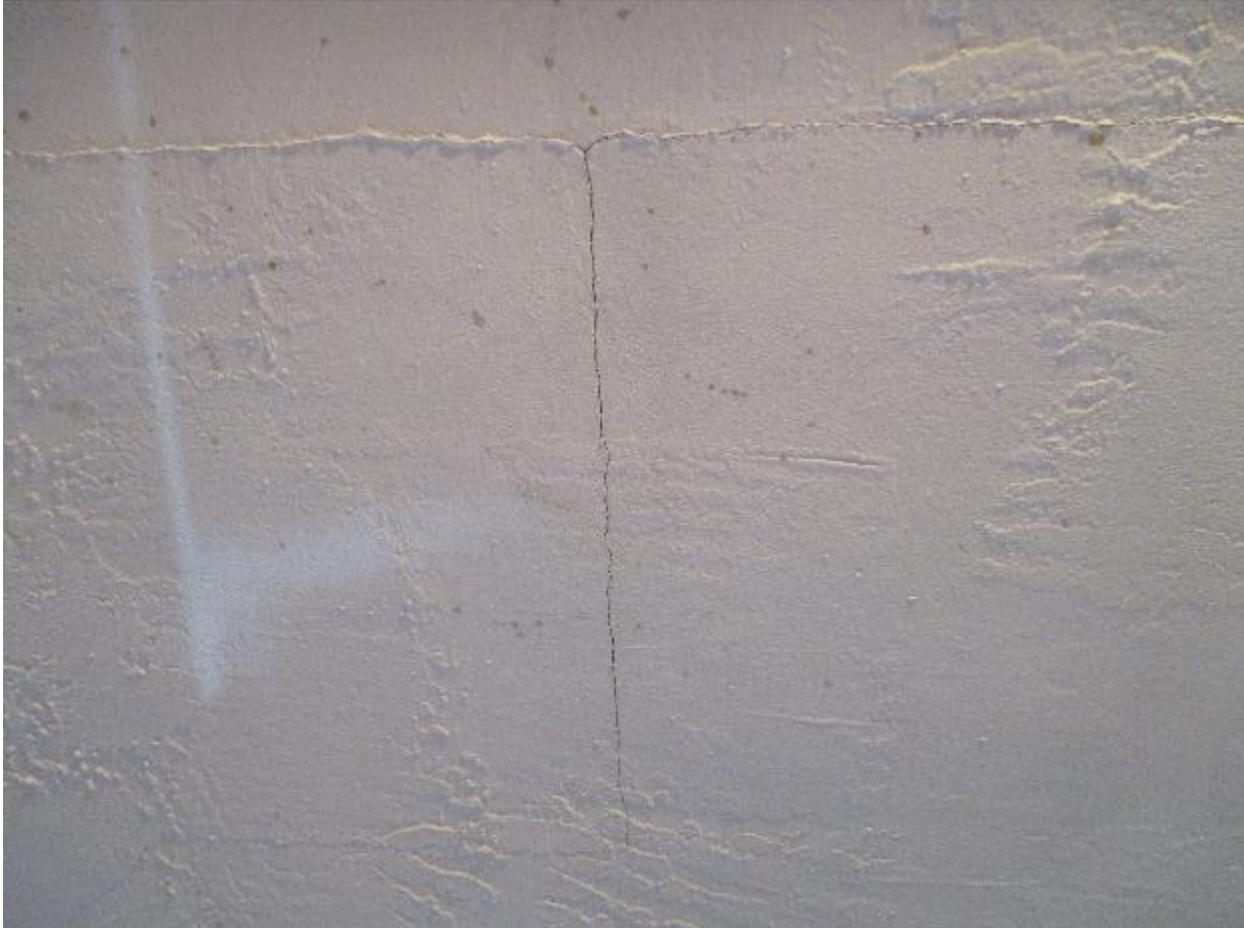
Cracks on ceiling not of structural importance but repairs related to drywall must be performed to secure the loose material.

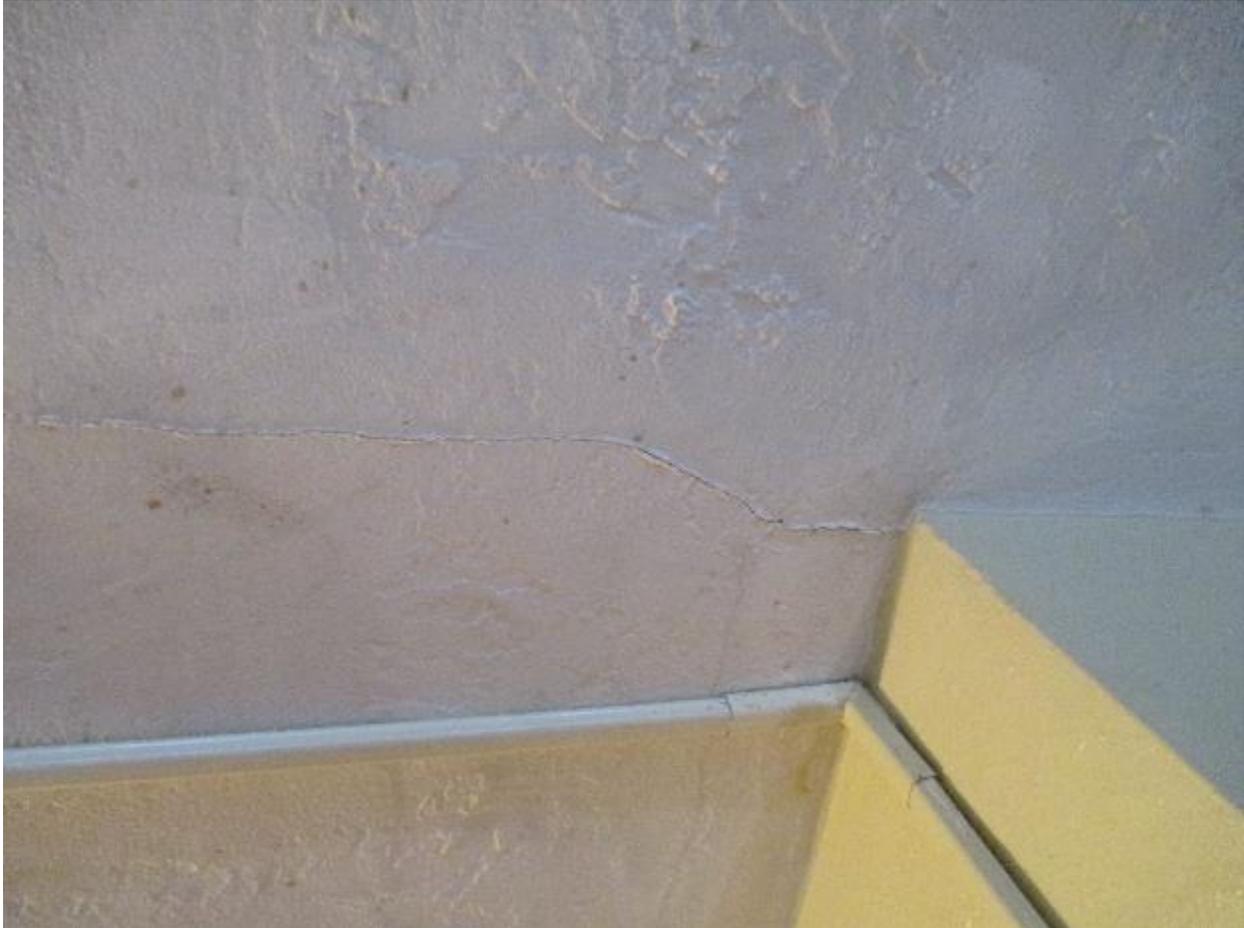
Cracks on ceiling not of structural importance but repairs related to drywall must be performed to secure the loose material.

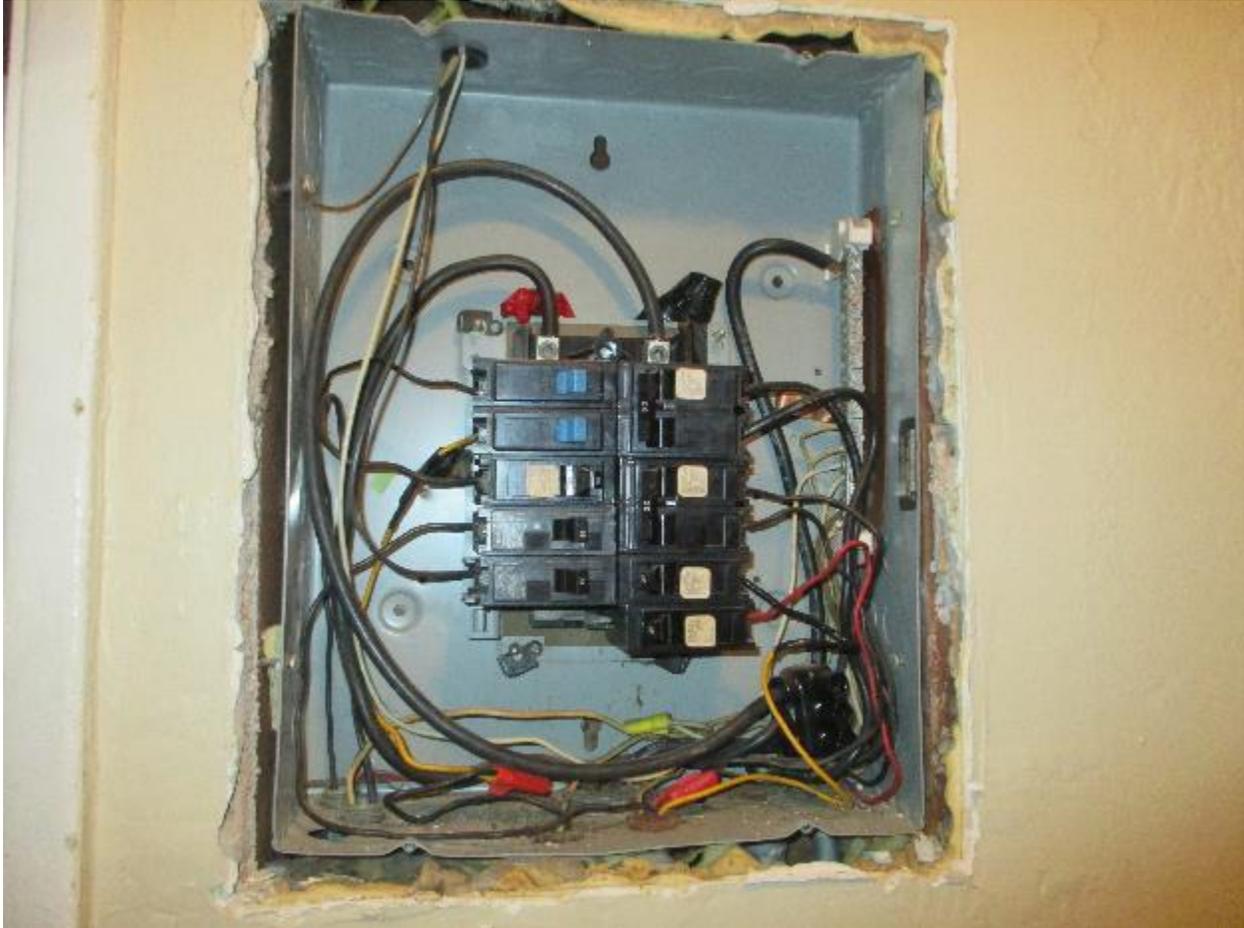
Incomplete or missing ground system. Grounding is worth adding to your system because it adds protection against electrical shock. Grounding provides a third path for electricity to travel along, so if there is a leak of any sort, it will flow into the earth rather than into the body of a person who touches a defective fixture, appliance, or tool.

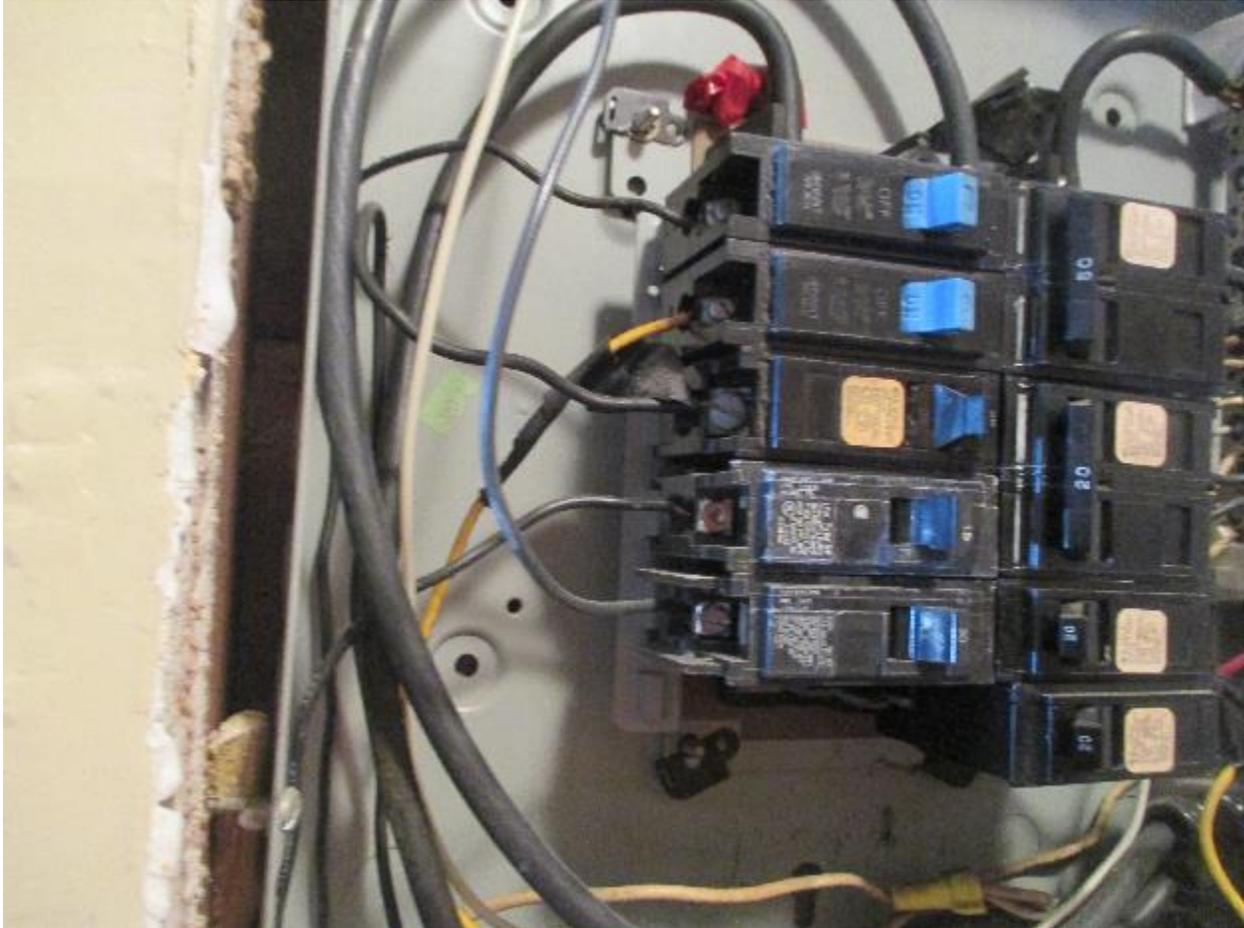
Incomplete or missing ground system. Grounding is worth adding to your system because it adds protection against electrical shock. Grounding provides a third path for electricity to travel along, so if there is a leak of any sort, it will flow into the earth rather than into the body of a person who touches a defective fixture, appliance, or tool.

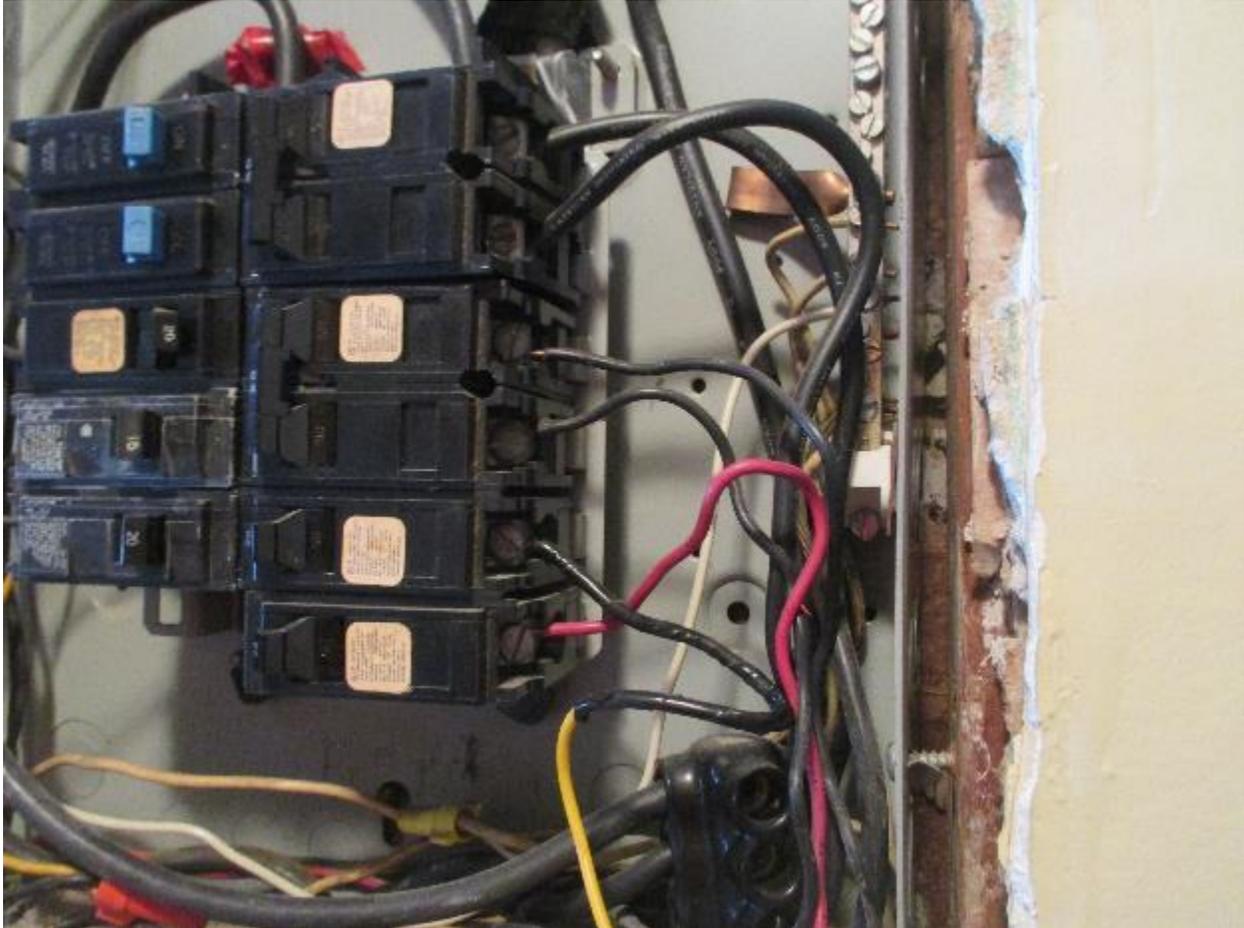
Incomplete or missing ground system. Grounding is worth adding to your system because it adds protection against electrical shock. Grounding provides a third path for electricity to travel along, so if there is a leak of any sort, it will flow into the earth rather than into the body of a person who touches a defective fixture, appliance, or tool.

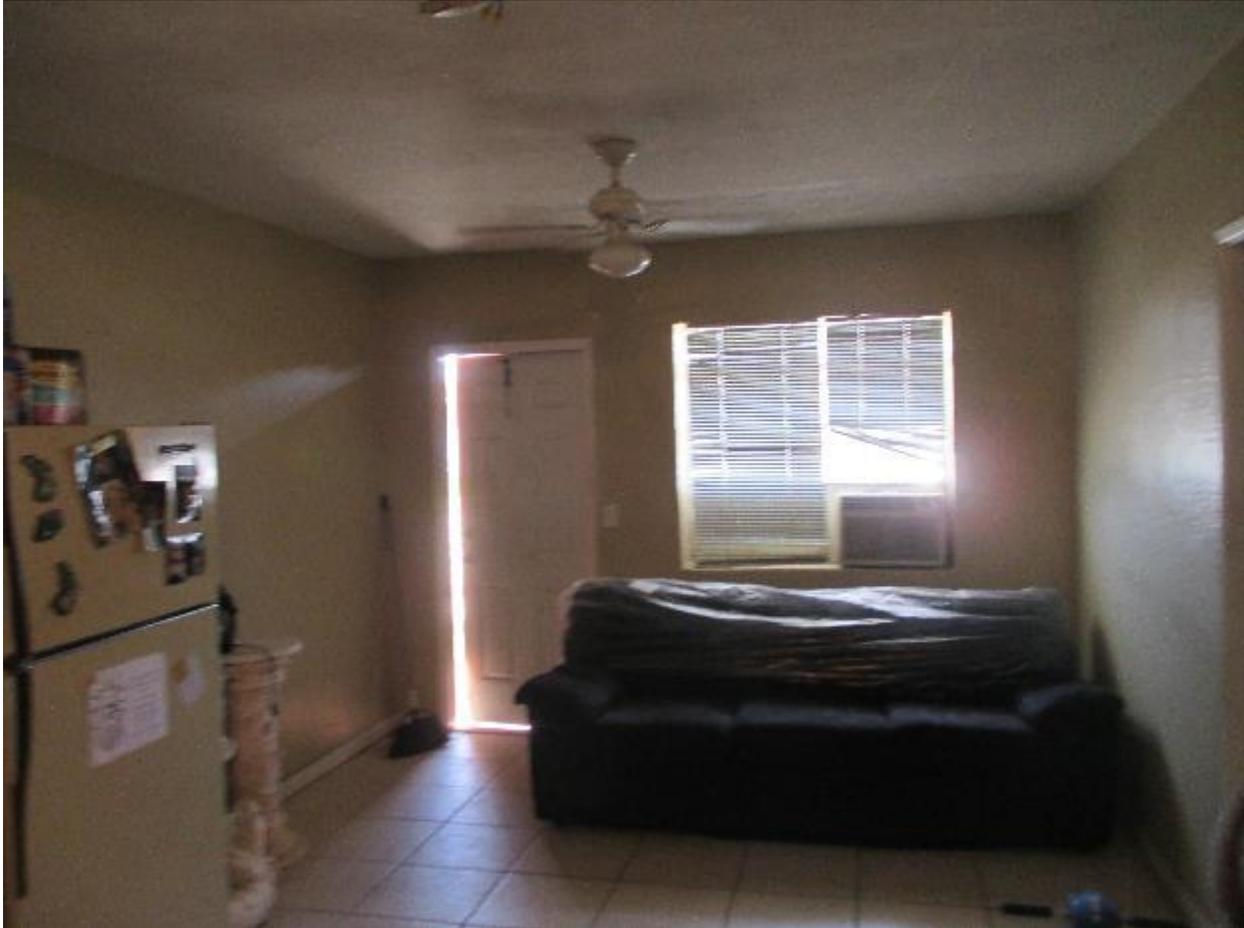
Interior finishes were found in general good condition at the time of inspection with exceptions as noted and shown in photographs.

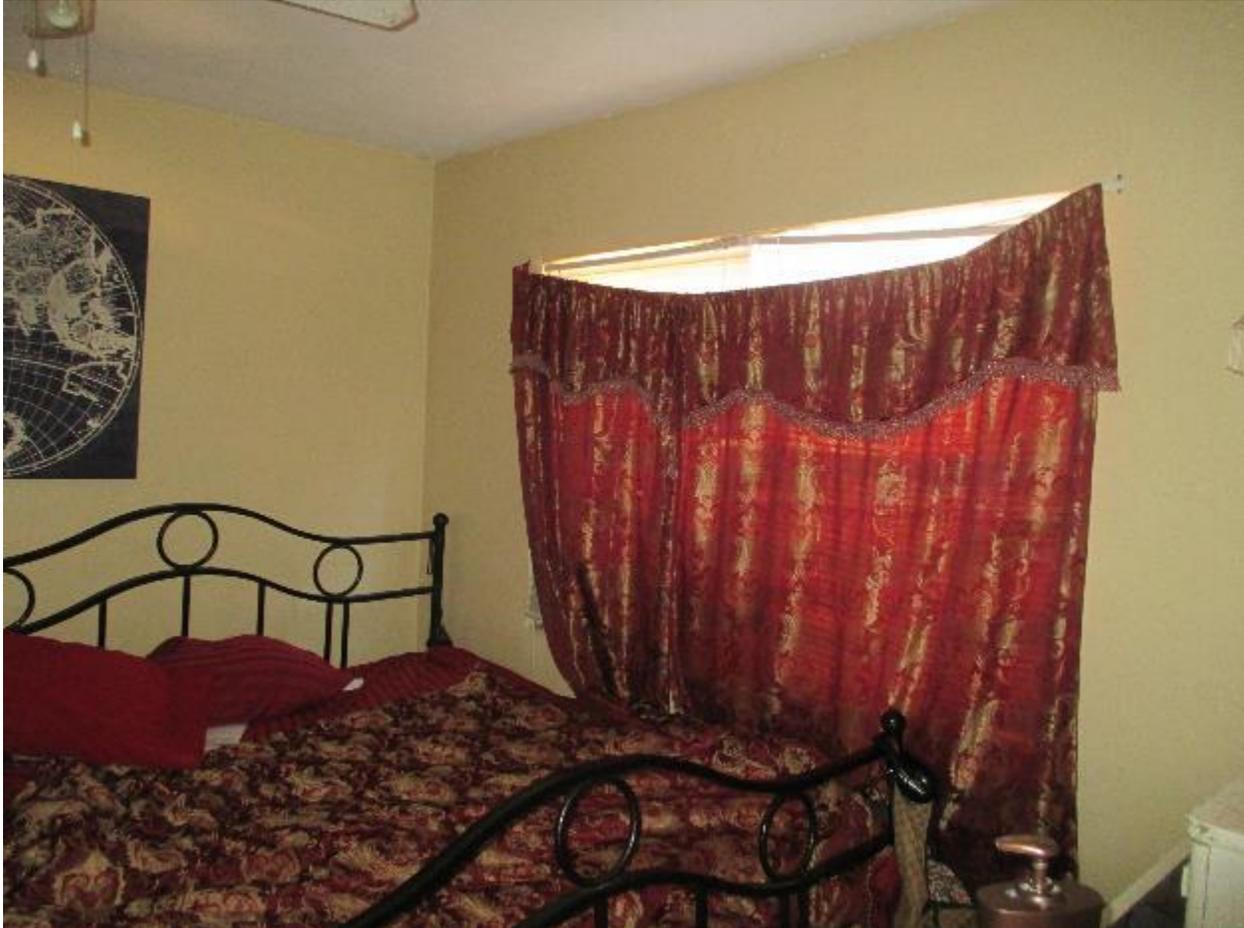
Interior finishes were found in general good condition at the time of inspection with exceptions as noted and shown in photographs.

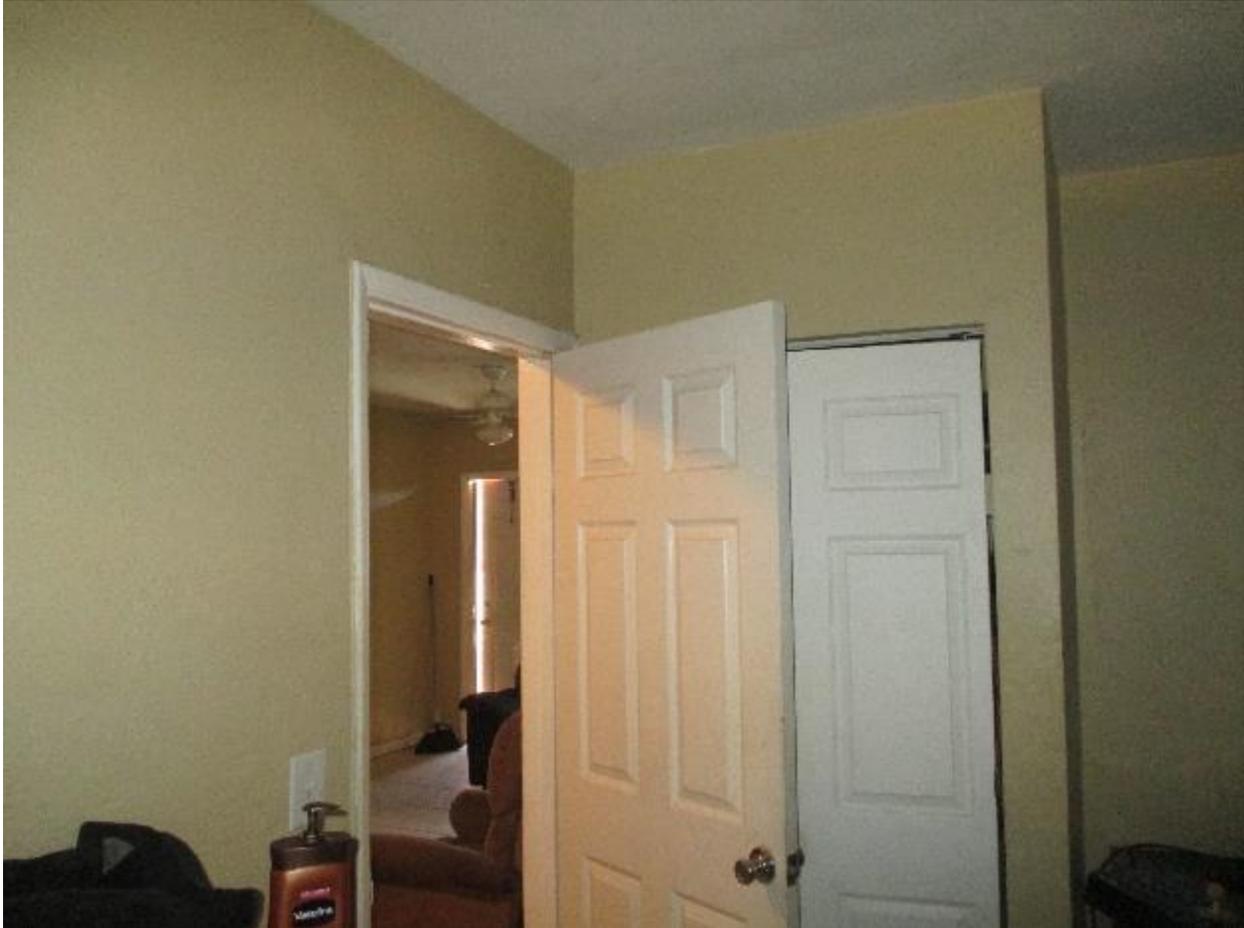
Interior finishes were found in general good condition at the time of inspection with exceptions as noted and shown in photographs.

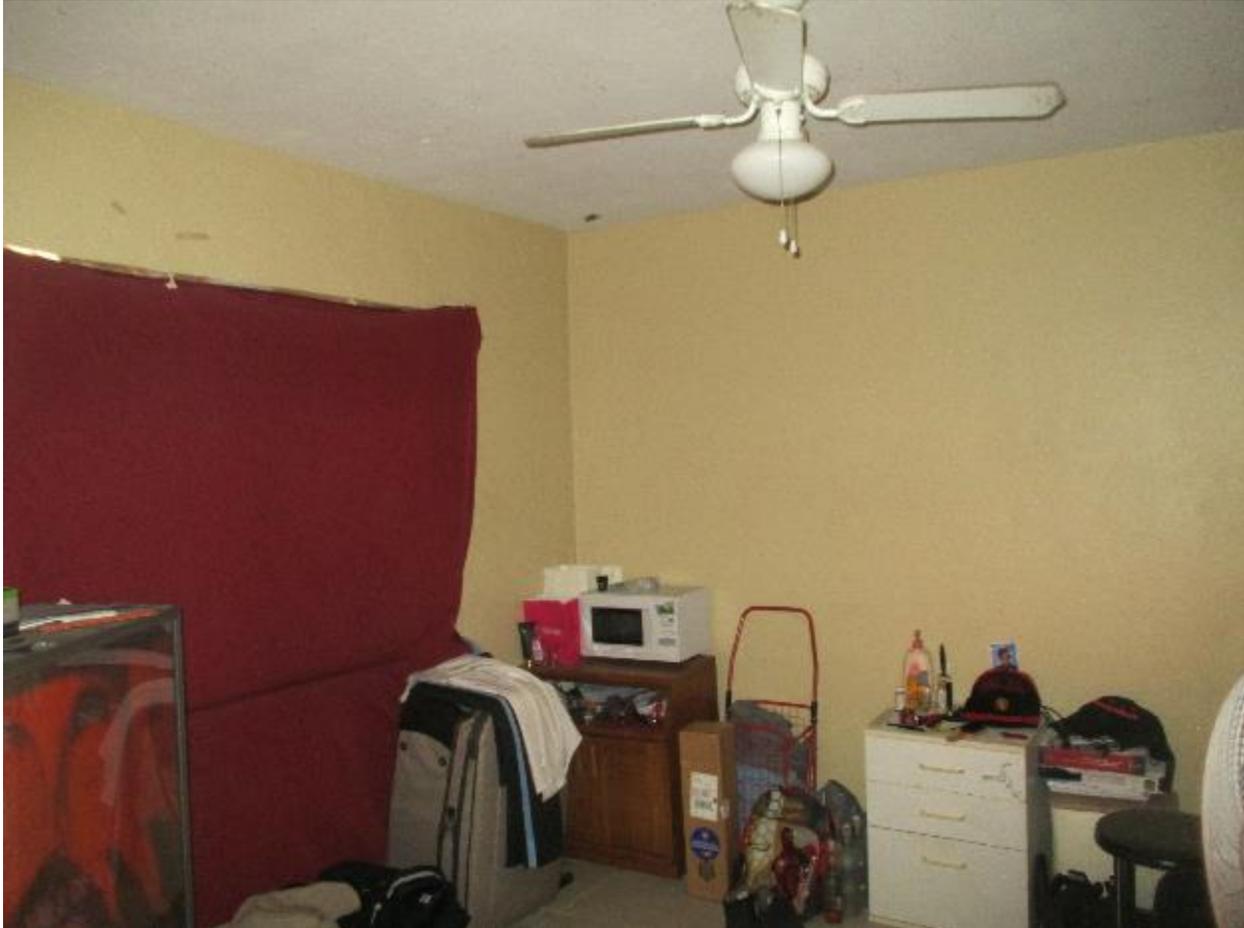
Interior finishes were found in general good condition at the time of inspection with exceptions as noted and shown in photographs.

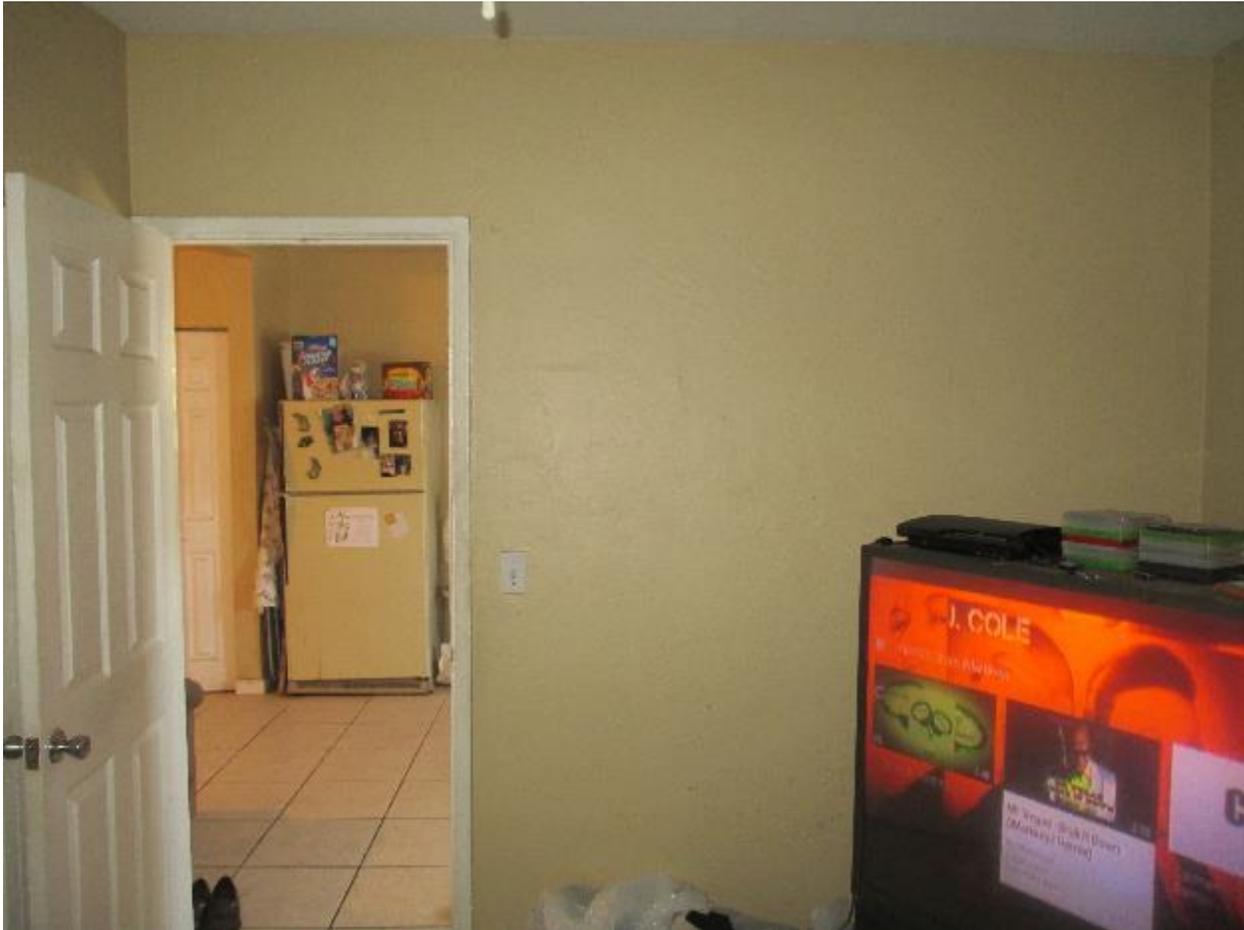
Interior finishes were found in general good condition at the time of inspection with exceptions as noted and shown in photographs.

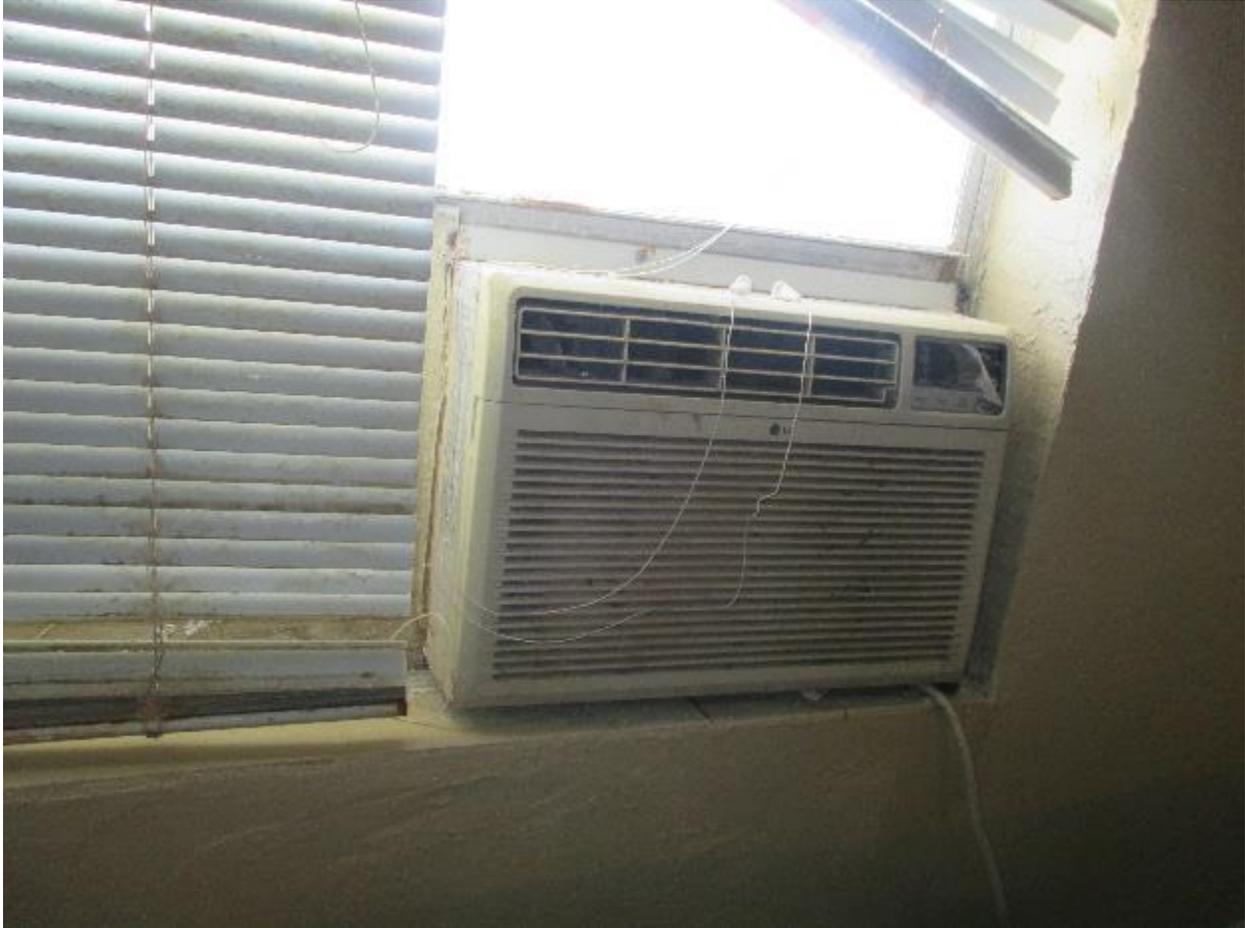
Ac in good working condition at the time of inspection.

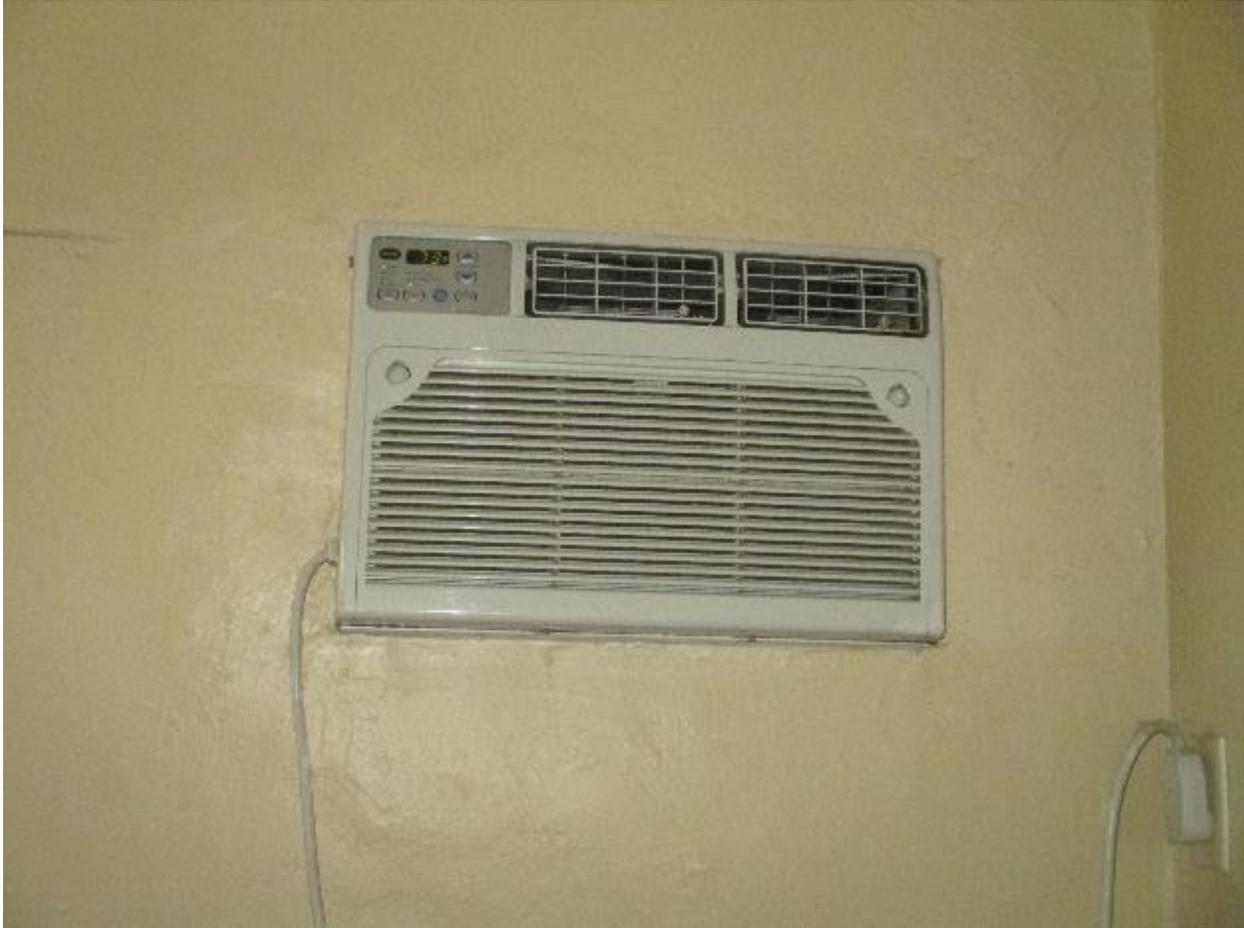
Ac in good working condition at the time of inspection.

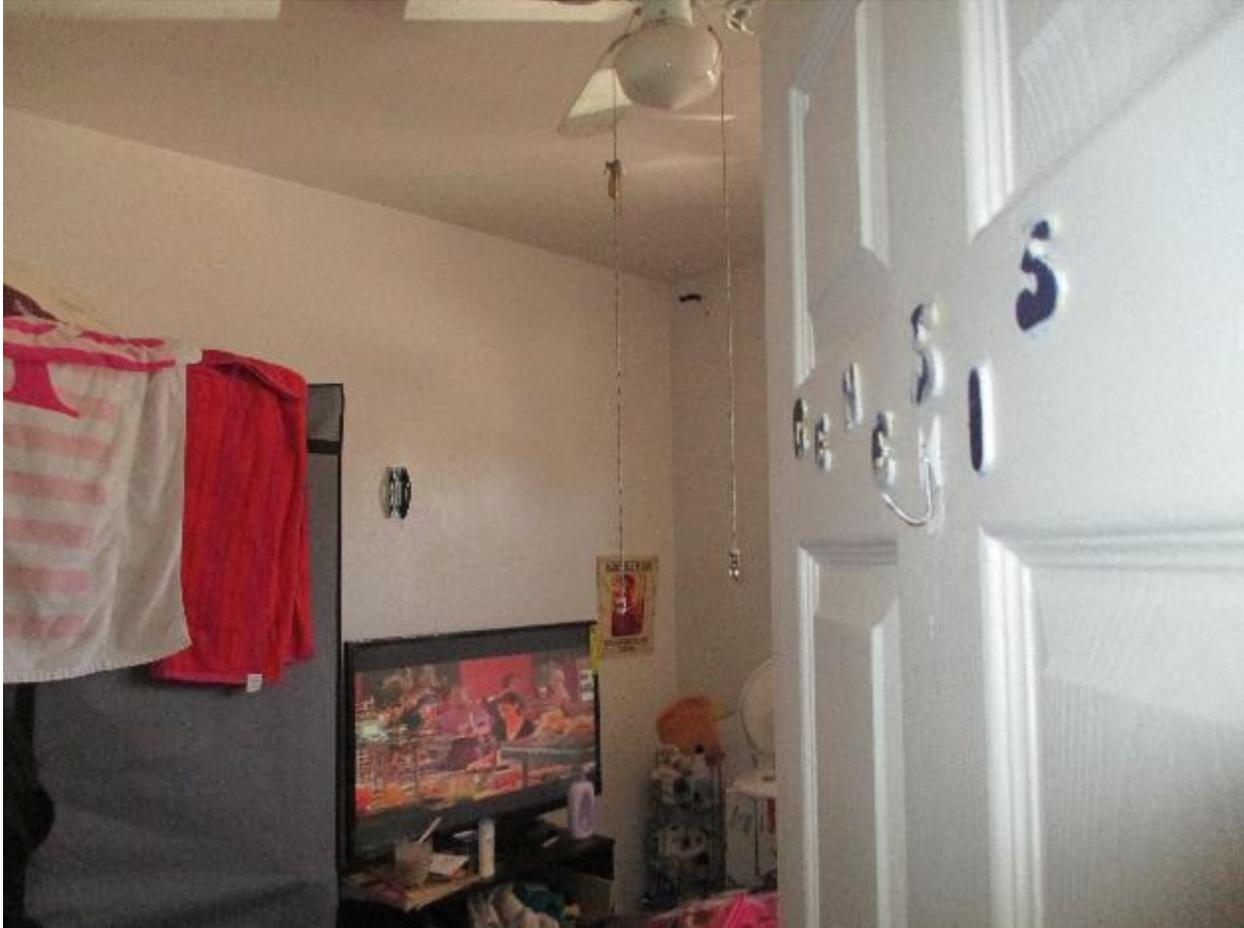
Interior finishes were found in general good condition at the time of inspection with exceptions as noted and shown in photographs.

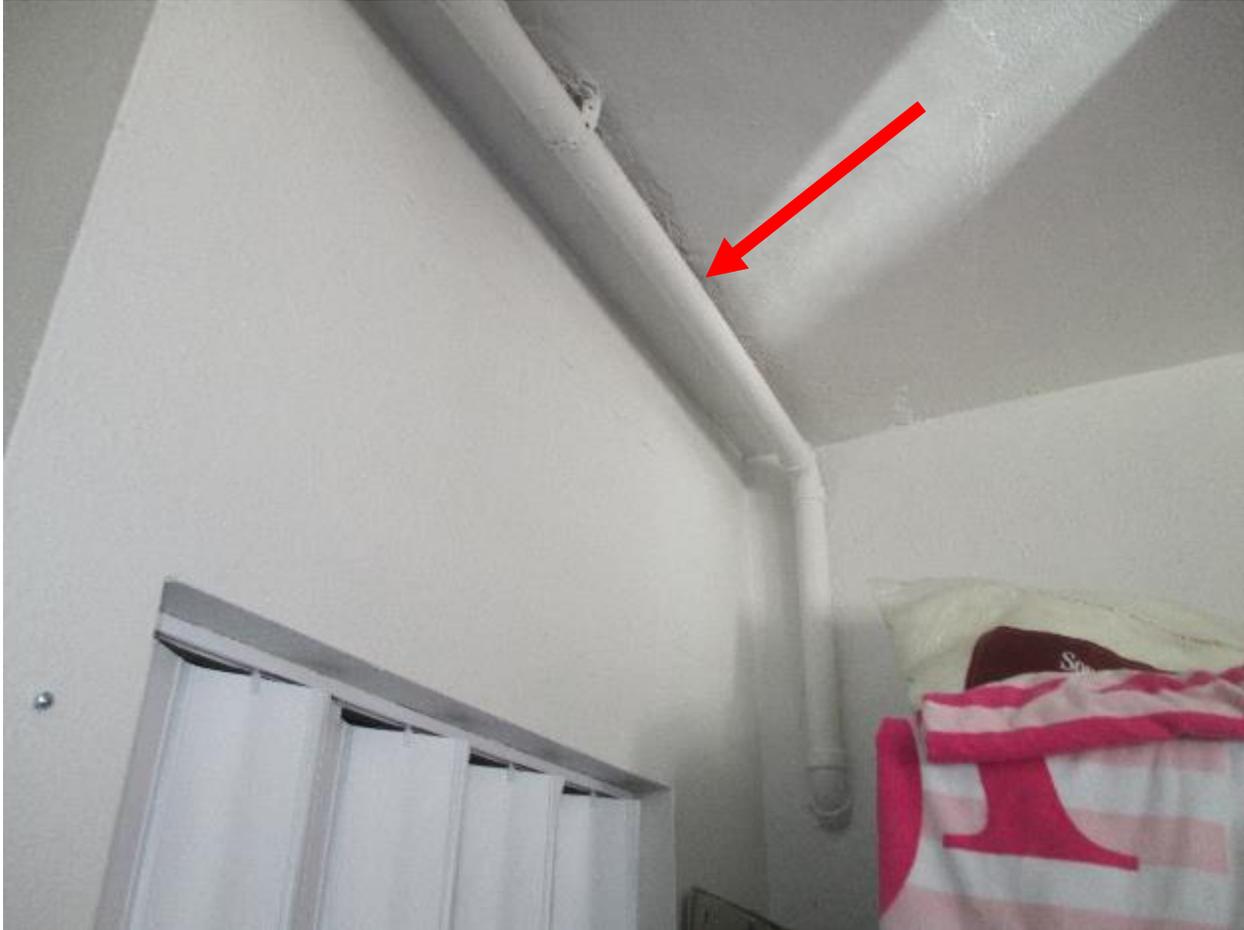
Plumbing requires rerouting.

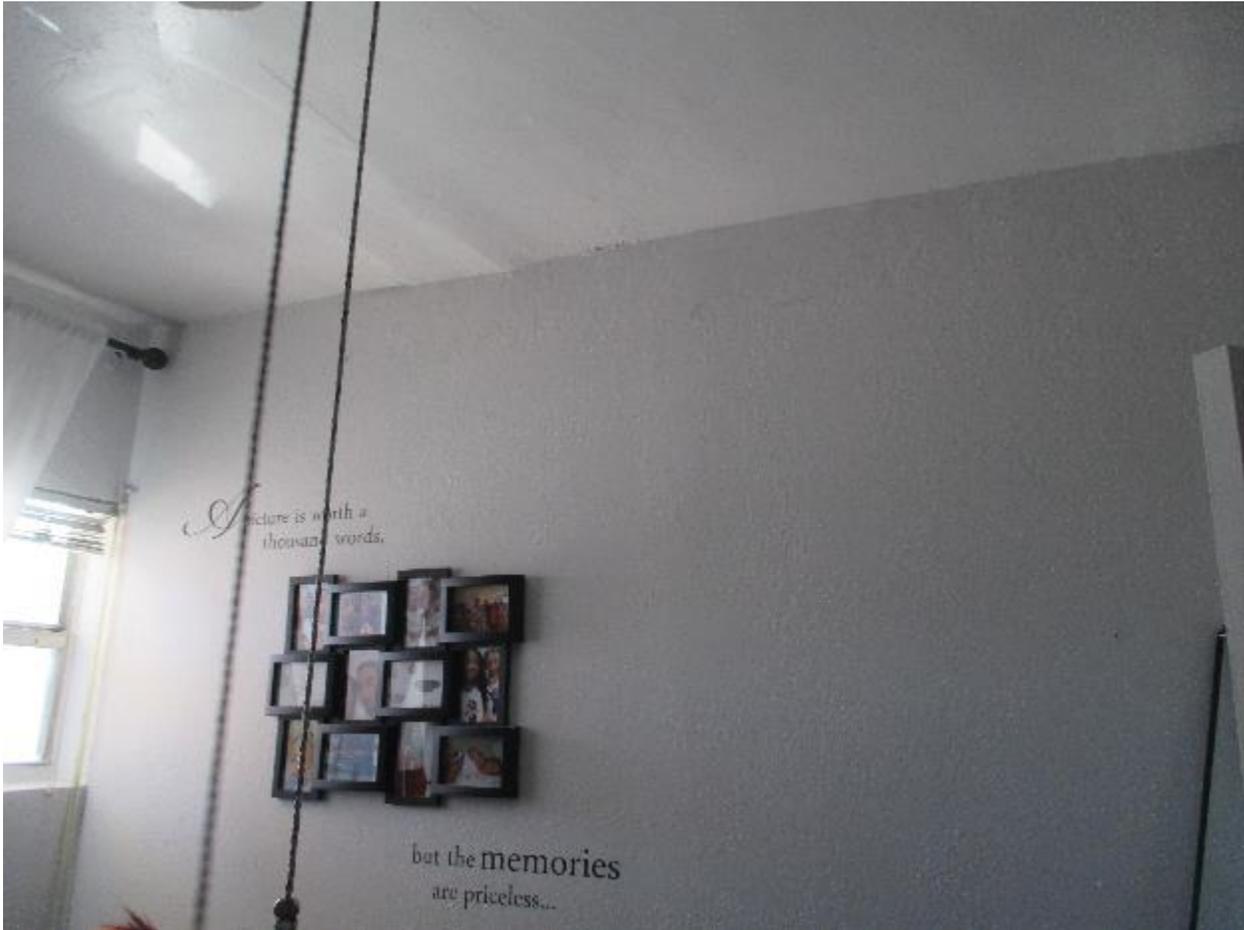
Interior finishes were found in general good condition at the time of inspection with exceptions as noted and shown in photographs.

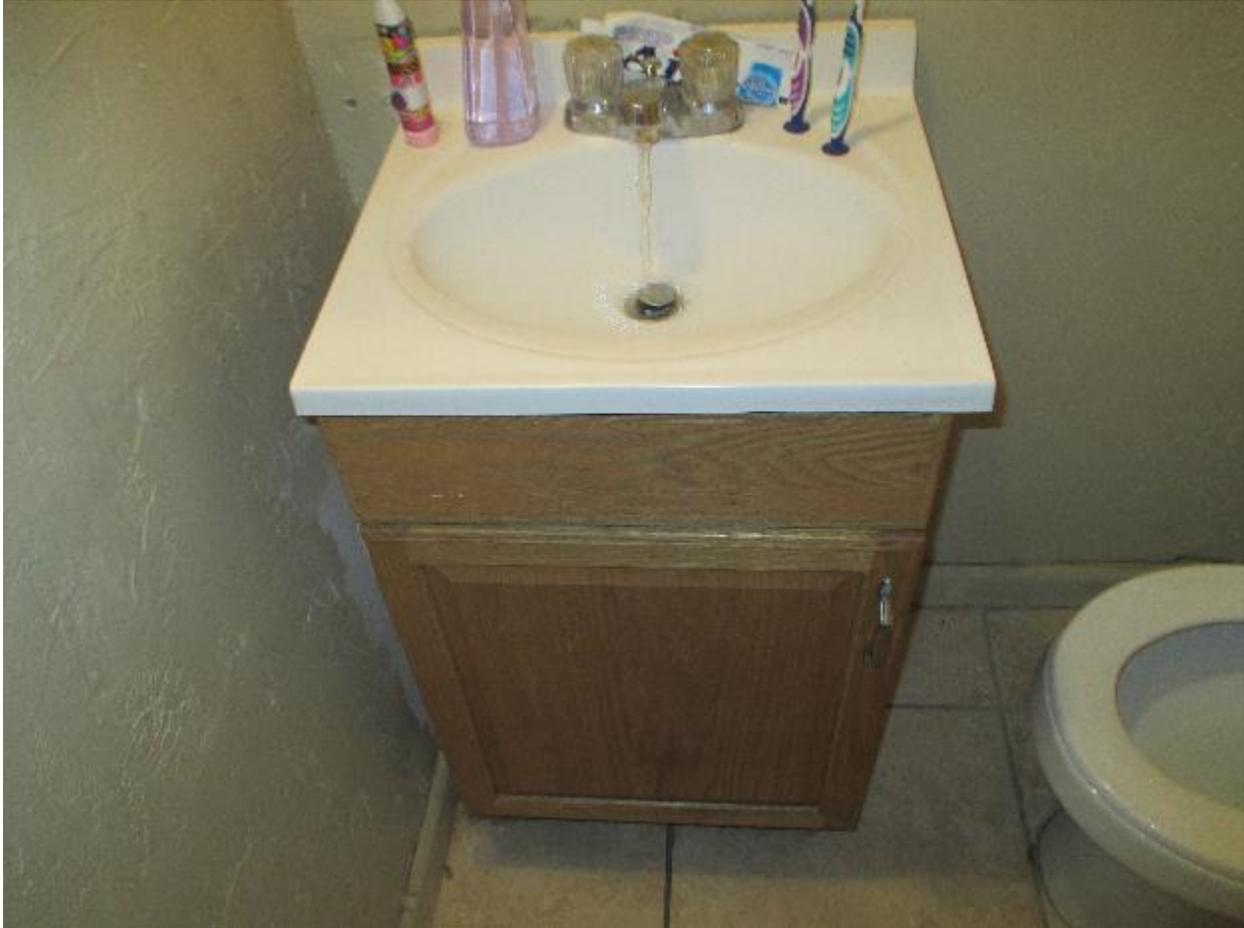
Plumbing systems tested for proper flow. No leaks or deficiencies noted on drain and supply lines.

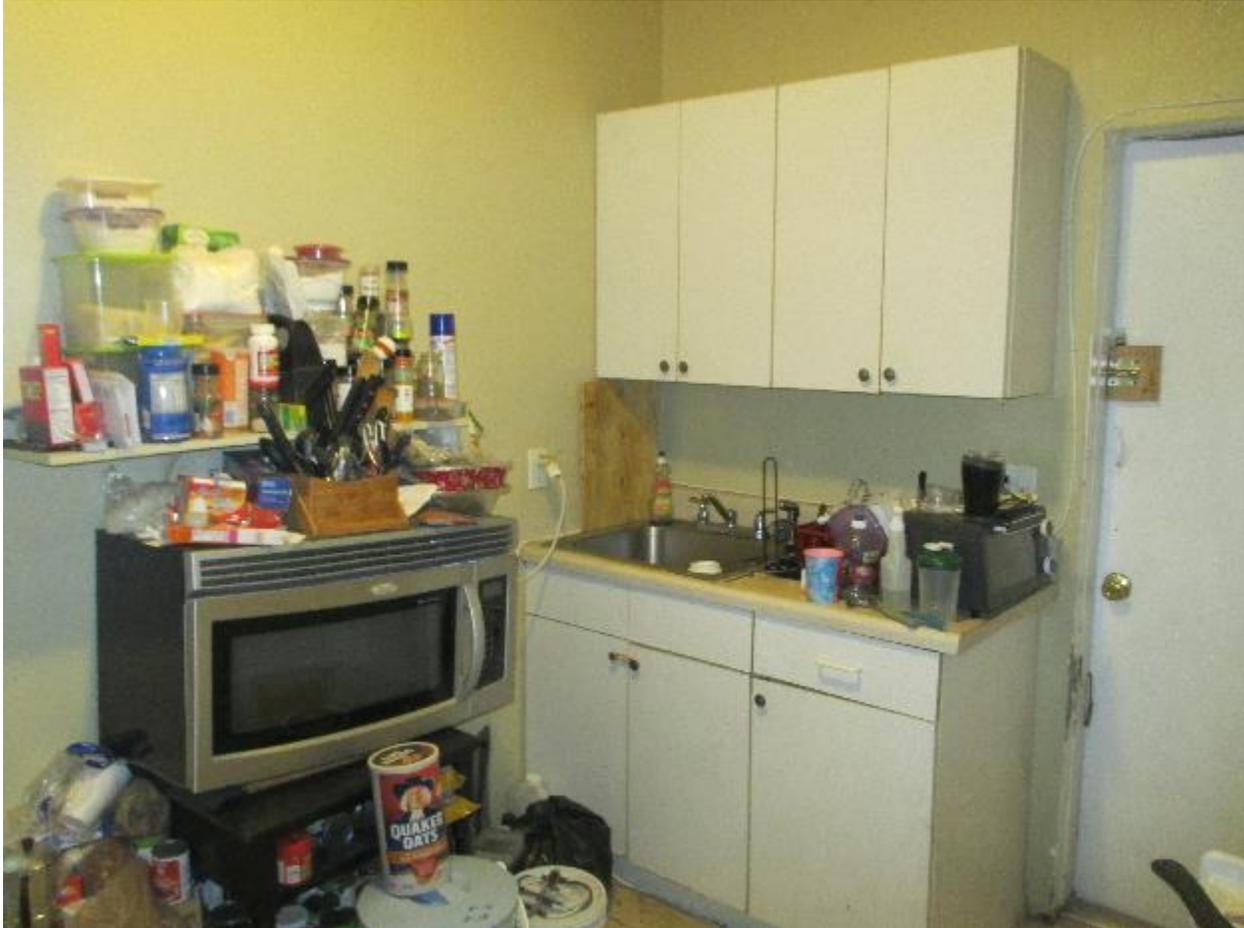
Interior finishes were found in general good condition at the time of inspection with exceptions as noted and shown in photographs.

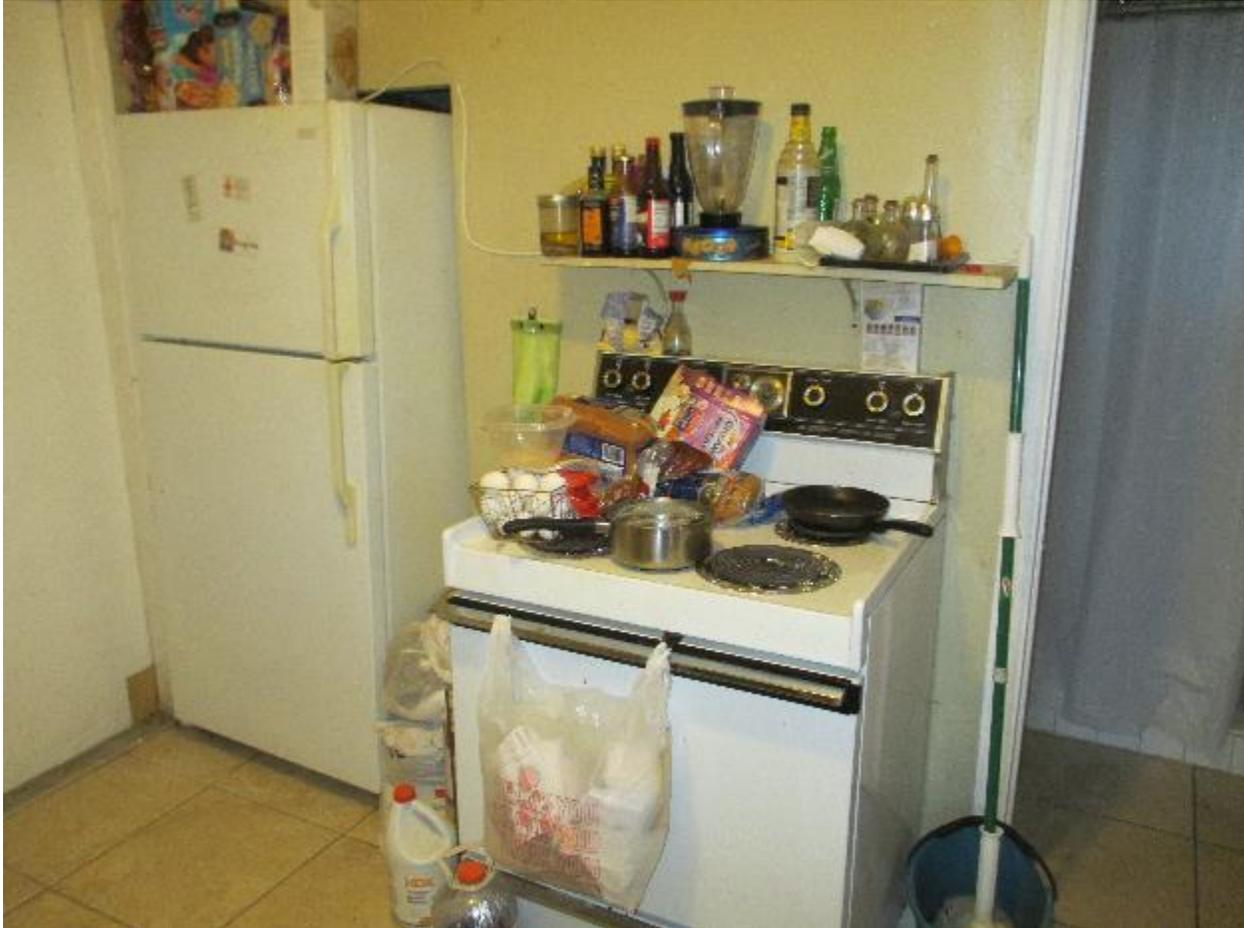
Interior finishes were found in general good condition at the time of inspection with exceptions as noted and shown in photographs.

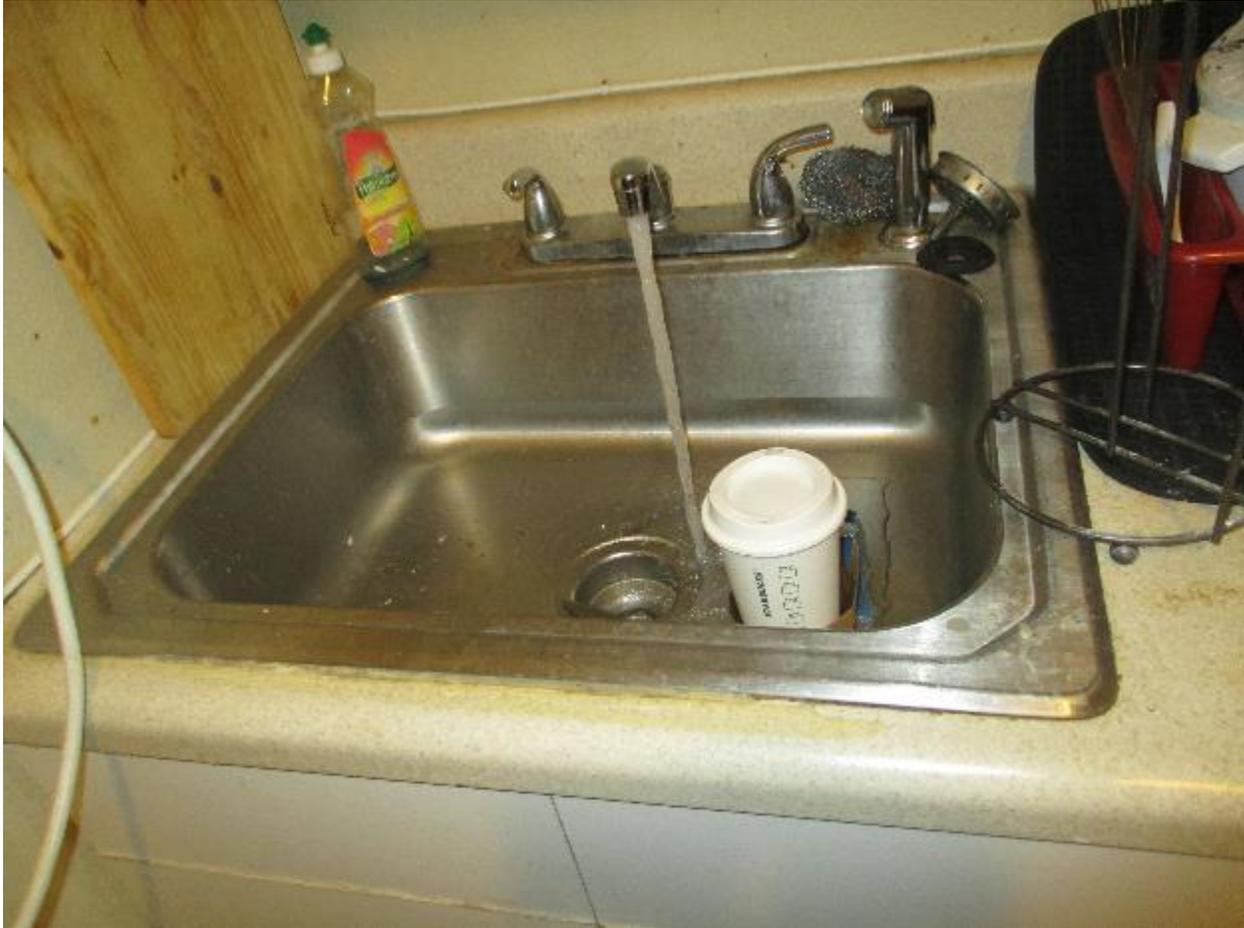
Plumbing systems tested for proper flow. No leaks or deficiencies noted on drain and supply lines.
