PROPERTY INSPECTION OR ASSESSMENT OF DAMAGES

ADDRESS: **SOMEWHERE , FL**
CLIENT: **GAIA GC**
ID No: **2015000**
DATE: **12/31/xxxx**

GAIA CONSTRUCTION INC.
CGC 1516136 FLORIDA
HI-2792 FLORIDA
8028867-B2 INTERNATIONAL CODE COUNCIL

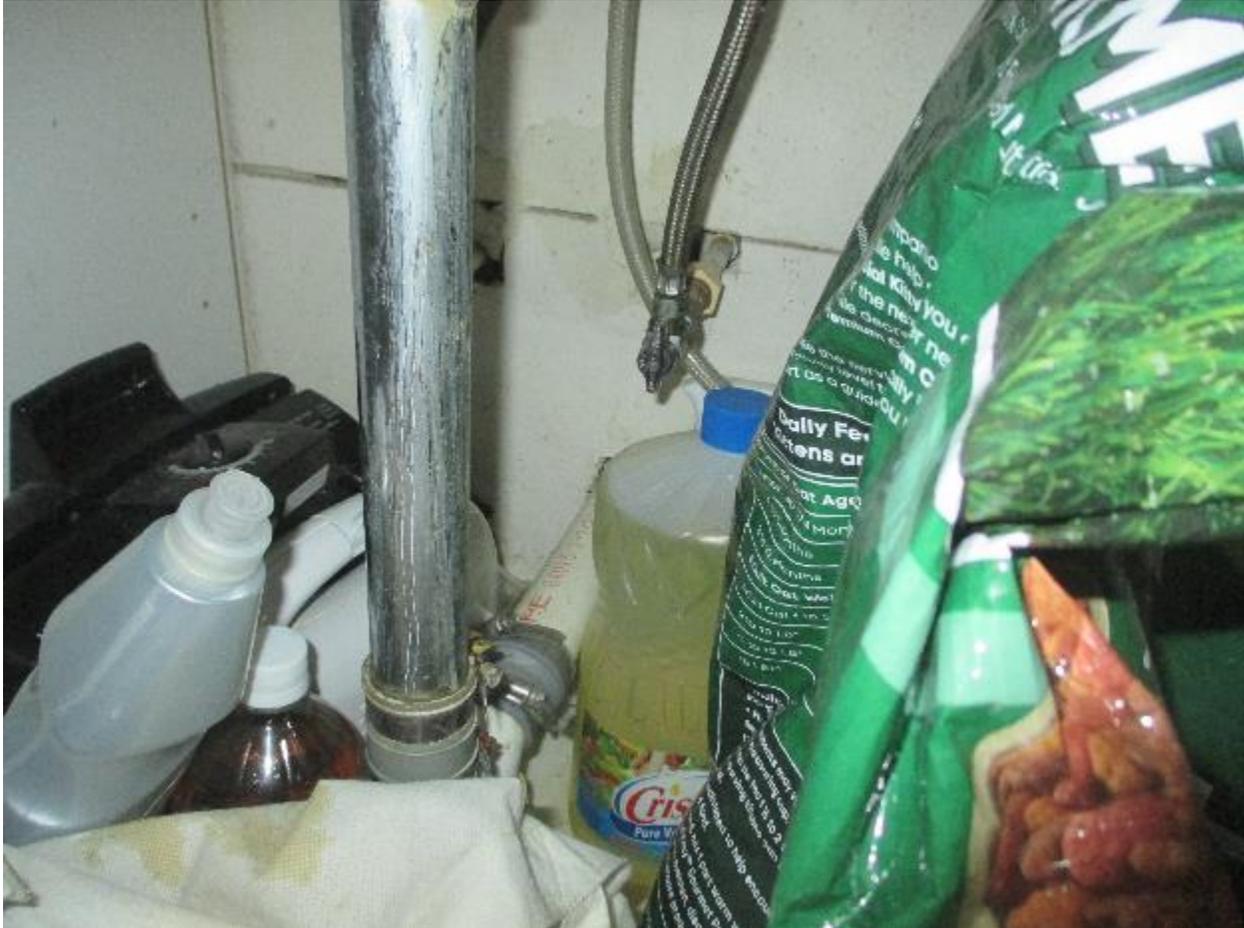
Plumbing systems tested for proper flow. No leaks or deficiencies noted on drain and supply lines.

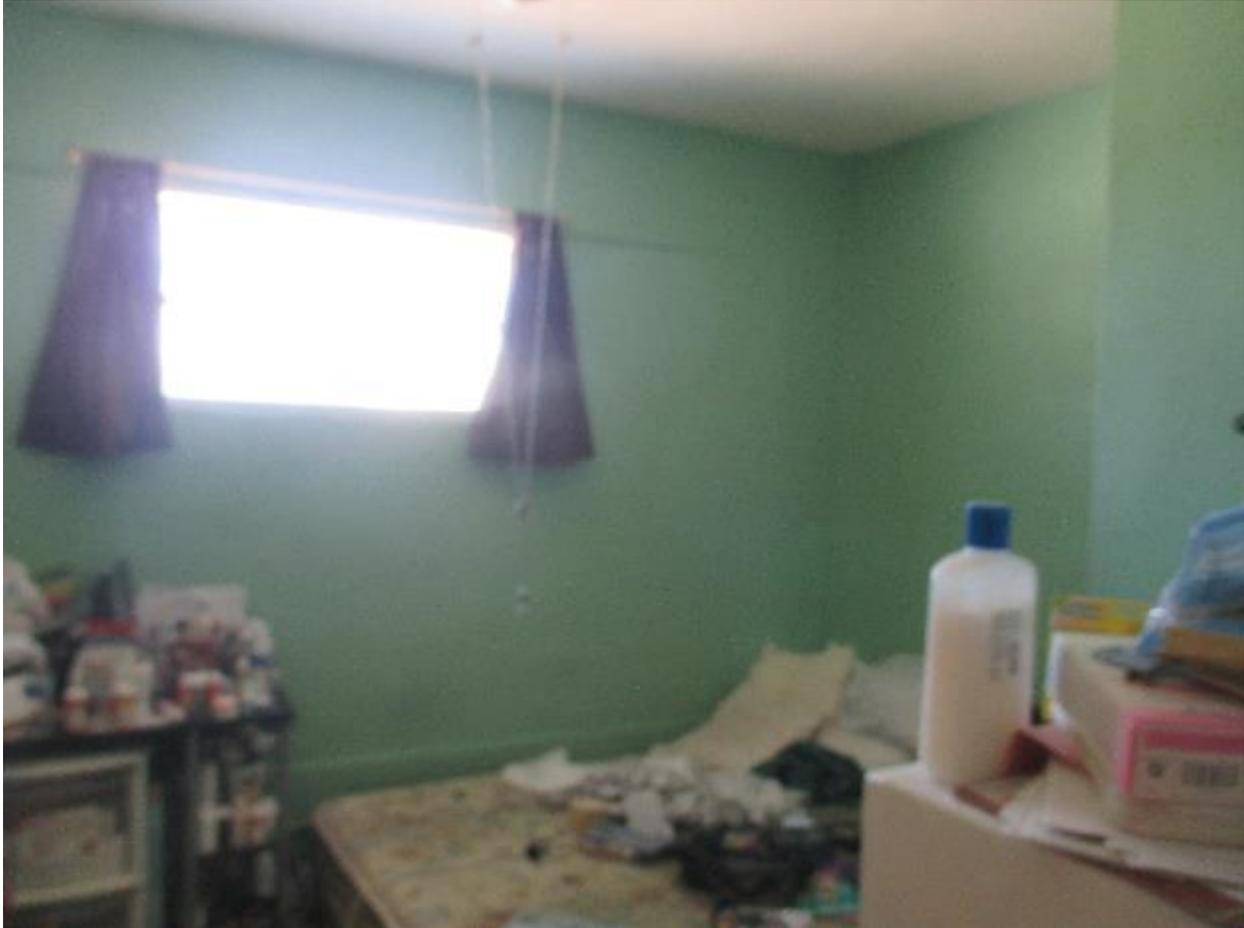
Interior finishes were found in general good condition at the time of inspection with exceptions as noted and shown in photographs.

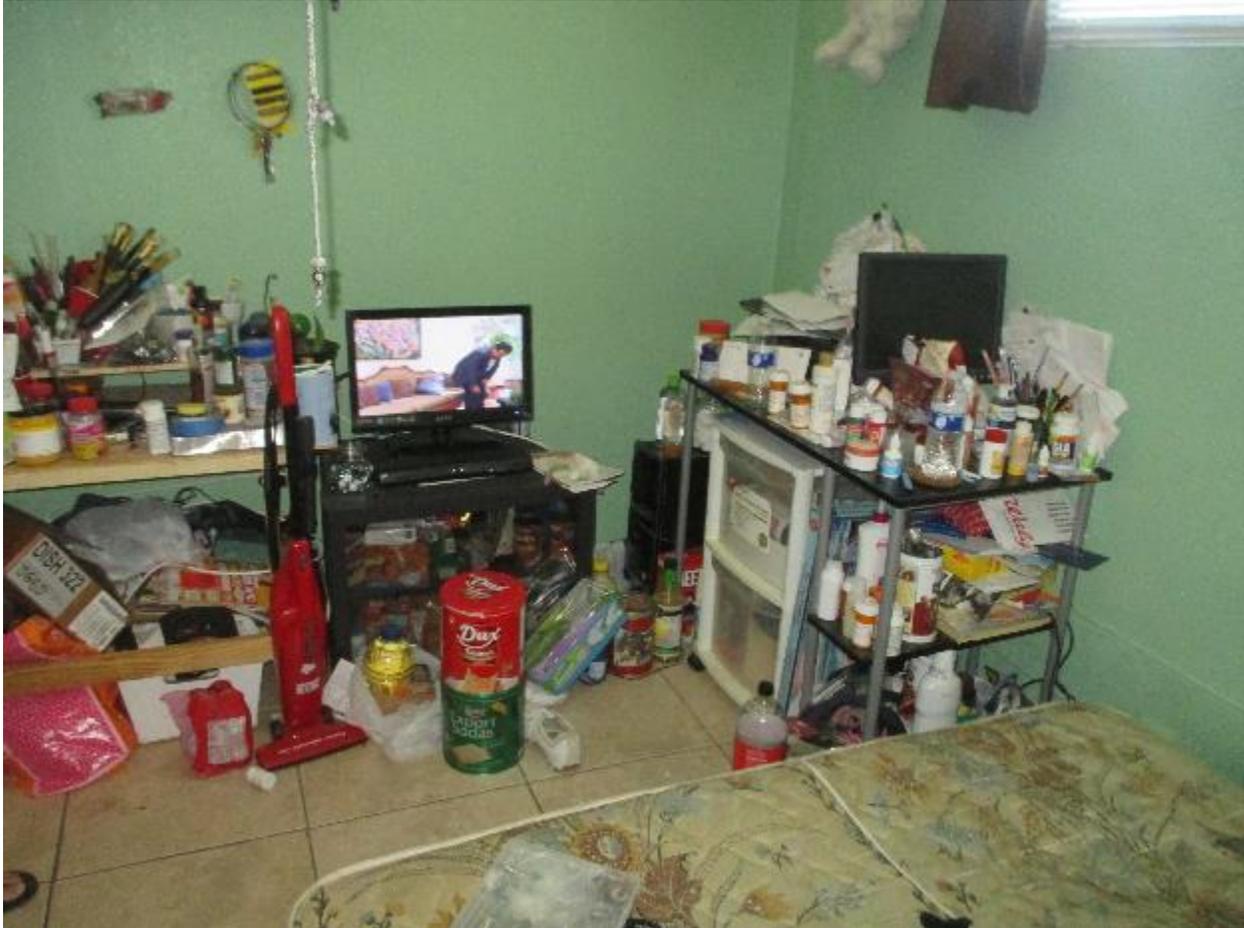
Interior finishes were found in general good condition at the time of inspection with exceptions as noted and shown in photographs.

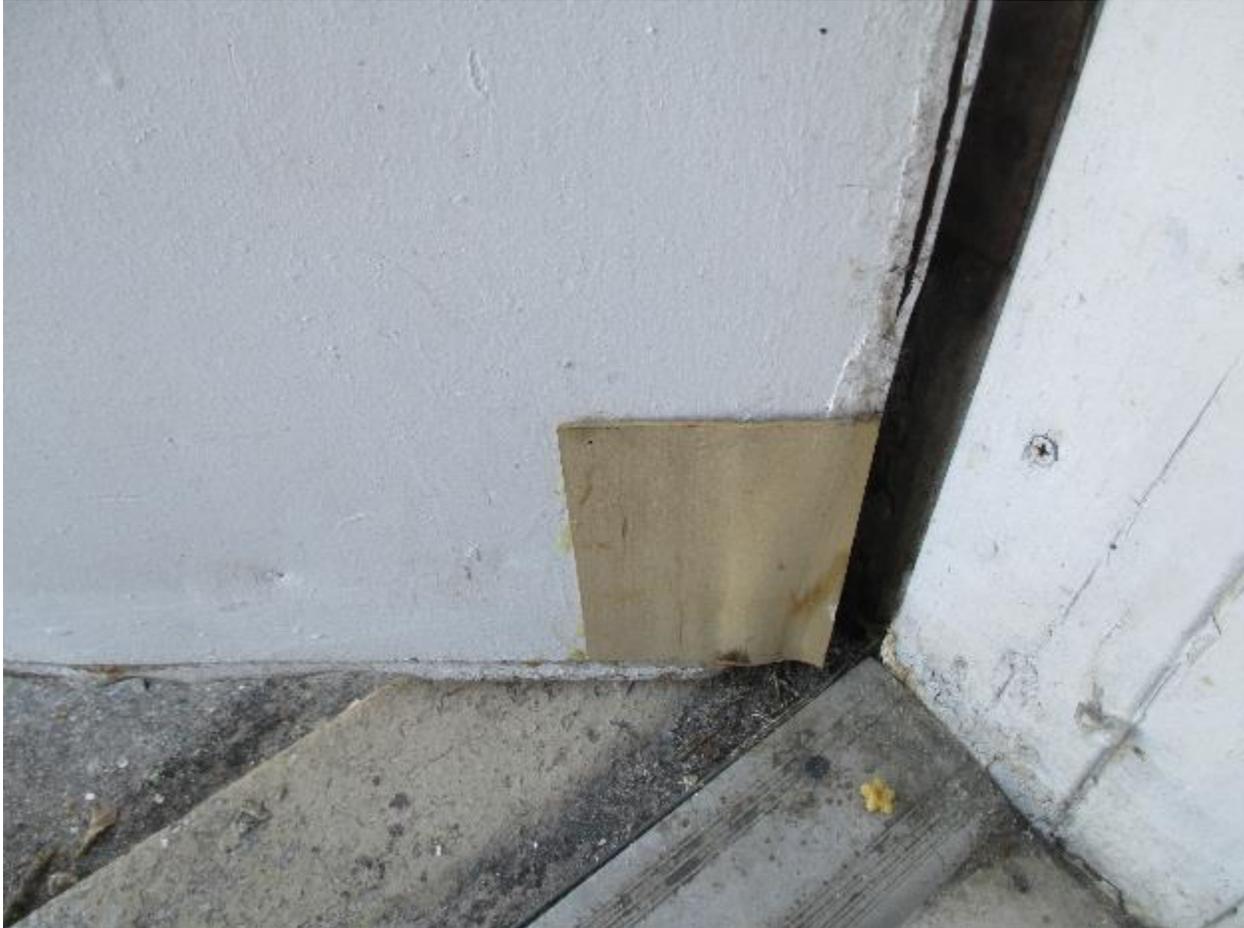
Exterior door(s) require replacement. Currently beyond possibilities of repair.

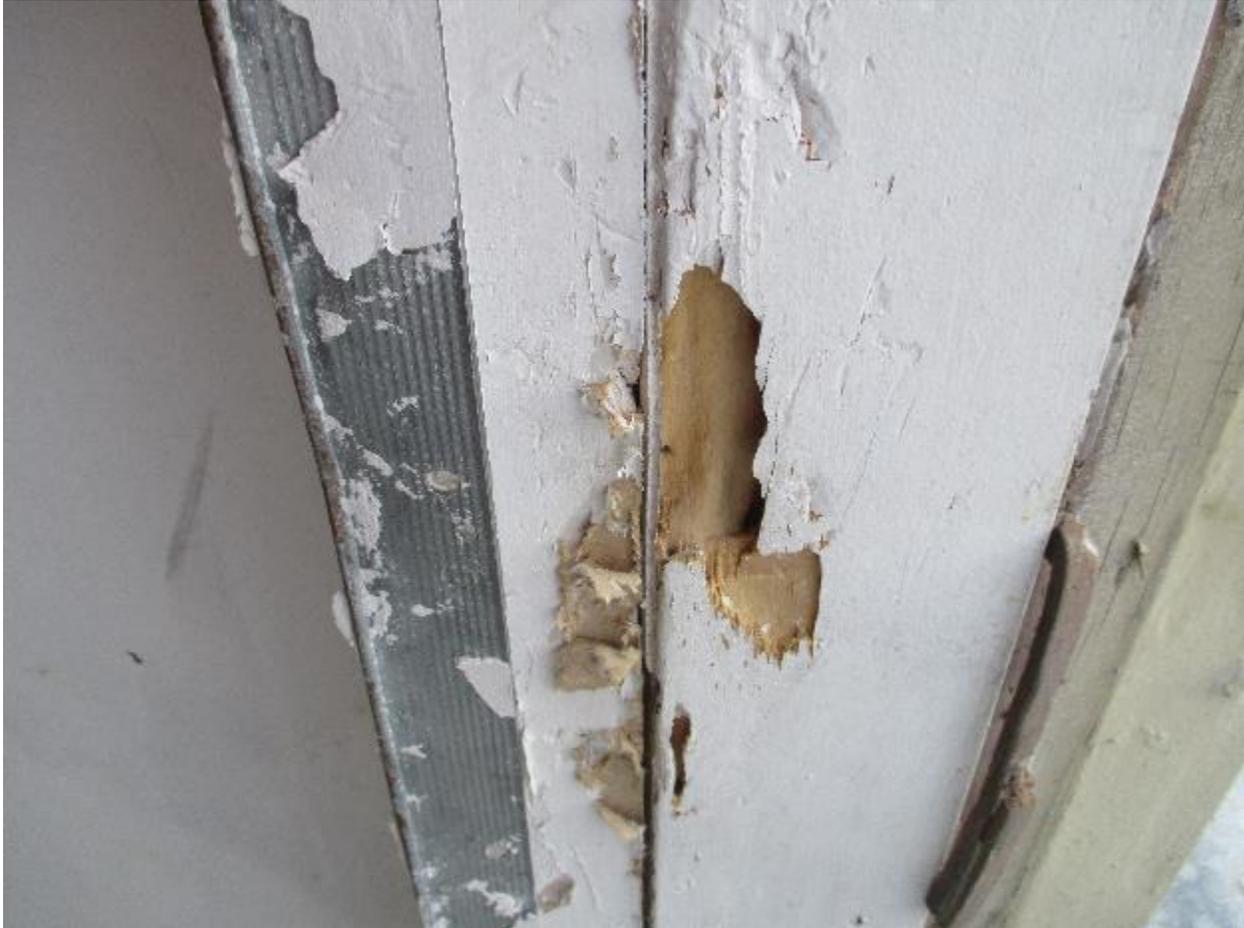
Exterior door(s) require replacement. Currently beyond possibilities of repair.

Signs of wood destroying organism related damage were noted during inspection. We recommend to have the property treated against WDO using a certified pest control company

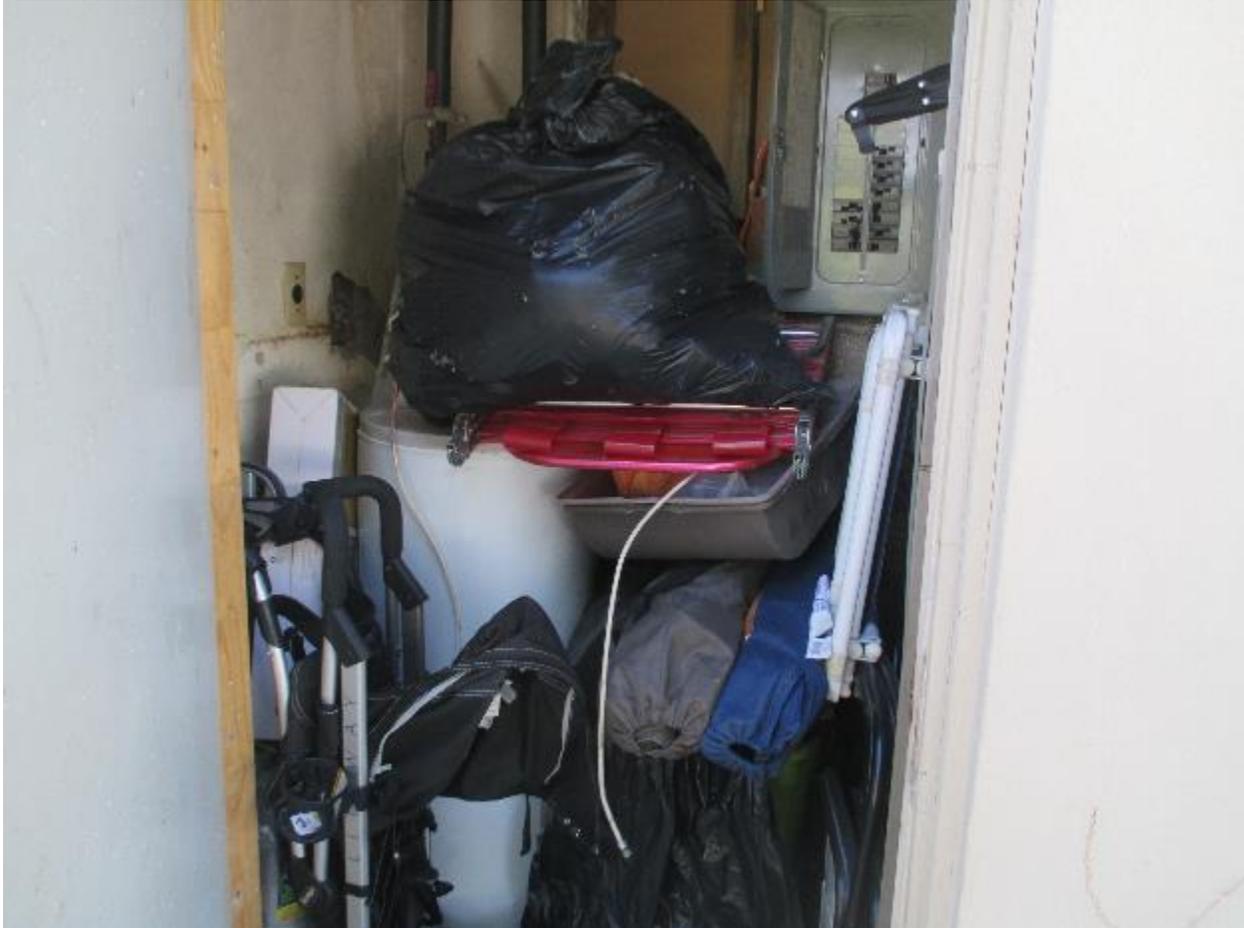
Unable to access breaker box or water heater at time of inspection.

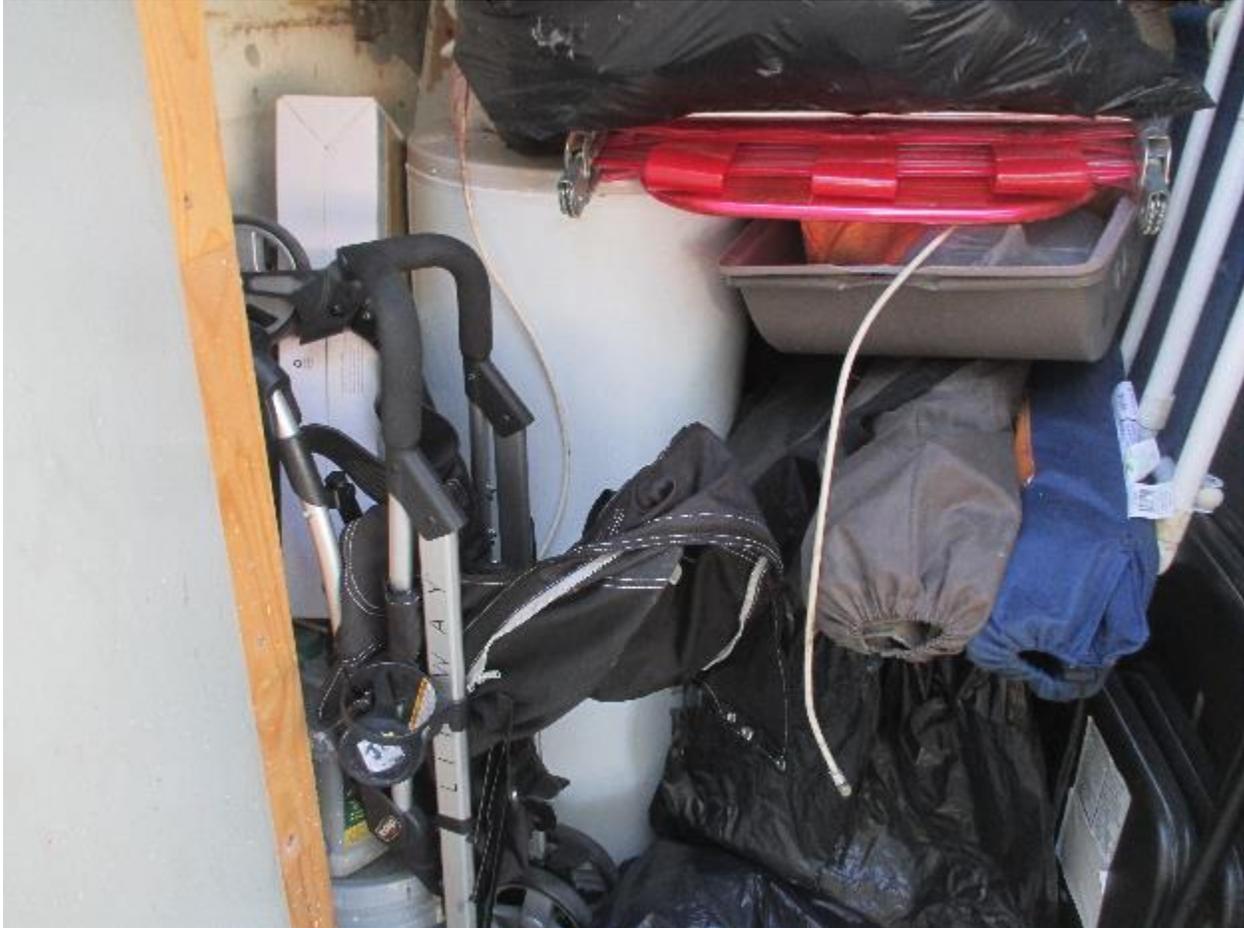
Unable to access breaker box or water heater at time of inspection.

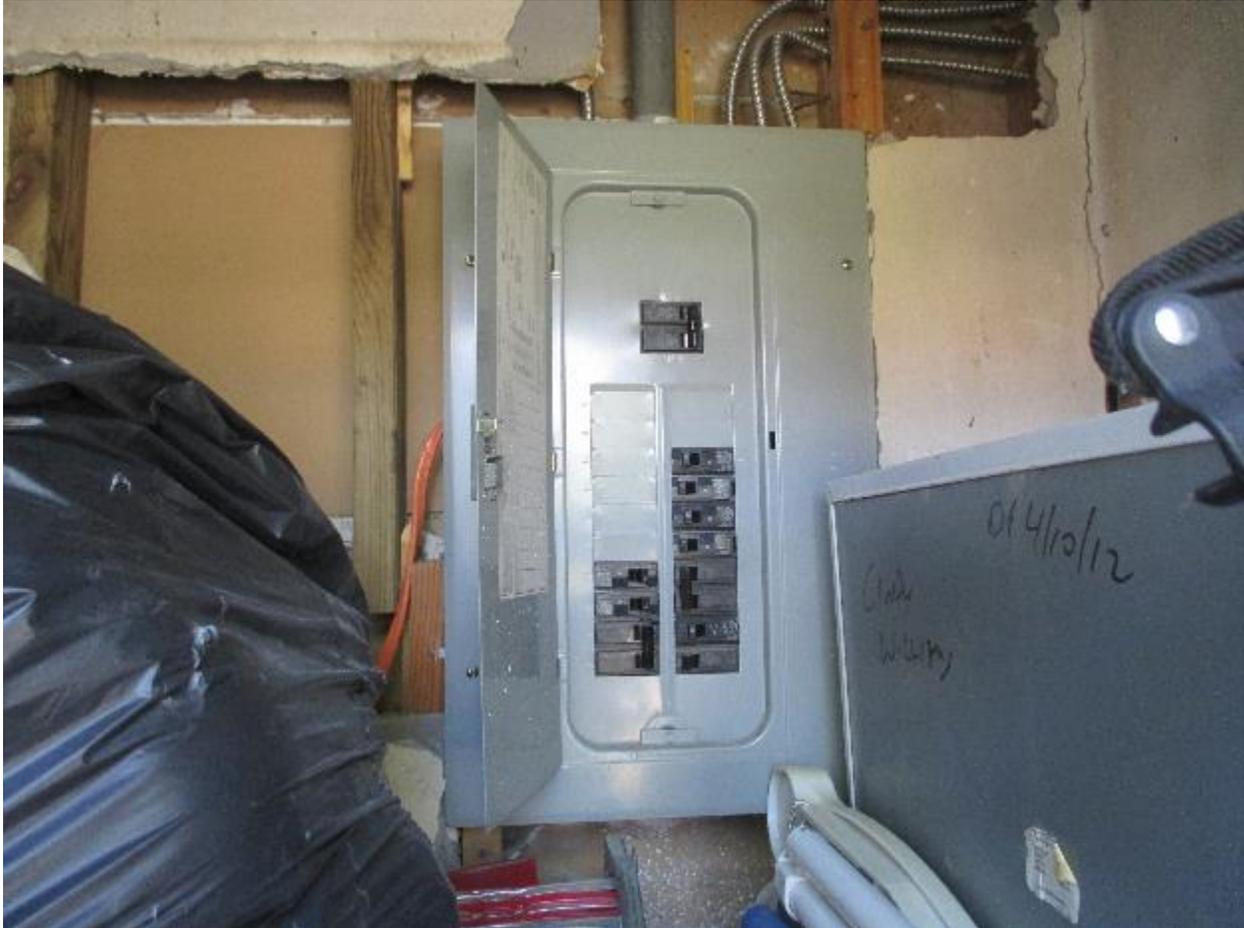
Unable to access breaker box or water heater at time of inspection.

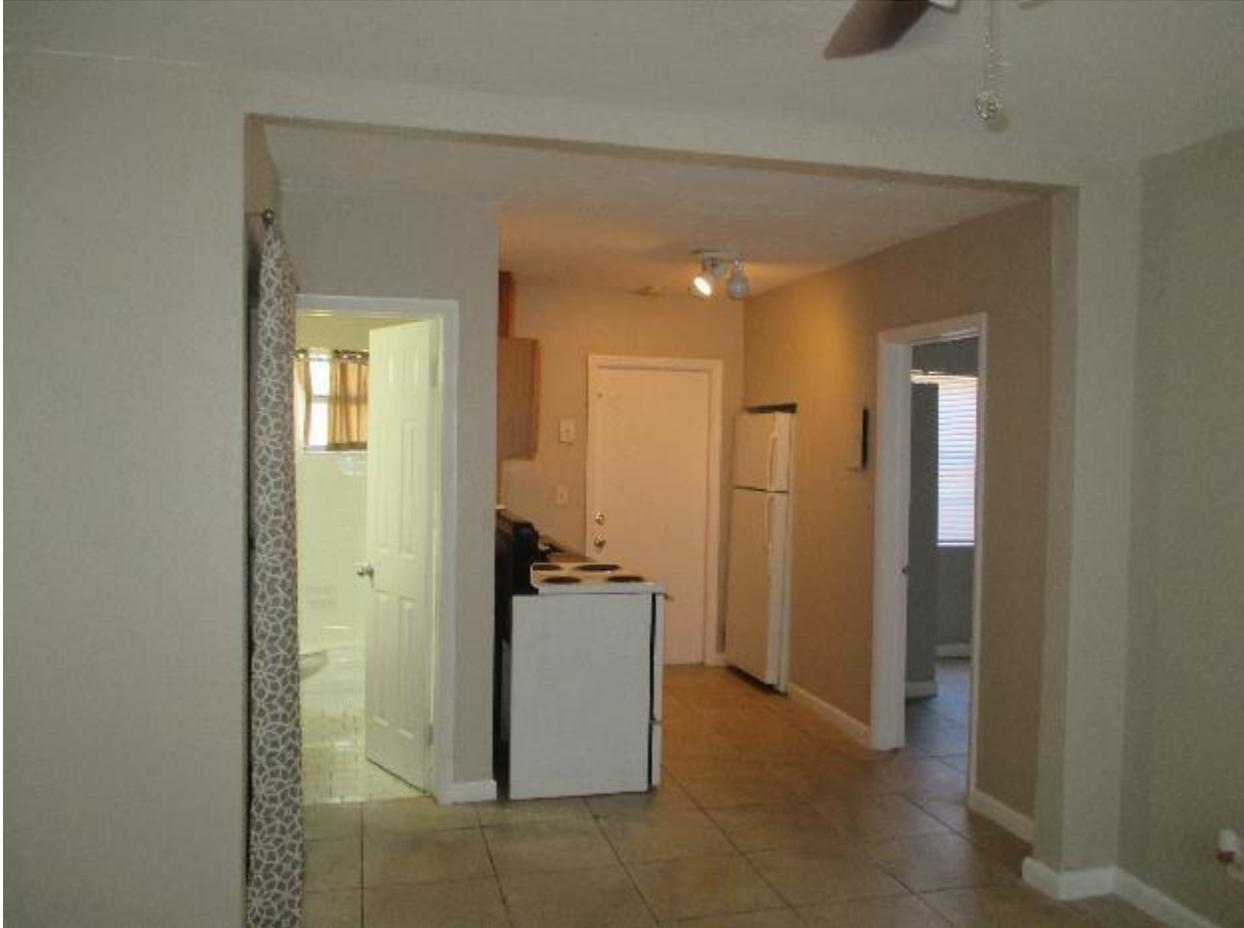
Interior finishes were found in general good condition at the time of inspection with exceptions as noted and shown in photographs.

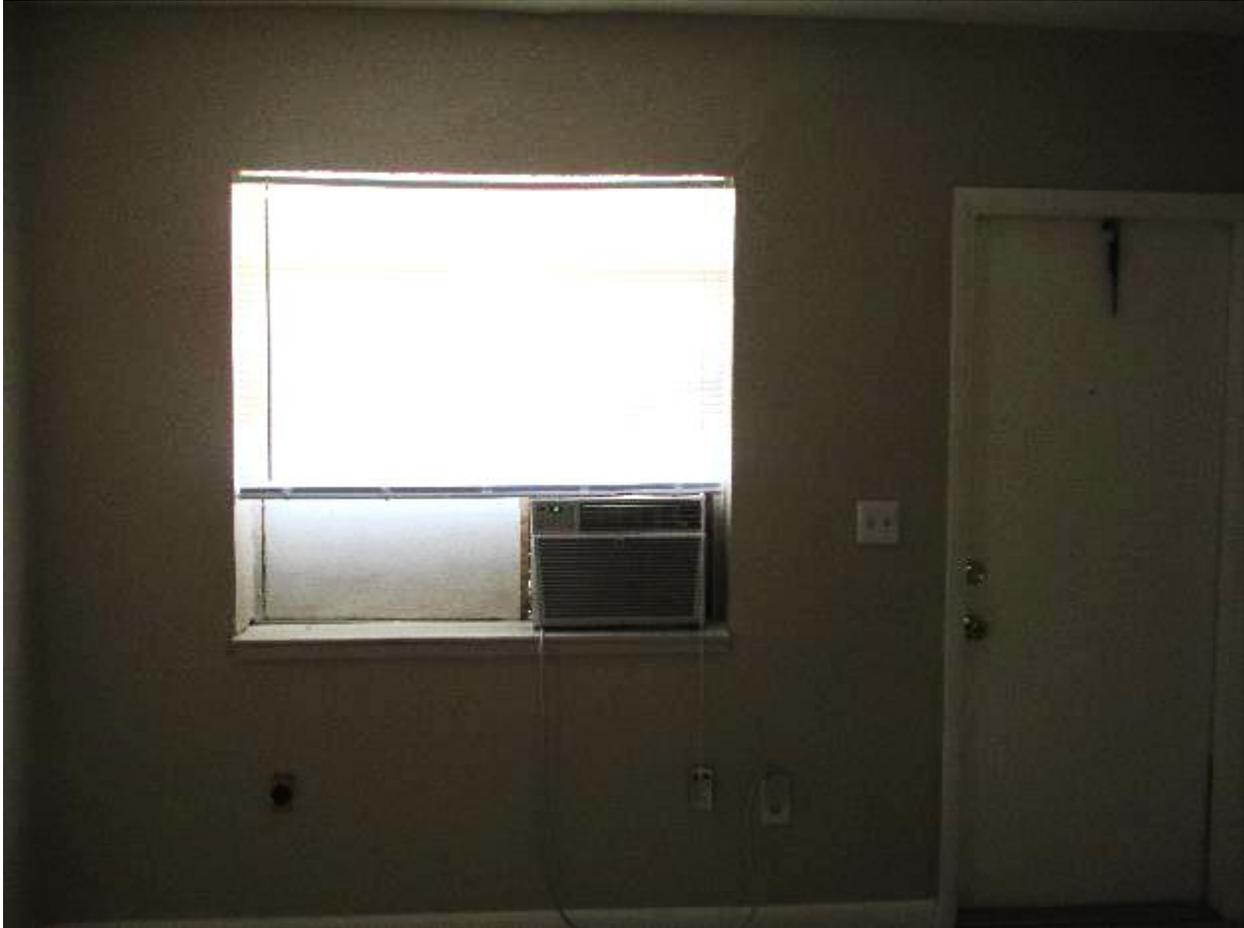
Interior finishes were found in general good condition at the time of inspection with exceptions as noted and shown in photographs.

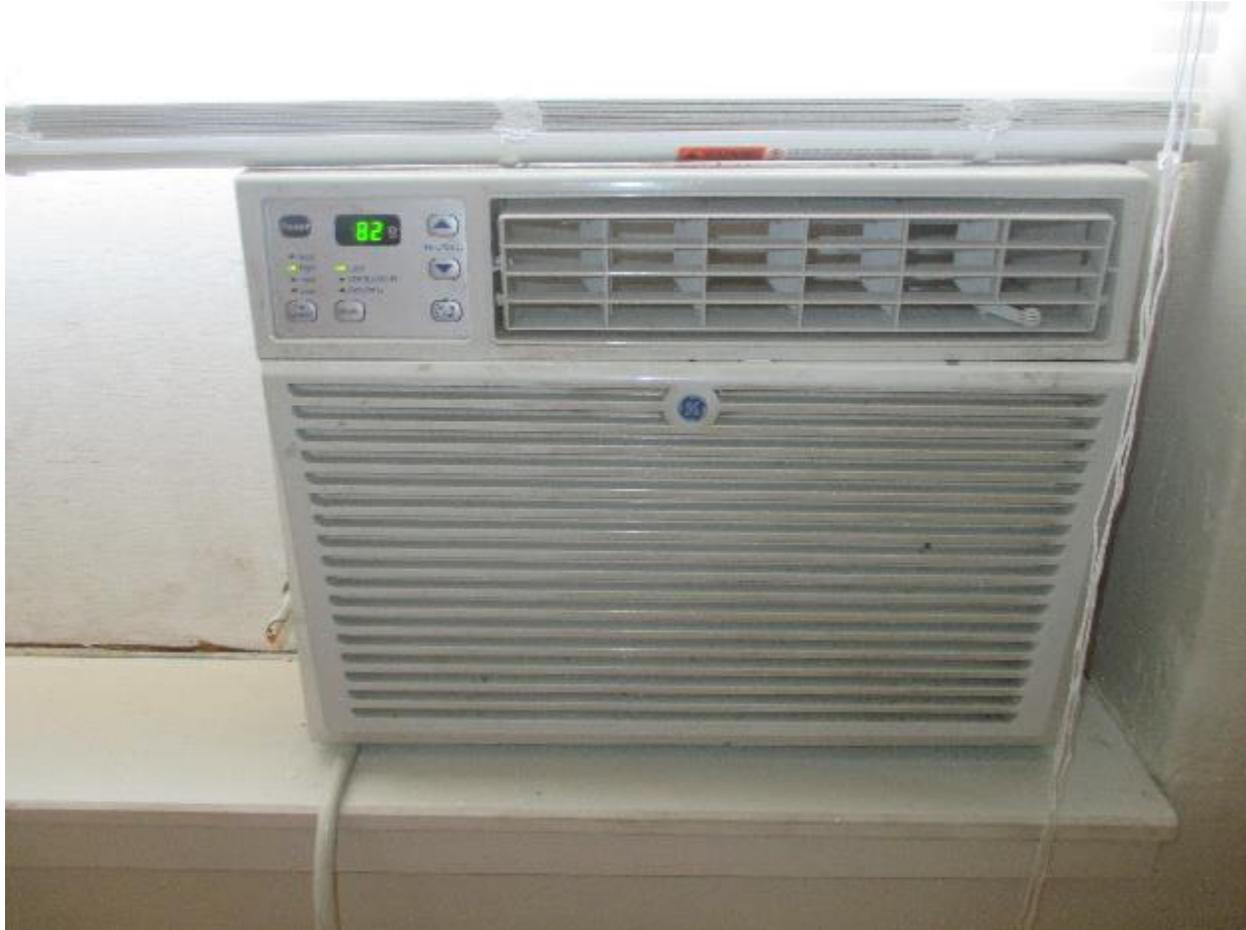
Ac in good working condition at the time of inspection.

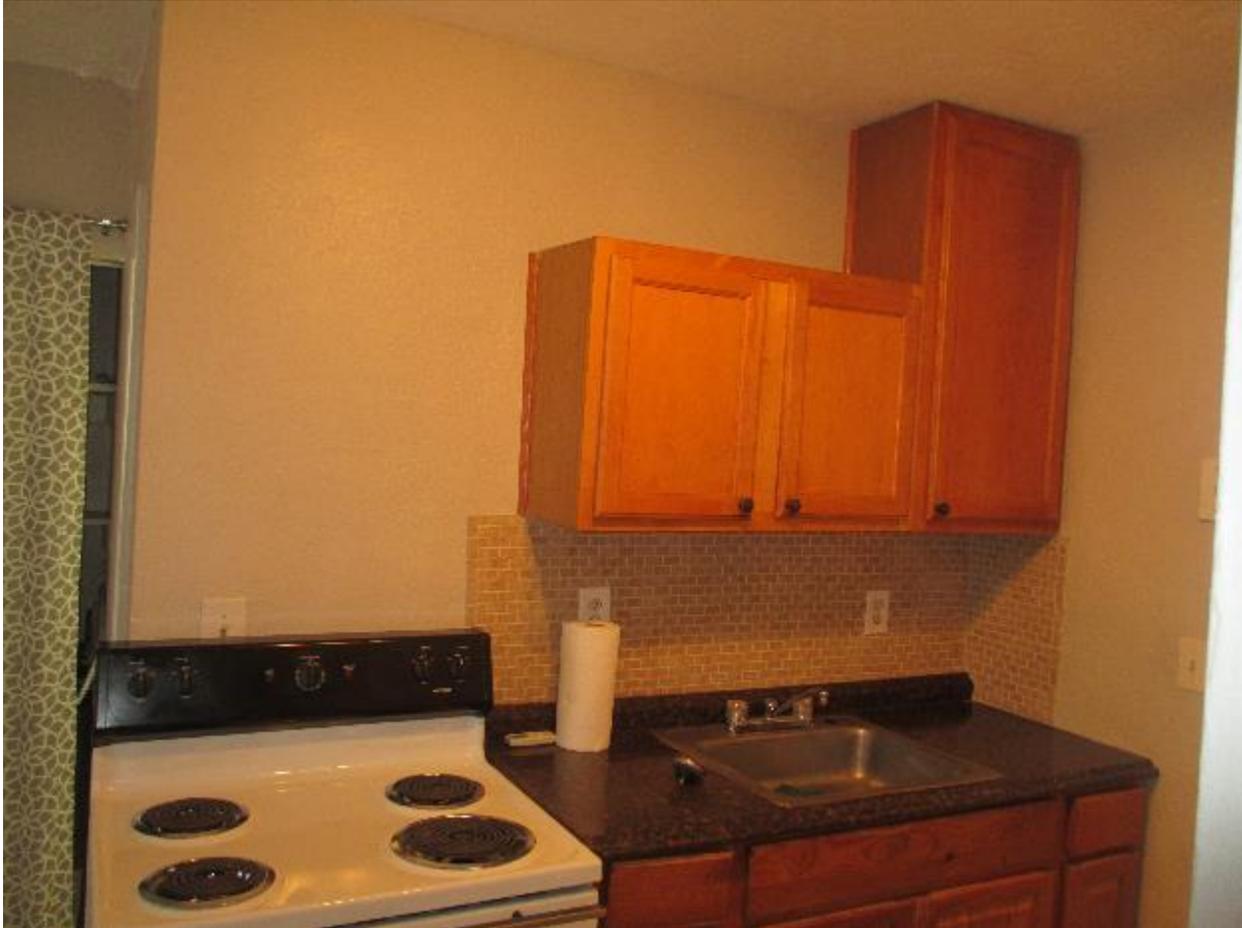
Interior finishes were found in general good condition at the time of inspection with exceptions as noted and shown in photographs.

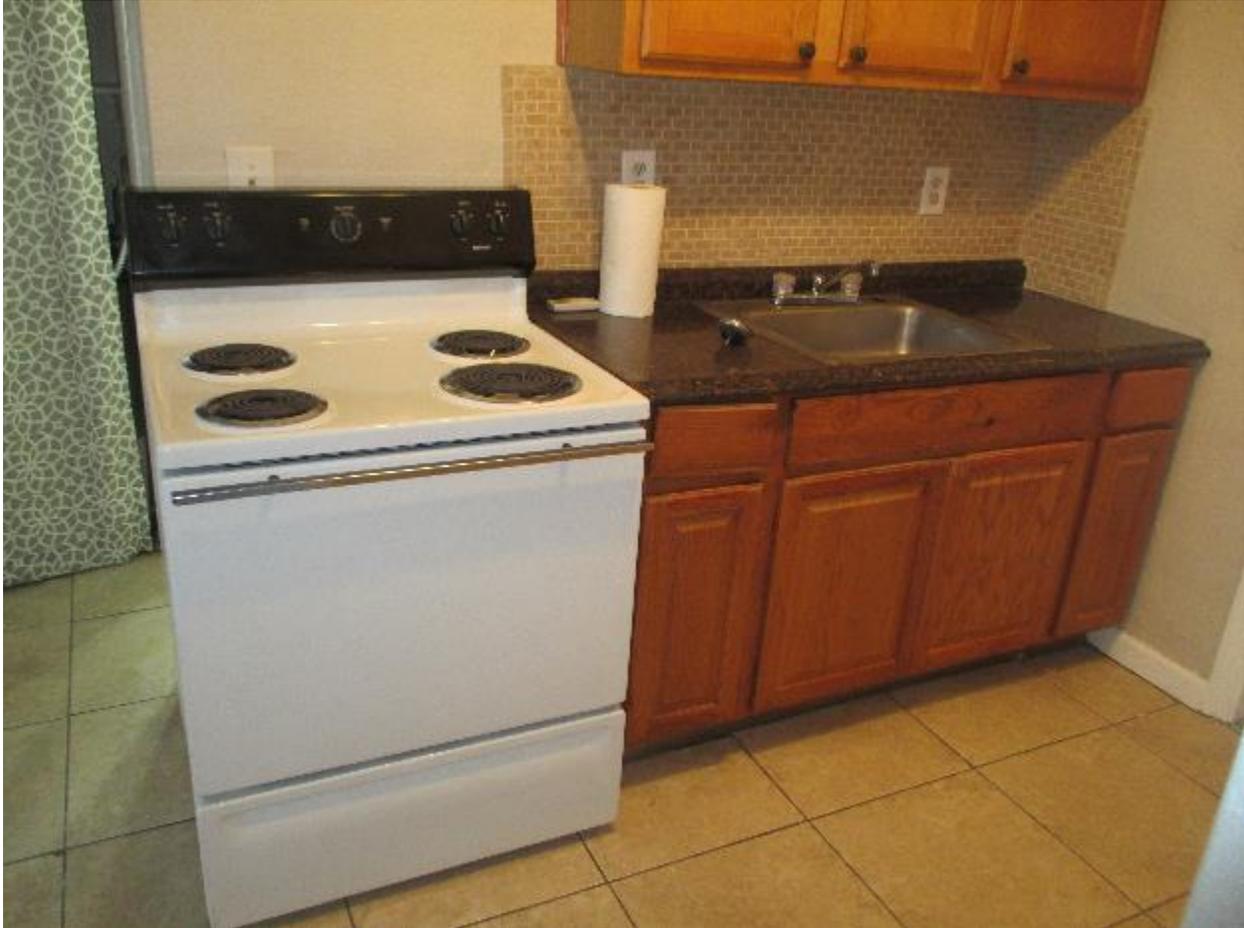
Interior finishes were found in general good condition at the time of inspection with exceptions as noted and shown in photographs.

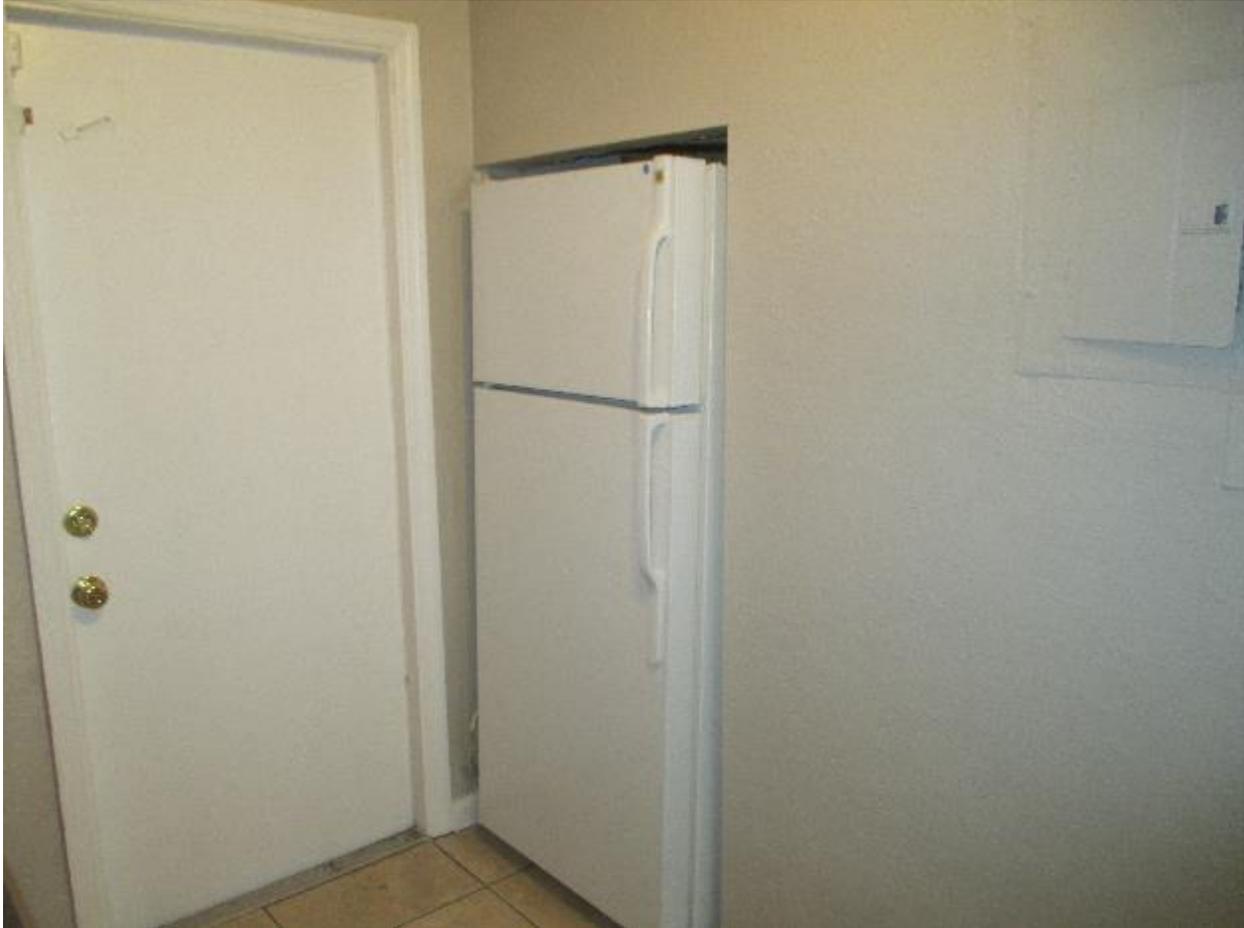
Interior finishes were found in general good condition at the time of inspection with exceptions as noted and shown in photographs.

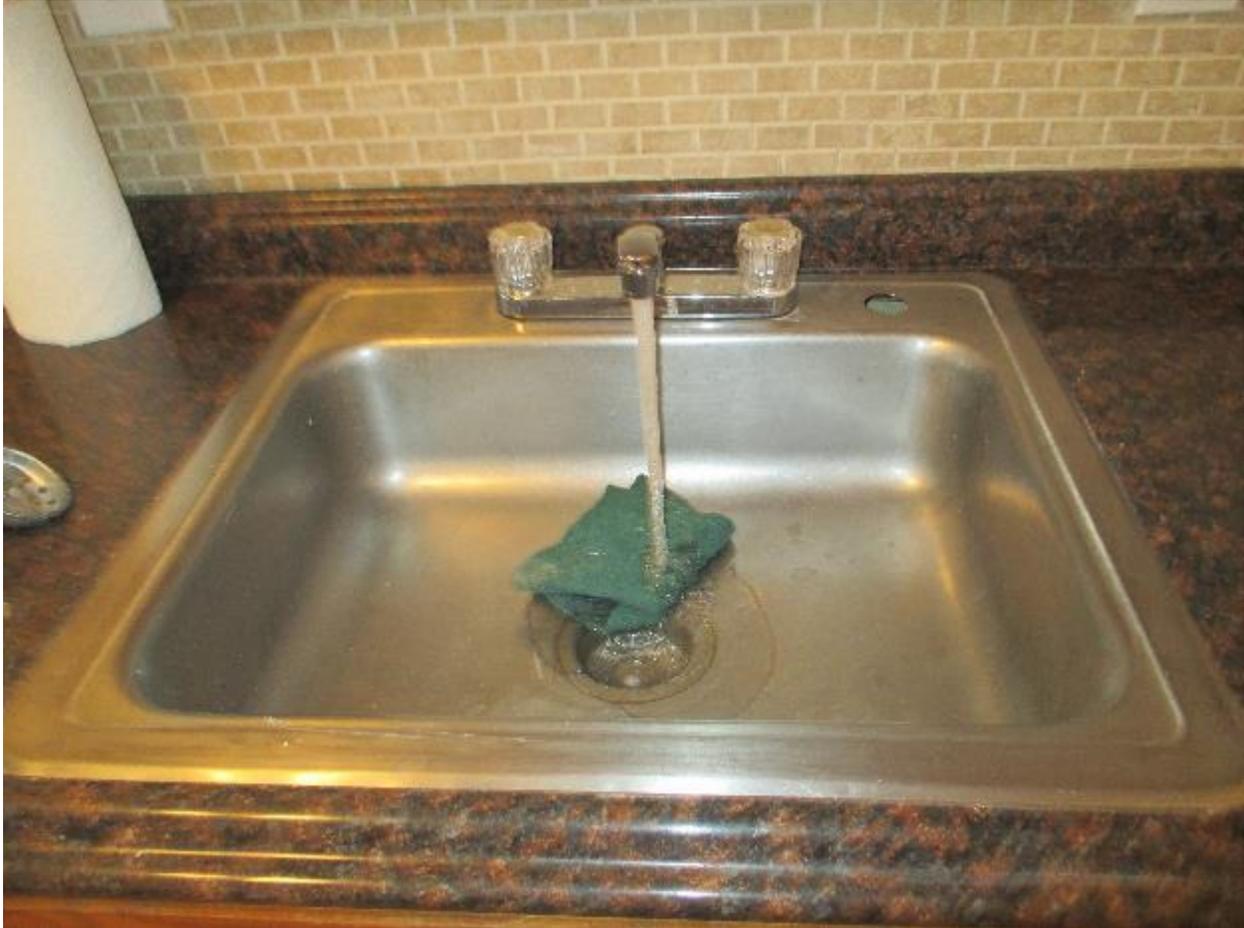
Plumbing systems tested for proper flow. No leaks or deficiencies noted on drain and supply lines.

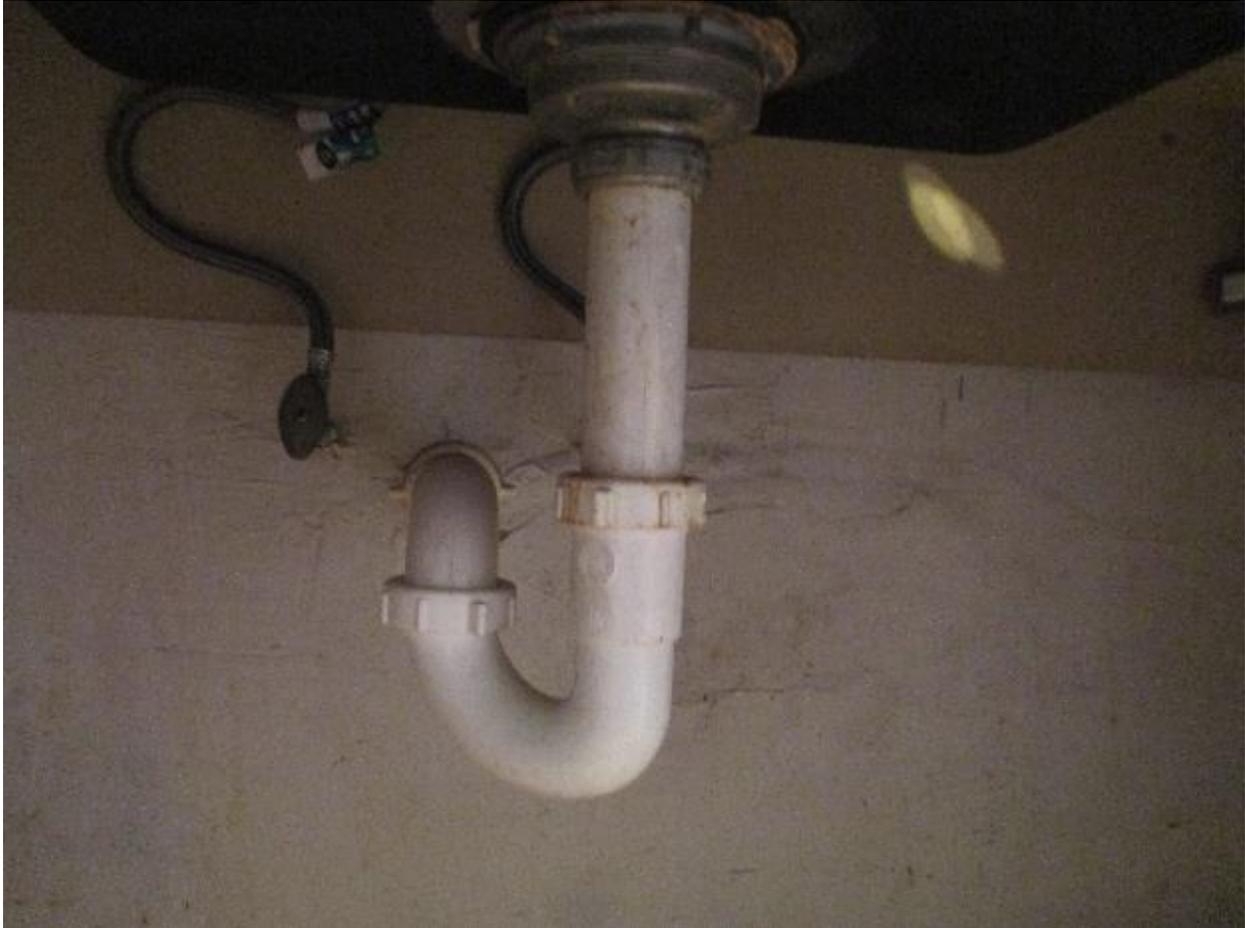
Plumbing systems tested for proper flow. No leaks or deficiencies noted on drain and supply lines.

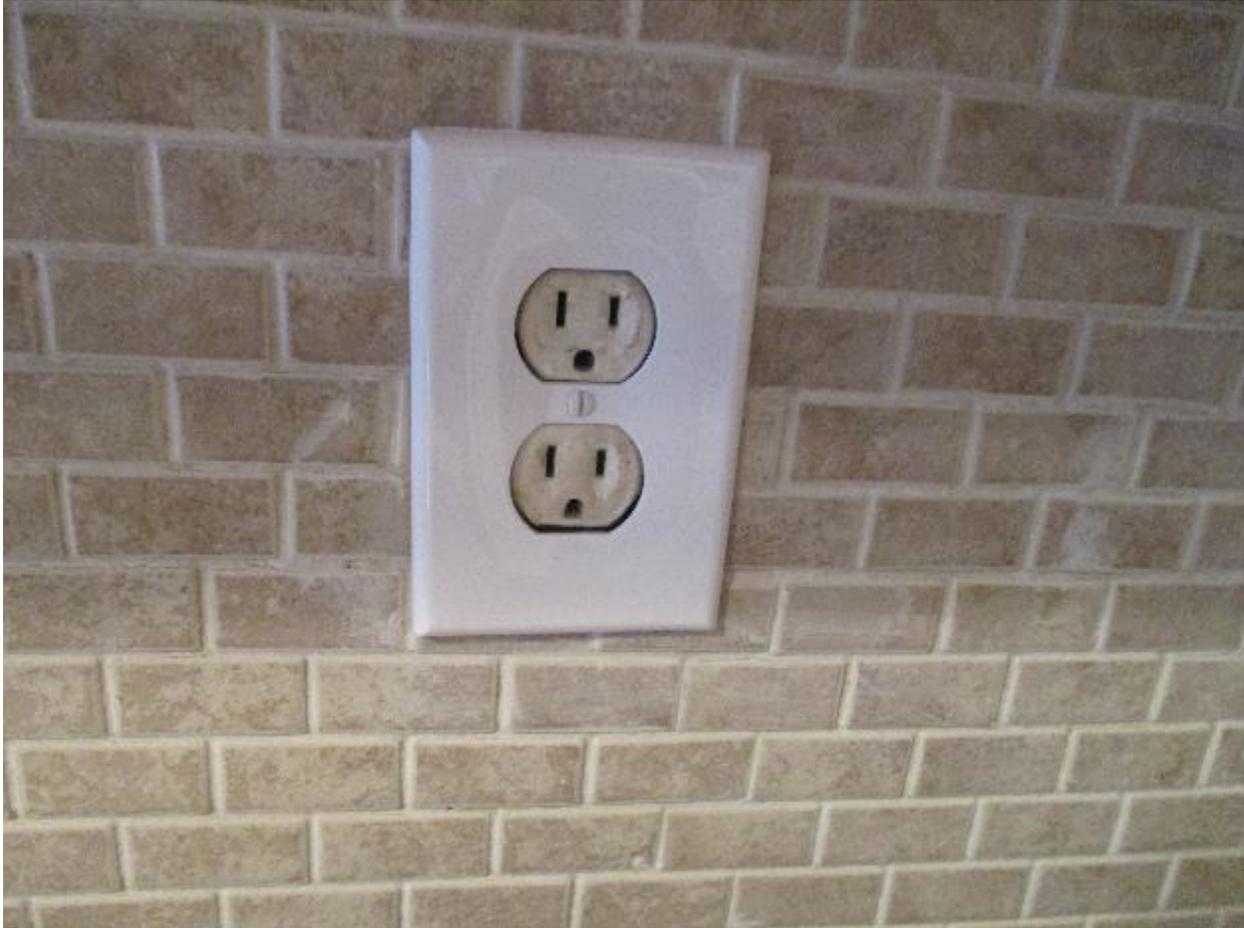
GFCI receptacles installation is required at wet areas such as bathrooms and kitchens.

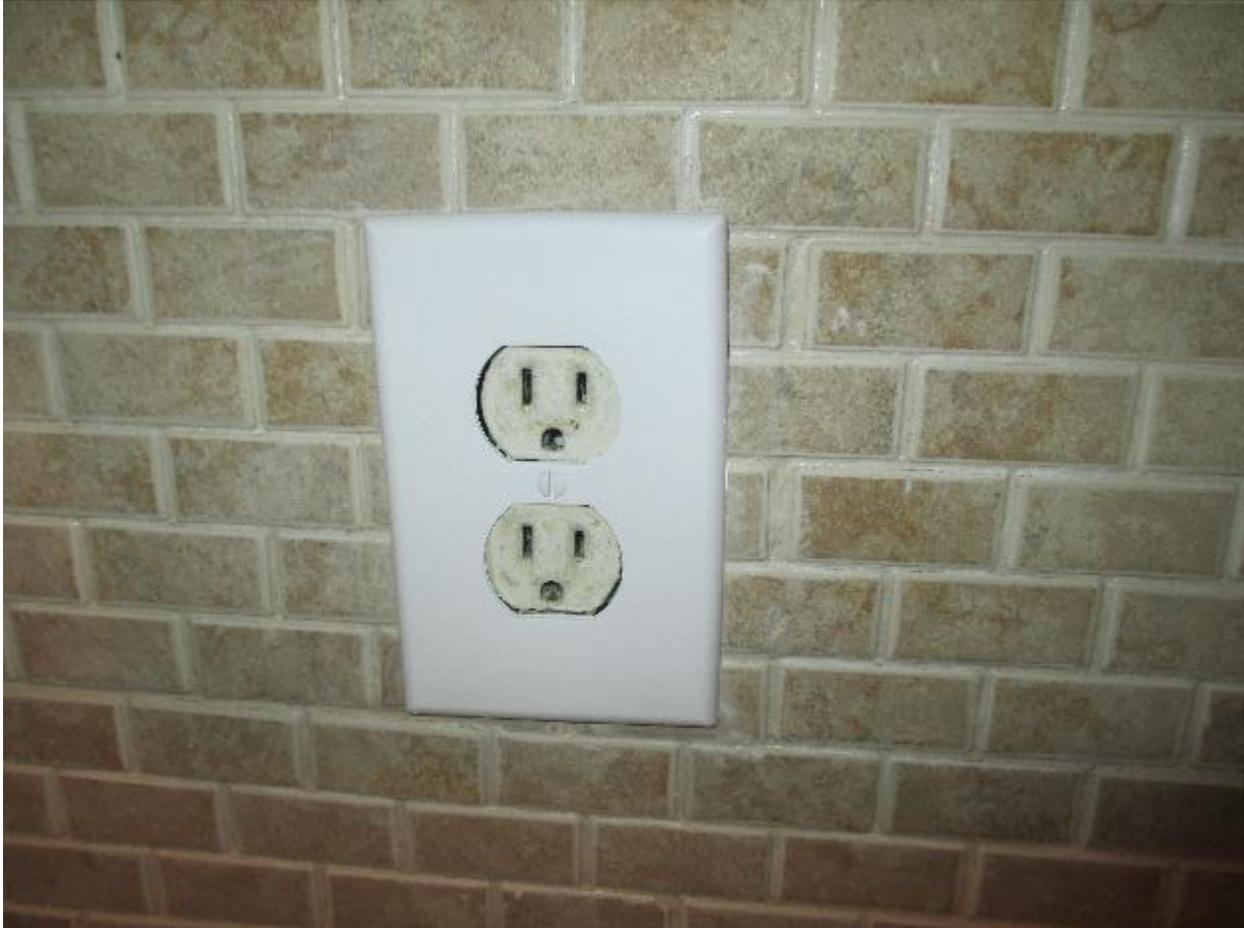
GFCI receptacles installation is required at wet areas such as bathrooms and kitchens.

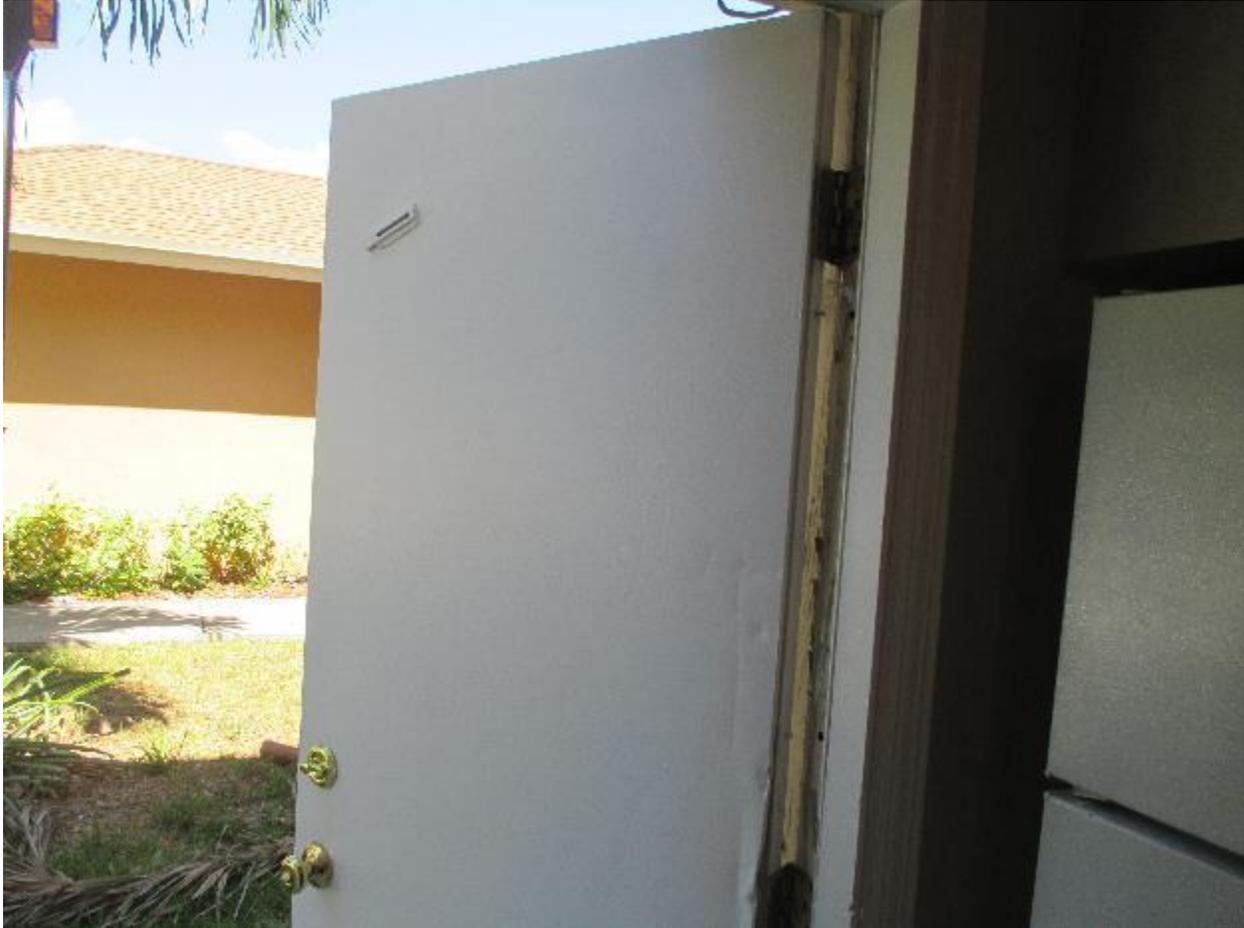
Exterior door(s) require replacement. Currently beyond possibilities of repair.
