PROPERTY INSPECTION OR ASSESSMENT OF DAMAGES

ADDRESS: **SOMEWHERE , FL**
CLIENT: **GAIA GC**
ID No: **2015000**
DATE: **12/31/xxxx**

GAIA CONSTRUCTION INC.
CGC 1516136 FLORIDA
HI-2792 FLORIDA
8028867-B2 INTERNATIONAL CODE COUNCIL

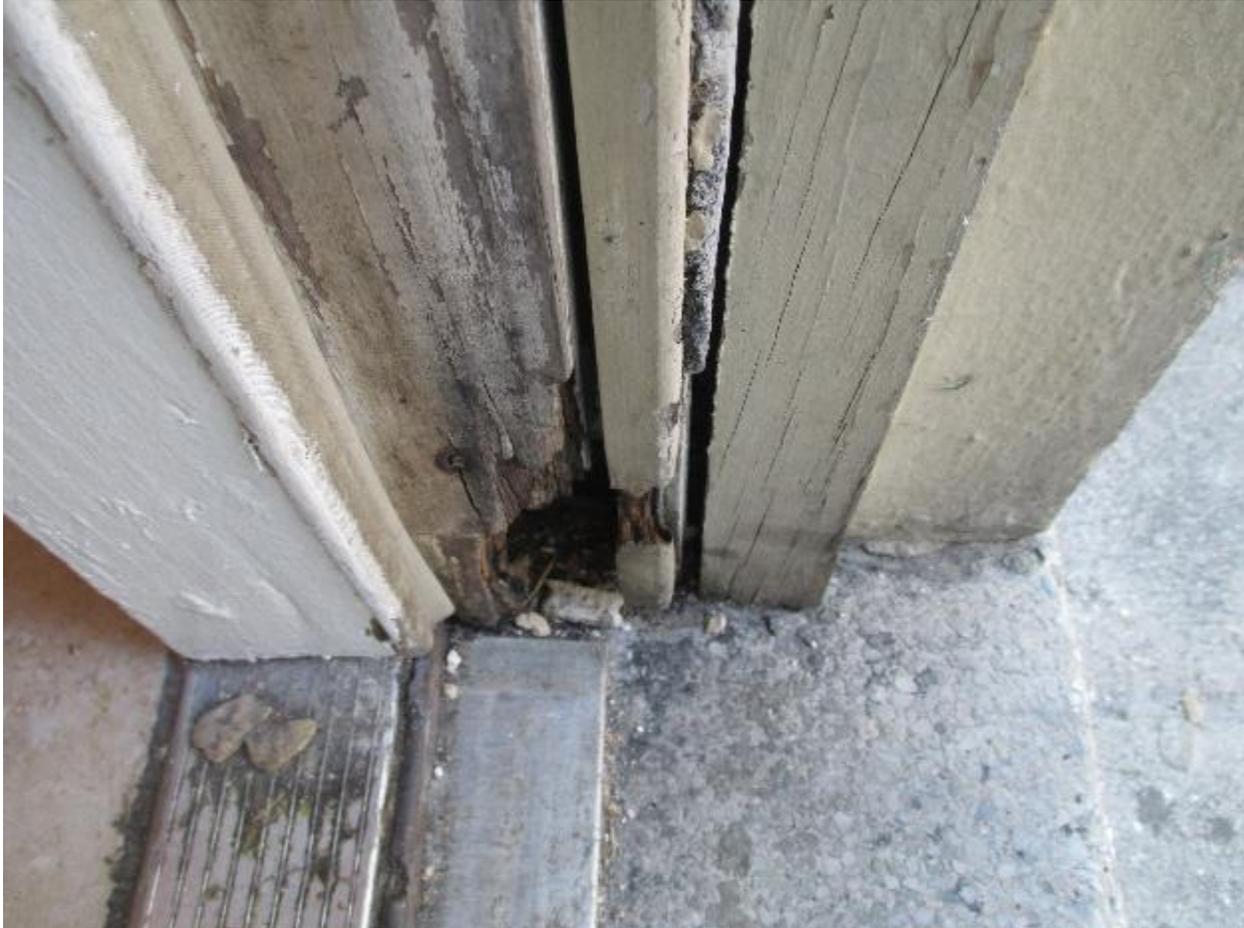
Exterior door(s) require replacement. Currently beyond possibilities of repair.

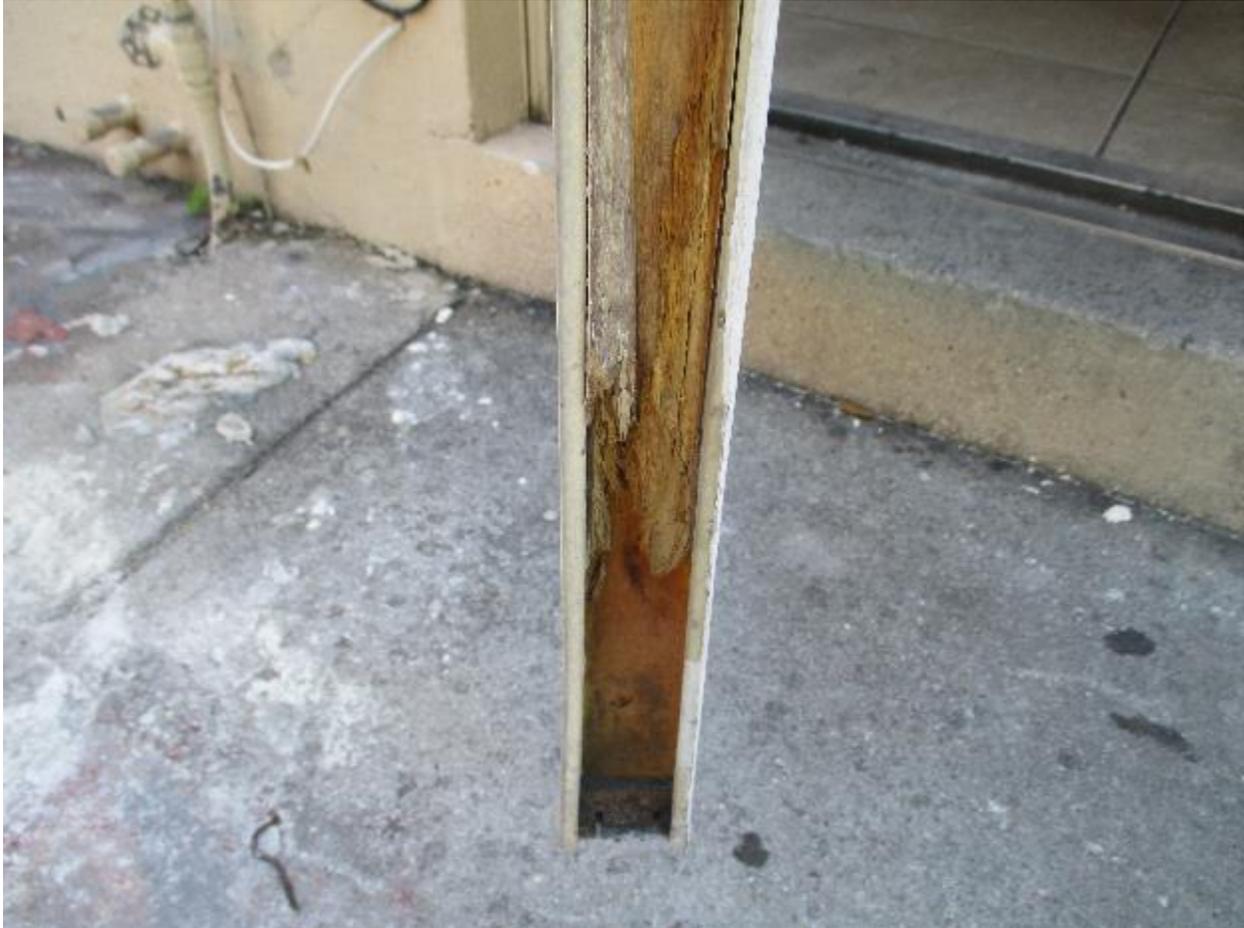
Exterior door(s) require replacement. Currently beyond possibilities of repair.

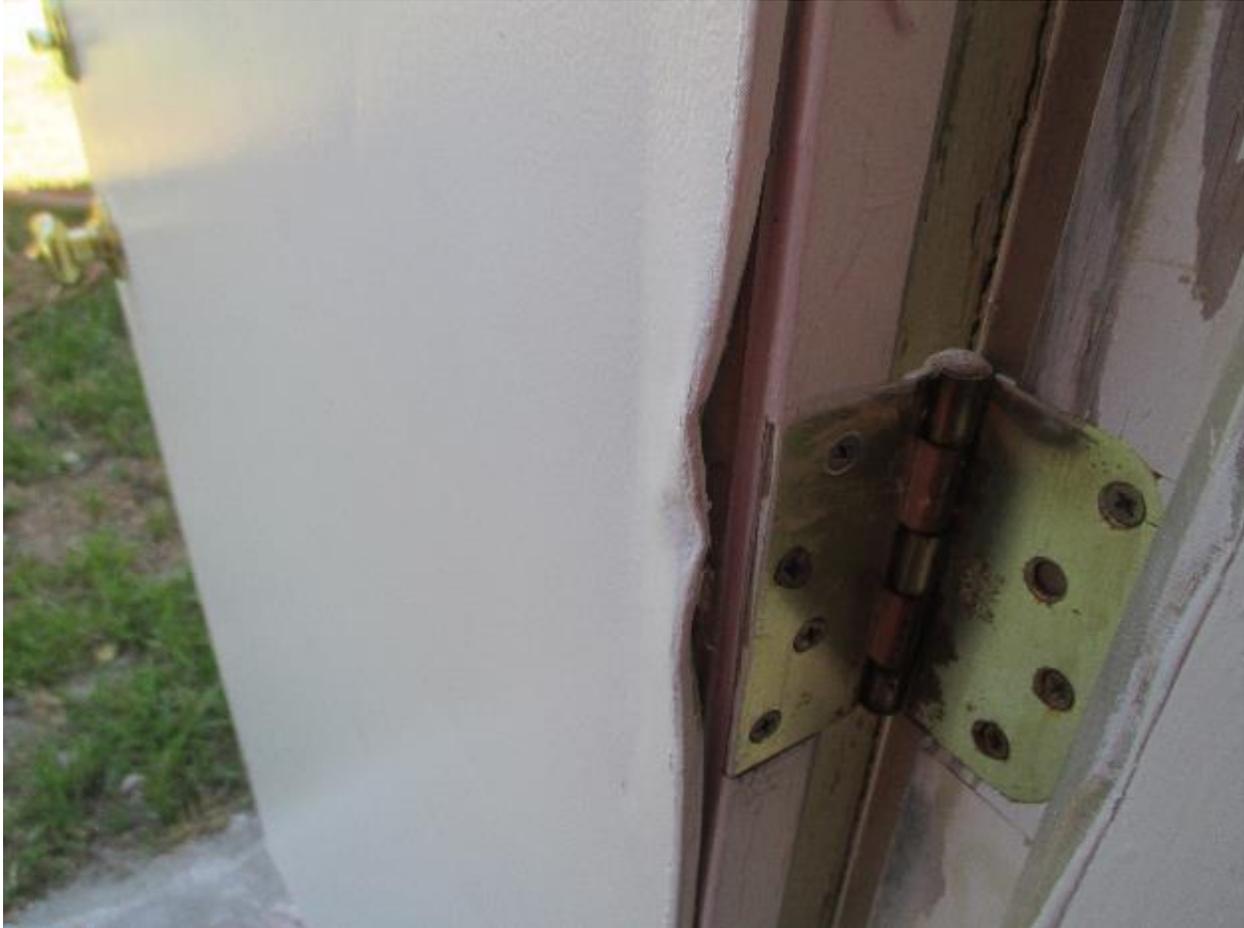
Exterior door(s) require replacement. Currently beyond possibilities of repair.

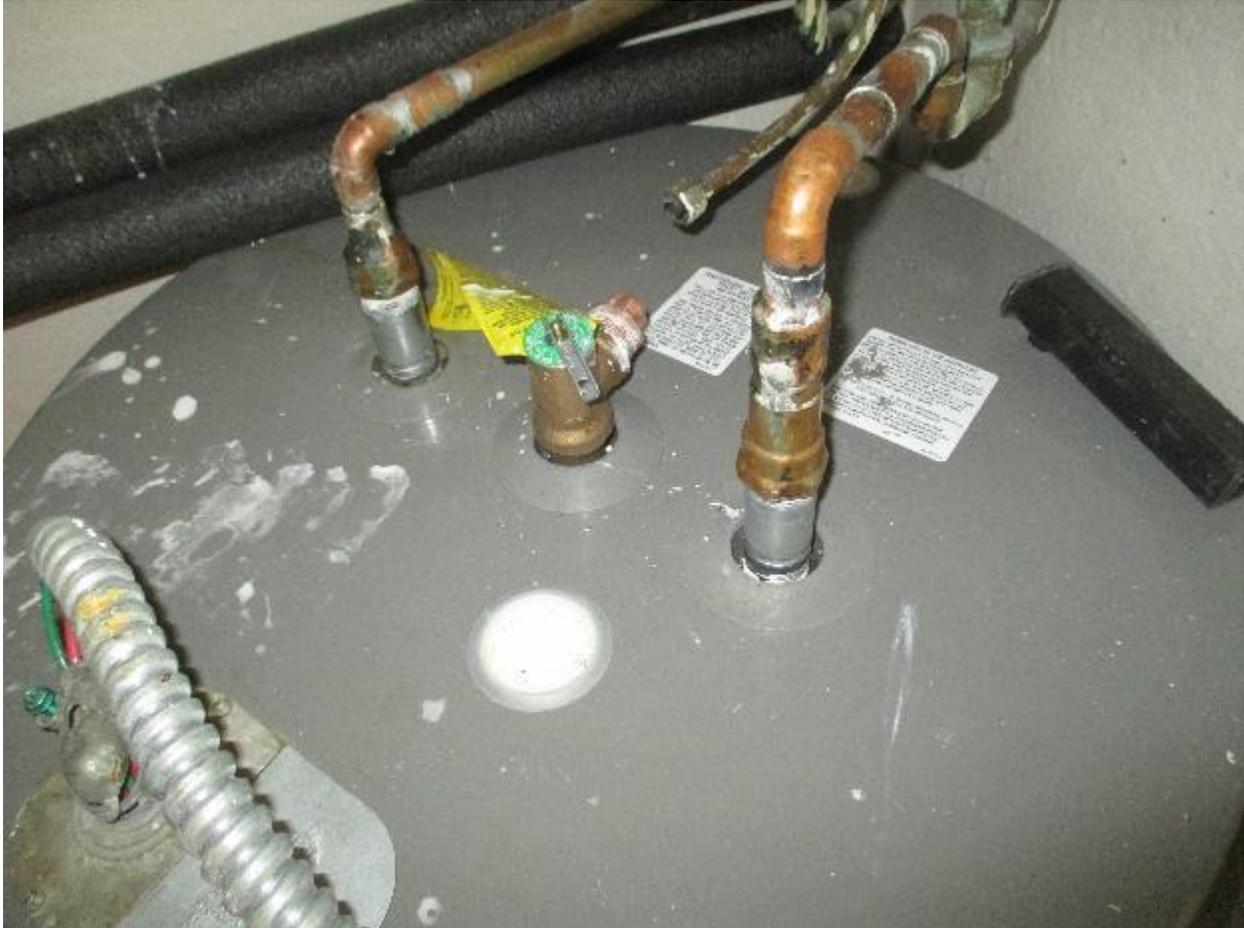
Water heater pressure release valve without release valve / not properly installed.

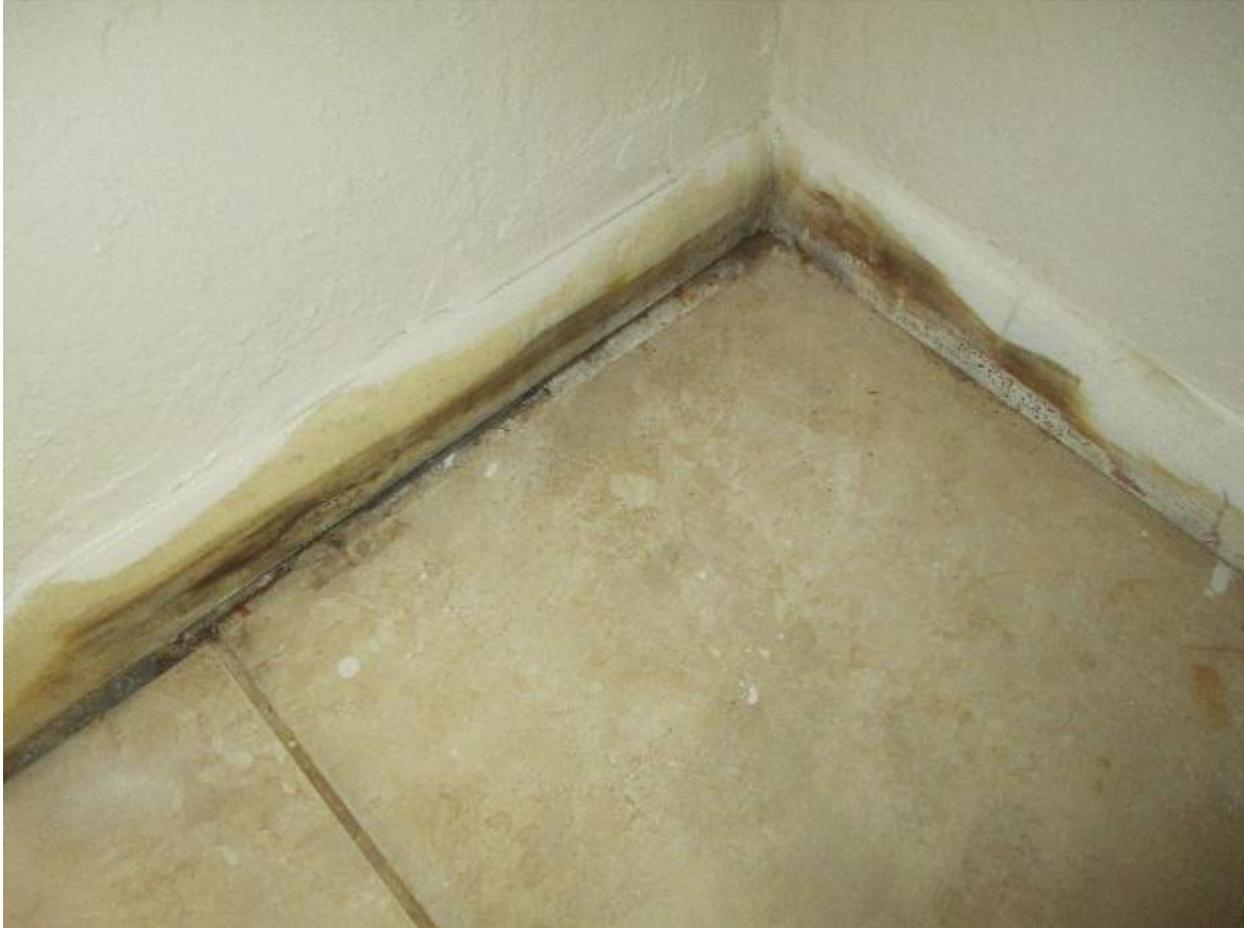
Mold growth caused by water damage is visible. Do not attempt to remove damaged surfaces related to Mold growth or with signs of mold growth on your own. Hire only licensed and Insured Mold remediation services.

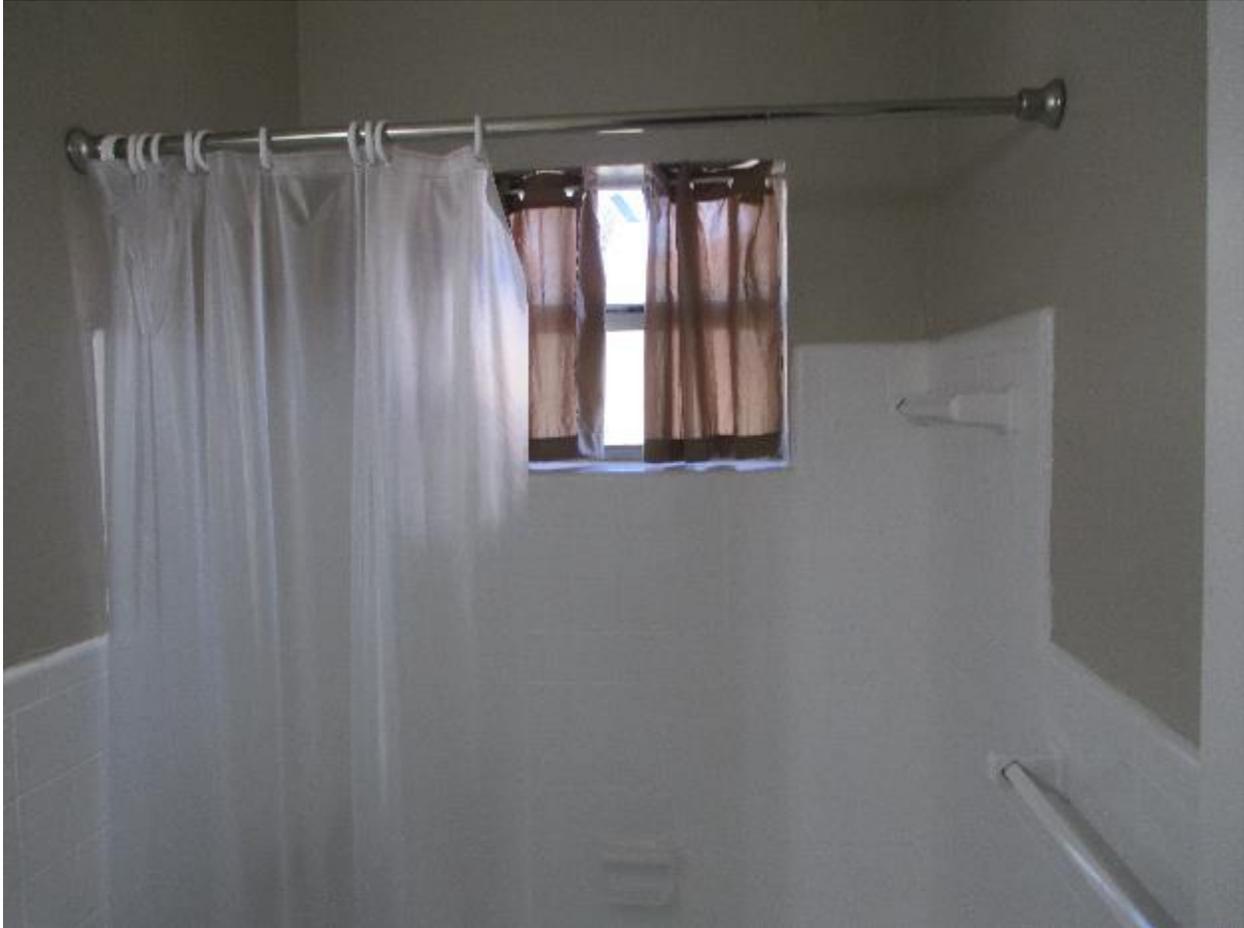
Interior finishes were found in general good condition at the time of inspection with exceptions as noted and shown in photographs.

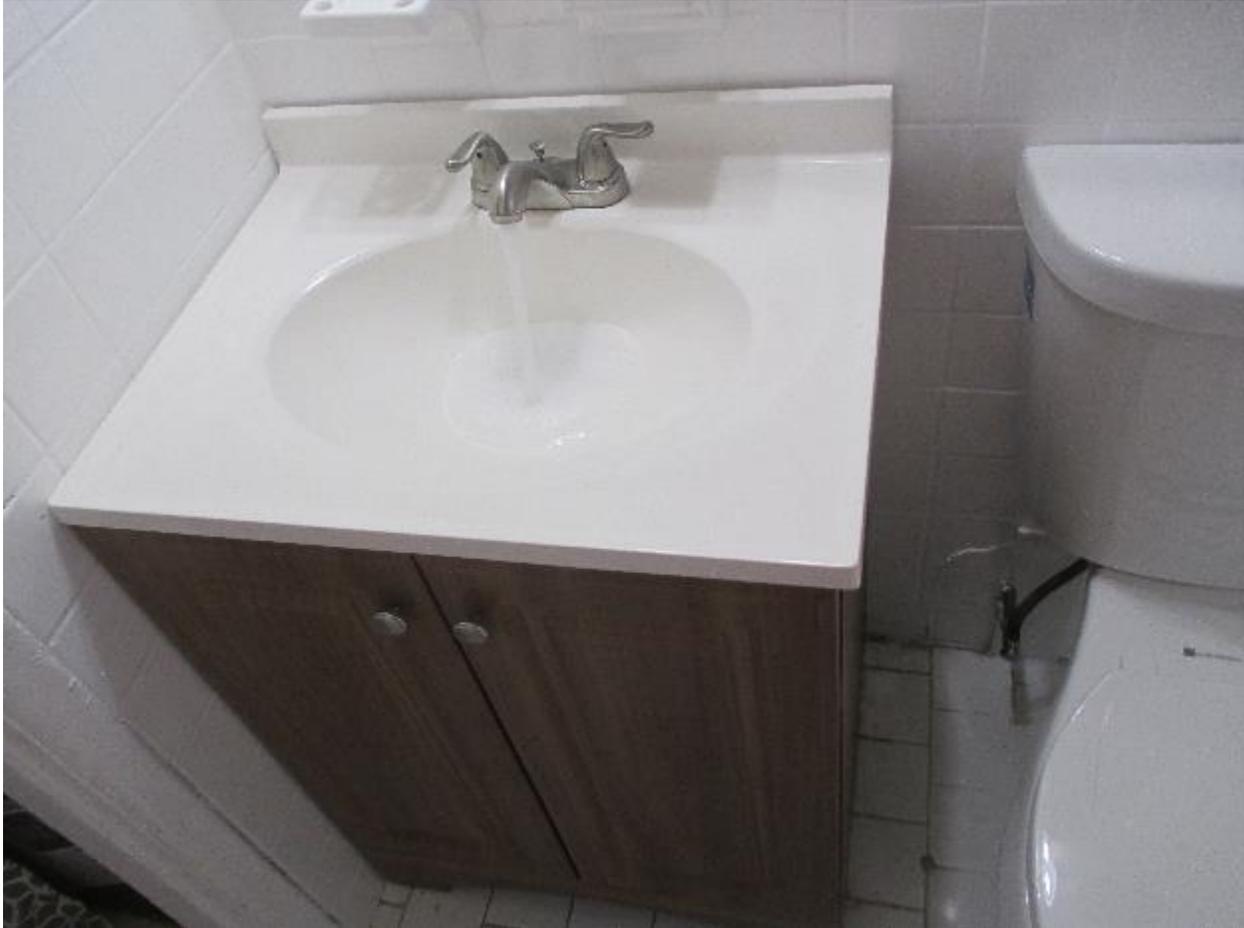
Plumbing systems tested for proper flow. No leaks or deficiencies noted on drain and supply lines

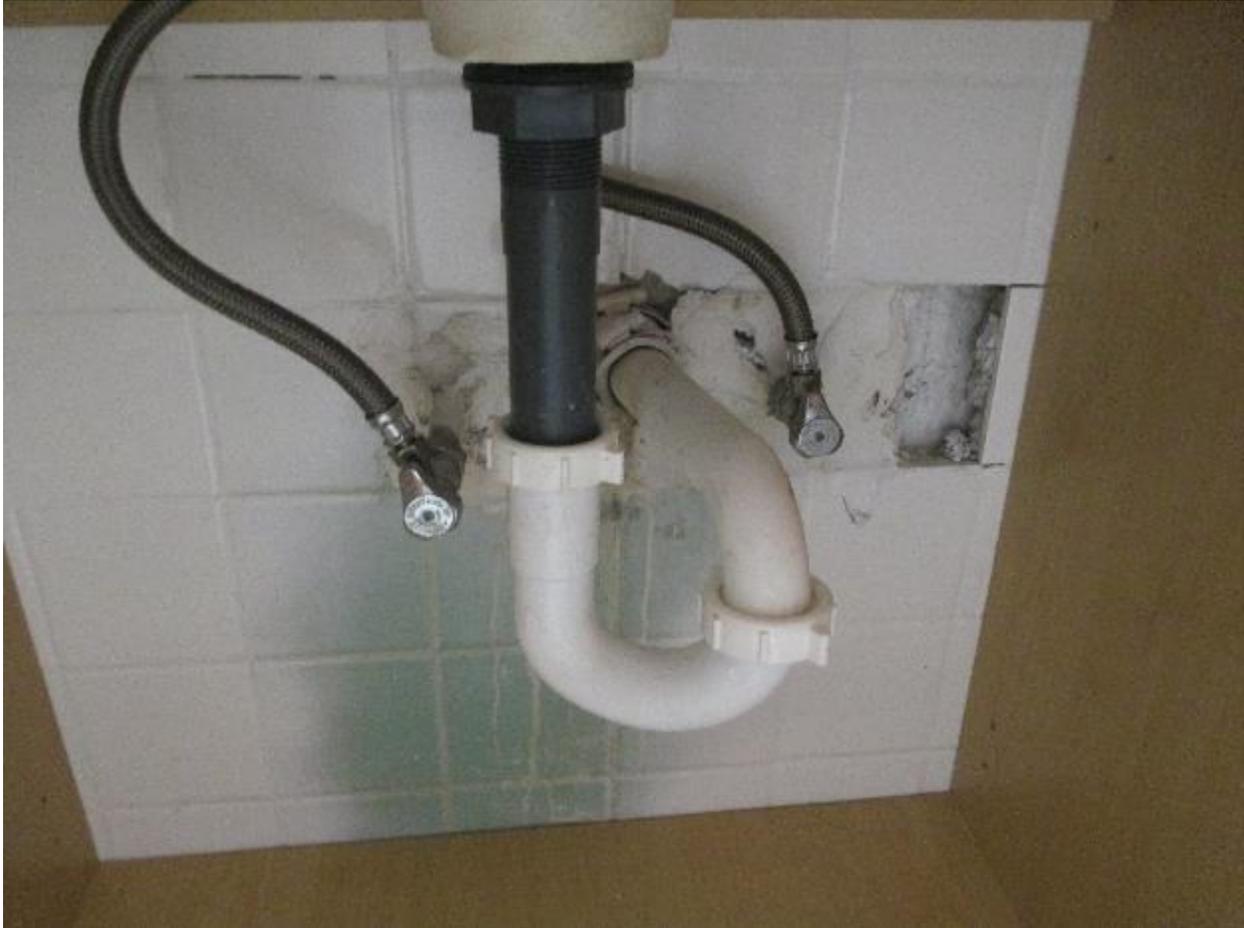
Plumbing systems tested for proper flow. No leaks or deficiencies noted on drain and supply lines

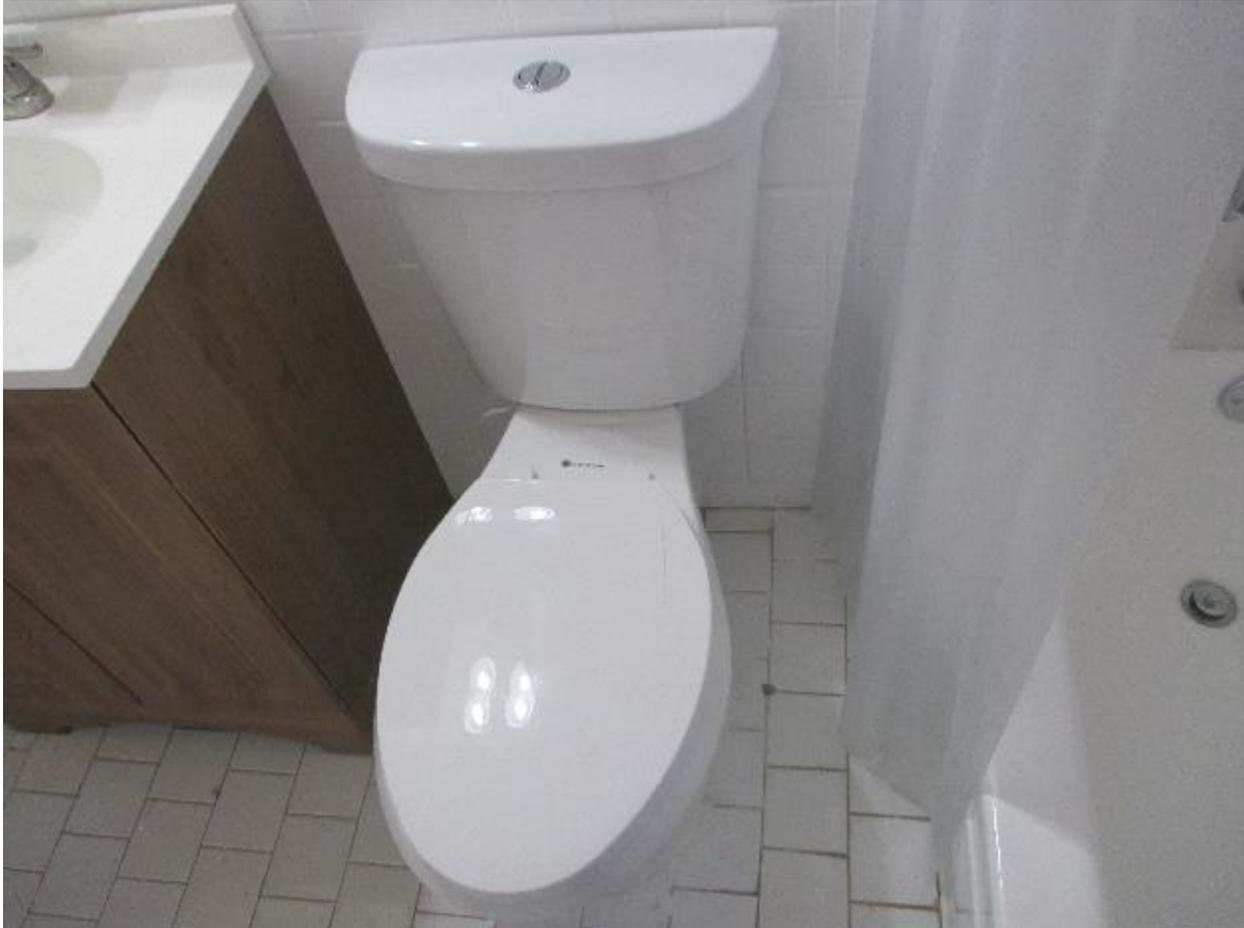
Interior finishes were found in general good condition at the time of inspection with exceptions as noted and shown in photographs.

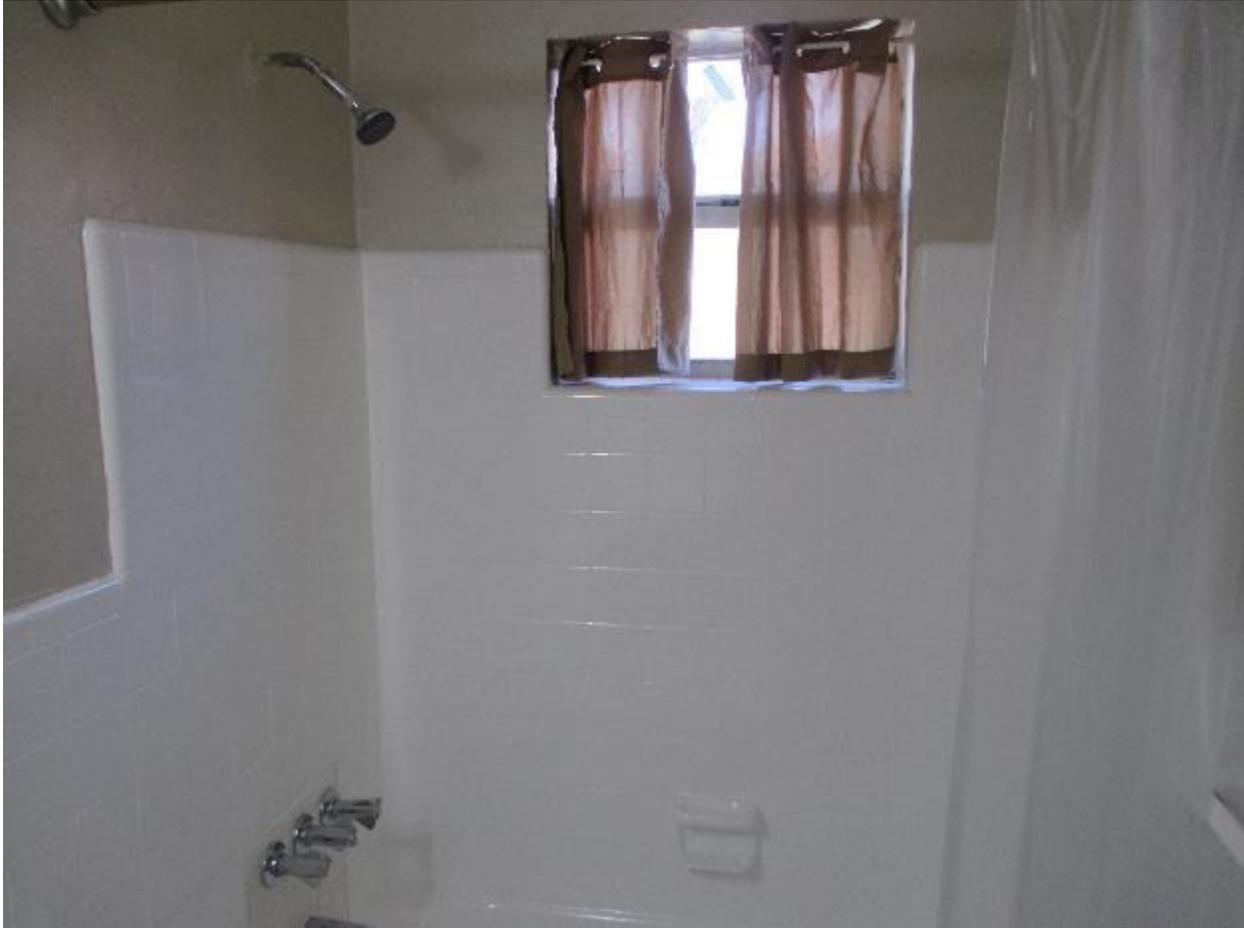
Interior finishes were found in general good condition at the time of inspection with exceptions as noted and shown in photographs.

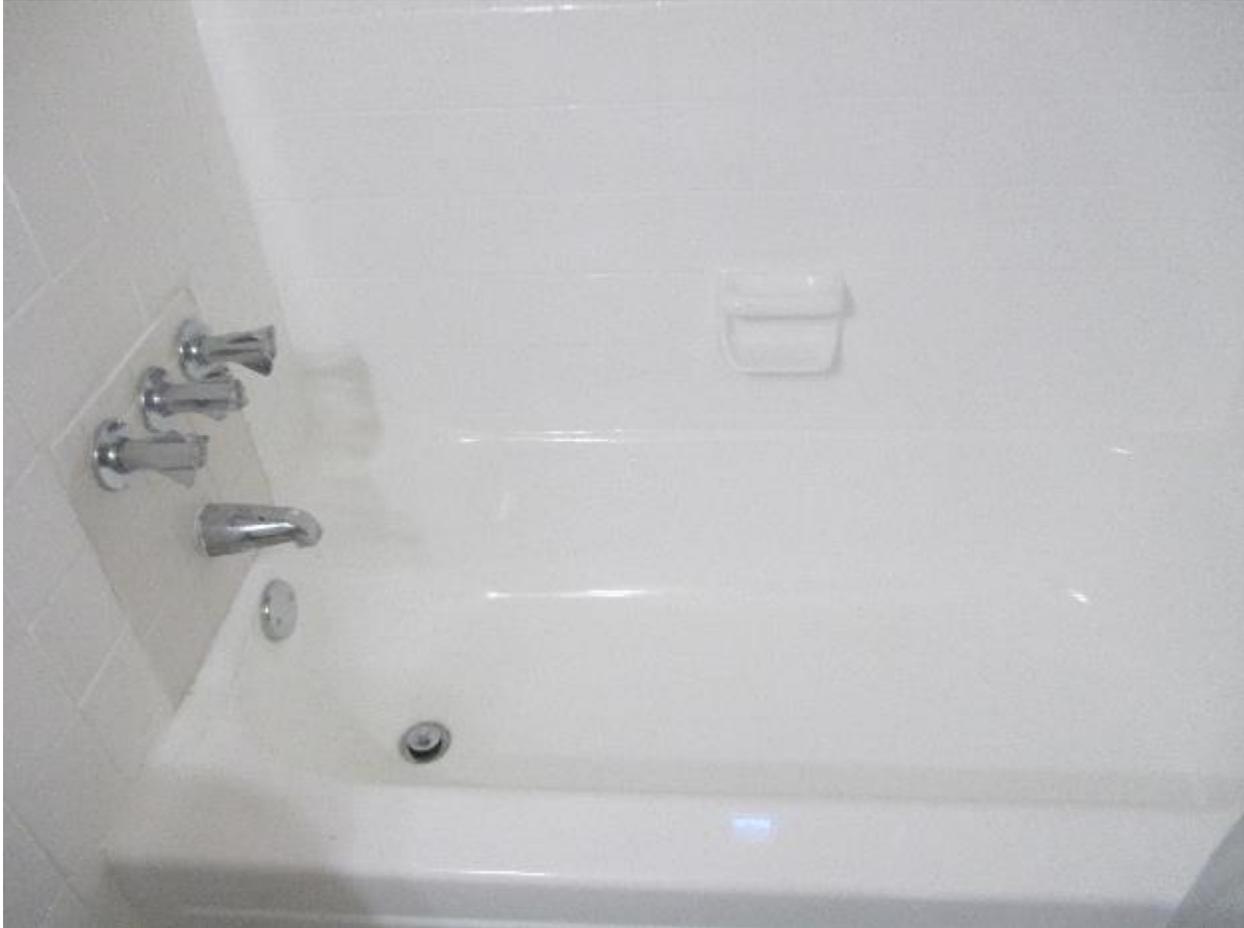
Interior finishes were found in general good condition at the time of inspection with exceptions as noted and shown in photographs.

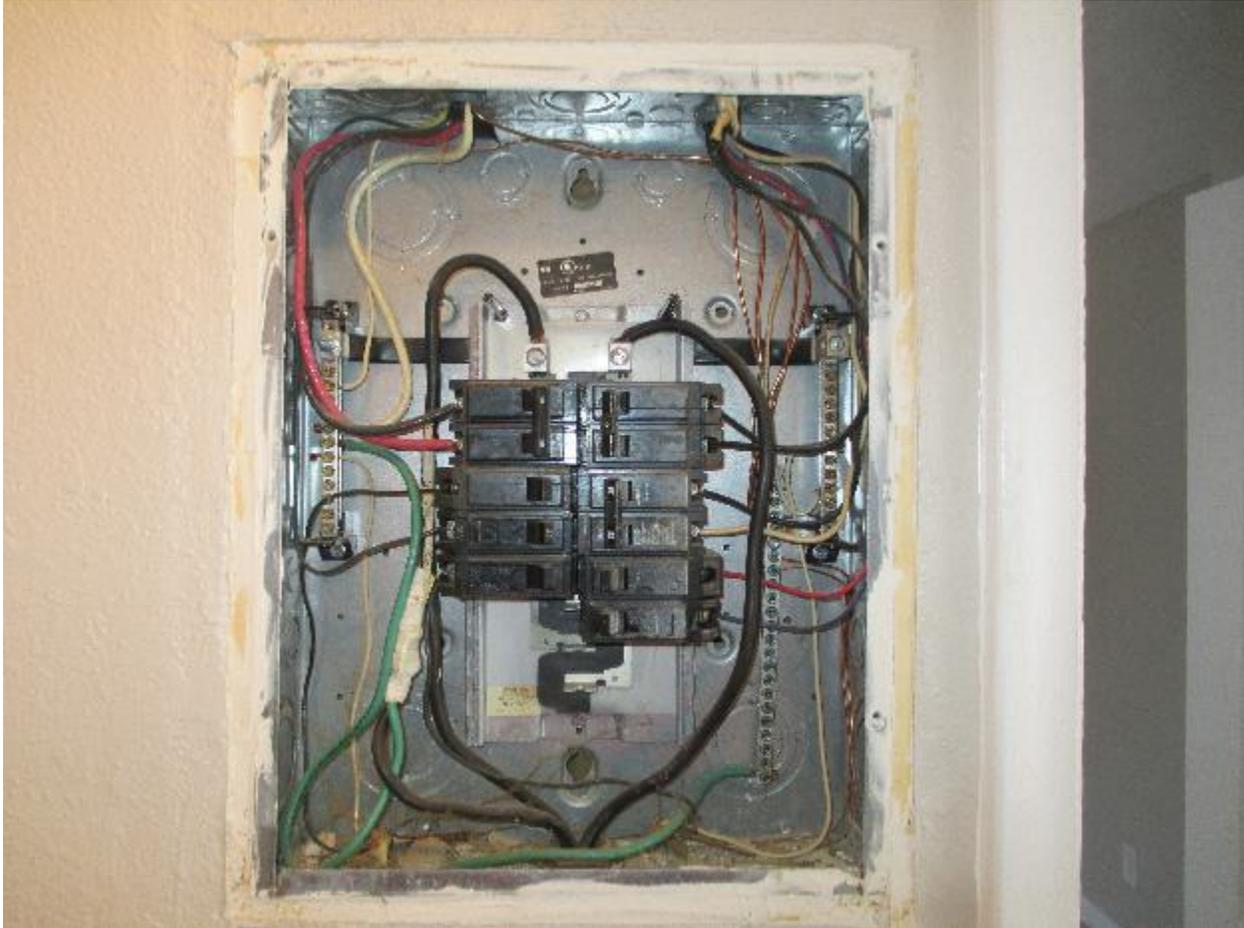
Electrical breaker panel in good condition at the time of inspection.

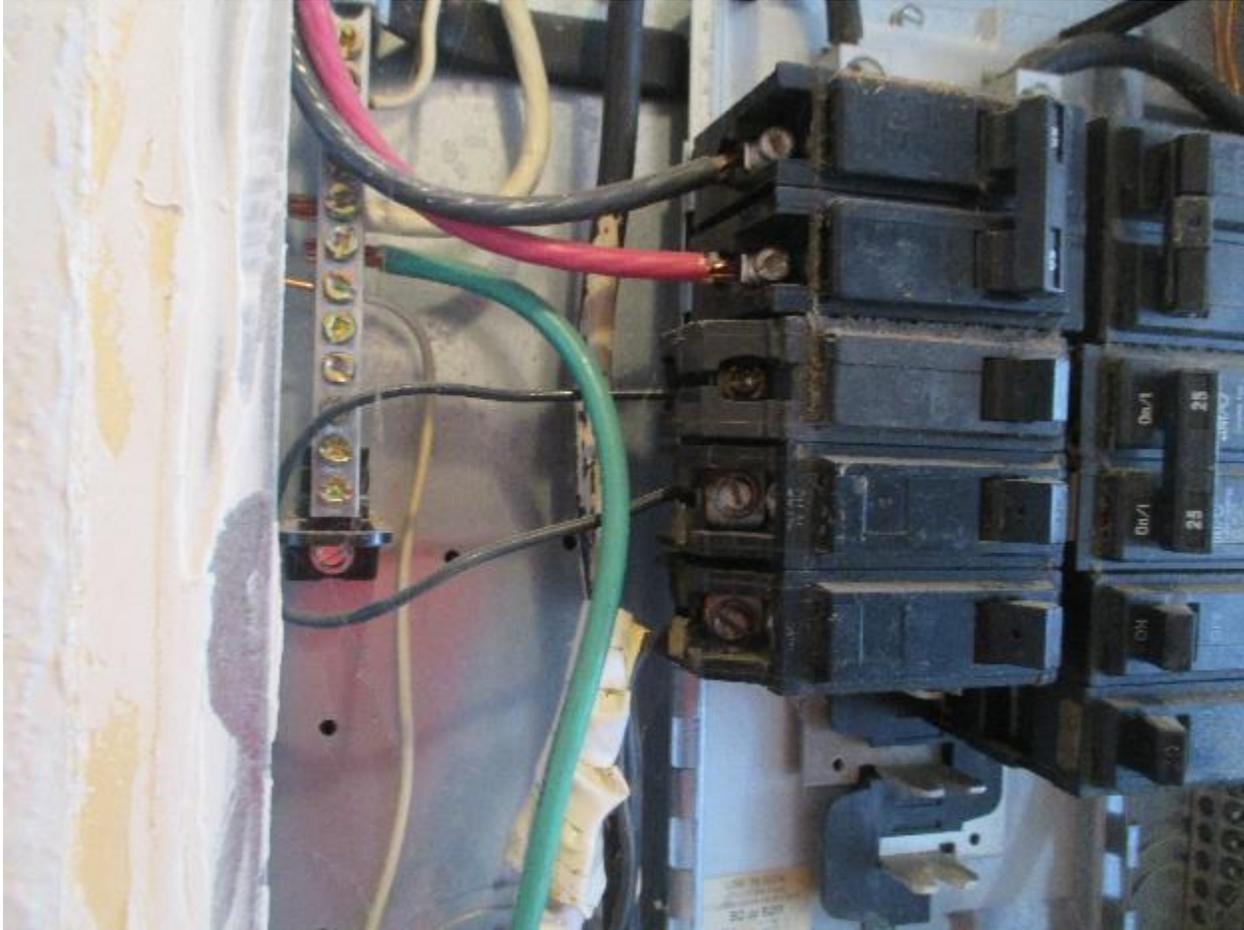
Electrical breaker panel in good condition at the time of inspection.

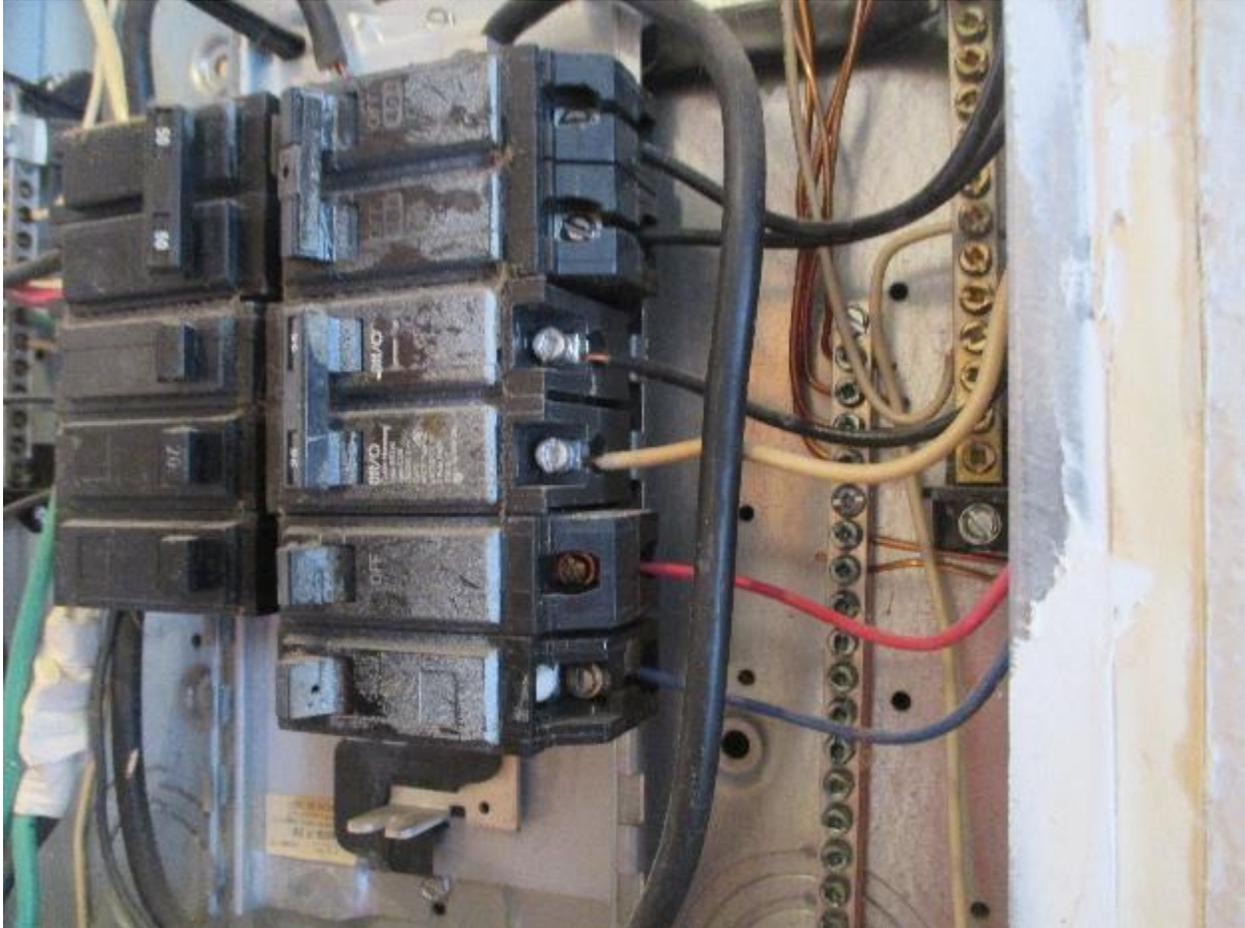
Electrical breaker panel in good condition at the time of inspection.

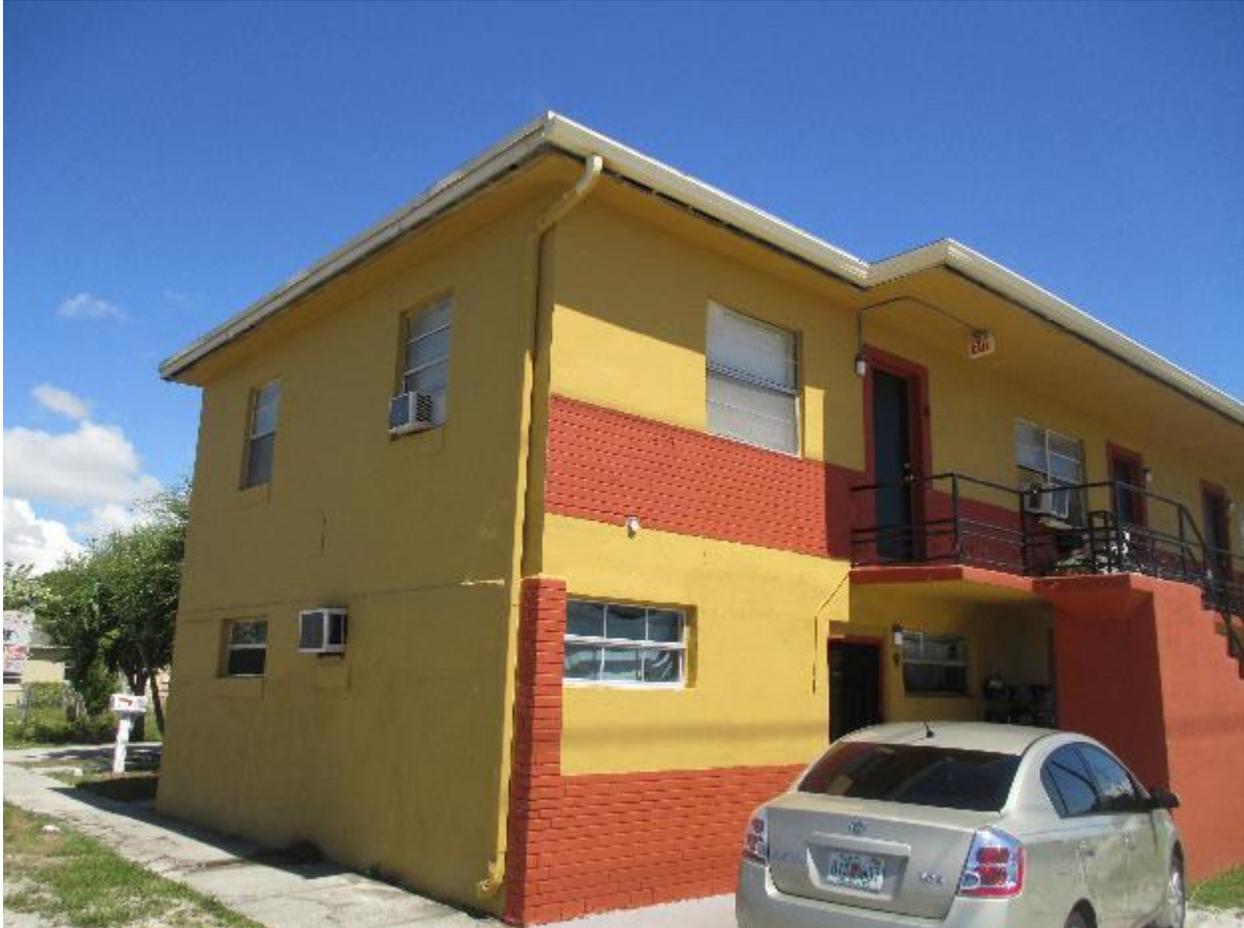
Exterior finishes were found in general good condition at the time of inspection with exceptions as noted and shown in photographs.

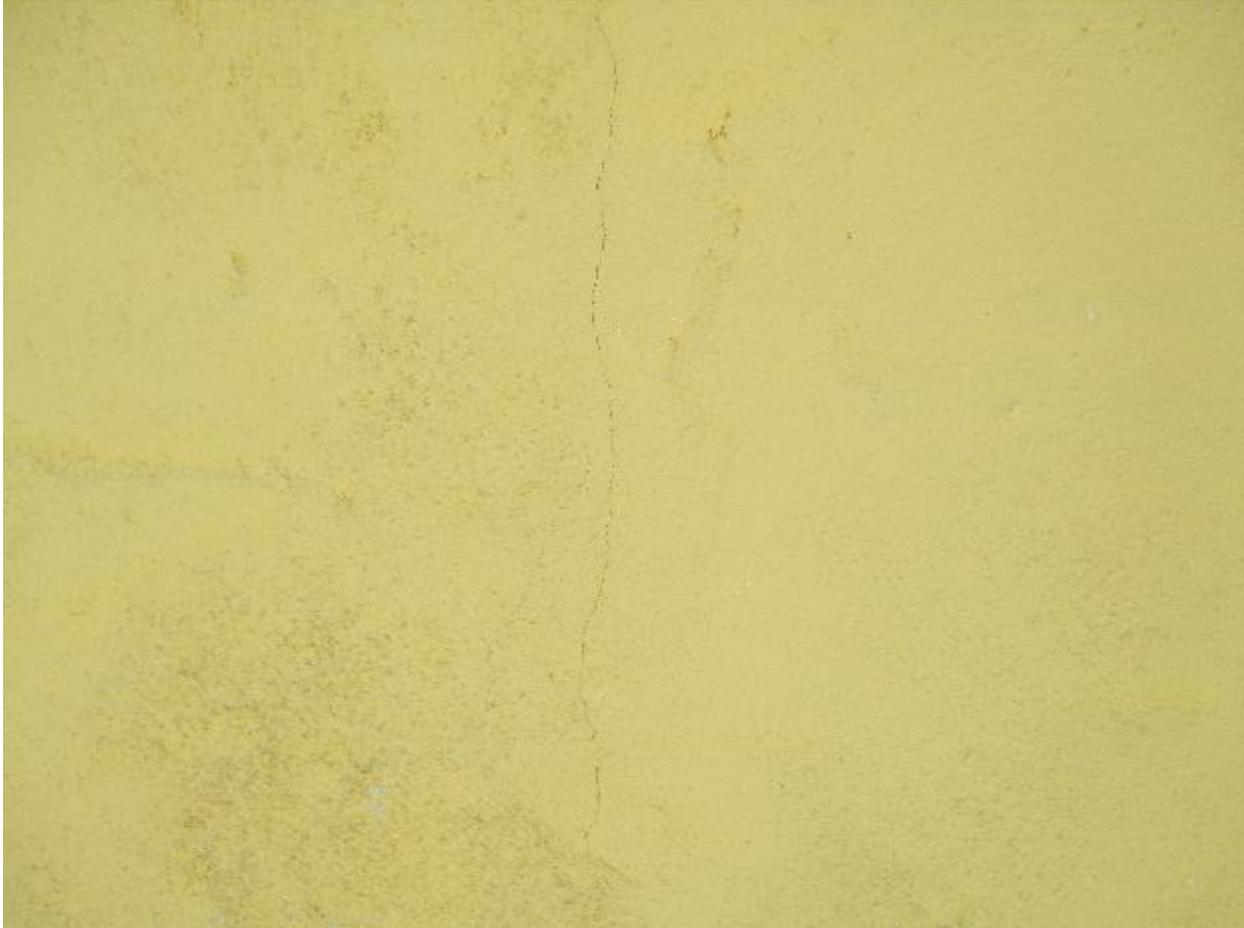
Cracks on vertical planes due to foundation settlement indicating downward and lateral movement. These types of cracks do compromise the ability of the building to function as designed and avoid water intrusion. Structural repair and proper waterproofing treatment are required to avoid further damage to the interior of the building and water infiltration.

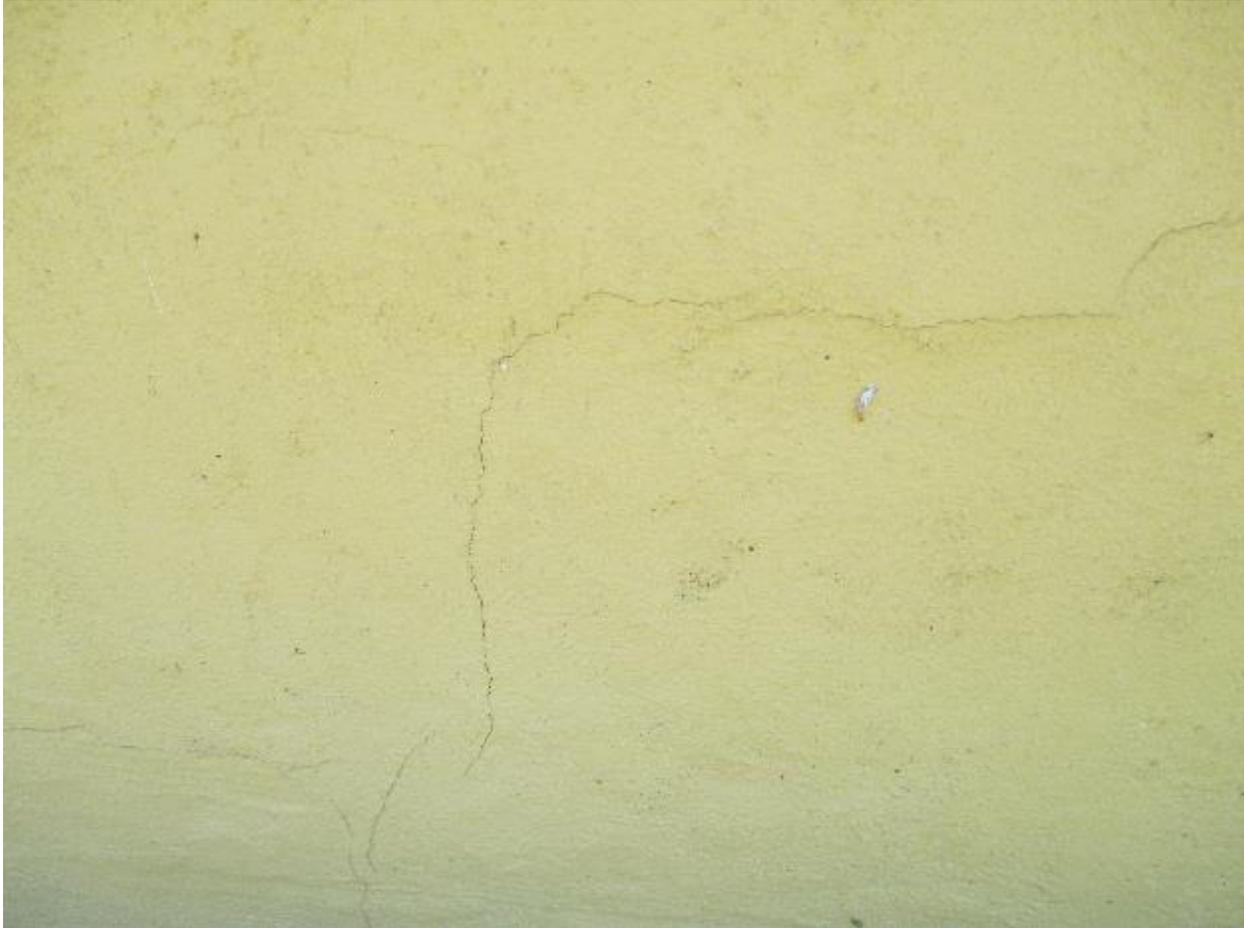
Cracks on vertical planes due to foundation settlement indicating downward and lateral movement. These types of cracks do compromise the ability of the building to function as designed and avoid water intrusion. Structural repair and proper waterproofing treatment are required to avoid further damage to the interior of the building and water infiltration.

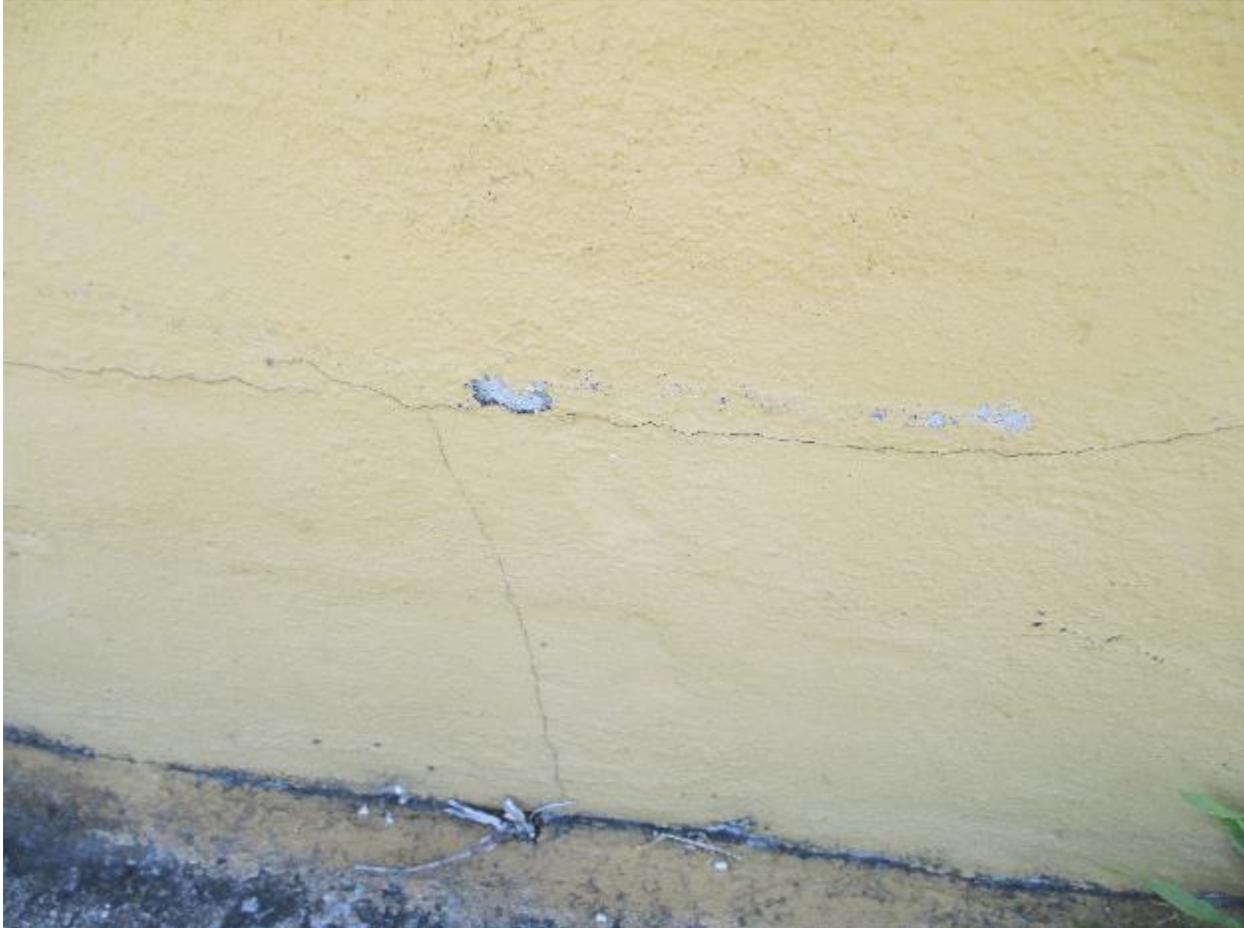
Cracks on vertical planes due to foundation settlement indicating downward and lateral movement. These types of cracks do compromise the ability of the building to function as designed and avoid water intrusion. Structural repair and proper waterproofing treatment are required to avoid further damage to the interior of the building and water infiltration.

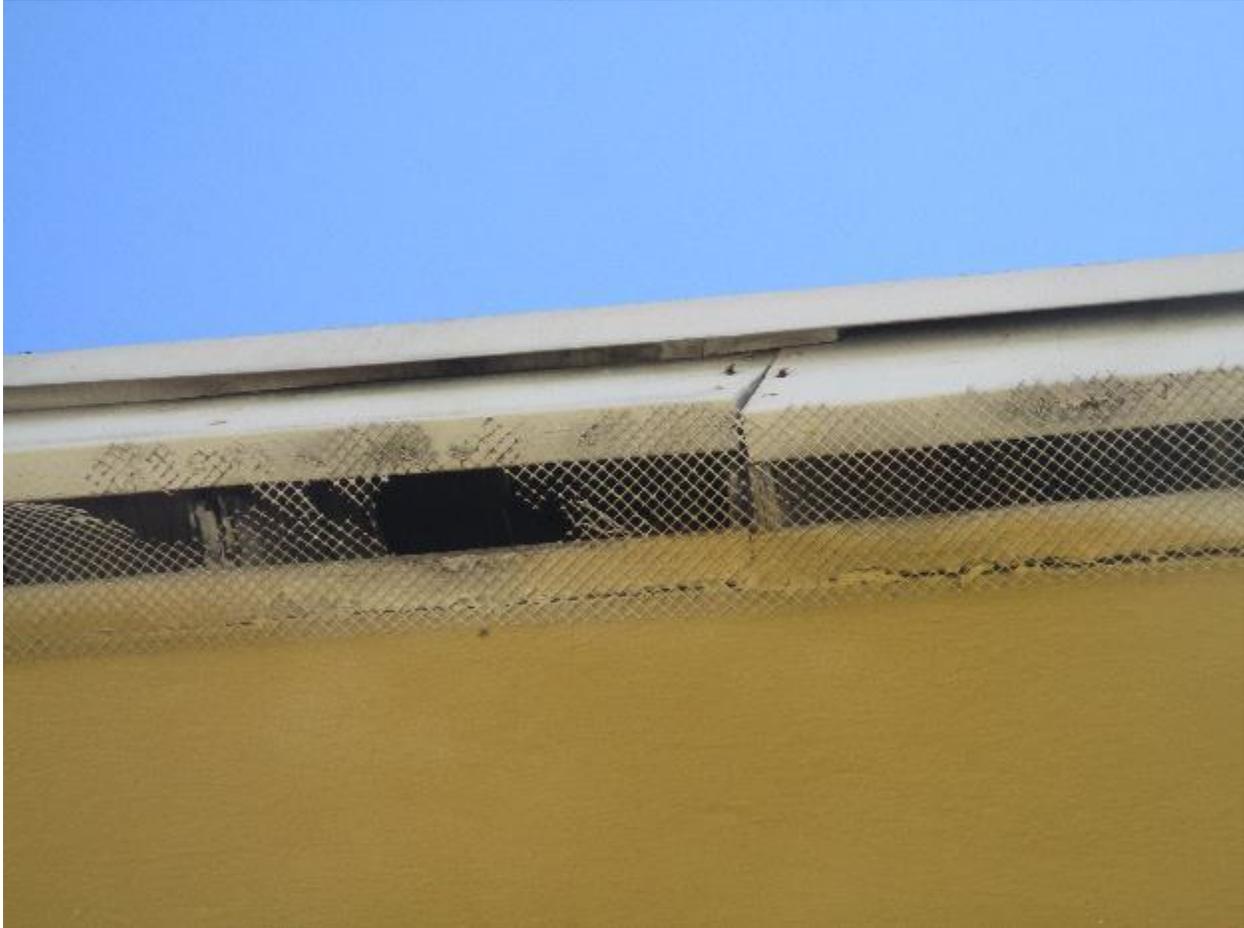
Exterior soffit screen repair required.
