PROPERTY INSPECTION OR ASSESSMENT OF DAMAGES

ADDRESS: **SOMEWHERE , FL**
CLIENT: **GAIA GC**
ID No: **2015000**
DATE: **12/31/xxxx**

GAIA CONSTRUCTION INC.
CGC 1516136 FLORIDA
HI-2792 FLORIDA
8028867-B2 INTERNATIONAL CODE COUNCIL

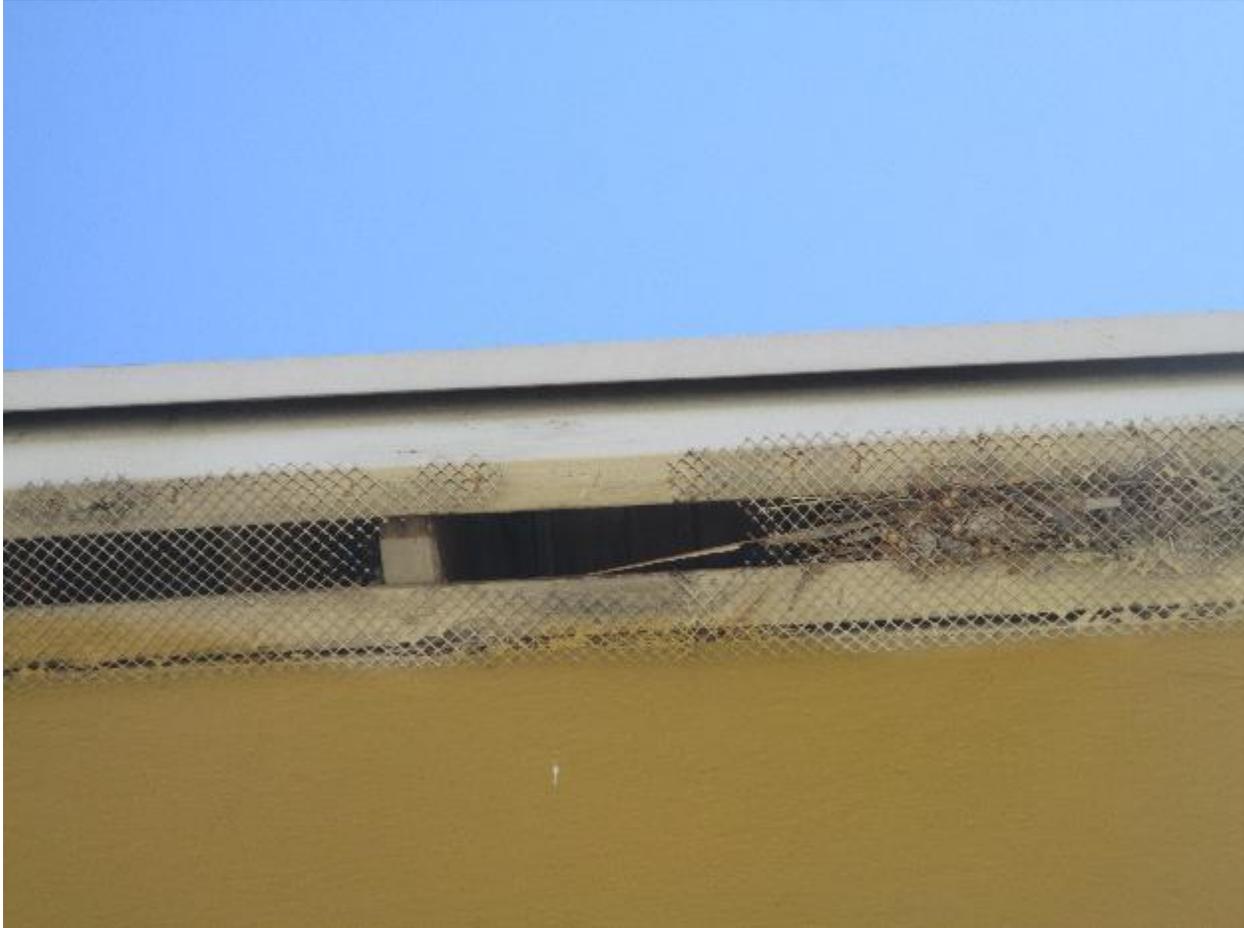
Exterior soffit screen repair required.

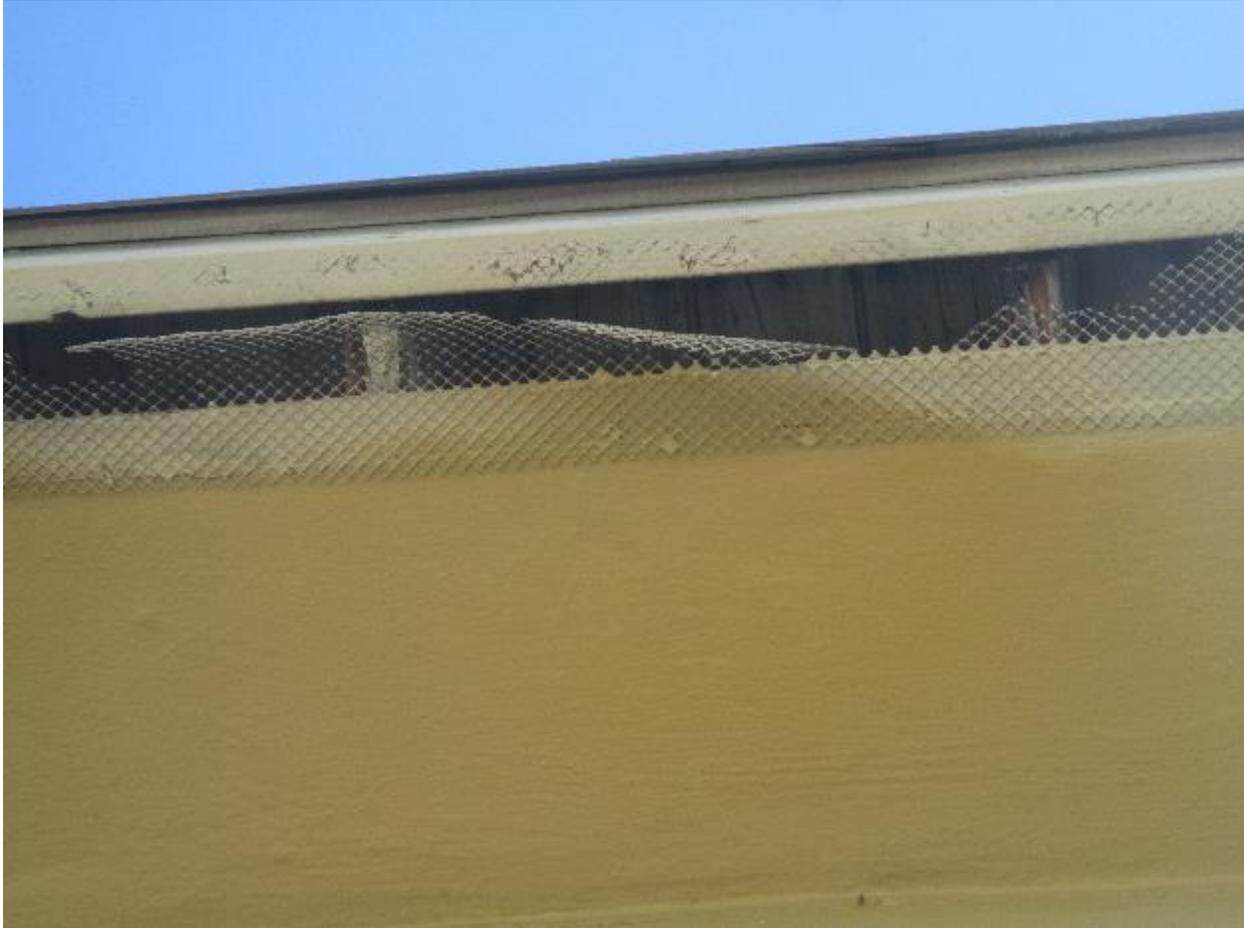
Exterior soffit screen repair required.

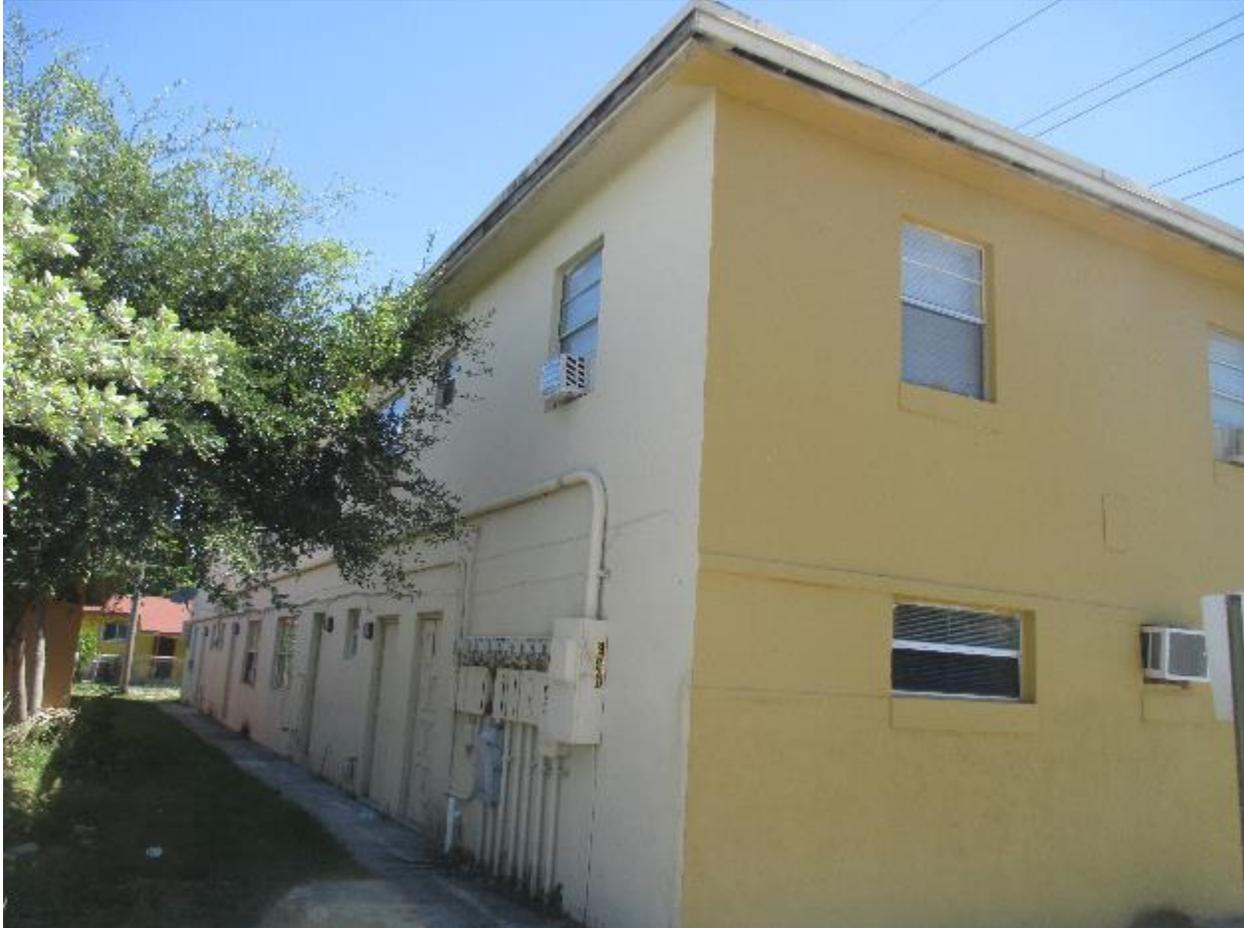
Exterior finishes were found in general good condition at the time of inspection with exceptions as noted and shown in photographs.

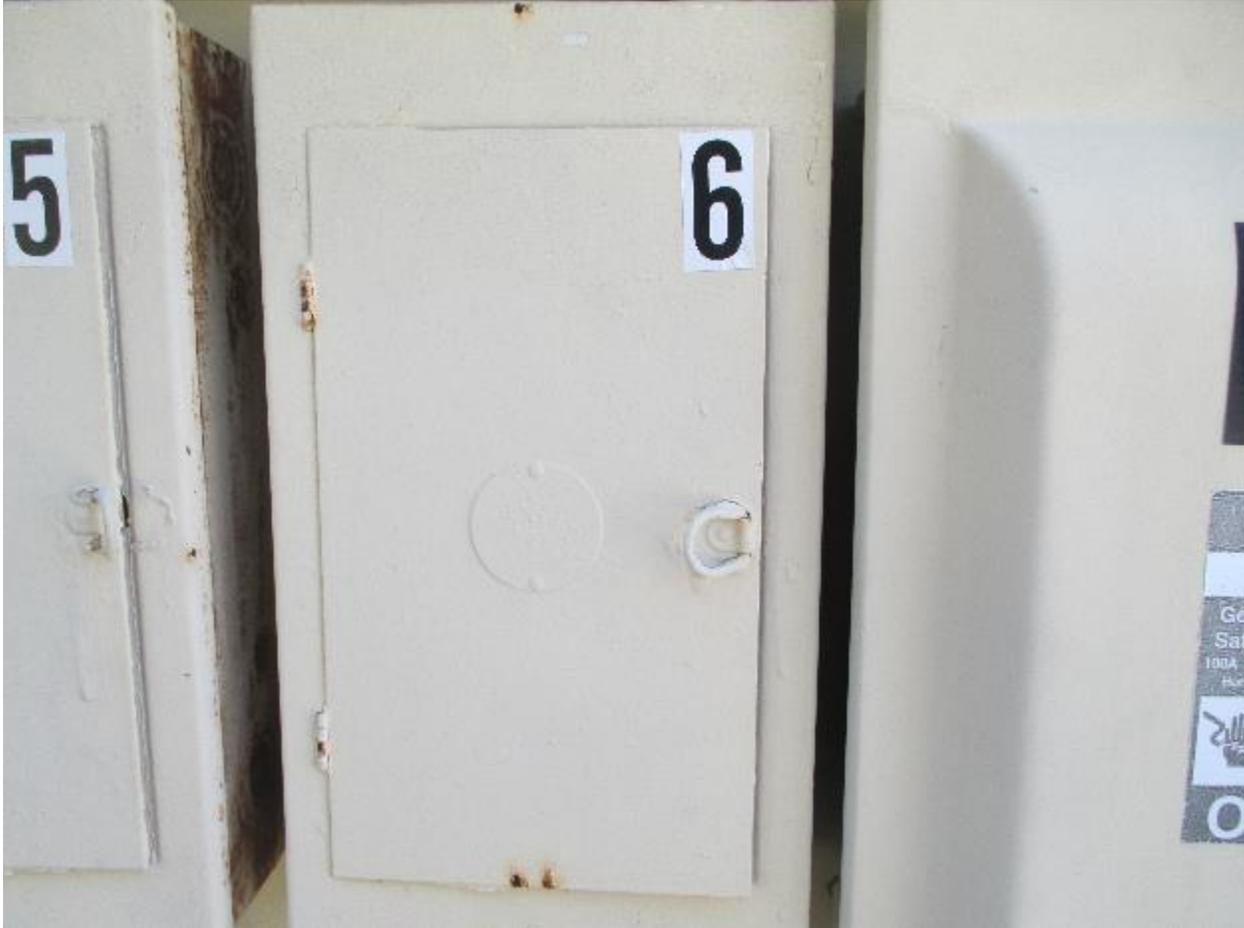
A complete upgrade of the electrical system is recommended including and not limited to GFCI's, smoke detectors, replace outlets and switches and make allowances for replacement of interior and exterior light fixtures. Beware that additional grounding will be required inside the property.

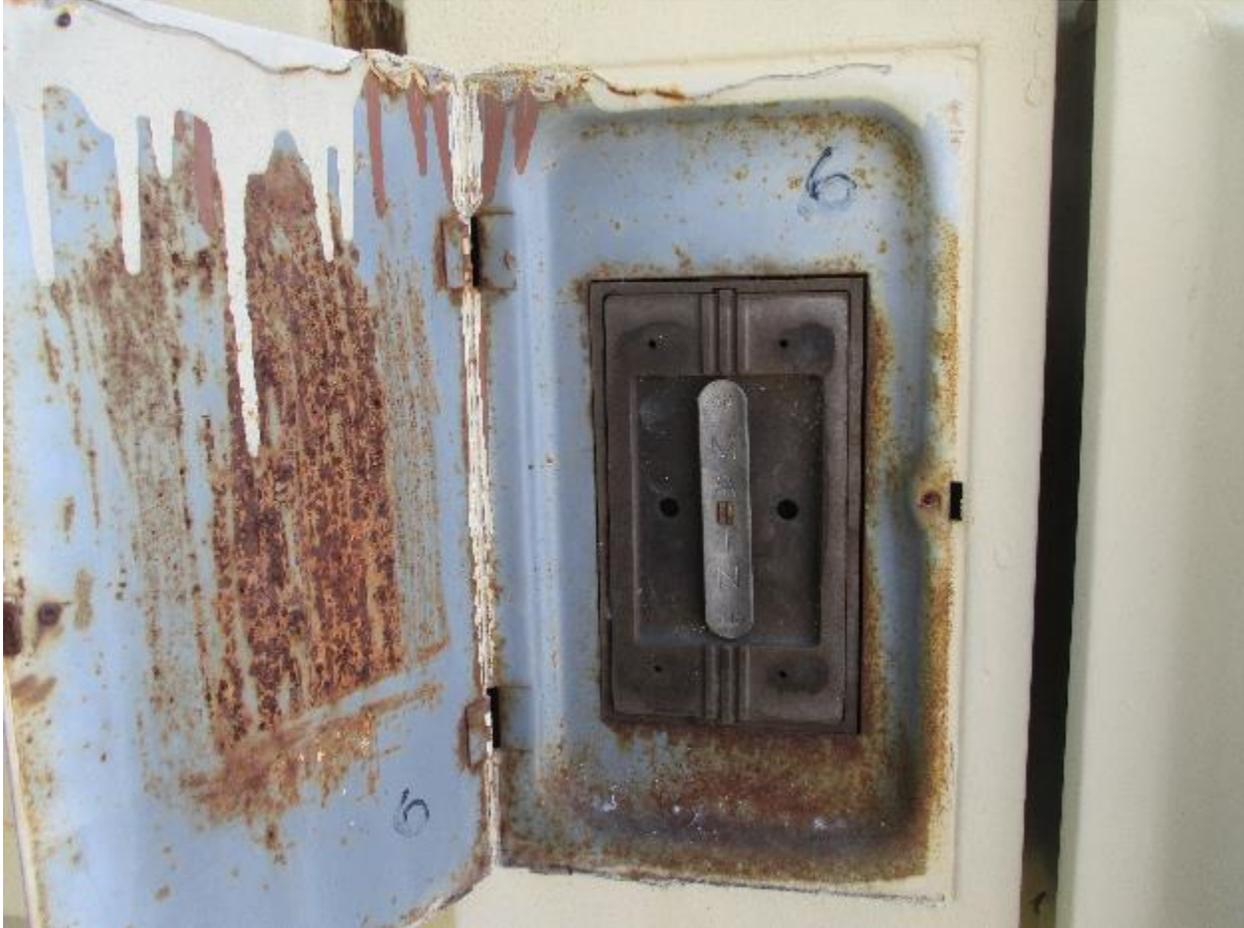
A complete upgrade of the electrical system is recommended including and not limited to GFCI's, smoke detectors, replace outlets and switches and make allowances for replacement of interior and exterior light fixtures. Beware that additional grounding will be required inside the property.

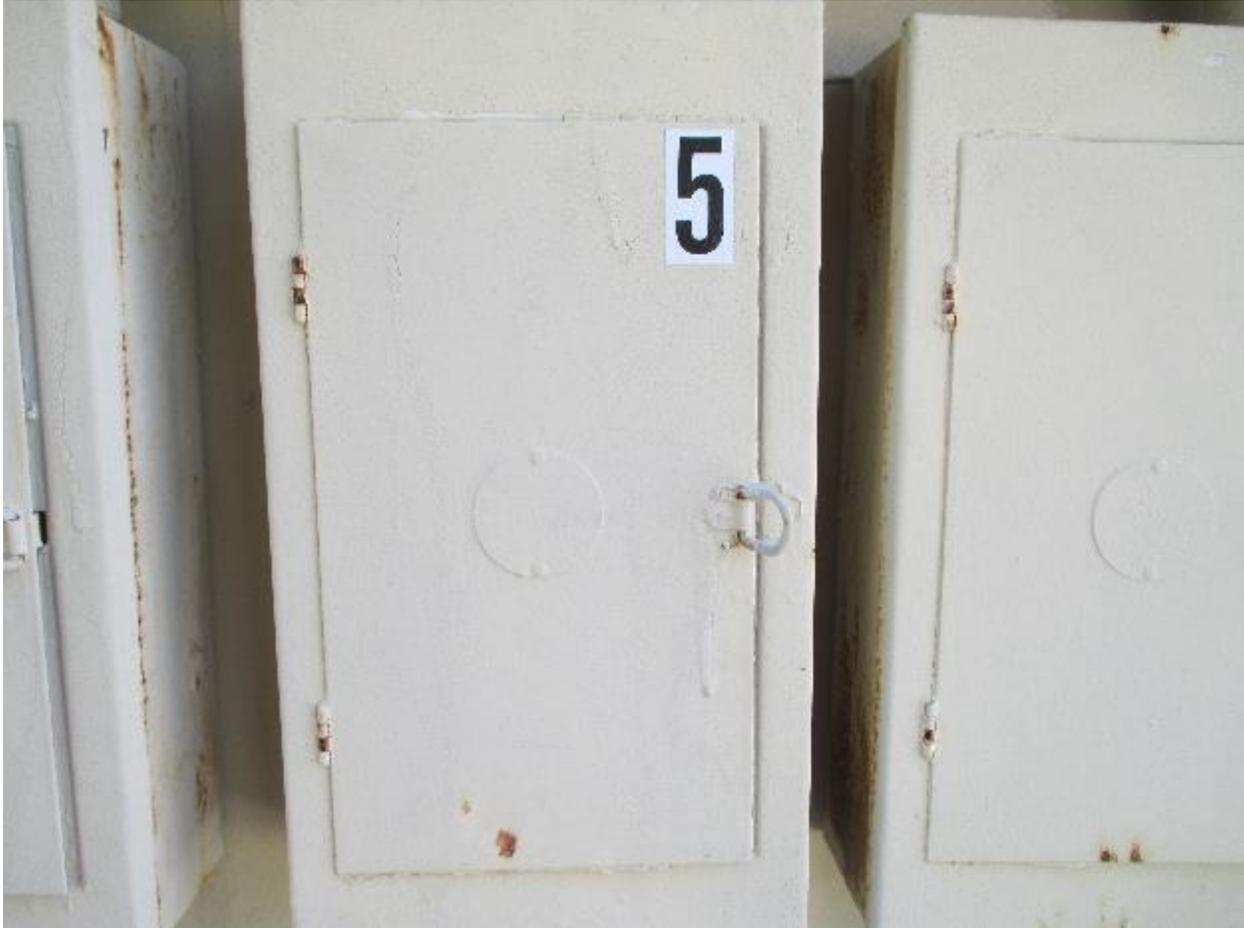
A complete upgrade of the electrical system is recommended including and not limited to GFCI's, smoke detectors, replace outlets and switches and make allowances for replacement of interior and exterior light fixtures. Beware that additional grounding will be required inside the property.

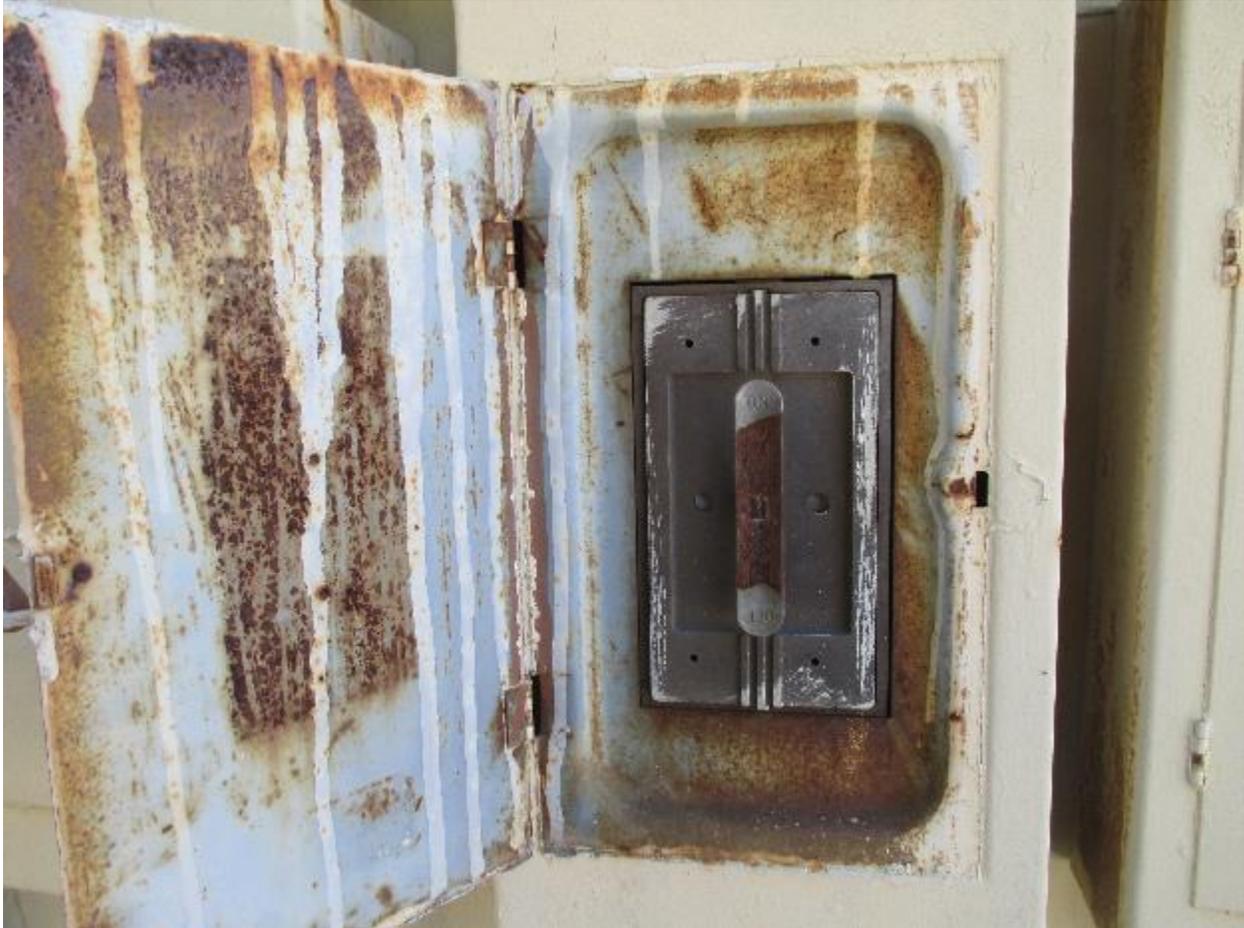
A complete upgrade of the electrical system is recommended including and not limited to GFCI's, smoke detectors, replace outlets and switches and make allowances for replacement of interior and exterior light fixtures. Beware that additional grounding will be required inside the property.

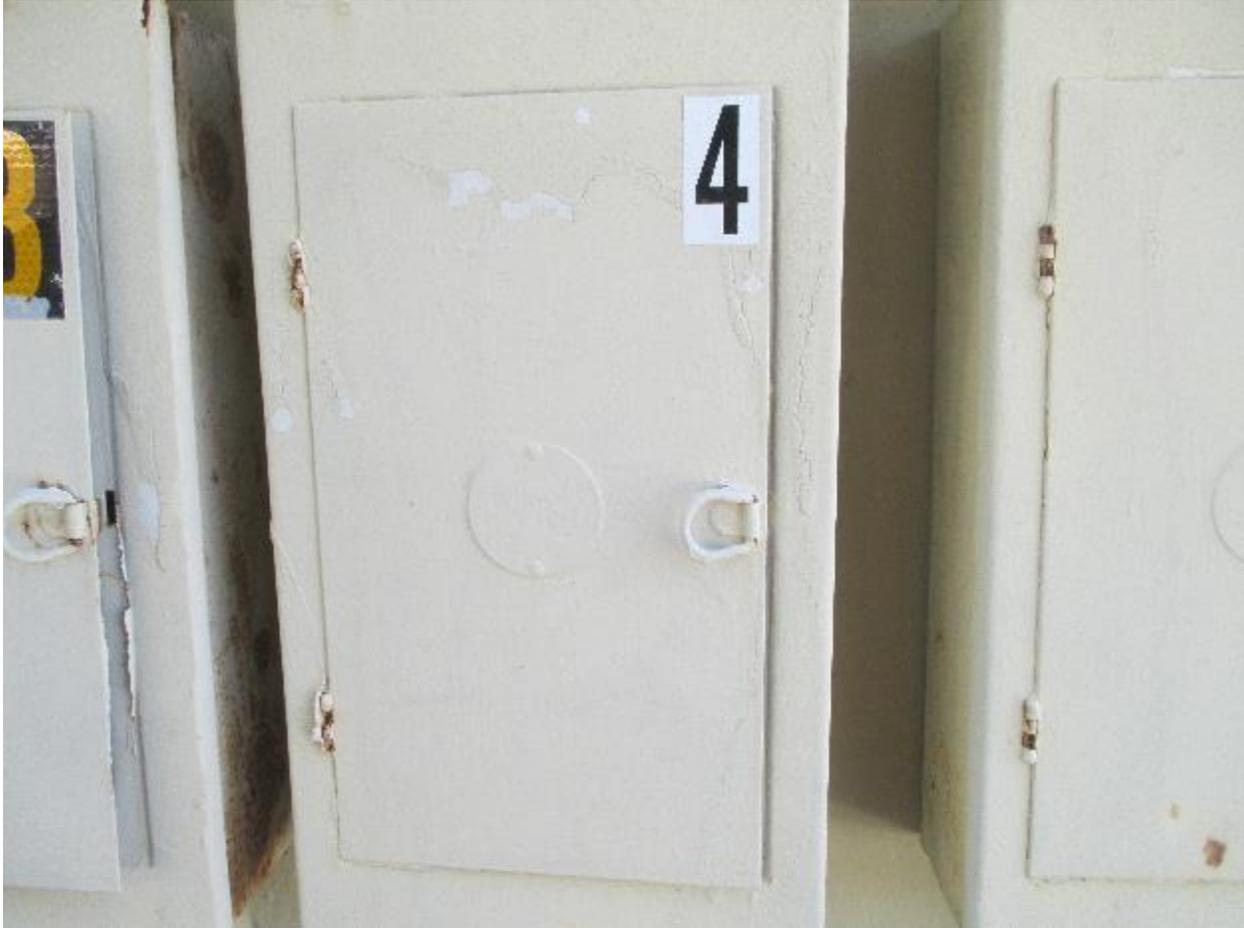
A complete upgrade of the electrical system is recommended including and not limited to GFCI's, smoke detectors, replace outlets and switches and make allowances for replacement of interior and exterior light fixtures. Beware that additional grounding will be required inside the property.

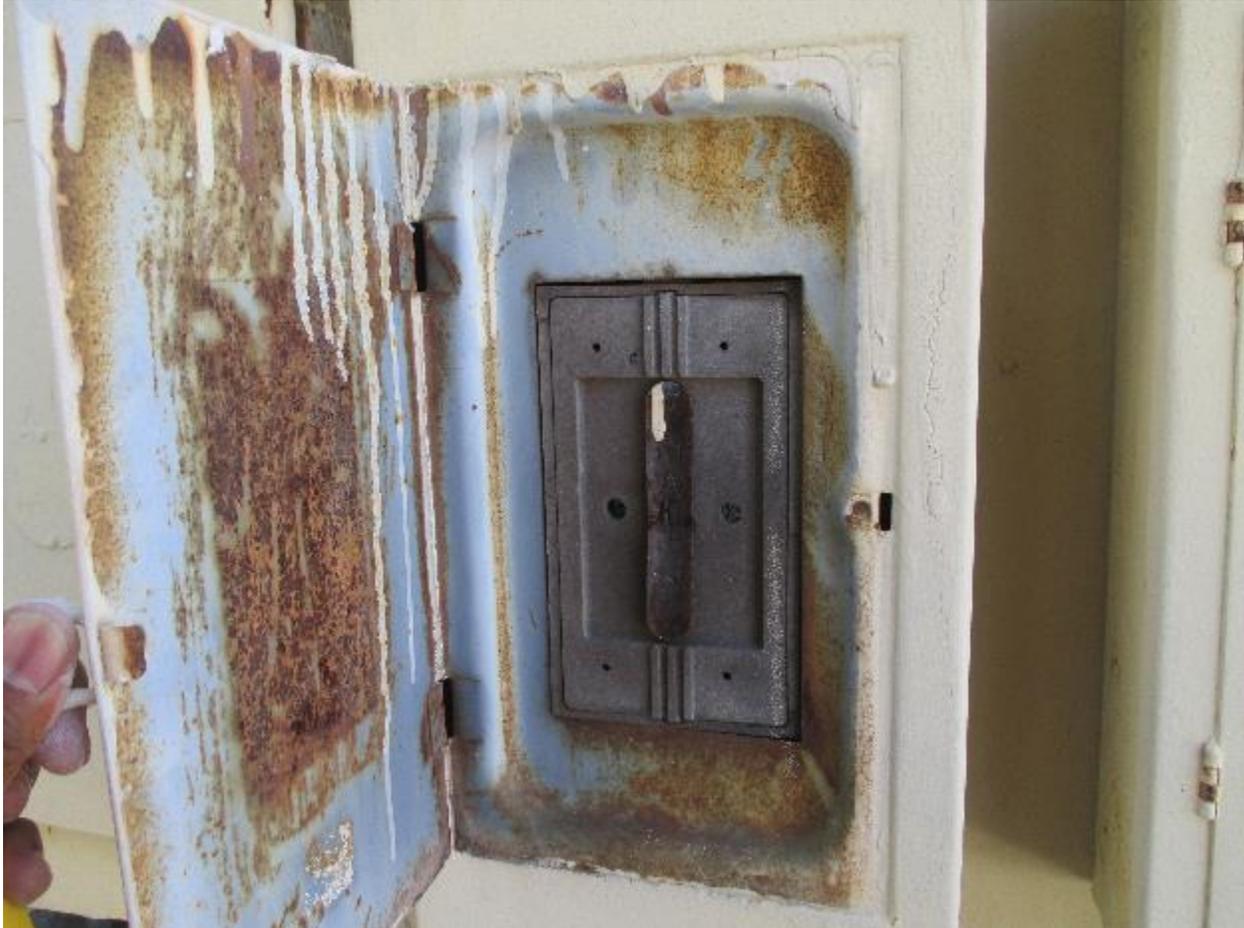
A complete upgrade of the electrical system is recommended including and not limited to GFCI's, smoke detectors, replace outlets and switches and make allowances for replacement of interior and exterior light fixtures. Beware that additional grounding will be required inside the property.

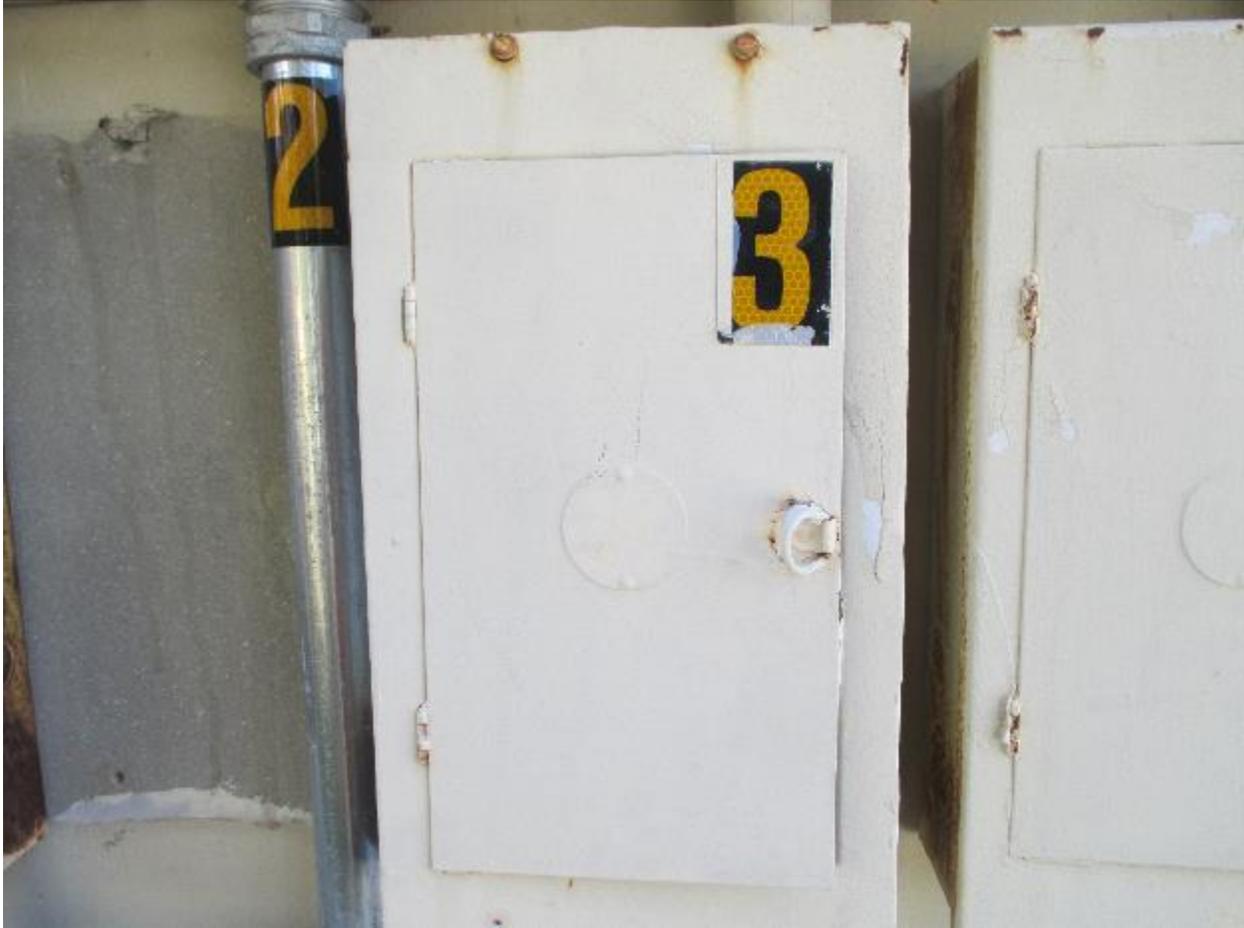
A complete upgrade of the electrical system is recommended including and not limited to GFCI's, smoke detectors, replace outlets and switches and make allowances for replacement of interior and exterior light fixtures. Beware that additional grounding will be required inside the property.

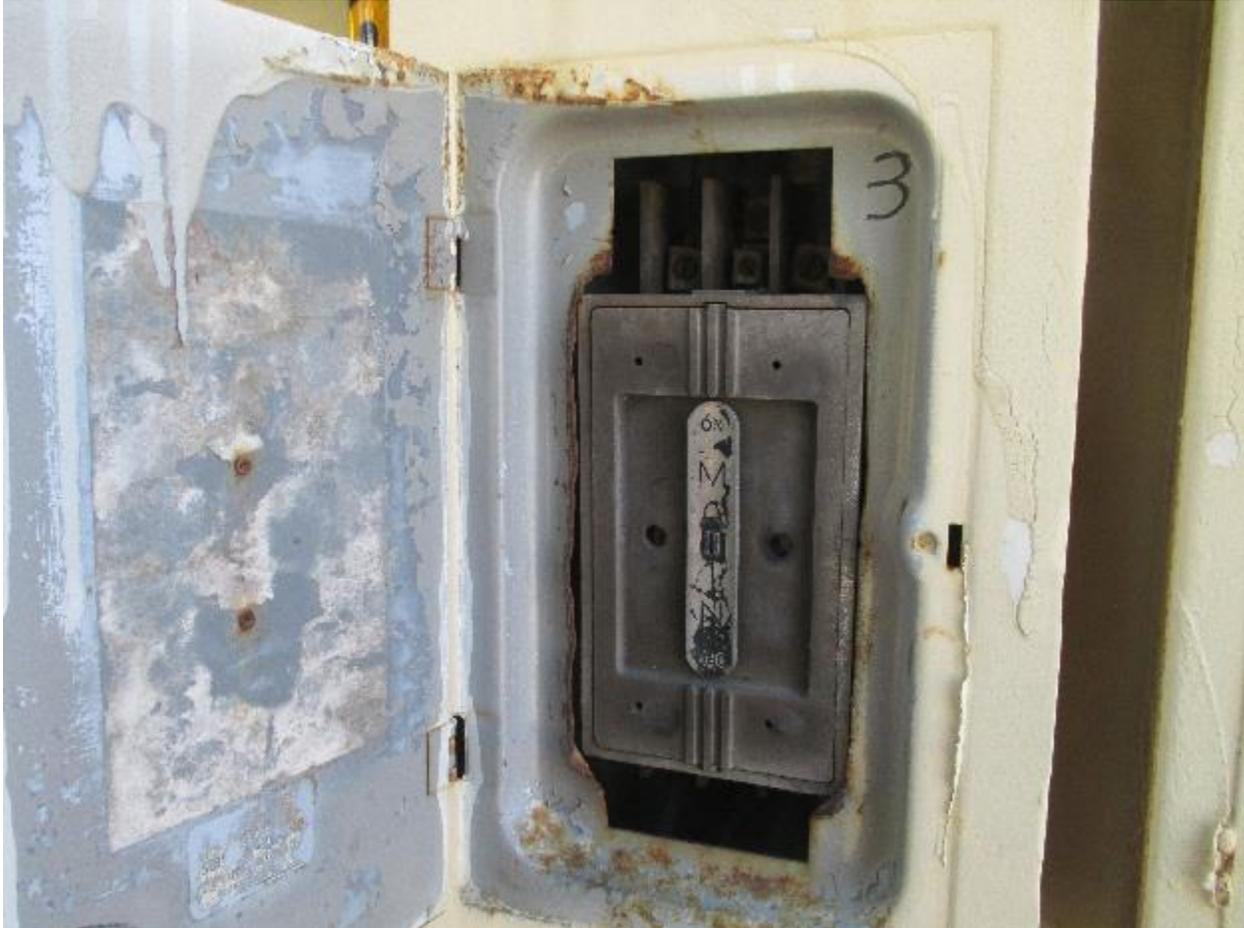
A complete upgrade of the electrical system is recommended including and not limited to GFCI's, smoke detectors, replace outlets and switches and make allowances for replacement of interior and exterior light fixtures. Beware that additional grounding will be required inside the property.

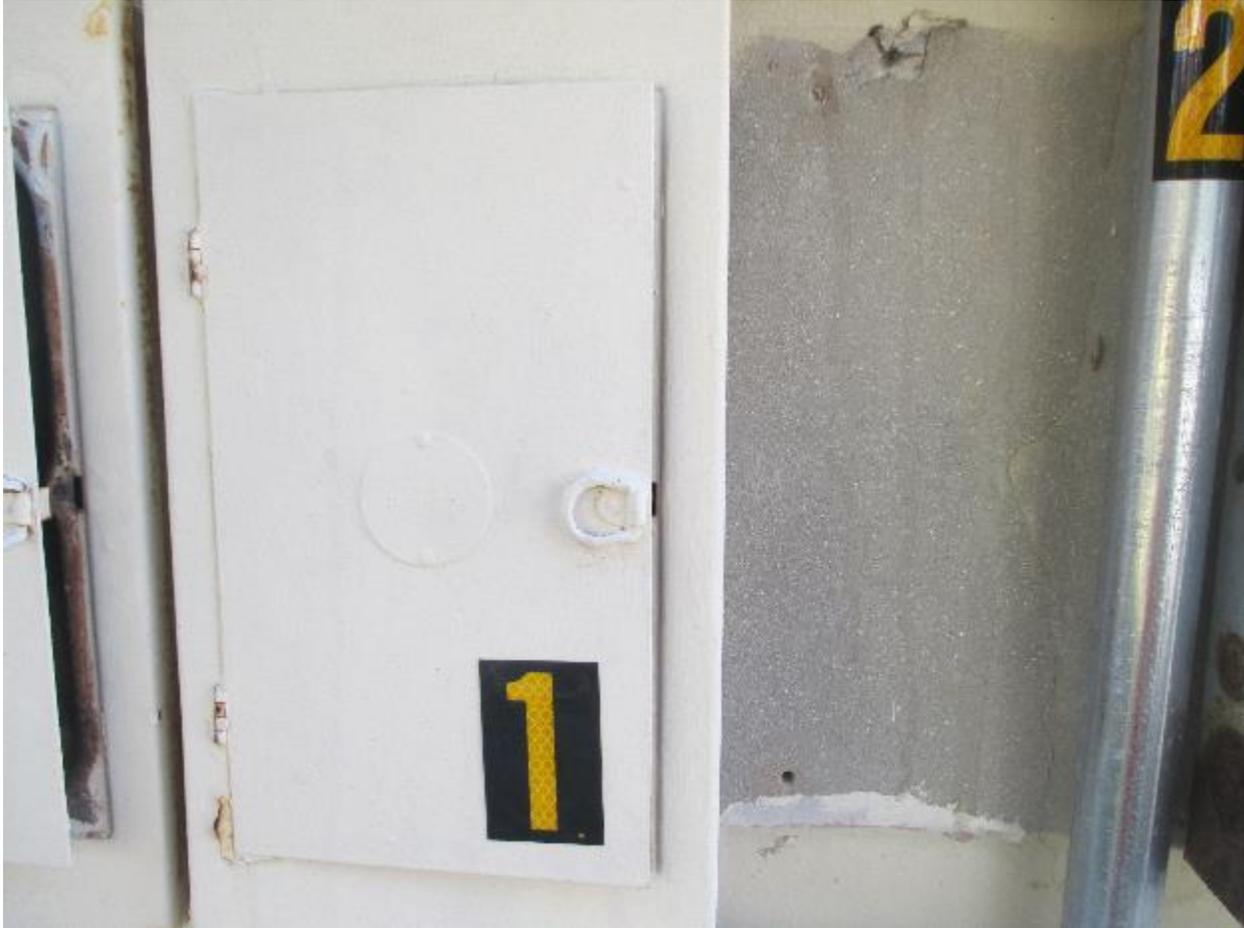
A complete upgrade of the electrical system is recommended including and not limited to GFCI's, smoke detectors, replace outlets and switches and make allowances for replacement of interior and exterior light fixtures. Beware that additional grounding will be required inside the property.

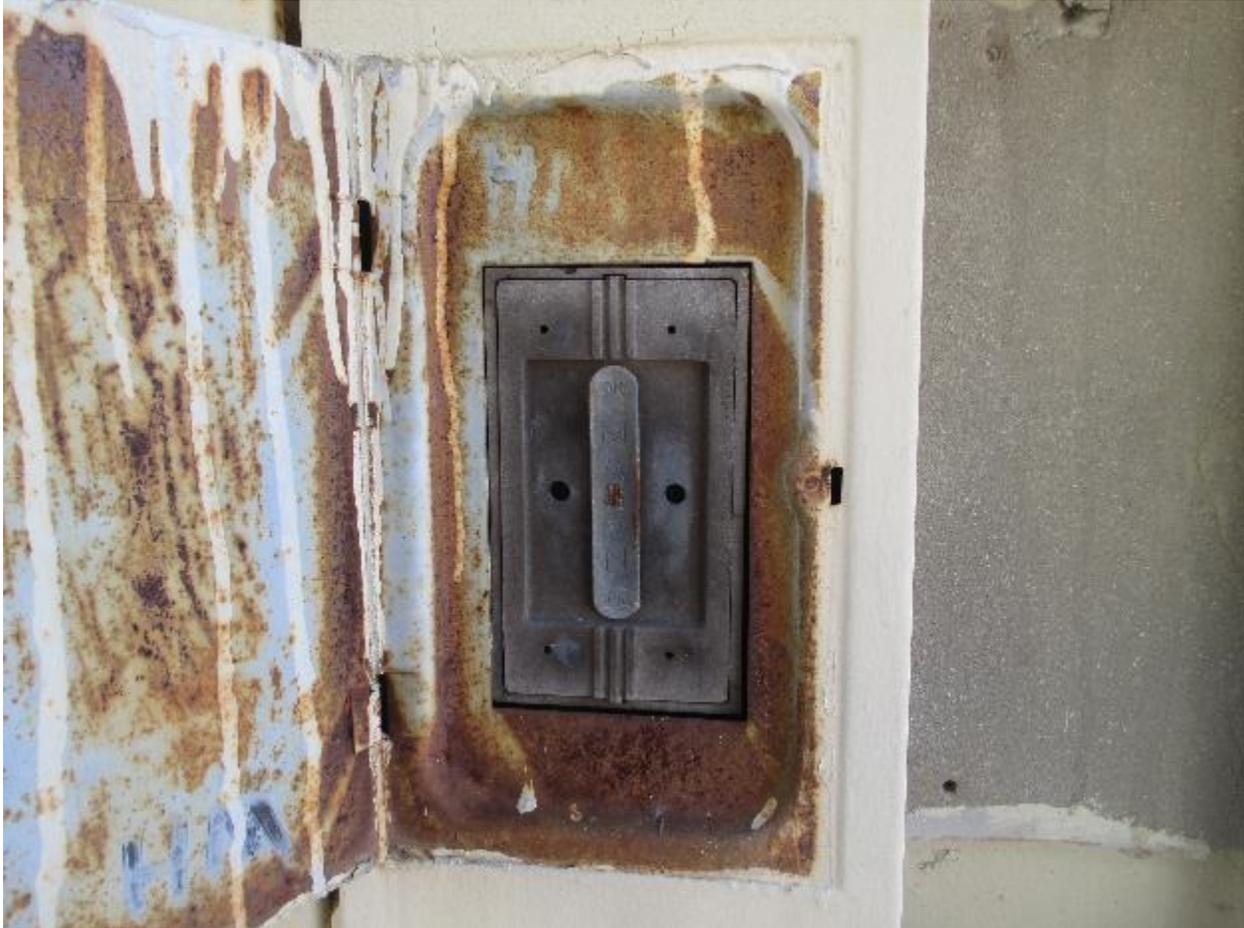
A complete upgrade of the electrical system is recommended including and not limited to GFCI's, smoke detectors, replace outlets and switches and make allowances for replacement of interior and exterior light fixtures. Beware that additional grounding will be required inside the property.

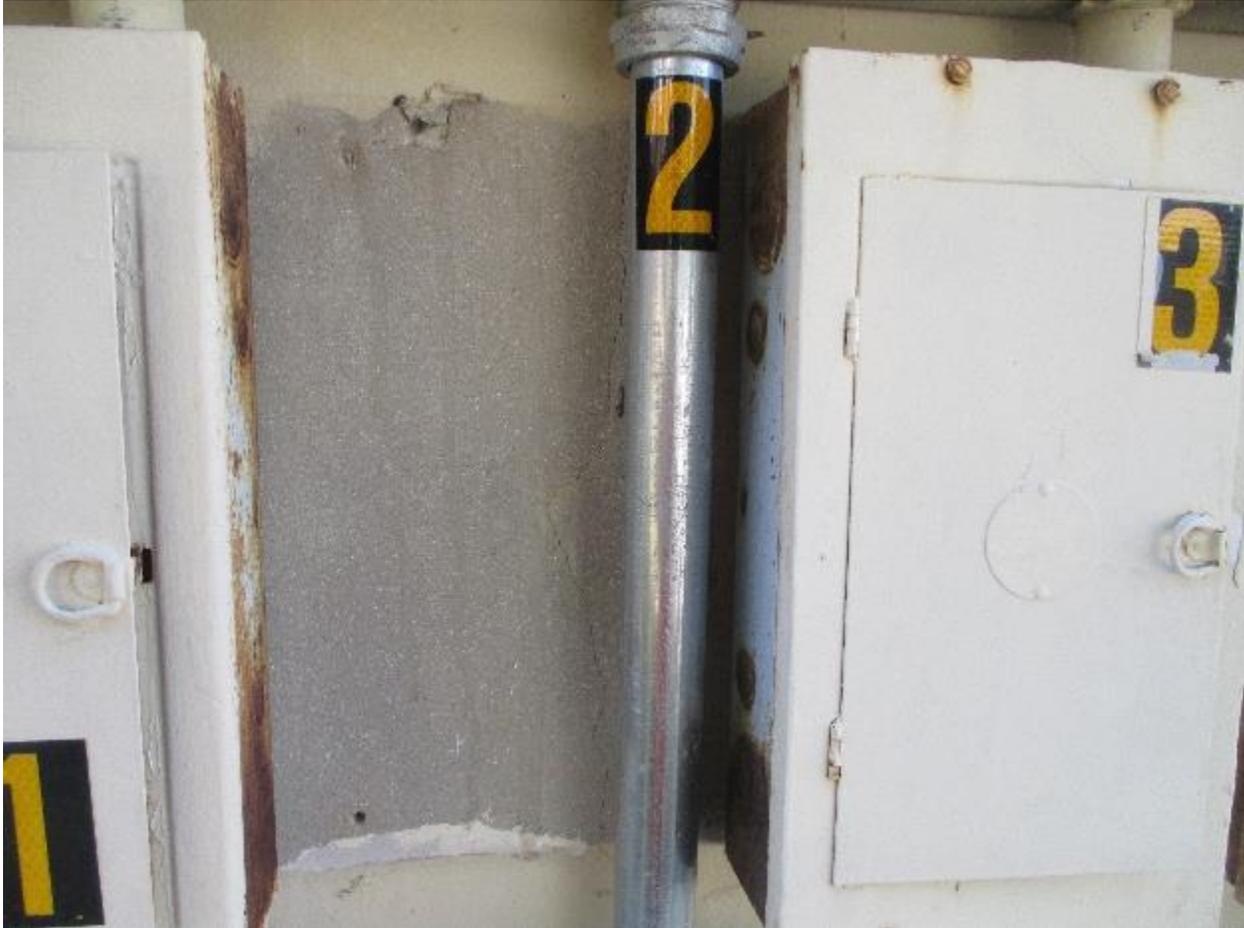
A complete upgrade of the electrical system is recommended including and not limited to GFCI's, smoke detectors, replace outlets and switches and make allowances for replacement of interior and exterior light fixtures. Beware that additional grounding will be required inside the property.

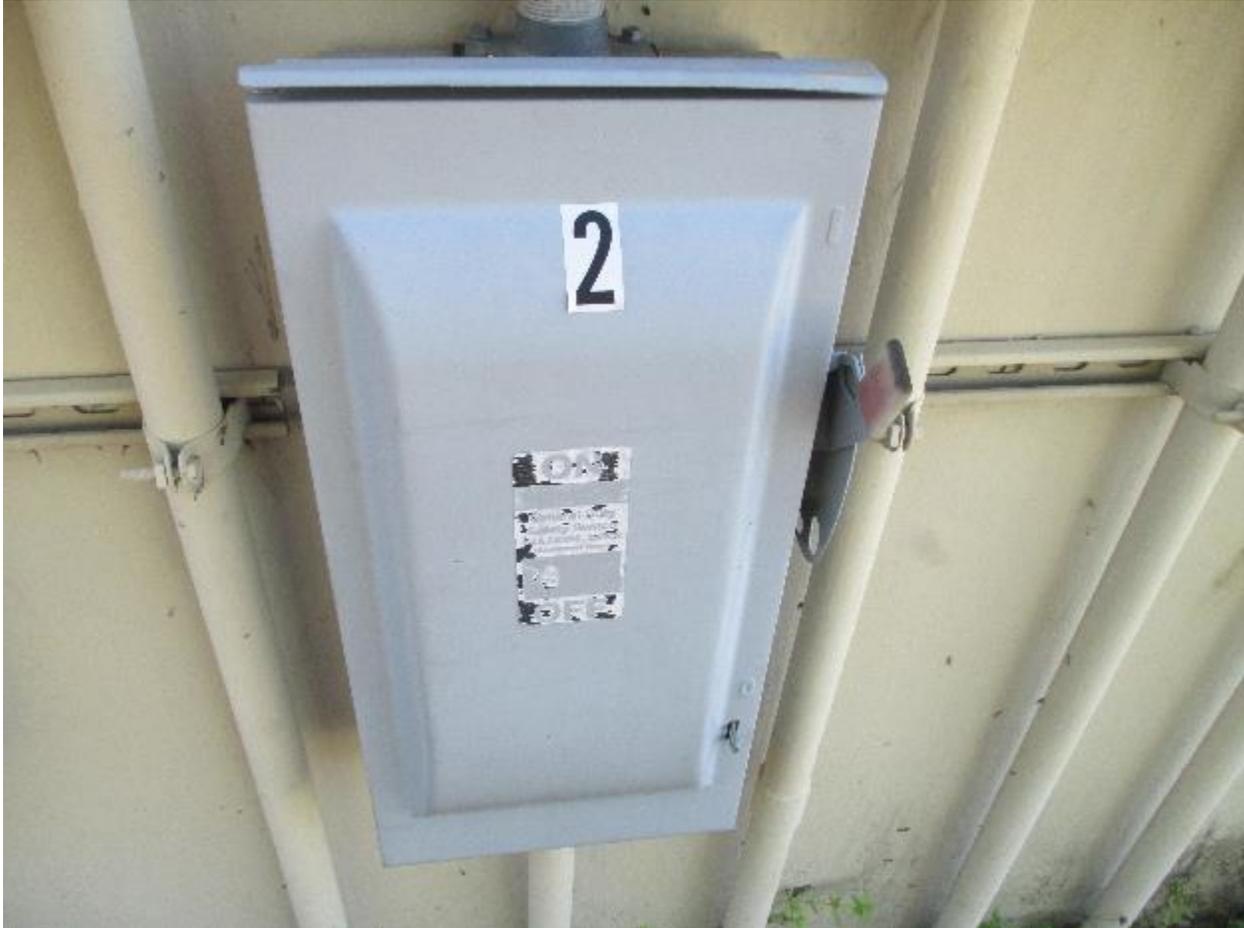
A complete upgrade of the electrical system is recommended including and not limited to GFCI's, smoke detectors, replace outlets and switches and make allowances for replacement of interior and exterior light fixtures. Beware that additional grounding will be required inside the property.

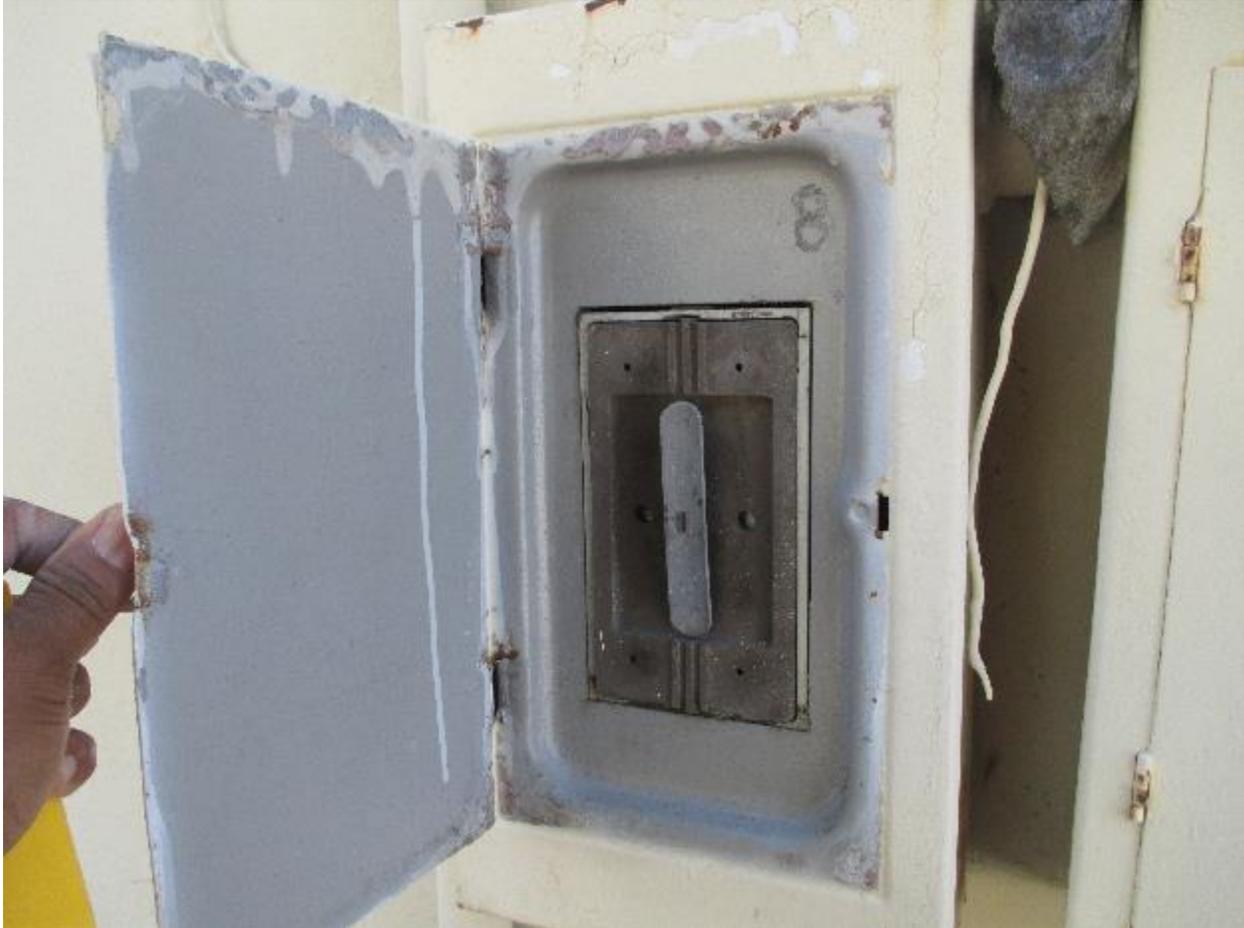
A complete upgrade of the electrical system is recommended including and not limited to GFCI's, smoke detectors, replace outlets and switches and make allowances for replacement of interior and exterior light fixtures. Beware that additional grounding will be required inside the property.

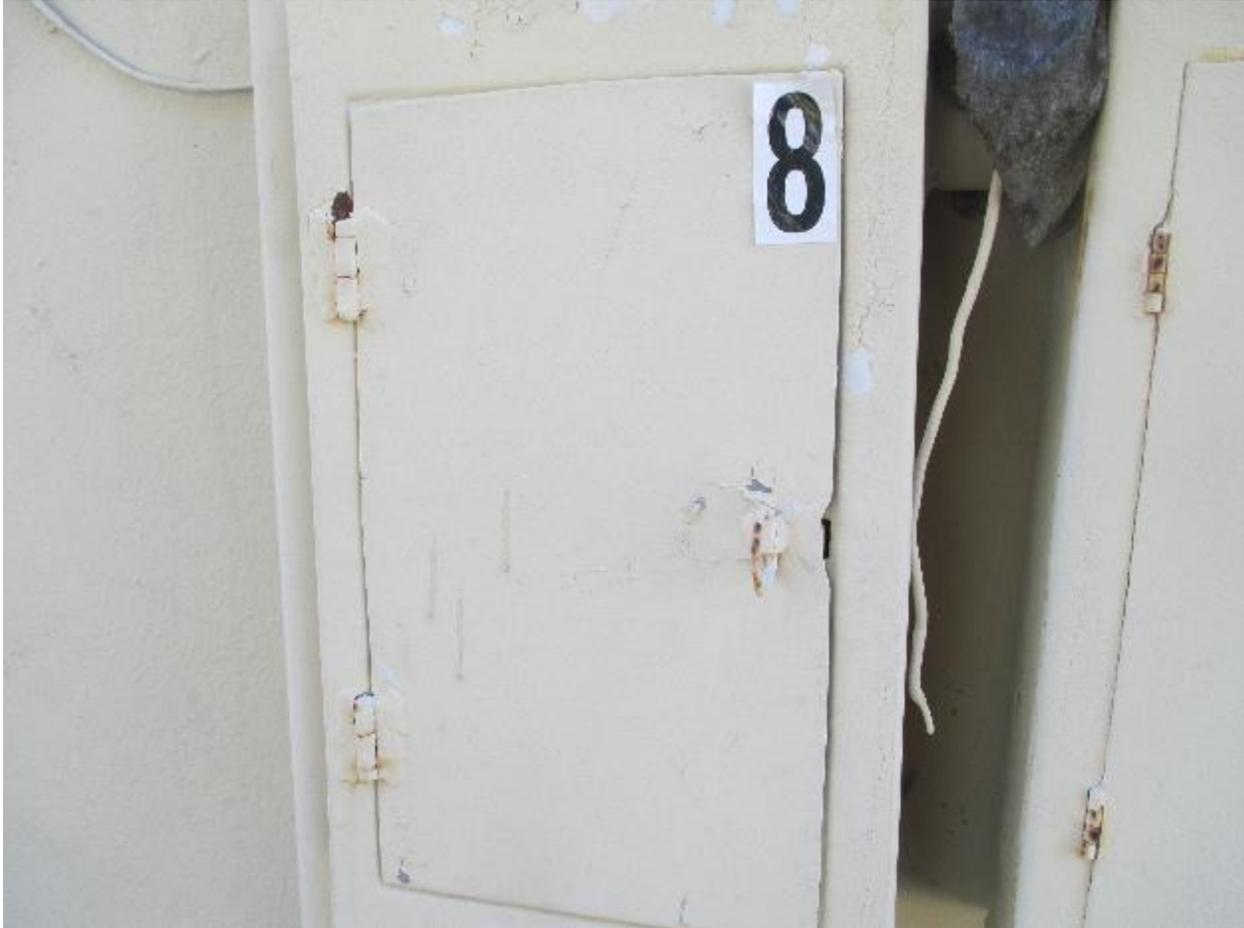
A complete upgrade of the electrical system is recommended including and not limited to GFCI's, smoke detectors, replace outlets and switches and make allowances for replacement of interior and exterior light fixtures. Beware that additional grounding will be required inside the property.

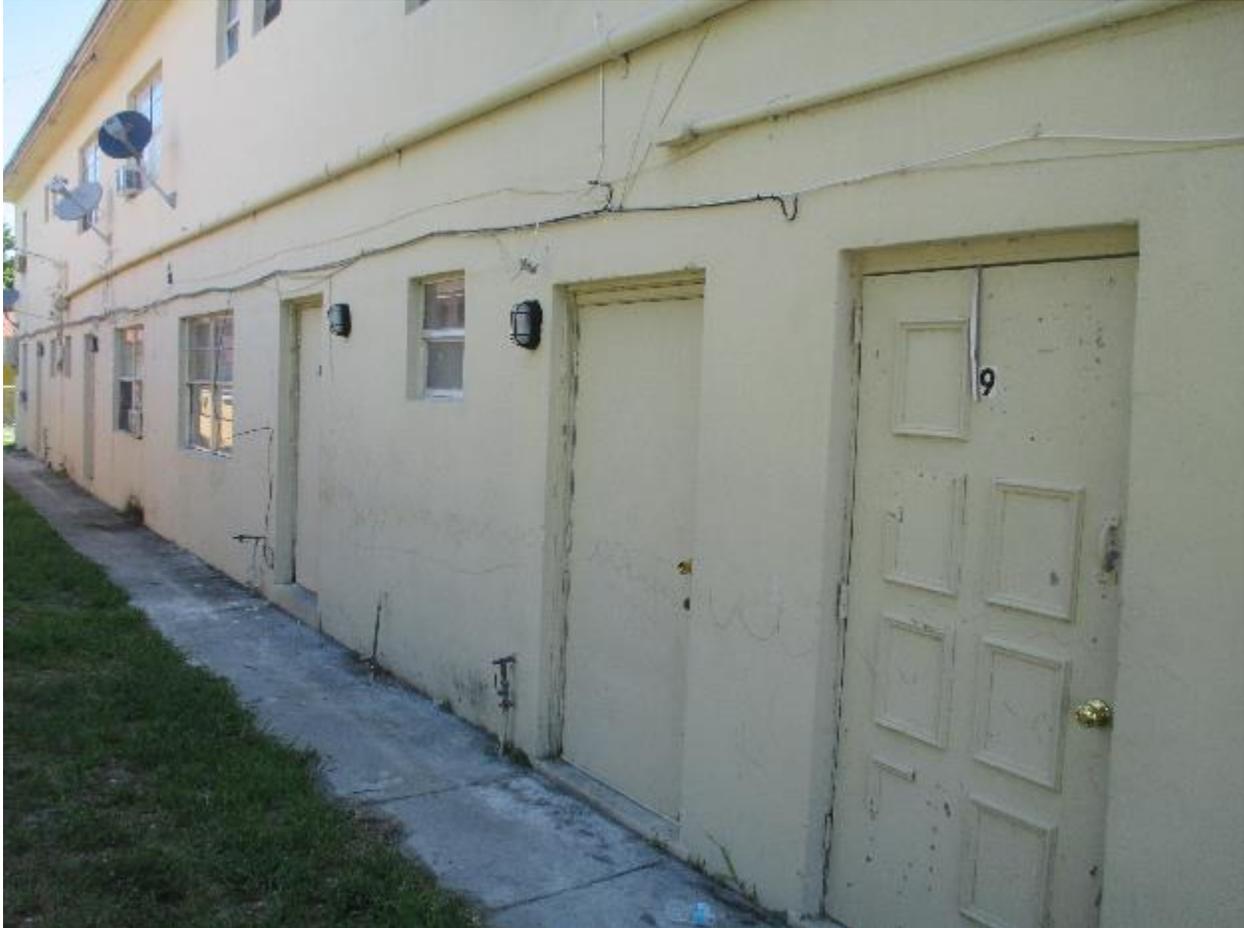
Exterior finishes were found in general good condition at the time of inspection with exceptions as noted and shown in photographs.

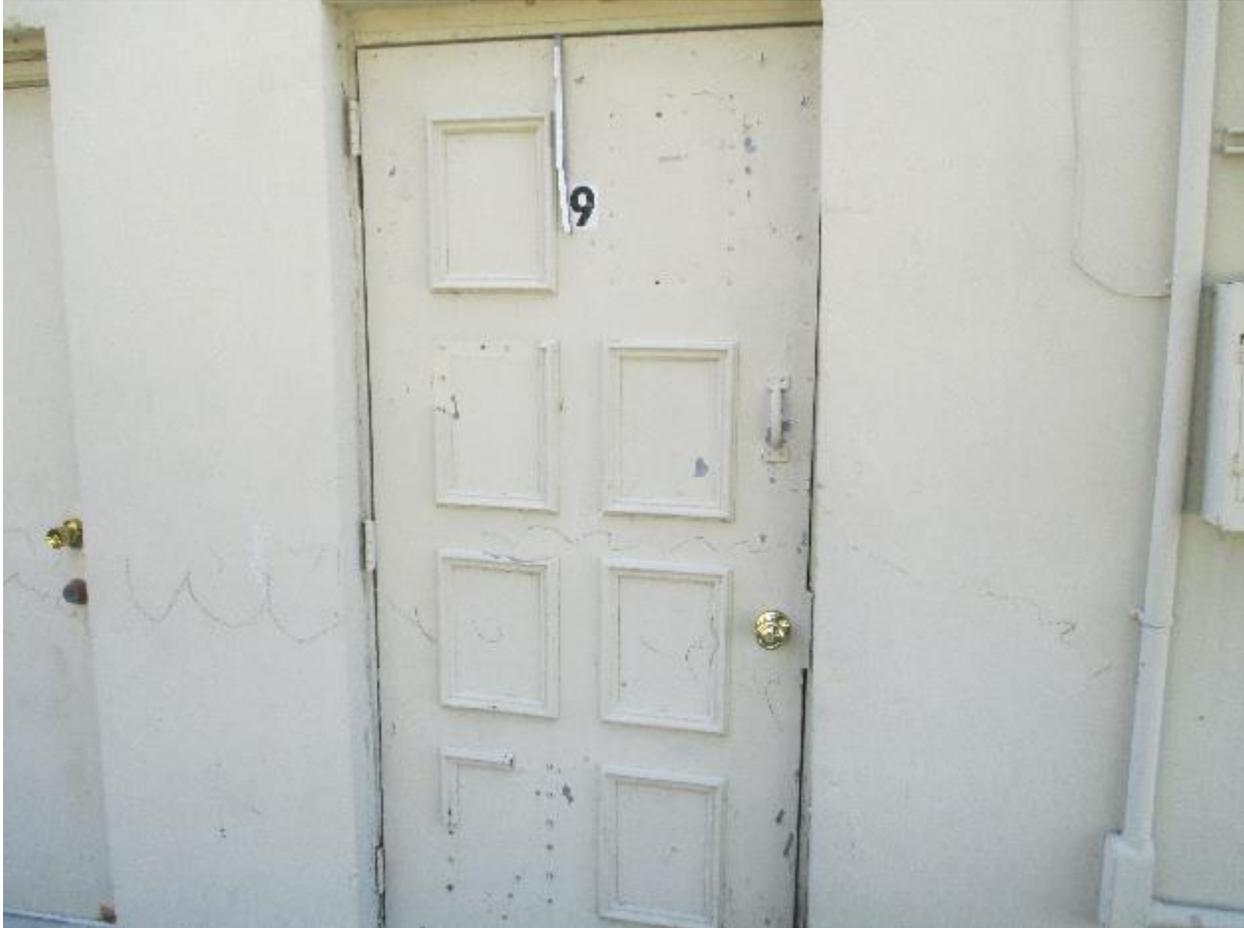
Exterior door(s) require replacement. Currently beyond possibilities of repair.
