PROPERTY INSPECTION OR ASSESSMENT OF DAMAGES

ADDRESS: **SOMEWHERE , FL**
CLIENT: **GAIA GC**
ID No: **2015000**
DATE: **12/31/xxxx**

GAIA CONSTRUCTION INC.
CGC 1516136 FLORIDA
HI-2792 FLORIDA
8028867-B2 INTERNATIONAL CODE COUNCIL

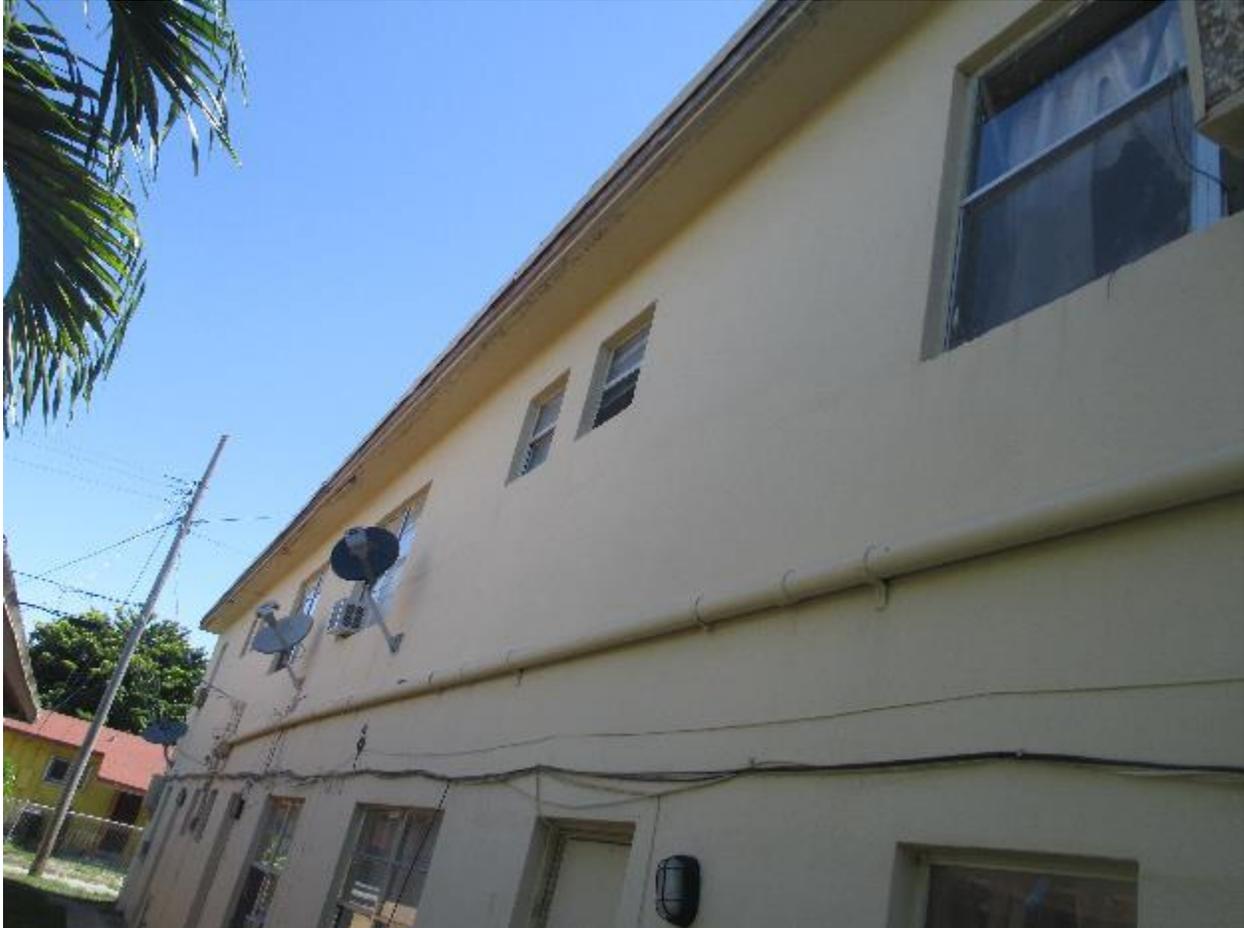
Exterior finishes were found in general good condition at the time of inspection with exceptions as noted and shown in photographs.

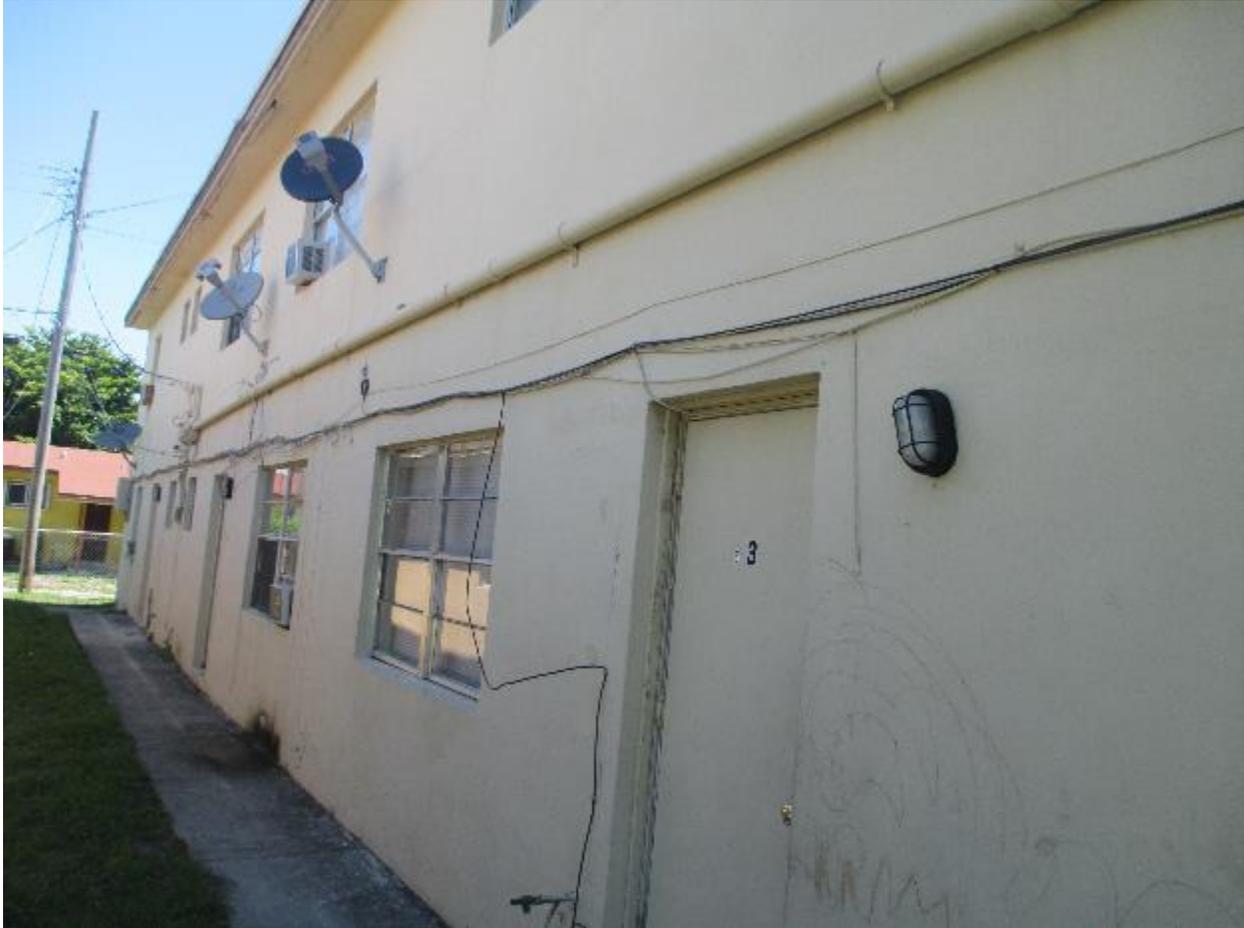
Exterior finishes were found in general good condition at the time of inspection with exceptions as noted and shown in photographs.

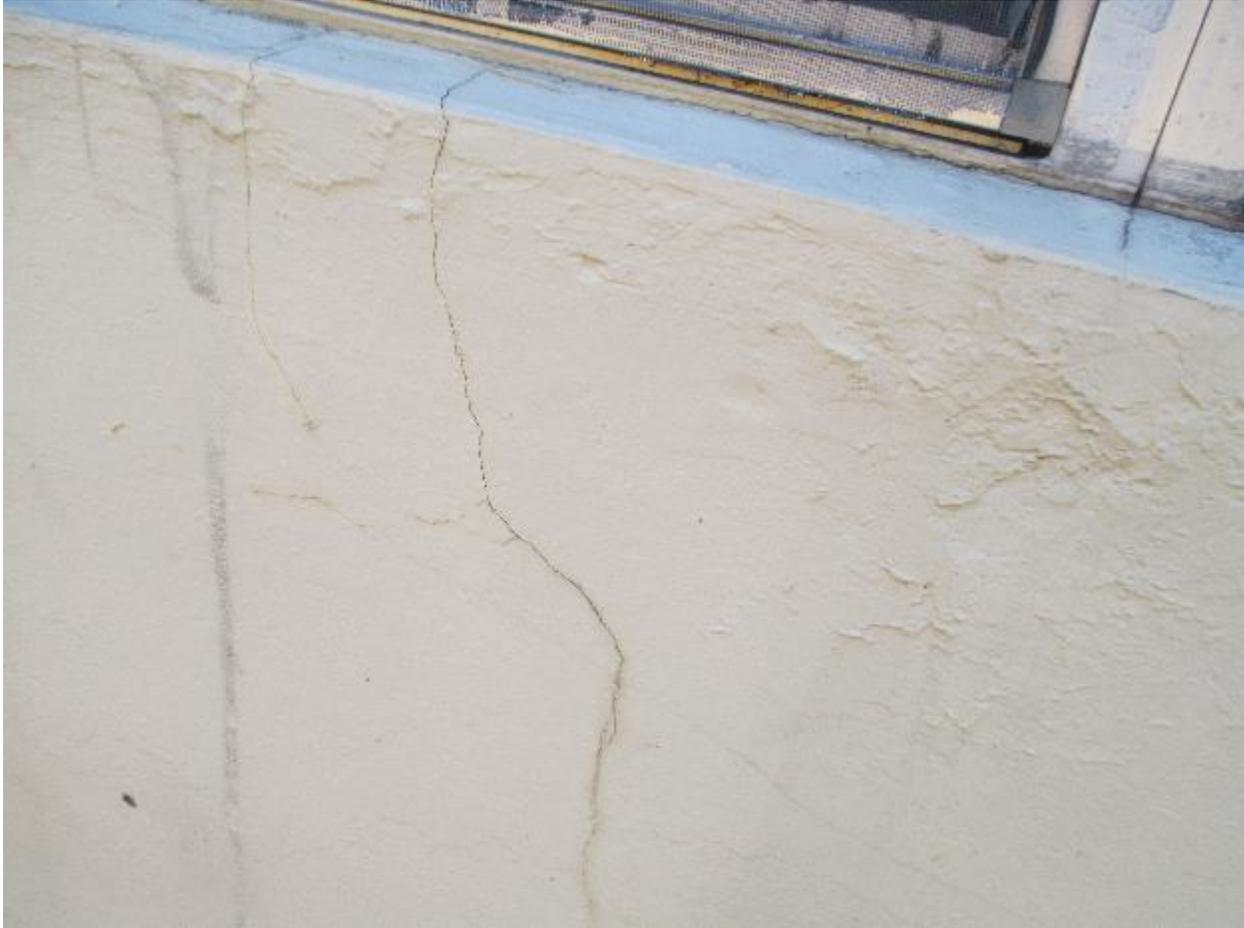
Cracks on vertical planes due to foundation settlement indicating downward and lateral movement. These types of cracks do compromise the ability of the building to function as designed and avoid water intrusion. Structural repair and proper waterproofing treatment are required to avoid further damage to the interior of the building and water infiltration.

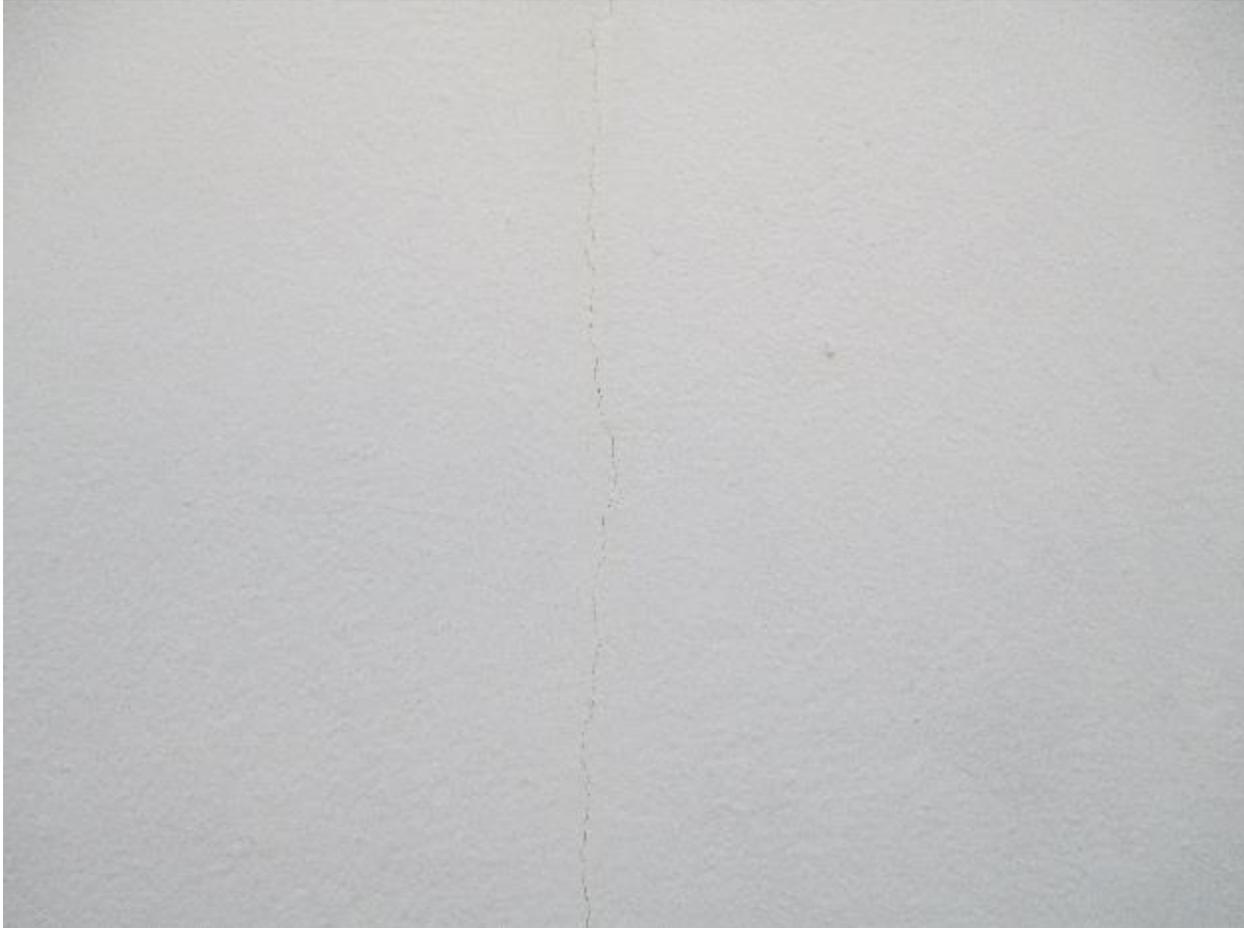
Cracks on vertical planes due to foundation settlement indicating downward and lateral movement. These types of cracks do compromise the ability of the building to function as designed and avoid water intrusion. Structural repair and proper waterproofing treatment are required to avoid further damage to the interior of the building and water infiltration.

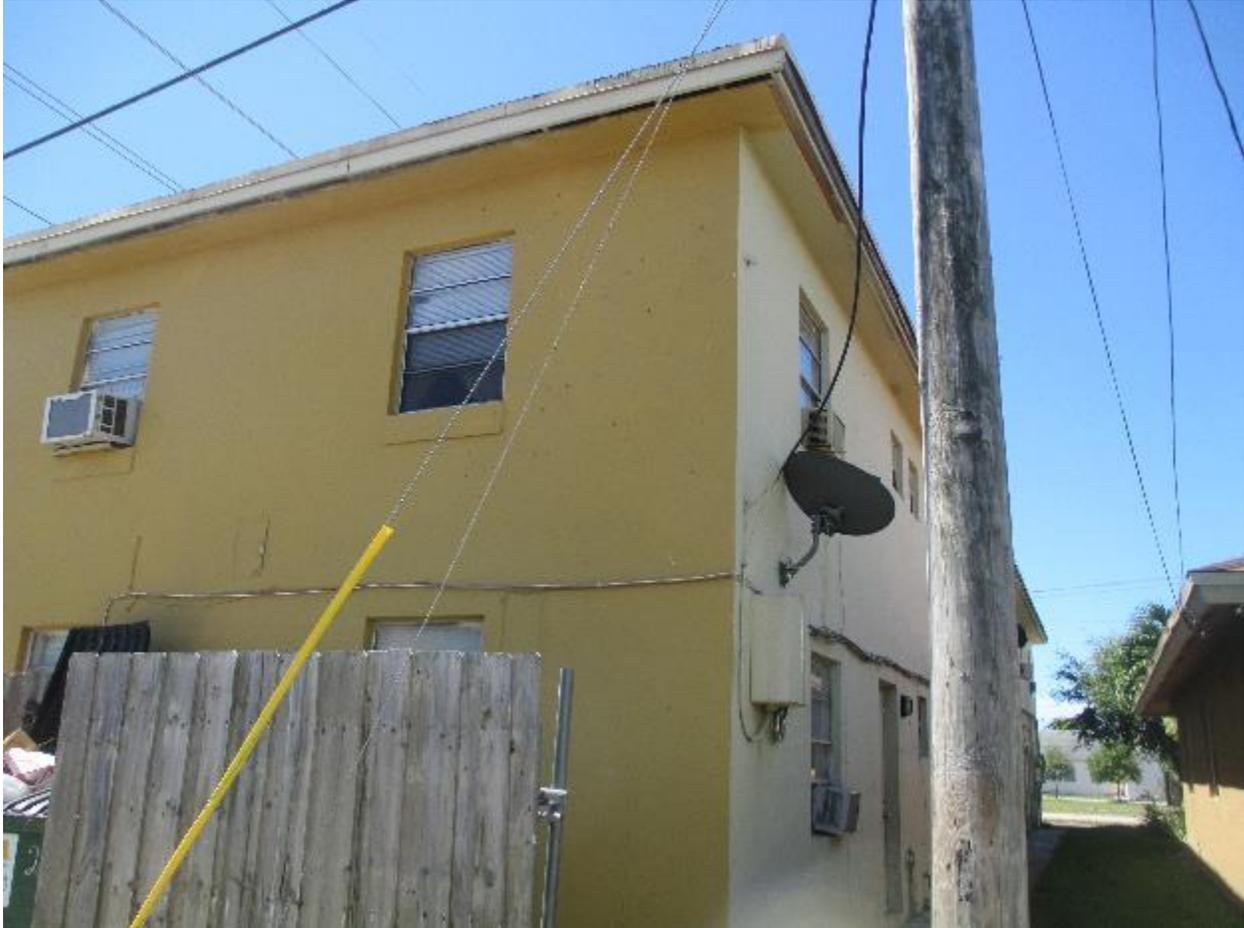
Exterior finishes were found in general good condition at the time of inspection with exceptions as noted and shown in photographs.

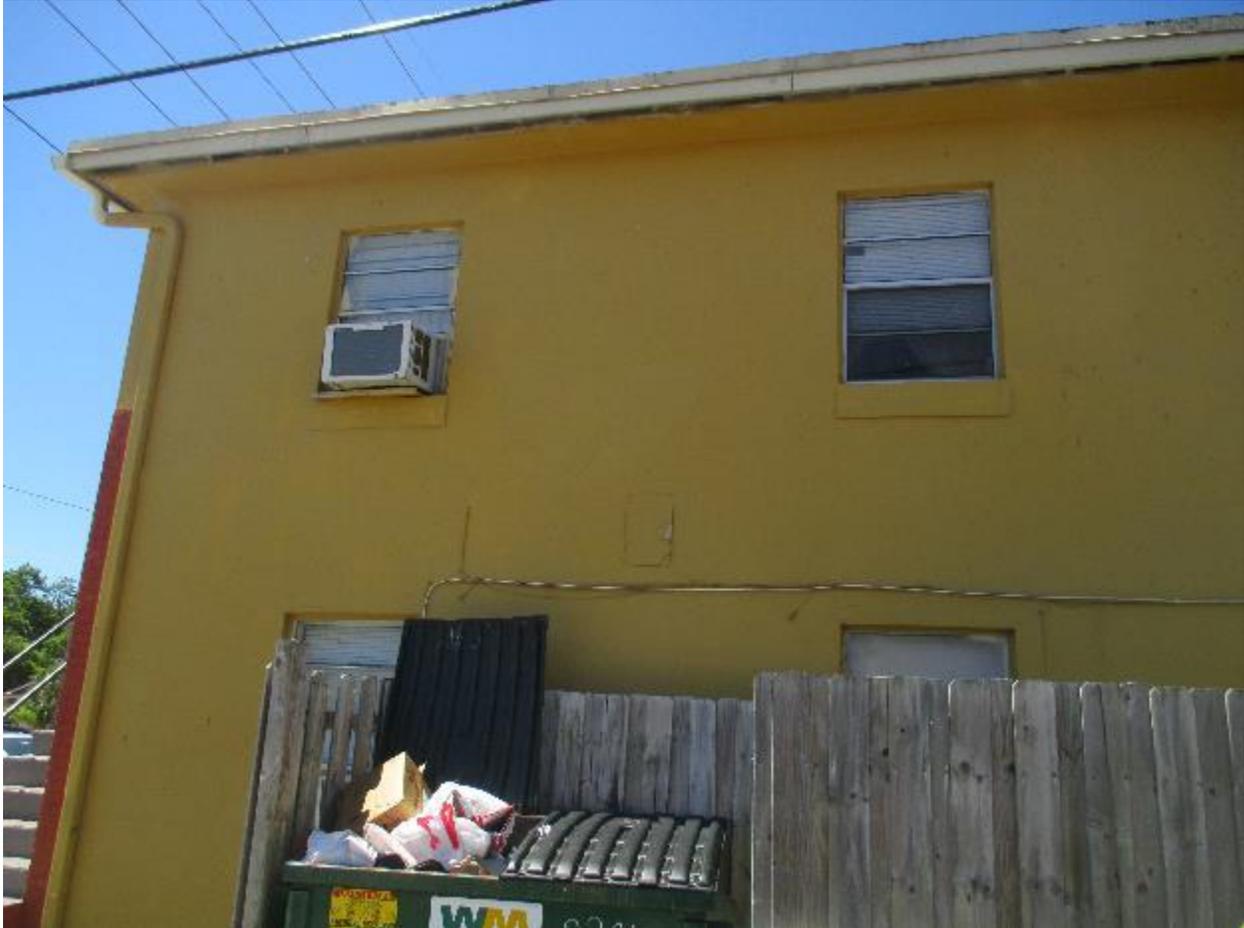
Exterior finishes were found in general good condition at the time of inspection with exceptions as noted and shown in photographs.

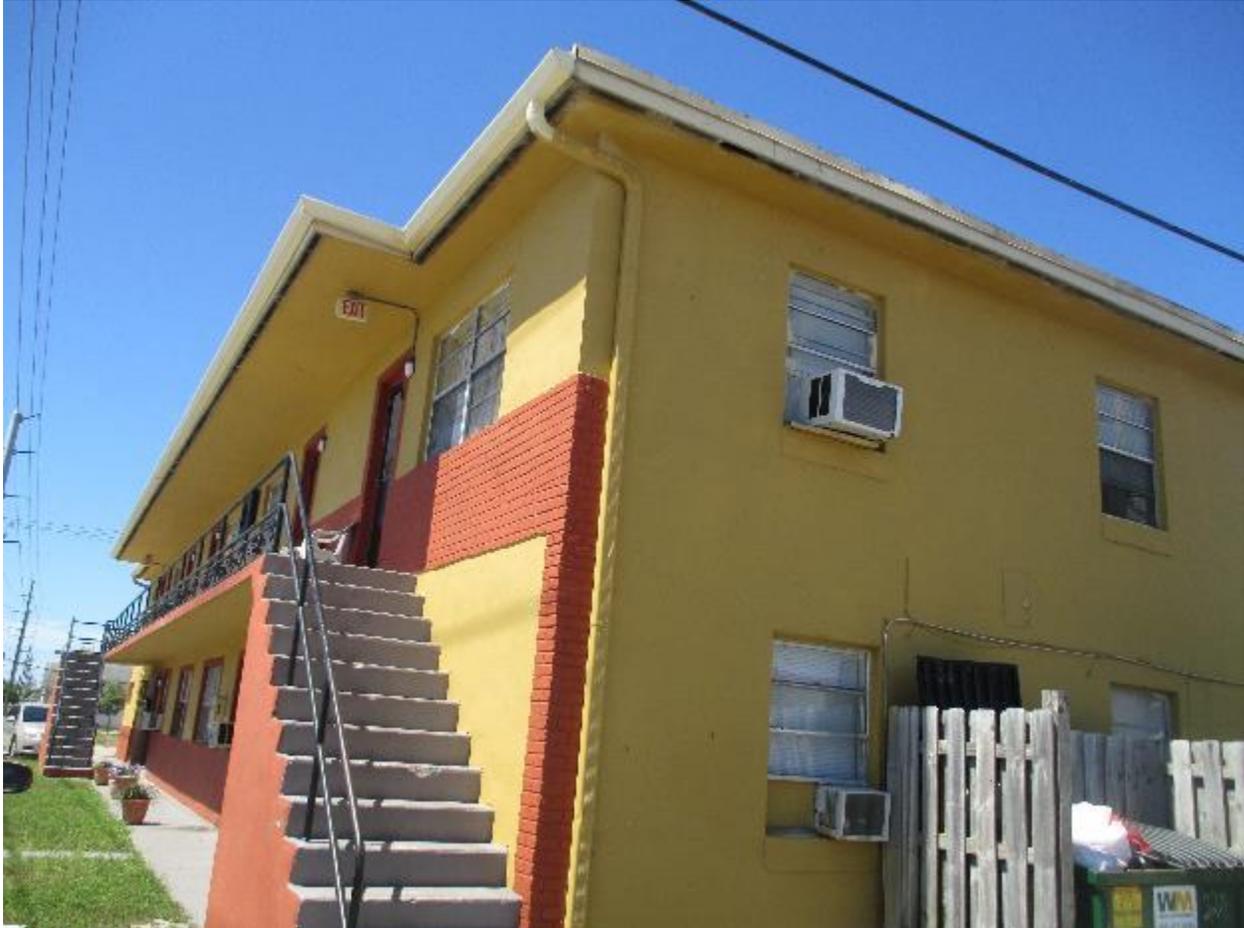
Exterior finishes were found in general good condition at the time of inspection with exceptions as noted and shown in photographs.

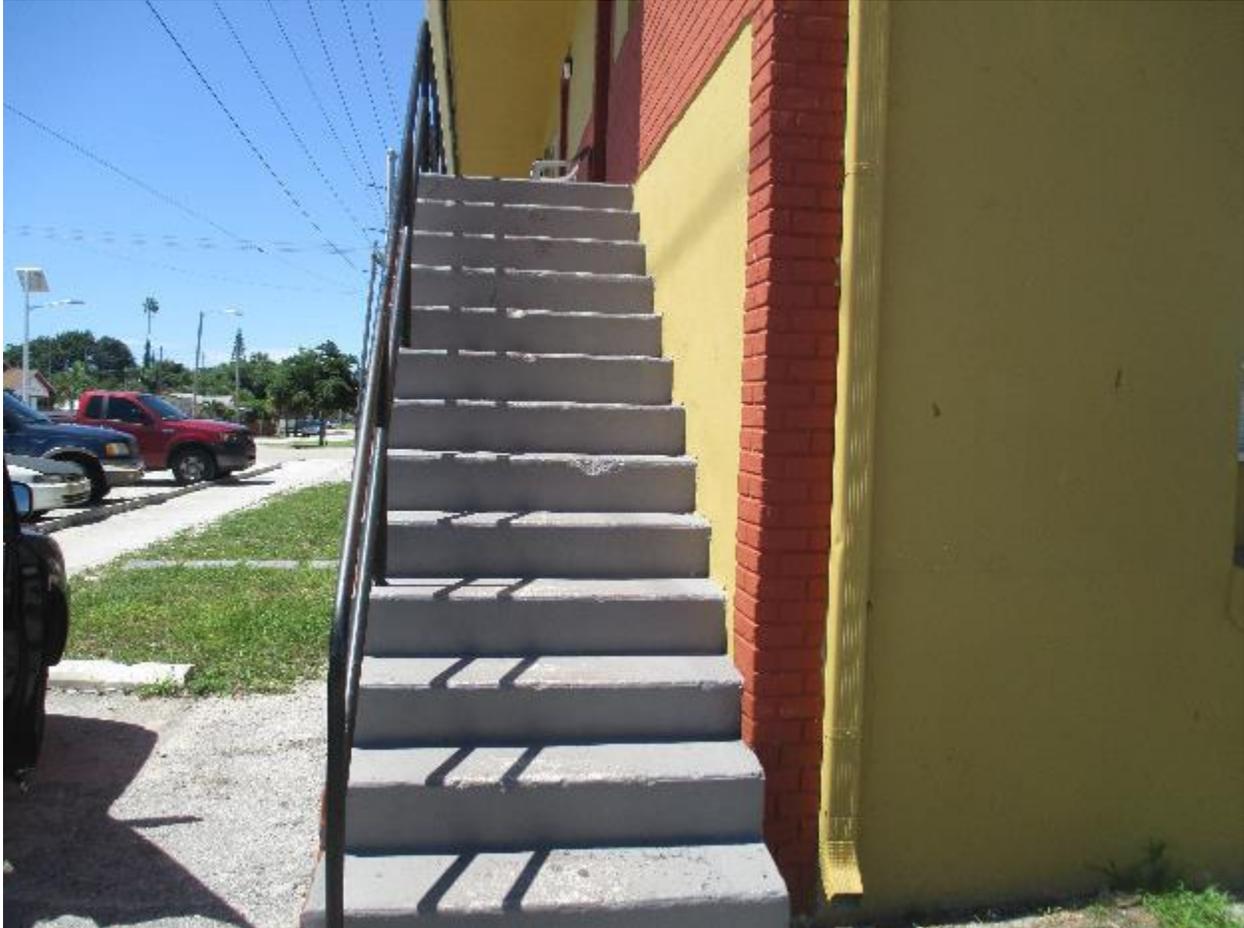
Exterior finishes were found in general good condition at the time of inspection with exceptions as noted and shown in photographs.

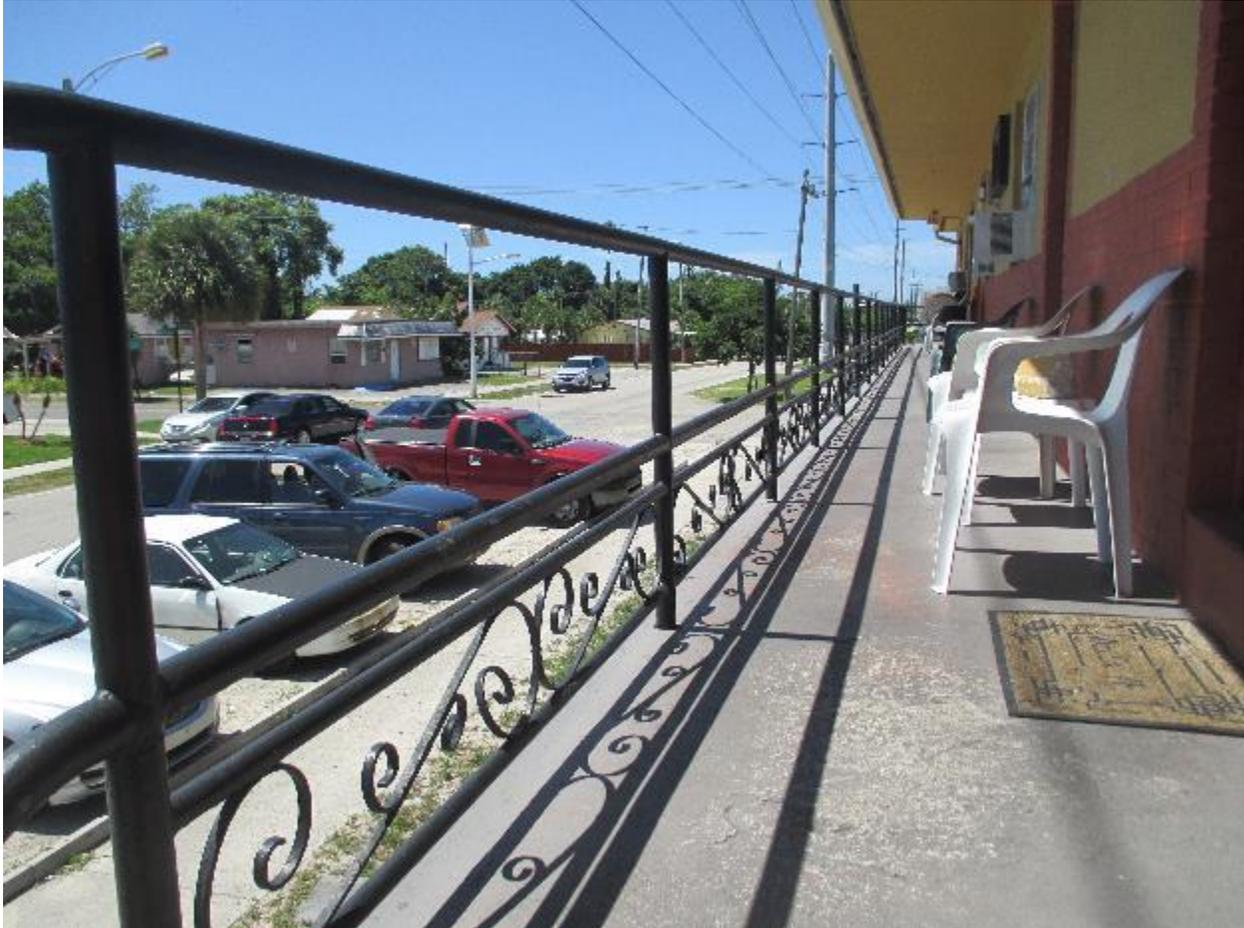
Exterior finishes were found in general good condition at the time of inspection with exceptions as noted and shown in photographs.

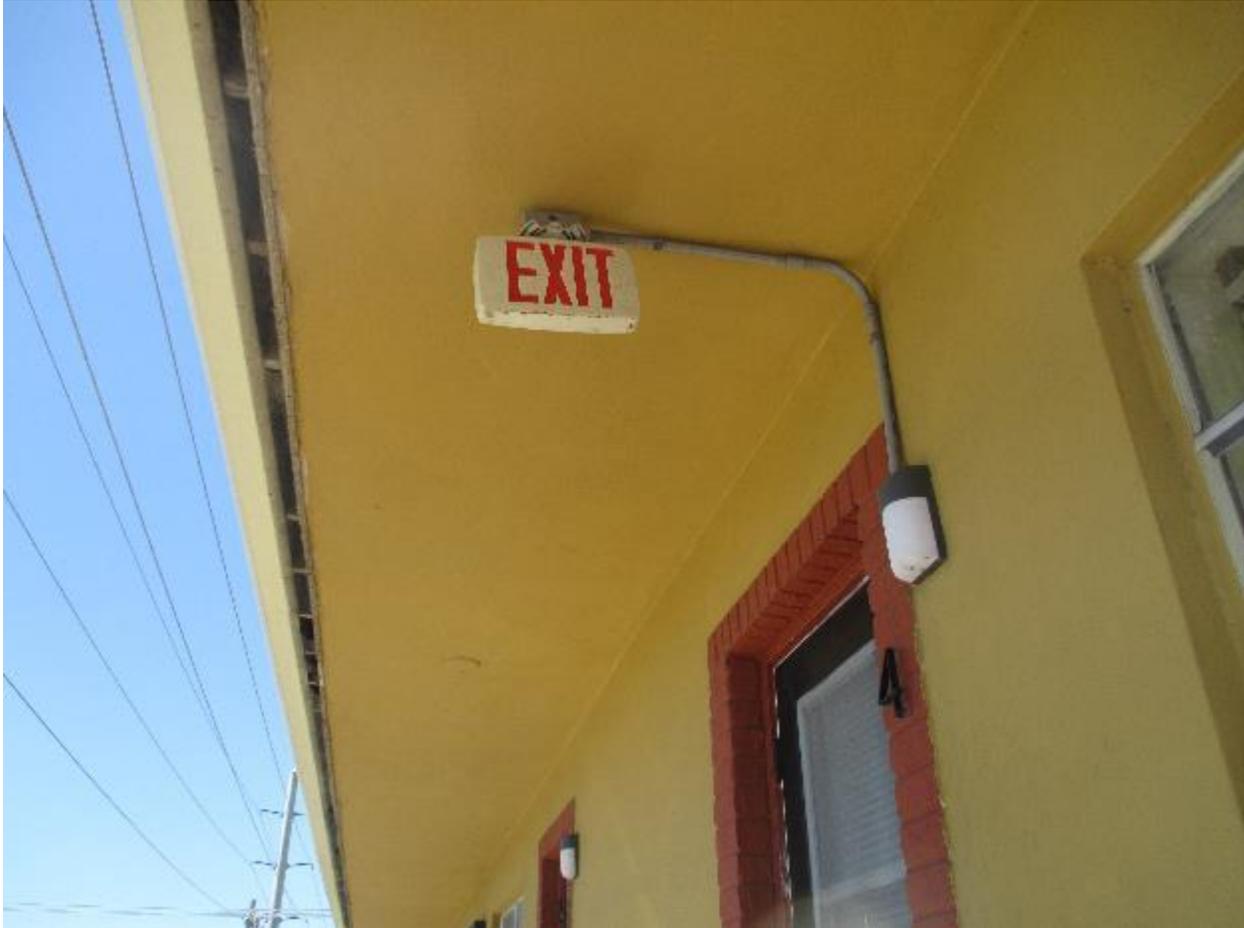
Exterior finishes were found in general good condition at the time of inspection with exceptions as noted and shown in photographs.

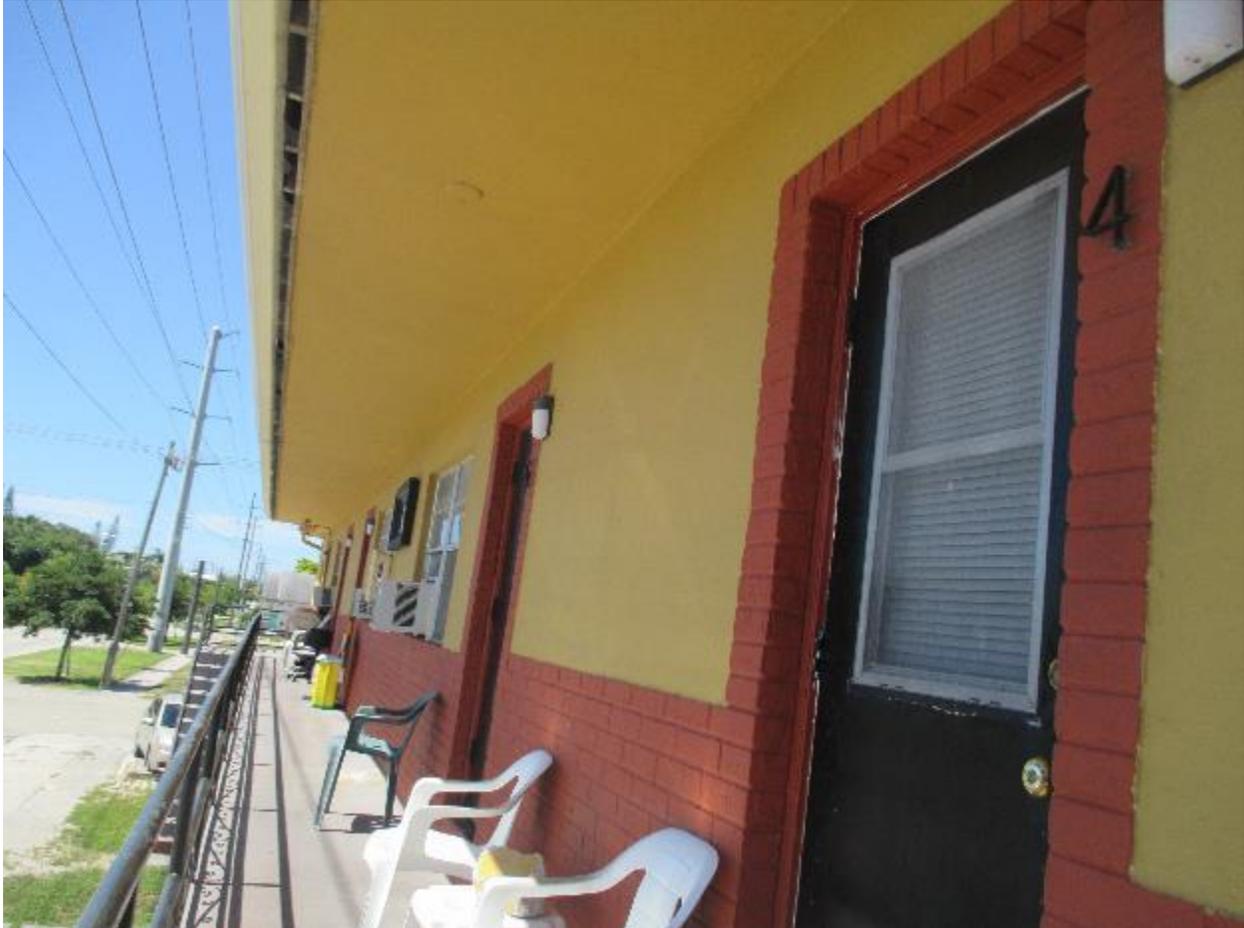
Exterior finishes were found in general good condition at the time of inspection with exceptions as noted and shown in photographs.

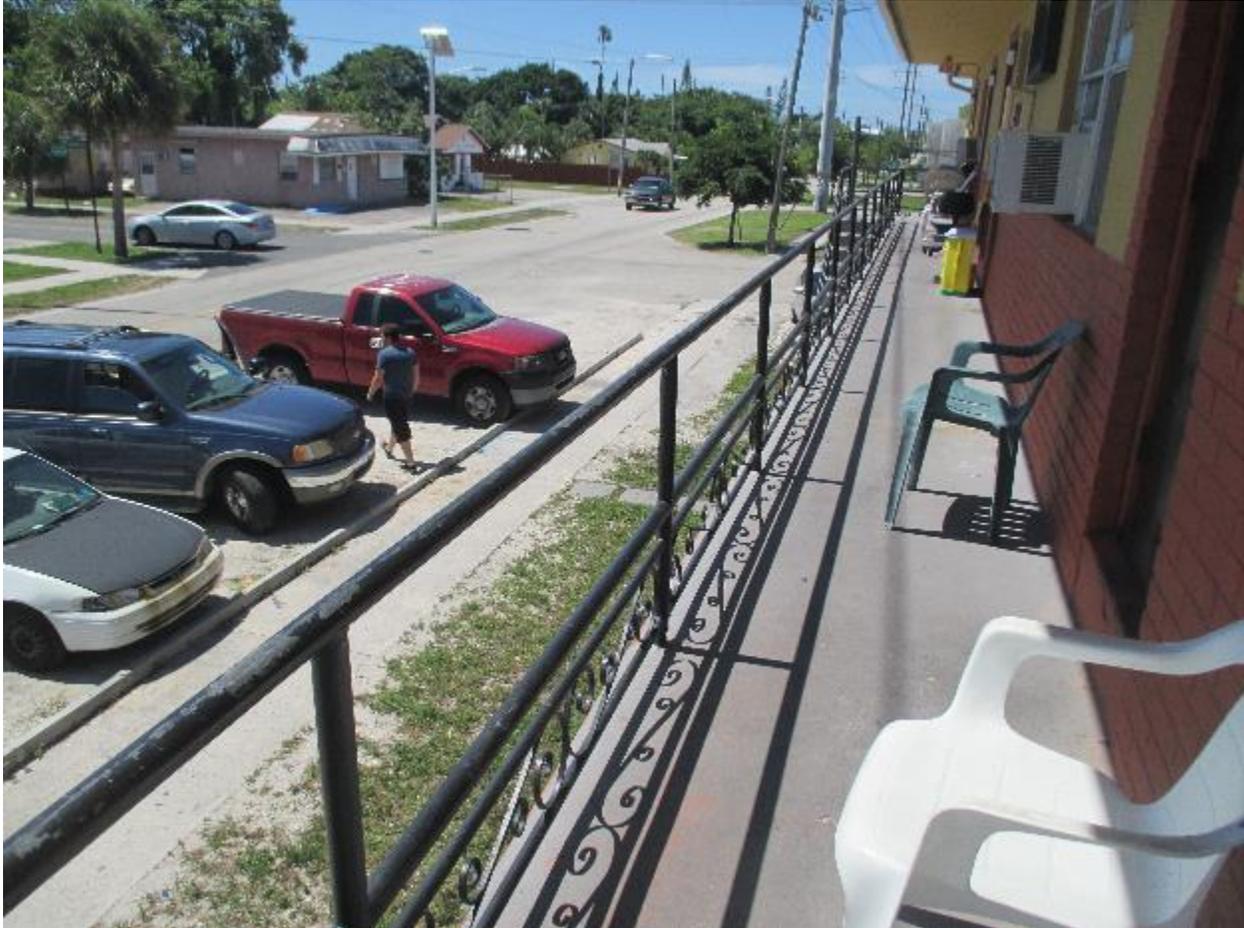
Exterior finishes were found in general good condition at the time of inspection with exceptions as noted and shown in photographs.

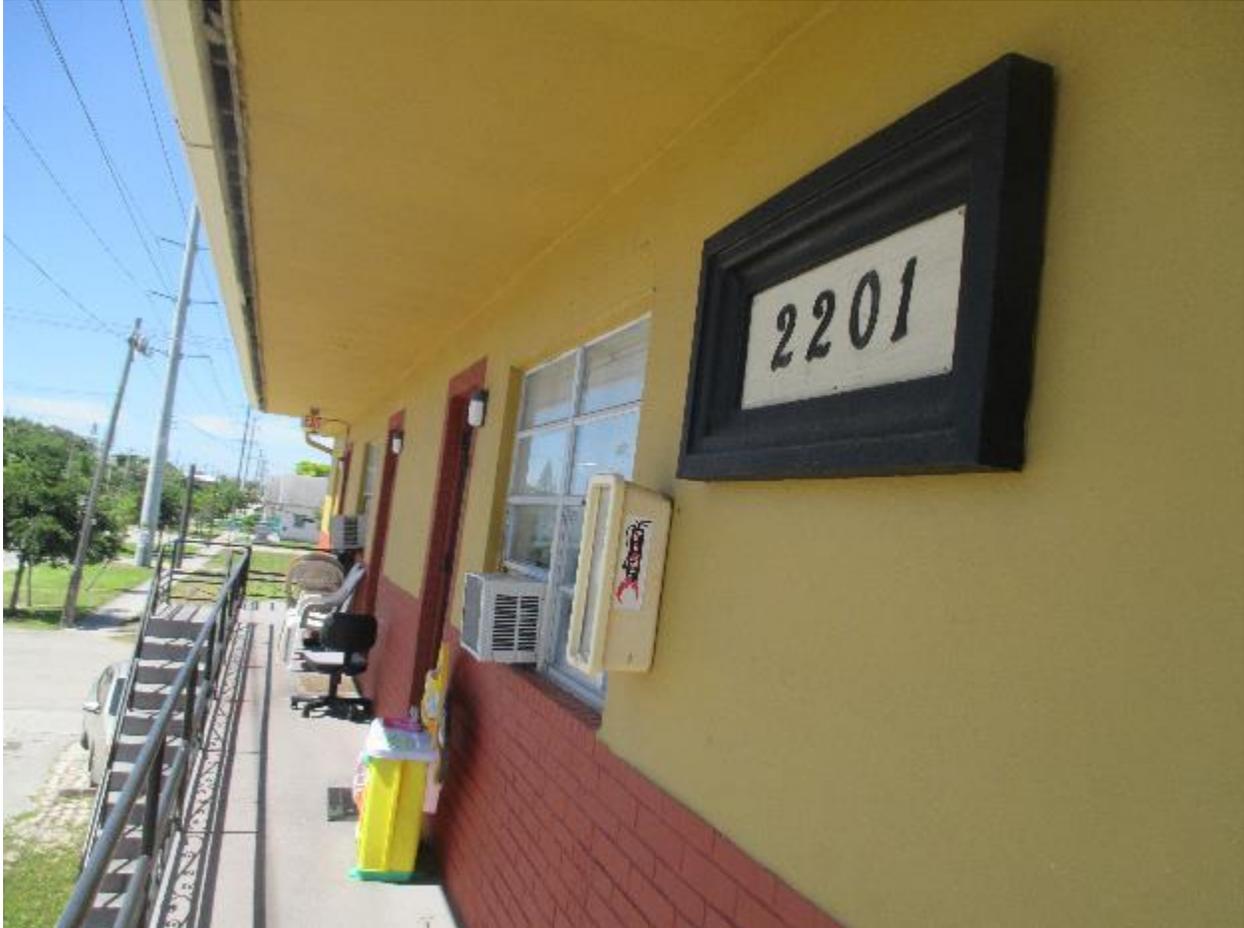
Exterior finishes were found in general good condition at the time of inspection with exceptions as noted and shown in photographs.

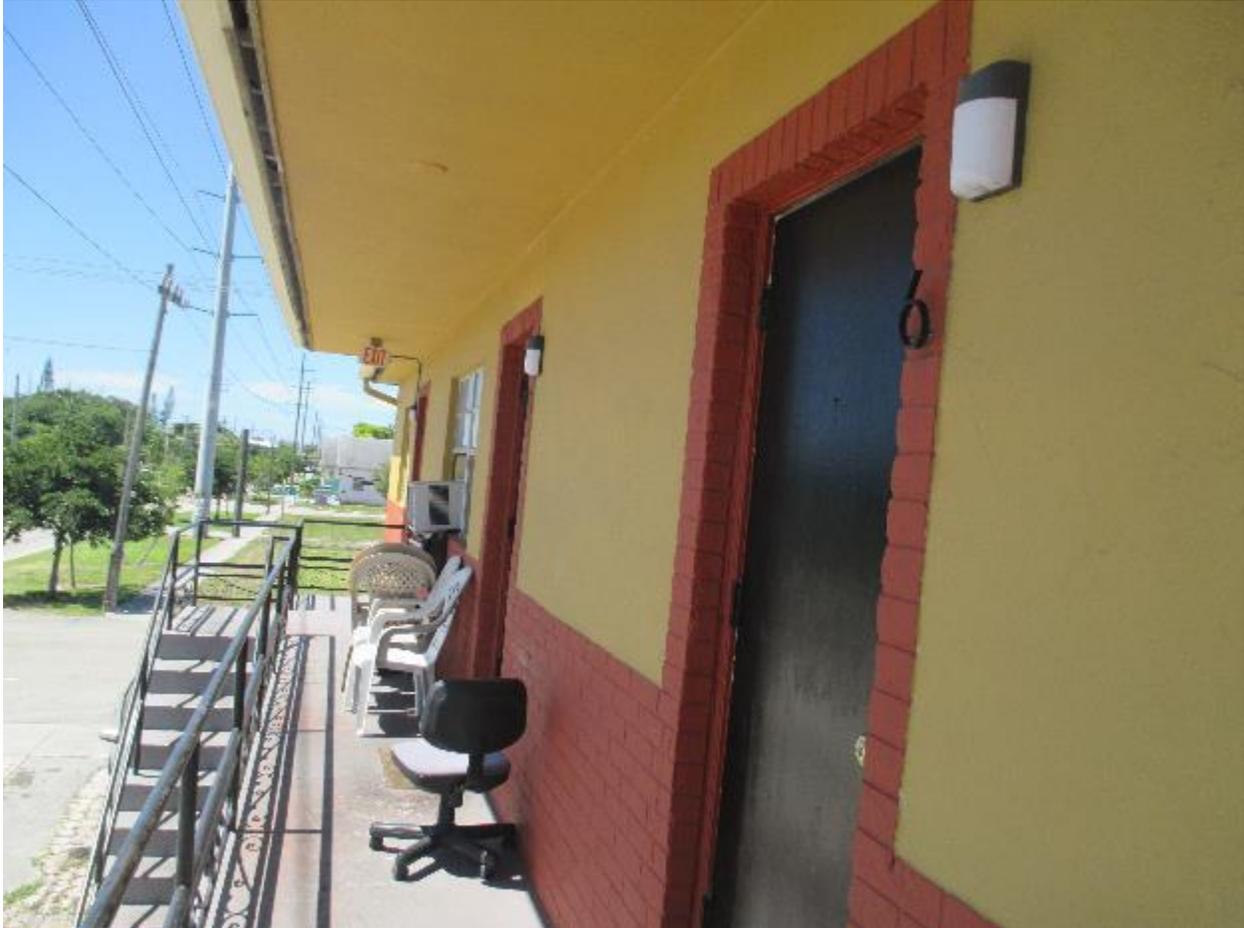
Exterior finishes were found in general good condition at the time of inspection with exceptions as noted and shown in photographs.

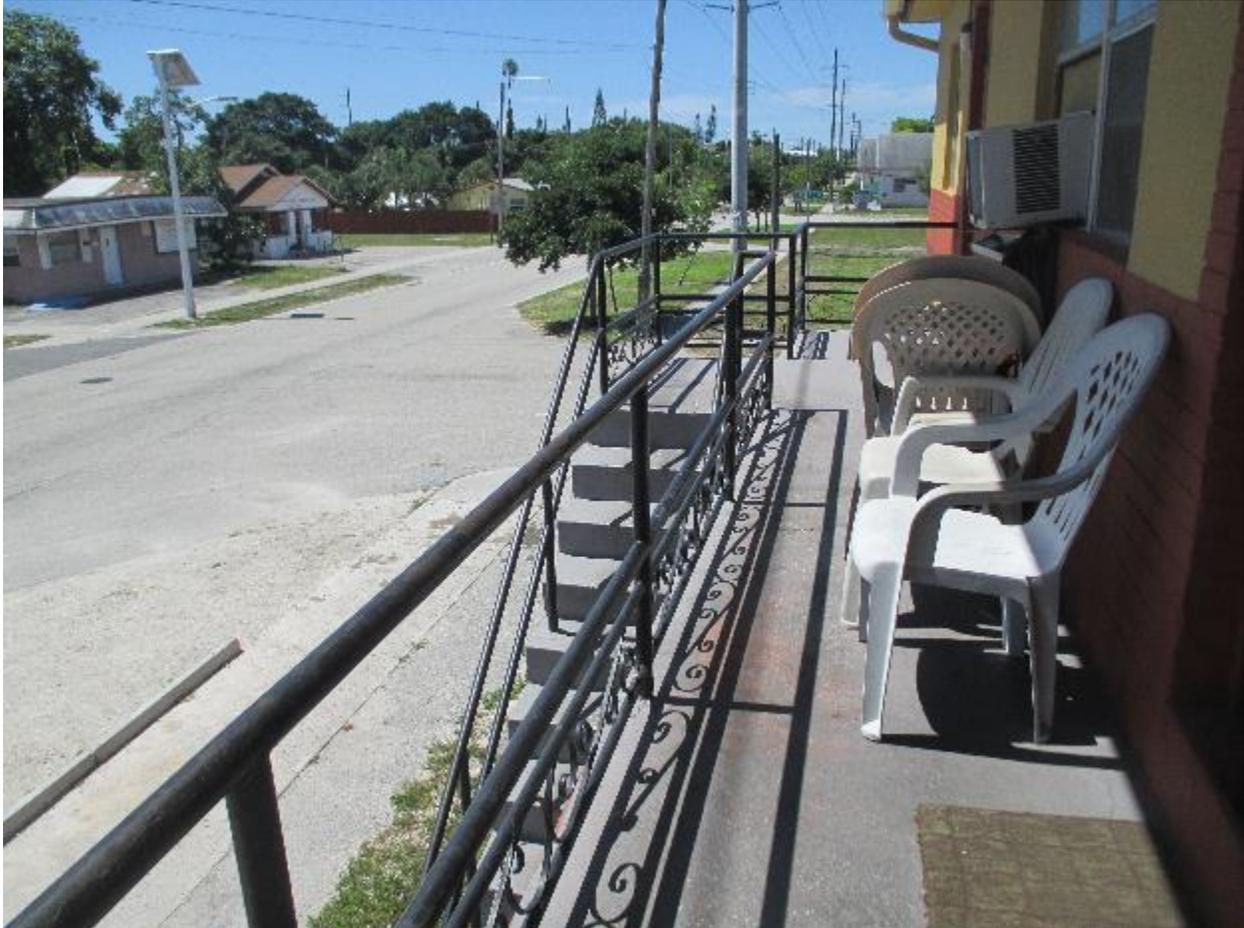
Exterior finishes were found in general good condition at the time of inspection with exceptions as noted and shown in photographs.

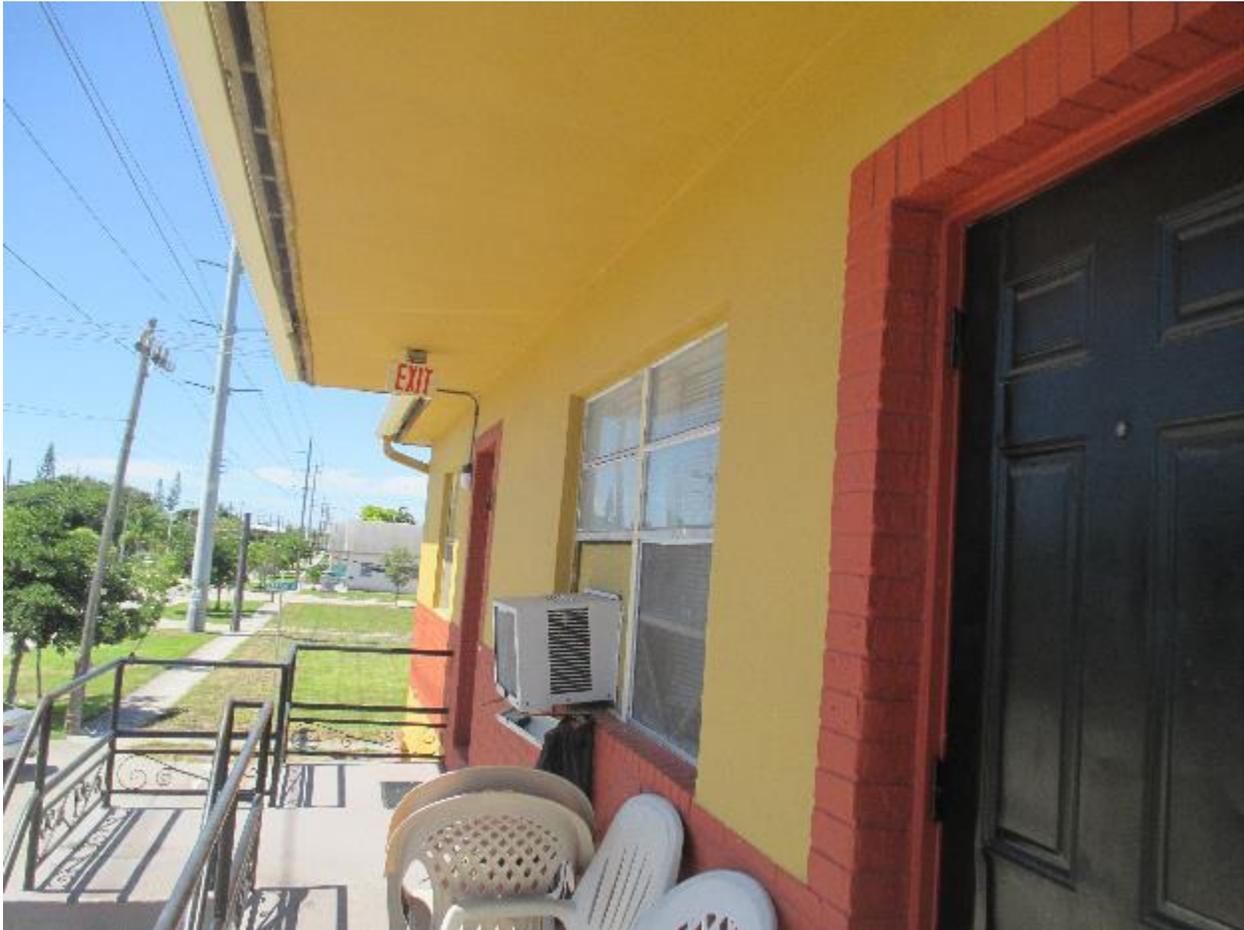
Exterior finishes were found in general good condition at the time of inspection with exceptions as noted and shown in photographs.

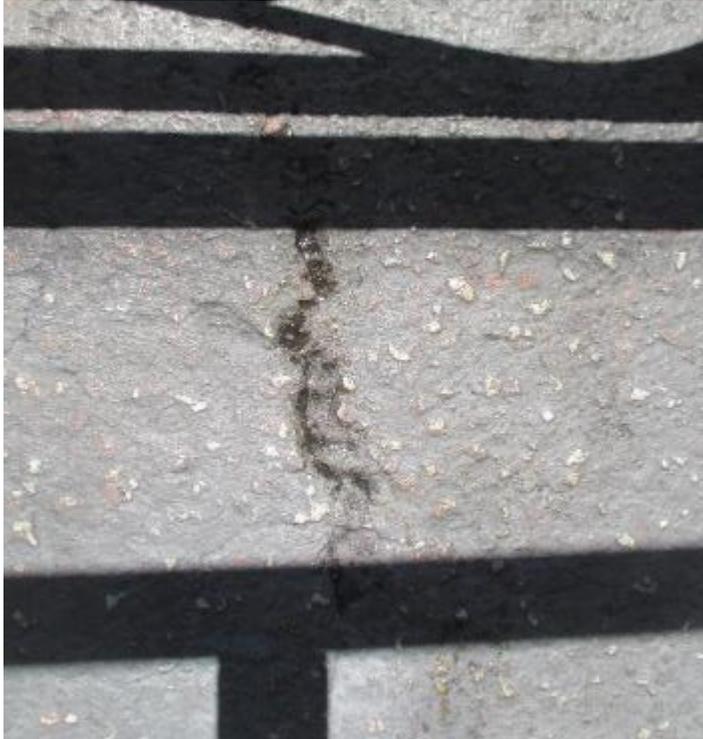
Cracks in slab.

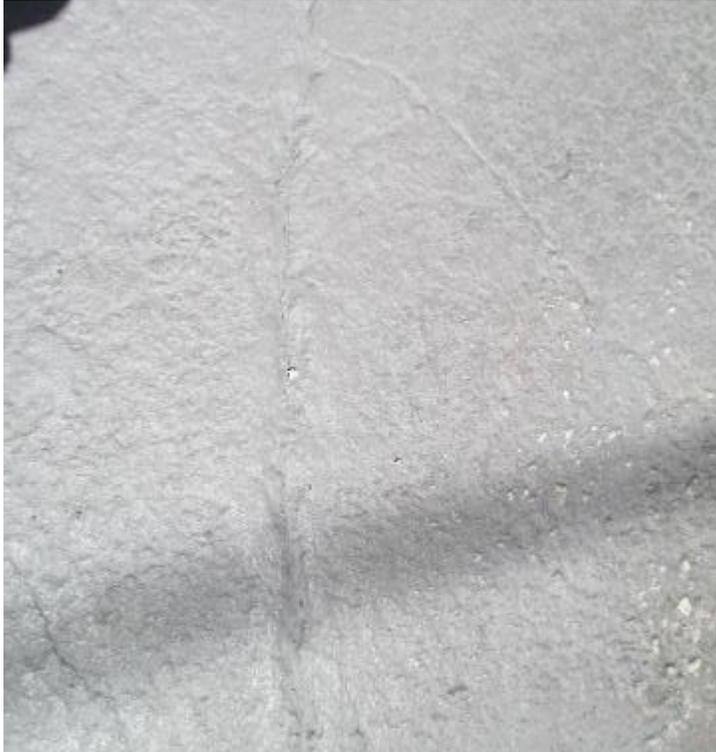
Cracks in slab.

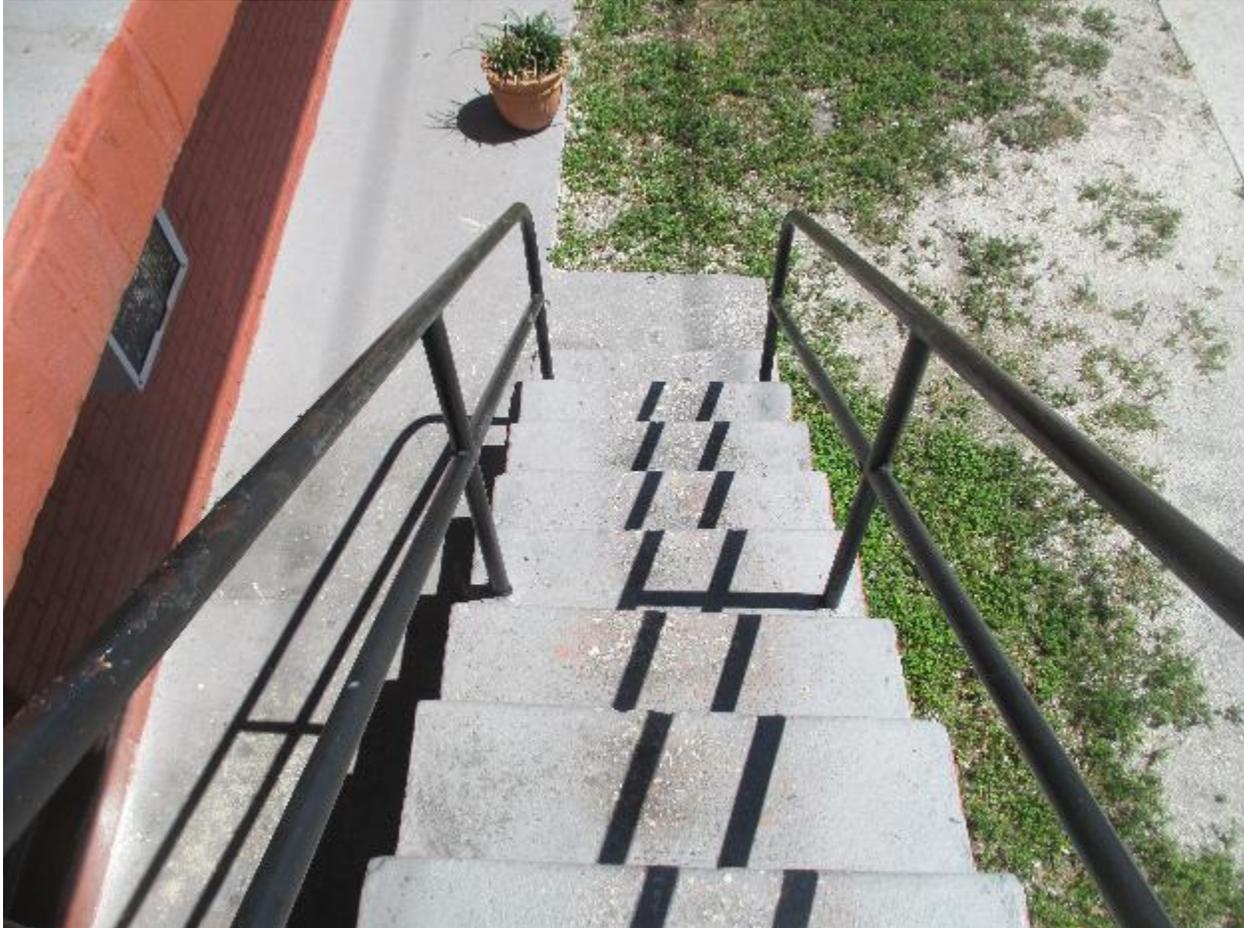
Exterior finishes were found in general good condition at the time of inspection with exceptions as noted and shown in photographs.

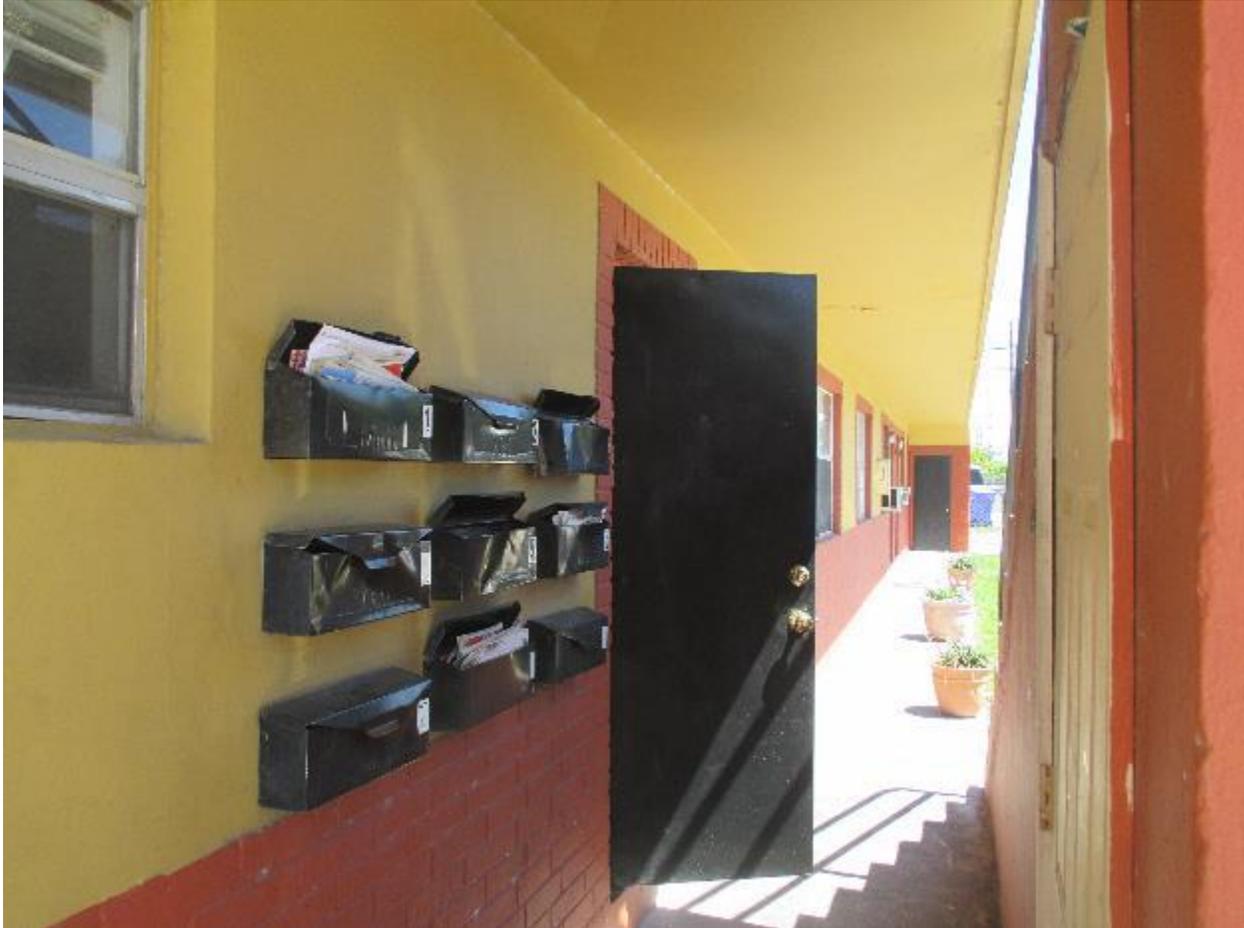
Exterior finishes were found in general good condition at the time of inspection with exceptions as noted and shown in photographs.
