PROPERTY INSPECTION OR ASSESSMENT OF DAMAGES

ADDRESS: **SOMEWHERE , FL**
CLIENT: **GAIA GC**
ID No: **2015000**
DATE: **12/31/xxxx**

GAIA CONSTRUCTION INC.
CGC 1516136 FLORIDA
HI-2792 FLORIDA
8028867-B2 INTERNATIONAL CODE COUNCIL

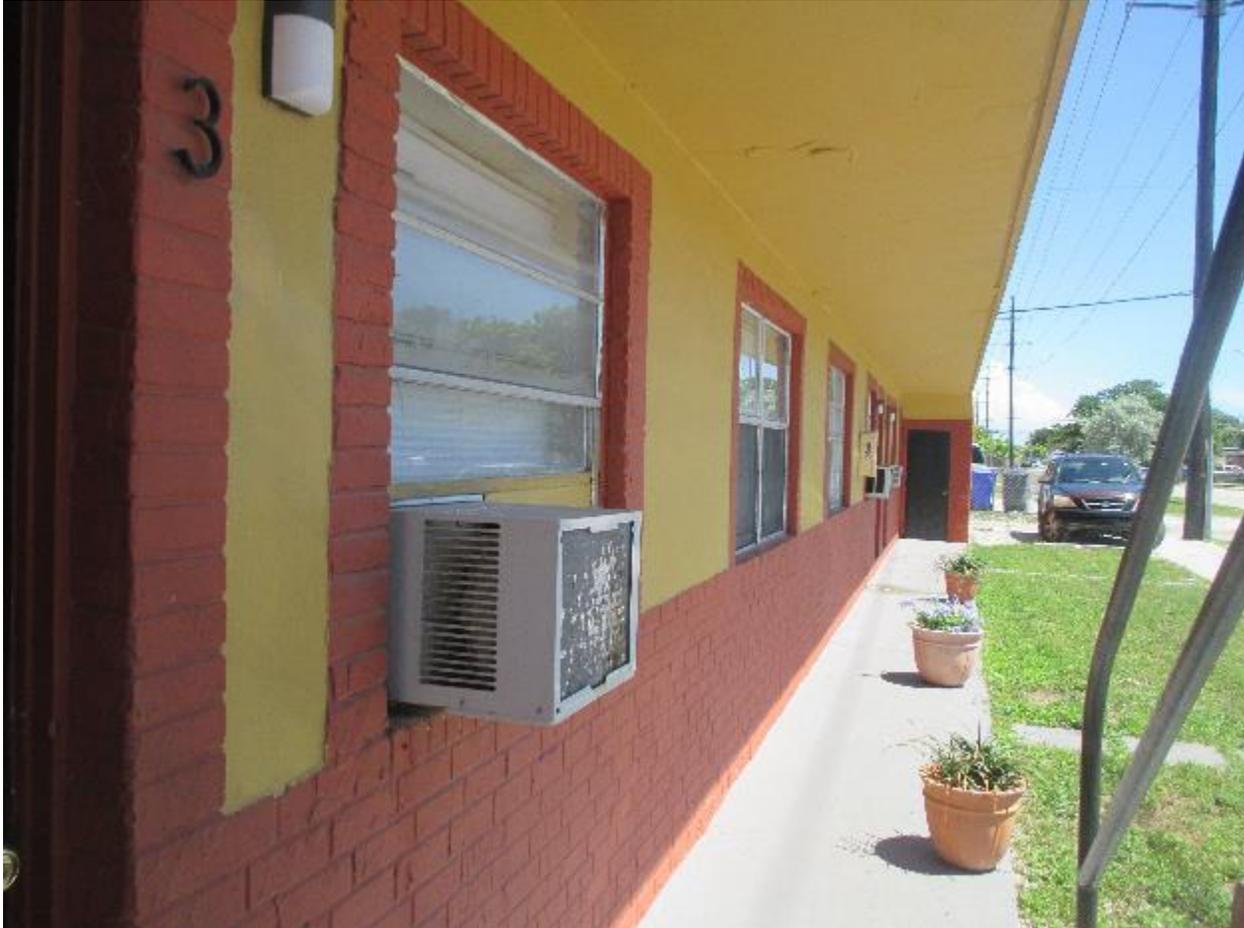
Exterior finishes were found in general good condition at the time of inspection with exceptions as noted and shown in photographs.

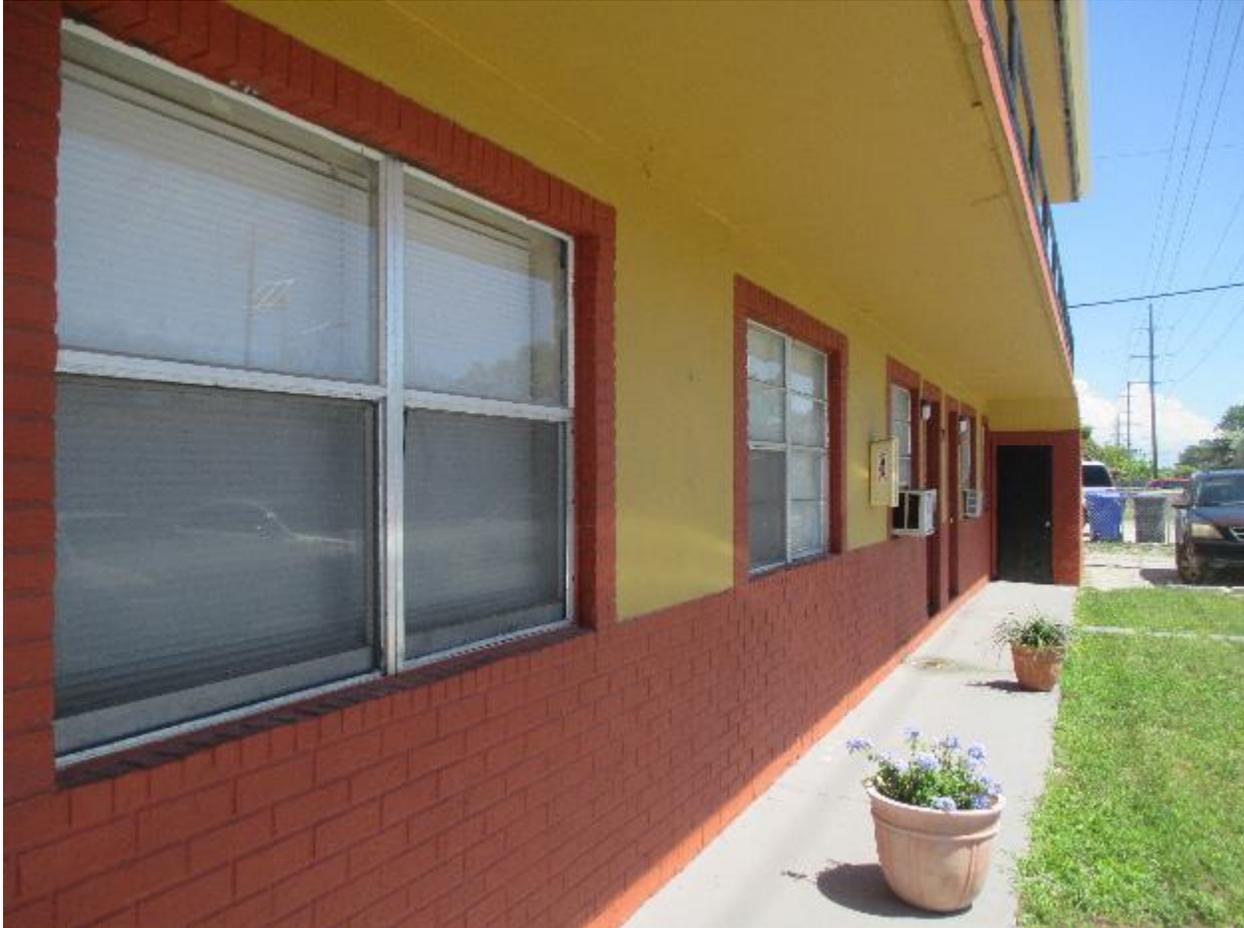
Exterior finishes were found in general good condition at the time of inspection with exceptions as noted and shown in photographs.

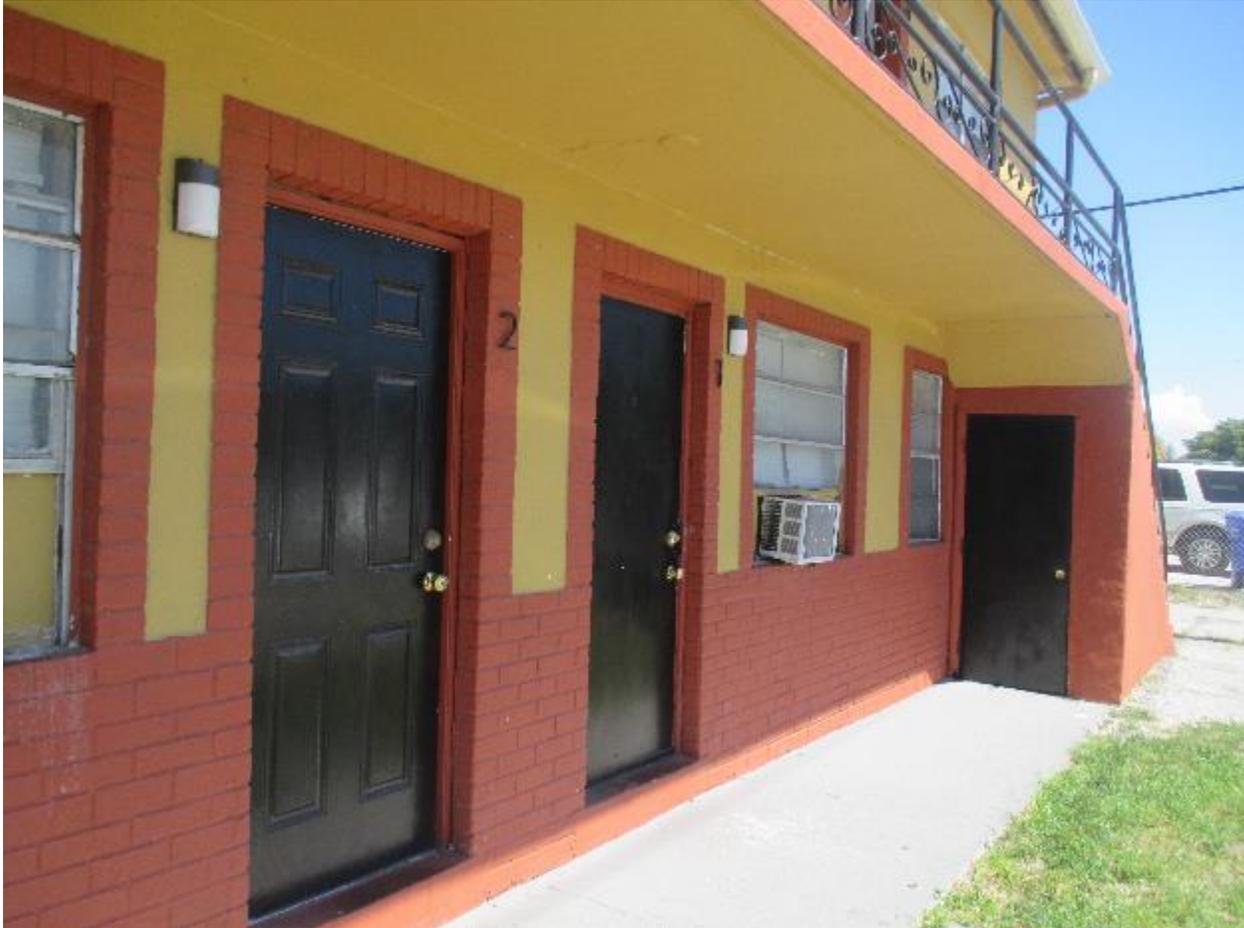
Exterior finishes were found in general good condition at the time of inspection with exceptions as noted and shown in photographs.

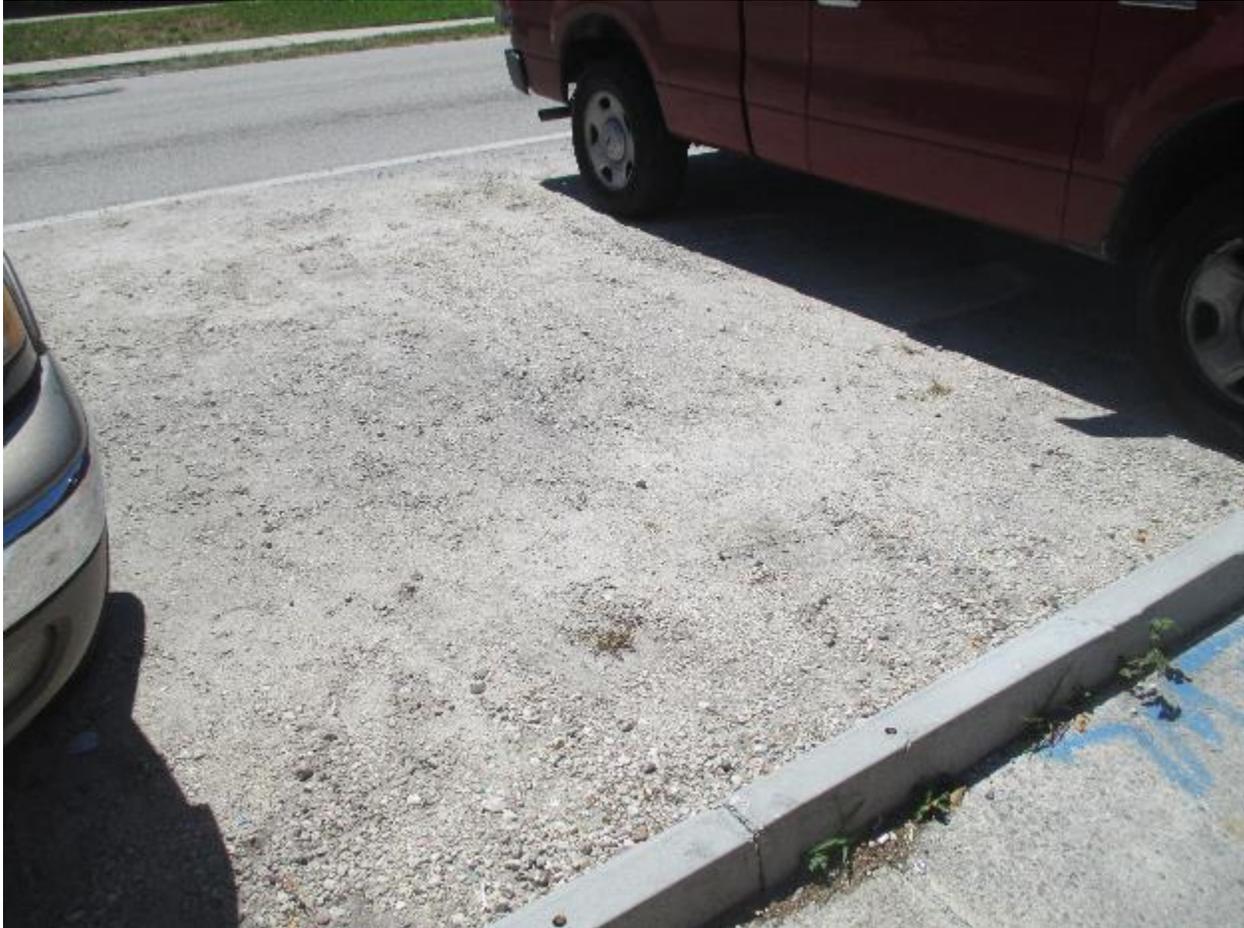
Missing driveway surface.
