PROPERTY INSPECTION OR ASSESSMENT OF DAMAGES

ADDRESS: Somewhere, FL
CLIENT: GAIA GC
ID No: 2015000
DATE: 12/31/2015

INSPECTION OR ASSESSMENT BY:

GAIA CONSTRUCTION INC.
CGC 1516136 **FLORIDA**
HI-2792 **FLORIDA**
8028867-B2 **INTERNATIONAL CODE COUNCIL**

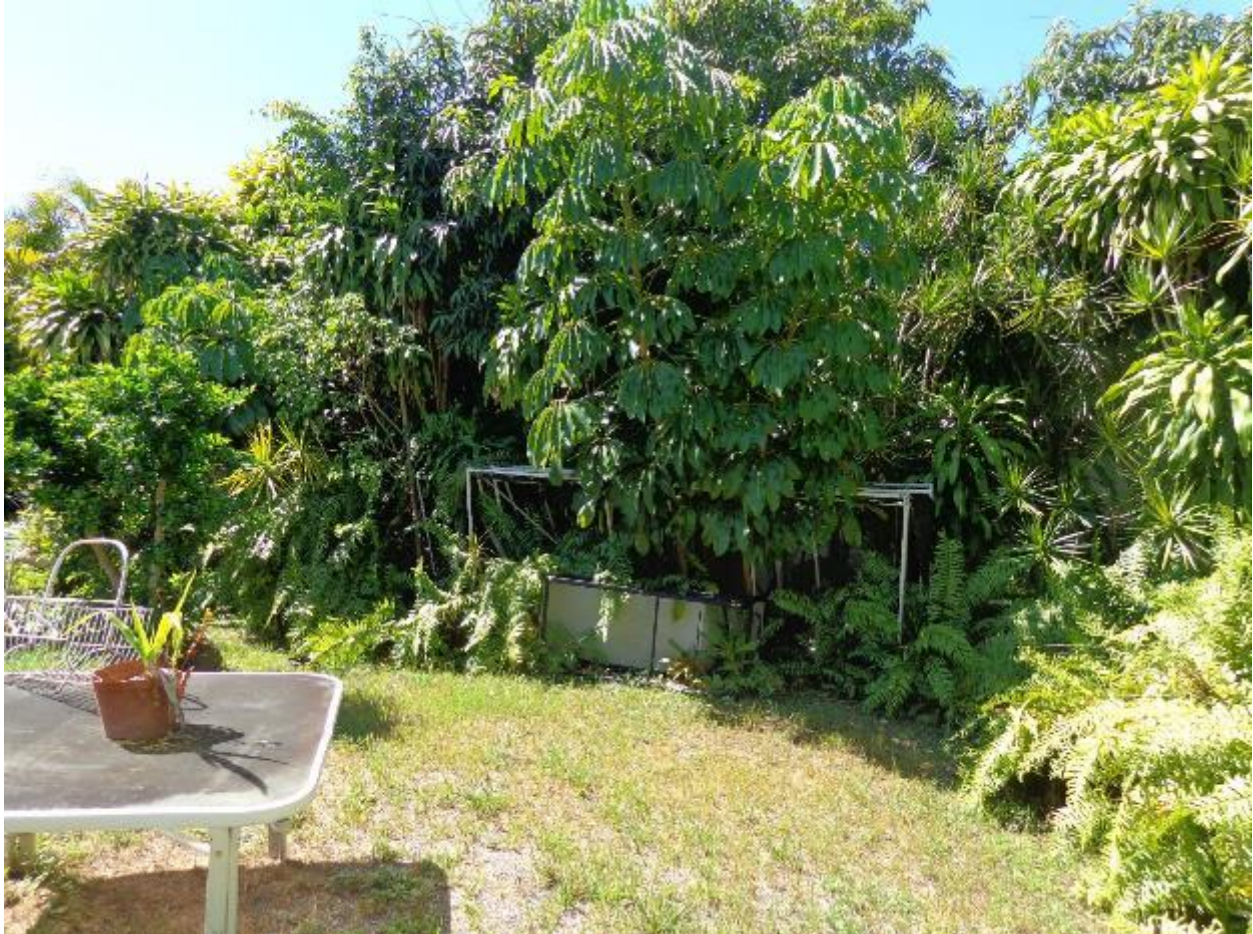
Allowances must be made for the removal of overgrown vegetation.

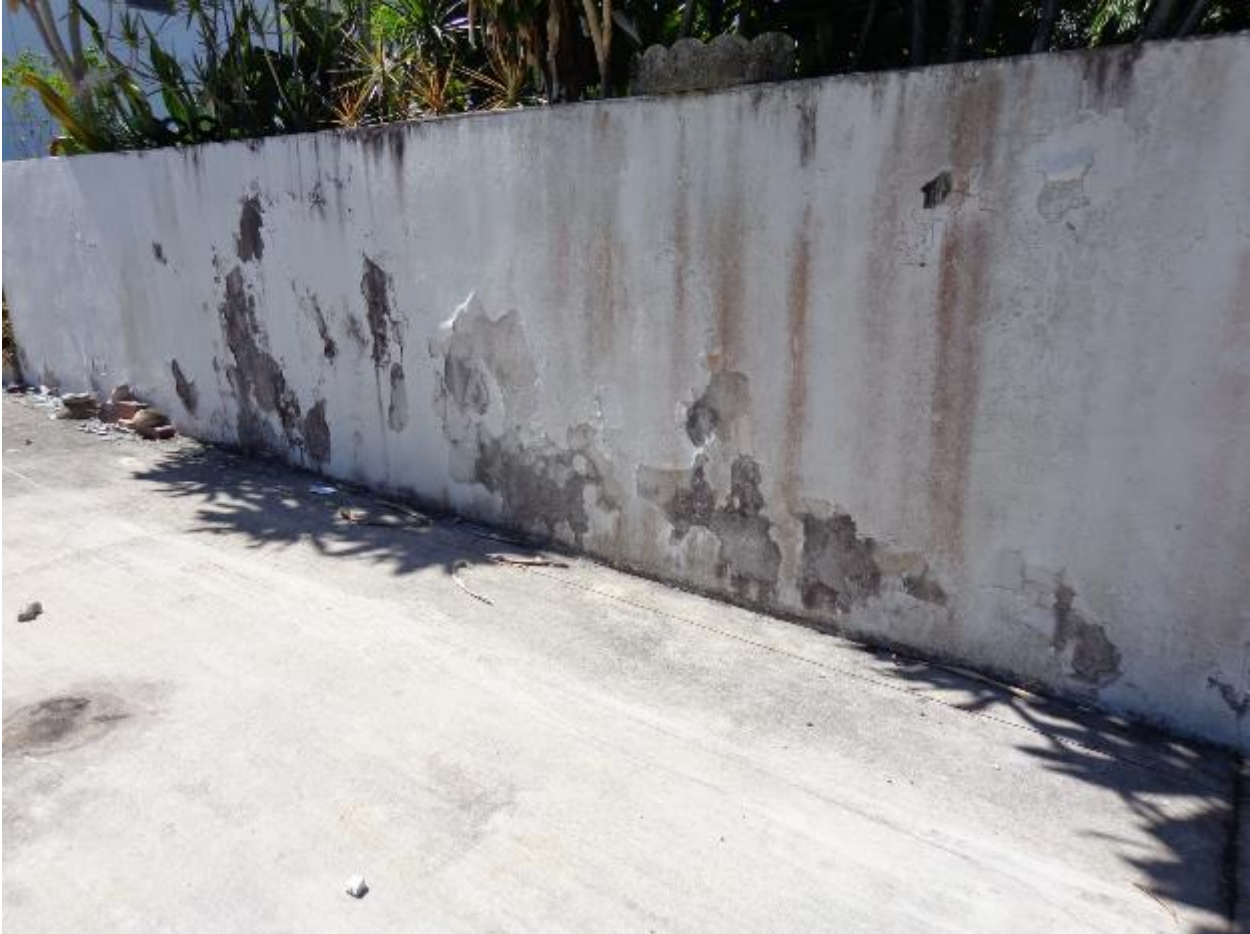
Exterior walls require proper waterproofing application in order to avoid water damage caused by fracture of the stucco work.

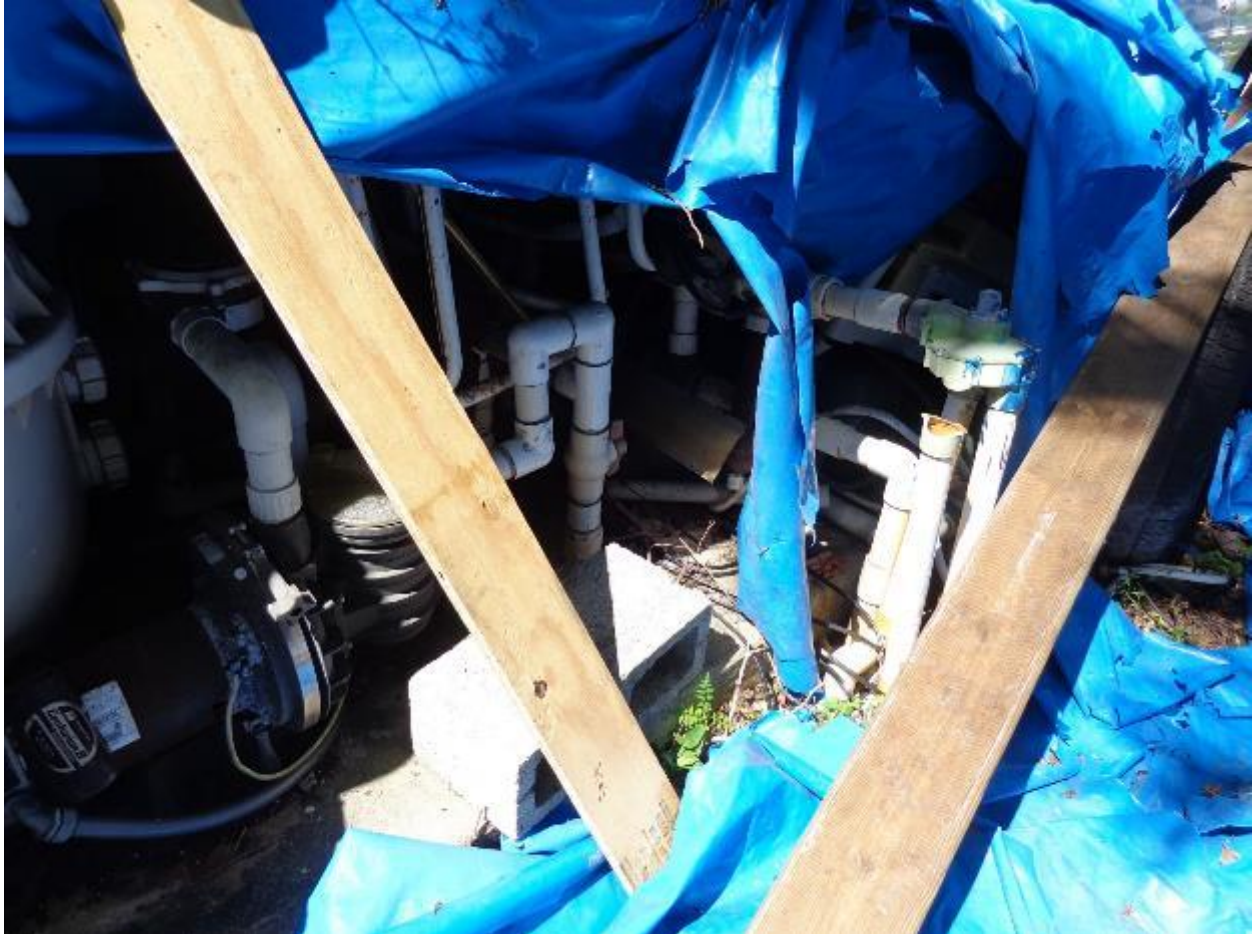
Equipment not tested / not running at the time of inspection. Electrical service unavailable at the time of inspection.

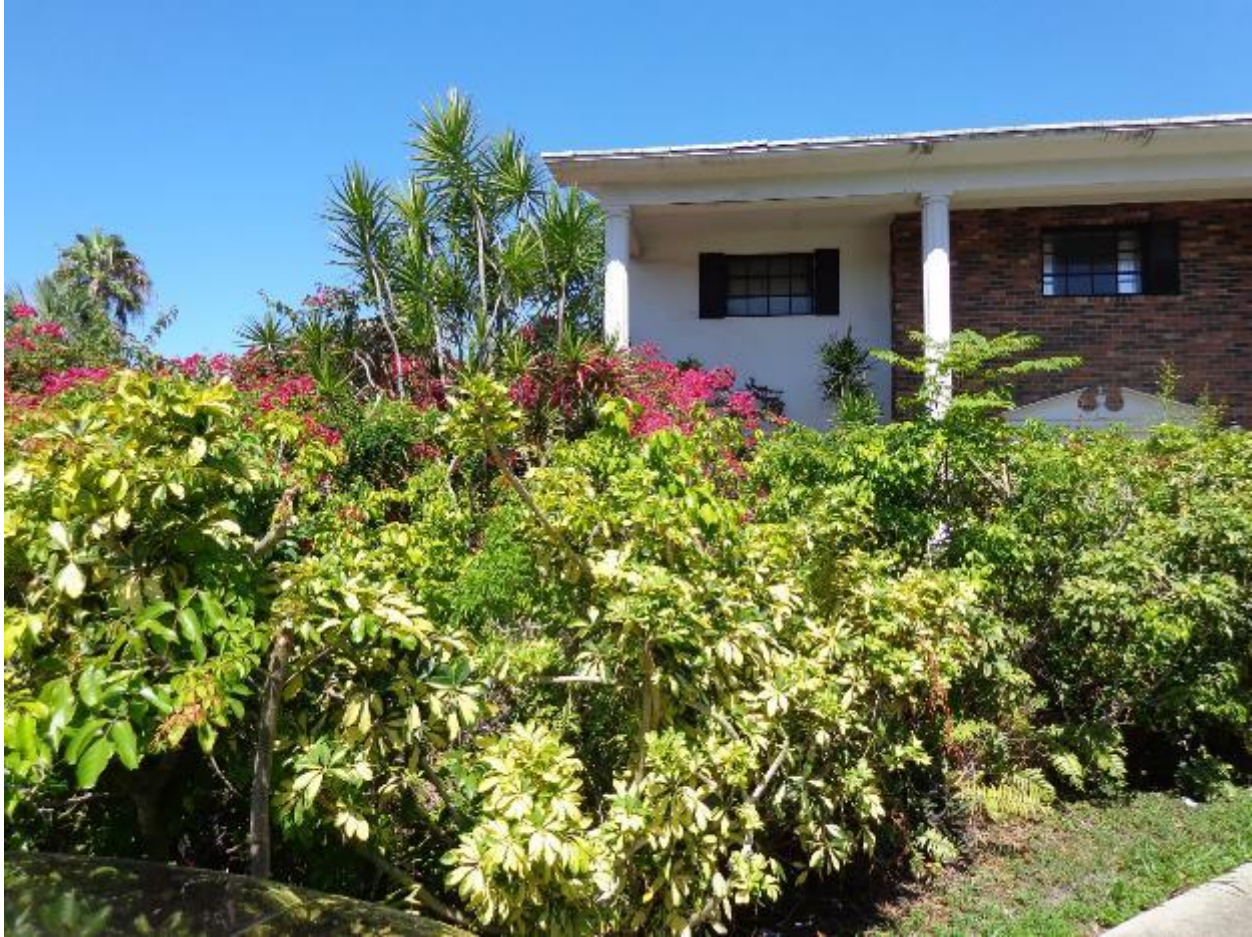
Allowances must be made for the removal of overgrown vegetation.

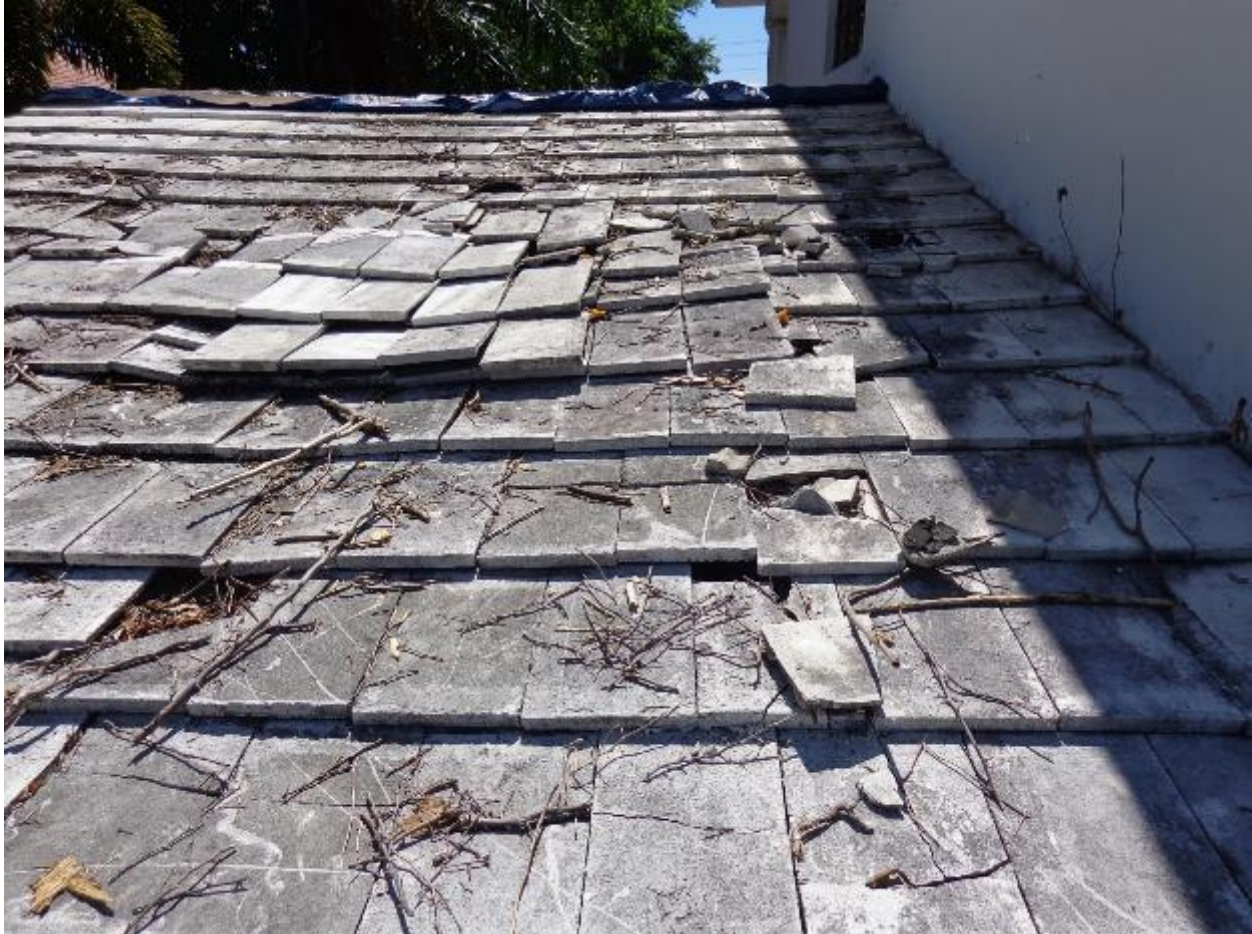
Roof covering has reached the end of its useful life; new roofing is required to be installed on the entire property.

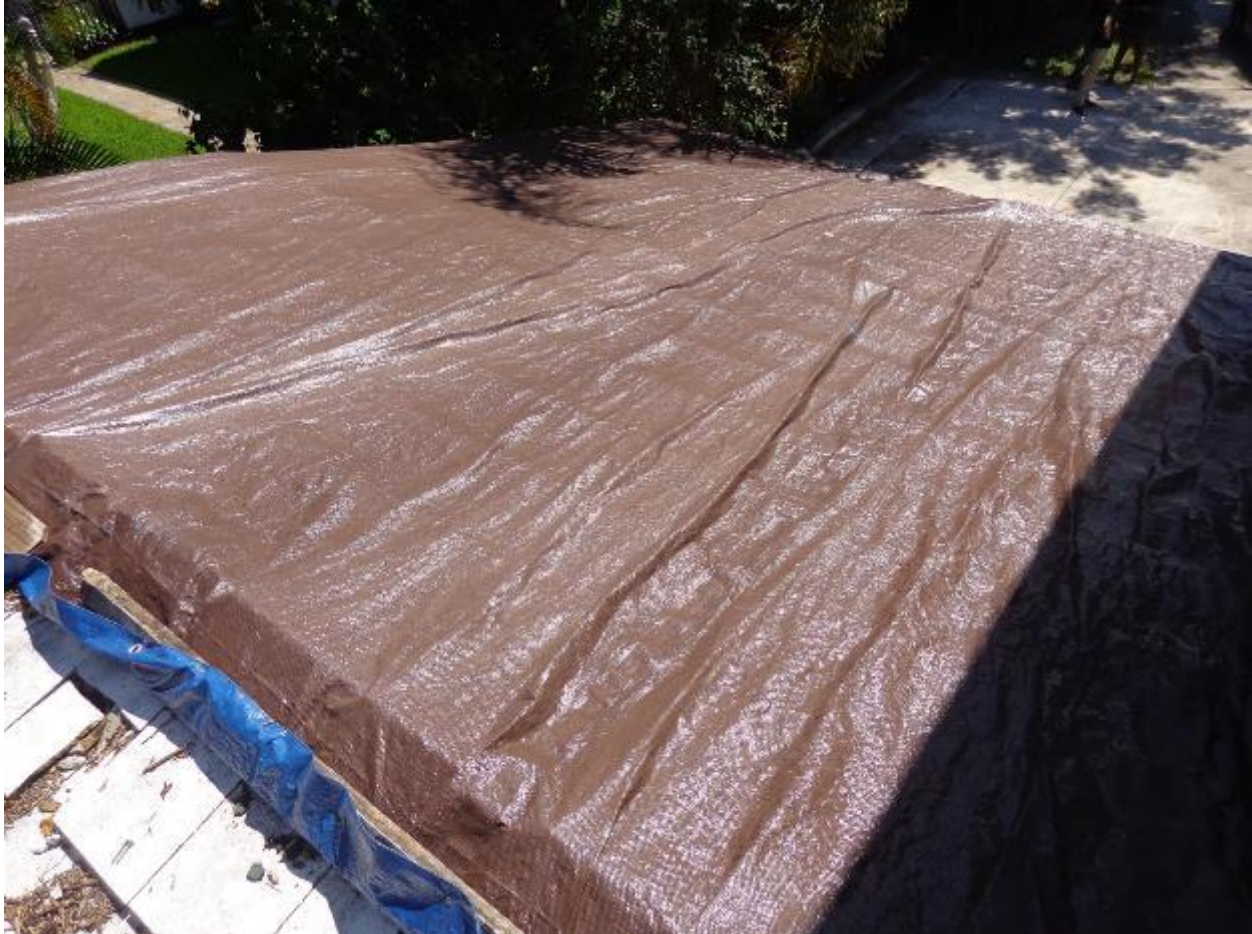
Roof covering has reached the end of its useful life; new roofing is required to be installed on the entire property.

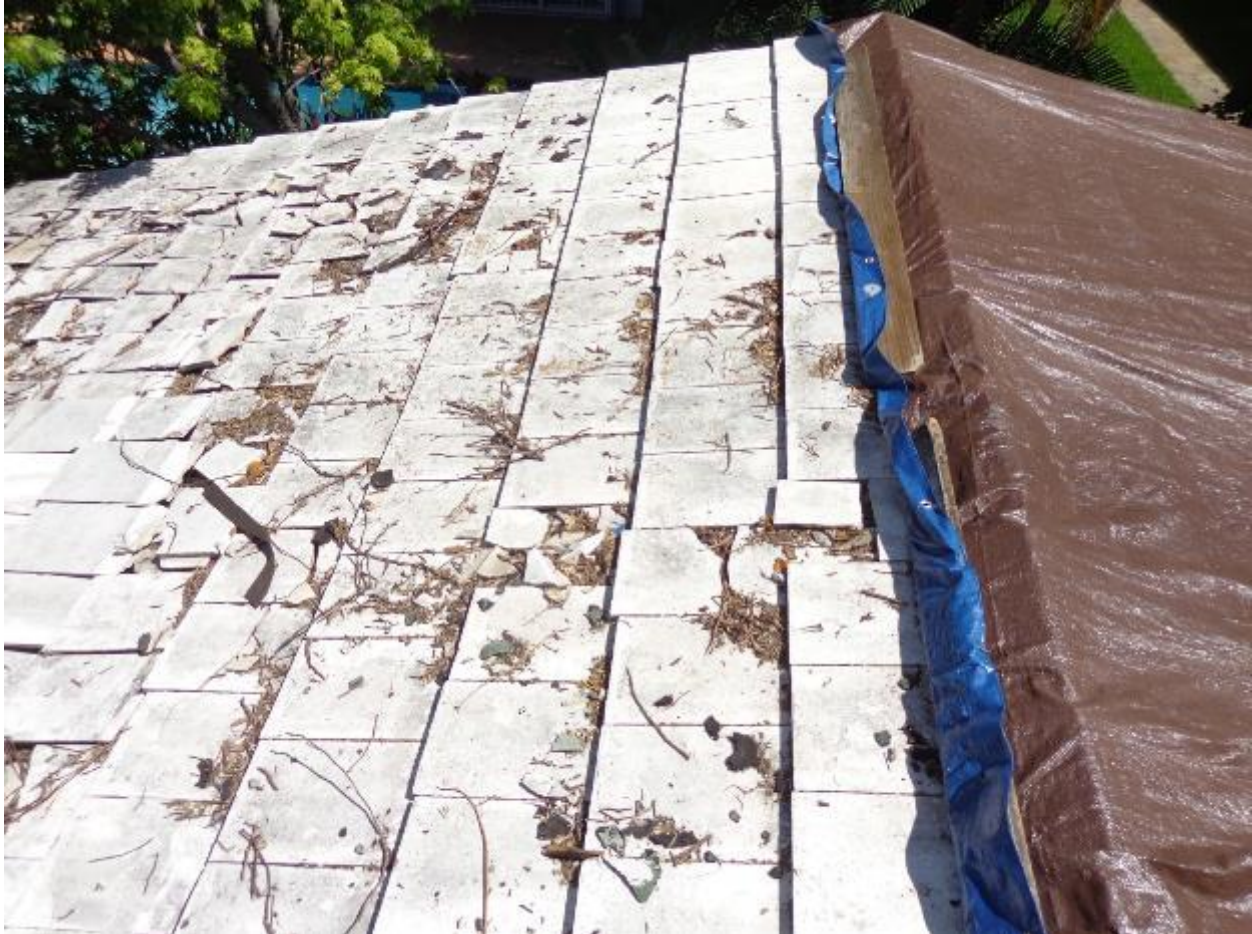
Roof covering has reached the end of its useful life; new roofing is required to be installed on the entire property.

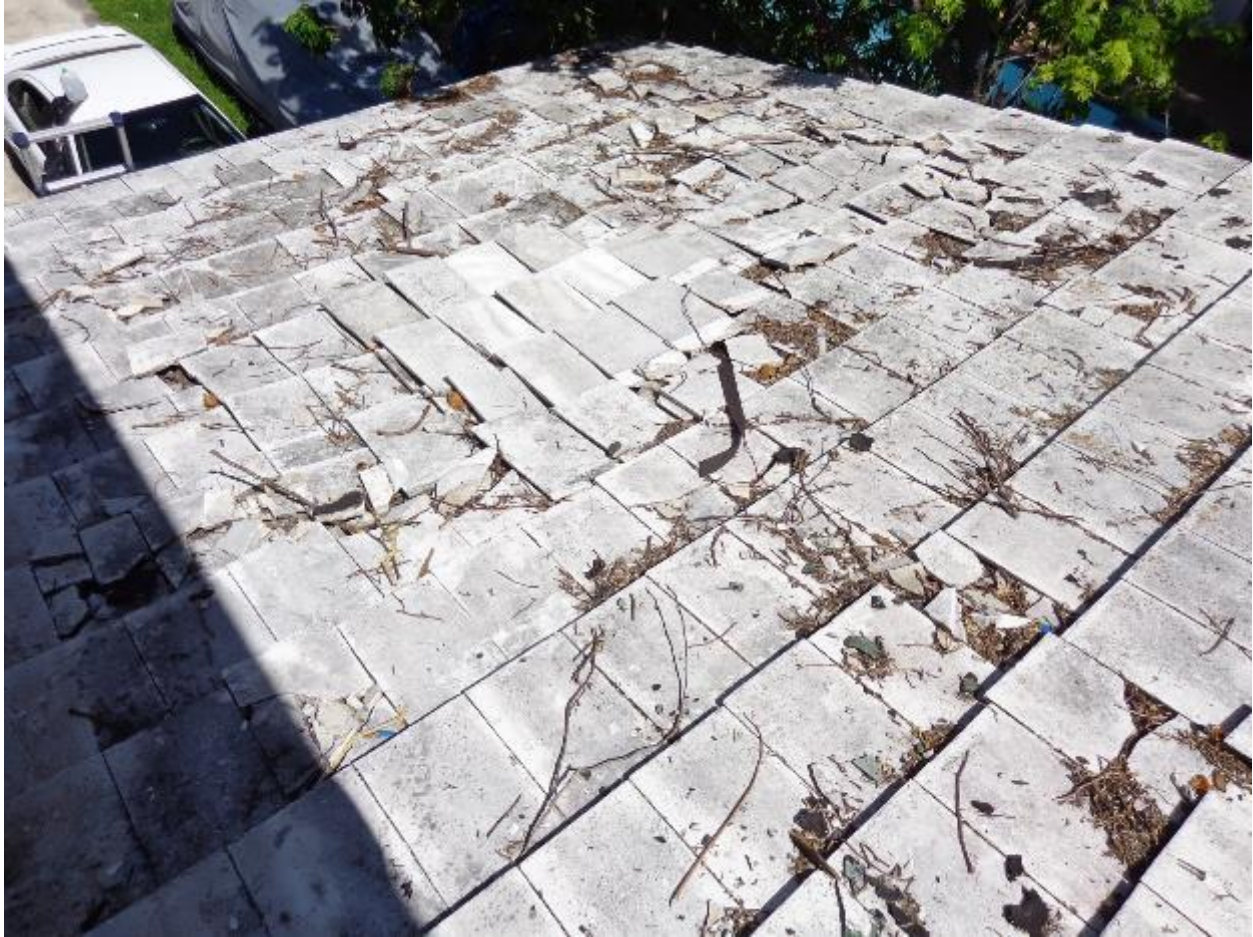
Roof covering has reached the end of its useful life; new roofing is required to be installed on the entire property.

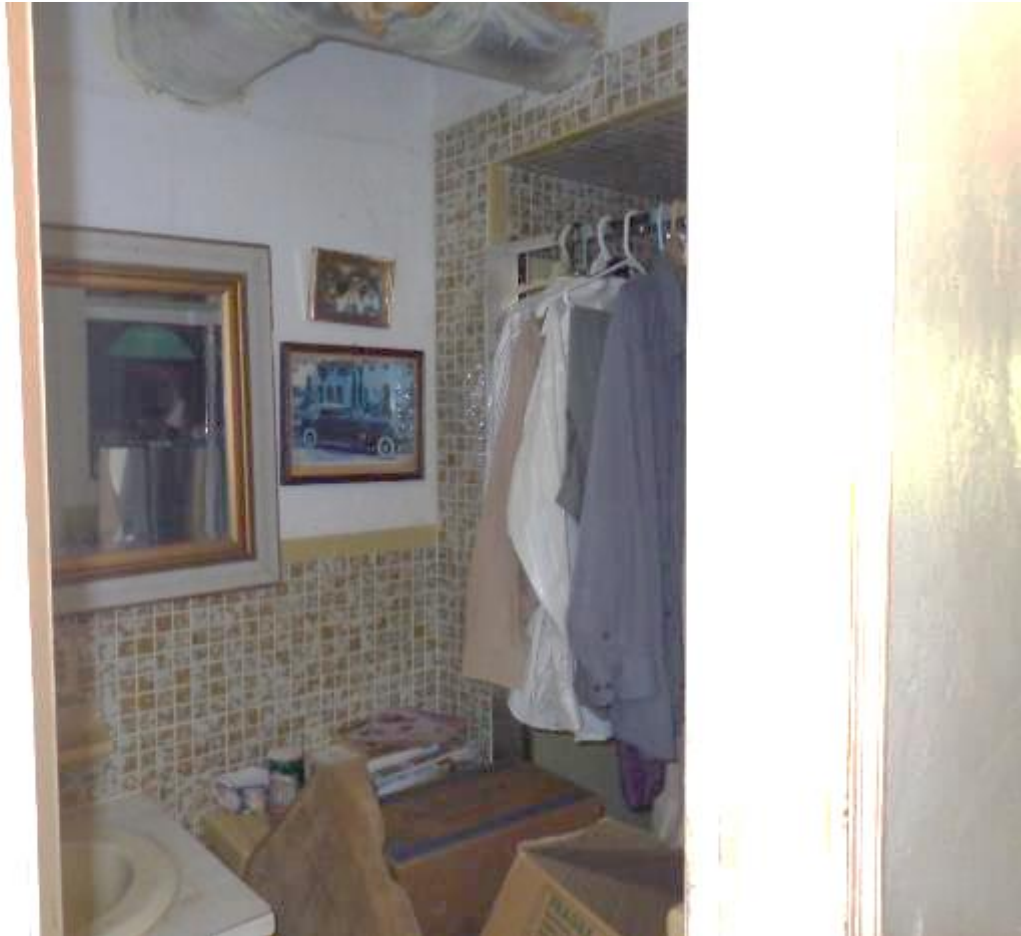
Allowances must be made for the complete upgrade of finishes in bathroom(s).

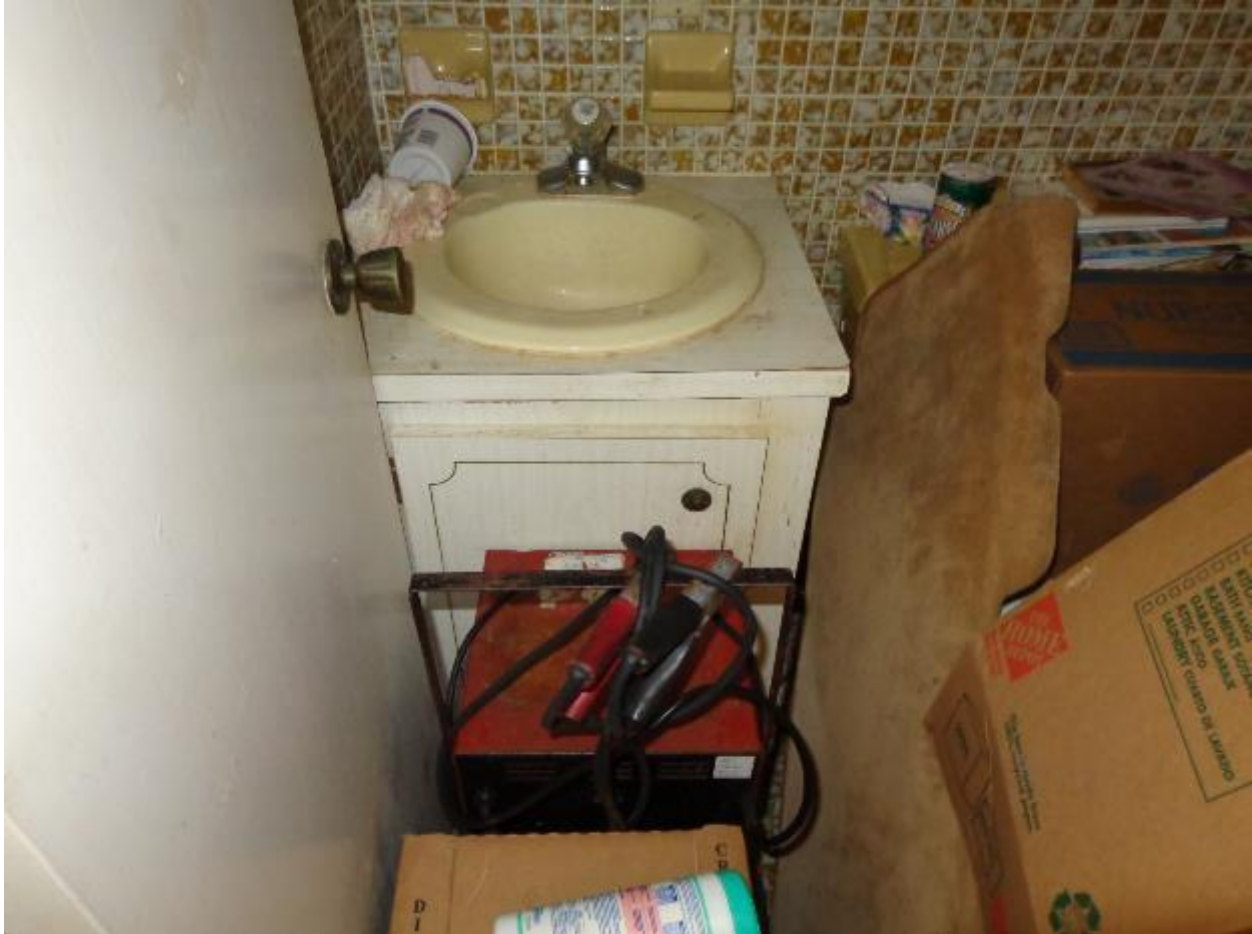
Allowances must be made for the complete upgrade of finishes in bathroom(s).

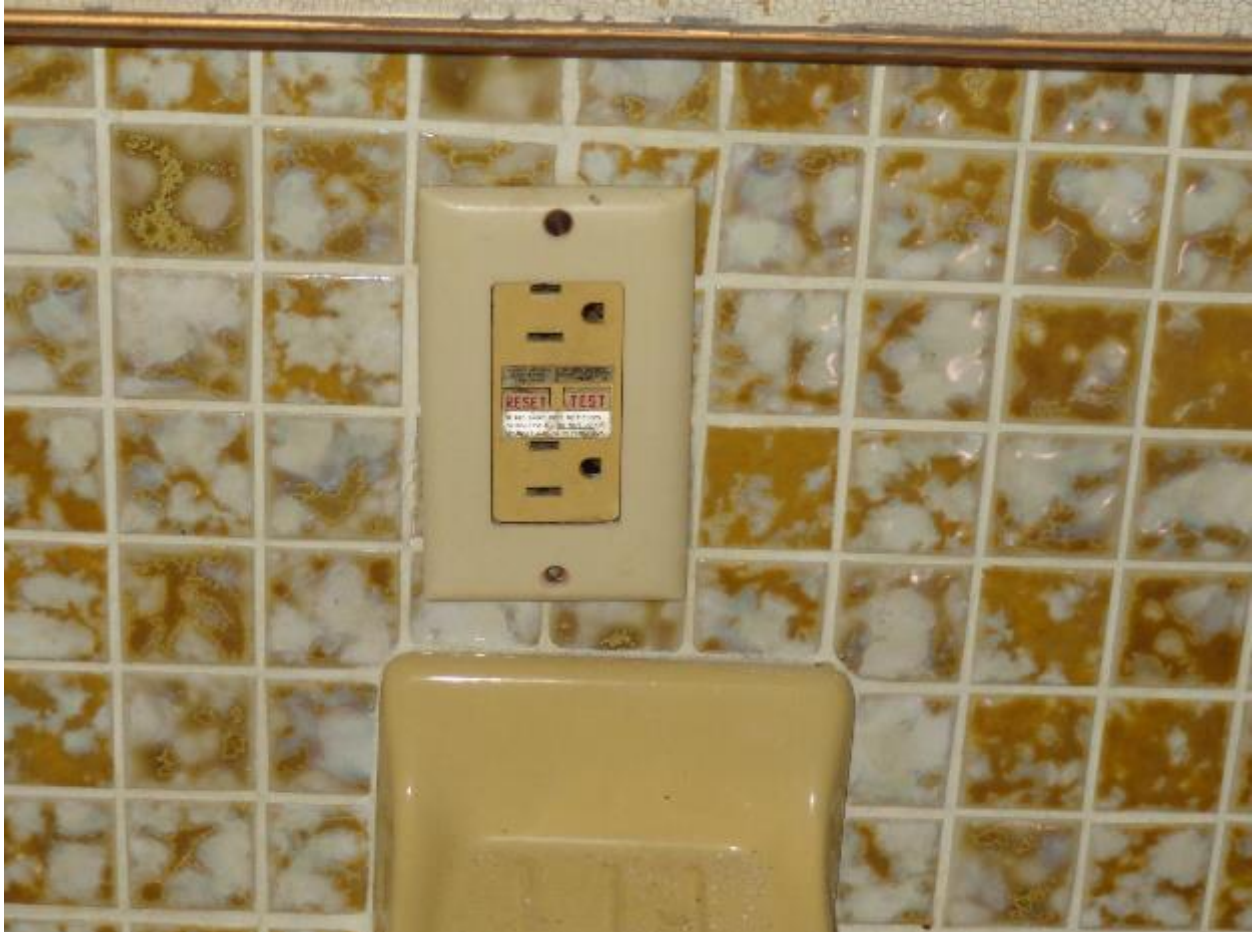
A complete upgrade of the electrical system is recommended including and not limited to GFCI's, smoke detectors, replace outlets and switches and make allowances for replacement of interior and exterior light fixtures. Beware that additional grounding will be required inside the property.

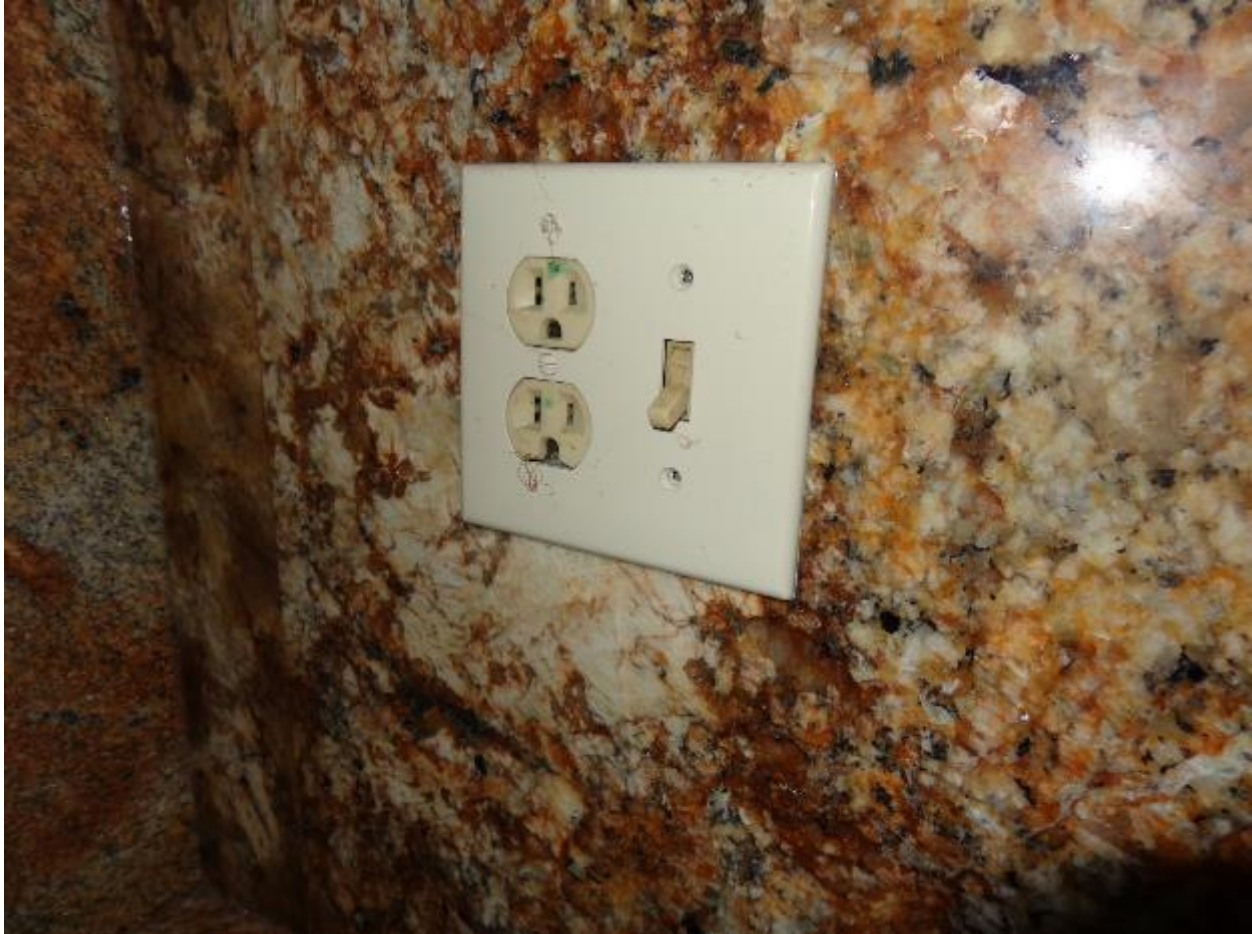
GFCI receptacles installation is required at wet areas such as bathrooms and kitchens.

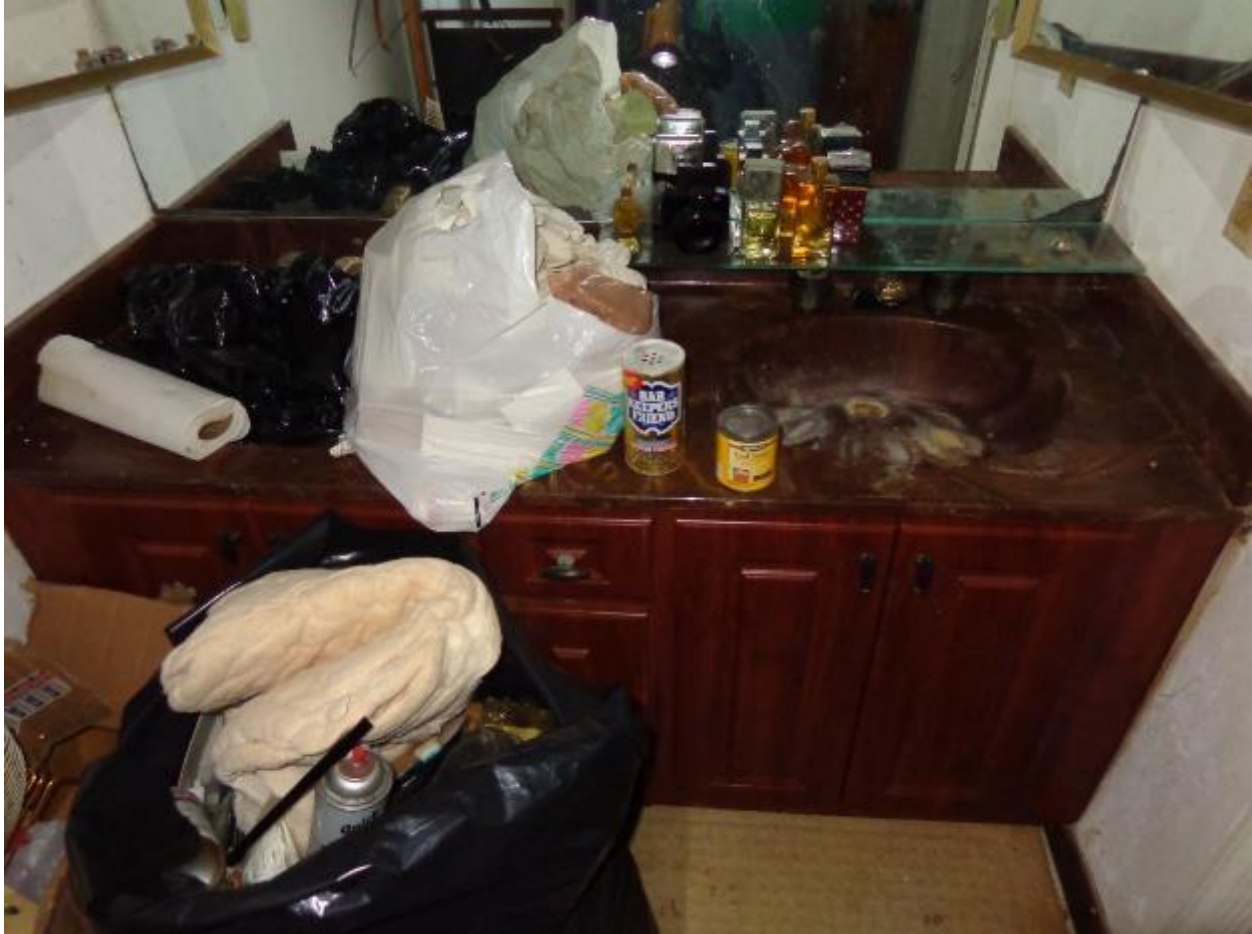
Allowances must be made for the complete upgrade of finishes in bathroom(s).

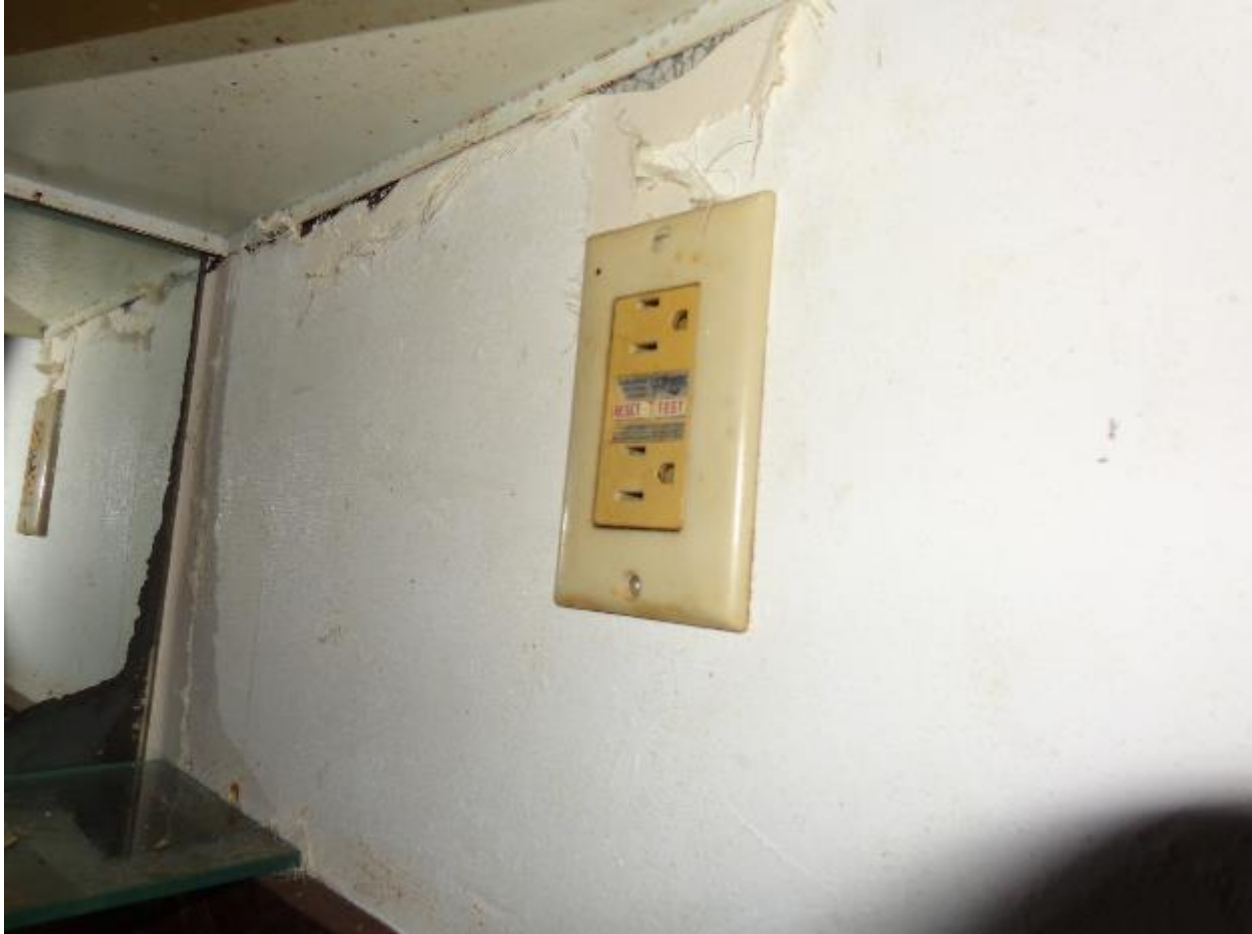
GFCI receptacles installation is required at wet areas such as bathrooms and kitchens.

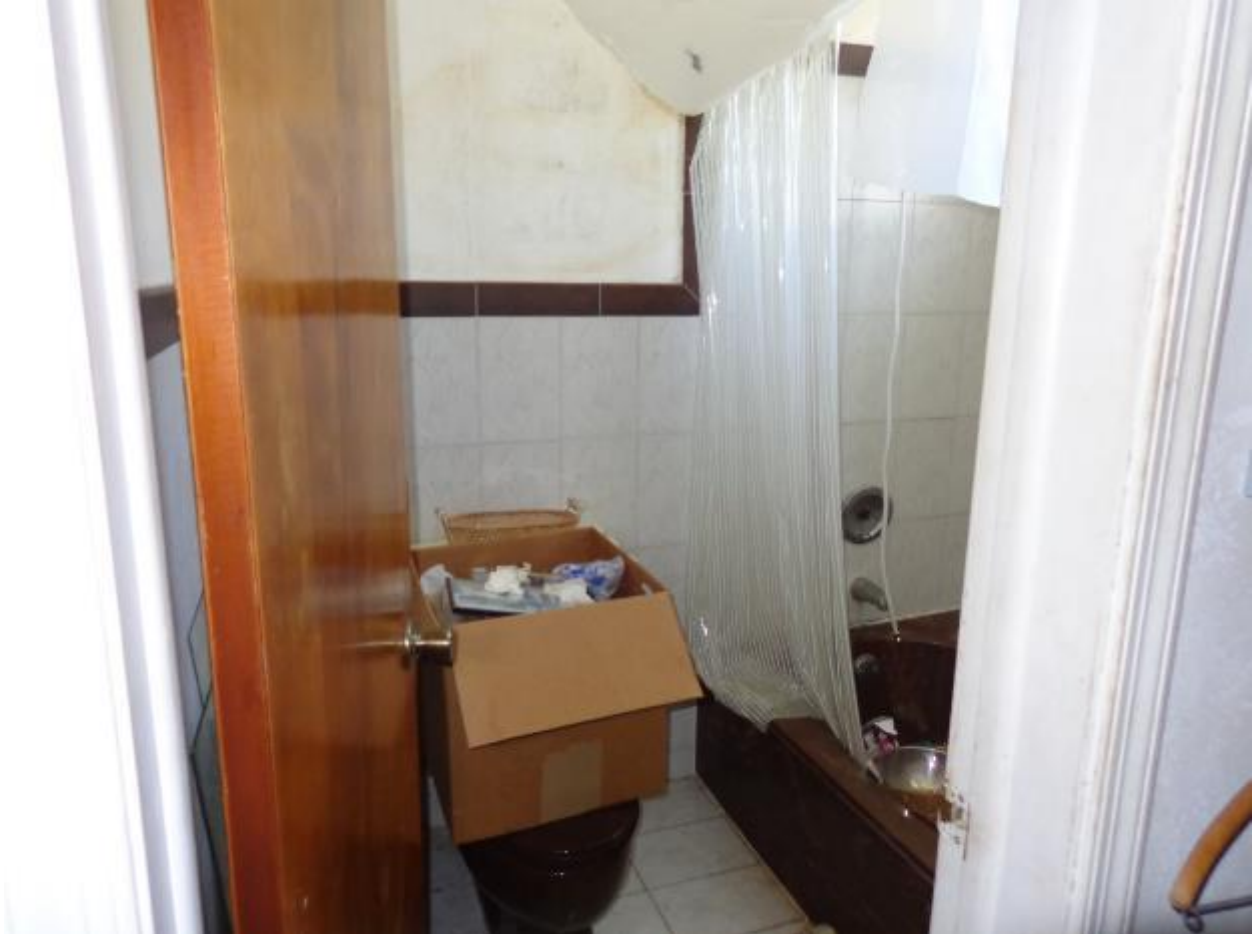
Allowances must be made for the complete upgrade of finishes in bathroom(s).

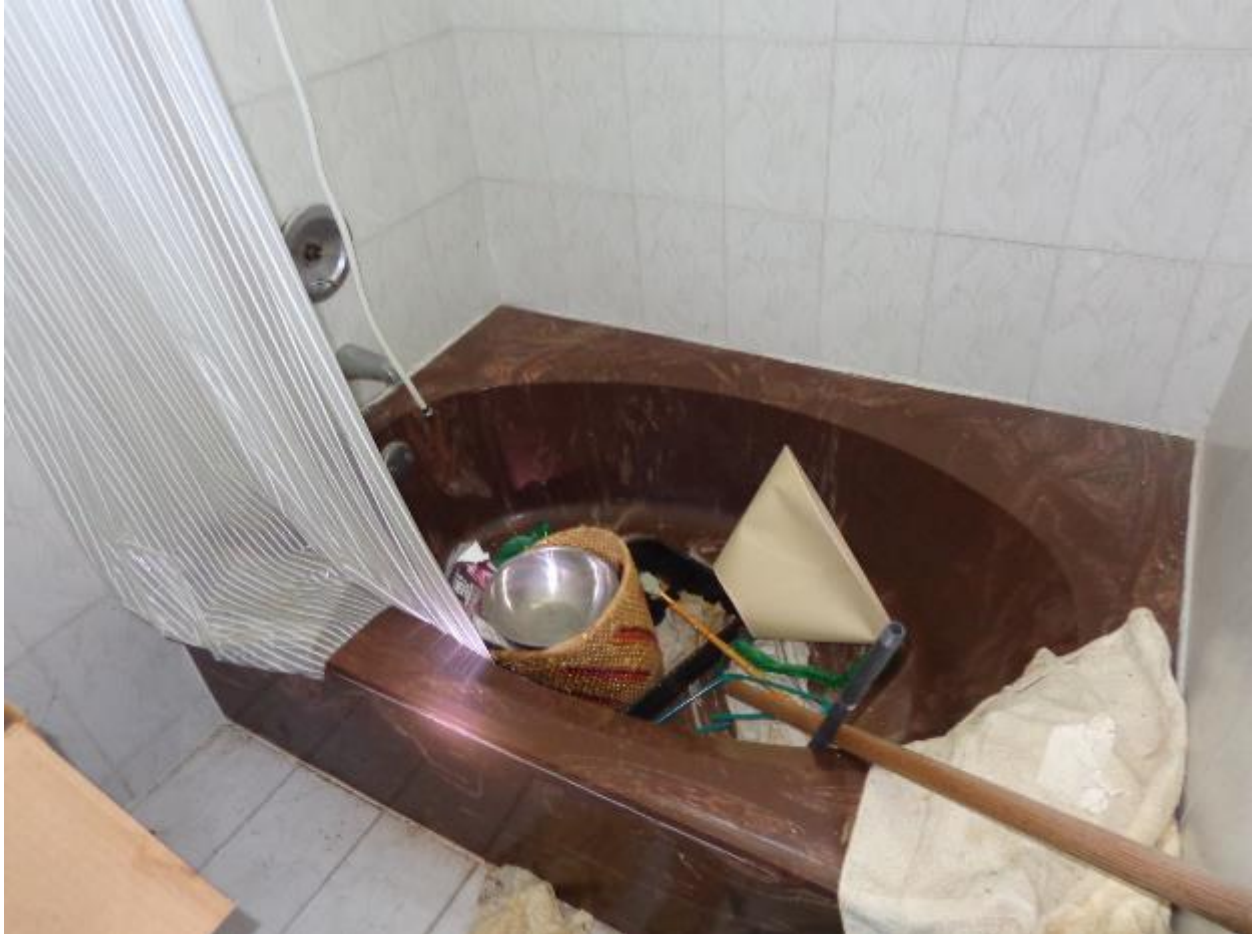
Allowances must be made for the complete upgrade of finishes in bathroom(s).

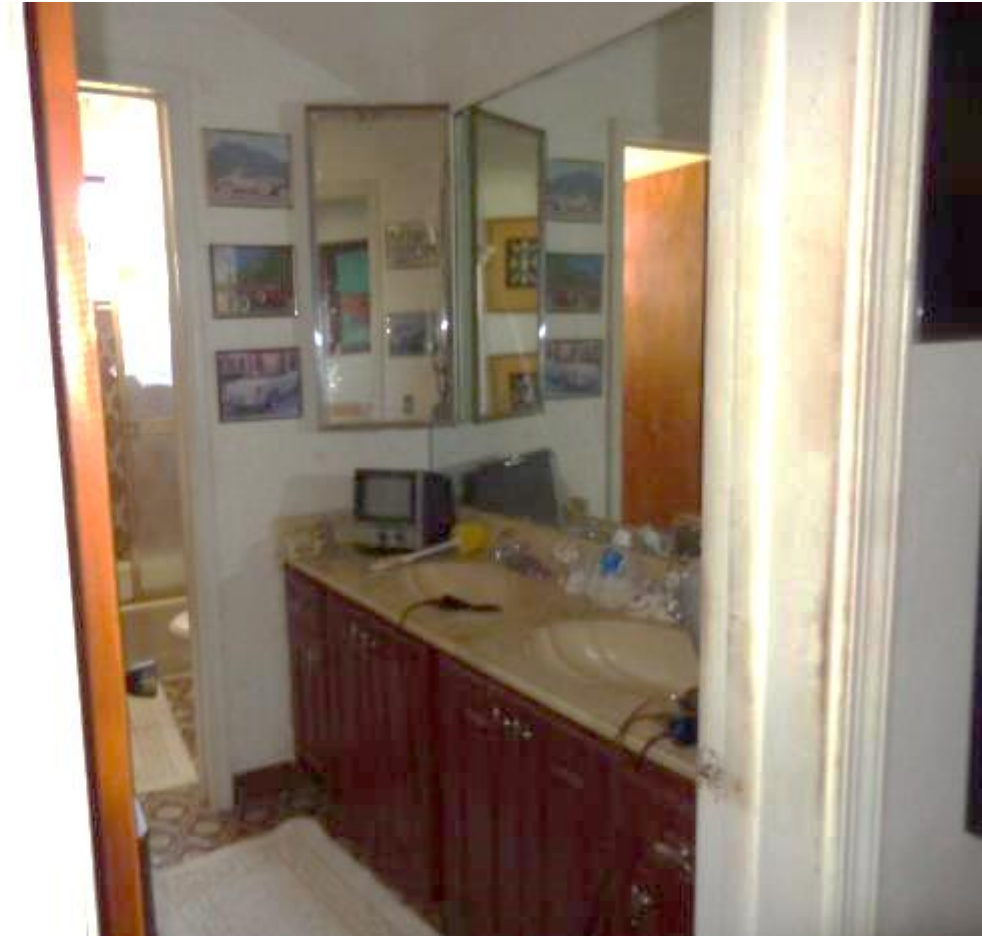
Allowances must be made for the complete upgrade of finishes in bathroom(s).

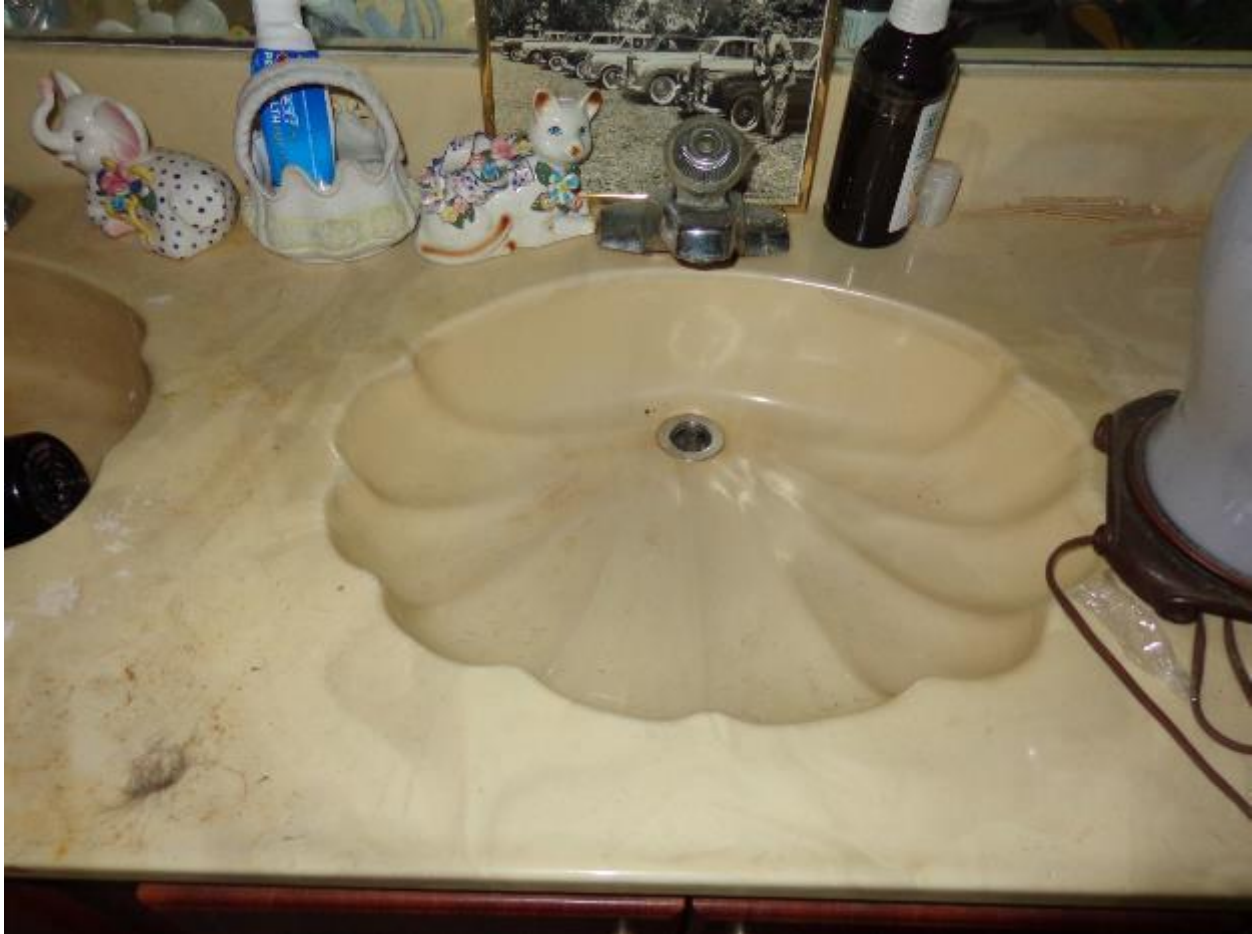
Allowances must be made for the complete upgrade of finishes in bathroom(s).

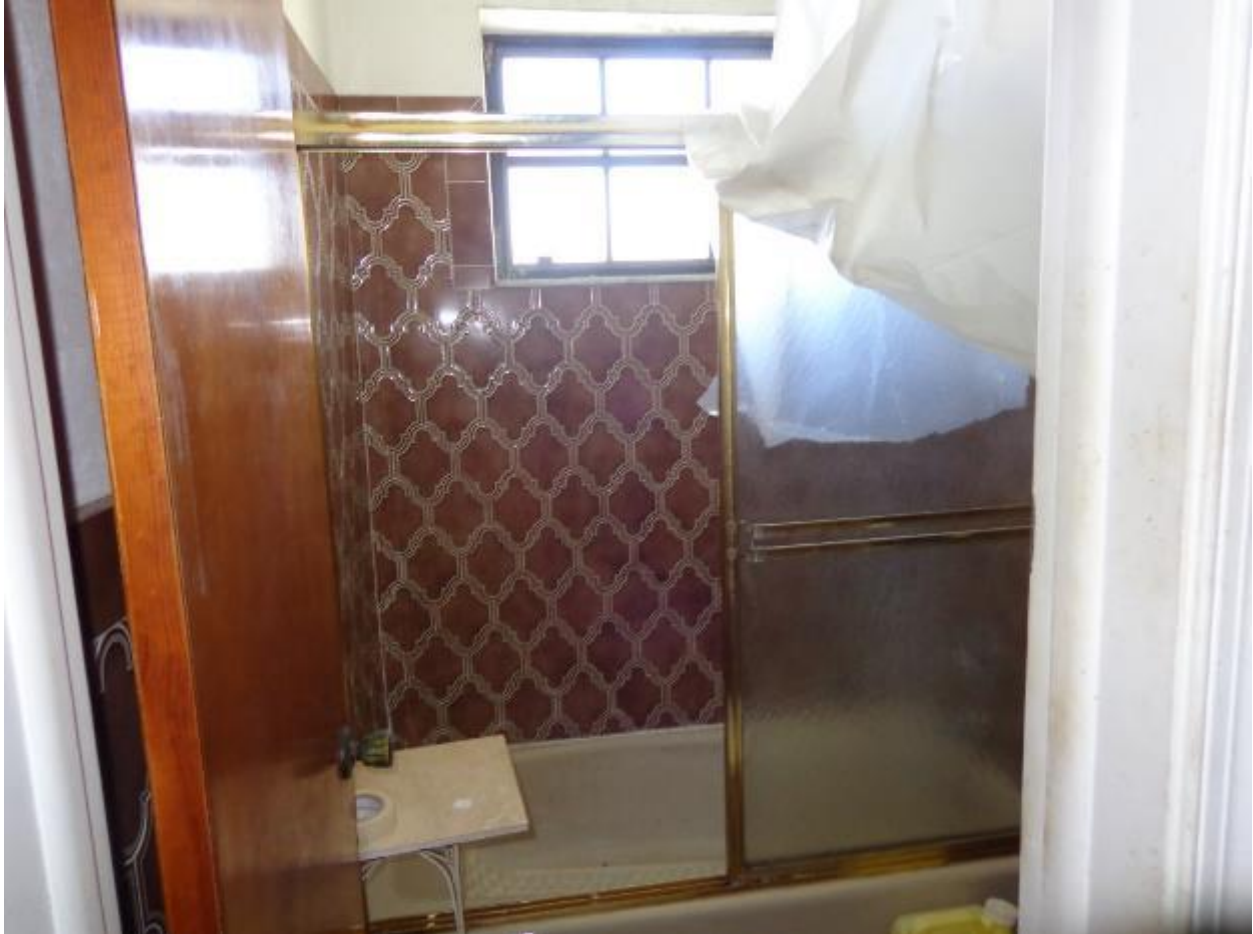
Allowances must be made for the complete upgrade of finishes in bathroom(s).
