PROPERTY INSPECTION OR ASSESSMENT OF DAMAGES

ADDRESS: Somewhere, FL
CLIENT: GAIA GC
ID No: 2015000
DATE: 12/31/2015

INSPECTION OR ASSESSMENT BY:

GAIA CONSTRUCTION INC.
CGC 1516136 **FLORIDA**
HI-2792 **FLORIDA**
8028867-B2 **INTERNATIONAL CODE COUNCIL**

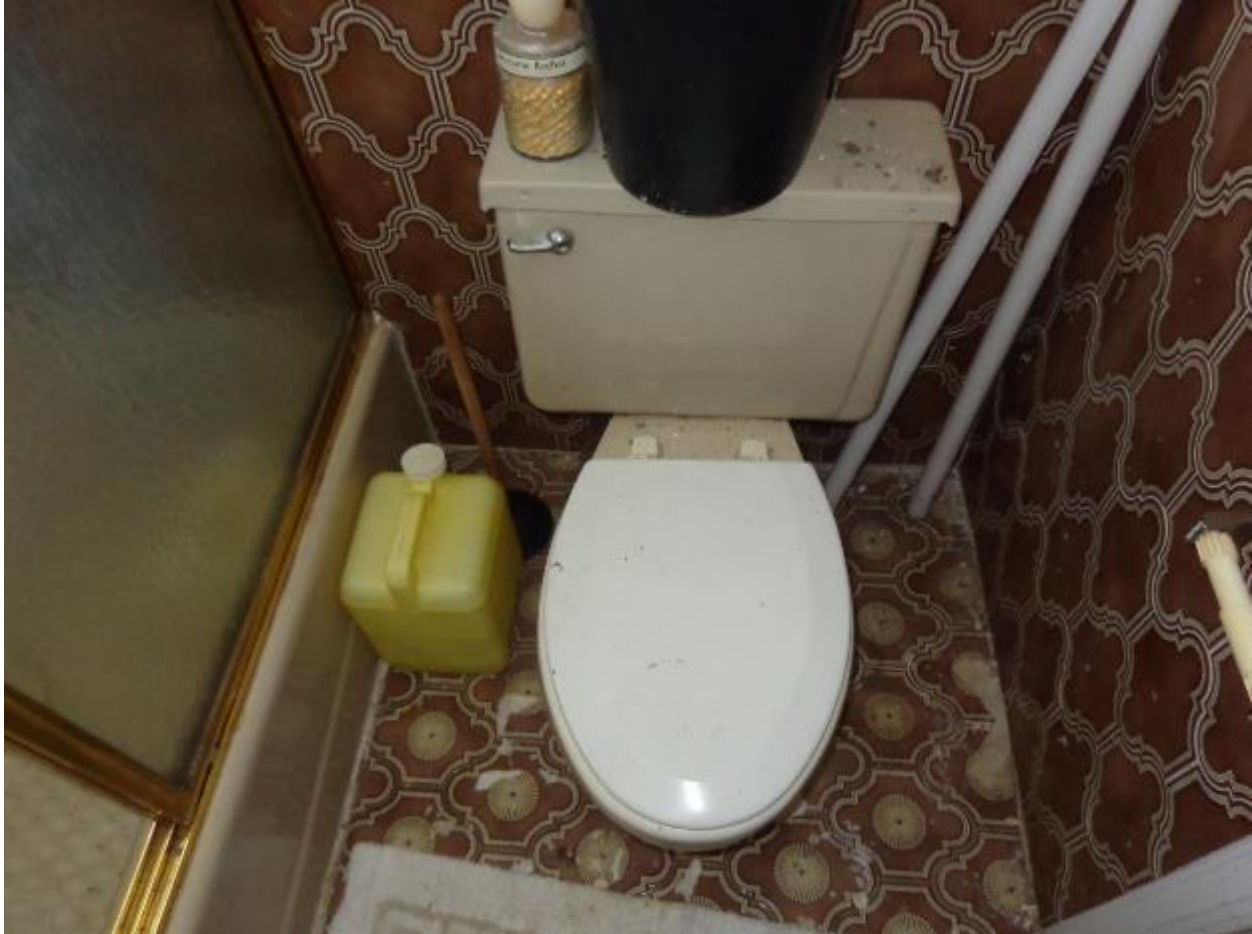
Allowances must be made for the complete upgrade of finishes in bathroom(s).

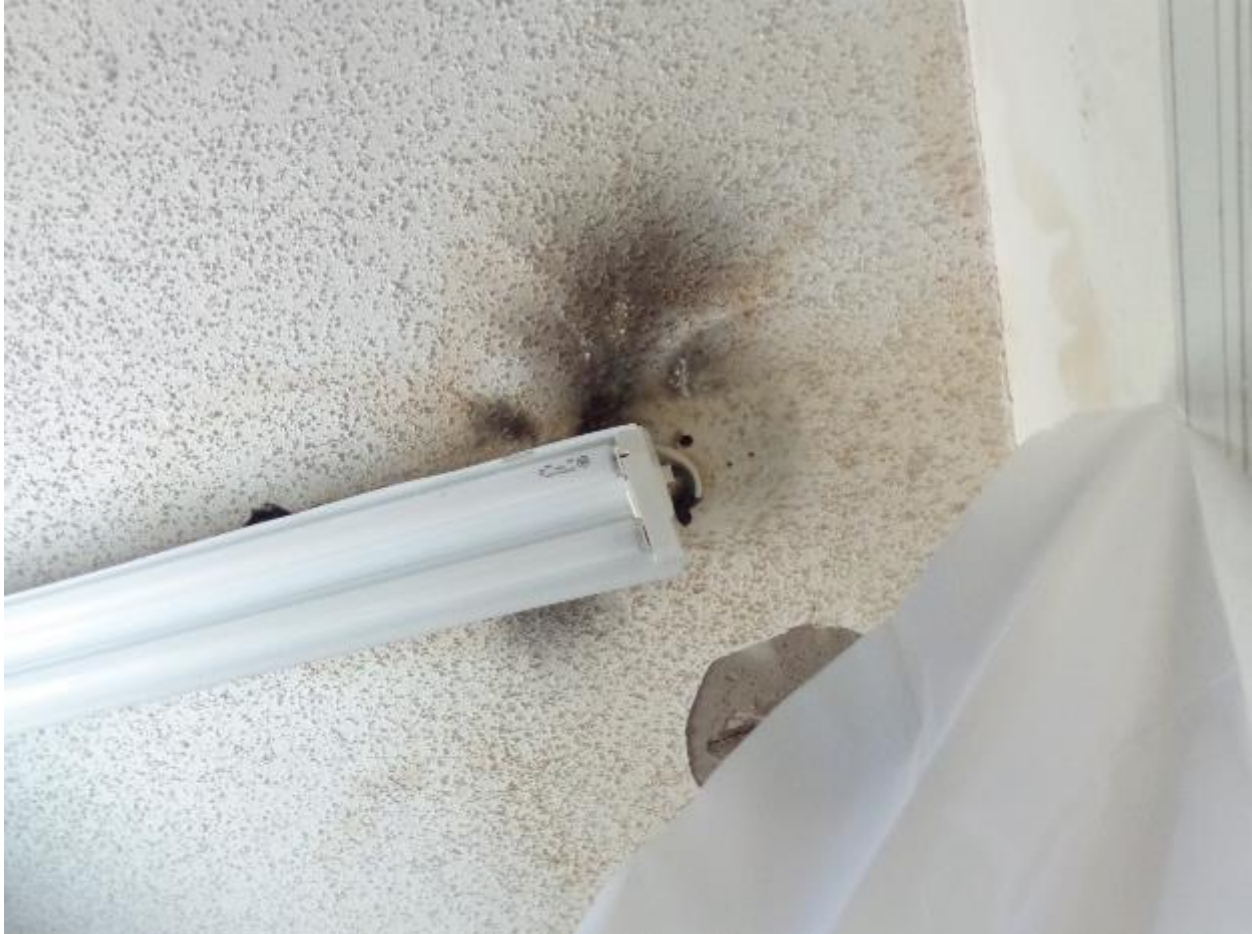
Signs of water infiltration due to roof failure noticed at the habitable space ceiling; allowances must be made for roofing and ceiling repair

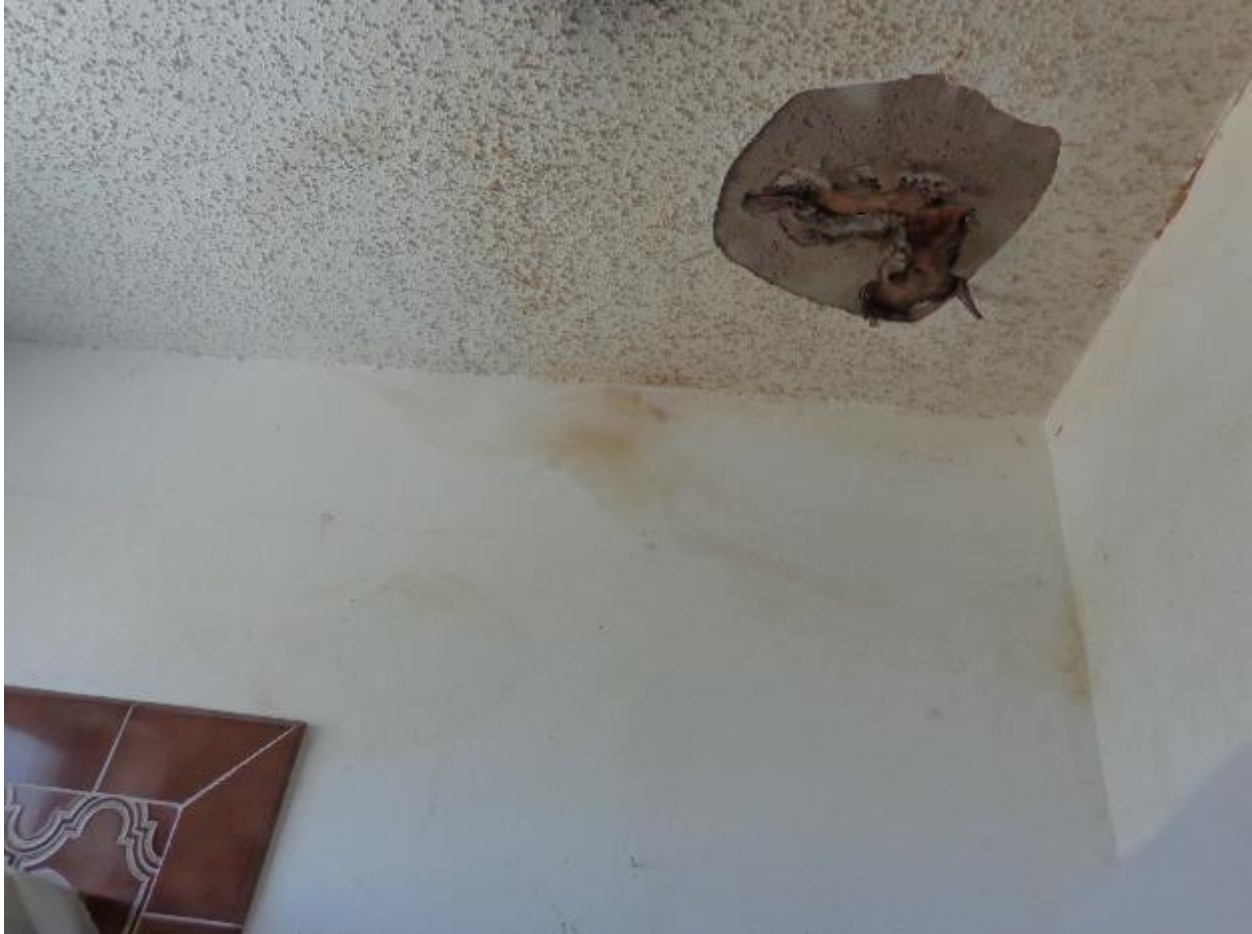
Signs of water infiltration due to roof failure noticed at the habitable space ceiling; allowances must be made for roofing and ceiling repair

Mold growth caused by water damage is visible. Do not attempt to remove damaged surfaces related to Mold growth or with signs of mold growth on your own. Hire only licensed and Insured Mold remediation services.

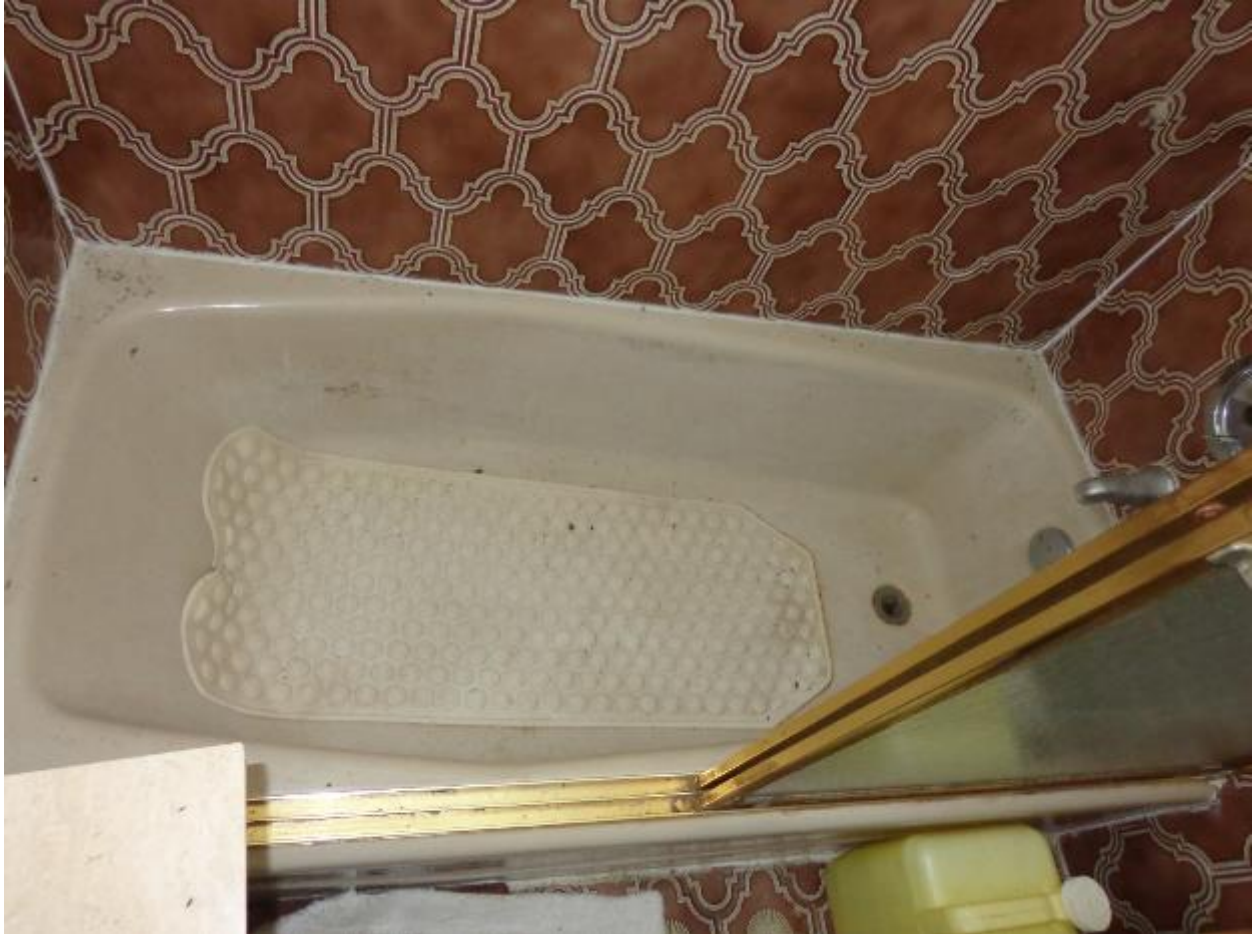
Allowances must be made for the complete upgrade of finishes in bathroom(s).

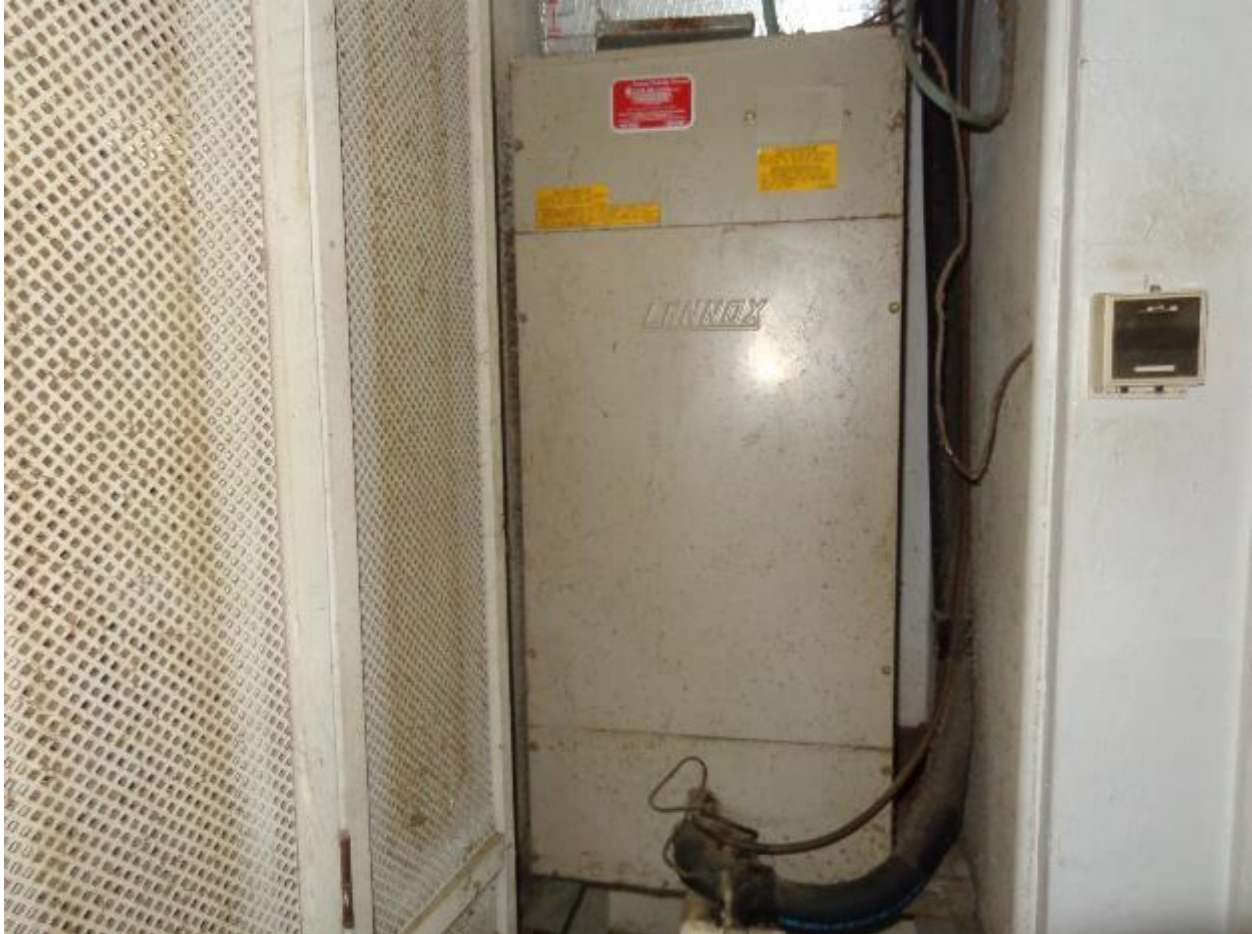
HVAC did not operate during the inspection, allowances must be made for repair or replacement

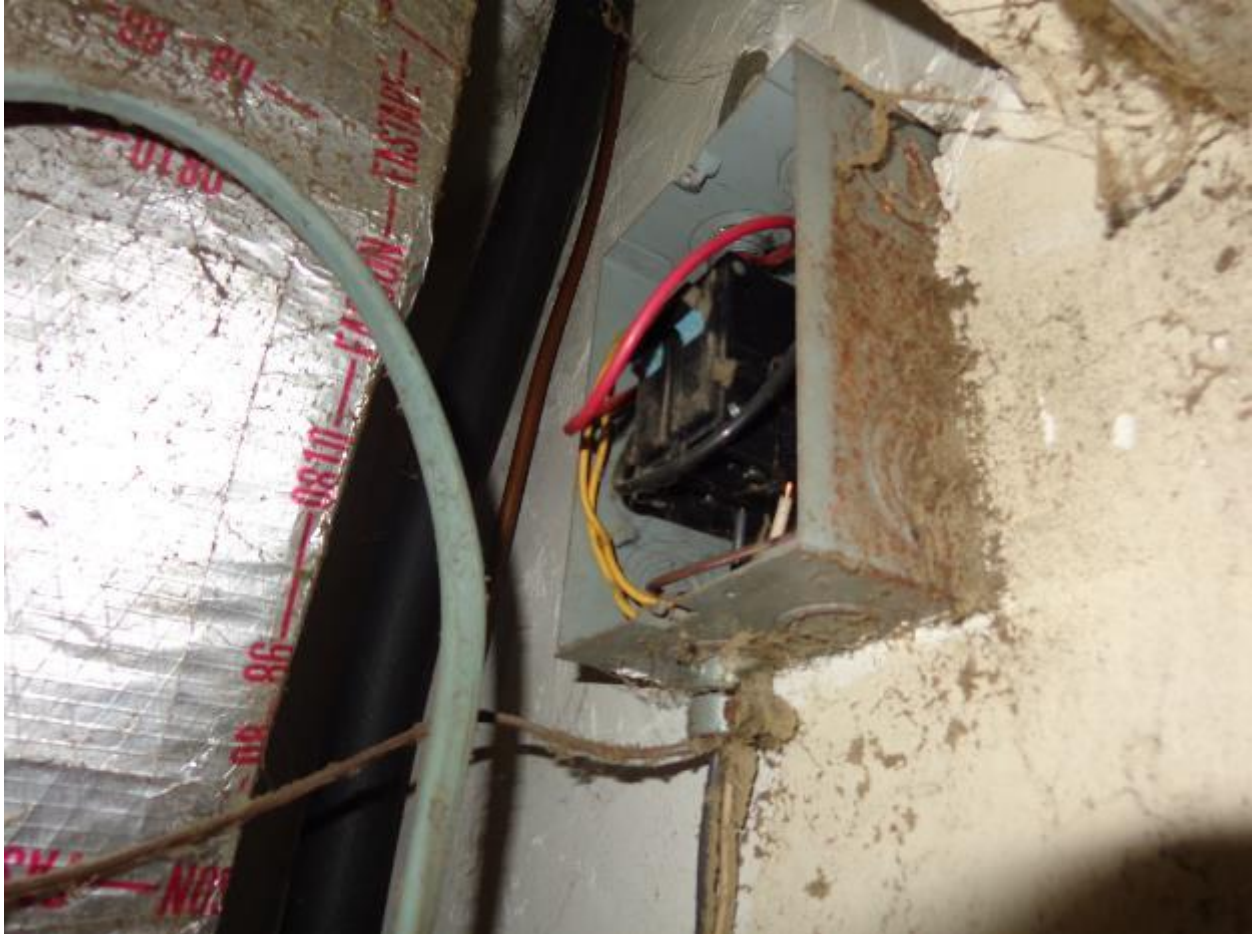
A complete upgrade of the electrical system is recommended including and not limited to GFCI's, smoke detectors, replace outlets and switches and make allowances for replacement of interior and exterior light fixtures. Beware that additional grounding will be required inside the property.

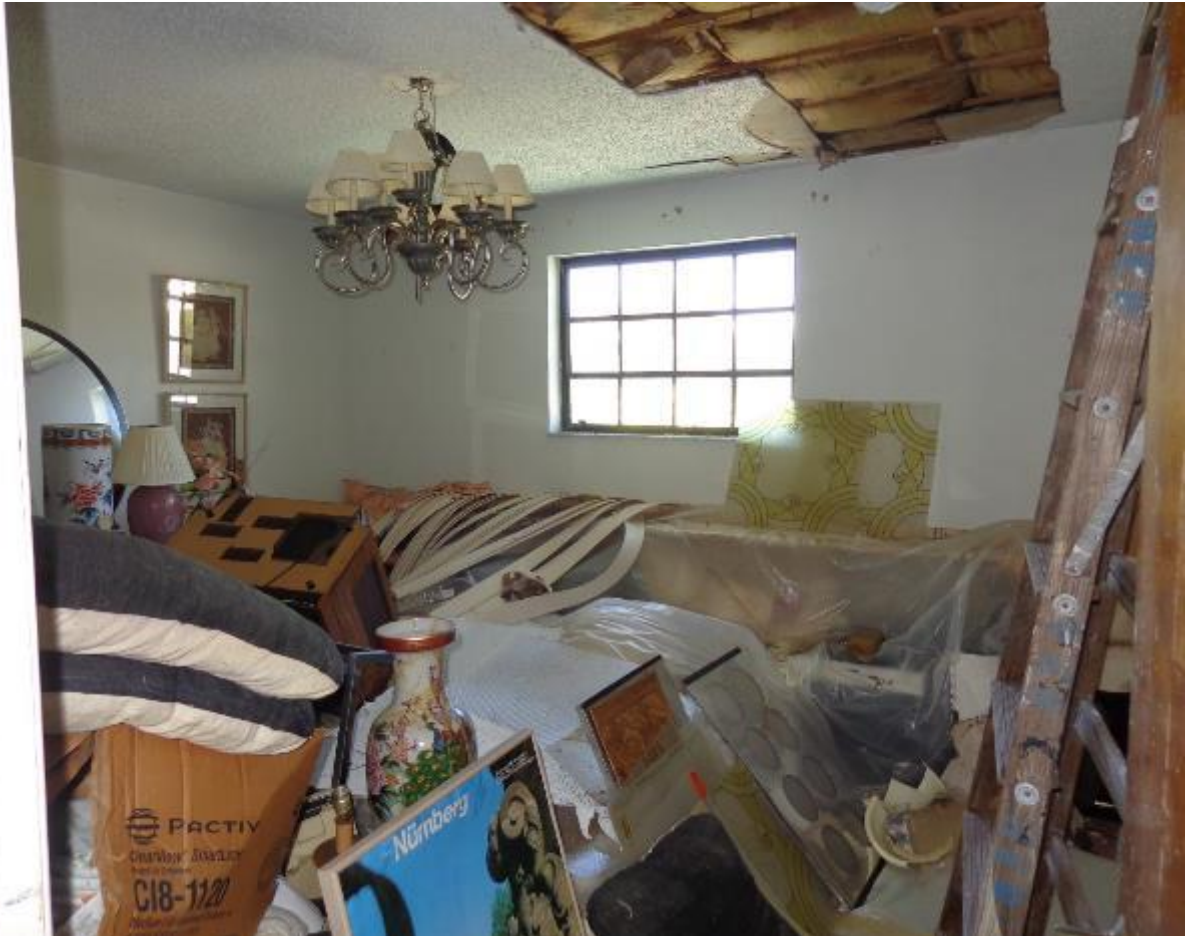
A complete rehabilitation of the interior must be done in order to provide move in conditions. Plumbing, electrical and Ac systems require replacement or repairs. Wood destroying organism active in the property. Drywall repairs required.

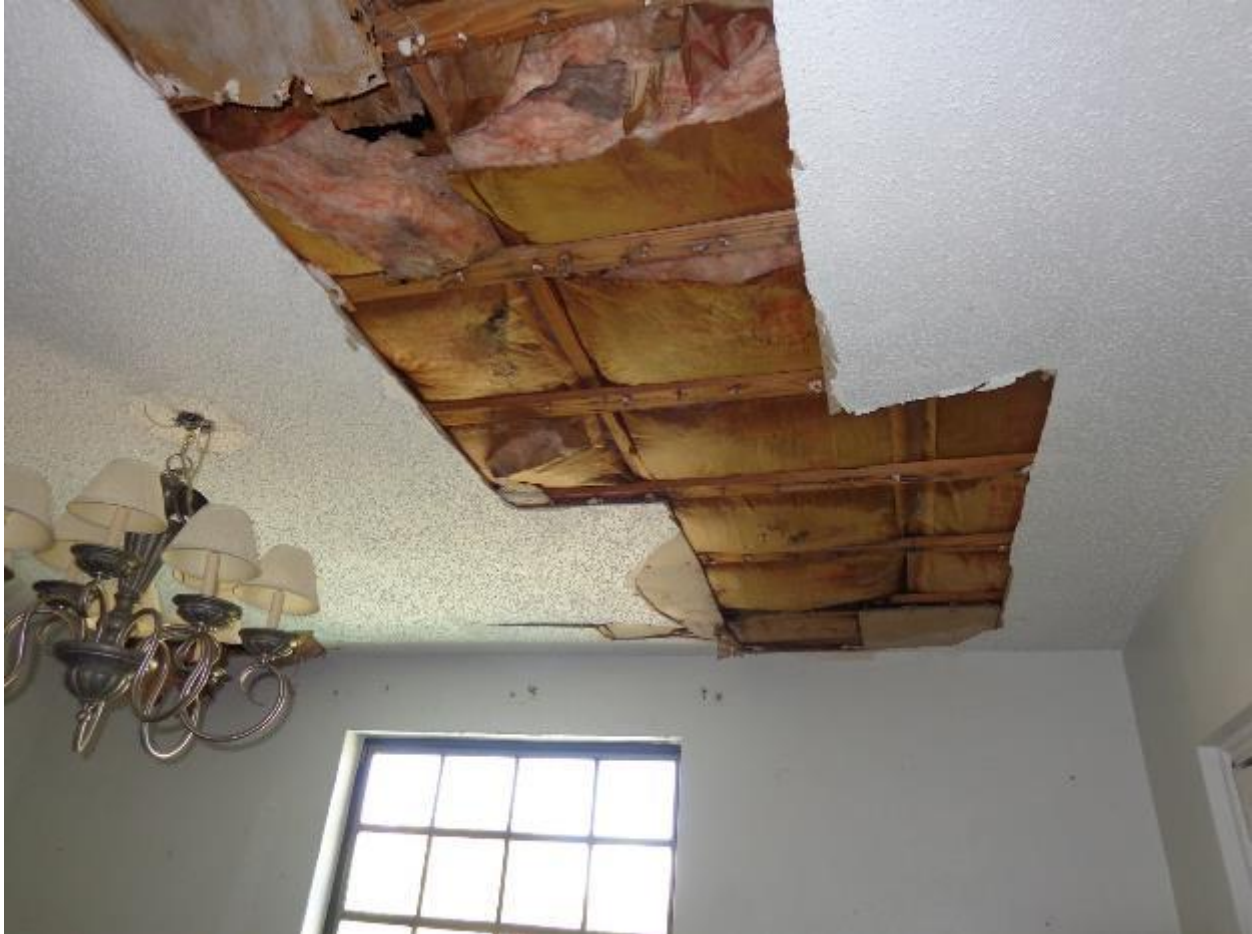
Signs of water infiltration due to roof failure noticed at the habitable space ceiling; allowances must be made for roofing and ceiling repair

Drywall repairs required.

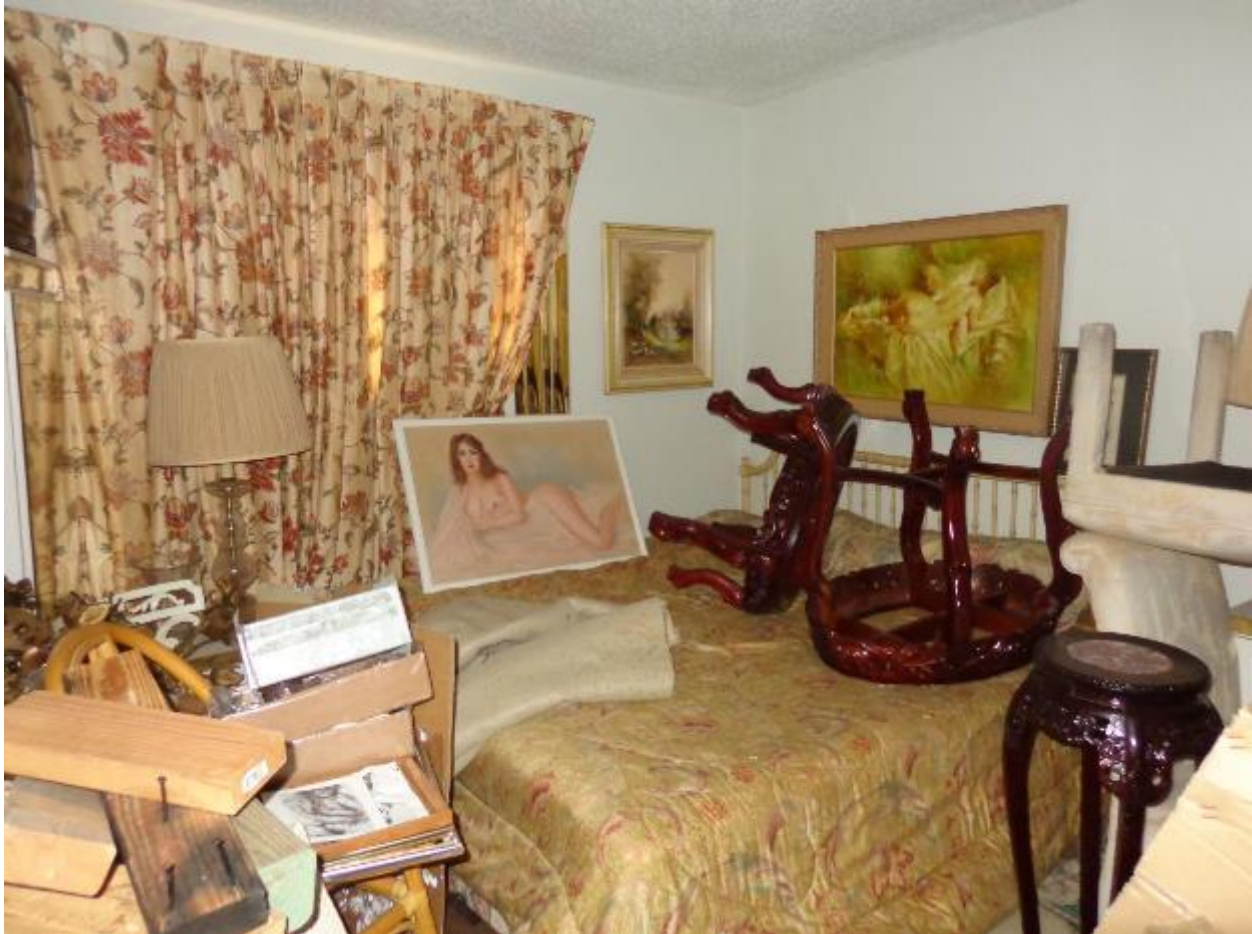
A complete rehabilitation of the interior must be done in order to provide move in conditions. Plumbing, electrical and Ac systems require replacement or repairs. Wood destroying organism active in the property.

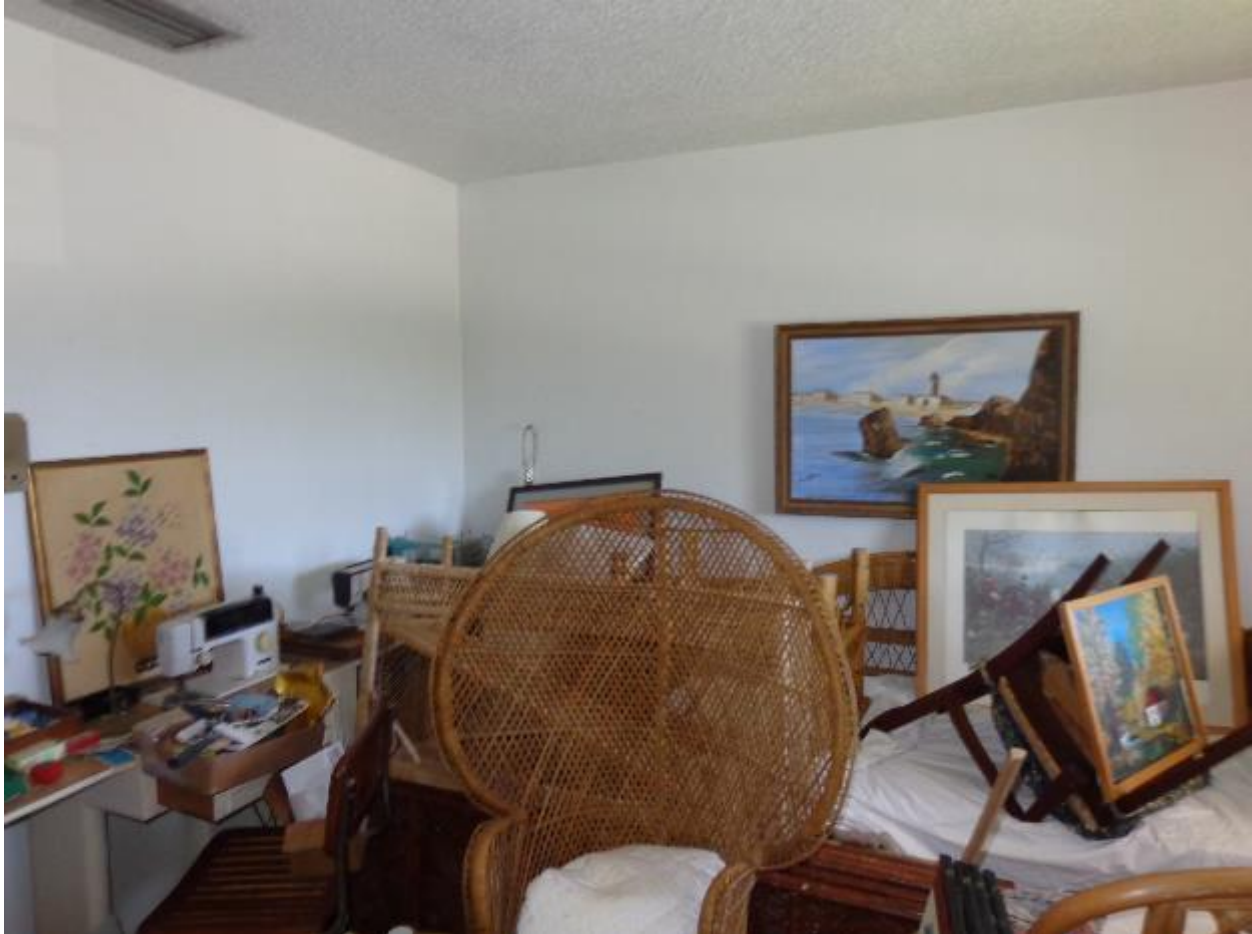
A complete rehabilitation of the interior must be done in order to provide move in conditions. Plumbing, electrical and Ac systems require replacement or repairs. Wood destroying organism active in the property.
